NOAA Technical Memorandum NOS OR&R 2

## **PAVEMENT IN PATAGONIA, ASPHALT IN ALASKA:**

### **Case Studies in Oil Spill Pavement Formation, Fate, and Effects**

April 1999

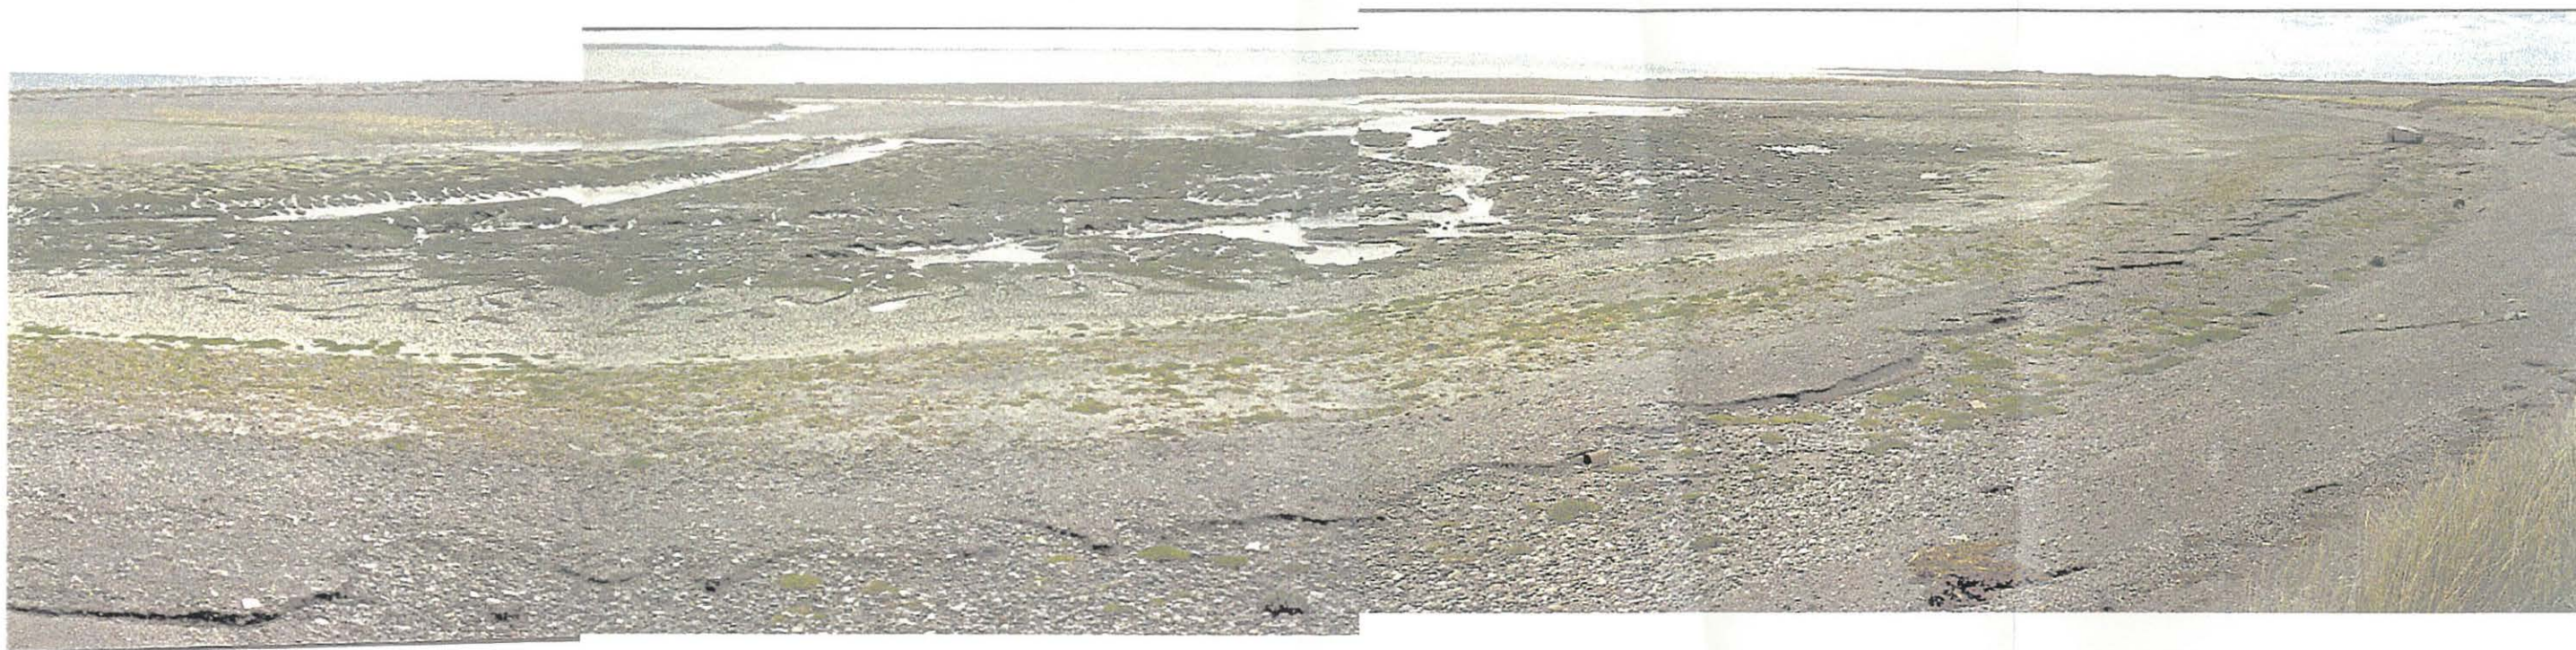
Plate iii. Panoramic view of Punta Espora backbeach showing extent of asphalt pavement from the *Metula* spill. Digital composite of photographs by G. Shigenaka.

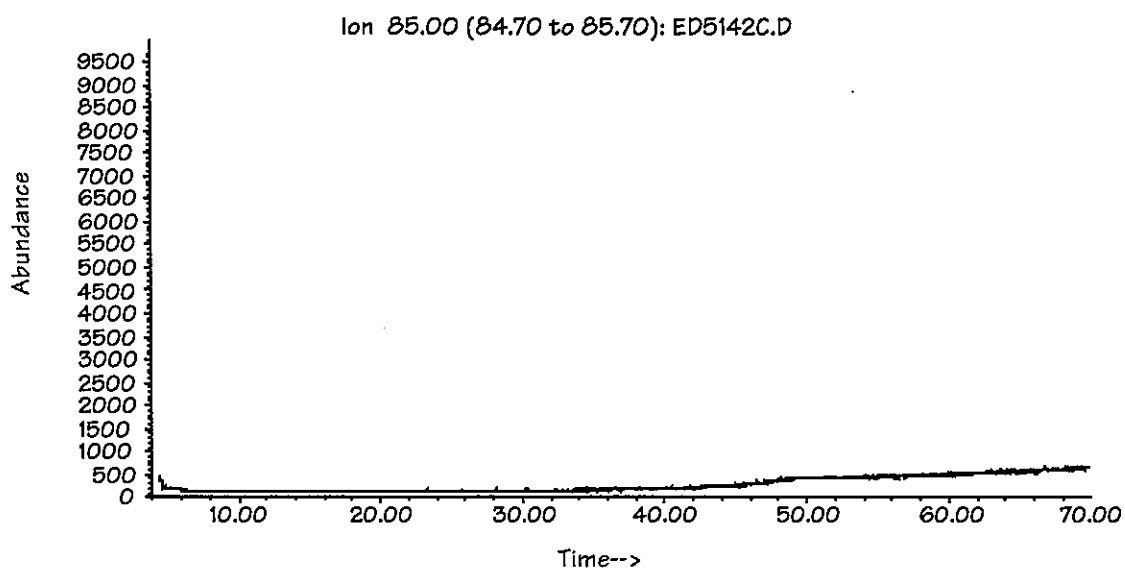
Figure 4 compares the alkane chromatographic profiles ( $m/z$  85) of an Arabian Light crude oil and the *Metula* hexane extract. The *Metula* samples reflected extensive alteration by physical and biological processes of degradation: The GC trace of the heavily weathered pavement exhibited little or no alkane profile remaining and only trace levels of aromatic hydrocarbons.

Figure 4. Comparison of the alkane chromatographic profile (m/e 85) for unweathered Arabian Light crude oil (top) and a pavement sample collected at the Metula Punta Espora spill site (bottom).

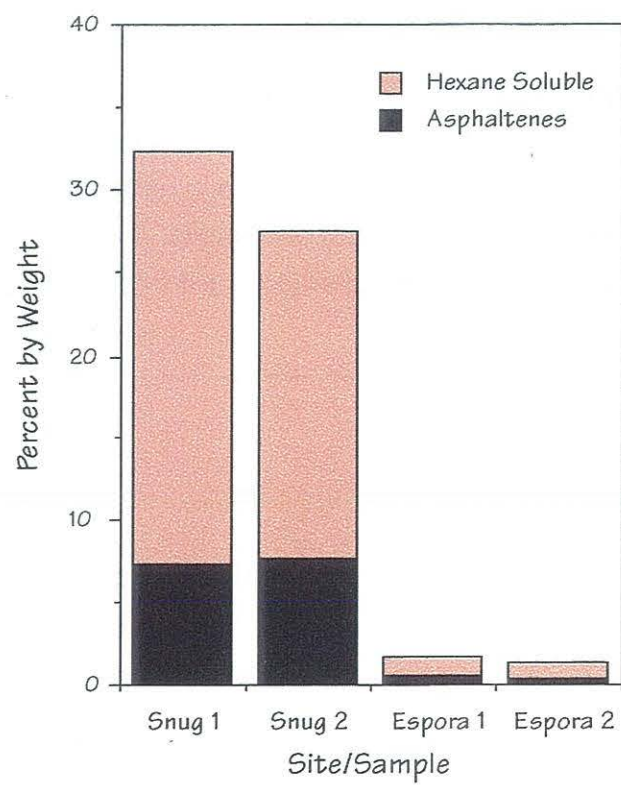
Figure 5 compares the relative concentration of asphaltenes with total extractable petroleum hydrocarbons. The two pavements from the *Metula* site (Espora 1 and Espora 2) are significantly lower in percent oil than the samples collected at the *Exxon Valdez* site (Snug 1 and Snug 2). The average concentration of extractable petroleum hydrocarbons in the *Metula* pavements was only 1.6%, compared with a mean of 31% at the *Exxon Valdez* site. The percent asphaltenes follow a similar trend 0.36% compared with 7.3%. The *Exxon Valdez* pavement contained 20 times the oil extracted from the *Metula* pavement samples.

Figure 5. Relative concentration of percent asphaltene to total extractable petroleum hydrocarbons in pavement samples from Snug Harbor and Punta Espora.

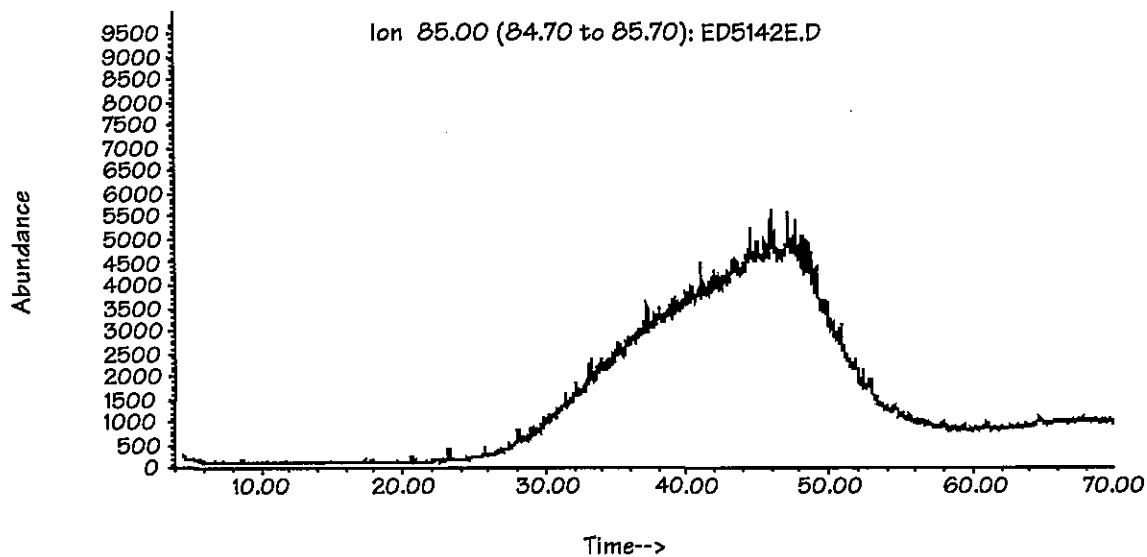
Figure 8. Comparison of the alkane chromatographic profile (m/e 85) of a Punta Espora pavement sample (top) and a pavement sample collected at the Snug Harbor site (bottom). The y-axes on both are expanded to highlight what little alkane signature is present.

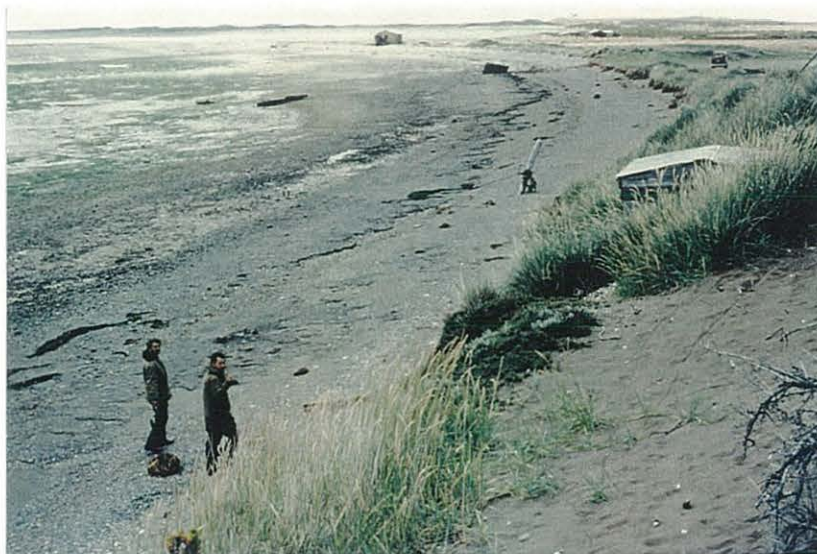
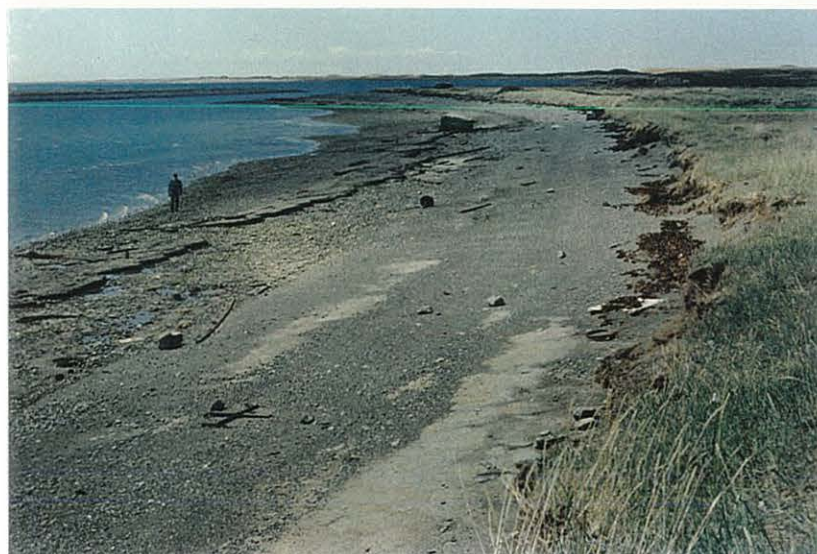
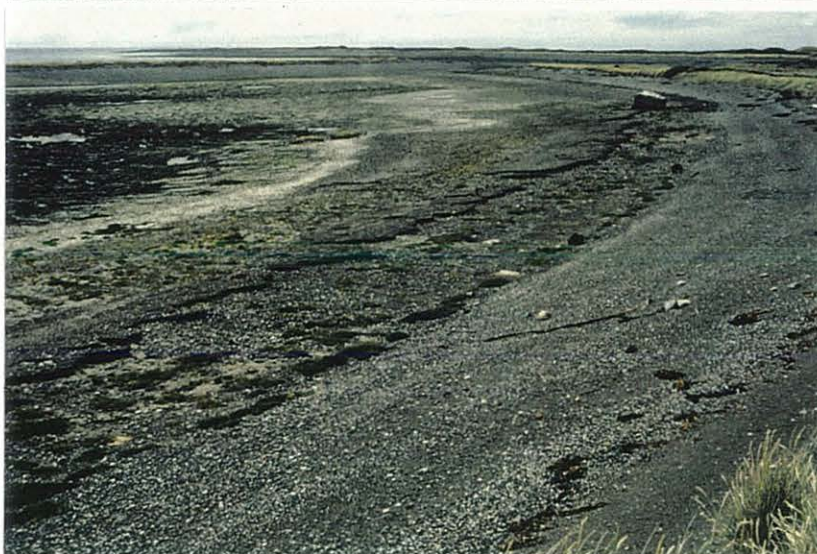
Plates 1-3. Punta Espora backbeach site in 1977 (Plate 1), 1987 (Plate 2), and 1995 (Plate 3). Photos by E. Owens (1&2) and G. Shigenaka (3).

There has been surprisingly little change in the character or extent of the asphalt pavement on the Espora backbeach between 1977 and 1995. Three years after the spill, Hann (1977) described the area as "...paved like an airport ramp with oil 2 to 10 inches deep in the sediment." He estimated that between 1974 and 1977, about 10% of the pavement had eroded. At that time (1977), Hann predicted that the asphalt pavement would remain for 7 to 10 years. However, in the 10-year period (1977-87) following this prediction, Owens and Robson (1987) noted that only 1 to 2 m had eroded along the landward margin of the pavement. Comparison of Plates 12 and 13 indicates that erosion between 1987 and 1995 has been equally as slow, with probably less than a 1- to 2-m reduction in band width.

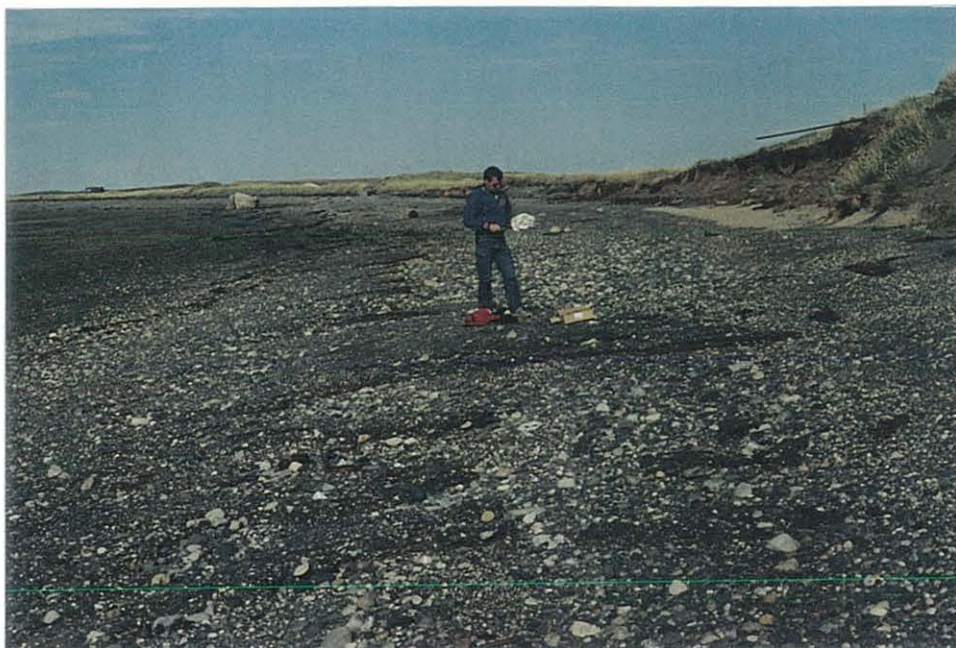
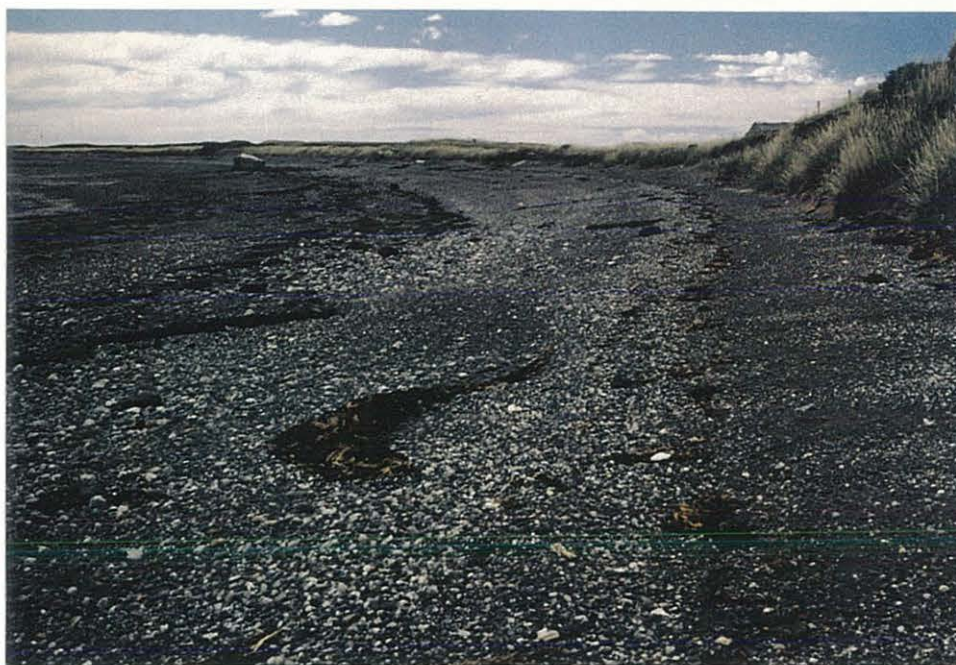
Plates 4-5 Punta Espora backbeach site in 1987 (Plate 4) and 1995 (Plate 5). Photos by E. Owens (4) and G. Shigenaka (5).

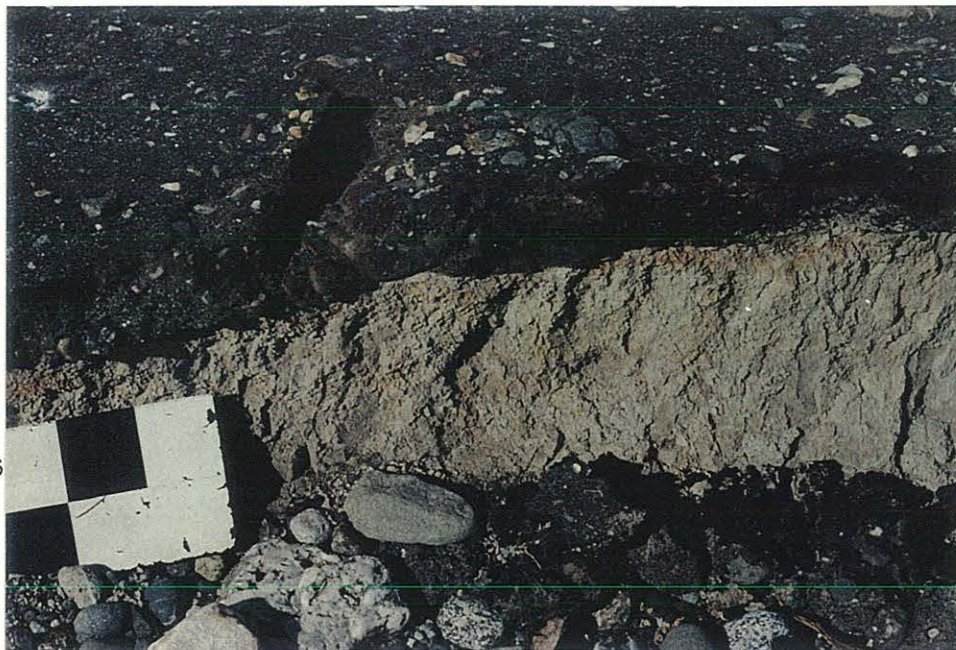
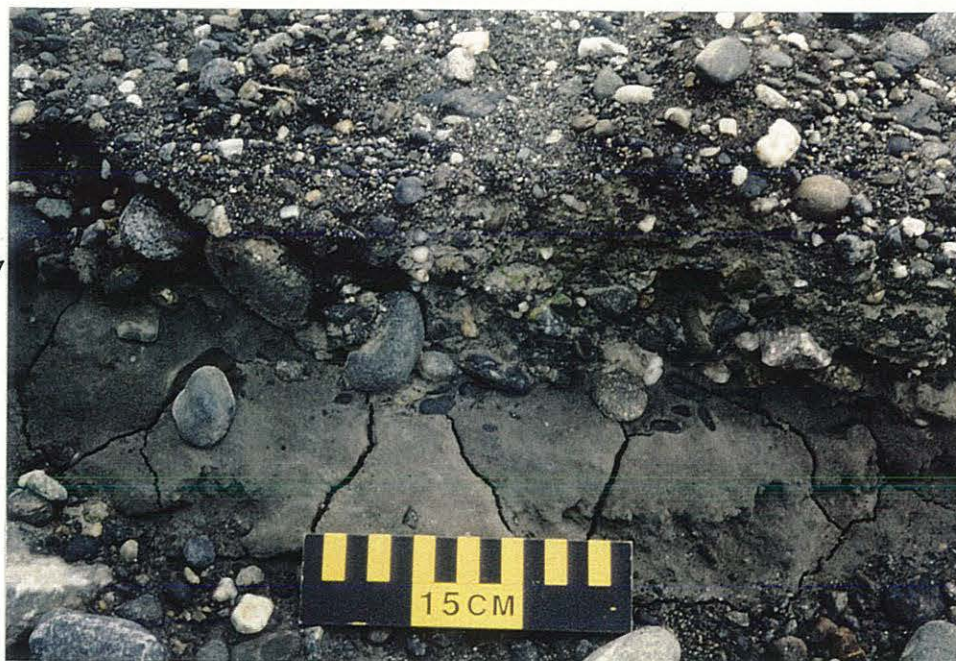
Plates 6-7. Closeup of leading edge of Punta Espora pavement in 1987 (Plate 6) and 1995 (Plate 7). Photos by E. Owens (6) and G. Shigenaka (7).

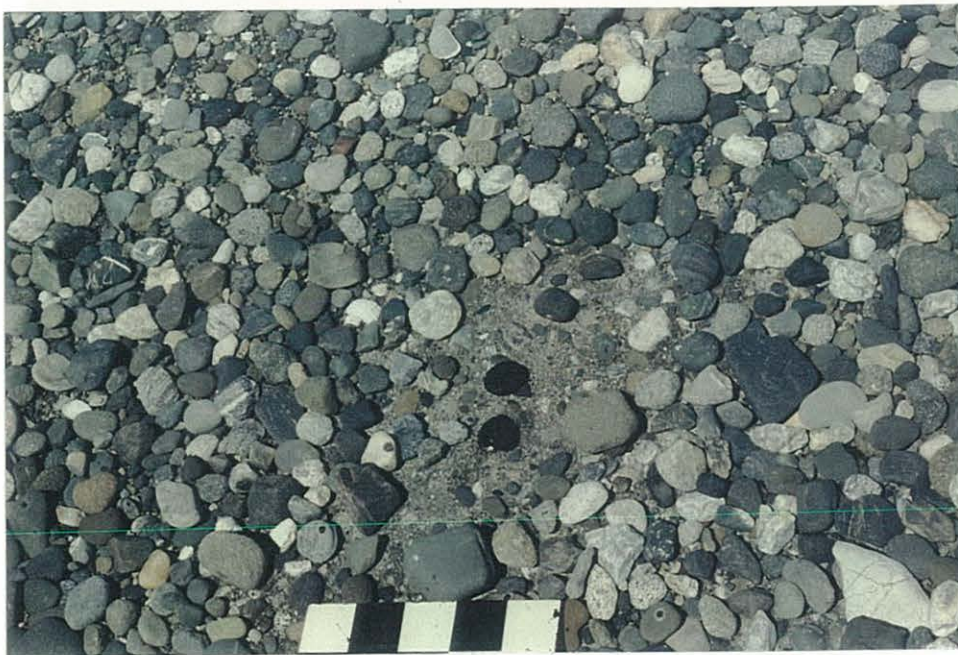
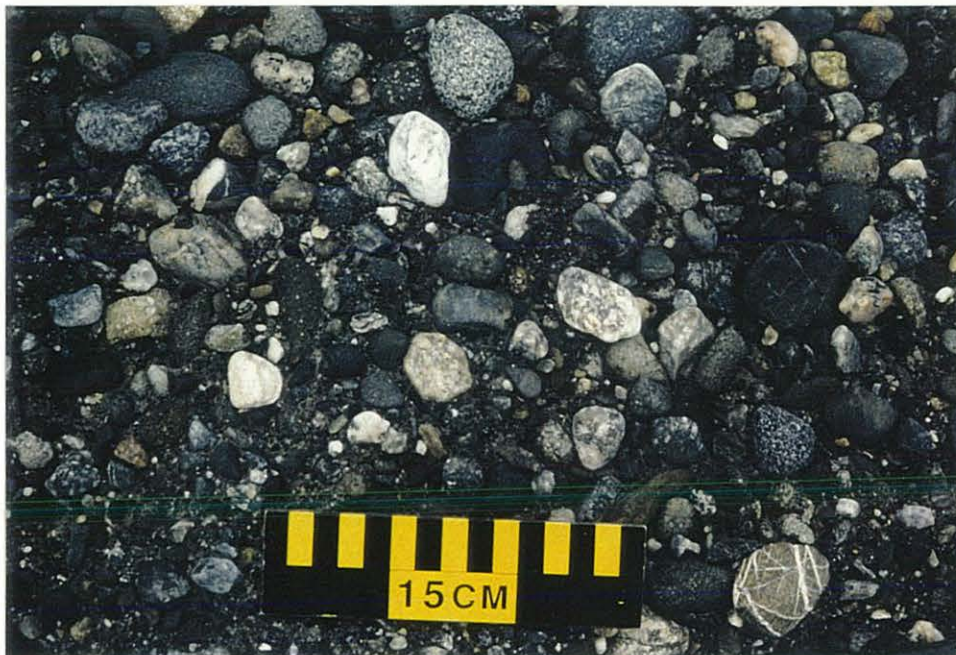
Plates 8-9. View of Punta Espora pavement surface in 1987 (Plate 8) and 1995 (Plate 9). Photos by E. Owens (8) and G. Shigenaka (9).

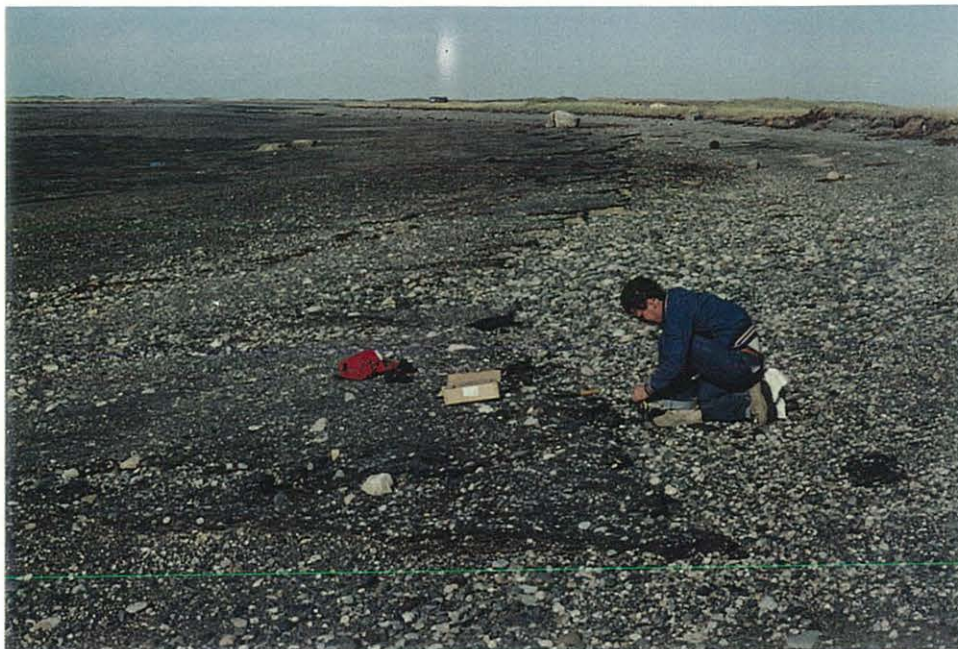
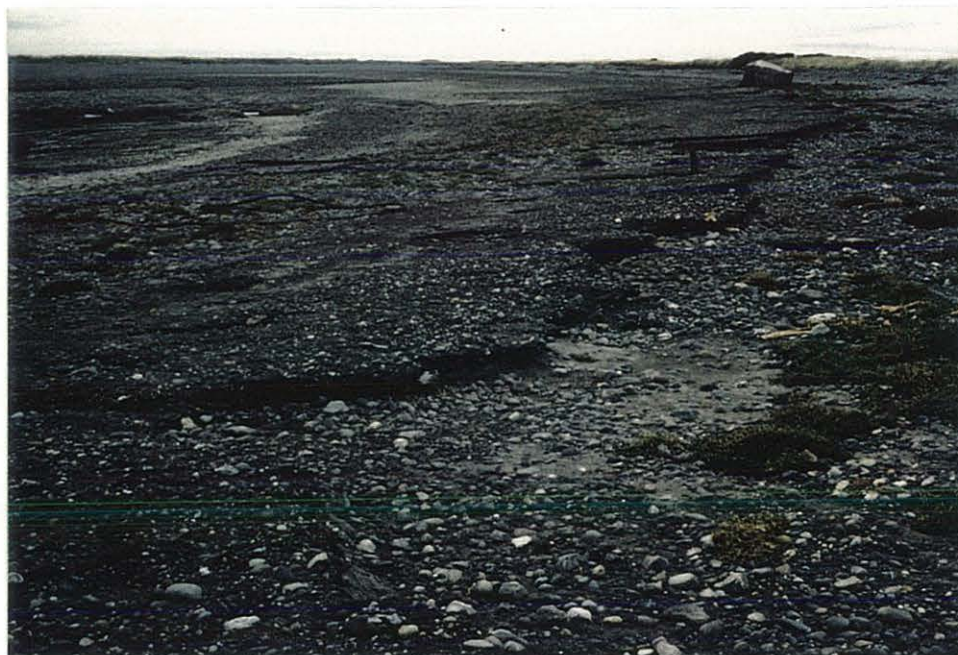
Plates 10-11. Punta Espora backbeach site in 1987 (Plate 10) and 1995 (Plate 11). Photos by E. Owens (10) and G. Shigenaka (11).

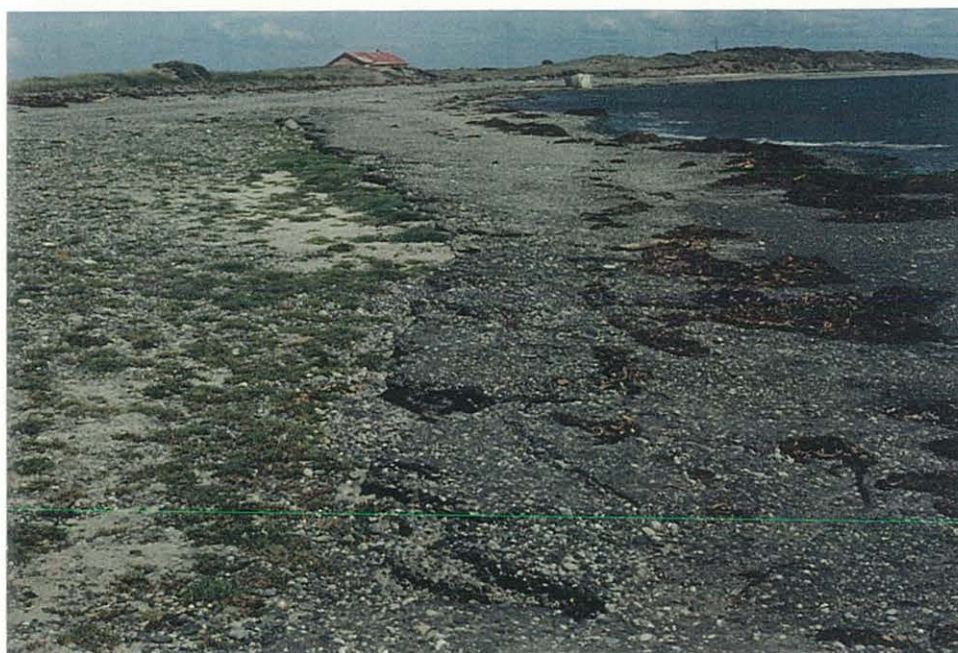
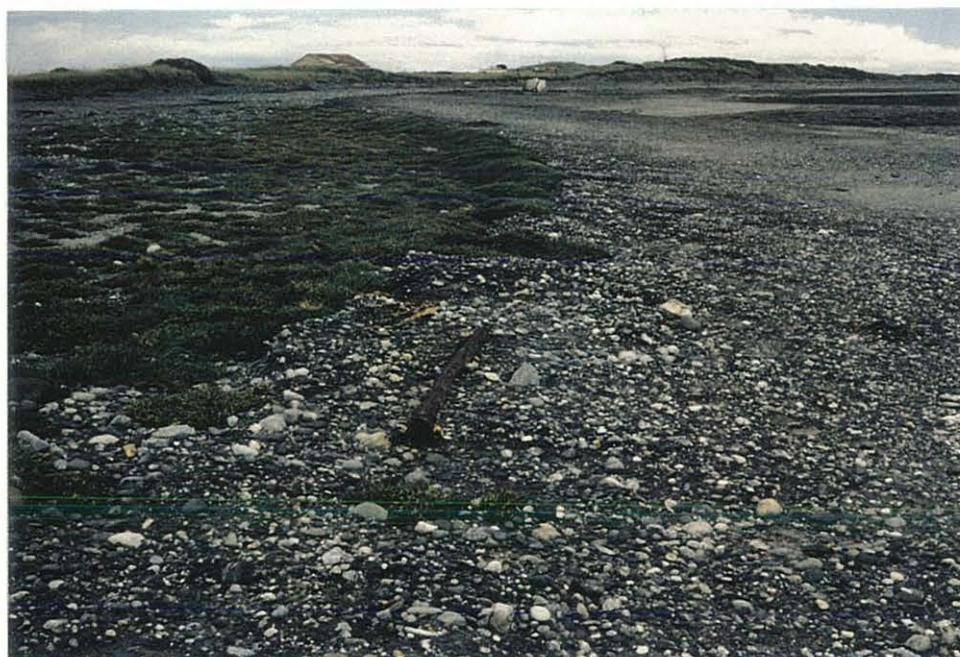
Plates 12-13. Punta Espora backbeach site in 1987 (Plate 12) and 1995 (Plate 13). Note *Salicornia ambigua* on landward (left) side of pavement. Photos by E. Owens (12) and G. Shigenaka (13).

At the Snug Harbor site affected by the *Exxon Valdez* and the Punta Espora backbeach "paved" by the *Metula*, the physical alteration of beach substrate has most noticeably influenced high intertidal and supratidal plant growth. That is, the impenetrable surface caused by the asphalt formation in both locations has restricted the distribution of plant species normally expected to occur there. This is illustrated in Plates 13 and 20. Plate 20 shows a tall marsh-type grass, *Elymus mollis*, at the upper edge of the Snug Harbor site constrained from further incursion toward the water by the asphalt. Figure 13 depicts a similar (though lower intertidal) situation at Punta Espora in which *Salicornia ambigua* is limited from seaward expansion down the beach by the presence of the asphalt pavement. In the Snug Harbor example, the *Elymus mollis* grass would likely not extend much lower into the intertidal, as its preferred habitat is upper intertidal and supratidal. At Punta Espora, the *Salicornia* probably would cover much of the upper intertidal zone presently covered by asphalt. At Snug Harbor, there was some evidence that the marsh grass at the margin of the asphalt pavement could push its root/rhizome system into the edge of the asphalt (Plate 21); at Punta Espora, there was no sign that *Salicornia ambigua* could incorporate, accommodate, or penetrate the pavement there.

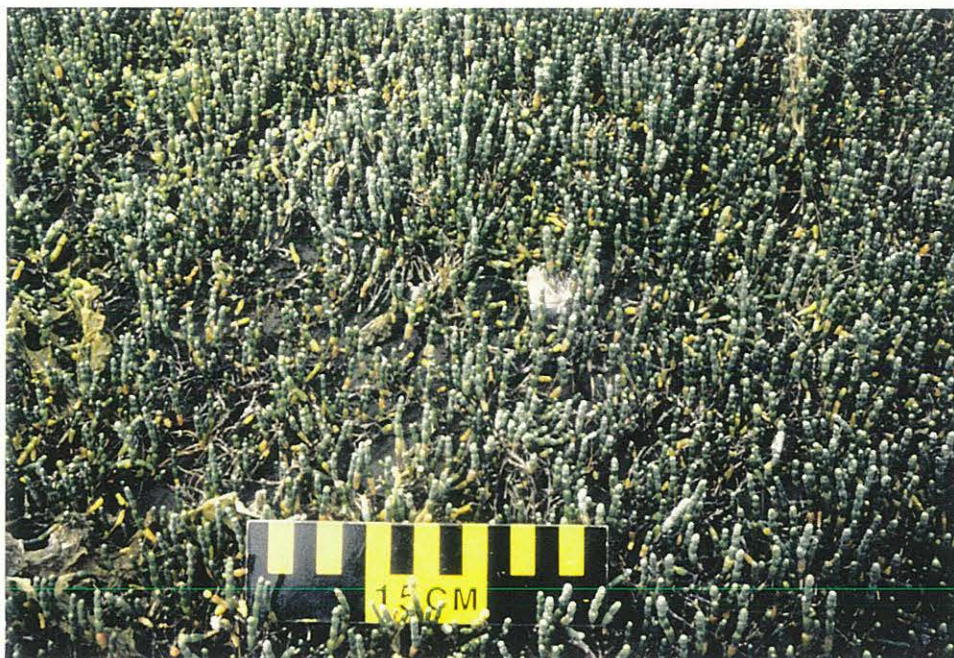
Plate 14

Closeup of *Salicornia ambigua* stand at Punta Espora, 1995. Photo by G. Shigenaka.

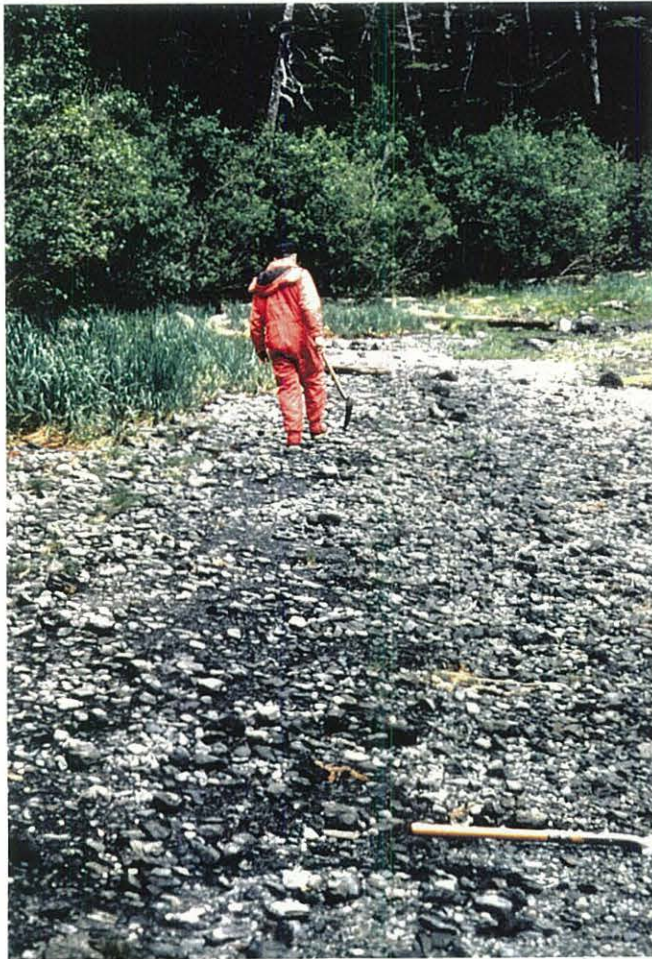
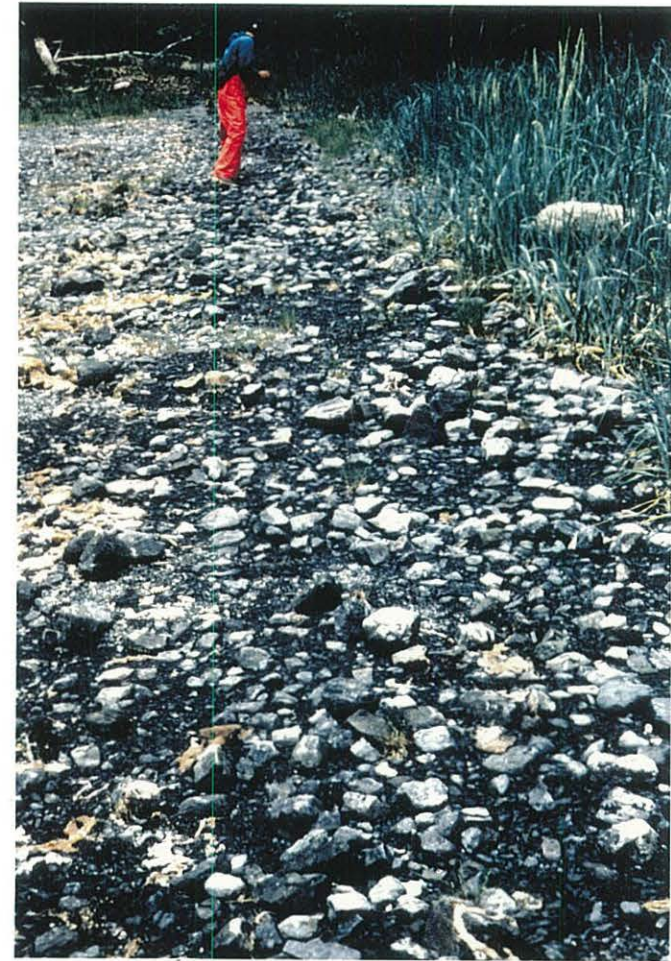
Plates 16-17. Snug Harbor setaside site, showing pavement at edge of intertidal in 1993, facing north (Plate 16), and 1997, facing south (Plate 17). Photos by G. Shigenaka.

An interagency survey team described the pavement in 1993 in the following way: "Asphalt pavement is well-defined, dry, and hard. The pavement is friable after being broken and chipped with a shovel portions (are) buried under 1 to 3 cm of pebbles." Photographs of the pavement in 1993 estimated by the survey team to measure 3 m x 50 m, are shown in Plate 16. Plate 18 shows a closeup of a piece of the pavement in June 1993. The material shows little or no signs of diminishing (except for the periodic sample collection by monitoring scientists, which over several decades may result in removal of the entire patch). Plates 17 and 19 basically repeat Plates 16 and 18 in 1997, 4 years after the first photos and 8 years after the spill.

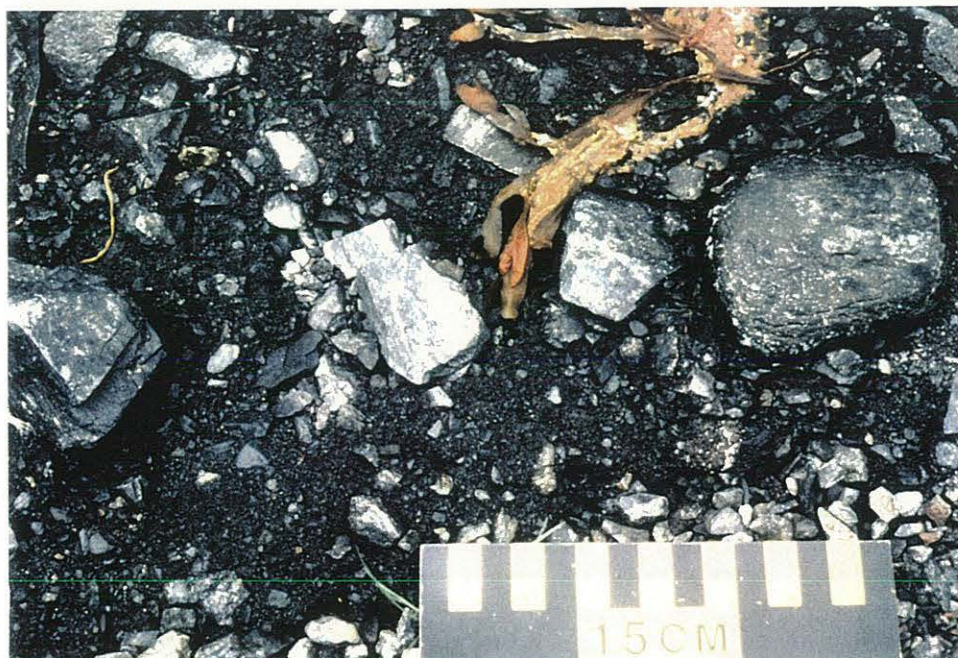
Plates 18-19. Closeup of surface of Snug Harbor pavement in 1993 (Plate 18) and 1997 (Plate 19). Photos by G. Shigenaka.

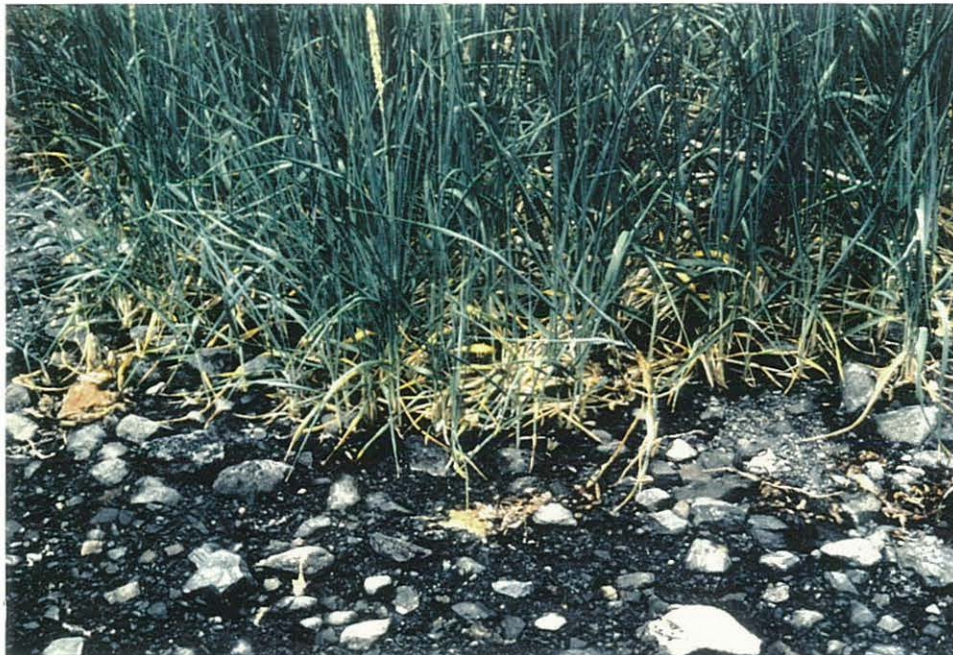
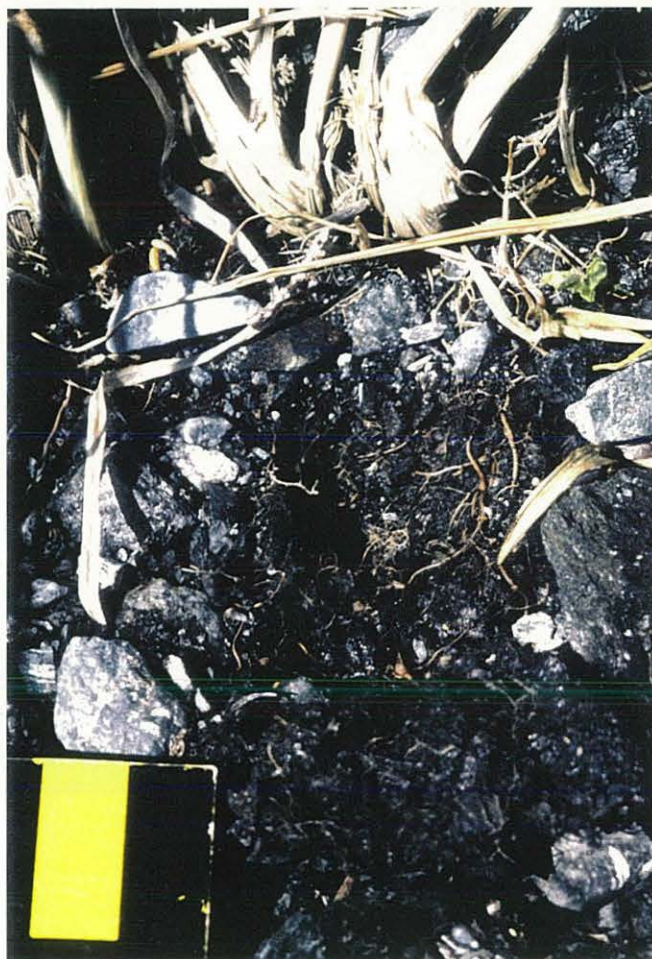
- Plates 18-19. Closeup of surface of Snug Harbor pavement in 1993 (Plate 18) and 1997 (Plate 19). Photos by G. Shigenaka.
- Plates 20-21. Upper edge of pavement at Snug Harbor showing adjacent *Elymus mollis* dunegrass in 1997 (Plate 20) and 1996 (Plate 21). Note growth of roots/rhizomes into pavement in Plate 21. Photos by G. Shigenaka.
