An Assessment of Chemical Contaminants in the Waters Around Cocos Island, Guam Using Polyethylene Passive Water Samplers

NOAA National Centers for Coastal Ocean Science
Stressor Detection and Impacts Division

NOAA TECHNICAL MEMORANDUM NOS NCCOS 261

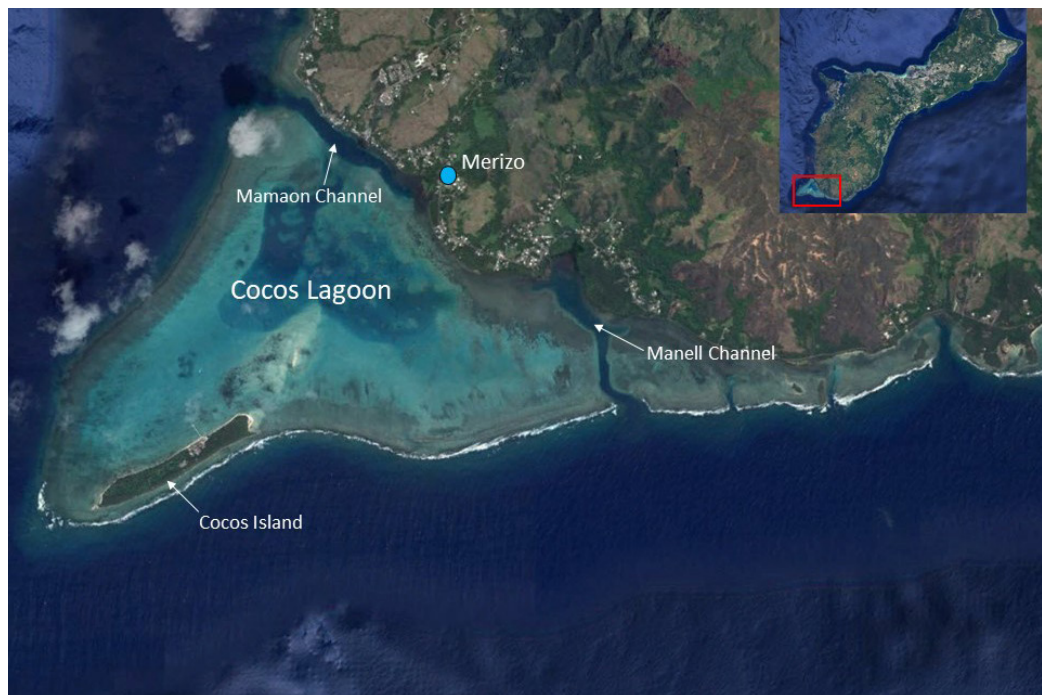
Figure 2. Cocos Lagoon, Guam including Cocos Island.

Triangular-shaped, Cocos Lagoon is approximately 8.9 km long on the south side, and 4.4 km at its widest point. The lagoon is separated from the open ocean by a series of fringing reefs and barrier islands, of which Cocos Island is the largest (Figure 2). Cocos Lagoon is an important area for subsistence fishing, and a popular area for recreational activities including fishing, boating and diving. The lagoon is fairly shallow, with an average depth of approximately 2 meters. Towards the center of Cocos Lagoon, depths

approach 12 meters. Two channels, the Manell Channel and the Mamaon Channel, connect Cocos Lagoon with the open sea. The Manell Channel with depths up to 11 meters, drains to the Pacific Ocean while the Mamaon Channel, with depths to nearly 26 meters, drains to the Philippine Sea. Current (water flow) studies conducted by Randall *et al.* (1975) indicated that the southern barrier reef of Cocos Lagoon is exposed to higher wave energy which results, when normal tradewinds are blowing, in a greater volume of water entering from the south, and producing a general northward current within the lagoon.

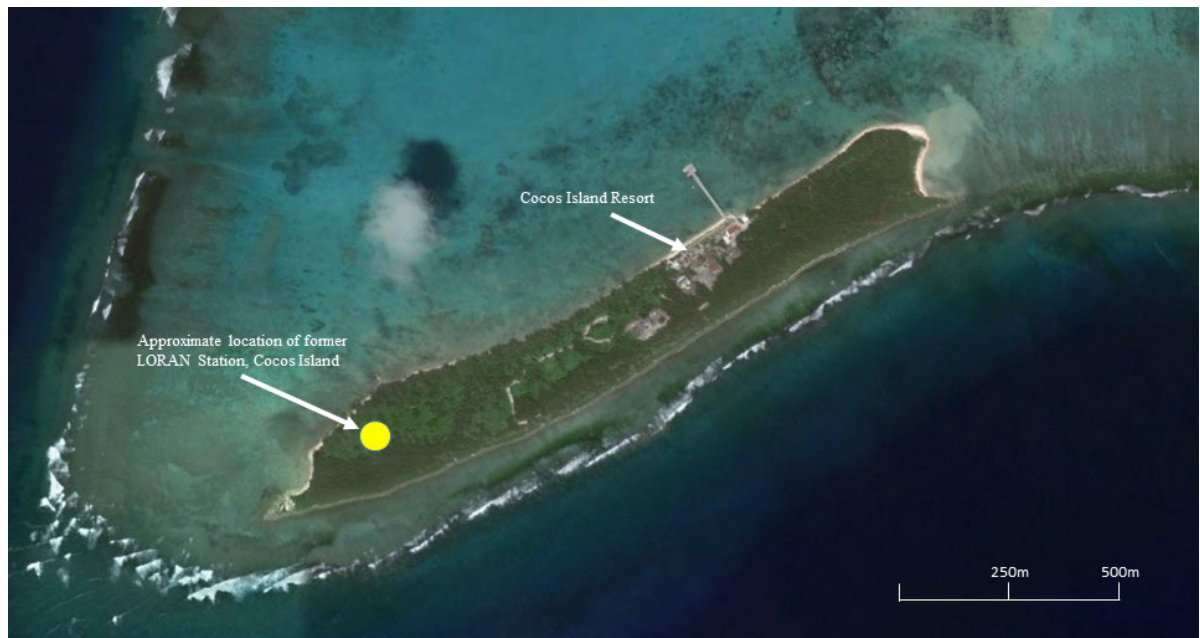
Figure 3. Location of the former LORAN Station Cocos Island, and current resort area.

Cocos Island is thought to have formed through the accumulation of unconsolidated materials carried by waves and currents, and has a maximum elevation of less than 2 meters (Emery, 1962). Between 1944 and 1963, the US Coast Guard (USCG) operated a long-range navigation or LORAN station towards the southern end of Cocos Island. LORAN was a hyperbolic radio navigation system used by the US beginning in World War II. A map showing the approximate location of the Cocos Island LORAN station can be seen in Figure 3. Electrical transformers at the station were used to convert the power supplied by diesel generators to run the LORAN equipment. Anecdotal information provided by former USCG personnel stationed at Cocos Island, during the time the LORAN station was operational, indicated that debris from the station was sometimes taken to the lagoon side of the island to be carried away by passing typhoons, or was buried on the island (Element Environmental, 2014).

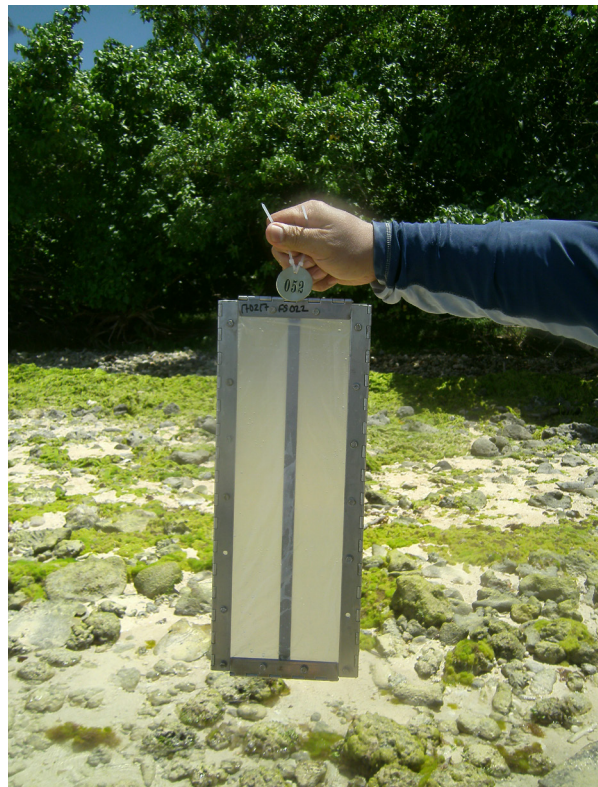
Figure 4. Image of PED and PED frame prior to deployment.

the rebar. The rebar was then pounded into place. Once the support structures were installed, the combination PED and frames were removed from the cooler and their serial numbers recorded. Nitrile gloves were worn by personnel at each site, both in the water and in the boat for those handling the PEDs. Each combination frame and PED was also assigned a brass tag with a unique number to ensure proper identification of the PED at the time of retrieval. Each tag was ziptied to the frame before installation. After the serial number and identifier tags were recorded and attached, the PED and frame were transported to the installation site and ziptied to the support rebar stakes.

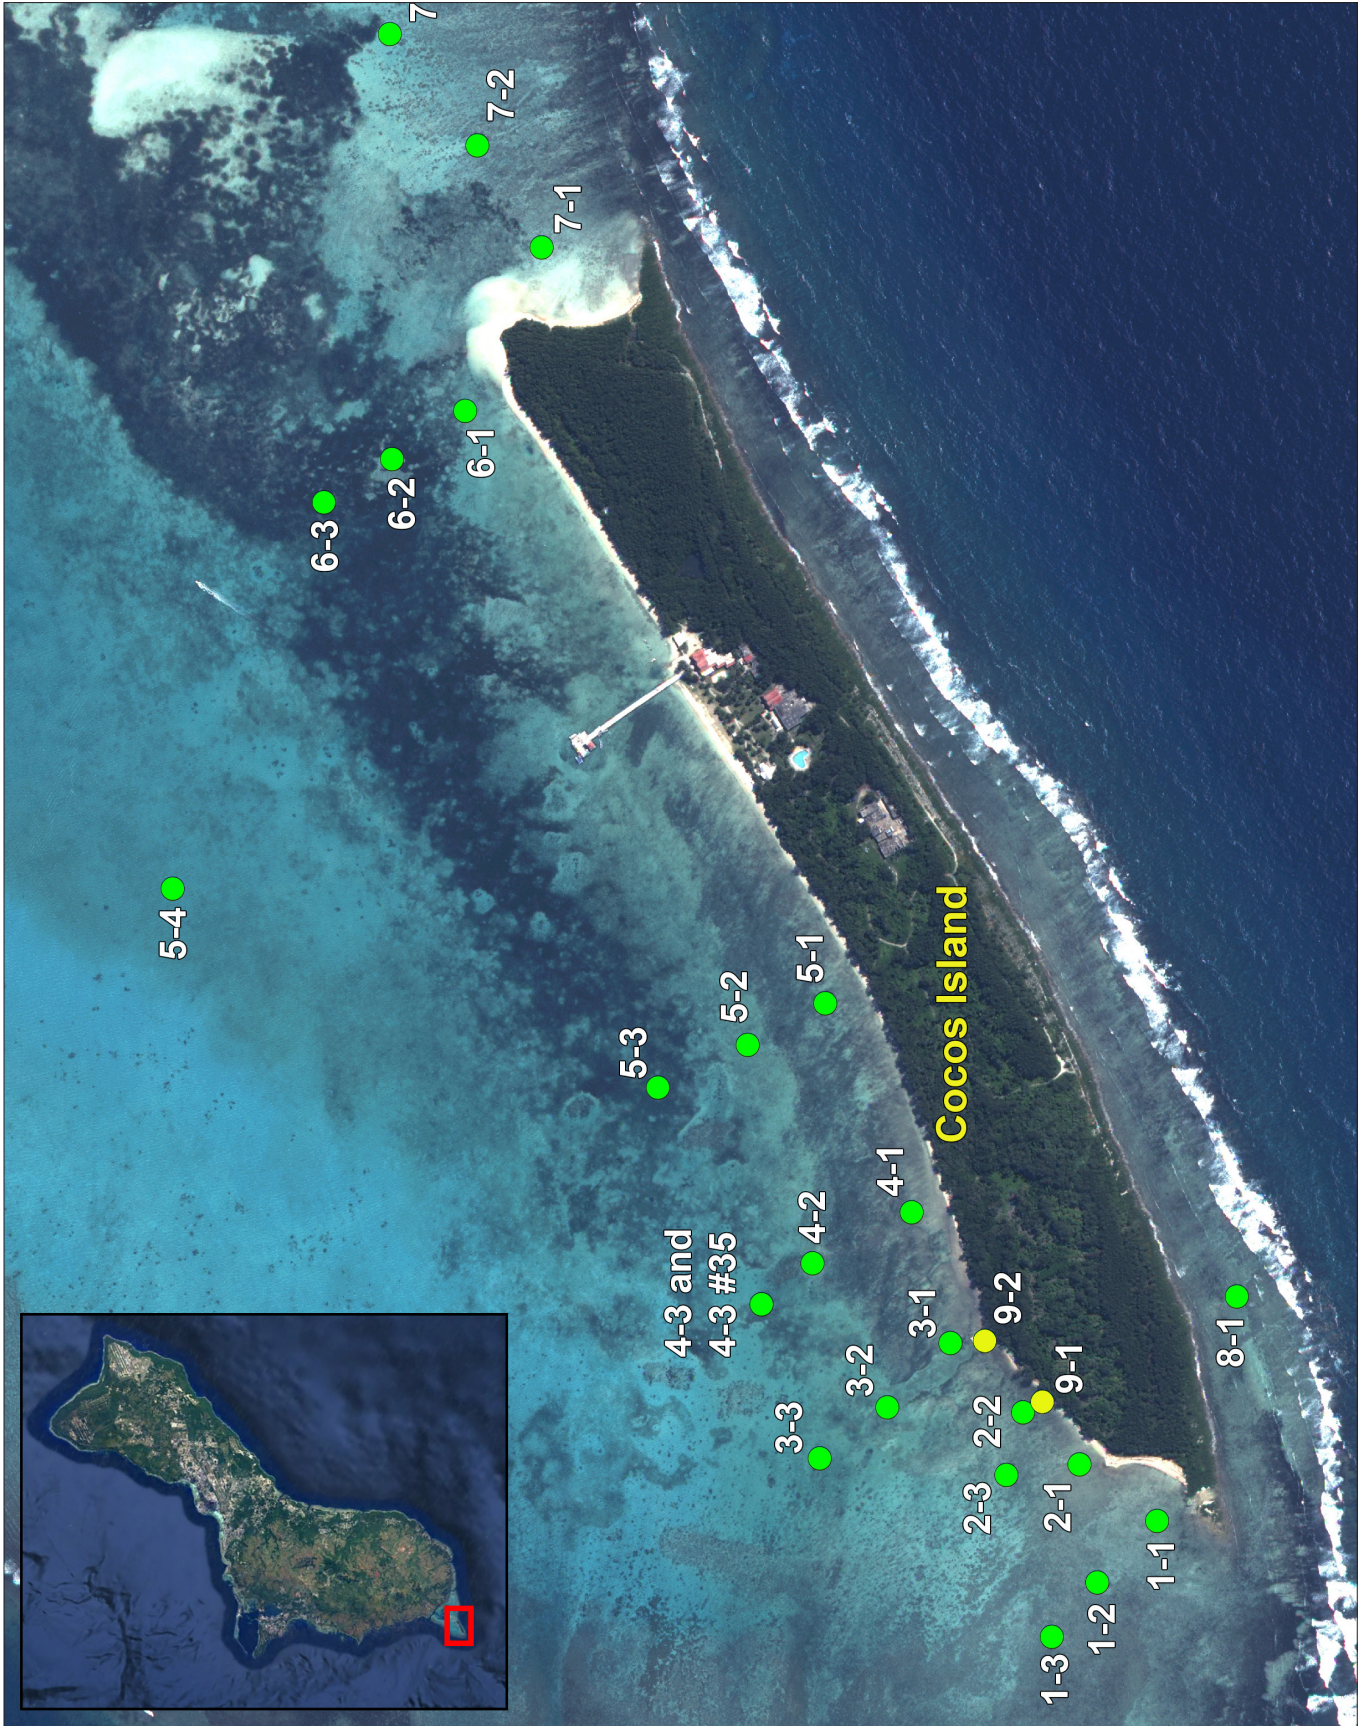
Figure 5. Location of the PEDs successfully deployed and retrieved from around Cocos Island, Guam. Yellow dots indicate the location of those PEDs buried in the sand just below the high water mark.

was some biofouling noticed on the PEDs retrieved after deployment, the degree of biofouling, even those embedded in the sand appeared roughly the same between sites. The jars were then placed in a cooler on ice while in the field, and then placed in a freezer at Guam EPA. The PEDs that had been deployed at site 8-2 were not found during retrieval.

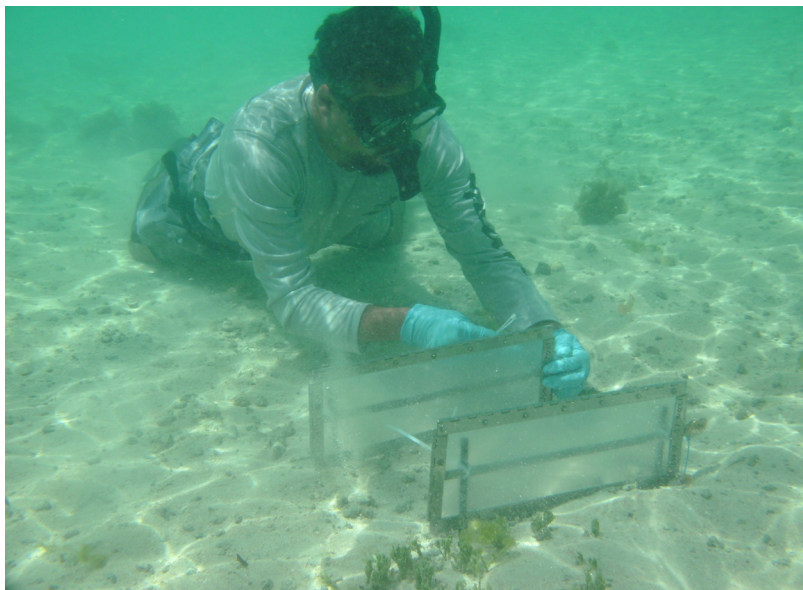
were oriented with their long edge parallel to the sediment, so that the PED was exposed to the water. Figure 6 and the cover of this report show two PEDs deployed at a site, with this orientation.

Figure 6. Image of NOAA scientist installing duplicate PEDs in the waters around Cocos Island, Guam.

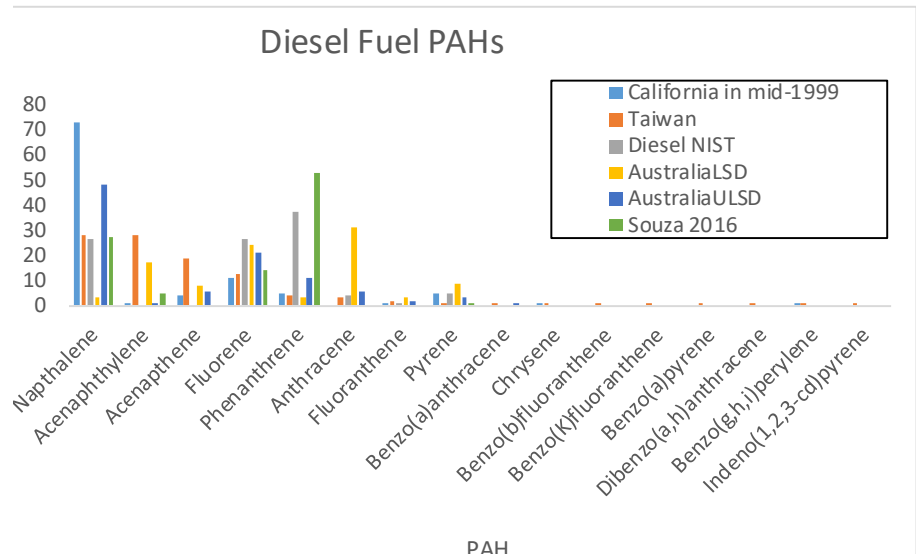
Figure 8. PAHs commonly found in diesel fuels. Note that PAH data are in percent of total. Data from de Souza *et al.* (2016), Dobbins *et al.* (2006), and Lim *et al.* (2005).

usually not found in diesel fuels, or are at very low concentrations relative to other PAHs present. This also can be seen in Figure 8, where PAHs larger than pyrene are typically absent or at very low concentrations in diesel fuel. Figure 9 provides a breakdown of these same PAHs found on the

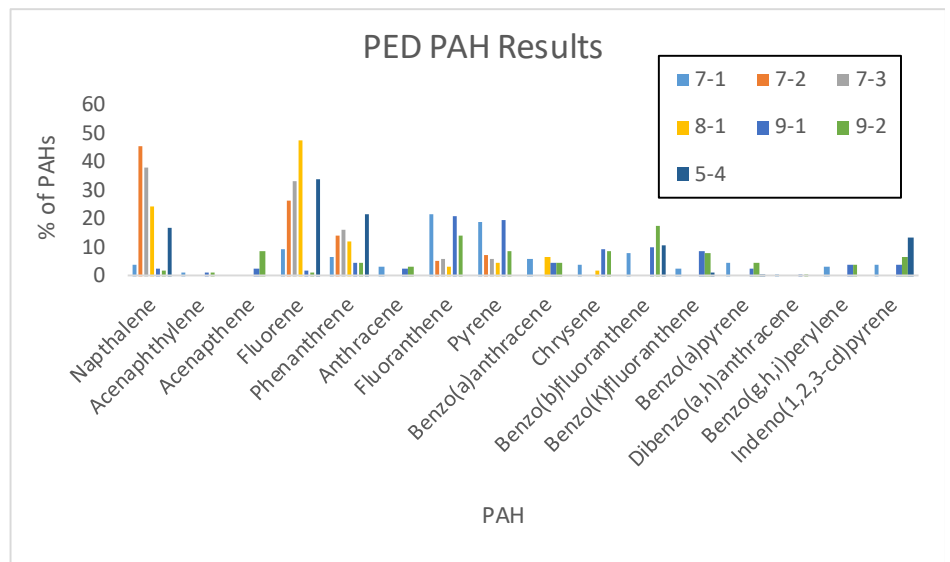
Figure 9. Total PAHs detected on the PEDs at various locations around Cocos Island, Guam. Note that PAH data are in percent of total.

PEDs. There appear to be some similarities, including the presence of naphthalene, fluorene and phenanthrene that are found in diesel fuels and were detected on the PEDs,

however, the higher molecular weight PAHs (i.e., greater than pyrene), were found on the PEDs as well, indicating that these PAHs could be associated with the combustion of fuels like gasoline and perhaps diesel.

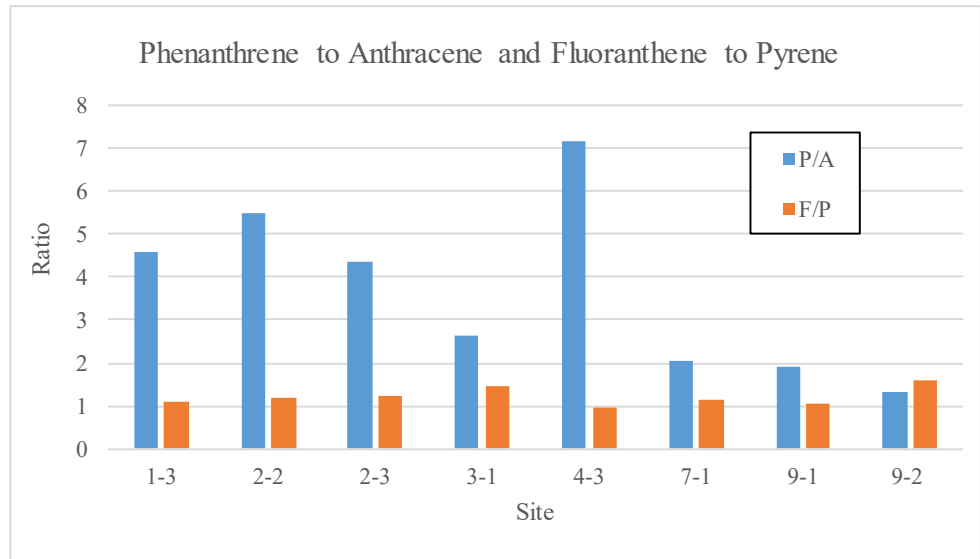
Figure 10. Ratio of phenanthrene to anthracene (P/A) and fluoranthene to pyrene (F/P) from PEDs deployed around Cocos Island, Guam.

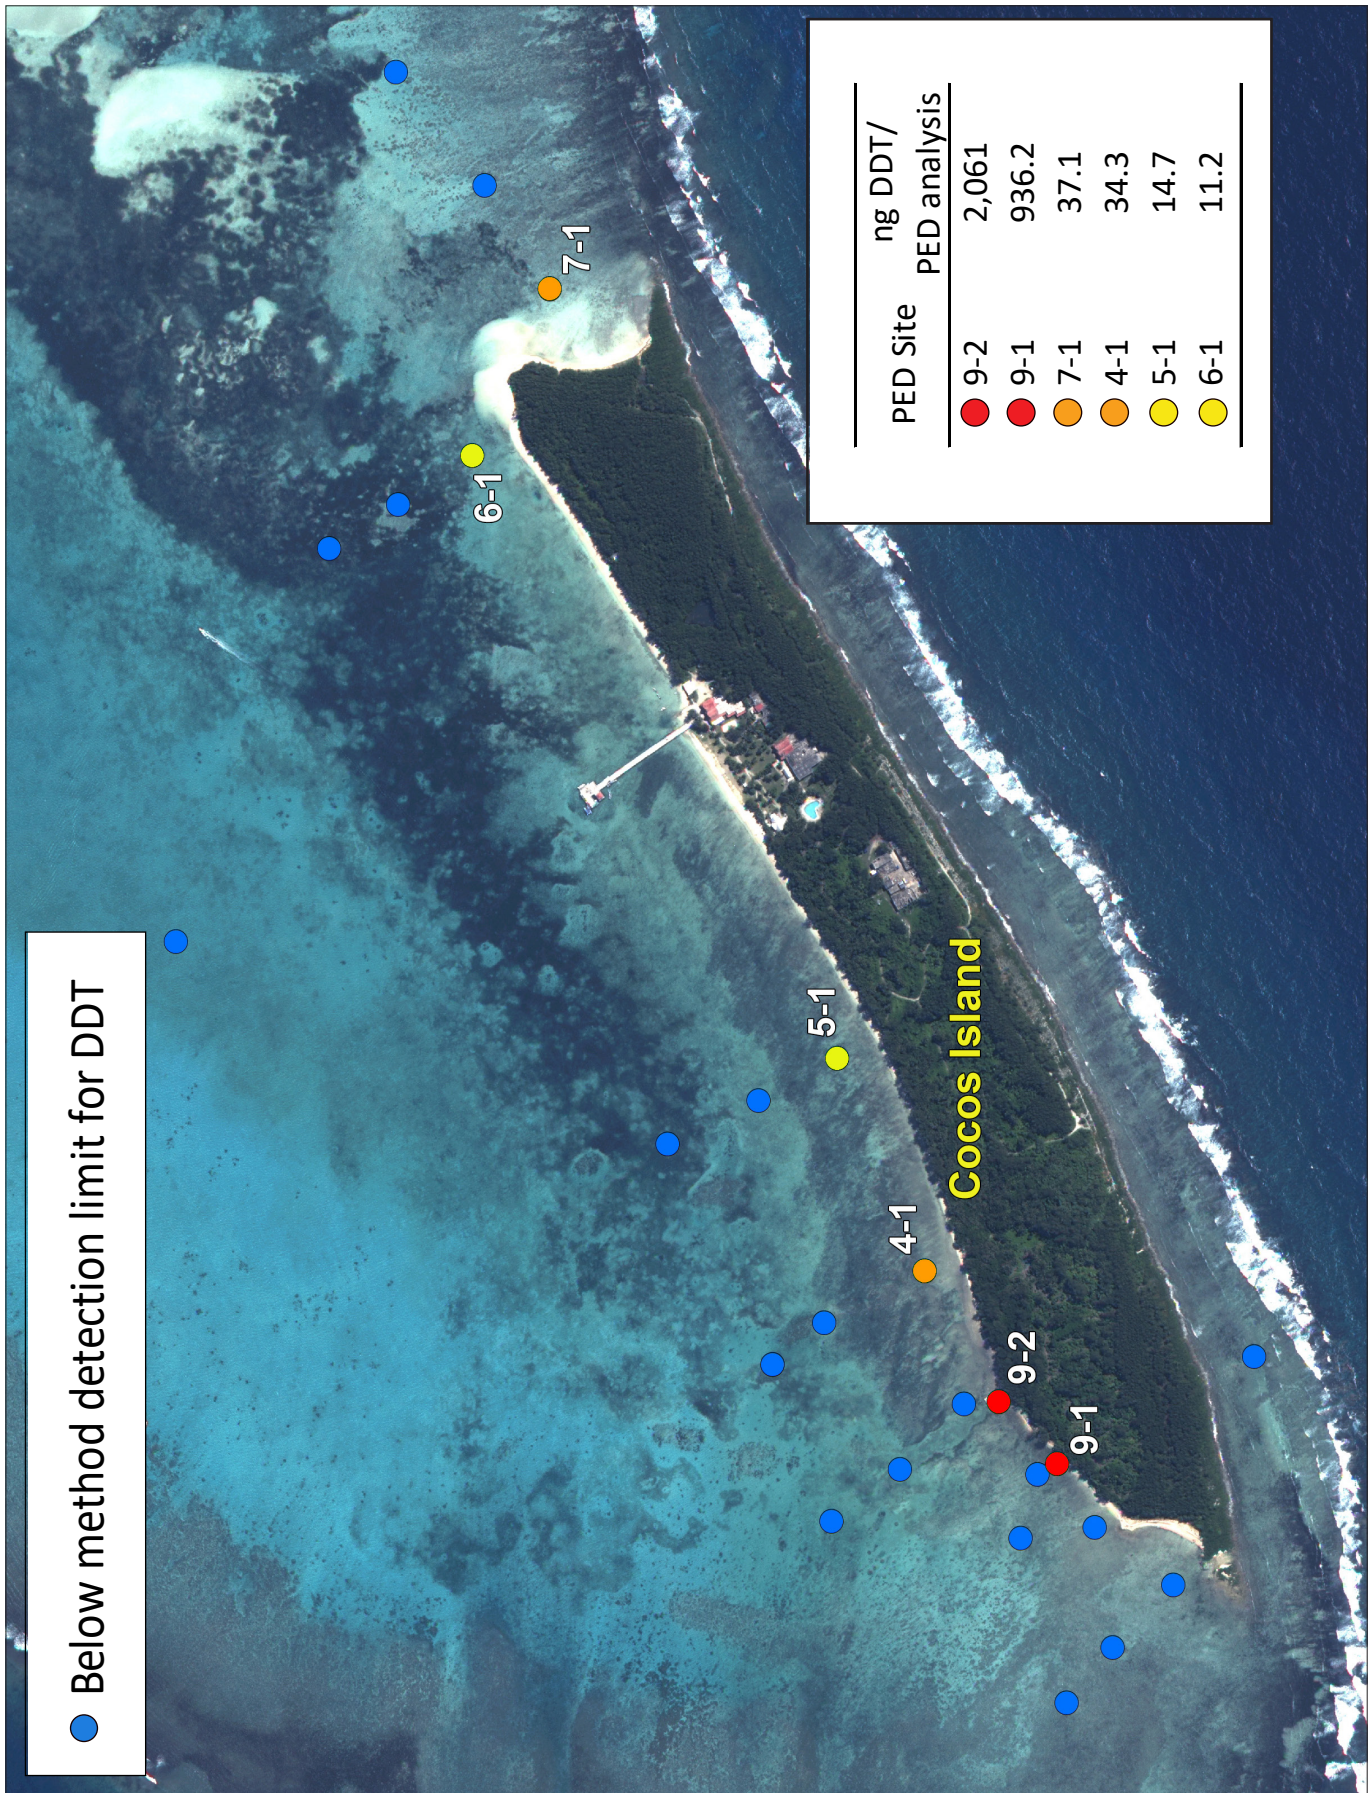
Figure 11. Concentration of total DDT found on the PEDs deployed around Cocos Island, Guam.

The results from the analysis of the PEDs for the organochlorine pesticide DDT and its metabolites (termed total DDT) can be seen in Figure 11. Unlike the results from the analysis of PAHs, the detections of total DDT on the PEDs all occurred at the very nearshore sites, including 9-1, 9-2, 4-1, 5-1, 6-1, and 7-1. At over 75 percent of the sites where the PEDs were deployed, however, DDT was

either not detected or was below the method detection limit (Figure 11 and Appendix I). A nonparametric Wilcoxon test on nearshore versus PED sites further out in Cocos Lagoon, including sites 9-1 and 9-2 found a significant

The highest concentrations of total DDT were at sites 9-1 and 9-2. The concentration of total DDT on the PEDs at 9-1 was 936 ng, the concentration at 9-2, however, was over 2,000 ng. As with the PAHs, sites 9-1 and 9-2 where the PEDs were buried in the sand adjacent to the site of the former LORAN station, the total DDT concentrations were substantially elevated. There were also somewhat elevated levels on the PEDs deployed on the northeast side of Cocos Island, in the area where it is thought that sand may have been moved, perhaps from around sites 9-1 and 9-2.

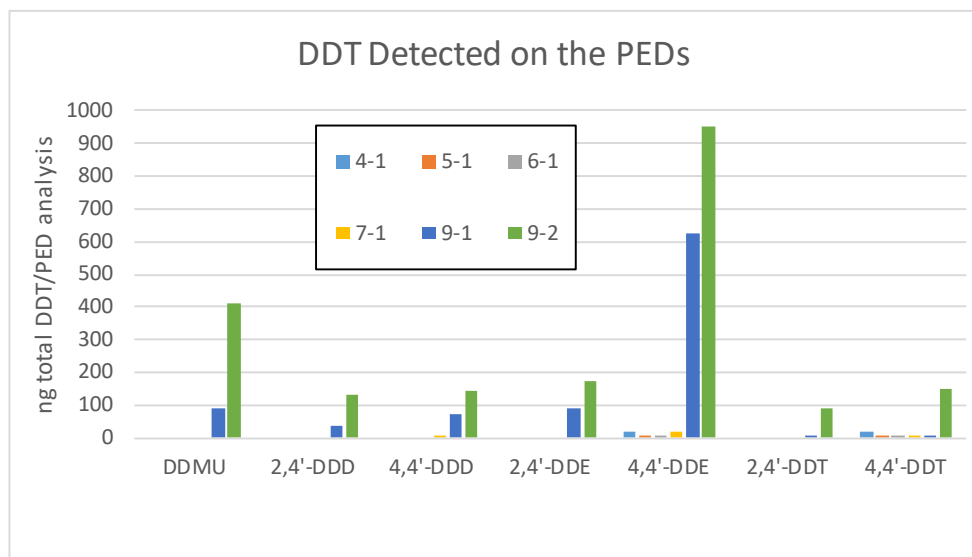
Figure 12. Parent (4,4'-DDT and 2,4-DDT) and DDT degradation products detected on the PEDs deployed around Cocos Island, Guam.

Figure 12 shows the parent and degradation products of DDT from the sites where total DDT was detected. From this figure, it can be seen that the degradation product DDE, was the major component of total DDT found on the PEDs. The parent compounds made up approximately 2 and 12 percent of the total DDT found on the PEDs at sites 9-1 and 9-2, respectively. In contrast, Pait *et al.* (2010) found that the parent DDT compounds comprised approximately 68 percent of the total DDT present in sediments at a site in Vieques, Puerto Rico, possibly indicating a more recent

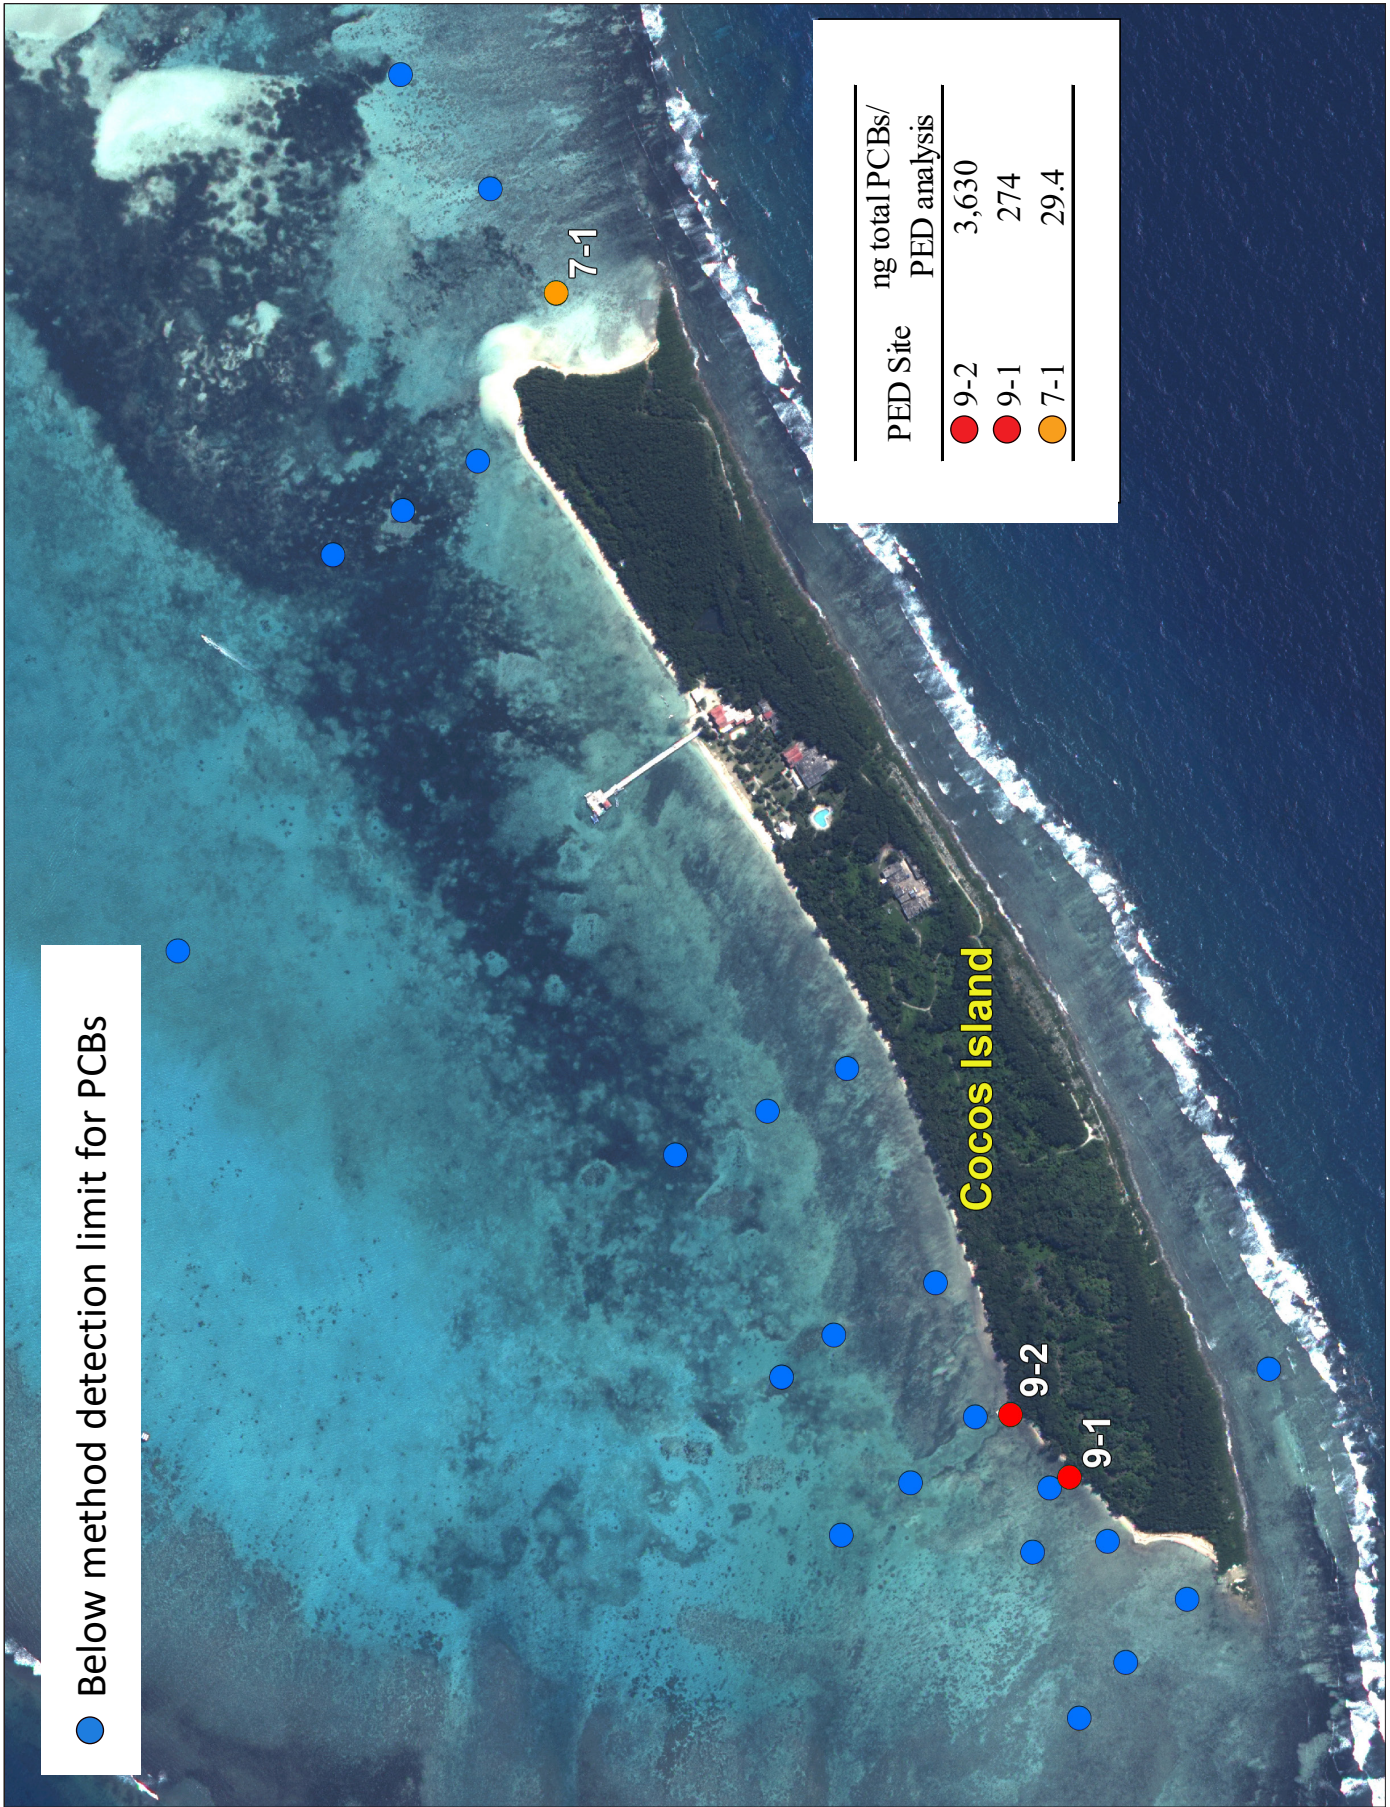
Figure 13. Concentration of PCBs found on the PEDs deployed around Cocos Island, Guam.

The results of the analysis of PCBs on the PEDs can be seen in Figure 13. As noted earlier, PRCs, or performance reference compounds, were added to the PEDs prior to their shipment to Guam. The PRCs are used to model how close the deployed PED is to equilibrium. Appendix K contains total PCB values with and without the PRCs. For assessing the concentration of PCB accumulated by the PEDs during

deployment, the totals without the PRCs were plotted in Figure 13.

It can be seen in Figure 13 that only the PEDs deployed at sites 7-1, 9-1, and 9-2 had detectable levels of total PCBs. The highest concentration of total PCBs, as was found for total PAHs and for total DDT, was at site 9-2. The concentration was over 3,600 ng/PED analysis. The next highest concentration was at the adjacent 9-1 site (274 ng). A nonparametric Wilcoxon test on nearshore versus PED sites further out in Cocos Lagoon, failed to detect a significant difference (ChiSquare = 1.96702, $p = 0.3740$) in total PCBs moving from nearshore areas to the sites further out in Cocos Lagoon.
