# **MAPPING DATA ACQUISITION AND PROCESSING SUMMARY REPORT**

**CRUISE EX-17-06: Laulima O Ka Moana**

**Exploring Deep Monument Waters Around Johnston  
Atoll (ROV/Mapping)**

**January 30, 2018**

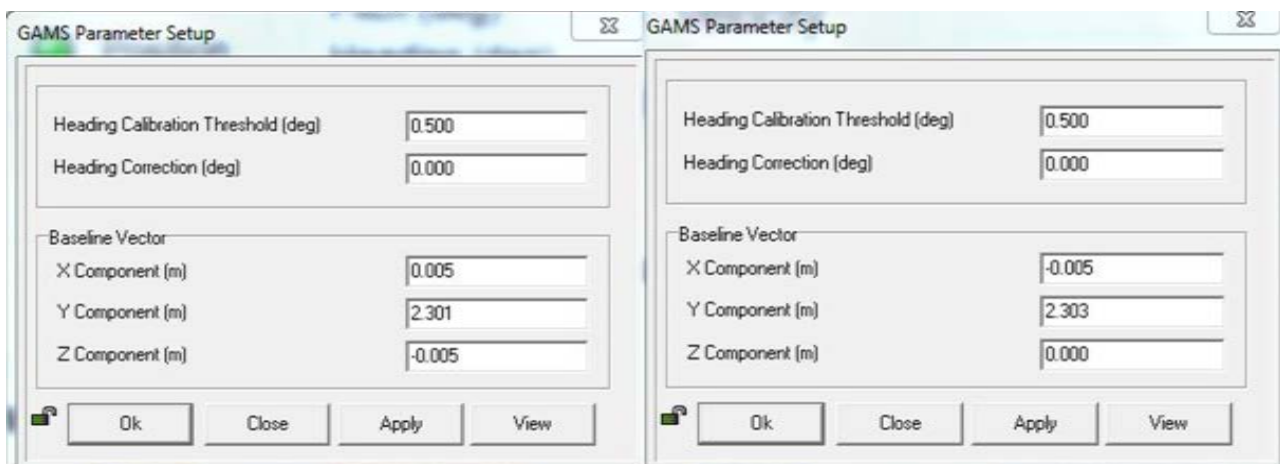
Figure 1. Pre-calibration (05 July 2017, left) and post-calibration (08 July 2017, right) GAMS parameters. The GAMS solution calculated at the start of EX1706 was applied immediately before data collection for multibeam calibration.

Figure 1 shows the pre- and post-calibration GAMS solutions. Differences between the pre- and post-calibration GAMS solutions correspond to a horizontal rotation of the GNSS antenna lever arm (from the primary antenna to the secondary antenna) of approximately  $0.25^\circ$  [i.e.,  $\arctan(dX/dY)$ ] in the clockwise direction looking down (positive compass convention). The X component shows the largest change in this lever arm, according to the GAMS result. It is not clear whether this 10 mm alongtrack difference resulted from slight physical alteration of the antenna location or other causes rooted in the uncertainty / repeatability of the GAMS. At the very least, it confirms that no major modification was made unintentionally to the antenna position during dry dock. Because the POS MV utilizes antenna phase measurements to augment the motion sensor heading data, this GAMS result may be partially reflected in the multibeam heading calibration result of  $0.1^\circ$ .

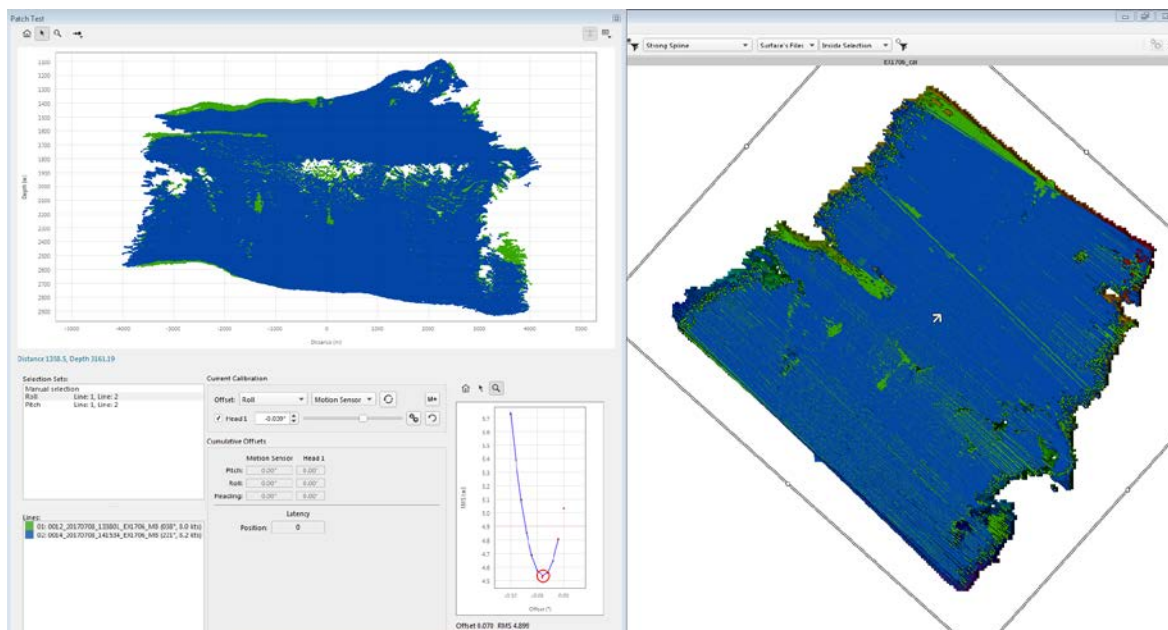
Figure 7. Testing the calibration 'Autosolver' in Qimera using all soundings in the cleaned roll calibration lines. This feature calculates the RMS error between two calibration lines over a customizable range of calibration values and reports the angular offset that is expected to produce the minimum error (naturally, this method is most reliable with large sample counts of high-quality soundings with few outliers). The 'Autosolver' result of  $-0.039^\circ$  confirmed the visual estimate of  $-0.04^\circ$ .

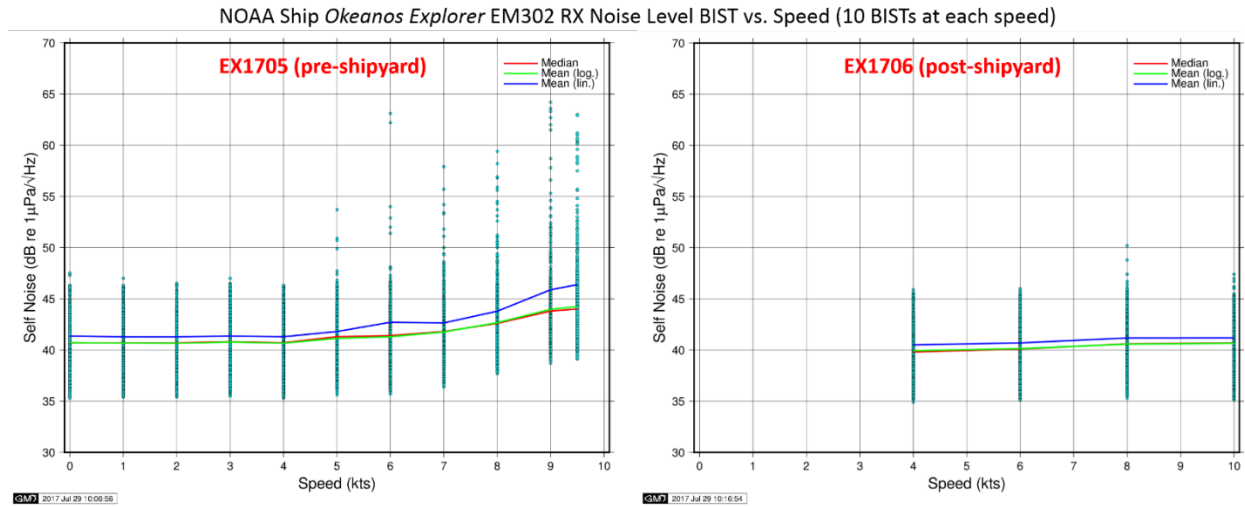
Figure 11. Plots of EM302 RX Noise Level BIST results during EX1705 (left) and EX1706 (right). Speeds greater than 4 kts during EX1705 (pre-shipyard) showed increasing noise levels, which are not observed at higher speeds in the EX1706 (post-shipyard) data. These results suggest a significant reduction in flow noise associated with removal of biofouling and repair of fairing compound along the array edges. The EX1706 noise levels at 4-10 kts are in a similar range as those observed on other vessels (e.g., UNOLS ships) considered to be relatively quiet platforms.

Taken together, the plots in Figures 11, 12, and 13, show a significant improvement in the noise environment perceived by the RX array across the range of speeds (4-10 kts). The trend of increasing noise levels with increasing speed observed during EX1705 (pre-shipyard) is not readily apparent in the EX1706 (post-shipyard) data, suggesting a significant reduction in flow noise along the array faces and/or vessel noise. Because no major machinery or electrical changes are known to have occurred during the shipyard period, this improvement in noise levels can likely be attributed to removal of biofouling from the array faces and hull, as well as the repair of fairing compound/epoxy on the array edges.

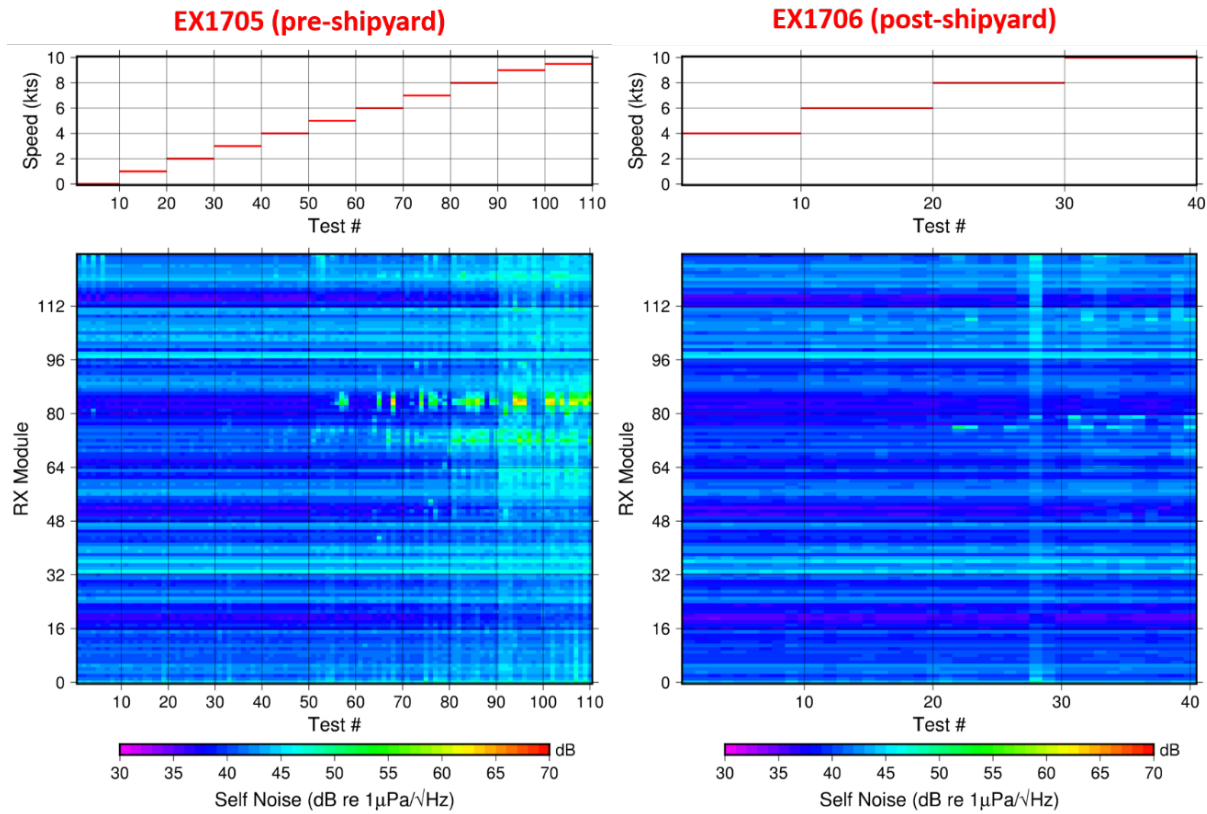
NOAA Ship *Okeanos Explorer* EM302 RX Noise Level BIST vs. Speed (10 BISTs at each speed)

Figure 12. Plots of EM302 RX Noise Level BIST results plotted for each RX module across all tests. This format clearly shows that some modules exhibit consistently higher or lower noise levels across both datasets (horizontal stripes). The direct relationship between speed and flow noise is clear in the shift from dark blue to light blue in the EX1705 panel (left). No significant increase in flow noise is observed in the EX1706 panel (right); note that test 28 resulted in higher noise levels across all modules, likely due to swell impact on the hull or transient machinery noise.

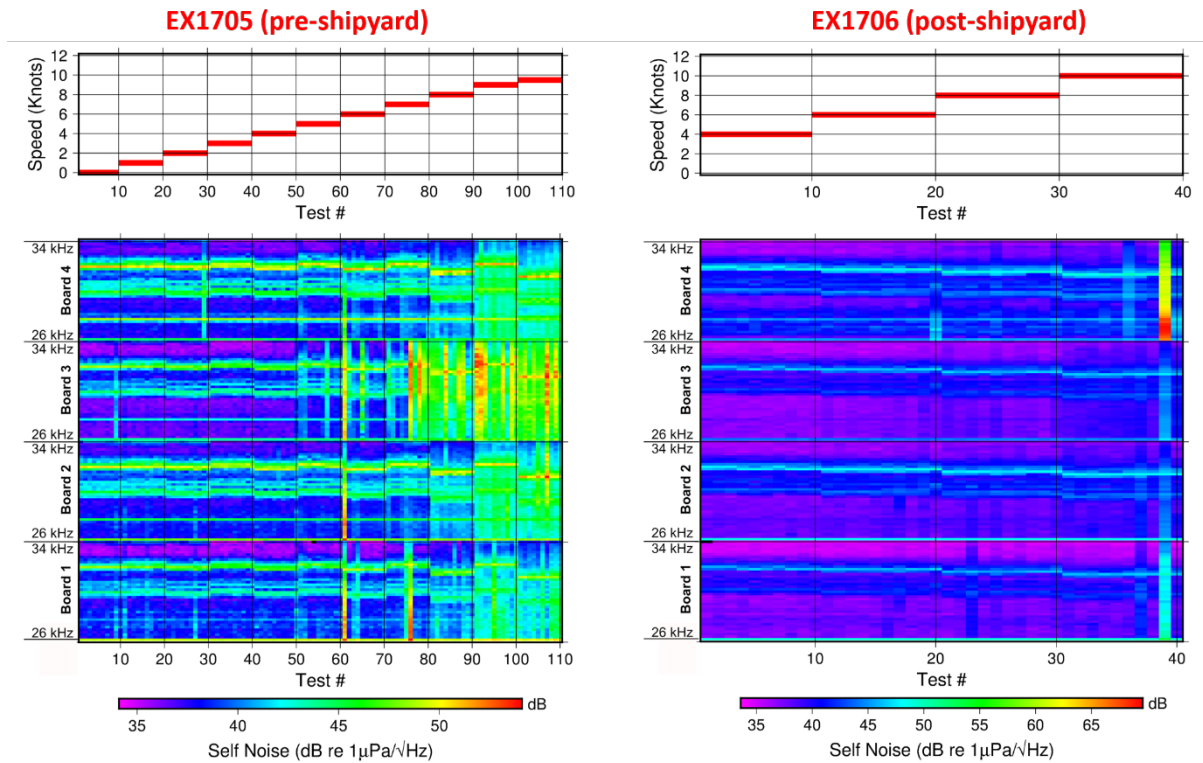
NOAA Ship *Okeanos Explorer* EM302 RX Noise Spectrum BIST vs. Speed (10 BISTs at each speed)

Figure 13. Plots of EM302 RX Noise Spectrum BIST results for EX1705 and EX1706. These plots indicate the noise levels at frequencies of interest (26-34 kHz) measured on each RX board. A clear improvement is made from EX1705 to EX1706, even at low speed and low flow conditions (i.e., at 4 kts, before the start of the strong direct relationship between speed and noise develops in the noise level plots above). The cause of the high value in EX1706 test 39 (especially on Board 4) is not clear, but this appears to be an isolated event in that dataset.

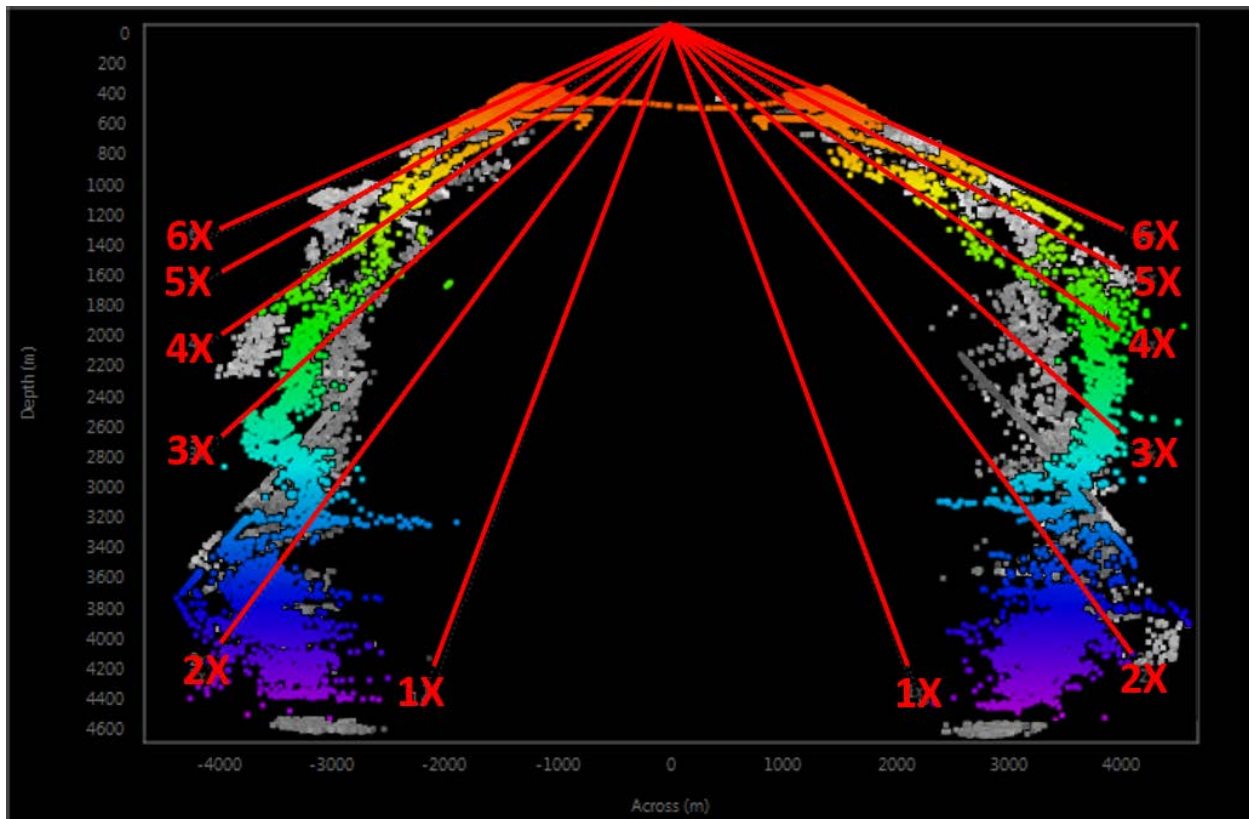
Figure 14. Chart of swath coverage versus depth for data collected offshore Oahu at the conclusion of EX1705 (pre-shipyard, gray) and EX1706 (post-shipyard, colored by depth). The outermost port and starboard soundings are plotted for each ping to visualize the maximum swath coverage achieved. The red lines indicate the total swath coverage as multiples of water depth. In general, these results indicate a general improvement in coverage in the range of 2000-3000 m.

The swath coverage results presented below in Figure 14, suggests slight improvements in swath coverage after the shipyard period, primarily between 2000-3000 m. This is a depth range where the EM302 should maintain Deep mode down to ~3300 m under typical survey conditions, according to the manufacturer specification. It was noticed during both EX1705 and EX1706 that the EM302 frequently required a ping mode change from Deep to Very Deep to maximize swath coverage and improve sounding quality in depths approaching 3000 m. The swath extinction results indicate a slightly improved ability to ‘delay’ this shift to deeper water (evident by a hard limit at 52° per side, or ~2.4 times water depth total coverage in Very Deep). Reduced coverage seen in the EX1706 data between depths of 600-1600 m (most notably on the port side), is likely a consequence of the vessel heading relative to the slope.

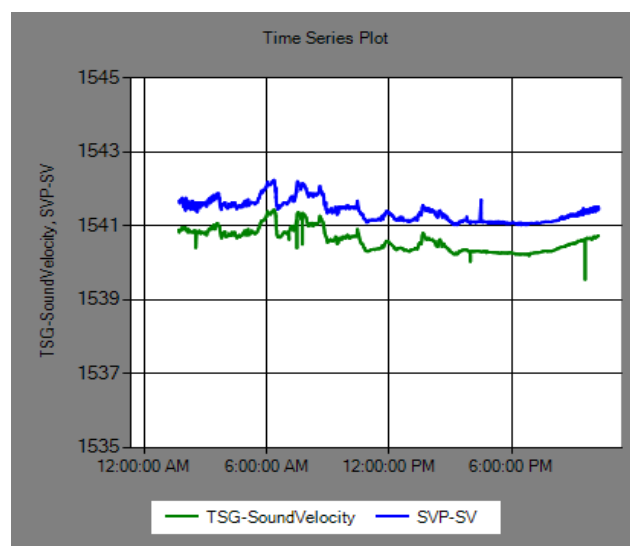
**Figure 15. Plot of sound speed estimated from TSG and Reson SVP probe collected for 24 hours.**

The temperature different of  $\sim 0.3$  °C between SBE19 and TSG is expected as the temperature sensor of TSG is not located at the input but the sampled water has to travel across the ship length to get to the temperature sensors located in dry lab. Comparison of SBE19, Reson SVP and TSG showed (Figure 15) that Reson SVP is reading sound speed 1 m/s lower than TSG and SBE 19. Comparison plots between TSG and Reson SVP over longer period of times (24 hours) showed that the sound speed difference ( $\sim 1$  m/s) was consistently observed between TSG and Reson SVP. It is recommended that Reson SVP should be monitored for its variations and manufacturer be consulted for the update on calibration of the probe.

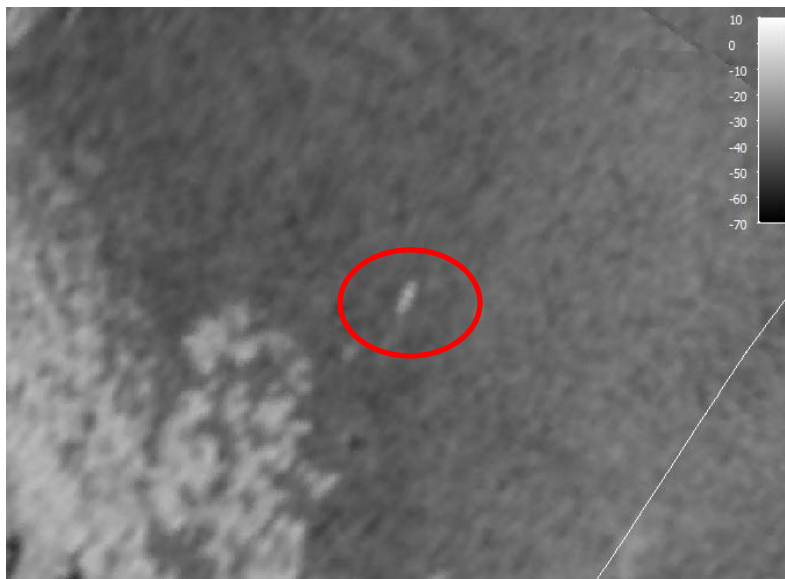
Figure 16. Seafloor backscatter mosaic (obtained from Line # 30) showing a distinct target (highlighted in red circle).

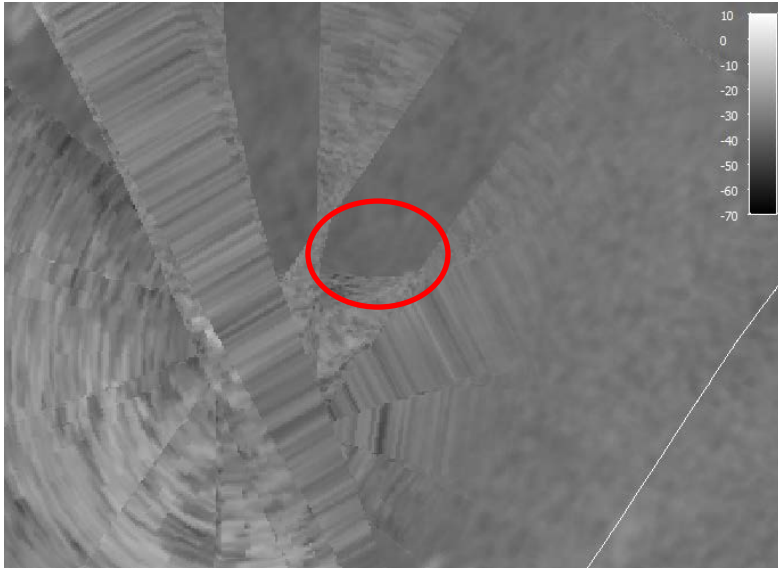
Figure 17. Seafloor backscatter mosaic after combining the data obtained with EM 302 run in 3D scanning mode (Line # 21)

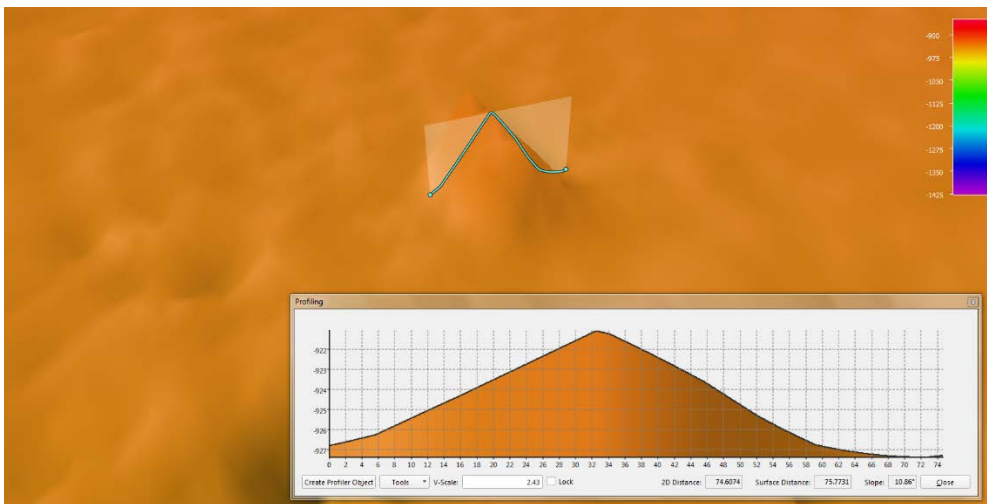
Figure 19. Profile of Line 31 bathymetry over the distinct target obtained with survey line 30.

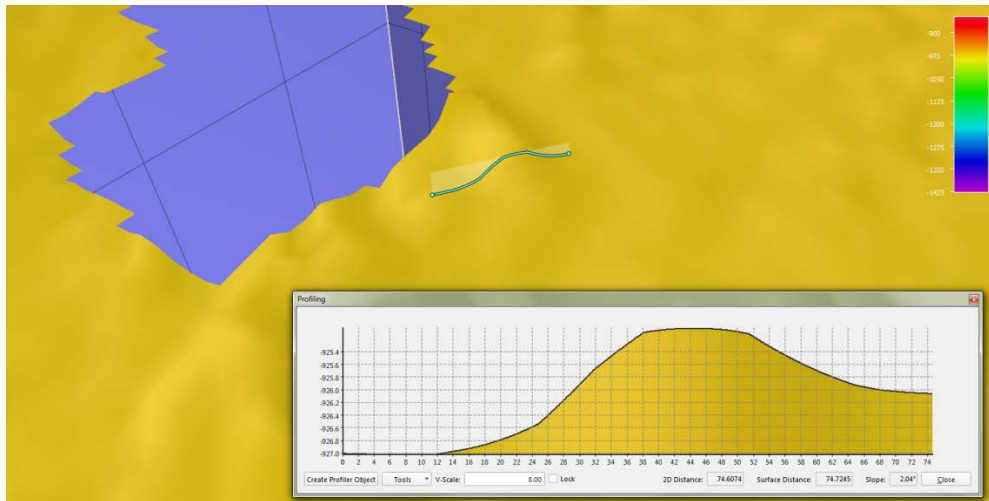
Figure 20. Profile of bathymetry over the distinct target obtained with 3D scanning mode (line#21).

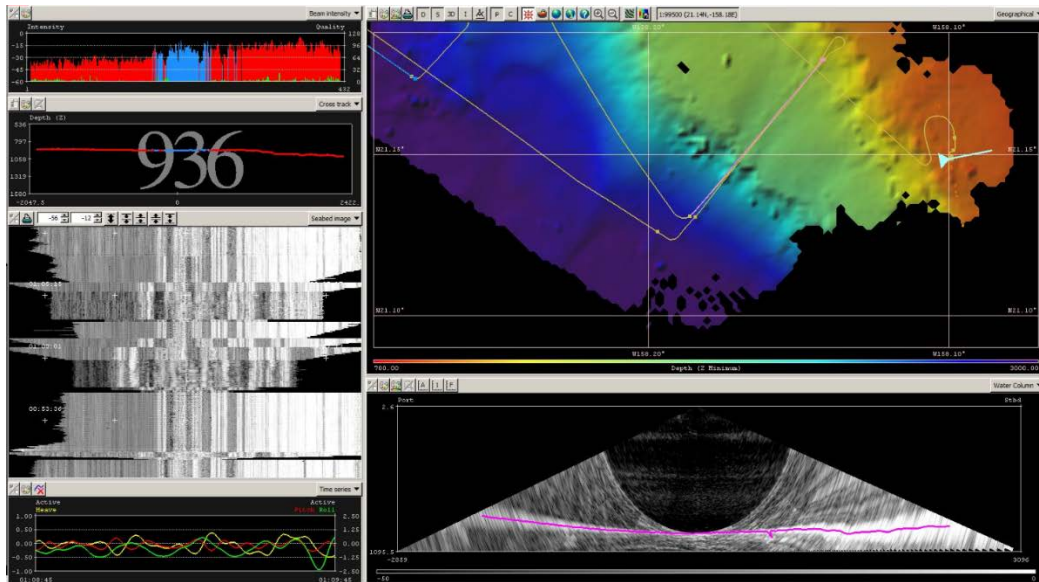
Figure 21. Plot of sound speed estimated from TSG and Reson SVP probe collected for 24 hours.

To estimate the corrections for each different depth mode, same seafloor has to be surveyed in different modes. During this cruise, the ship was stationed over a guyot (Figure 21) in dynamic position (DP) mode where the ship held position while EM302 data were collected in different modes (Table 6). Differences in backscatter in different modes were apparent (Figure 21). Further processing of these lines is in progress to estimate the corrections to BSCorr.txt.

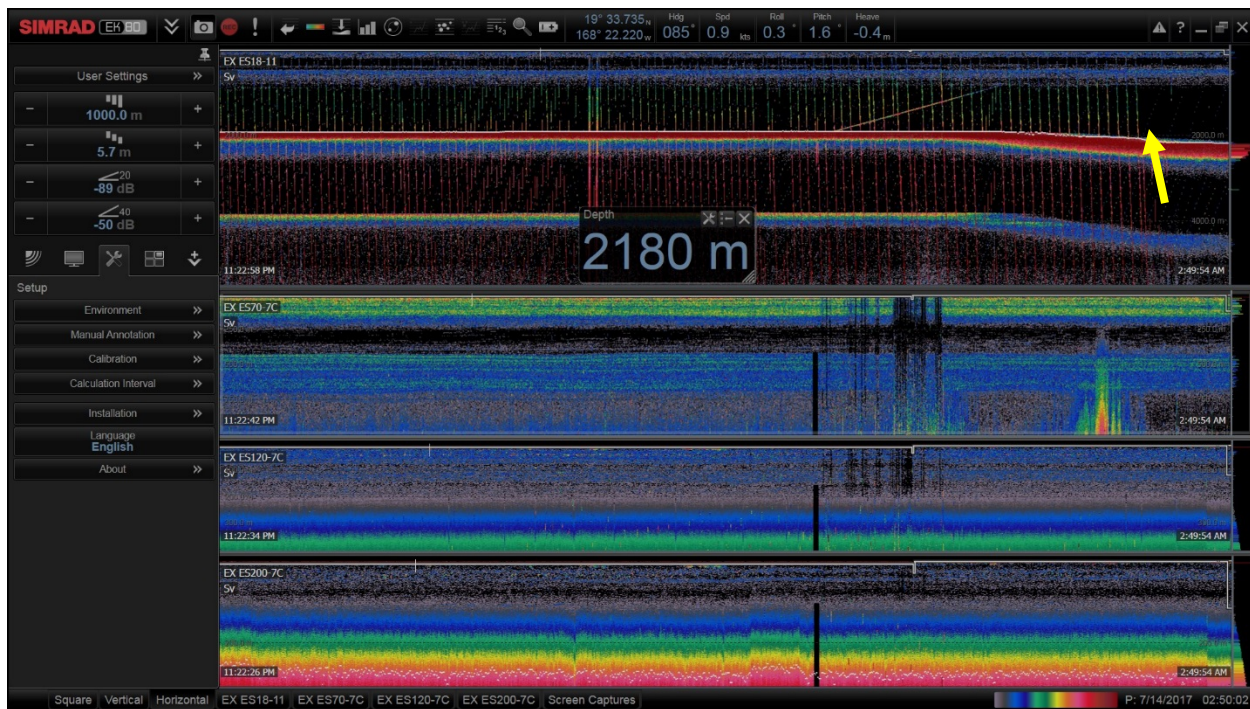
Figure 8. Plot of EK60 top panel showing 18 kHz EK 60 data. Yellow arrow shows the location of ROV recovery.

During dive 02, EK 60s (all frequencies) were operated at request of scientists interested in water column. 18 and 38 Khz EK 60 showed interference with ROV USBL (see Figure 28). Possible solutions to mitigate interference between USBL and EK 60 are being assessed.
