Measurement of Turbidity, Suspended Sediments and Nutrients in Three Rivers that Drain to the Achang Preserve from the Manell Watershed, Guam

NOAA TECHNICAL MEMORANDUM NOS NCCOS 268

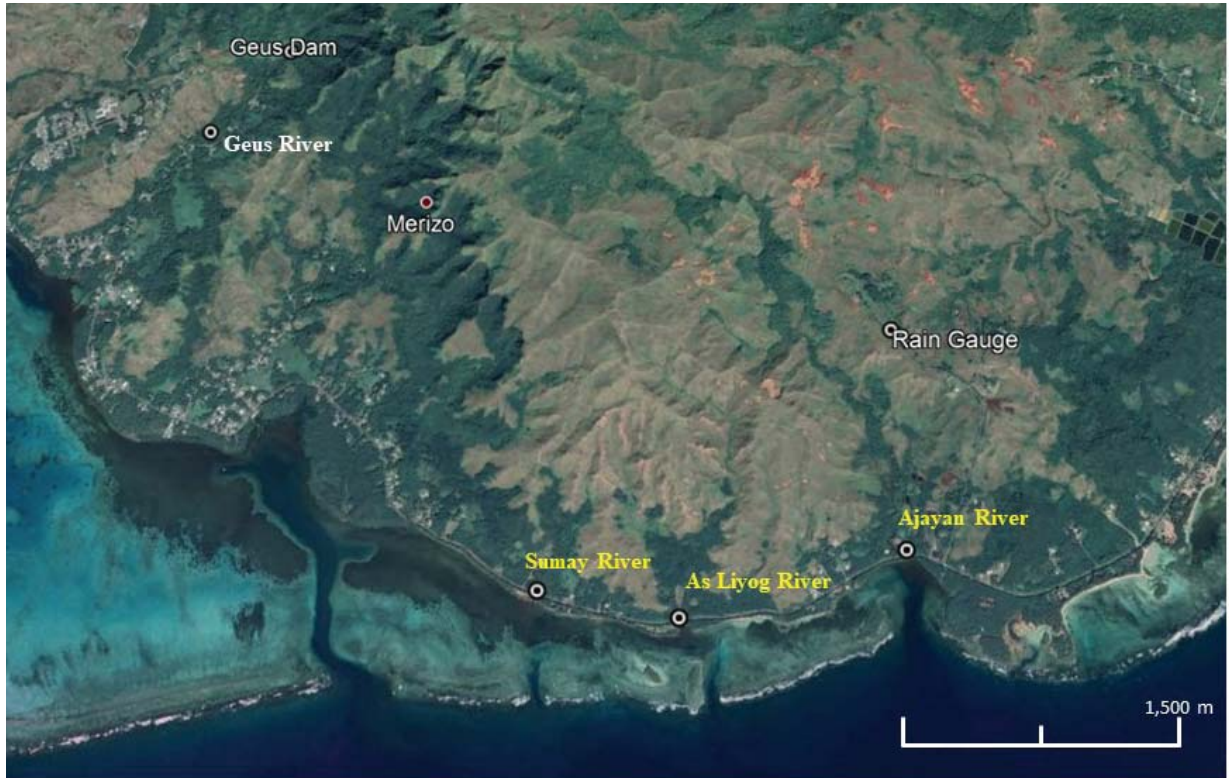
Figure 4. Location of the monitoring sites in the Manell watershed, along with the location of the rain gauge station.

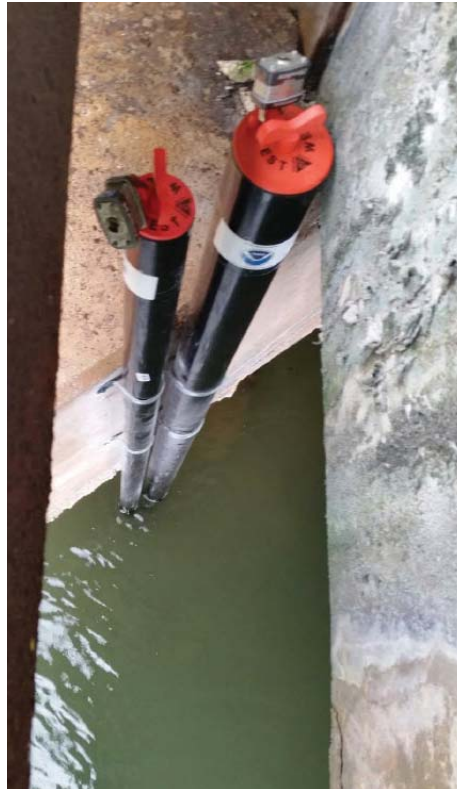
Figure 5. Photograph of turbidity logger (right) and level logger (left) housings attached to the Ajayan River bridge abutment.

A turbidity logger was deployed in the Ajayan River, within a separate dedicated PVC housing secured to the Ajayan Bridge (Figure 5). The turbidity logger was suspended in the water column approximately 0.46 m above the streambed. The turbidity logger was a Manta 2 water

quality logging sonde with a turbidity sensor equipped with a self-cleaning wiper. The As Liyog River was too shallow for a turbidity logger.

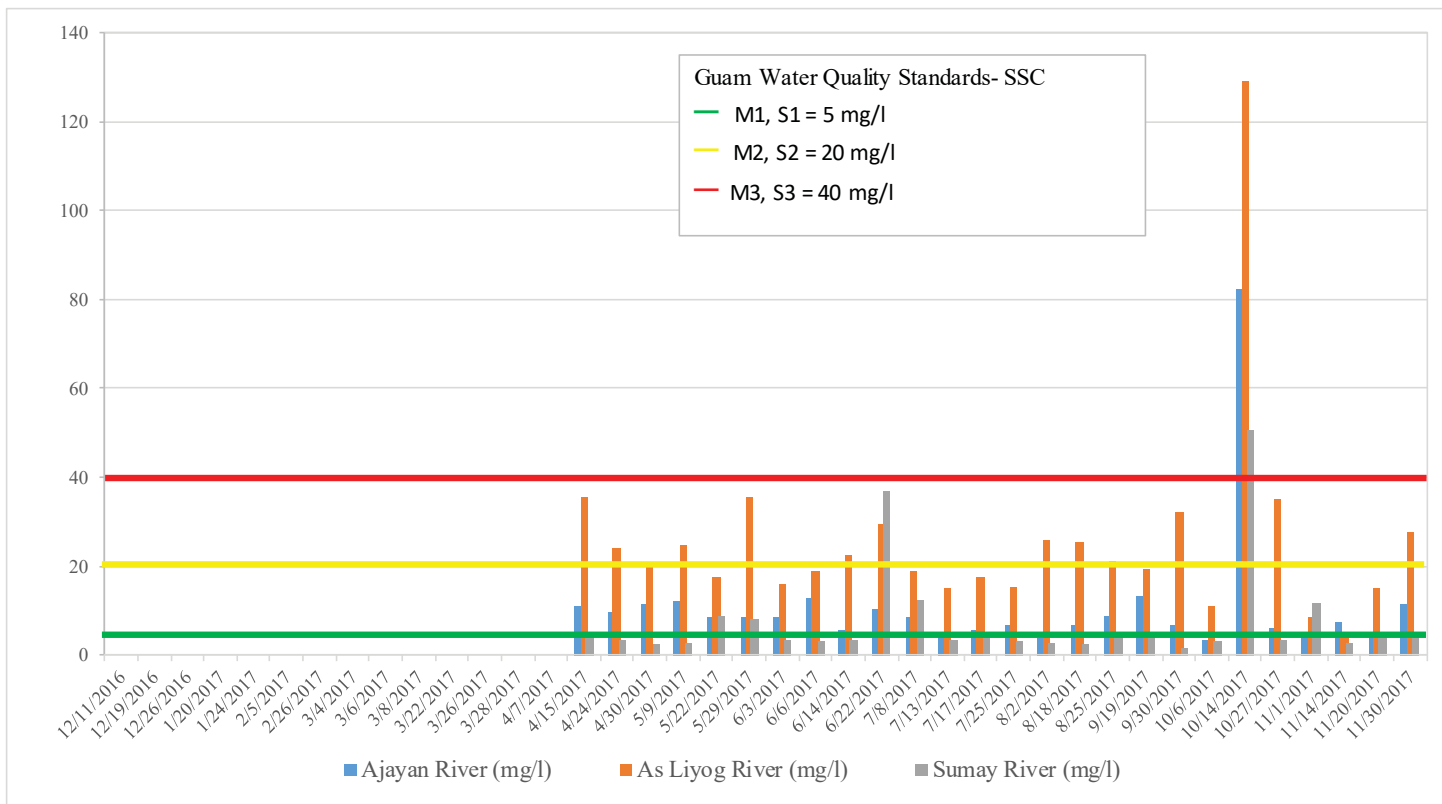
Figure 9a. Suspended sediment concentration (SSC) (mg/l) in the three rivers for the period 12/11/2016 - 11/30/17 compared to Guam water quality standards.

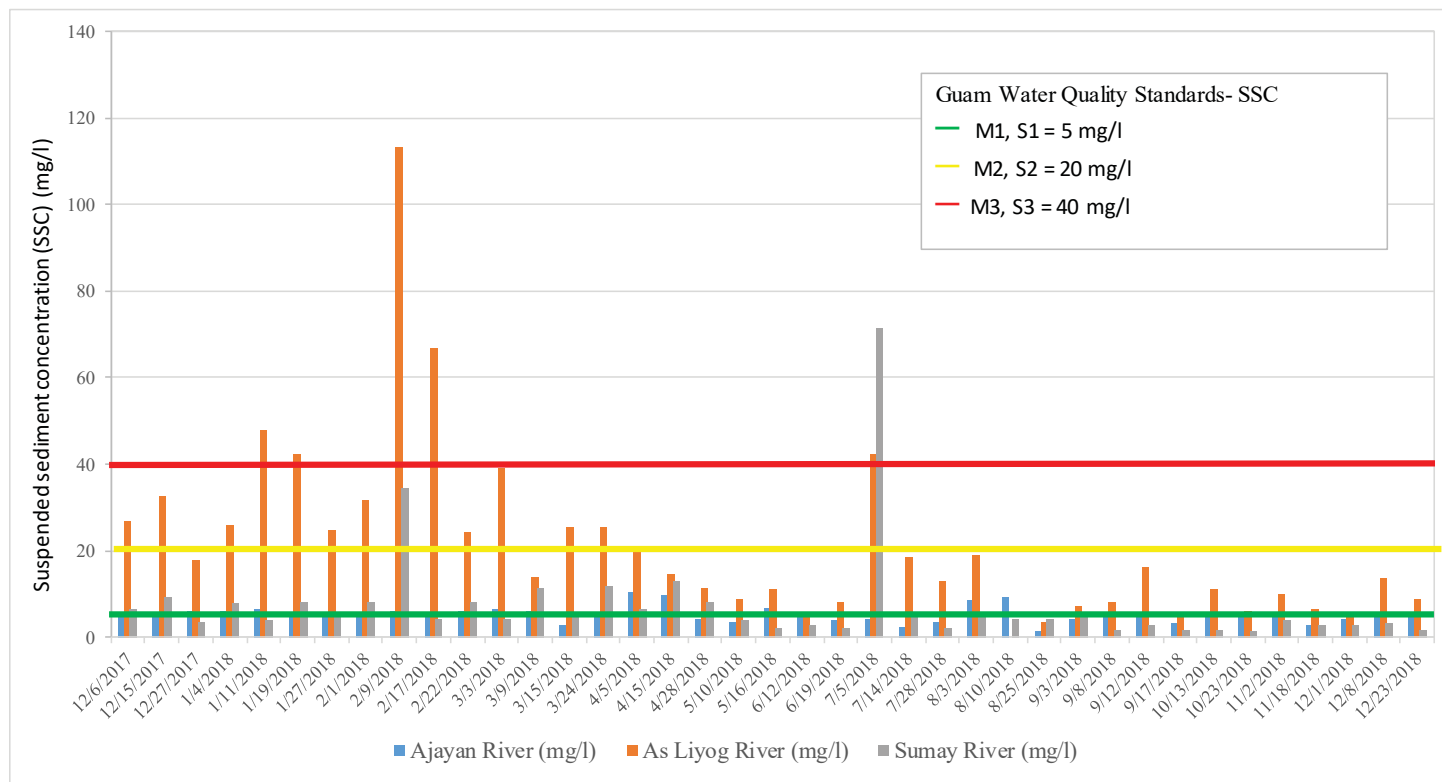
Figure 9b. Suspended sediment concentrations (SSC) (mg/l) in the three rivers for the period 12/6/2017 - 12/23/2018 compared to Guam water quality standards.

In Figure 9b, it appears that SSC could have been lower in the second half of 2018. A variety of factors could impact the SSC found

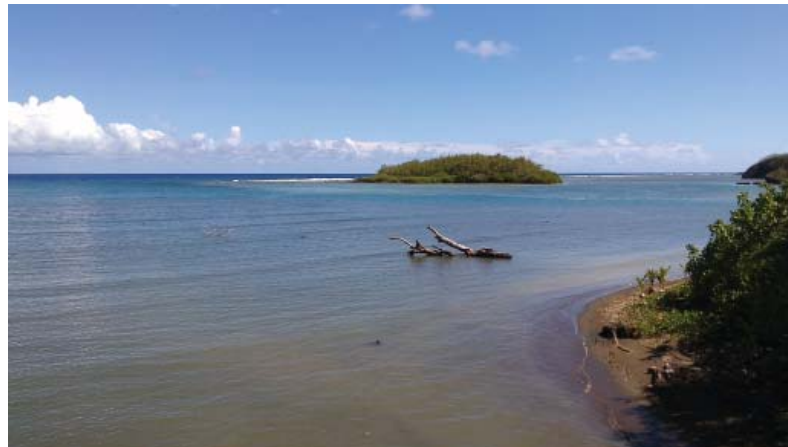
Figure 11. Outflow from the Ajayan River into the Achang Preserve. Note the turbidity plume going out into the Preserve.

sampling event, when water samples were collected for SSC and nutrients. Figure 11 shows an image of the turbidity plume moving out into the Achang Preserve from the Ajayan River.

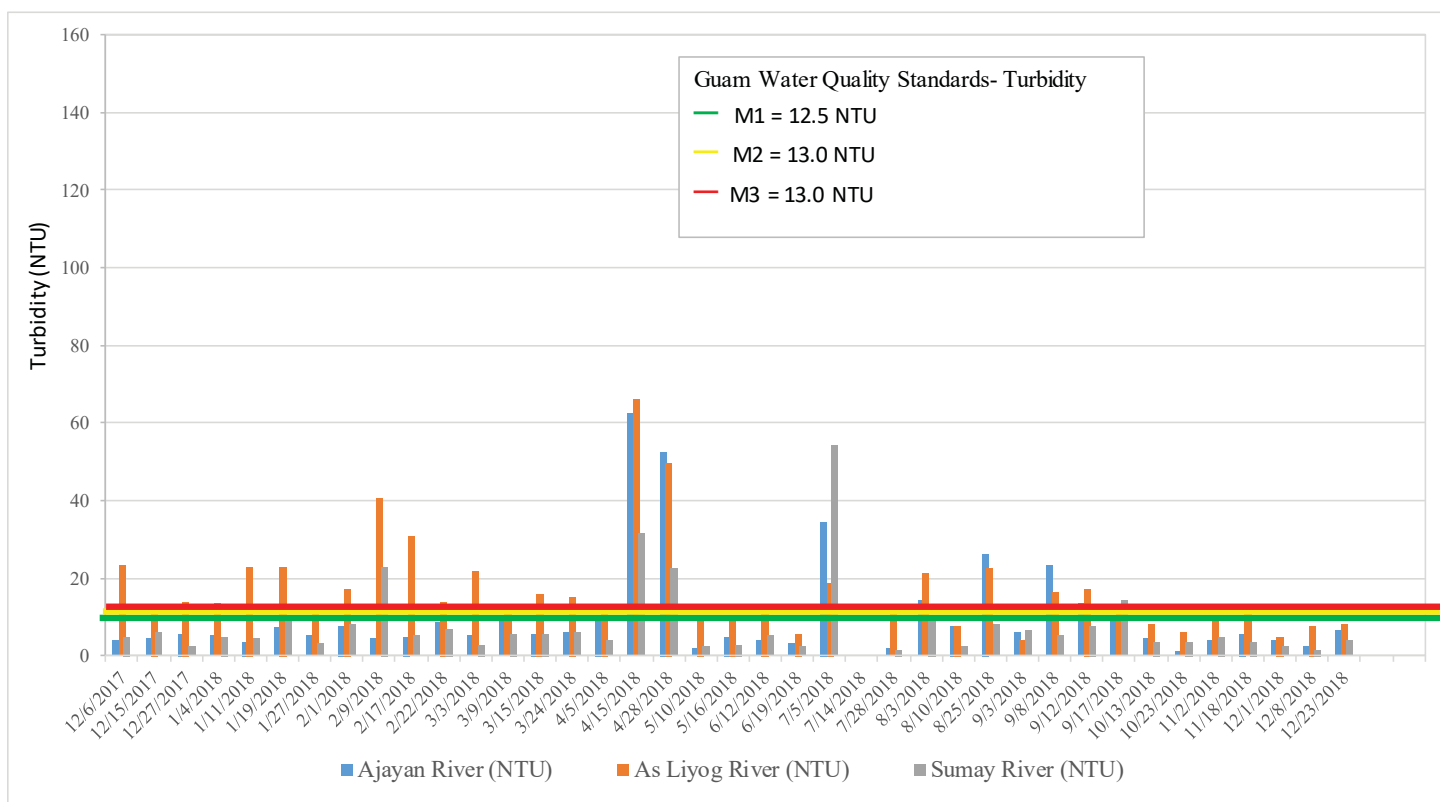
Figure 12b. Turbidity (NTU) in the three rivers for the period 12/6/2017 - 12/23/2018 compared to Guam water quality standards.

Graphs of the results of the Hach turbidity measurements over time can be seen in Figures 12a and 12b. The Guam turbidity standards for M1/S1 waters have been designated

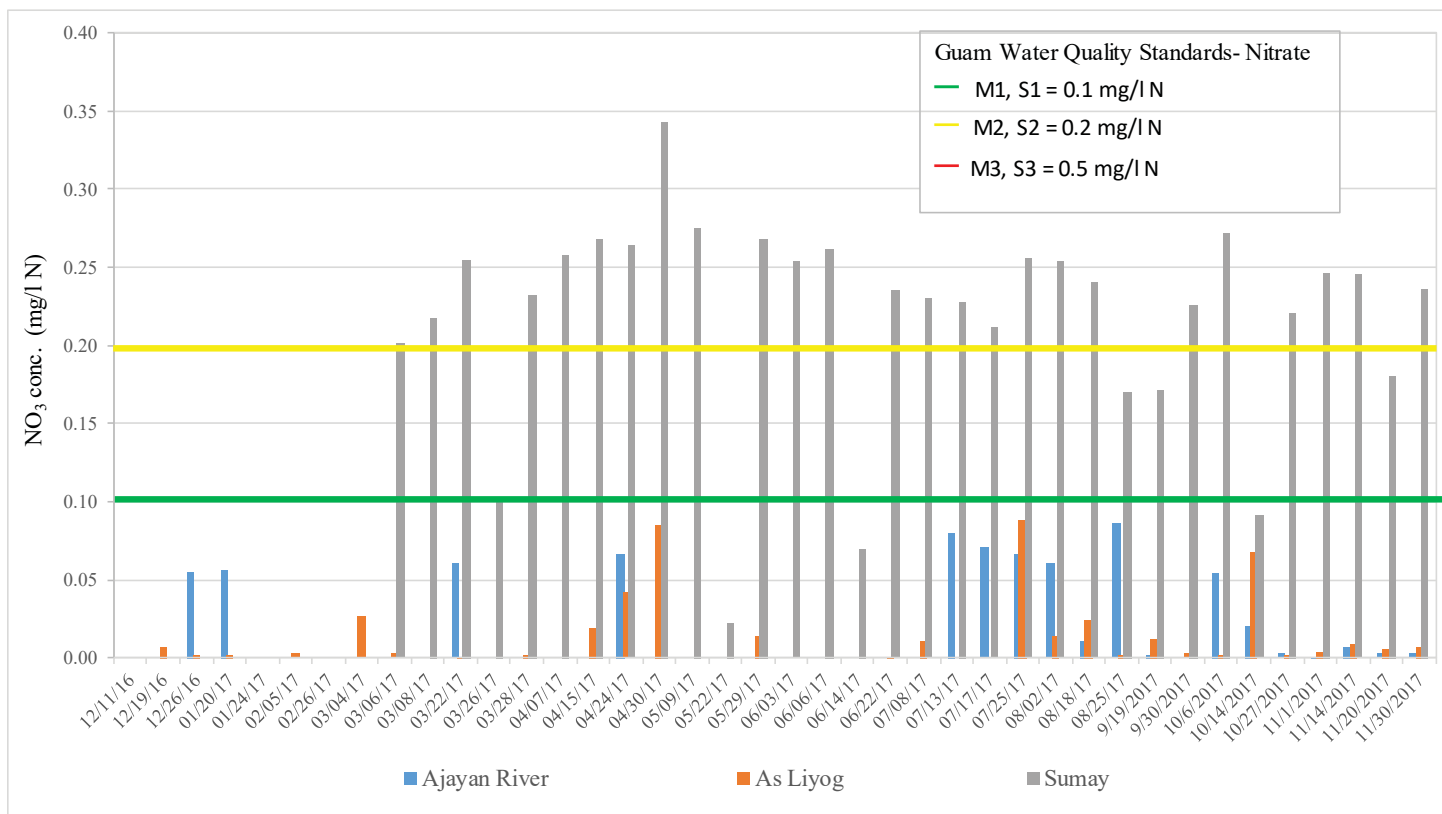
Figure 14a. Nitrate concentrations (mg/l) in the three rivers for the period 12/11/2016-11/30/17 compared to Guam water quality standards.

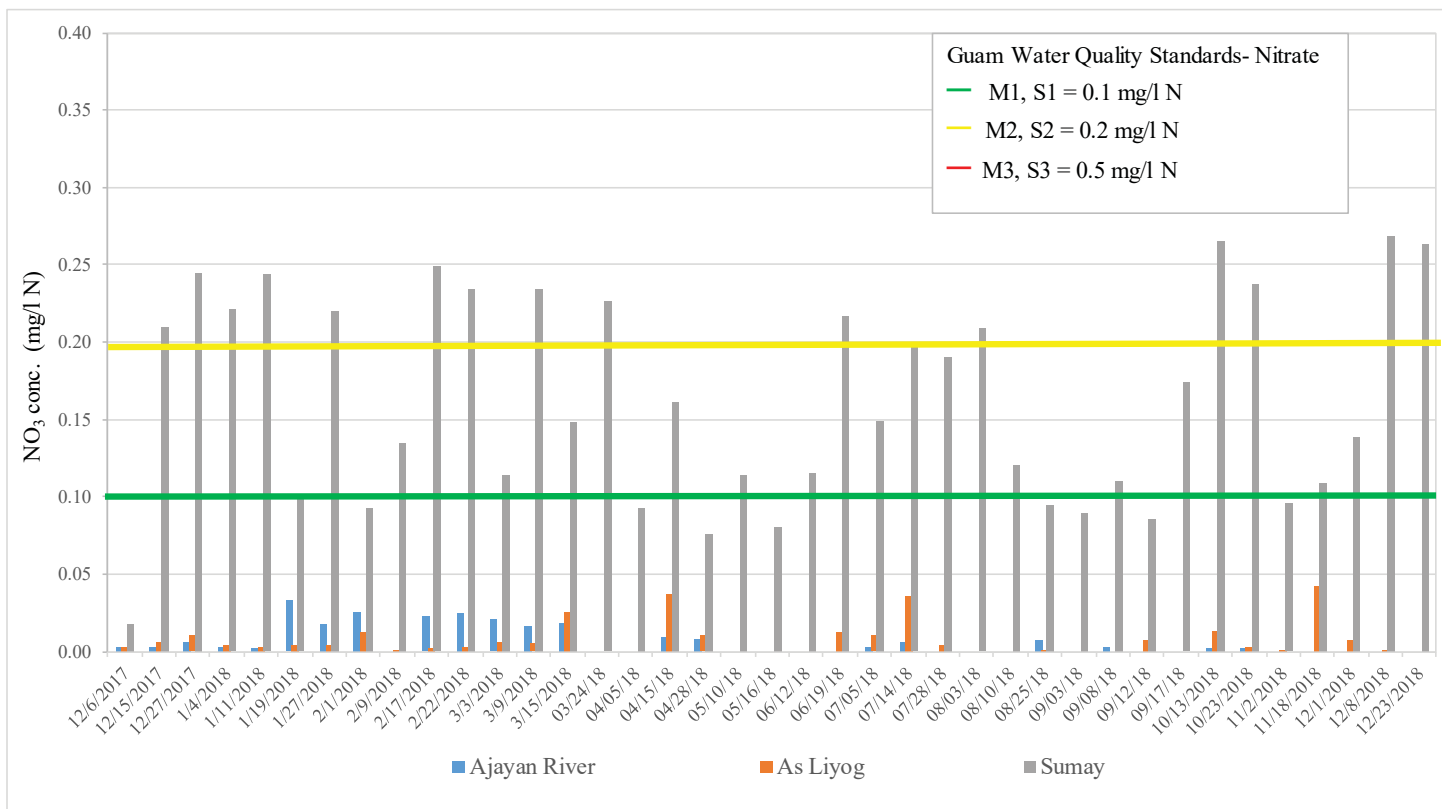
Figure 14b. Nitrate concentrations (mg/l) in the three rivers for the period 12/6/2017-12/23/18 compared to Guam water quality standards.

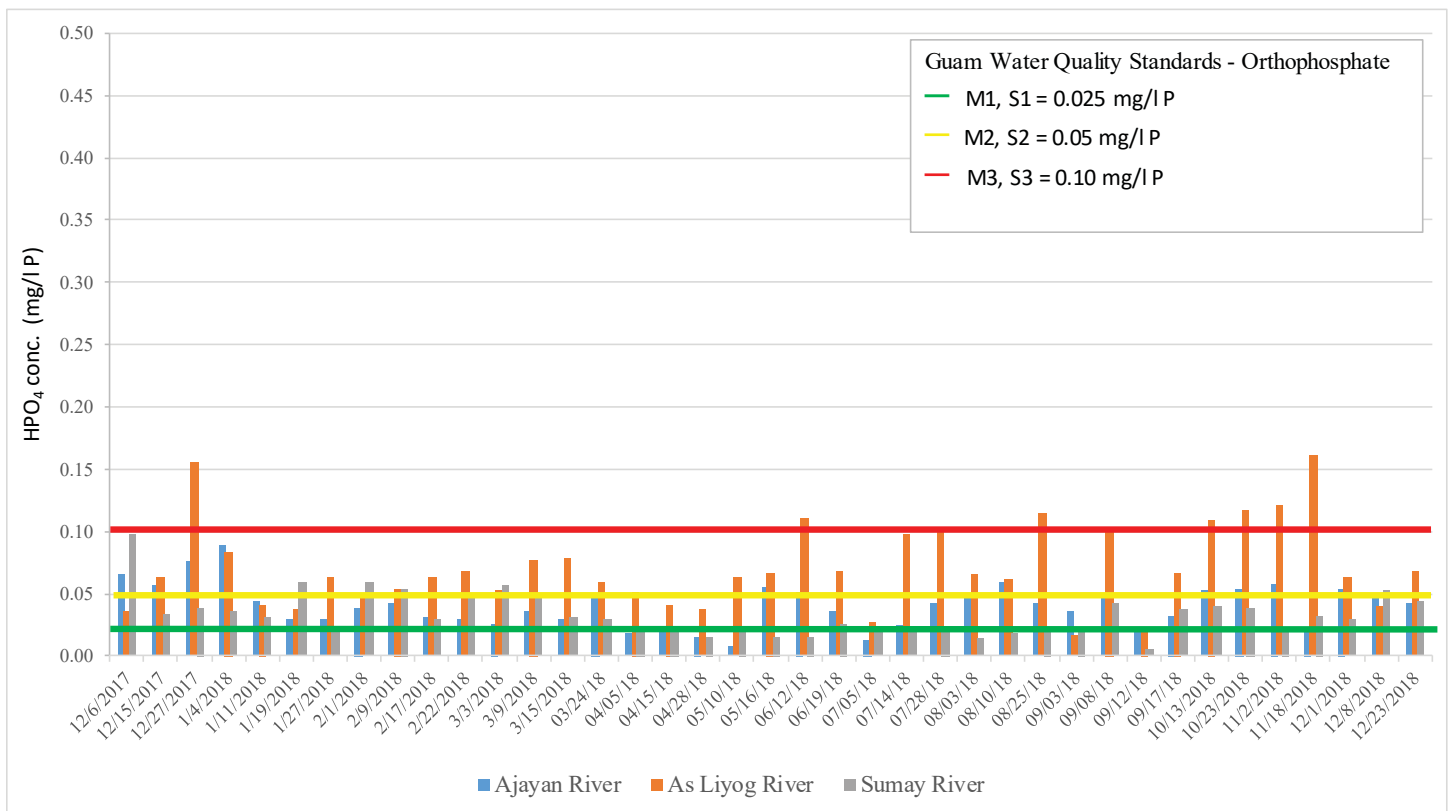
Figure 16b. Orthophosphate (HPO₄⁻) concentrations (mg/l) in the three rivers for the period 12/6/2017 - 12/23/2018 compared to Guam water quality standards

The results of the monitoring of orthophosphate for the Ajayan, As Liyog and Sumay river sites are shown graphically in Figure 16a and 16b. Superimposed on both graphs are the Guam water quality standards for orthophosphate for marine and surface waters. In Figure 16a, it can be seen that all three sites exceeded not only the M1/S1 (excellent) and M2/S2 (good) standards, but at times, all three sites exceeded the M3/S3 (fair) standard of 0.025 mg/l orthophosphate.

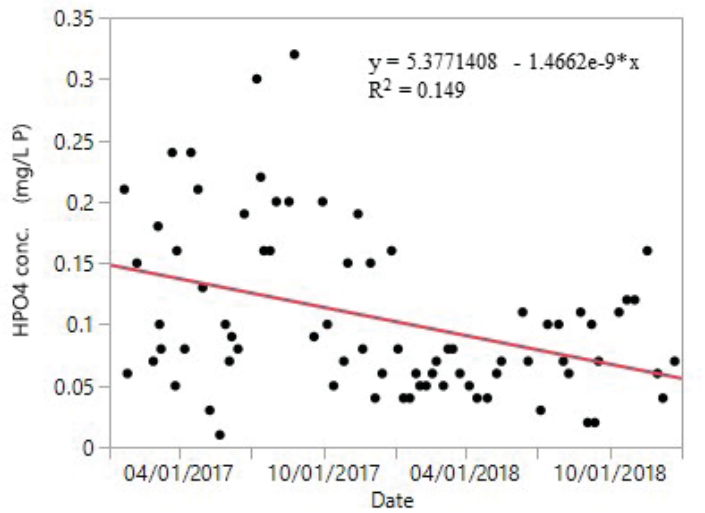
Figure 17b. Orthophosphate over time in water samples from the As Liyog River site.

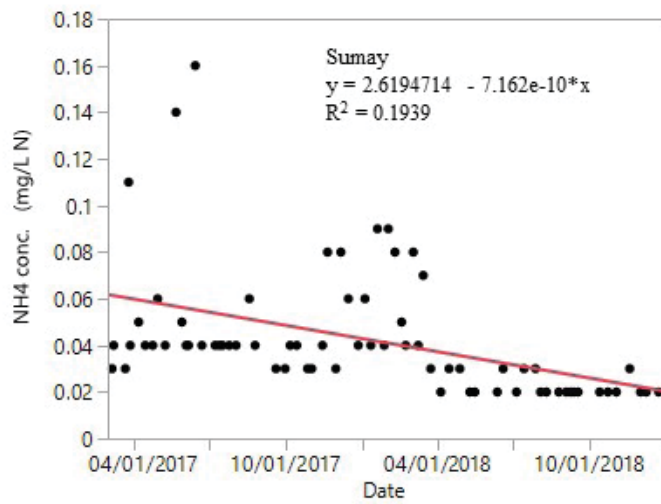
Appendix D. Ammonium concentrations over time at the three sites in the Manell watershed.

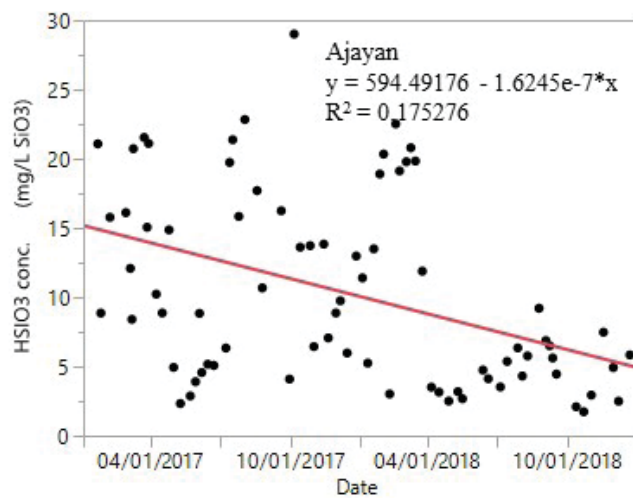
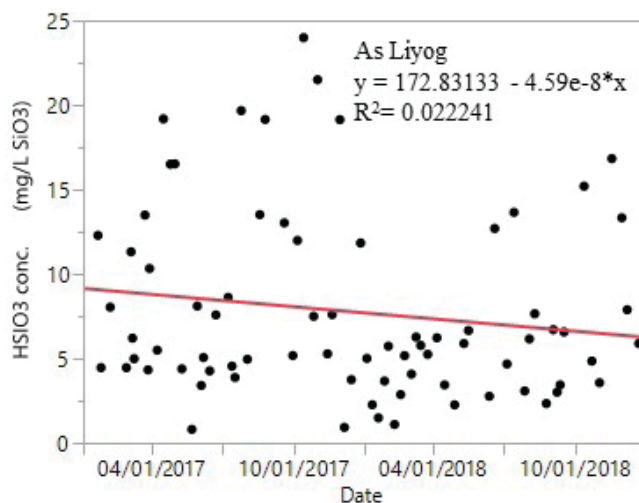
Appendix E. Silica (HSiO_3^-) concentrations over time at the three sites in the Manell watershed.
