SENTRY OPERATIONS REPORT FOR THE
PC1705 DEMOPOULOS CRUISE
DRAFT

WHOI Sentry Operations Group

NOAA Ship Pisces — Sept 12, 2017 to September 25th, 2017

Publication Date: September 22, 2017

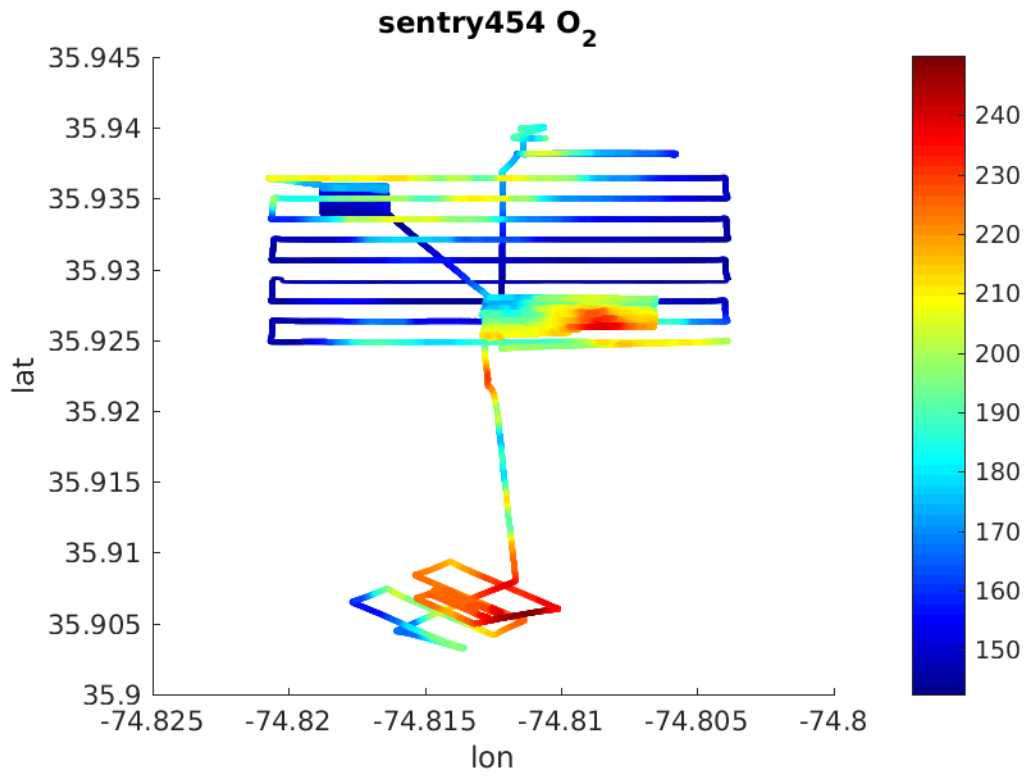
Figure 6: O₂ sensor data during dive 454.

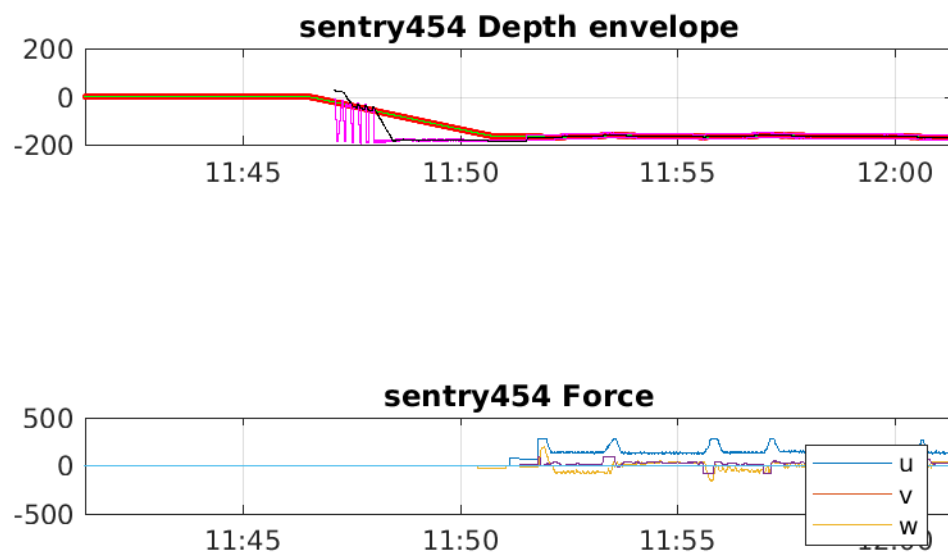
Figure 8: Bottom Approach for during dive 454.

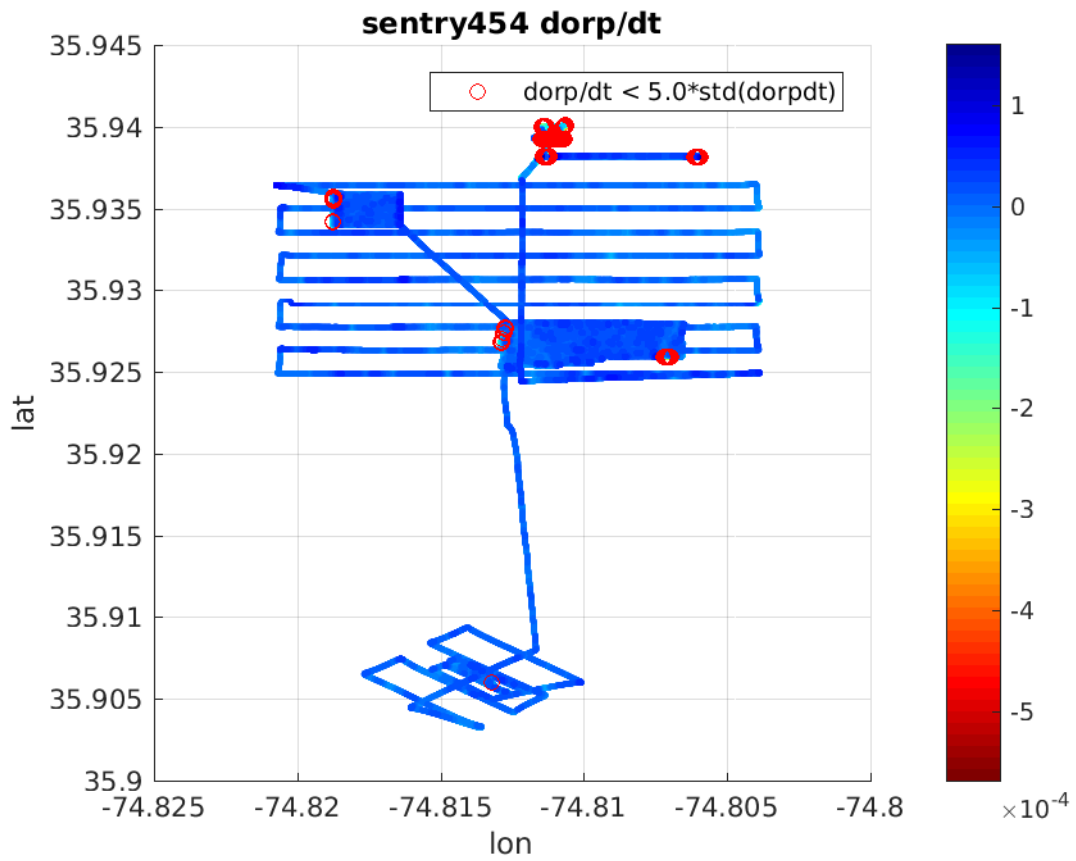
Figure 9: MAPR orp data during dive 454.

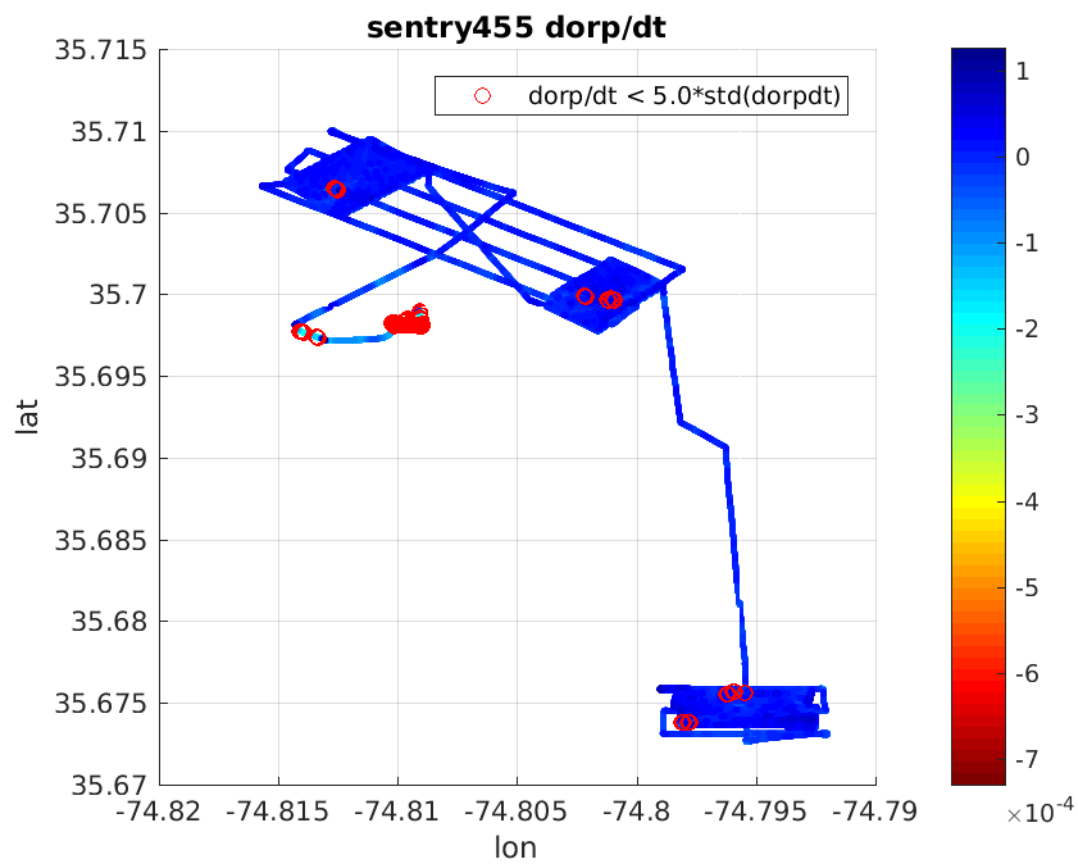
Figure 14: ORP sensor data during dive 455.

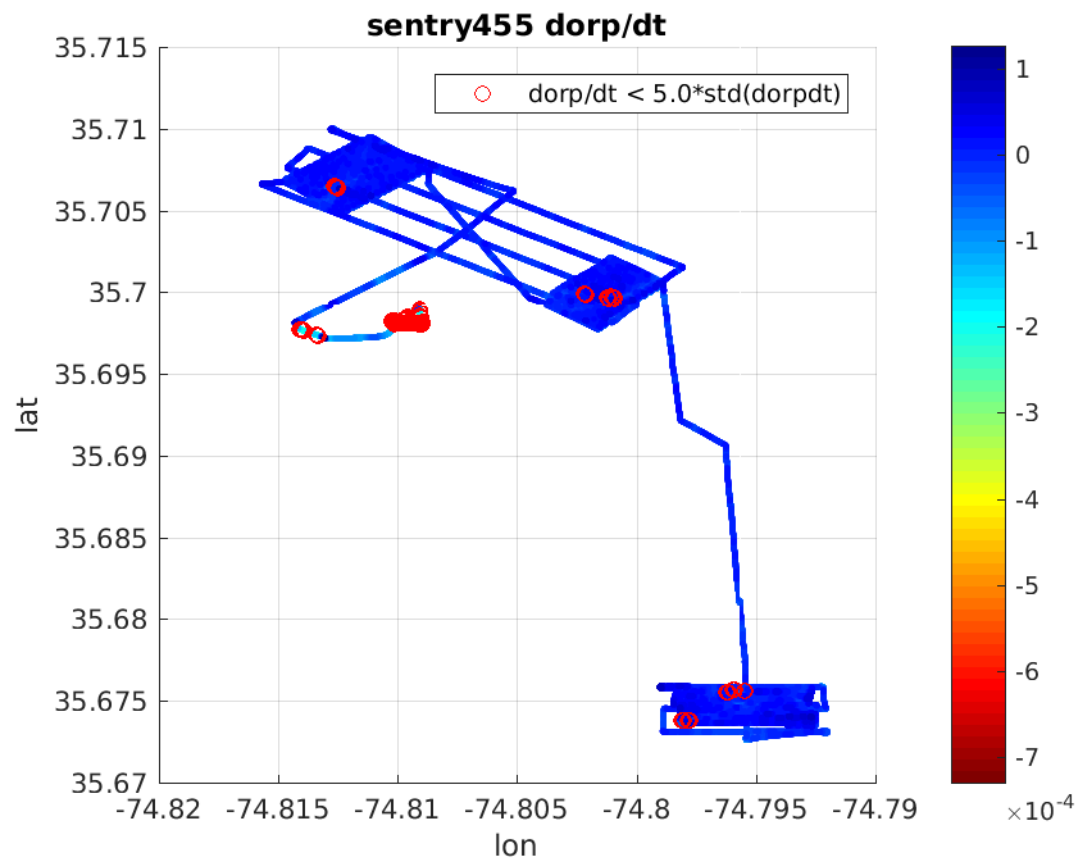
Figure 17: MAPR orp data during dive 455.

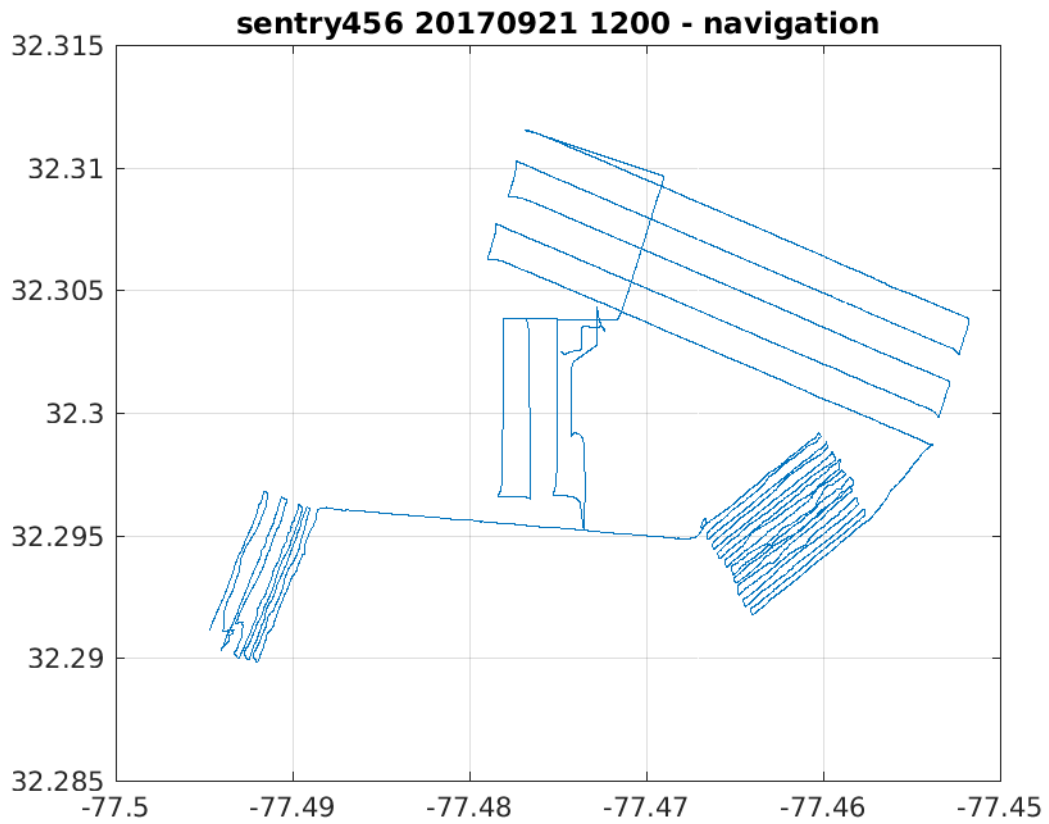
Figure 18: Latitude/Longitude plot of Sentry dive 456 based on post-processed navigation.

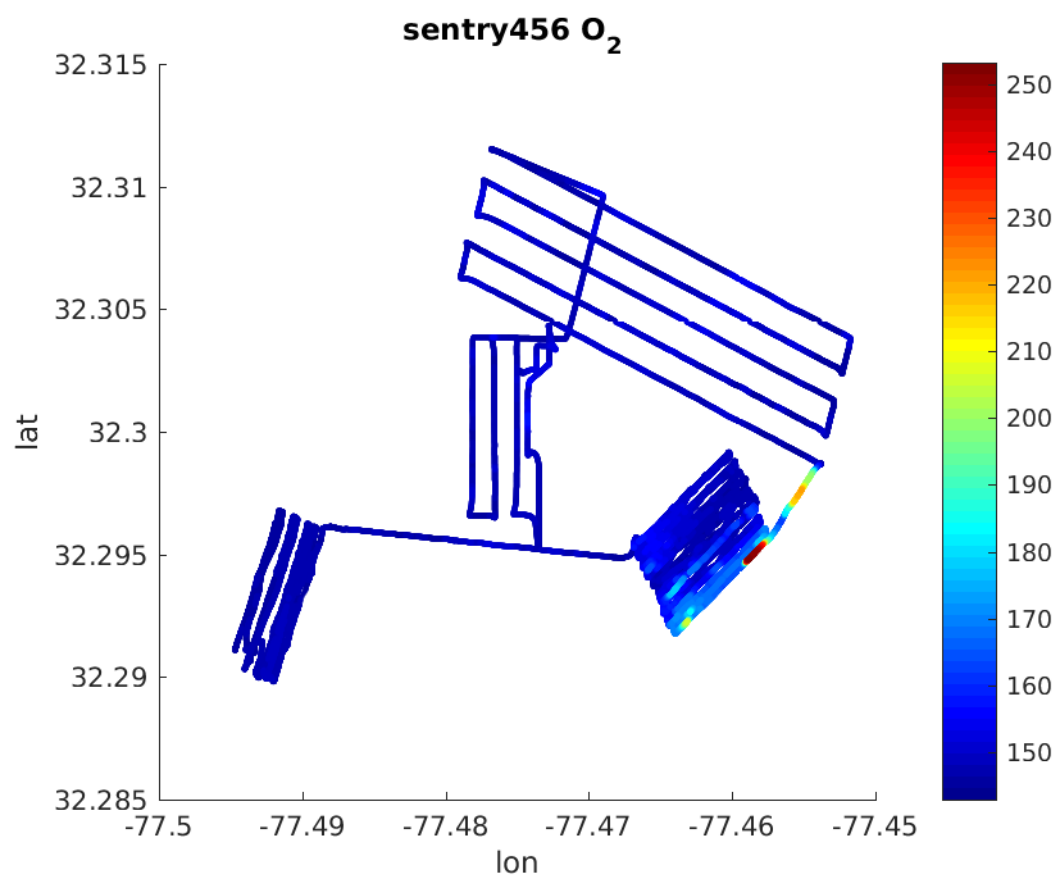
Figure 23: O₂ sensor data during dive 456.

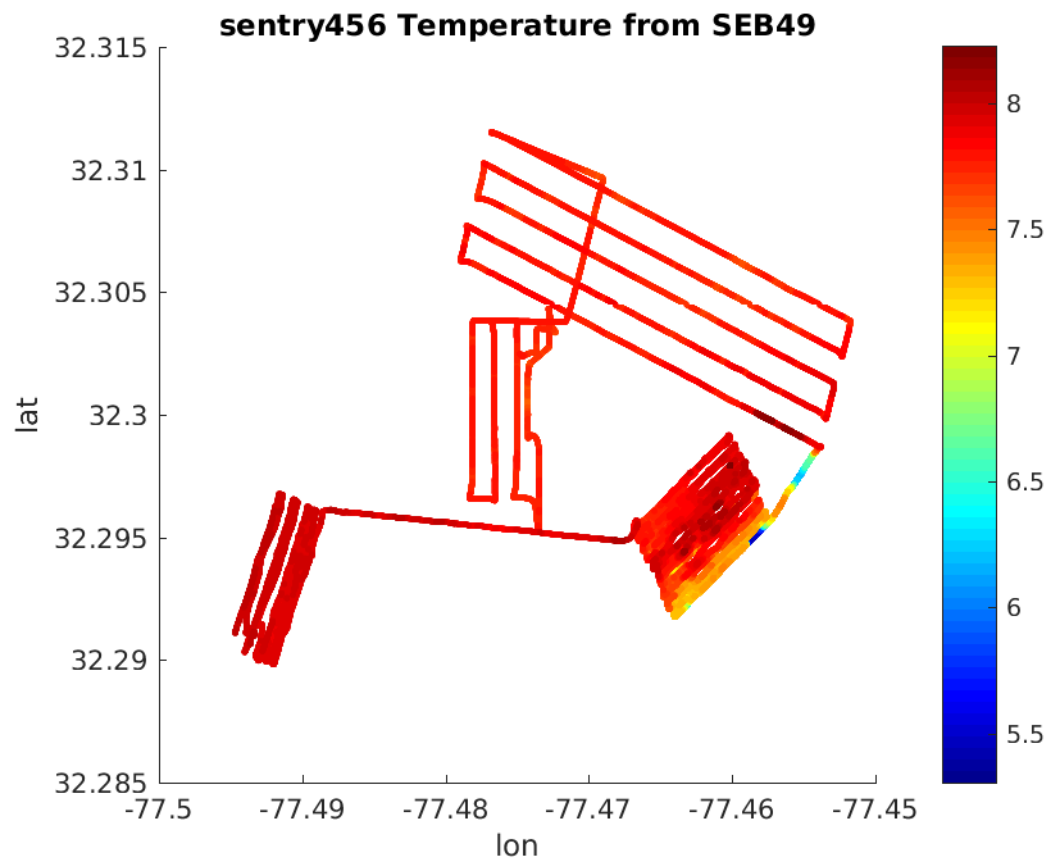
Figure 24: Temperature sensor data during dive 456.

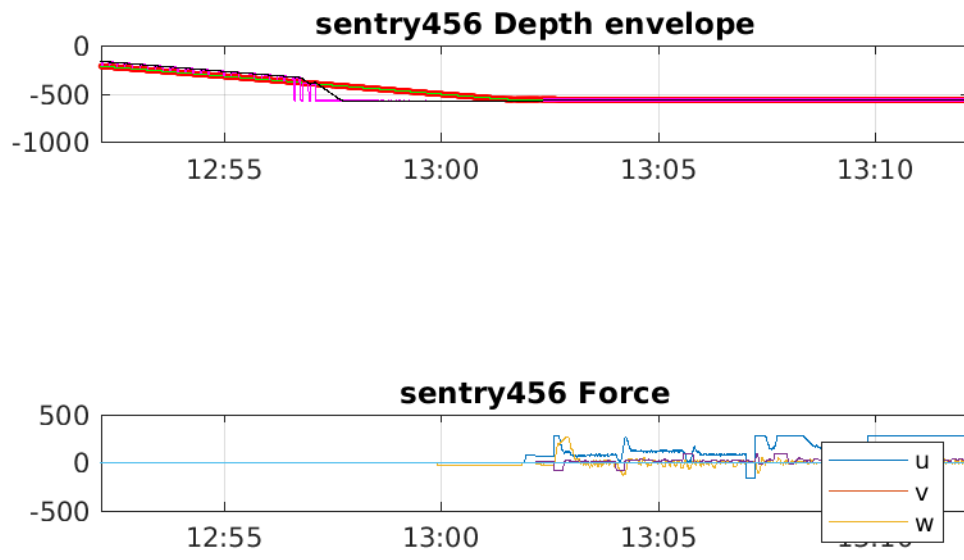
Figure 25: Bottom Approach for during dive 456.

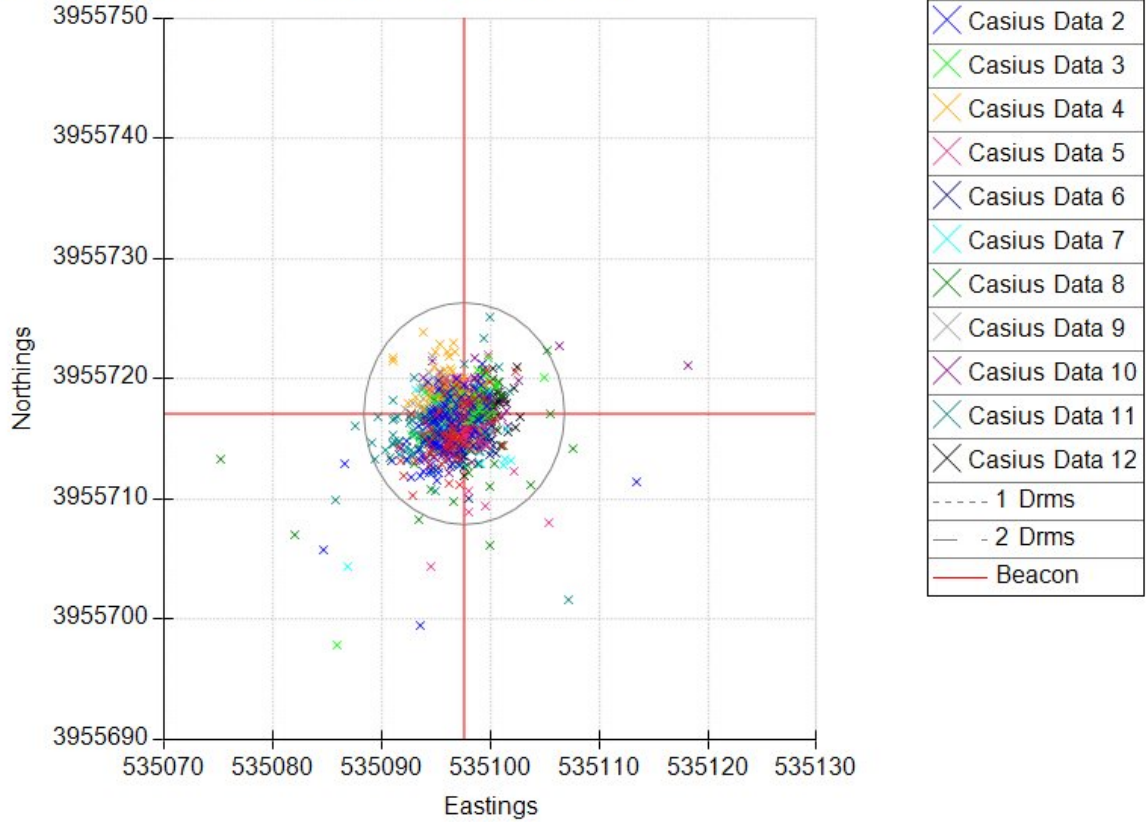
2D Scatter - After CASIUS

Before CASIUS (distance)	After CASIUS (distance)	Before CASIUS (% depth)	After CASIUS (% depth)
39.4% Beacon Positions (1 sigma)	9.0m	2.1m	0.62	0.14
50.0% Beacon Positions (CEP)	9.9m	2.4m	0.68	0.17
63.2% Beacon Positions (1 Drms)	11.3m	2.9m	0.78	0.20
86.5% Beacon Positions (2 sigma)	14.0m	4.6m	0.97	0.31
98.2% Beacon Positions (2 Drms)	17.5m	9.2m	1.20	0.63

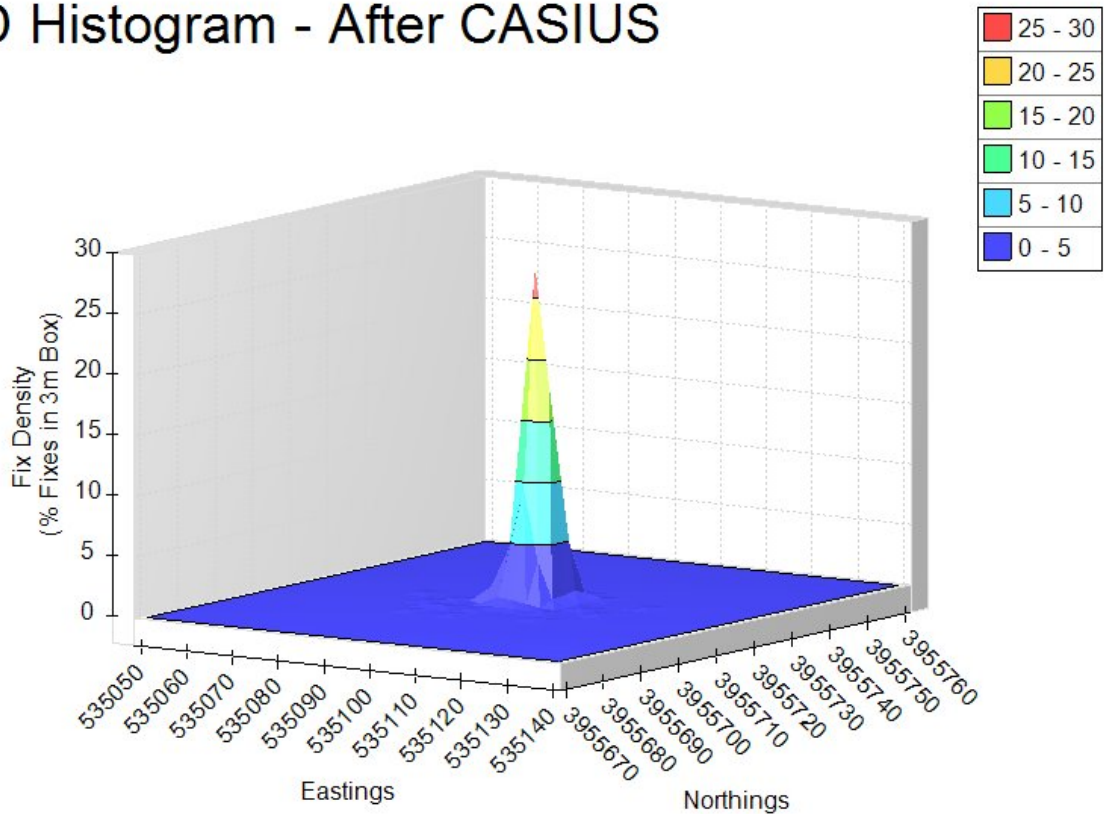
3D Histogram - After CASIUS
