Watershed restoration as a tool for improving coral reef resilience against climate change and other human impacts

Austin J. Shelton III^{a,*} and Robert H. Richmond^b

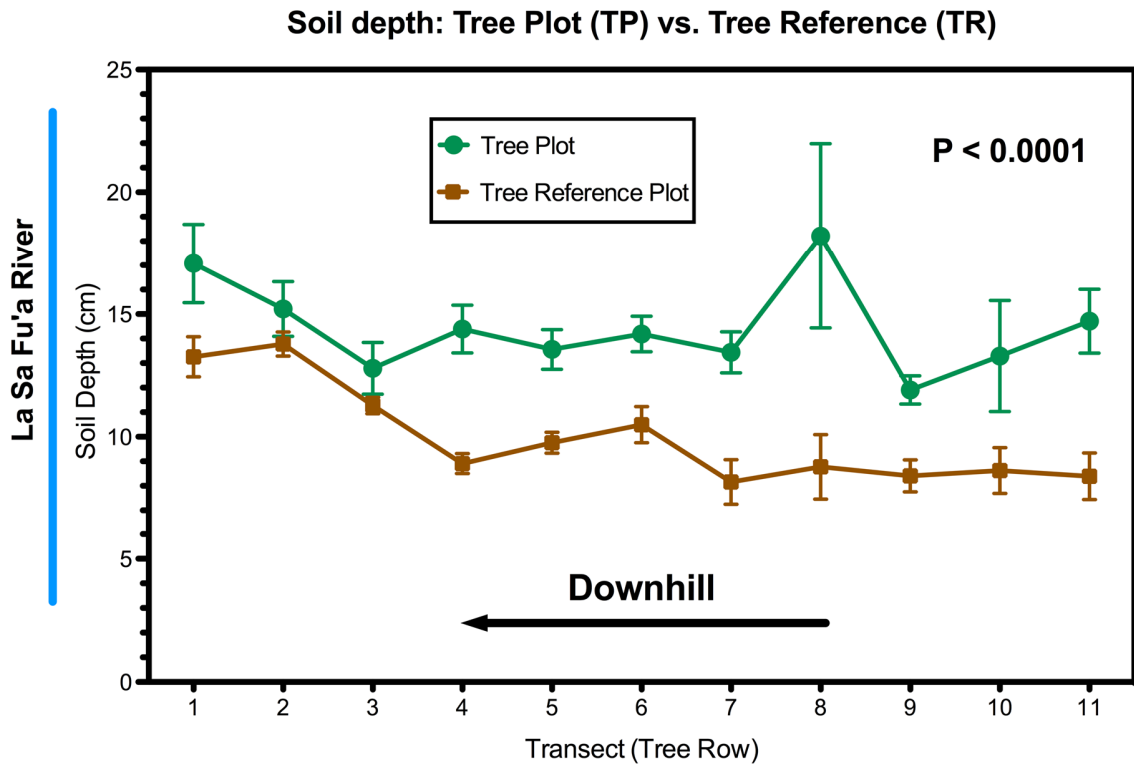
Figure 3. Soil depth of tree planting plot vs. reference plot: Soil accumulation was measured in Restoration Plot 2 using soil probes and compared between the Tree Plot and Reference Plot. The mean soil depth difference between the two areas was 4.46cm. The total mass of accumulated soil in the tree plot was 77.2 metric tons. Error bars indicate standard error of mean (SEM). ($P < 0.0001$, $t = 6.6$, $df = 20$)

The mean soil depth at TP was 14.5 cm and 10.0 cm at TR (Figure 3). The difference in mean soil depth between the plots indicated 4.5 cm of sediment accumulation in the TP site. A t-test indicated the difference was extremely significant ($P < 0.0001$, $t = 6.6$, $df = 5.426$). Over the 1652 m² area of the tree plot, the accumulation yielded a mass of 104.8 metric tons based on a bulk density of 1410 kg m⁻³ calculated from onsite soil samples (Equation 1, Table 1). There was no significant difference between TP soil depth measurements taken directly behind trees and those taken in open spaces. However, soil depth measurements behind trees were significantly greater than soil depth measurements taken in TR ($P < 0.0001$, $t = 6.606$, $df = 83$) (Figure 4).

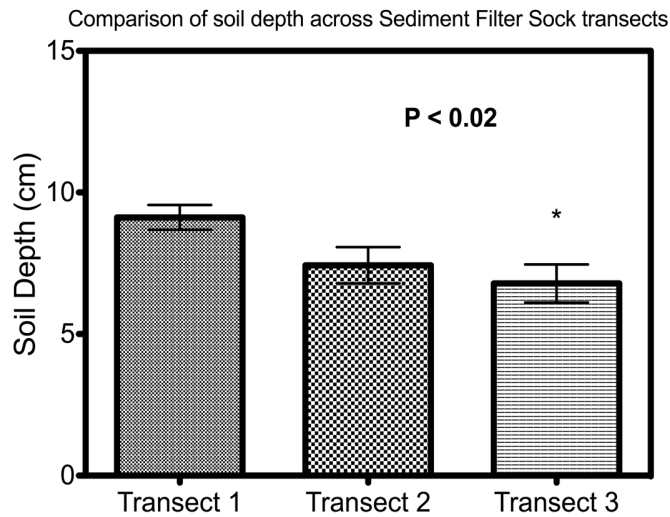
Figure 7 Parallel transects were placed at 1, 2, and 3 m distances behind each sediment filter sock (Figure 1). The mean soil depth of transects across all socks was compared. Soil depth decreased with increasing distance from socks. Error bars indicate standard error of mean (SEM). * indicates statistical significance ($P < 0.02$, $F = 4.367$, $df = 38$)

Field measurements uphill of sediment filter socks revealed that at least 115m² of soil surface was influenced by the presence of the socks. The majority of sediment typically collected directly behind the uphill side of the socks and tapered off with increasing distance from the socks (Figure 6). The mean soil depth of transects across all socks was compared. Soil depth decreased with increasing distance from socks ($P < 0.02$, $F = 4.367$, $df = 38$) (Figure 7).

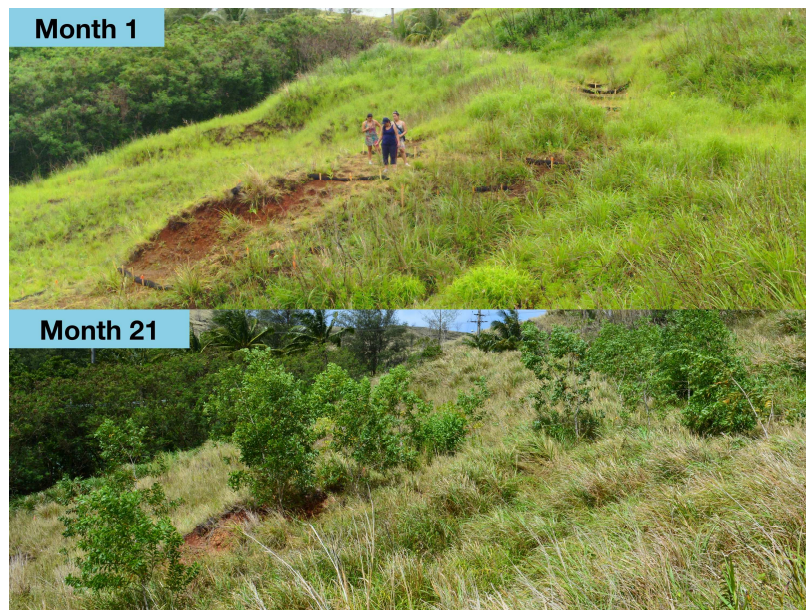
Figure 8 Time series photographs of Restoration Plot 2 Sock Plot (SP). Sediment filter socks were installed and *Acacia auriculiformes* tree seedlings were interspersed between the socks. Trees displayed healthy characteristics and heights of 7 m or greater 21 months after tree seedlings were planted.

The tree seedlings in TP were observed 21 months after planting (Figure 8). Their health was characterized based on height, foliage color and density, and thickness of branches and trunk. *Acacia auriculiformes* trees were 2 m to 6 m in height. The largest and most robust acacias in TP were those planted closest to the river. The growth of uphill acacia trees appeared stunted. There was evidence of deer rub scarring on tree barks. The native species grew less than 1 m. 13.6% of native species and 69.7% of acacias planted had survived (Table 3). There may be more surviving native trees hidden in tall grass and unaccounted for. None of the *Casurina equisetifolia* seeds that were scattered in and behind the uphill side of sediment filter socks germinated. Acacia trees in SP displayed stronger health indicators than TP acacias. The SR trees had thick layers of leaf litter under their canopies, flowering branches, and tree seedlings sprouting (Figure 9). Some trees grew to 8 m.

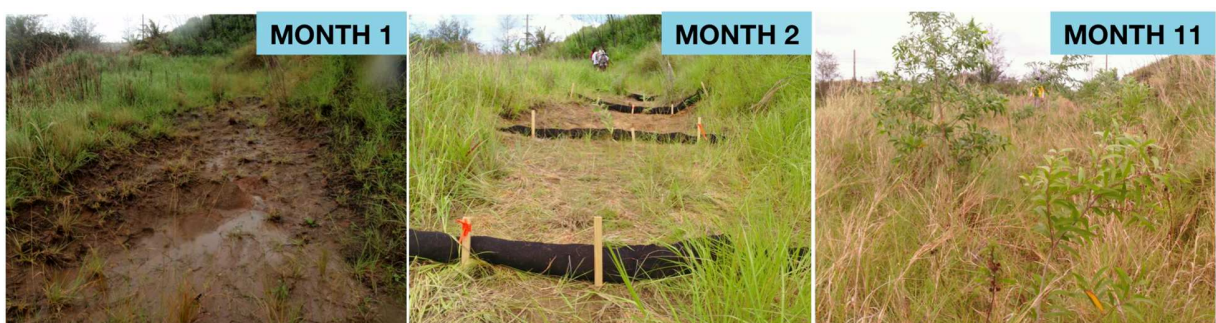
Figure 9 Time series photographs of Restoration Plot 2 Sock Plot (SP). An eroding hillside was chosen for treatment. Sediment filter socks were installed and *Acacia auriculiformes* tree seedlings were interspersed between the socks. The area was nearly completely revegetated after 11 months.

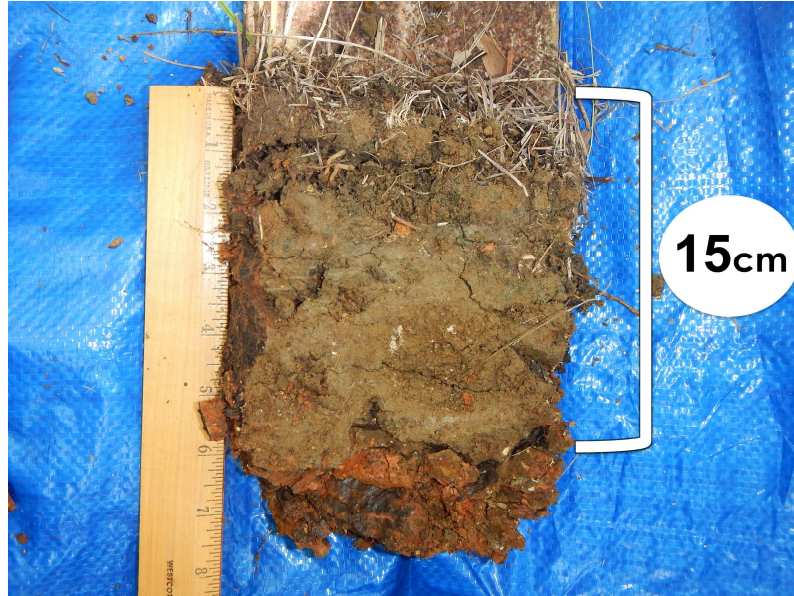
Figure 10. A soil profile removed from the ground used to confirm soil depth measurements taken with a soil probe. The top 15cm in the profile represents accumulated soil and detritus that deposited behind the sock. The soil profile displays a discontinuity at 15 cm depth and a shift to hardpan soil, or the pre-existing soil base.

A soil profile was removed from the ground in SP to verify soil depth measurements collected with the soil probe (Figure 10). The top 15 cm in the profile represents accumulated soil and detritus that deposited behind the sock. The soil profile displays a discontinuity at 15

cm depth and a shift to hardpan soil, or the pre-existing soil base. The 15 cm of accumulation was consistent with soil depth measurements using a soil probe in the same area.
