Impact of Hurricane Irma on Keewaydin Island, Southwest Florida Coast

Abstract: *Hurricane Irma made landfall along the southwest coast of Florida on September 10, 2017 with a sustained wind speed of 100 kts, causing extensive coastal erosion and overwash on Keewaydin Island. Pre- and post-LiDAR data analysis shows that the northern and central sections of the island sustained foredune erosion and vegetation loss, while the southern-most spit experienced minimal erosion. Analysis of LiDAR data since 2004 also show persistent erosion for most of the island while southern end is continuously prograding in the direction of the longshore current.*

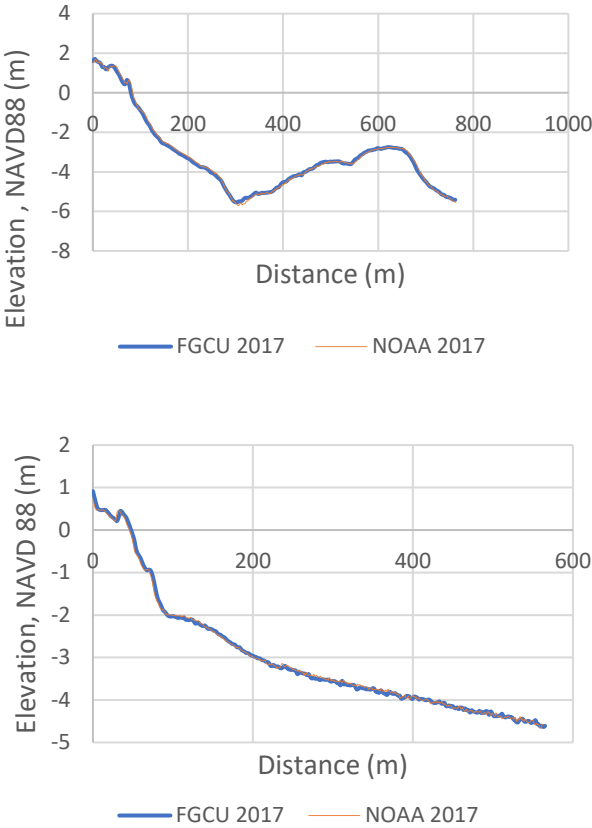
Figure 2. Beach profile comparison for skill assessment of DEM generation. Profiles extracted from the NOAA DEM compared with the DEM generated for this study. Data shown for monuments R-91 (top) and R-130 (bottom).

Elevation Model (DEM). Florida Department of Environmental Protection (FDEP) has established benchmark monuments at 1000-foot (304.8 m) intervals along the entire Florida coast. These R-monument locations were superimposed on the raster DEM, and shore normal profiles, extending from the R-monument to the seaward extent of the LiDAR foot prints, have been extracted. For the post-Irma LiDAR survey, we compared the generated DEM with that provided by NOAA and found that the accuracy of the DEM development is consistent with that of NOAA's. Results from this analysis are provided in Figure 2.

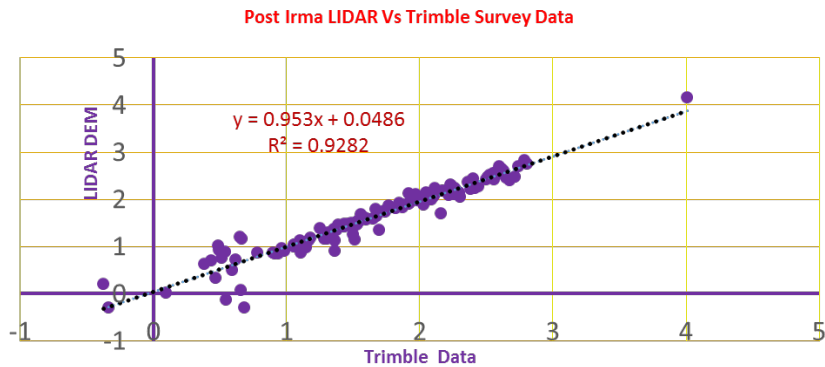
Figure 3. Validation of LiDAR data using post-Irma beach survey from a Trimble RTK unit.

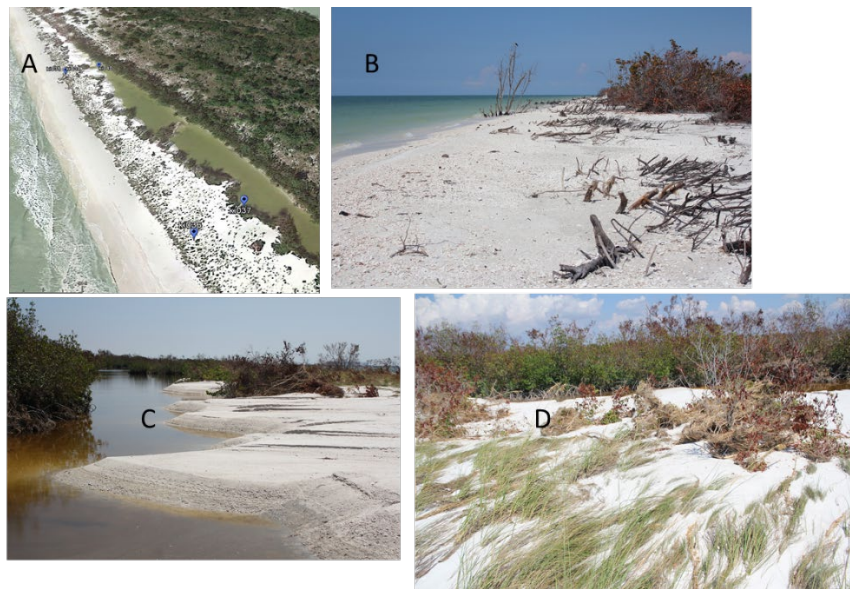
Keewaydin Island underwent significant geomorphologic change from the landfall of Hurricane Irma. Extensive beach erosion and overwash occurred at many locations (Figure 4). Points ki037 and ki040 in Figure 4A are located on overwash fans, which were deposited into the swale behind the beach during Hurricane Irma. Fans having thicknesses up to 2 m were observed towards the southern region of the island (Figure 4C). Also, most of the deeply buried stumps of Australian Pine trees, trees that were removed in a restoration effort in the late 1990s, were exposed when the hurricane-generated waves and storm surge stripped sediments from the foreshore (Figure 4B). However, near the southern terminus of the island, no major erosional features were observed, except for some vegetation loss towards the southern end.

Figure 4. Beach erosion and overwash observed on Keewaydin Island after Hurricane Irma.

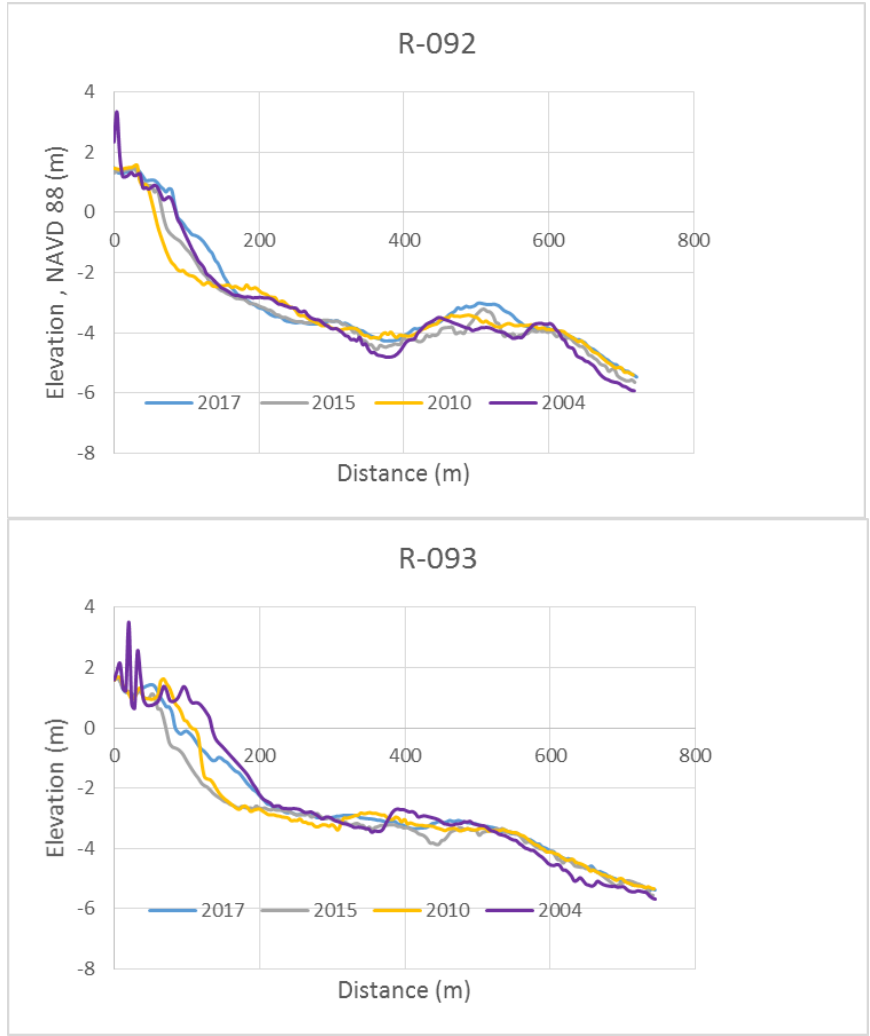
In the northern region of the island, a series of detached breakwaters were constructed in 1990's for beach stabilization. Along this section of the Keewaydin Island (R-monuments 92 and 93), foredune receded landward and deflated over time (Figure 5). The dunes present in 2004 were missing from the 2010 survey, indicating that Hurricanes Wilma and Katrina in 2005 caused extensive erosion in this northern region. For mid-island locations (R-110 and 111), foredunes

Figure 5. Beach profiles overlain for two northern stations along the Keewaydin Island.

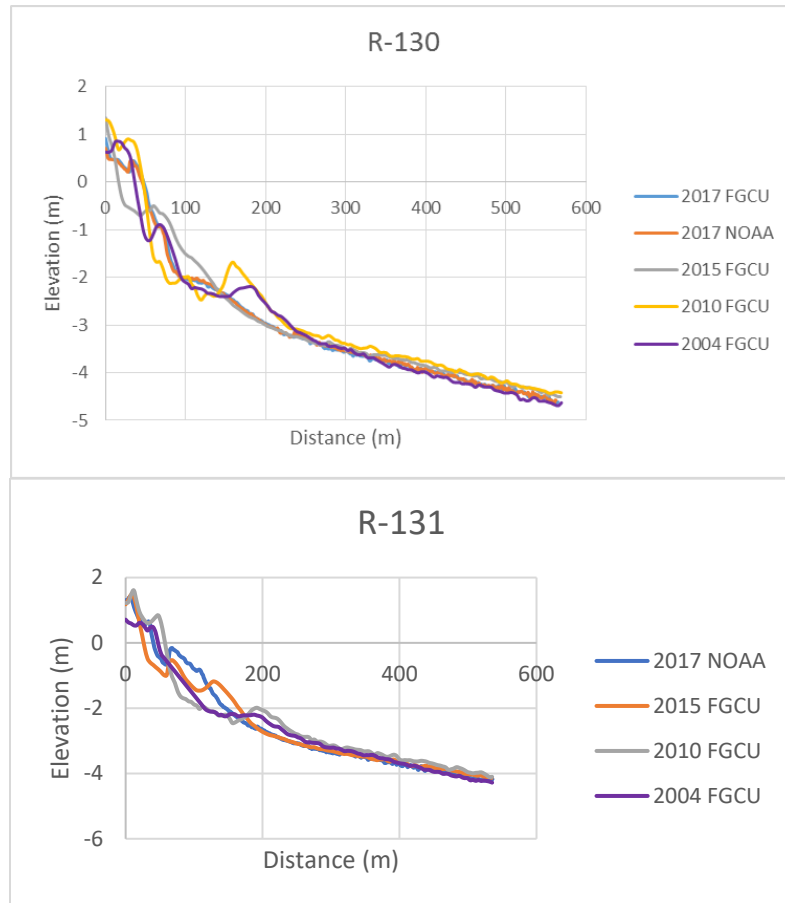
prograded seaward between 2004 and 2010 (Figure 6), but then retreated in 2017. Obviously, this retreat of foredunes from 2017 was due to erosion from the landfall of Hurricane Irma. The foredunes from the southern-most section of the island (Figure 7) show higher elevations in 2017 than previous years as well, with the exception of 2010. It is worth noting that consistent frontal beach erosion has been observed for most of the northern and central sections of the island, and that the eroded materials are being transported southward by longshore currents, resulting in the island's southward progradation, as reported by Novakowski et al., 2001).

Figure 7. Beach profiles overlain for two locations along the southern-most section of the Keewaydin Island.

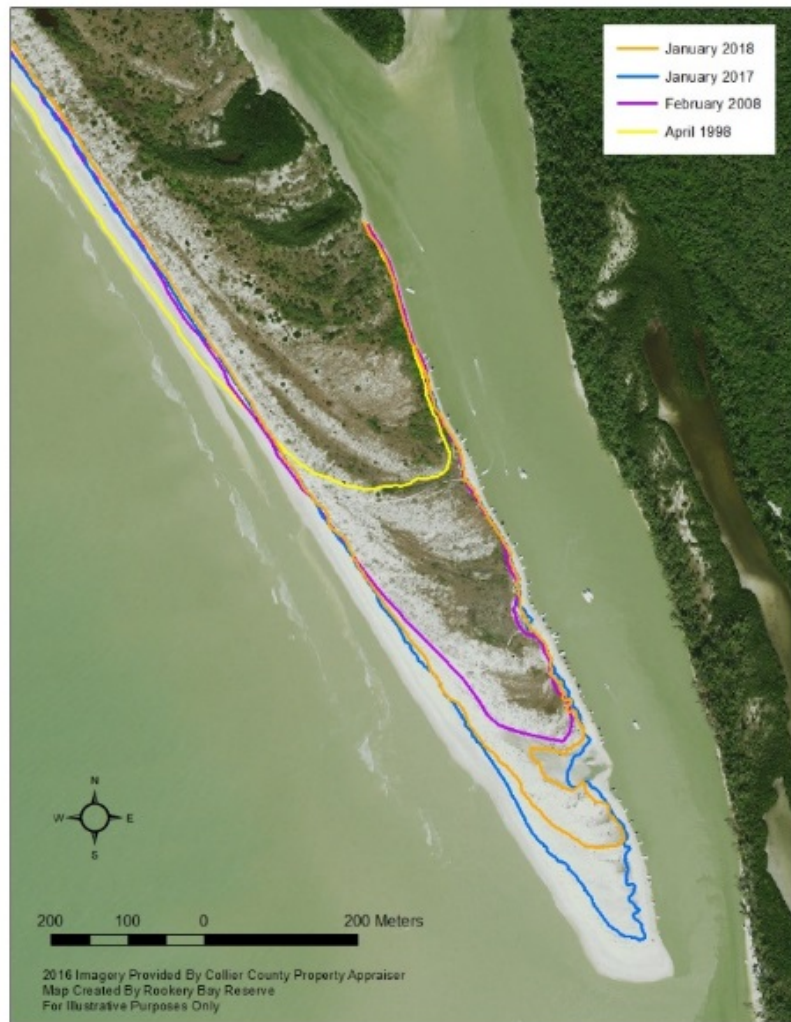
Georeferenced data from long-term vegetation line mapping (whereby the seaward-most extent of vegetation is mapped) from the southern-most section of Keewaydin Island is provided as Figure 8. It is evident that growth of the spit has continued since 1998. Curvilinear extension of alternating ridges and swales arching around the southern tip can be seen, as reported by Novakowski et al. (2001). Excess sand transported south by the long shore currents are deposited in

this region and reworked by the waves resulting in the berm-ridge development (Hine, 1979).

Figure 8. Progradation of the shoreline since 1998, based on annual vegetation line mapping. Data courtesy Jill Schmid, RBNERR.
