THE SPRING 1976 EROSION OF SILETZ SPIT, OREGON

with an analysis of
the causative wave
and tide conditions

Paul D. Komar
Barbara Ann McKinney

OREGON STATE UNIVERSITY
SEA GRANT COLLEGE PROGRAM
Publication no. ORESU-T-77-004

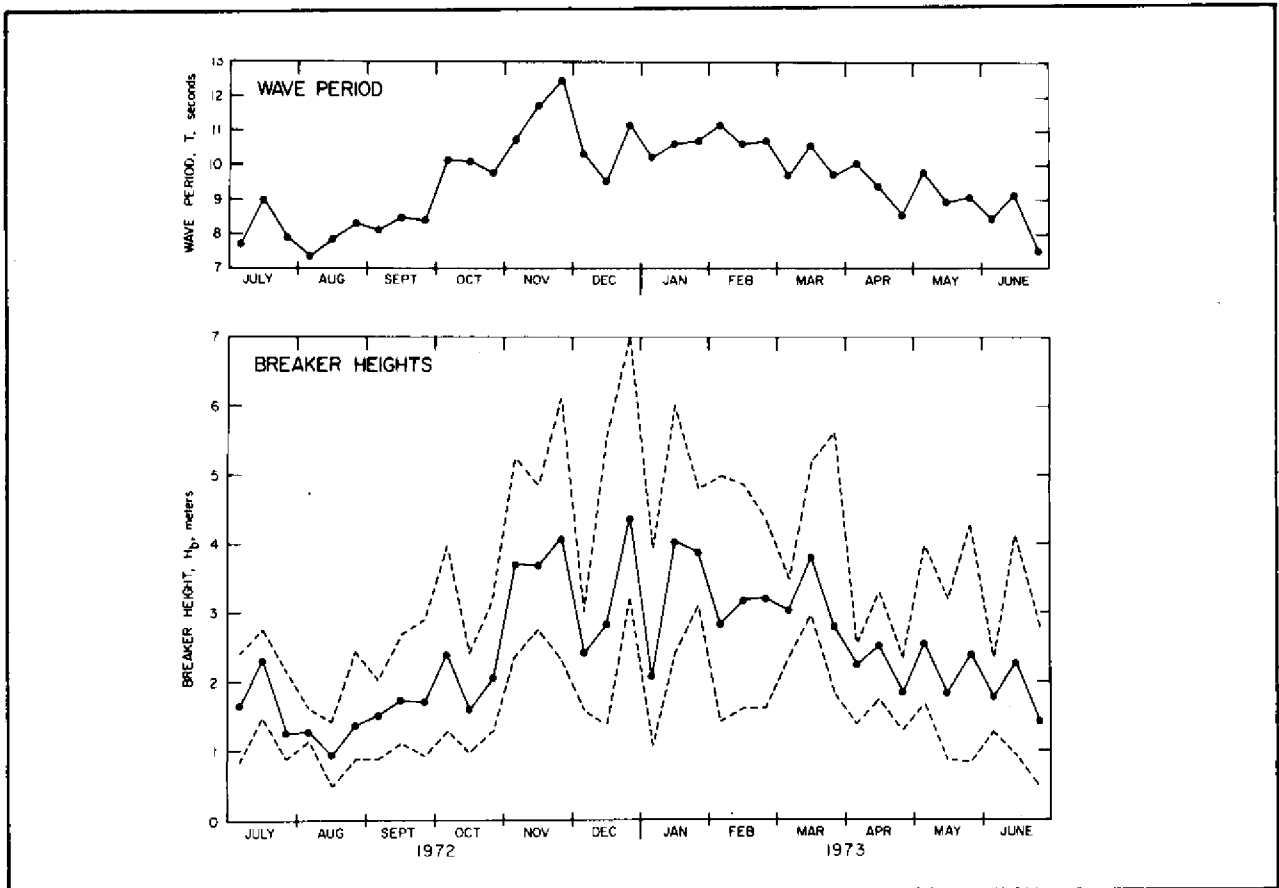
Fig. 2. Significant wave breaker heights and periods at Newport, Oregon, for July 1972 through June 1973, computed from wave measurements by the microseismometer system. (from Komar, et al. 1976)

Erosion of Siletz Spit and other areas of the Oregon coast is confined almost entirely to the winter months, November through March. This is because erosion is associated with high energy wave conditions limited to these months. Fig. 2 shows wave breaker heights and periods, taken from the wave data compilation presented in Komar, et al. (1976). Significant wave breaker heights were determined four times daily at the Marine Science Center, Newport, Oregon, by a seismic recording system that detects microseisms produced by waves. The wave-measuring system is described in detail by Quinn, et al. (1974) and Komar, et al. (1976).

The average significant breaker height H_b , plotted in Fig. 2, is a 10-day (one-third month) average. Maximum and minimum breaker heights measured during that one-third month are also plotted. The average H_b curve illustrates the overall increase in wave energy conditions from November through March. During these months, breaker heights average about 3 to 4 meters, in contrast to summer conditions when breaker heights average 1 to 2 meters. The maximum H_b curve of Fig. 2 reveals the largest storm conditions attained during any one-third month. Storms commonly produce breaker heights greater than 5 meters, and in the last third of December (actually on Dec. 24-25, 1972), breakers 7 meters high were measured. These are the highest wave conditions observed by the Newport seismic system since its installation in November 1971 (Komar, et al. 1976); these same waves caused the most severe damage due to erosion at Siletz Spit.

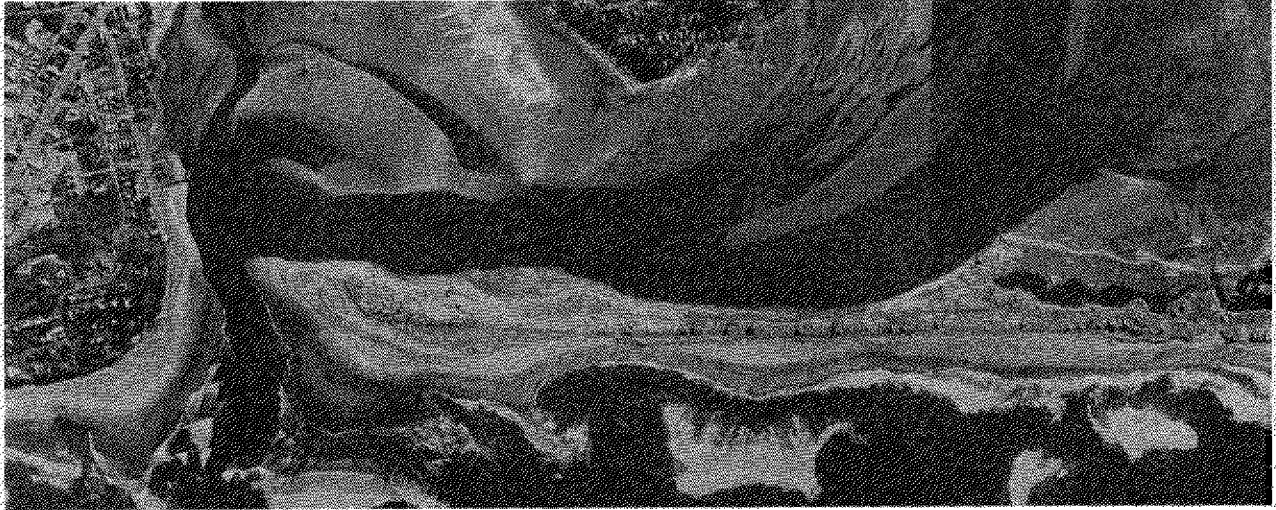
Fig. 3. Aerial photo mosaic of the northern half of Siletz Spit, taken on Feb. 5, 1976, showing erosion embayments on the ocean beach due to rip currents carrying sand offshore.

A mosaic of aerial photographs in Fig. 3 shows conditions on the spit on Feb. 5, 1976, a few days previous to the major storm. The most noticeable feature in these aerial photographs is the very pronounced embayment opposite the northernmost house on the spit. This embayment was produced by a rip current as described in connection with the earlier episodes of erosion. A second but lower amplitude embayment is located south of the most pronounced embayment; this embayment also became a center of dune erosion after the Feb. 18, 1976 storm. There is just a hint of an embayment opposite the southernmost beach houses shown in Fig. 3. This area was severely eroded during the December 1972 storm and on into January 1973. Evidence of erosion is apparent in the irregularity of the dune edge. The promontories fronting houses were held by riprap while empty lots eroded. South of the southernmost house is a series of four lots that were restored following the 1972-73 erosion that nearly reached the road. This area eroded again in spring 1976 and will be described later.

Another apparent feature in the aerial photographs of Fig. 3 is the older erosion scarp. It is most easily seen toward the north end of the spit and continues south past the immediate seaside front of the northernmost house. Rea (1975) and Rea and Komar (1975) determined from a series of aerial photographs that this erosion occurred about 1960, prior to house construction on the foredune area of the spit. As seen in

As in previous winters, the rip current embayments became centers for the 1976 erosion. Some foredune erosion had already occurred in the Feb. 5, 1976 aerials of Fig. 3, prior to the major storm of February 18. This early erosion is landward of the most pronounced embayment at the north. The embayment cut into the foredunes, and would have caused still more erosion except for the riprap present seaward of the northernmost house and the empty lots to its immediate south. Erosion was halted there, but went beyond the riprap line to the immediate north where no riprap was present. Erosion north of the riprap produced an erosion dune bluff about 1.5 meters high with a few drift logs protruding from the scarp (Fig. 5a). Wave swash also overtopped the riprap opposite the northernmost house, washing drift logs back into a line shoreward of the riprap line.

The presence of embayments along the beach, seen in Fig. 3, set the stage for the pronounced erosion that occurred during the Feb. 18, 1976 storm. As described in studies of erosion during previous winters (Rea 1975; Rea and Komar 1975; etc.), storm waves were able to travel shoreward through the deep water of embayments without breaking or losing energy until near the shoreline. This produced intense wave swash and therefore appreciable dune erosion. The nature of erosion associated with the Feb. 18, 1976 storm differed somewhat from that associated with the Dec. 24-25, 1972 storm. The difference can be attributed to tide heights at the time the storm occurred; the 1972 storm occurred during neap tides whereas the February 1976 storm took place during spring tides. The importance of tide levels in coastal erosion was already mentioned and is readily apparent. It has other effects, however, in addition to being a factor in the overall rate of dune retreat due to erosion. This can be seen in the area of the northernmost house on the spit, opposite the pronounced embayment of Fig. 3. Because of the high spring tide water level of Feb. 18, 1976, the swash of storm waves actually washed over the top of the spit rather than simply causing a further retreat of the dune escarpment. The effects can be seen in Fig. 5b, which shows the same area as 5a, but after the major storm. The wave swash went over the escarpment formed earlier in January and February, entirely flattening the area to an even slope; the escarpment disappeared. Immedi-

The greatest erosion in spring 1976 occurred in the second embayment (Fig. 3). It is apparent from these aerial photographs that as of February 5, erosion of the dunes had not occurred landward of the second embayment. Erosion became severe during the February 18 major storm. The foredunes retreated under attack of the wave swash, forming a high dune erosion bluff (Fig. 11). Four houses in the area were threatened, but riprap placement soon after erosion began prevented any immediate danger and somewhat limited the amount of erosion losses. Surveys along lot lines indicate that on the average the seaward edge of the vegetated portion of the dunes retreated by about 10 meters; if lower, unvegetated dunes are included in the erosion estimate, then about 24 meters of dune retreat occurred. As in earlier erosion episodes, numerous drift logs were exposed in the retreating, eroding dune bluff. Many of the logs were sawed by logging operations. In this area of the spit the 1960 erosion scarp is clearly seen in Fig. 3; the erosion which occurred in 1976 did not extend as far as the 1960 scarp. Thus the drift logs, including sawed logs, were emplaced in the foredunes during dune reformation following the 1960 erosion. This process of dune reformation following erosion is described by Rea (1975). That study found sawed logs shoreward of the 1960 erosion, indicating still greater episodes of erosion occurred prior to 1960 but after logging operations began on the Oregon coast, probably about the turn of the century. As indicated, the 1976 erosion did not extend beyond the 1960 scarp, so additional information on earlier erosion episodes could not be obtained.

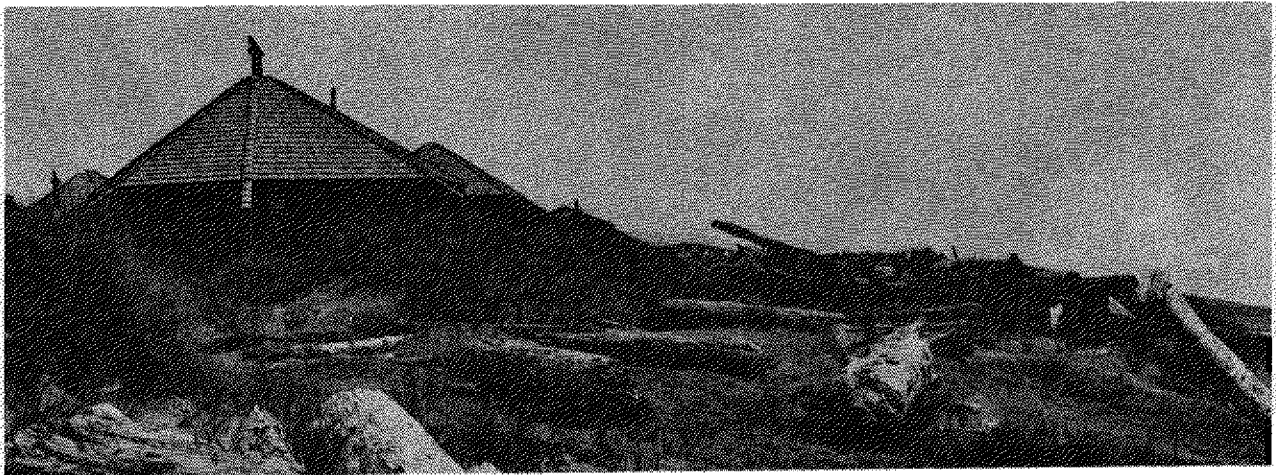
Fig. 4. Northernmost house on Siletz spit, viewed looking south with the ocean on the right. Immediately fronting the house is a dune bluff which marks the erosion scarp from an erosion episode about 1960. The gap in this bluff marks the beach access road used to bring riprap onto the beach and where waves washed over the spit during the storm of Feb. 18, 1976.

Fig. 4, this erosion scarp is apparent on the ground as a long, linear bluff. Many of the houses were constructed nearly even with this 1960 erosion scarp.

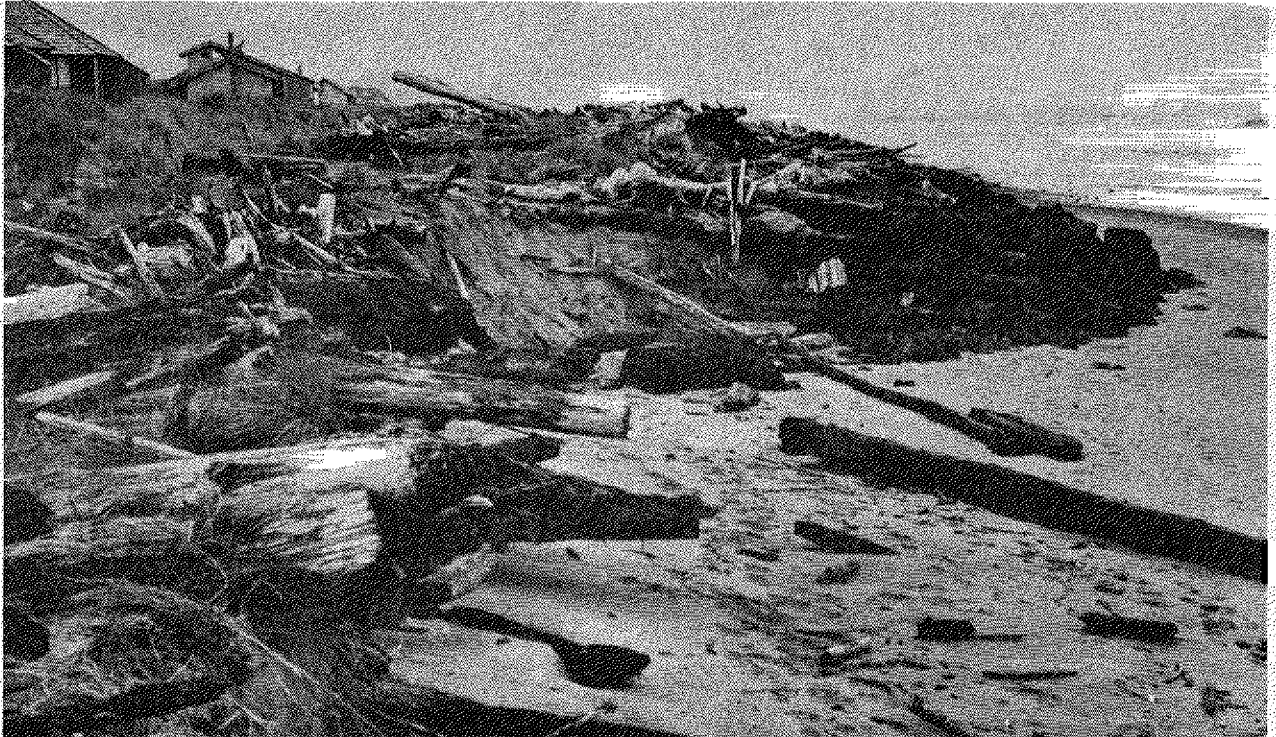
Fig. 5a. Erosional dune bluff on January 2, 1976, north of the northern most house on the spit.

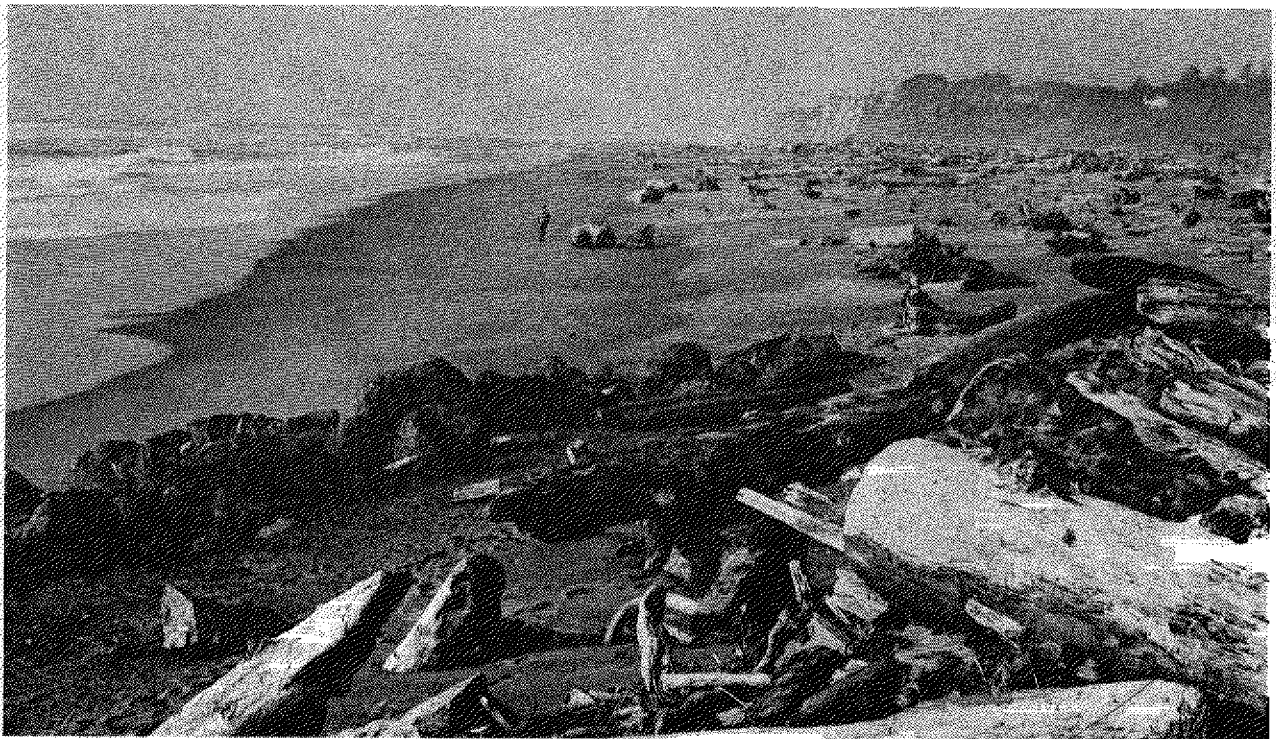
Fig. 5b. Same area as in photo 5a (except viewed north) on March 20, 1976, after a major storm had washed over the dune bluff on the upper photo, flattening it into an even slope.

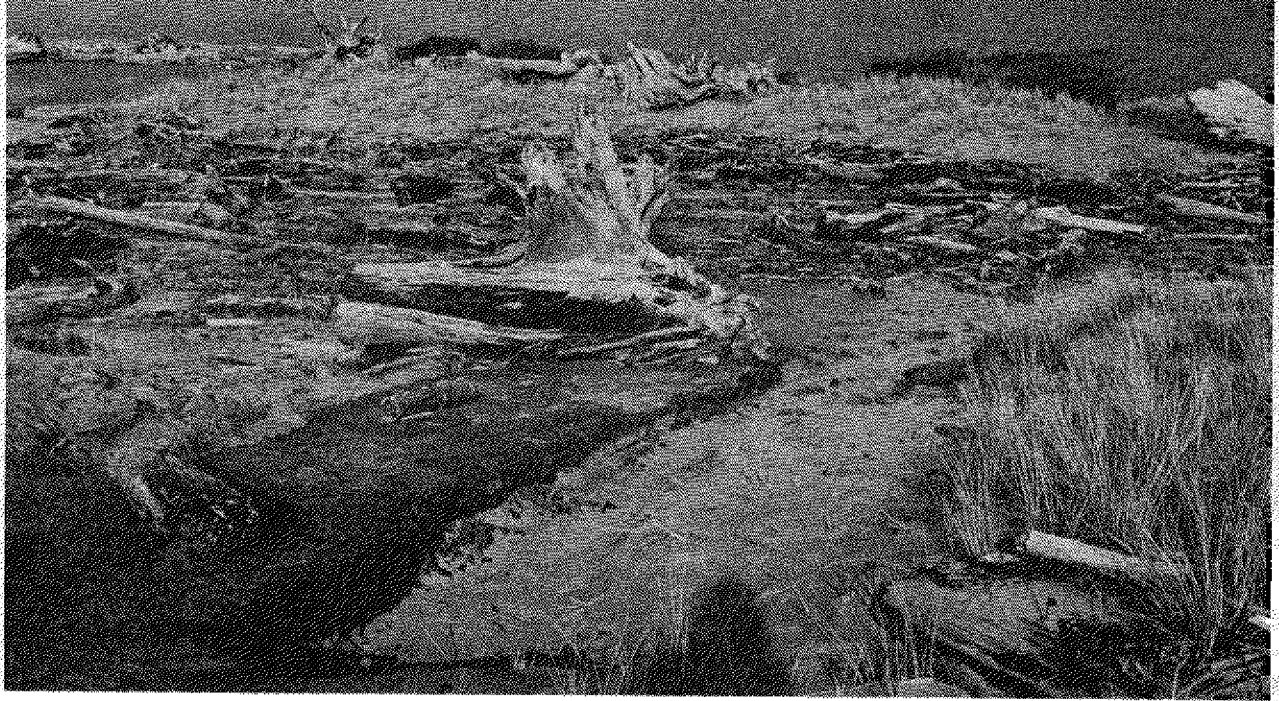
Fig. 6. Wash-over area north of the northern most house on Siletz Spit. Viewed toward Siletz Bay, in the foreground is the beach access road down which the wash-over water flowed, producing the gully. In the background is an accumulation of driftwood, which marks the pond area where the water accumulated.

ately north of the northernmost house was a small beach access road used for bringing riprap onto the beach. The waves washed through this lowered area, flowed over the top of the spit and accumulated in a pond on the backside of the spit. Fig. 6 shows the water-gullied access road and the accumulation of driftwood in the pond area.

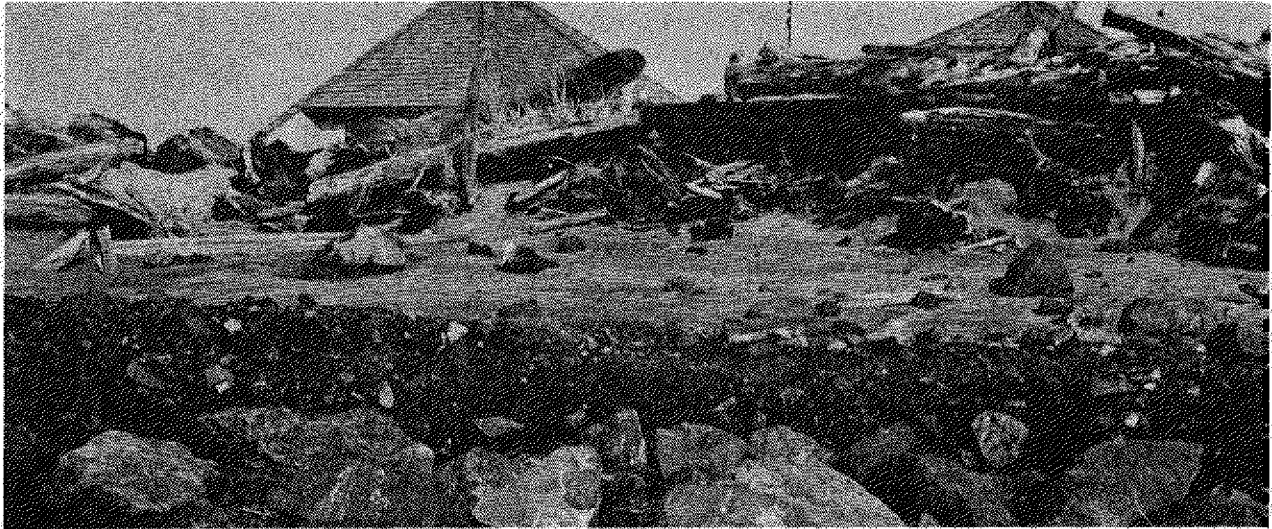
Fig. 8. Erosion of the riprap seaward of the northern most house, photographed on March 20, 1976. It is seen that some of the finer-grained material backing the larger rocks has been eroded away. Waves washed over the riprap, pushing back the drift logs into a pile.

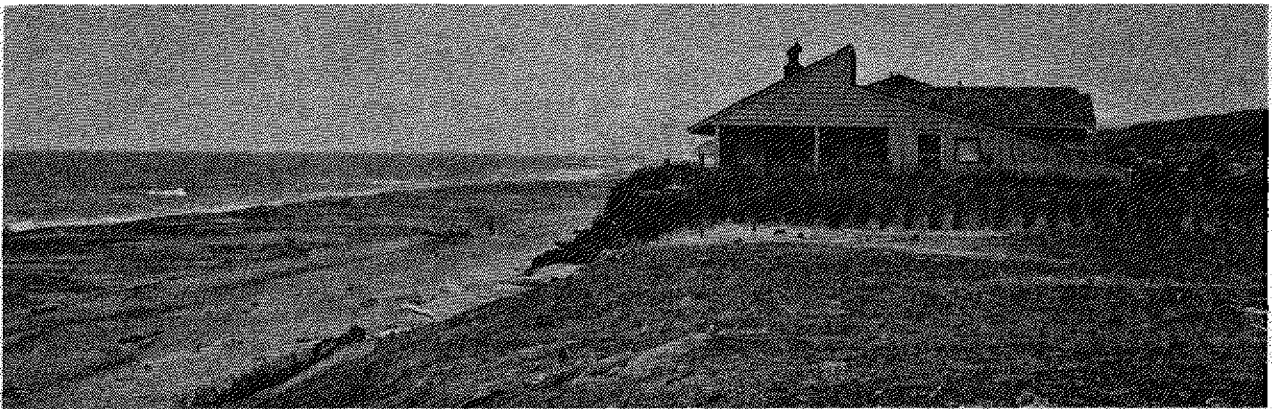
Fig. 9a. House in the mid spit area where severe erosion occurred during the winter of 1972-73 (compare with Figs. 3 and 4 of Komar and Rea 1976). The lots in the foreground have been restored by infilling of beach sands. Photo taken July 10, 1975.

The storm of Feb. 18, 1976 also differed from other winter storms since 1970 in that large drift logs were thrown atop the dunes. This is most clearly seen in lots that were restored after the 1972-73 erosion; restored lots were log-free prior to the storm. Fig. 9a shows the restored lots as of July 10, 1975 before the storm; Fig 9b is a photograph of the lots after the Feb. 18, 1976 storm. Fairly large logs were thrown up on the lots, well beyond the maximum extent of wave swash. There are other examples on the Oregon coast of storm waves throwing large logs for appreciable distances. Logs have been thrown through first-story windows of the Inn at Spanish Head in Taft, north of the Siletz Spit (Fig. 1).

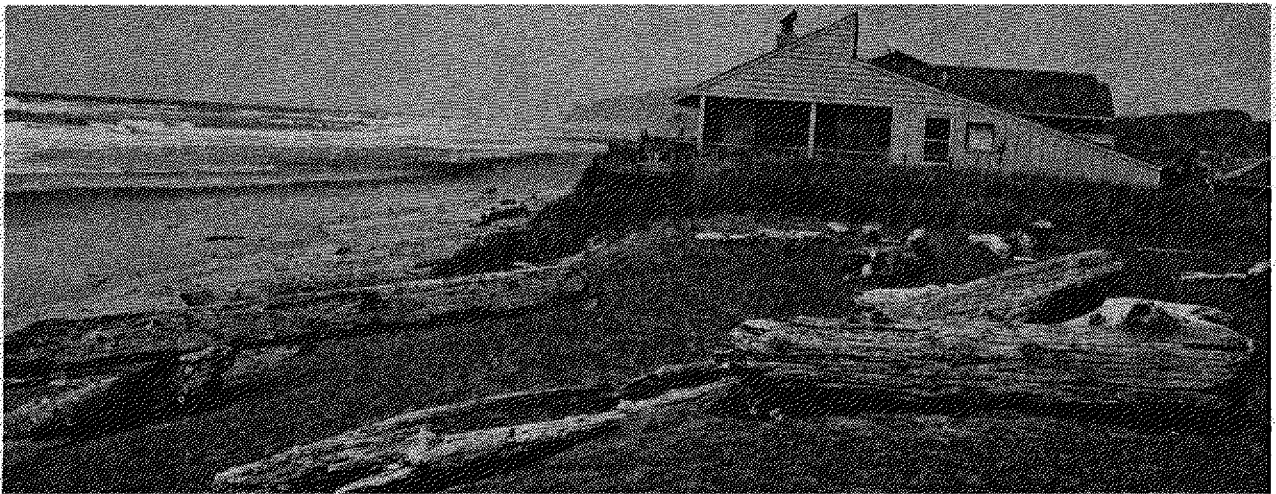
Fig. 9b. Same area as in photo 9a but after the Feb. 18, 1976 storm which threw logs atop the lot and caused some erosion of the property.

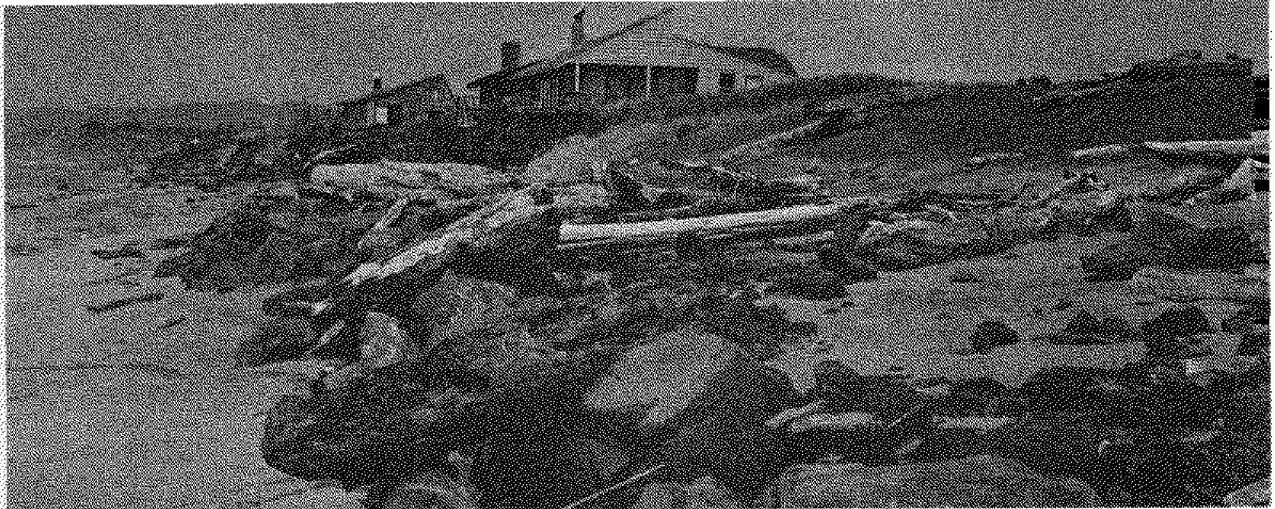
Fig. 10. Same area of the spit as in Fig. 9, showing where waves have washed over the riprap line causing some erosion of the riprap as well as the property.

in the area that suffered from erosion in 1972-73. As seen in Fig. 10, the seaward edges of the restored lots were eroded back, exposing the riprap placed to protect them. Like the riprap opposite the northernmost house, this riprap also was degraded somewhat; Fig. 10 shows a broad area where the backup nonpermeable material was eroded. The riprap fronting houses in the background of Fig. 10, placed at the height of the erosion in December 1972 to protect the houses, was further eroded. As discussed and shown in Komar and Rea (1975), due to hurried emplacement, this riprap is inferior; even in mild winters of moderate storms it has been washed away. The storm of Feb. 18, 1976 removed still more of this riprap so that the decks of two houses presently extend over the bluff. Much of the riprap is entirely gone, exposing the underlying dune sands.

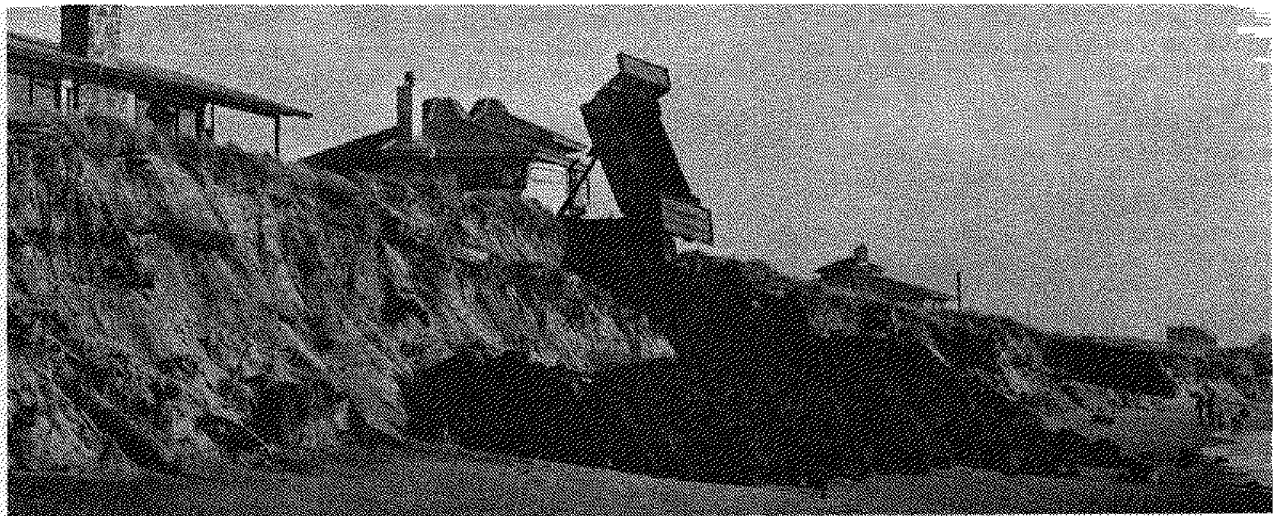
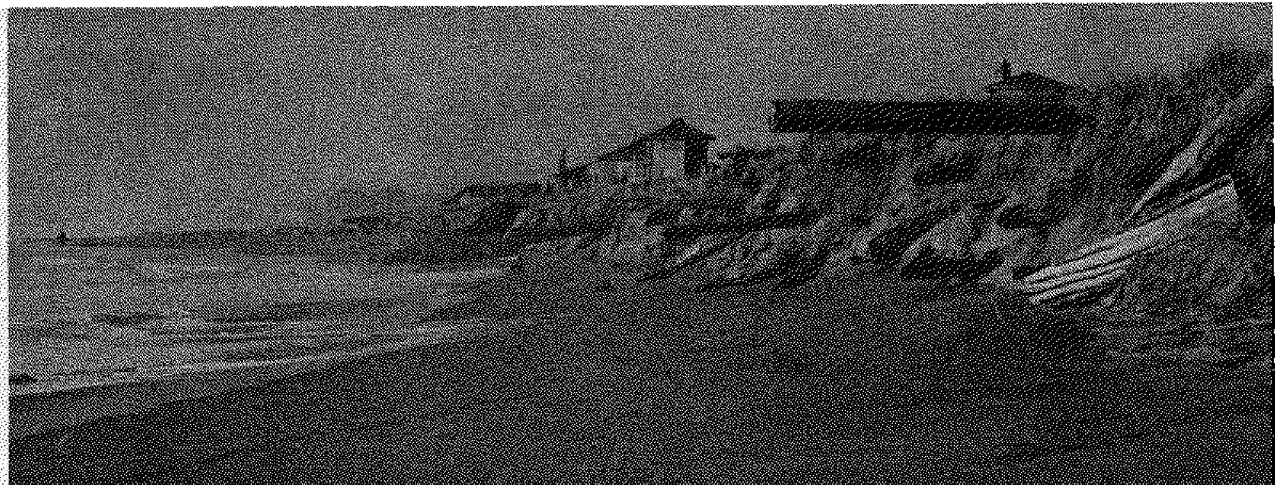
Fig. 11. Severe erosion in the mid spit area, shoreward of the middle rip current embayment seen in Fig. 3. Photos taken on March 10, 1976, but most of the erosion occurred during the Feb. 18, 1976 storm.

Fig. 11. View looking north.

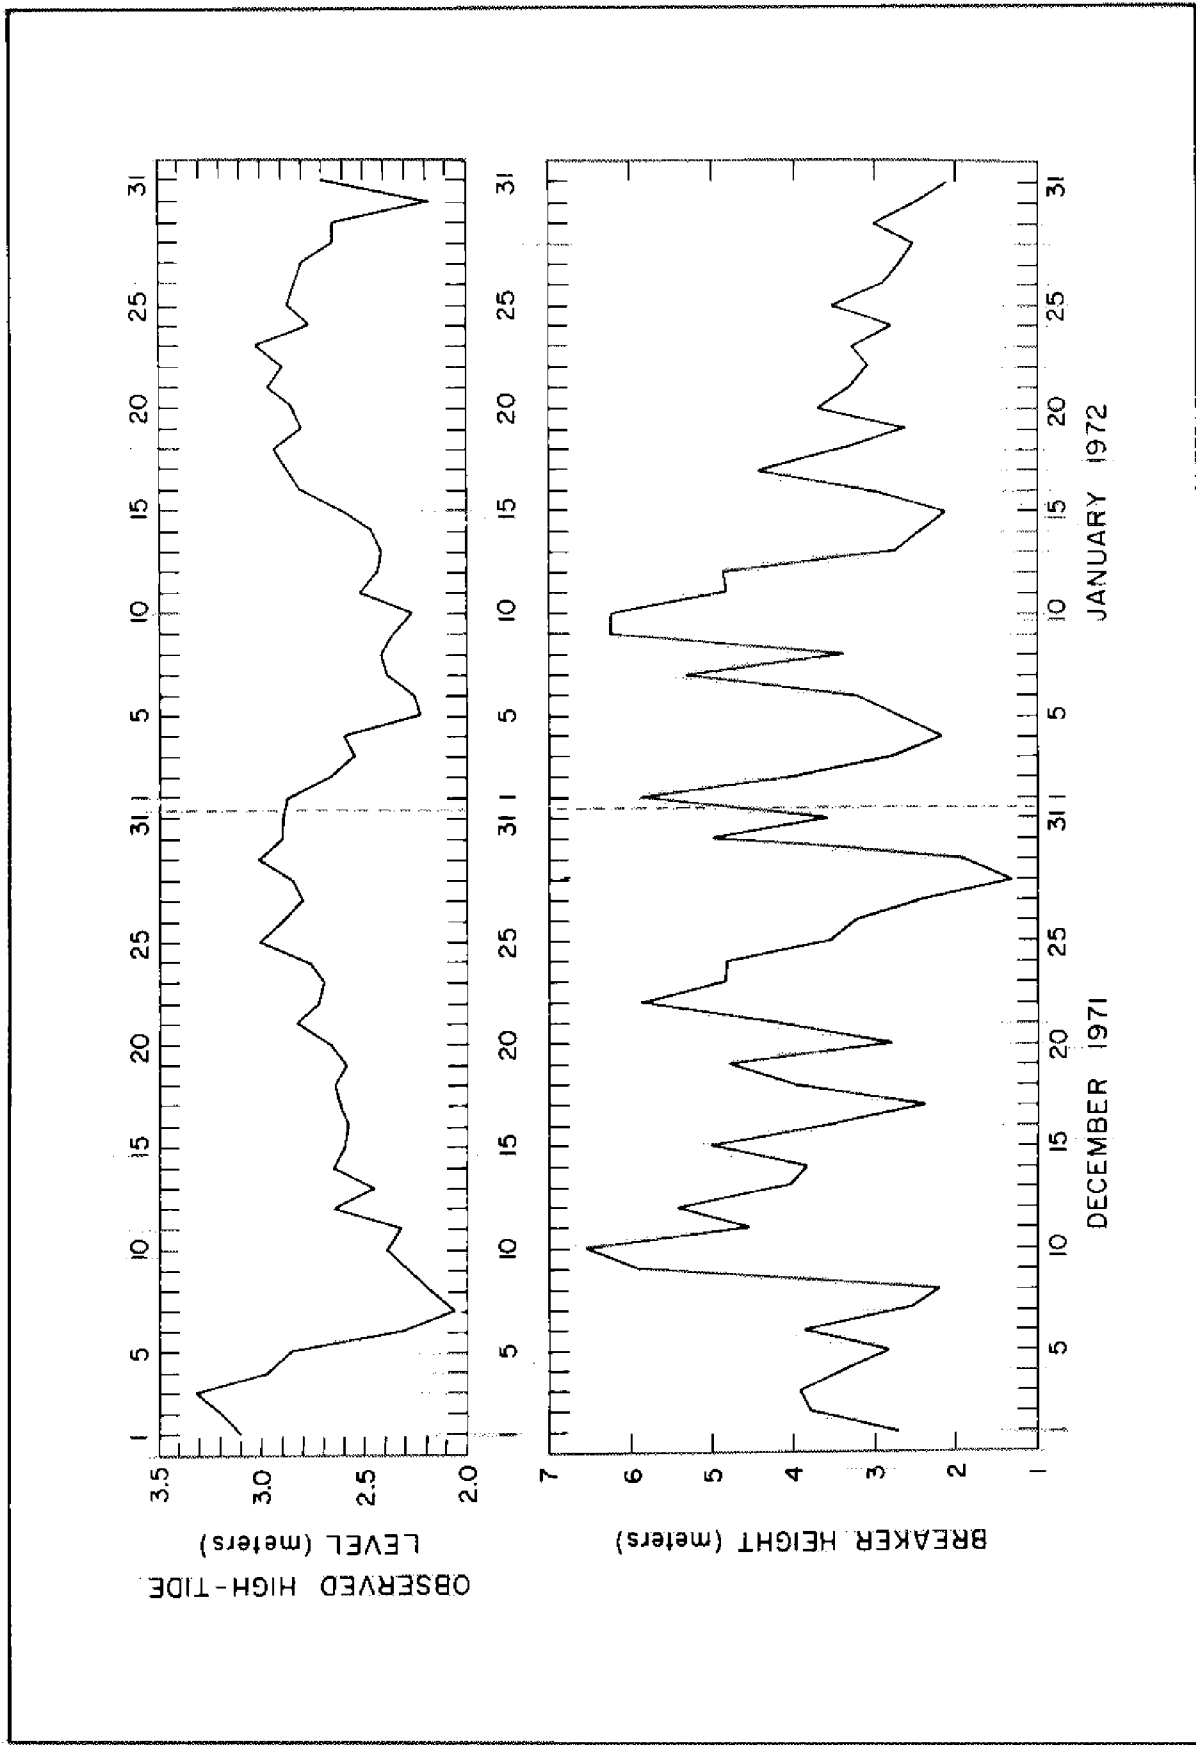
Fig. 12. Observed high tide levels and breaker heights measured at Newport, Oregon, during December 1971 and January 1972.

During winter 1971-72 (Fig. 12) breaker heights exceeded 6 meters twice (December 10 and January 10), but both periods occurred during neap tide conditions. Only minor erosion of dunes occurred on the spit that winter (Rea 1975).

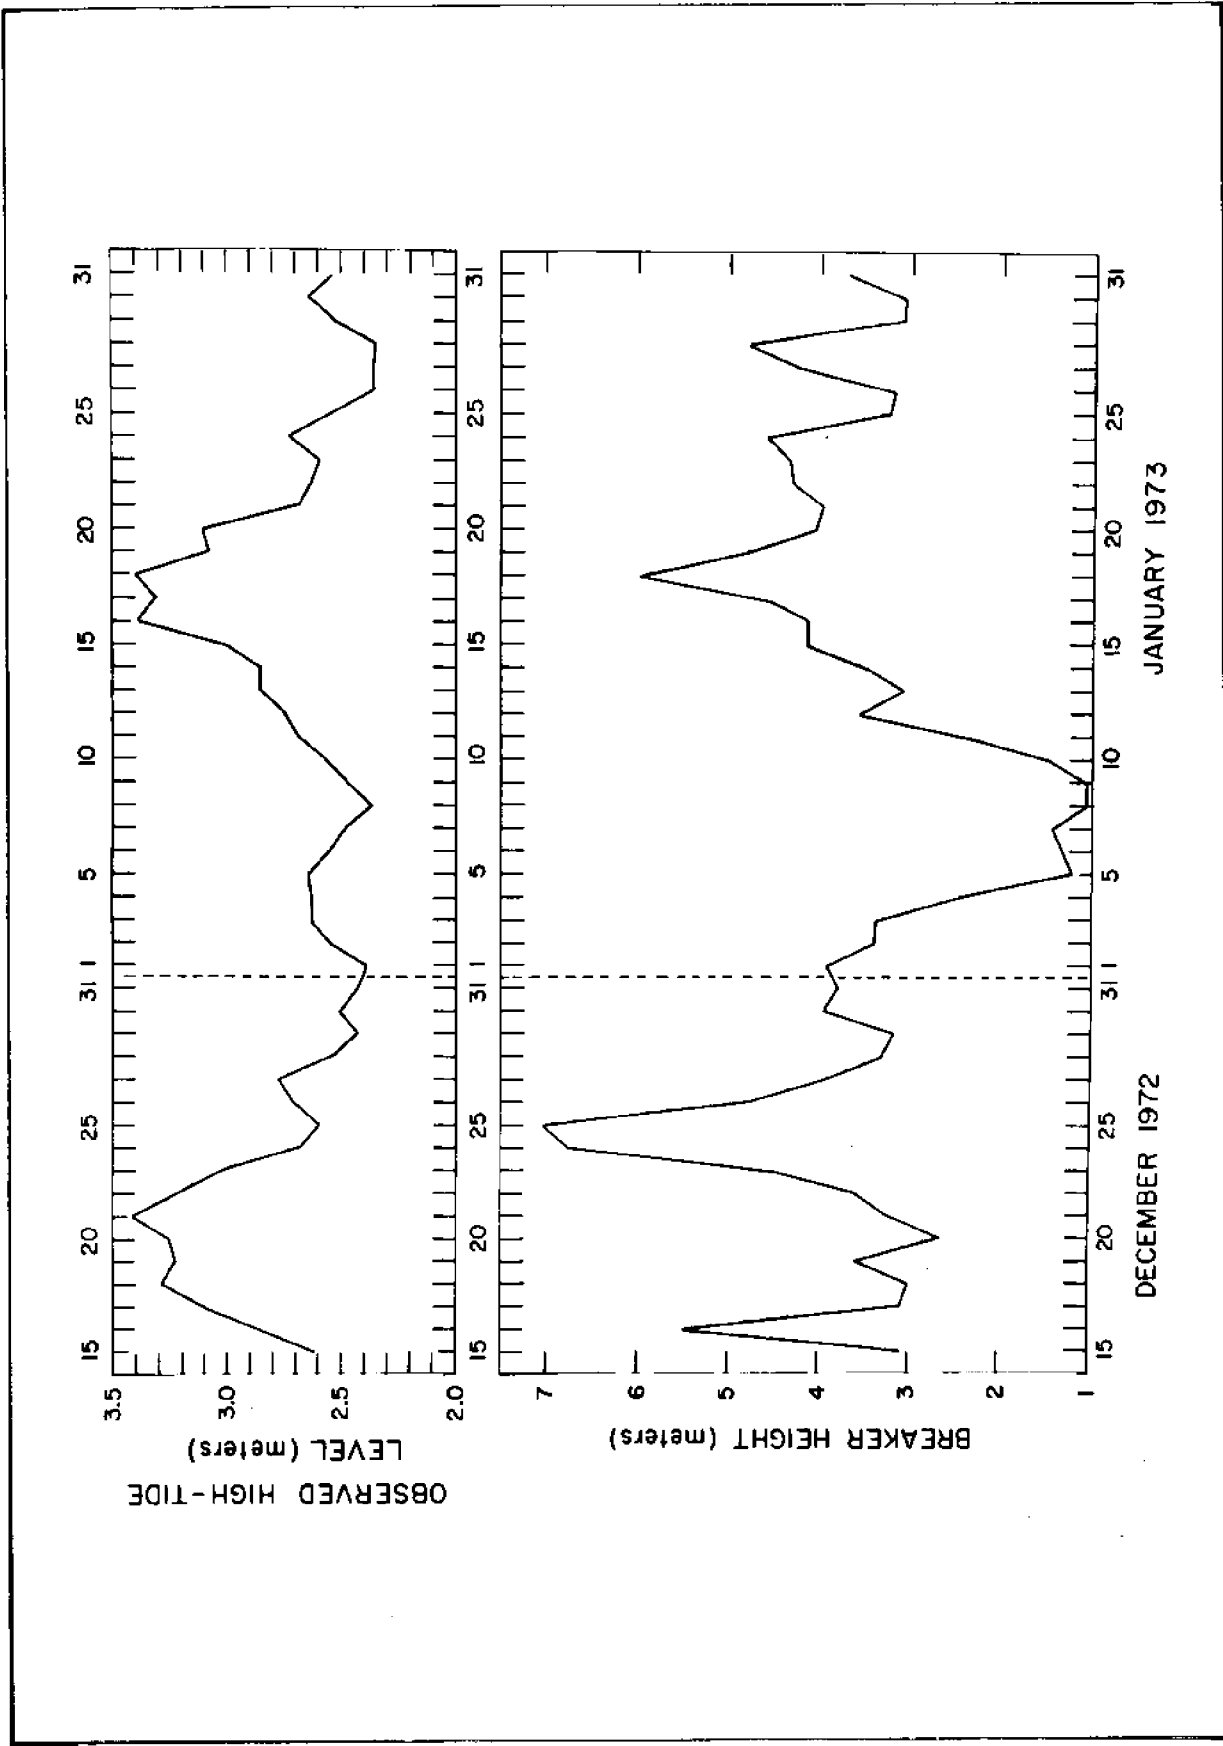
Fig. 13. Observed high tide levels and breaker heights measured at Newport, Oregon, during December 1972 and January 1973.

Considerable erosion occurred during winter 1972-73, especially during and following the storm of Dec. 24-25, 1972 when breaker heights exceeded 7 meters (Fig. 13). Although this storm occurred at neap tide, the waves were the largest measured by the

seismic system since its installation in 1971. The waves were large enough to reach the foredunes with sufficient energy to cause severe erosion. As already discussed, wave erosion was aided by the development of pronounced rip current embayments that cut into the beach berm. Following this major storm there was an unusual period of 10 to 15 days during which wave activity dropped to very low levels (Fig. 13), more like wave levels that prevail during the quiet summer months. In spite of this, erosion continued, but at a much slower rate. The pronounced rip current embayment allowed continued erosion by permitting wave swash against the dunes, even though the swash was weak under the small waves. On Jan. 18, 1973 a second storm occurred (Fig. 13); wave breakers were only about 6 meters high, but they occurred during spring tide conditions. Although the waves were lower than in the December 1972 storm, the higher tide level allowed the waves to lose less of their energy passing through the nearshore and allowed them to swash against a longer stretch of foredunes on the spit. Erosion accelerated over the rates maintained during the lesser wave conditions, but did not reach the extent experienced during the December 25 storm. It was this 1972-73 episode of erosion that was documented in the study of Rea (1975), Komar and Rea (1975, 1976), and which was summarized earlier in this report.

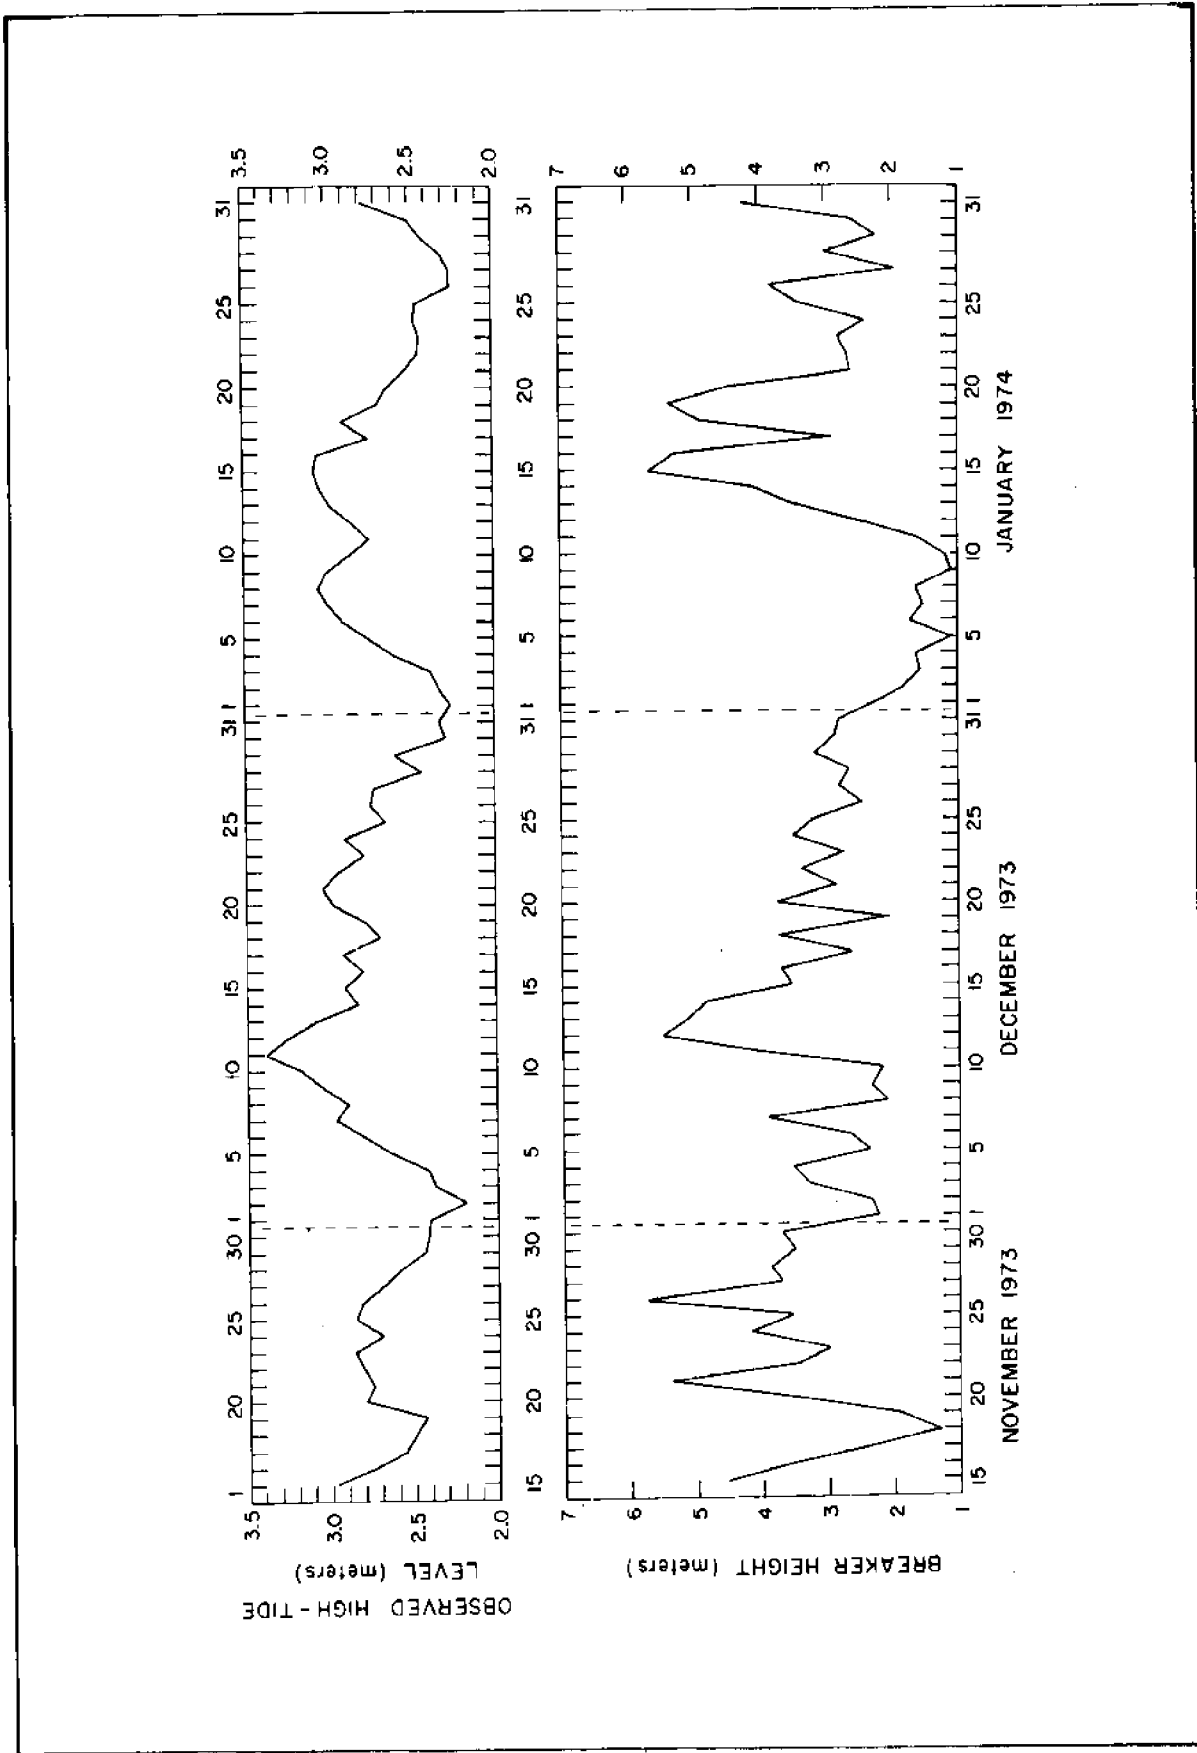
Fig. 14. Observed high tide levels and breaker heights measured at Newport, Oregon, during November 1973 through January 1974.

During the winters of 1973-74 (Fig. 14) and 1974-75 (Fig. 15), breaker heights never exceeded 6 meters. Such waves were not sufficiently large to cause severe erosion of the spit though some of the higher waves (5.5 meters) occurred during spring tide. Very little spit erosion took place during these winters.

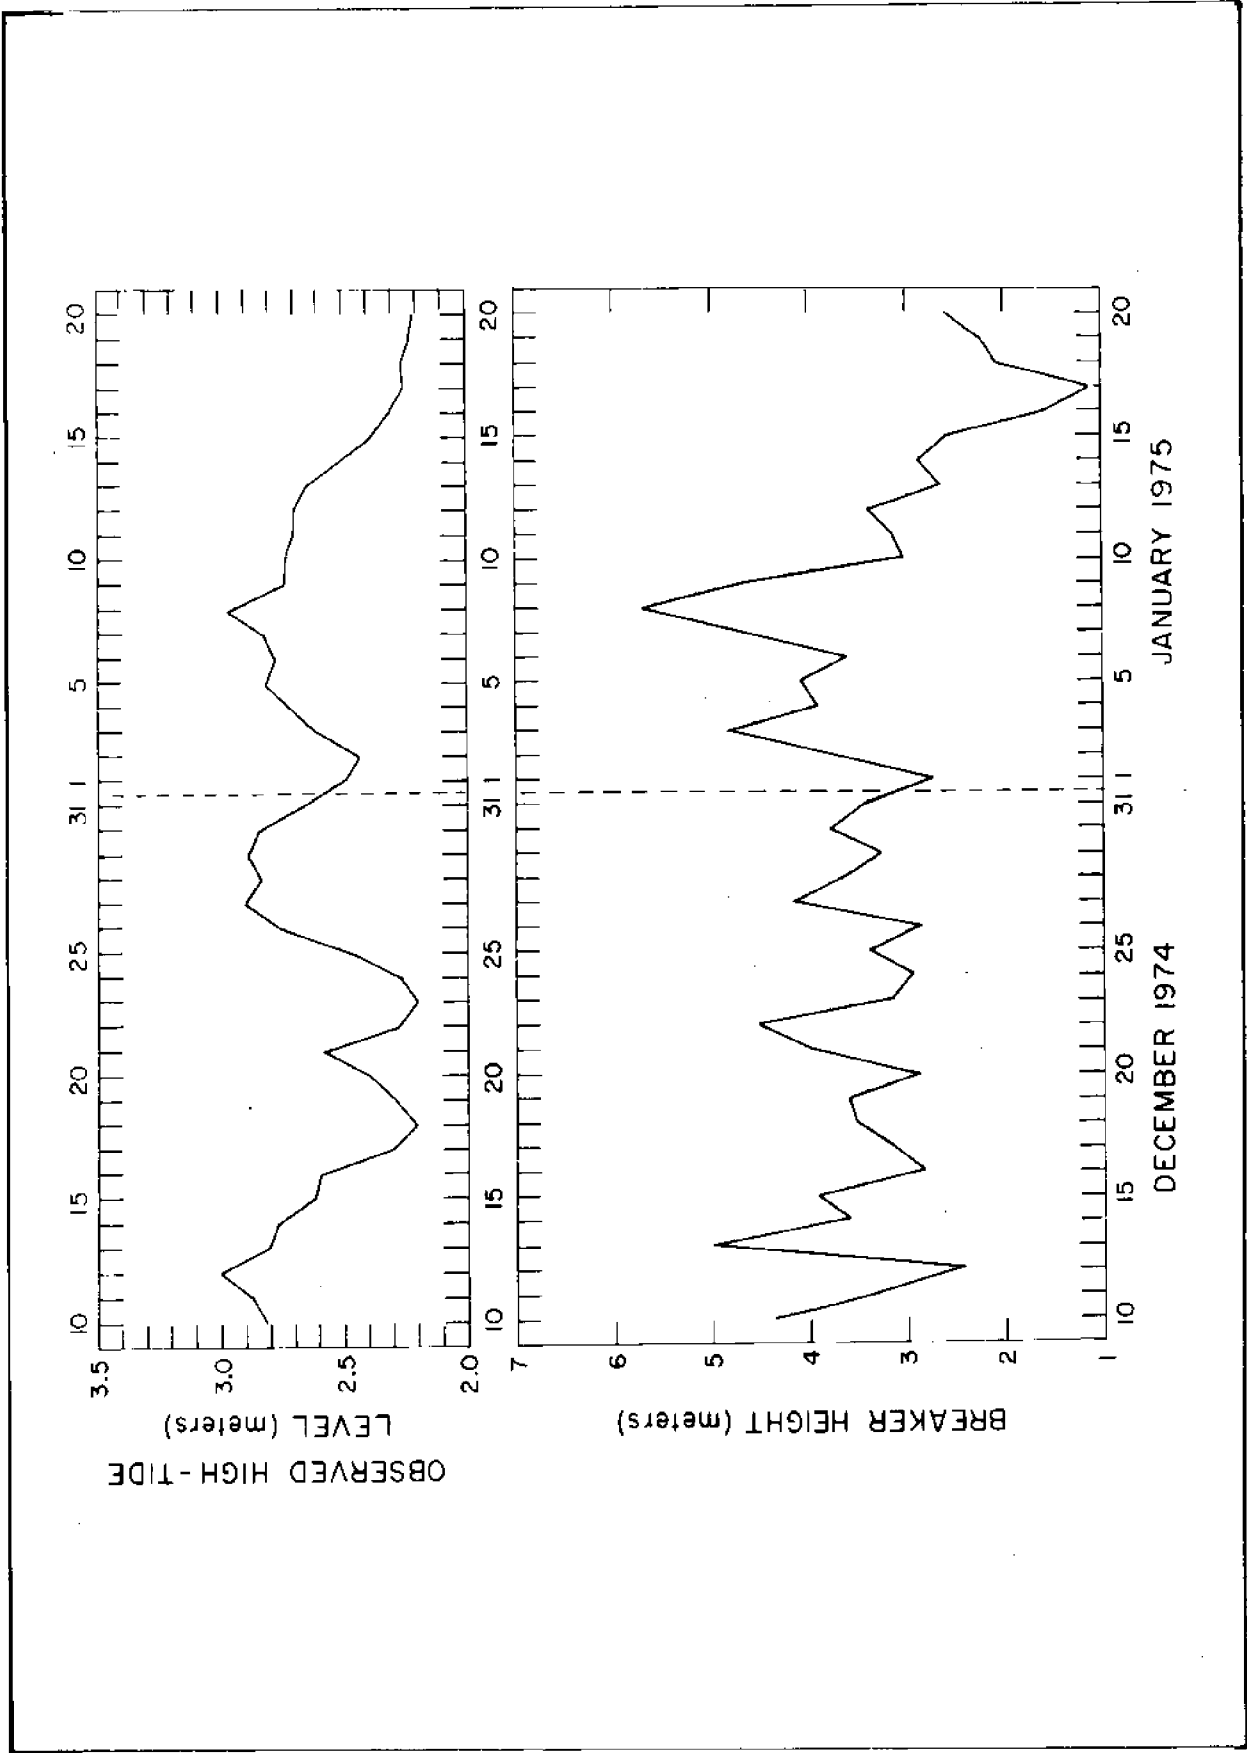
Fig. 15. Observed high tide levels and breaker heights measured at Newport, Oregon, during December 1974 and January 1975.
