THE SPRING 1976 EROSION OF SILETZ SPIT, OREGON

with an analysis of
the causative wave
and tide conditions

Paul D. Komar
Barbara Ann McKinney

OREGON STATE UNIVERSITY
SEA GRANT COLLEGE PROGRAM
Publication no. ORESU-T-77-004

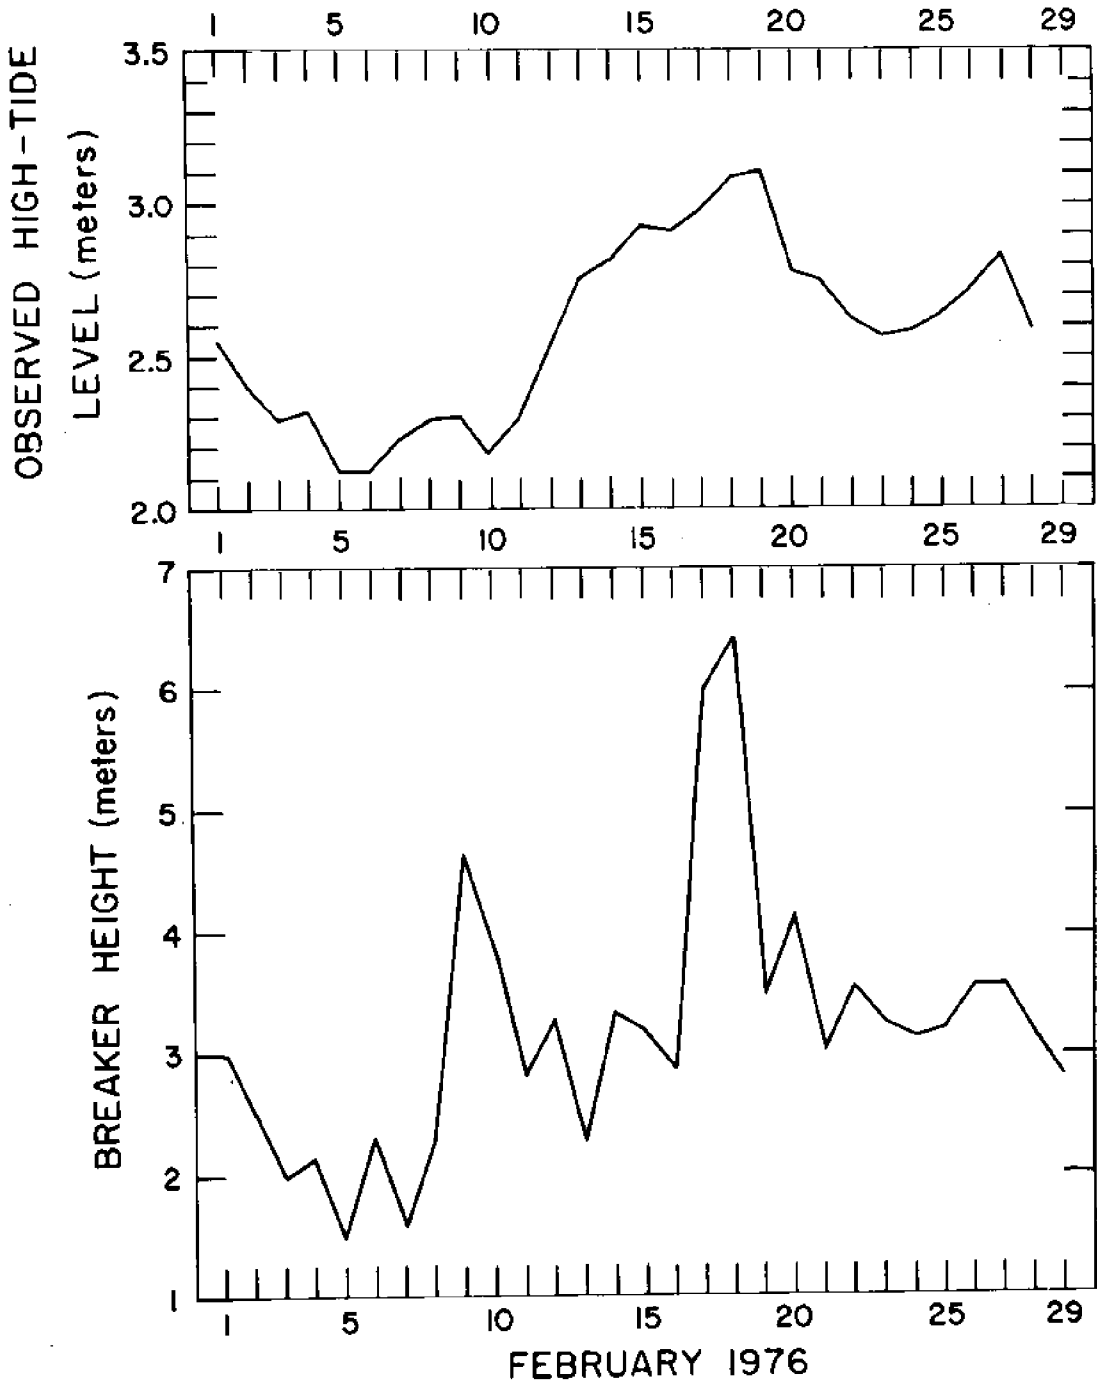
Fig. 16. Observed high tide levels and breaker heights, measured at Newport, Oregon, during February 1976. Erosion occurred on Siletz Spit due to the storm on February 18 at high spring tides.

The Feb. 18, 1976 storm breakers at Siletz Spit registered a significant wave height greater than 6 meters on the Newport seismometer (see Fig. 16). It was of special importance that, unlike the December 1972 storm, the storm breakers occurred during spring high tide conditions when the tide water level exceeded by 3 meters the mean lower low tide level.

As documented earlier in this report, considerable erosion again occurred on Siletz Spit from January to March 1976. Some erosion took place in January due to the exceptionally large rip current embayment that developed at the north end of the spit (Fig. 3). Most of the erosion was associated with the storm of Feb. 18, 1976 when breaker heights were about 6.5 meters (Fig. 16). The well-developed rip current embayments set the stage for erosion, but of particular importance to the erosion were the storm waves which occurred under spring tide conditions as shown by the curve of observed high-tide levels in Fig. 16. Therefore, although the waves were not as high as during Dec. 24-25, 1972, the water level was much higher due to the tides. The quantity of erosion measured in terms of the amount of dune bluff retreat was not
