# NESKOWIN SHORELINE ASSESSMENT

## Coastal Engineering Analysis of Existing and Proposed Shoreline Protective Structures

Prepared for The Neskowin Hazards Committee

March 12<sup>th</sup>, 2013

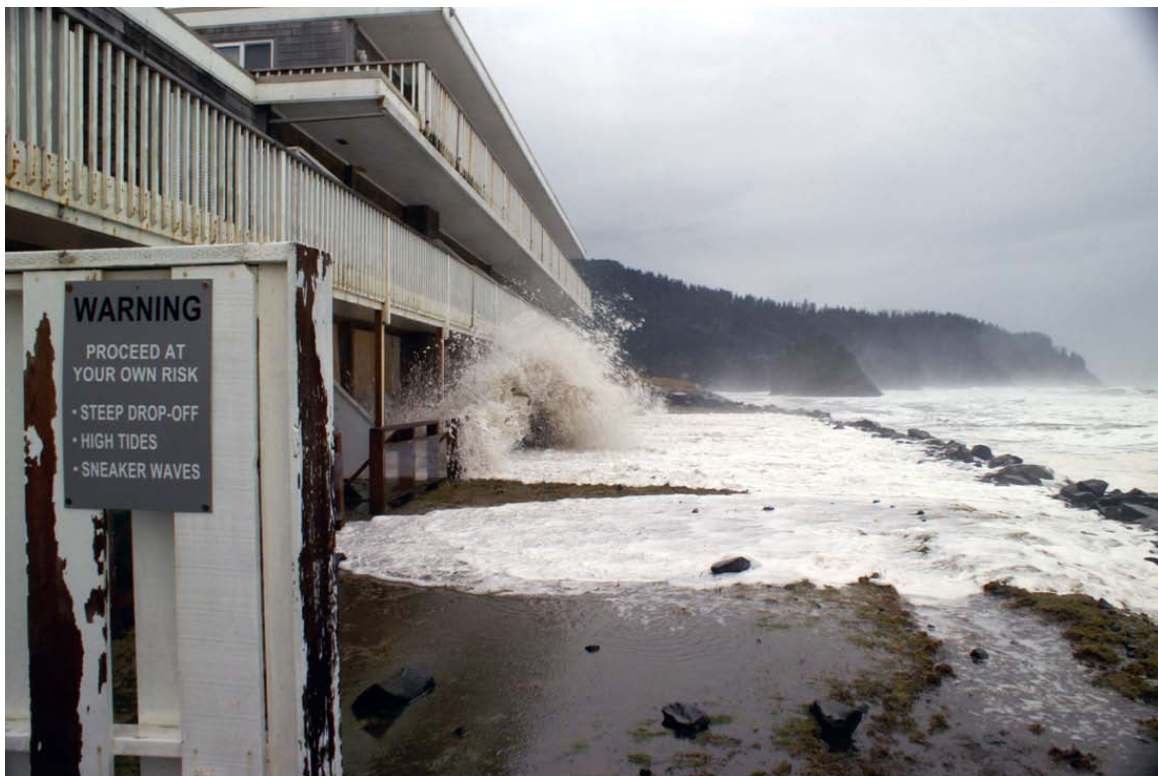
**High surf during high tide at Neskowin on Jan 9<sup>th</sup>, 2008.**

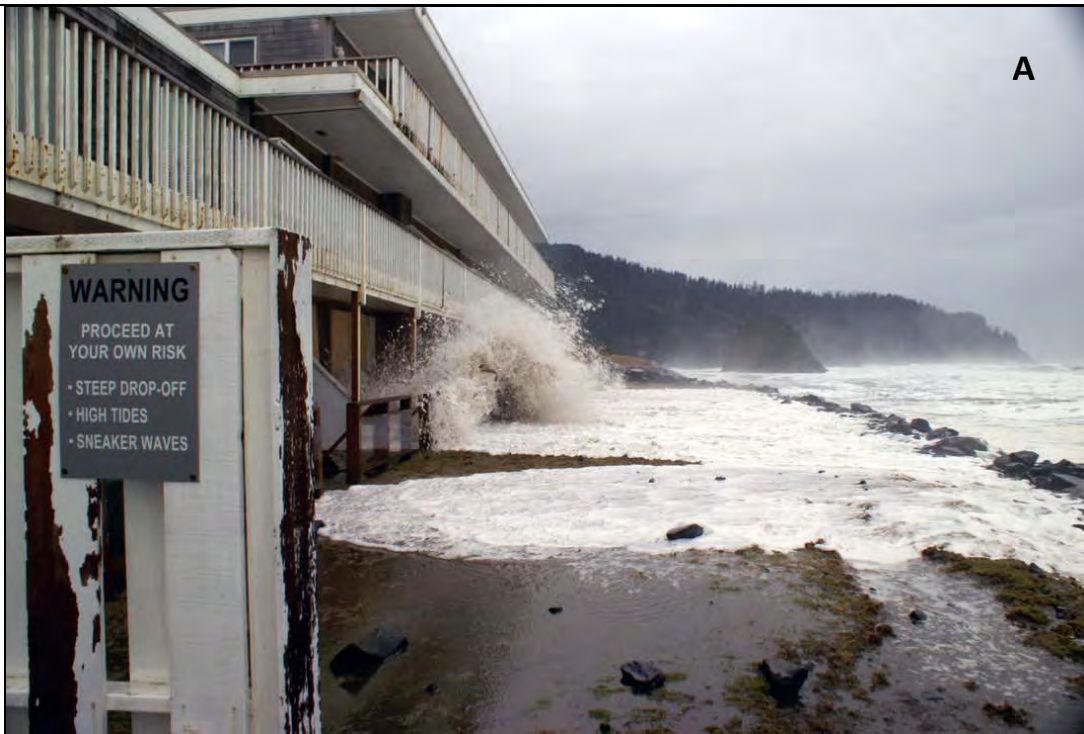
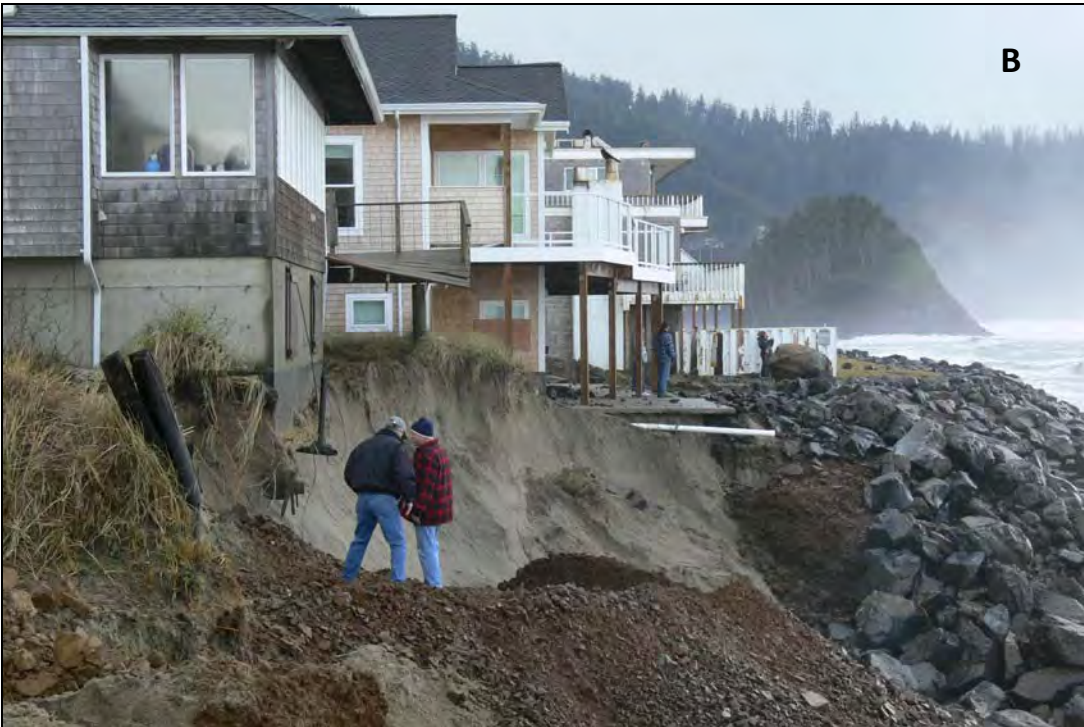
**Figure 2**

High Surf and Revetment Failure in Neskowin

The final cause of damages tends to be associated with failures of the shoreline armoring structures. There are several aspects of the existing armoring which may be contributing to the erosion damages. First, the revetment structures have a tendency to settle due to several factors including sand fluidization, scour at the toe from active reflection off of the structure, and the depth to bedrock in the north of the Proposal Rock portion of the study area. An examination of the nearest groundwater wells from the Oregon Water Resources Department in the vicinity of Neskowin (Table 1) show that the depth to bedrock is well below the elevation that any of these structures are likely to be built. Another exacerbating factor to structural damages is the volume of water that overtops the revetments. This volume can saturate soils and the revetment, weakening the structural integrity and fluidizing the sand behind the structure. Such an example occurred on January 5, 2008, overtopping wave water volumes saturated dune sands and contributed to a mass failure of the structure similar to a landslide (Figure 2b, NCHC, personal communication).

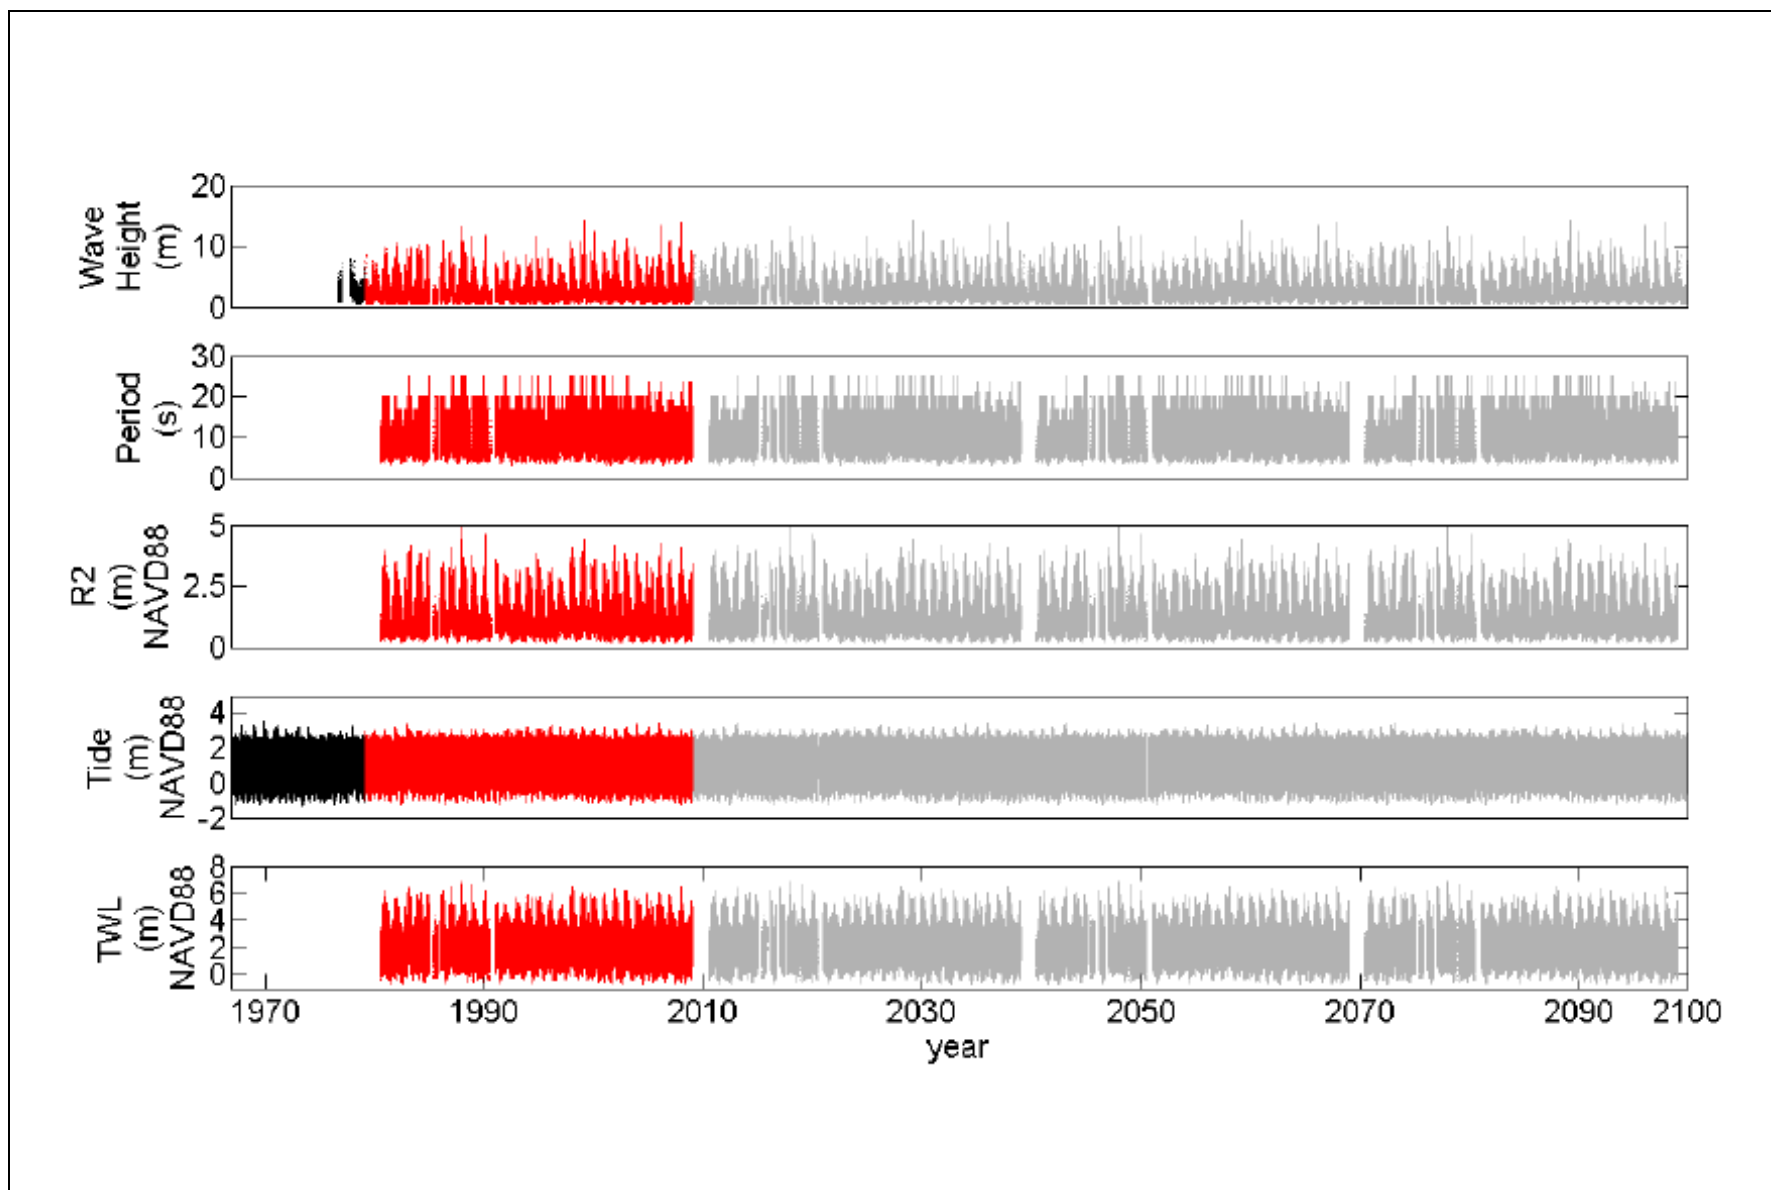
Time Series of Waves and Tides

Note: Red lines represent observed data, gray represent the synthetic dataset extended to 2100 using red data. Data represented by a black line was not used in the synthetic time series.

*Waves* – A composite time series of waves recorded at northwest buoys was acquired from Dr. Peter Ruggiero (Figure 4, Harris, 2011). This recorded time series was used to generate a future synthetic time series used in the engineering analysis. Additional information on this data set can be found in Harris 2011.

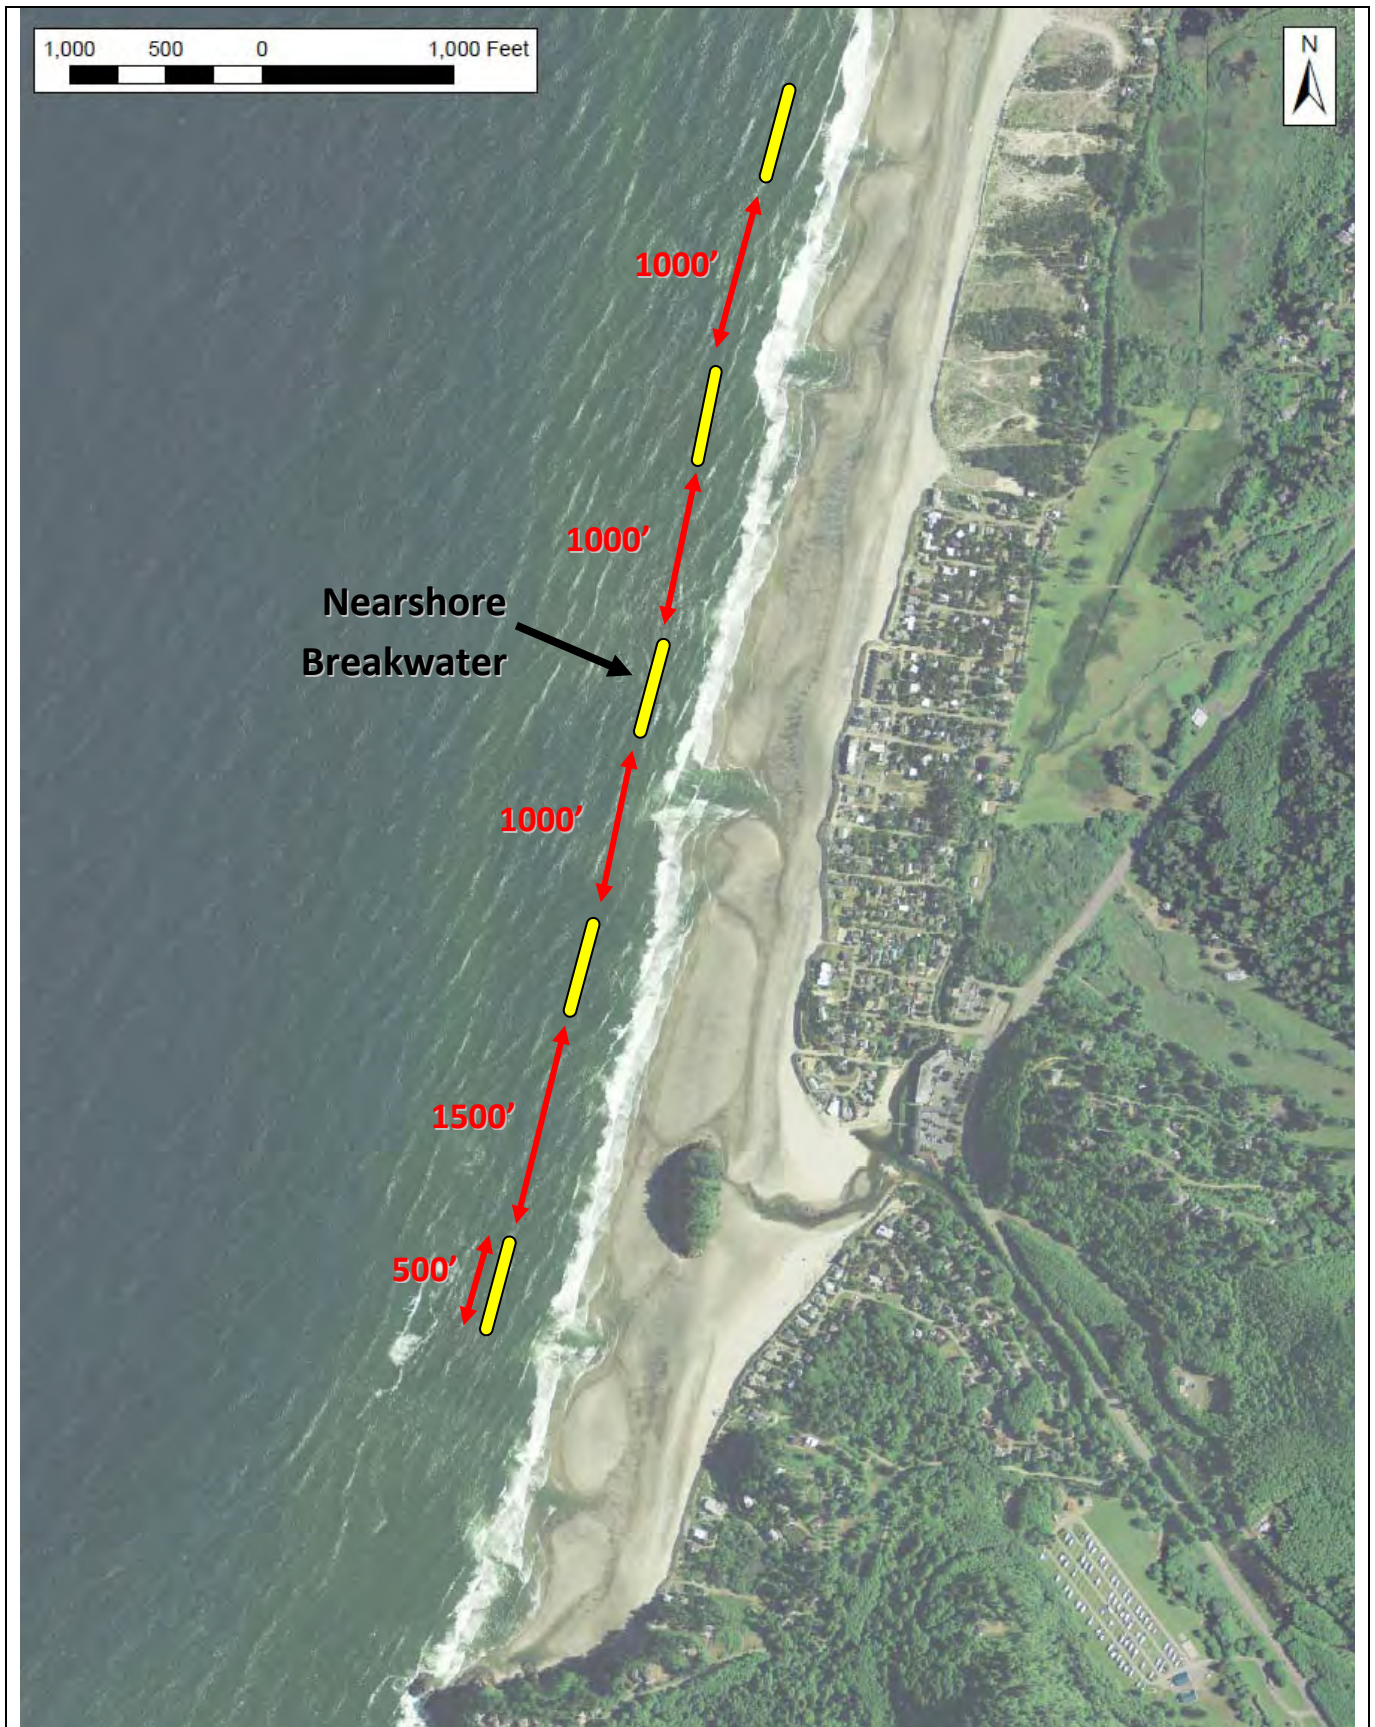
**Figure 7**  
Nearshore Breakwater Schematic

Note: Breakwater locations approximate and dimensions not to scale.

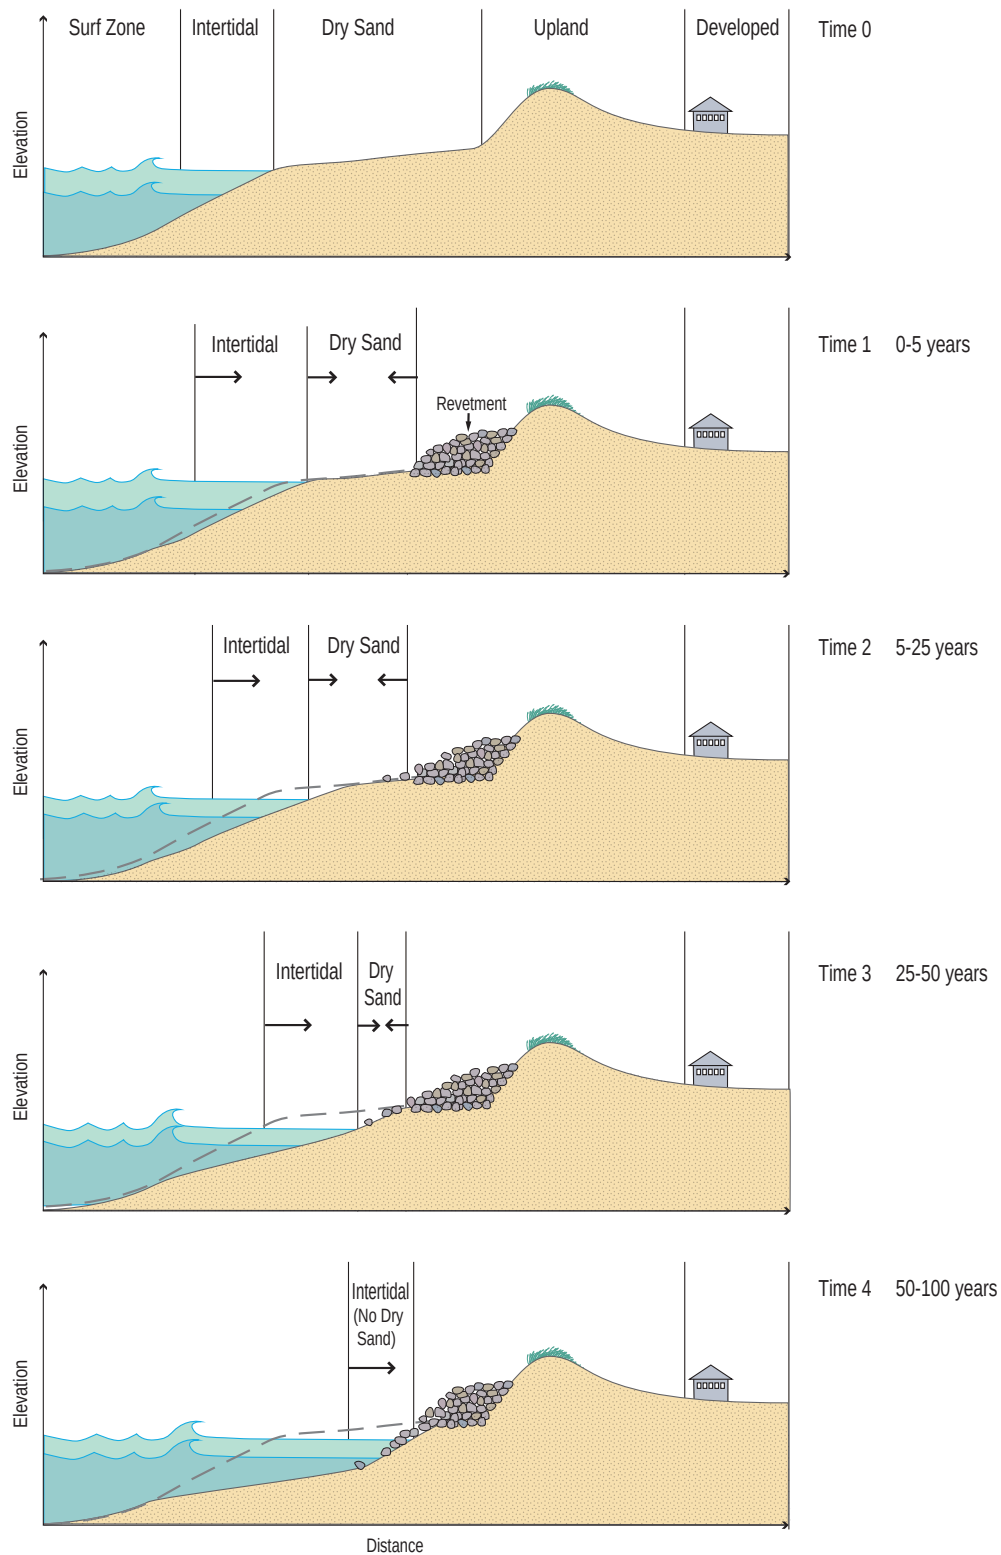
**Figure 12**  
Conceptual Design for Expanded Revetment

NOTE: Conceptual design not to be used for construction

The model was successfully verified with observations provided by DOGAMI and NCHC based on anecdotal wave overtopping observations from several events. While additional observations would be helpful, we believe that the methodology is adequate to estimate future damages. The analysis was largely dependent on NCHC and OPRD input for dates of historic events that caused observed failures. From this composite slope analysis it was determined that bolstering of the existing revetments to account for historic events under future rates of sea level rise identified by the National Research Council (2012), that the crest of the revetment should be raised by 8' to about 36' NAVD (Figure 12)
