## Living Shoreline - Little St. Simons Island Georgia

Final Report Prepared For:  
Southeast Aquatic Resource Partnership  
National Oceanic and Atmospheric Administration  
Community Based Restoration Grant Program  
Project 3011

**Project Title:** Living Shoreline - Little St. Simons Island, GA  
**Award Number:** SARP/NOAA Project 3011  
**Award Period:** February 2012 – February 2014  
**Grantee Organization:** The University of Georgia Marine Extension Service  
**Contact Person:** Thomas Bliss  
**Email:** tbliss@uga.edu  
**Phone Number:** 912.598.2348 ex: 107  
**Reporting period:** February 2012 - February 2014

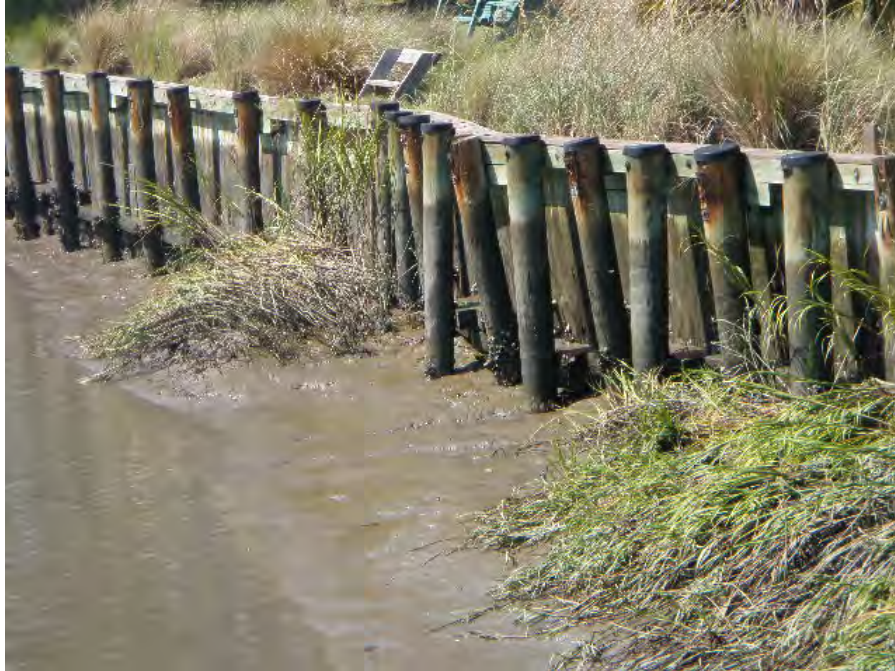
**Figure 2. Picture of failing bulkhead on Little St. Simons Island.**

Little St. Simons Island is a barrier island on the coast of Georgia that accessible only by boat (Figure 1). In the 1920's to 1930's a wooden bulkhead, approximately 370 feet long, was installed on the bank of Mosquito Creek, which is a tidal creek on the west side of the island. The bulkhead is located at the primary entrance to the island and had started to fail. Instead of replacing or repairing the current bulkhead Little St. Simons Island, LLC was interested in the construction of a living shoreline (Figures 2-3).

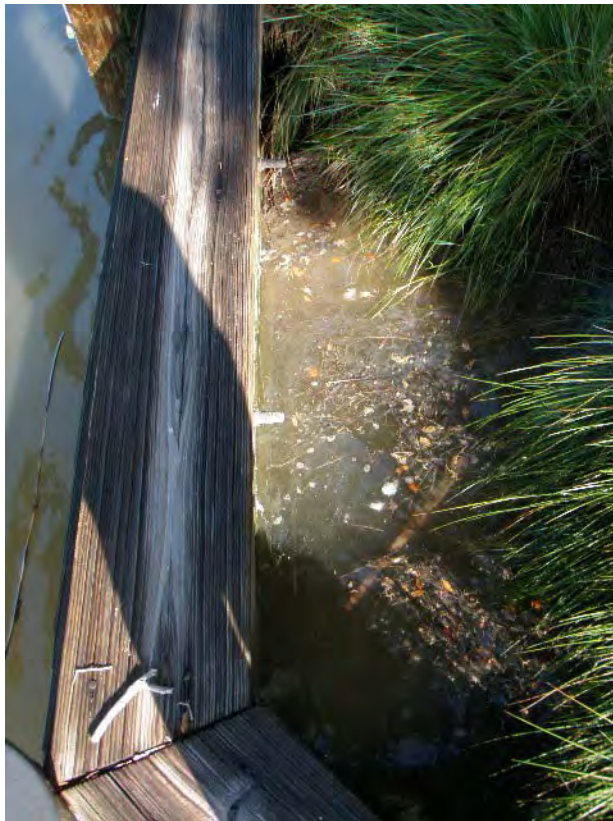
**Figure 3. Picture of water infiltration on land side (right of bulkhead) of bulkhead on Little St. Simons Island.**

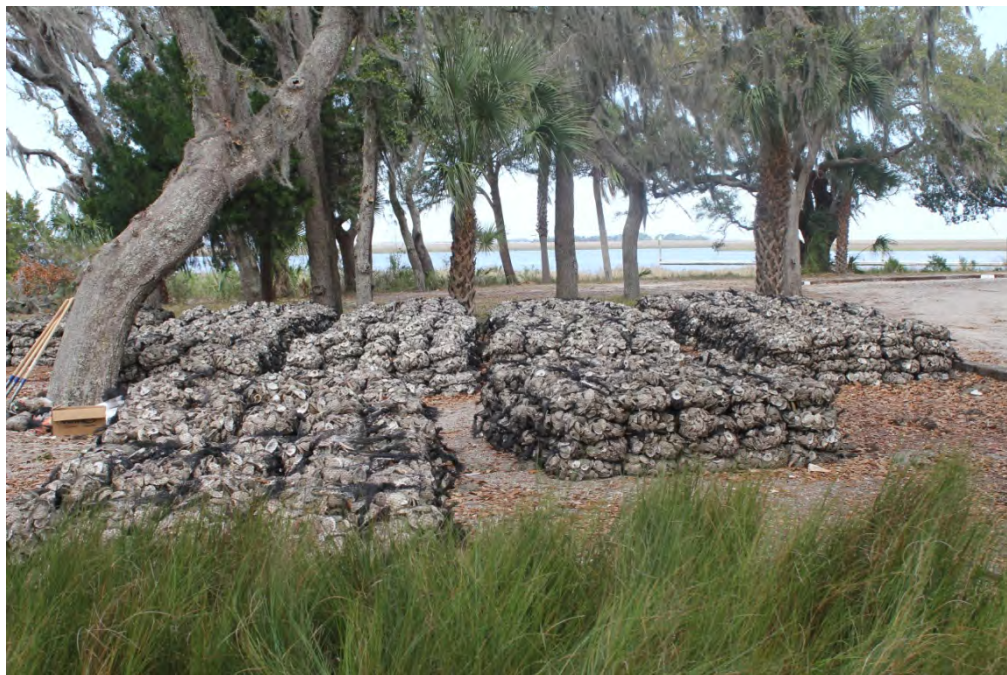
**Figure 4. Bagged oyster shell at Hampton Point Marina, St. Simons Island.**

Oyster shell and shell bagging supplies were delivered in Fall 2012 and additional shell arrived in Winter 2013. In total 4,875 bushels of oyster shell (11,900 bags) (Figure 4) were used for the shoreline. Six loads of shell were ordered, five from grant funds and one by GA-DNR CRD for a total of 4,500 bushels (11,000 bags), an additional 375 bushels was bagged (900 bags) from oyster shell present on LSSI that had been collected from past oyster roasts. Shell was bagged prior to construction and by AmeriCorps during construction. Shell was delivered to the

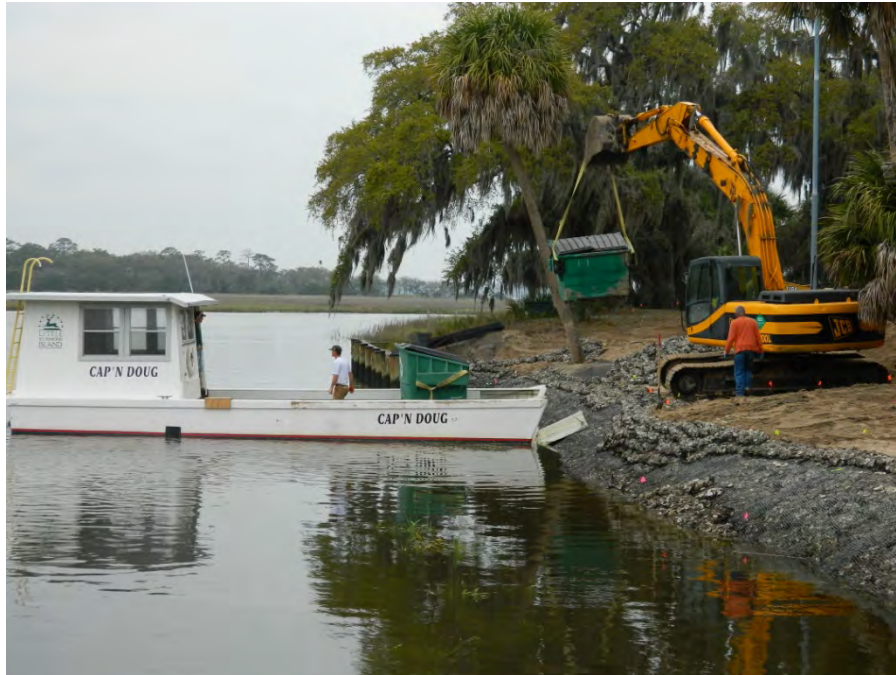
**Figure 5. Bagged oyster shell being offloaded to living shoreline site, Little St. Simons Island, GA.**

Hampton Point Marina and St. Simons Island and was bagged. Bagged shell was then loaded onto a barge owned and operated by LSSI and transported to Little St. Simons Island (Figure 5).

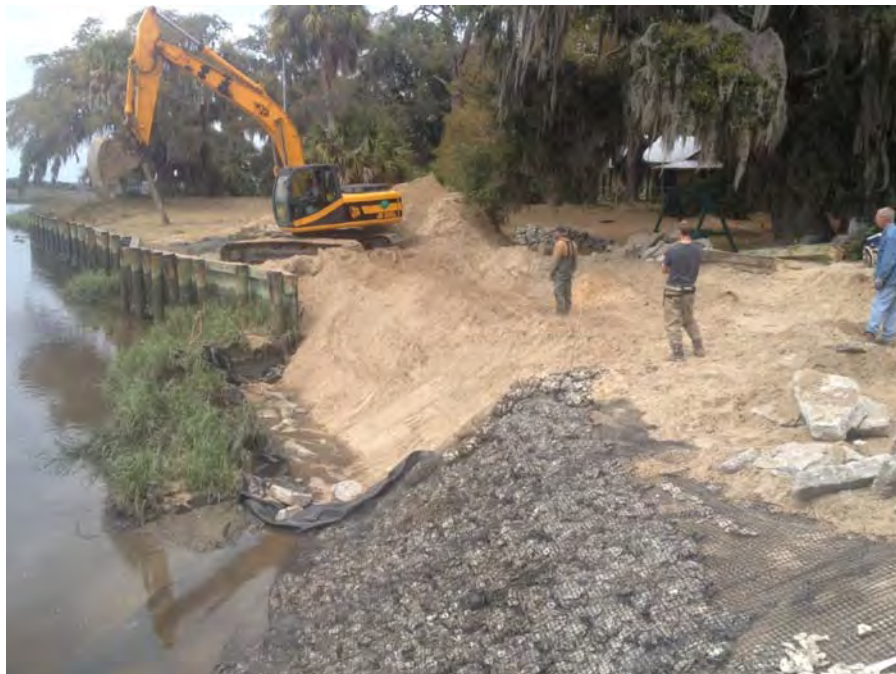
**Figure 6. Construction of living shoreline in sections, Little St. Simons Island, GA.**

Removal and installation of the living shoreline started in February 2013 and was completed in June 2013. Construction took longer than anticipated due to rainy weather. The bulkhead was removed in sections and then immediately sloped. Once the bank was sloped, a tow of rubble concrete was placed at the base to provide support for the oyster bags. The slope was then covered with a geo-textile grid and the first layer of shell bags laid in place to prevent erosion to the exposed stream bank (Figure 6). Bags were laid to an elevation of 1.3m above the mean high tide line. The layer of the geo-textile grid was then wrapped and brought back over the top of the first layer of oyster bags. The geo-textile was used to tie the first layer of shell bags together. Rebar hooks approximately 4ft long were spaced every three feet up the slope (vertically) and every five feet parallel to the creek (horizontally) to secure the oyster bags to the bank (Figure 7). Once the bulkhead has been removed and the first layer completed, a second layer of bagged oyster shell was laid over top and rebar hooks were pushed flush with upper layer of bags. The first layer of bags was completed in April 2013 and the second layer of bags was completed by the end of August 2013. Placement of bagged shell on the reef was handled by the contractor, instead of volunteers as we had planned, to ensure that bags were placed correctly.

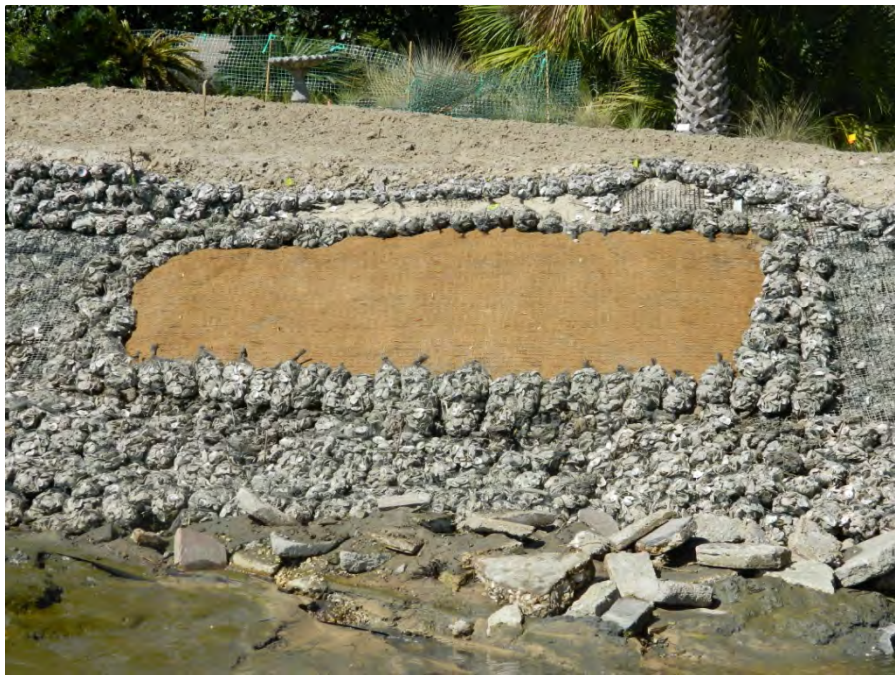
**Figure 9. Patch for marsh grasses to be planted into the living shoreline, Little St. Simons Island, GA.**

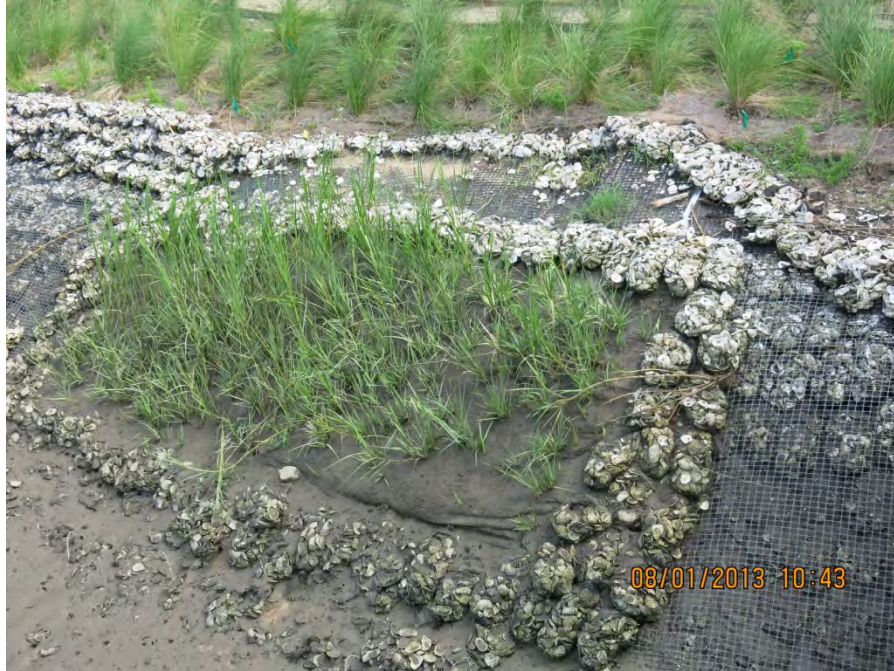
Figure 10. Marsh grasses planted as part of the living shoreline, Little St. Simons Island, GA.

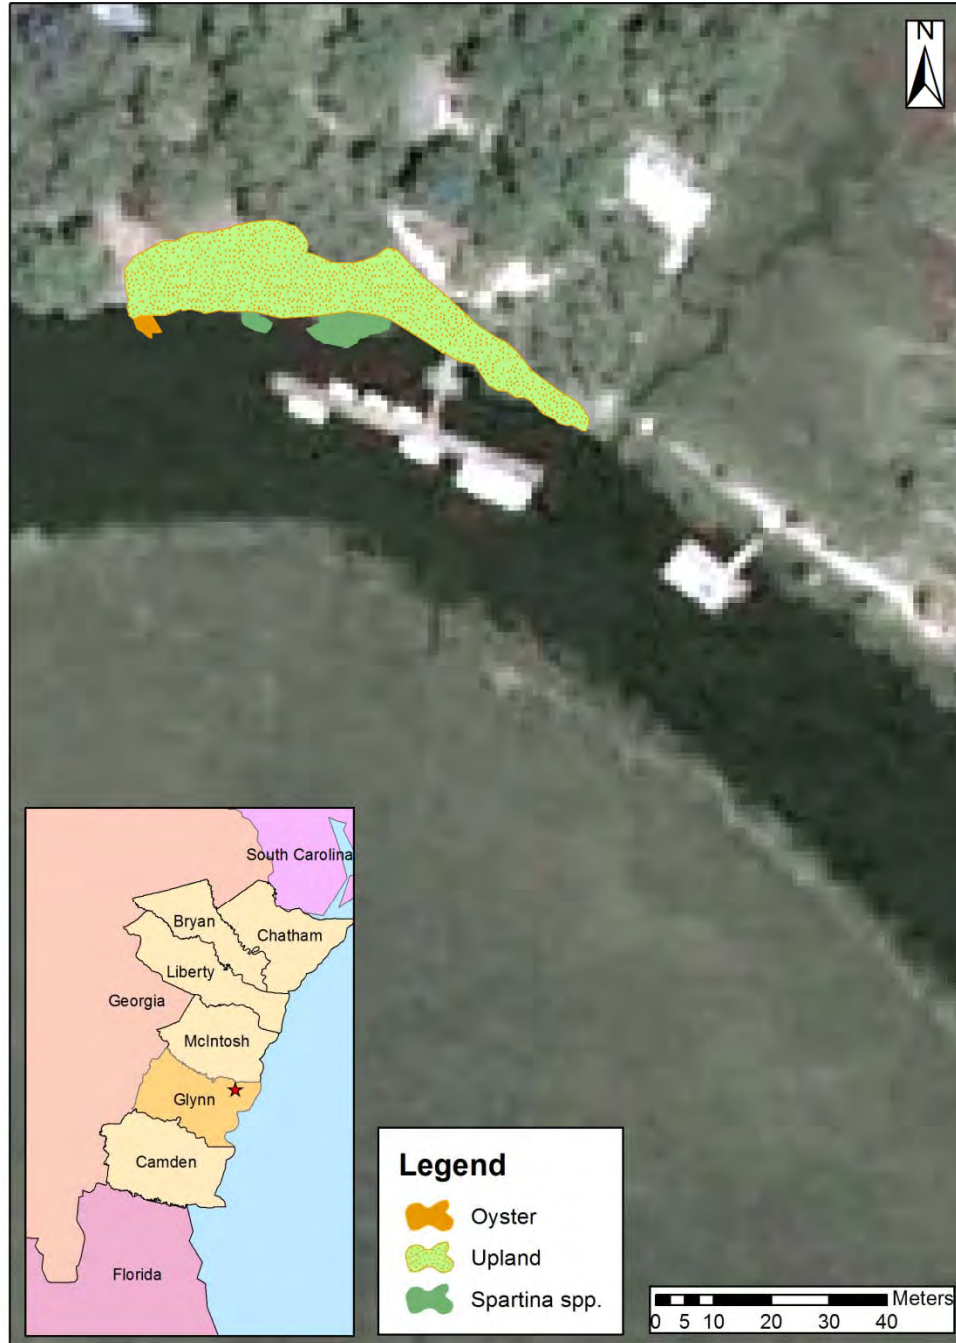
Figure 13. Location of *Spartina* and oysters at the site of the living shoreline prior to construction, Little St. Simons Island, GA.

Prior to construction the stream side part of the bulkhead was dominated by mud. Two *Spartina alterniflora* stands covered 53m<sup>2</sup> and one oyster reef 11m<sup>2</sup> were present (Figure 13). After construction the living shoreline measured 92m long and 3-6m wide and shell bags covered an area of 414m<sup>2</sup> and the natural reef found before construction was left intact for a total of 425m<sup>2</sup> of oyster shell. The two spartina stands present before construction were left in place and a four additional plots were incorporated into the slope of living shoreline for a total area 85m<sup>2</sup>. Two plots of sea oxeye were added to the shoreline and cover an area of 25m<sup>2</sup>. This increased the total area of oyster shell available by 414m<sup>2</sup> and 33m<sup>2</sup> of spartina and 25m<sup>2</sup> of sea oxeye. The extent of live oysters present on the reef covered the lower portion and covered 158m<sup>2</sup> (Figure 14). Monthly photopoints was established to monitor the progress of the living shoreline (Figures 15-28)

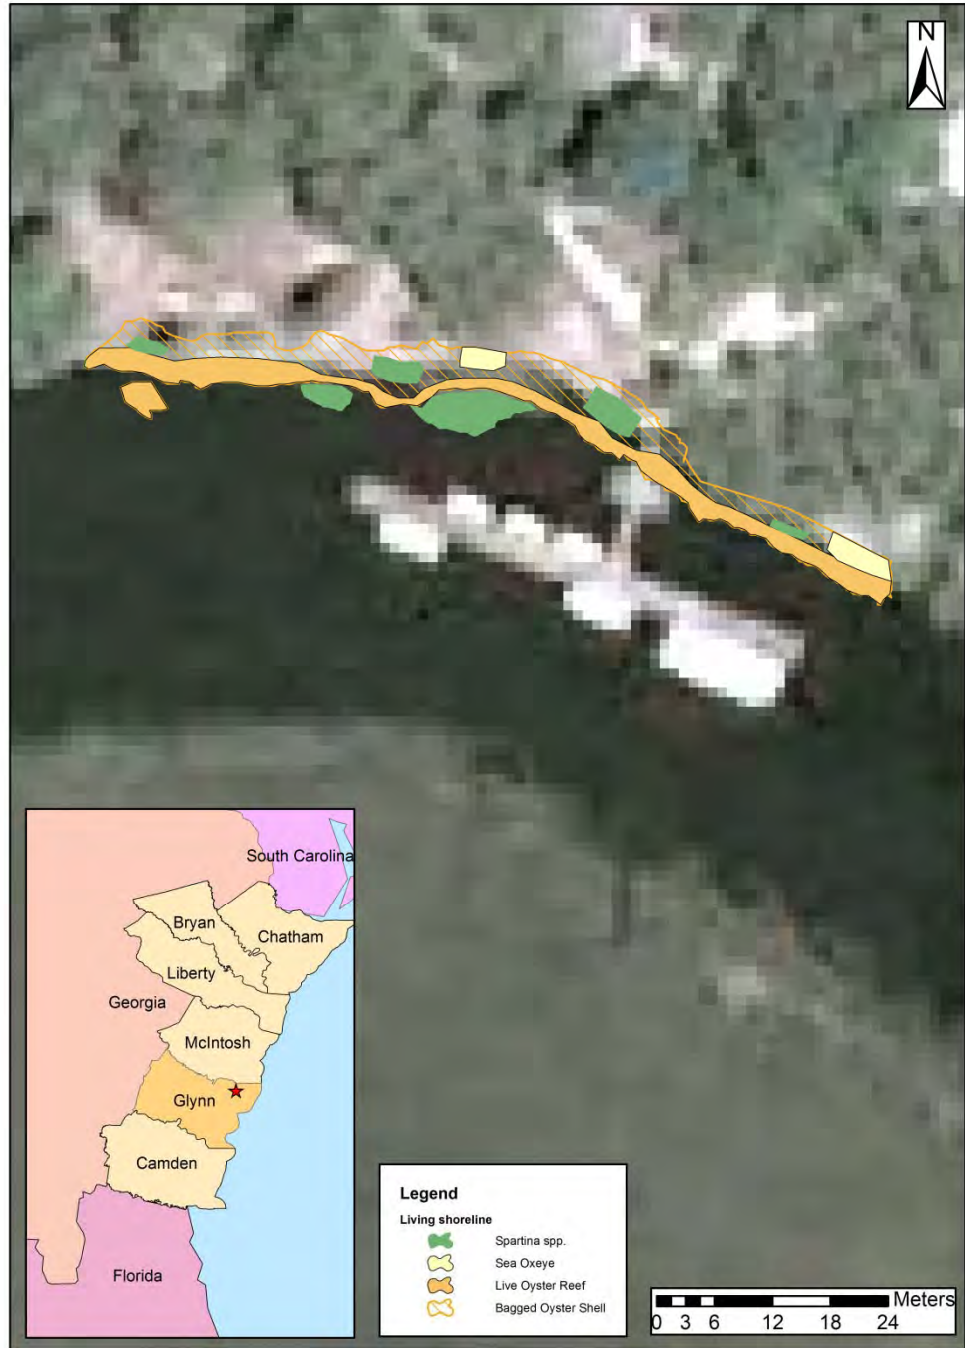
Figure 14. Location of *Spartina*, sea oxeye, bagged oyster shell, and live oysters at the living shoreline after its construction, Little St. Simons Island, GA.

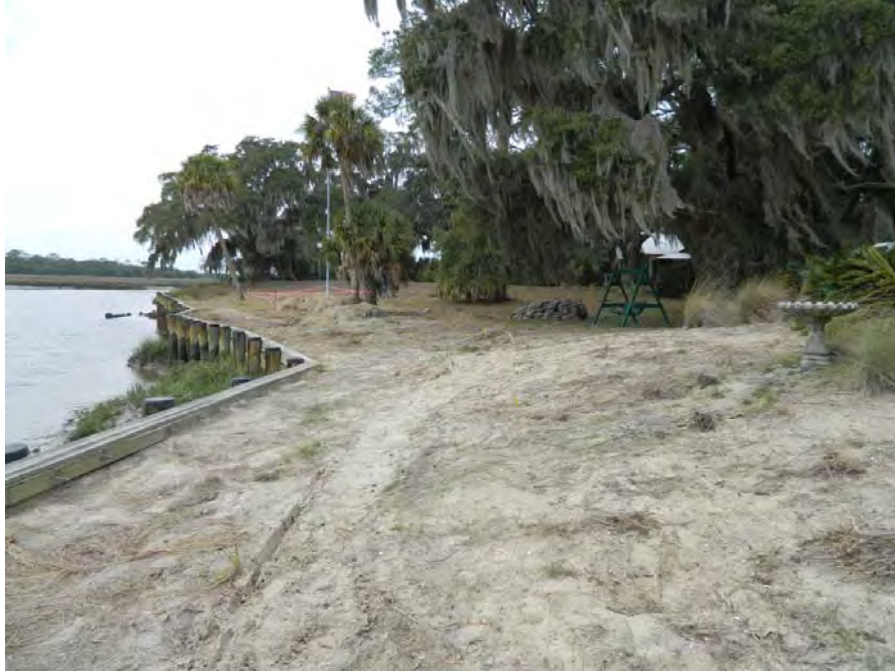
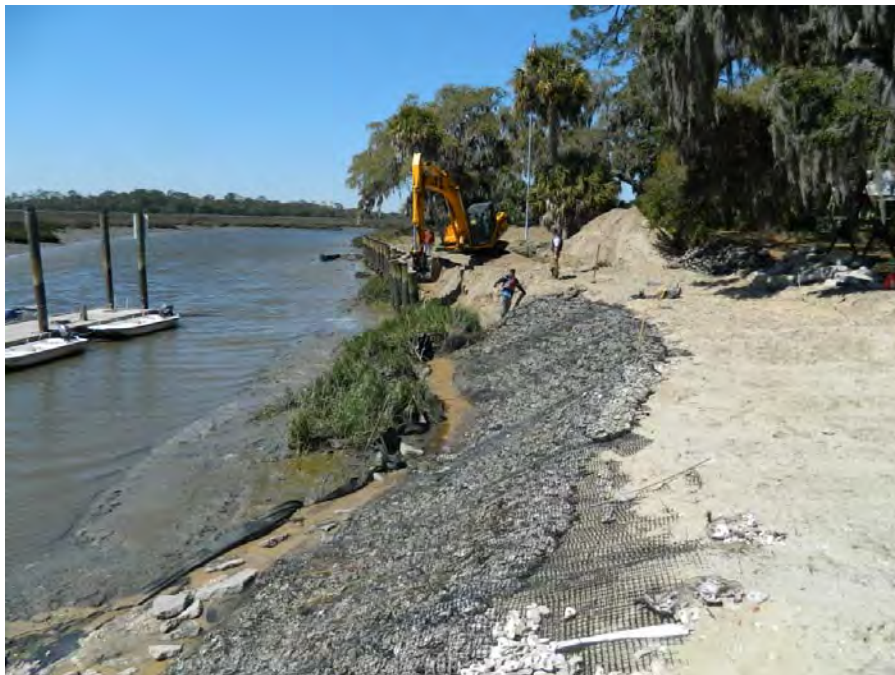
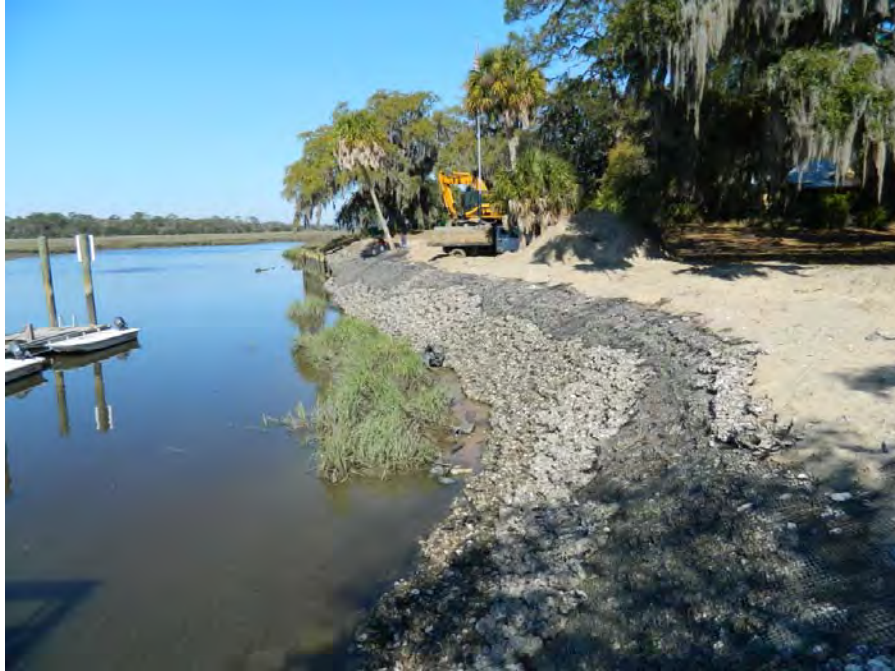
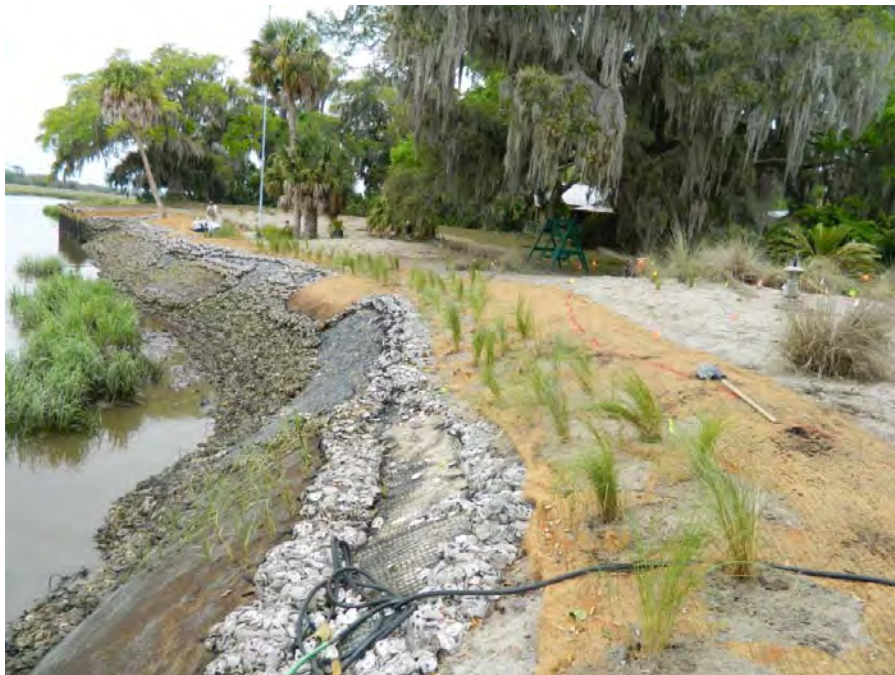
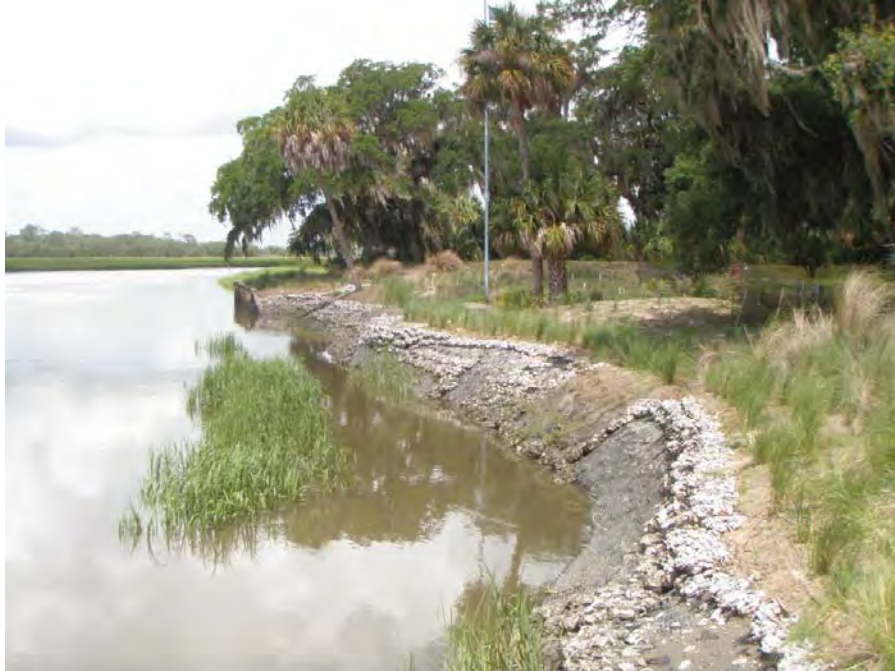
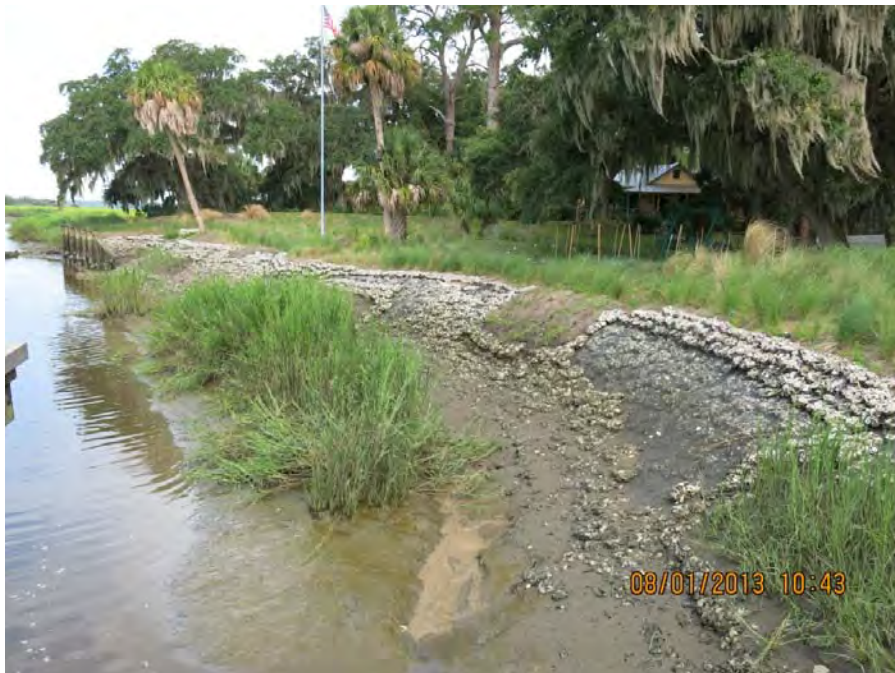
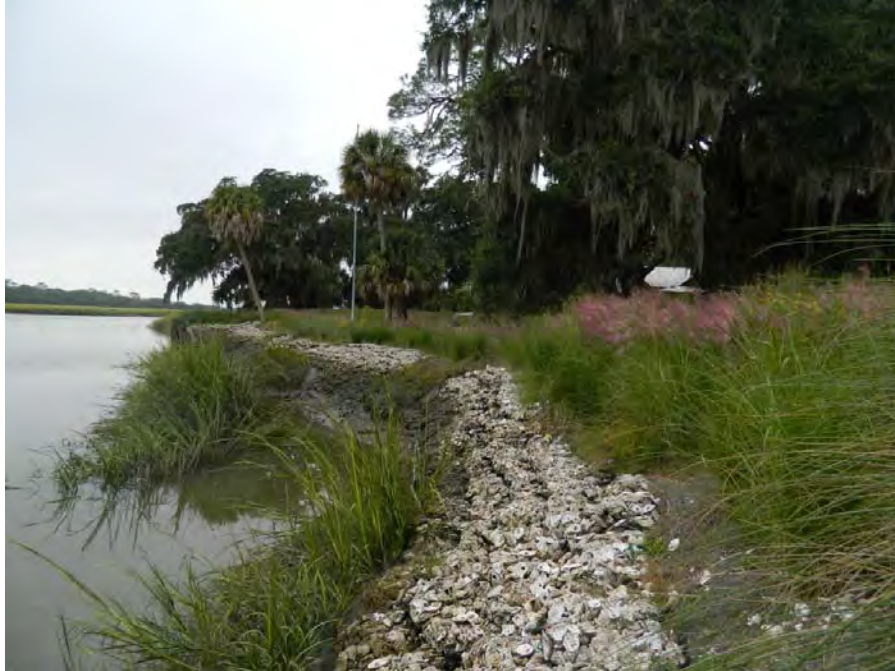
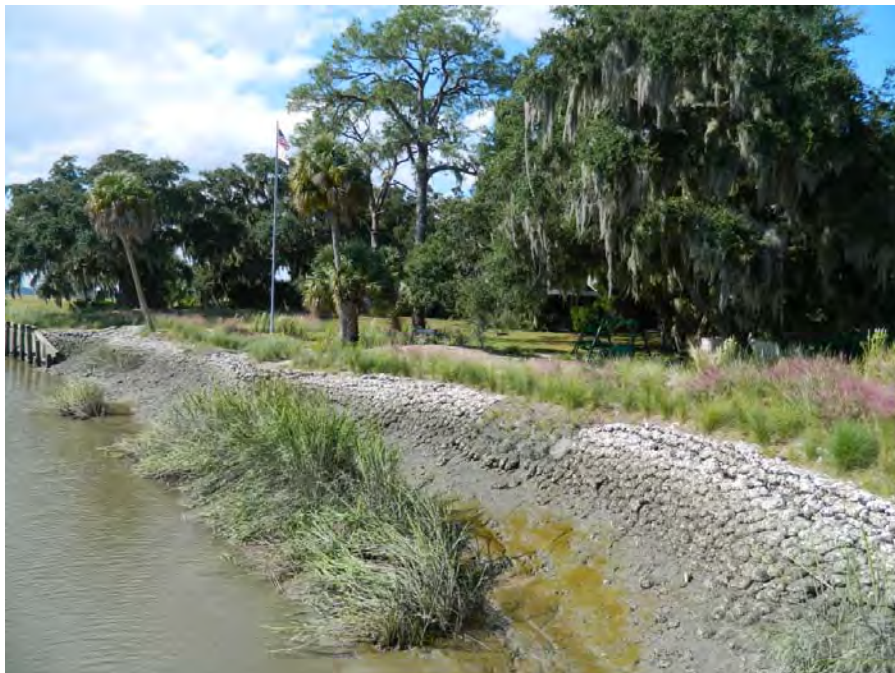
**Figure 15. West side of living shoreline February 2013 Little St. Simons Island, GA**

**Figure 16. West side of living shoreline March 2013, Little St. Simons Island, GA**

**Figure 17. West side of living shoreline April 2013, Little St. Simons Island, GA.**

**Figure 18. West side of living shoreline May 2013, Little St. Simons Island, GA.**

**Figure 19. West side of living shoreline June 2013, Little St. Simons Island, GA.**

**Figure 20. West side of living shoreline August 2013, Little St. Simons Island, GA.**

**Figure 21. West side of living shoreline September 2013, Little St. Simons Island, GA.**

**Figure 22. West side of living shoreline October 2013, Little St. Simons Island, GA.**

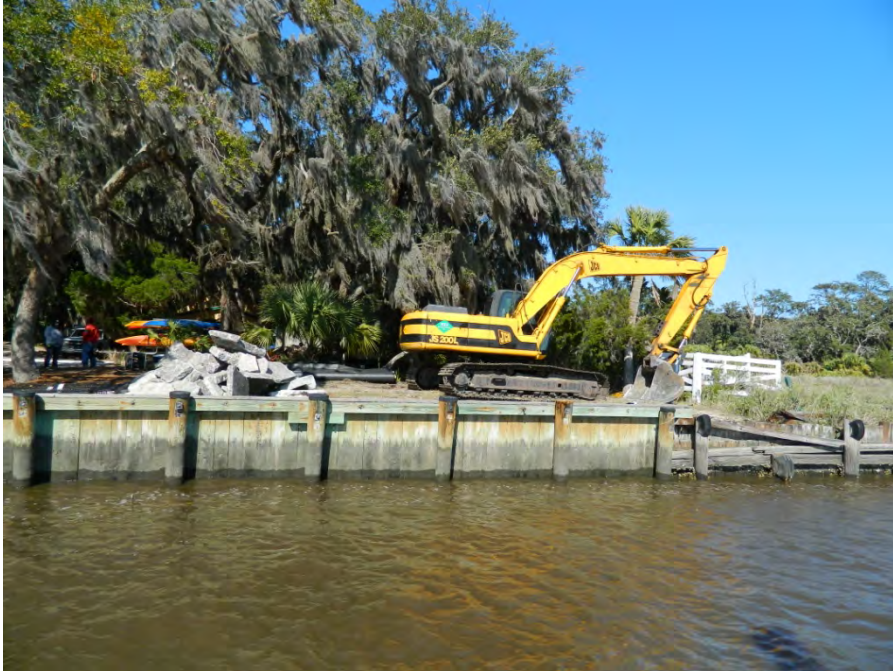
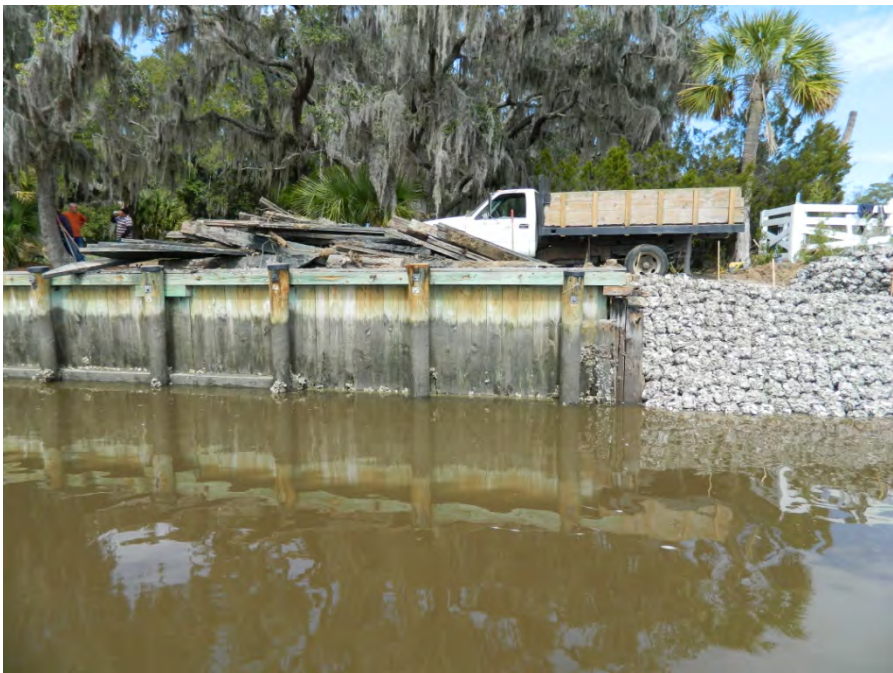
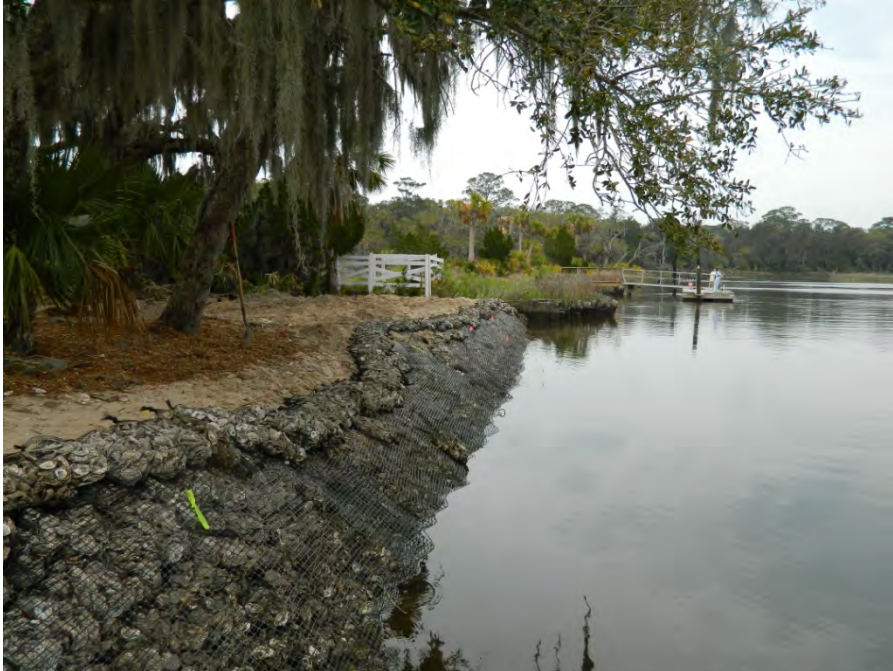
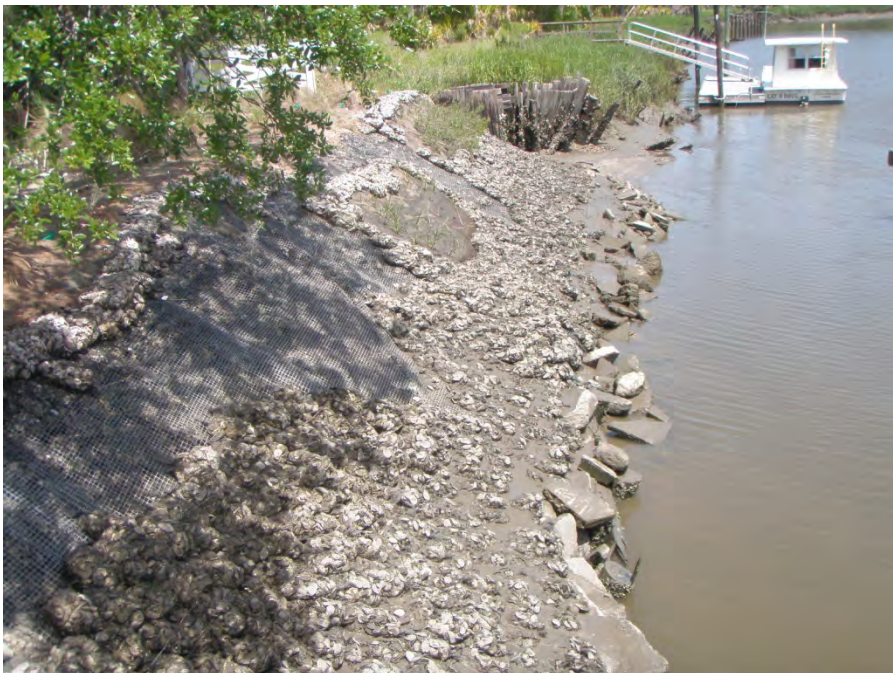
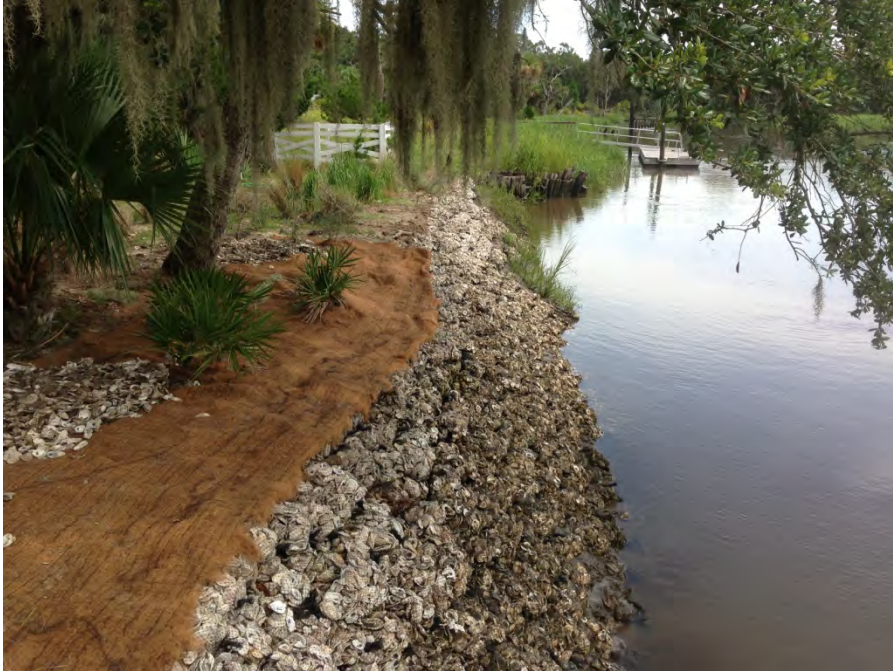
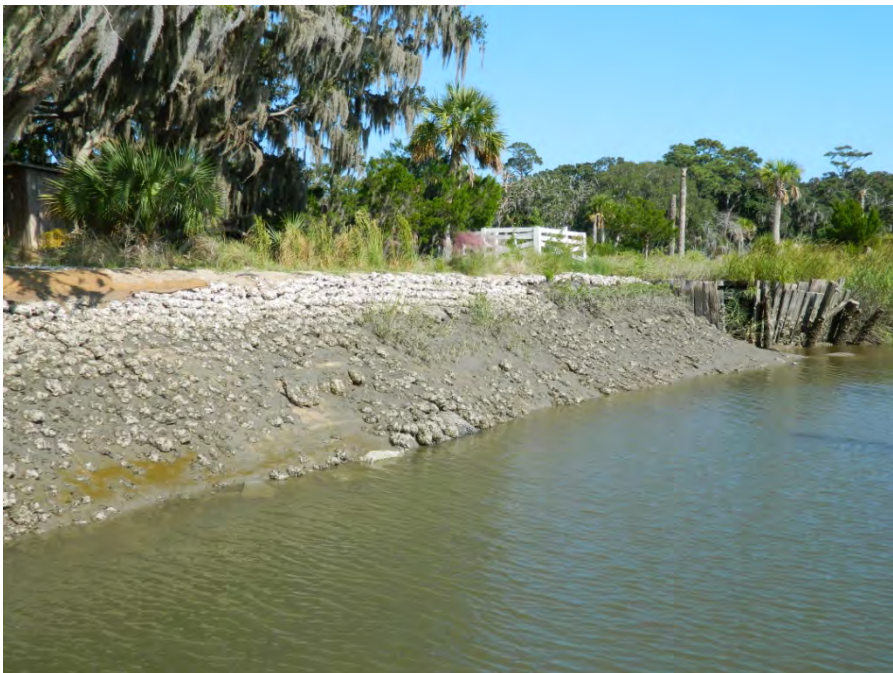
**Figure 23. East side of living shoreline February 2013, Little St. Simons Island, GA**

**Figure 24. East side of living shoreline March 2013, Little St. Simons Island, GA**

**Figure 25. East side of living shoreline April 2013, Little St. Simons Island, GA**

**Figure 26. East side of living shoreline June 2013, Little St. Simons Island, GA**

**Figure 27. East side of living shoreline August 2013, Little St. Simons Island, GA**

**Figure 28. East side of living shoreline October 2013, Little St. Simons Island, GA**

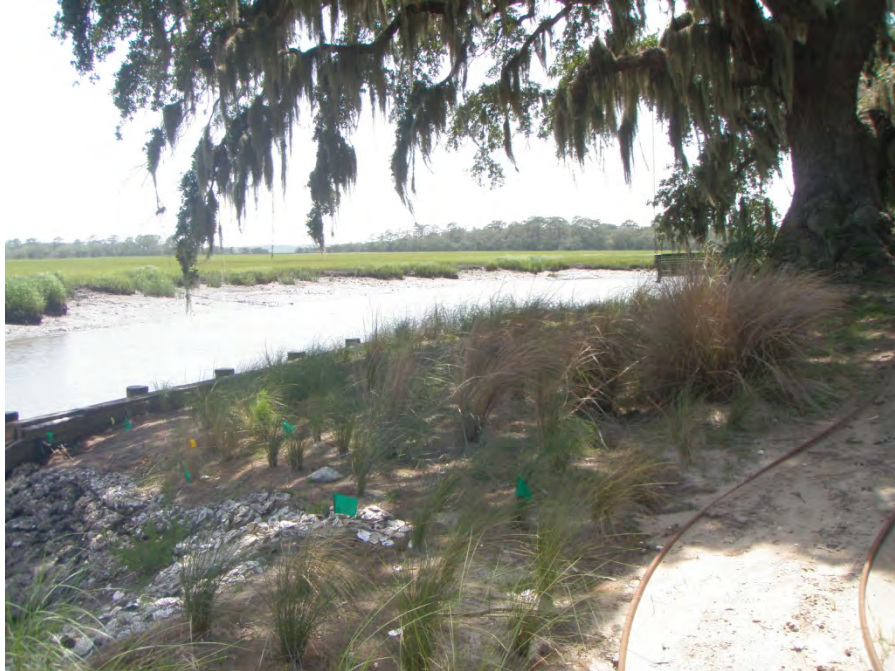
Figure 29. Flagging (dark green) set out in June 2013 to monitor for erosion, Little St. Simons Island, Ga.

Flagging set up at 5m intervals to monitor the top edge of the living shoreline for erosion was not successful (Figure 29). The flags were set up at the end of June when construction was complete, but flagging material did not hold up as anticipated and when we returned to sample flags had been removed or were missing. We did notice two small areas of erosion at the transition from the bagged shell to the upland that coincided with areas where runoff drained from the upland. Additional bags and soil were added to these areas and these areas continue to be monitored. The erosion also occurred early after construction before plants had time to get established. Since the flagging did not work for monitoring erosion, we got in contact with Dr. Jackson at Georgia Southern University who has a 3d ground LiDAR system and he agreed to take images of the living shoreline with his equipment on a bi-annual basis to monitor the site. He was able to visit the site in the fall, but images are not yet available.

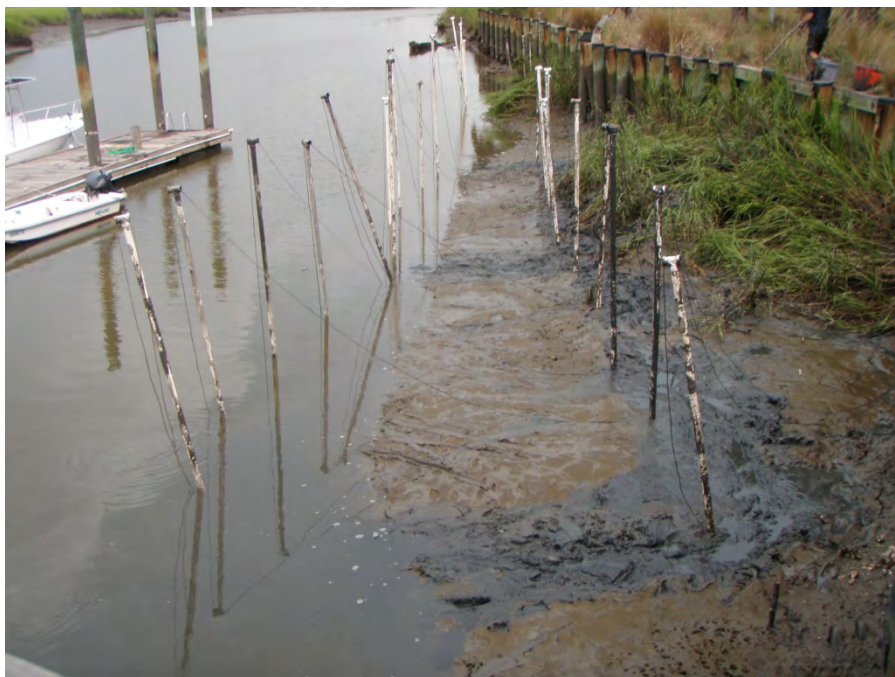
Figure 30. Bottomless lift nets set for deployment, at low tide, prior to construction of the living shoreline.

Prior to construction three locations were selected at the base of the bulkhead and were comprised of mud only, after construction three locations along the living shoreline were selected. A bottomless lift net that covered 24 m<sup>2</sup> (8m x 3m) made of 2.4 m tall Delta style netting with 3 mm (1/8 inch) mesh (Nylon Net Company) and a weighted base staked with stakes every half meter was used (Wenner *et al.* 1996; Coen *et al.* 1999). Each site was sampled one day each season (winter, spring, summer, and fall) during daylight hours. After nets were deployed water temperature, dissolved oxygen, pH, and salinity were recorded at the surface and at one meter below the surface using a Qunata (Hach Company). On the following low tide, net edges were checked for specimens as soon as the site was completely exposed (Figures 30-32). Once sampling was complete the nets were removed. Specimens collected were anesthetized in Finquel and placed in 10% seawater buffered formalin to store for identification. Species that could be identified and measured on site were released (Figure 33). Collected specimens were identified in the lab to species or highest classification level if species could not be determined. Fish were identified, enumerated by species, and total length standard length were recorded. Crustaceans were identified, enumerated by species, and measured. Prior to removal of the bulkhead and we collected a total 1,419 specimens and identified 7 species of crustaceans and

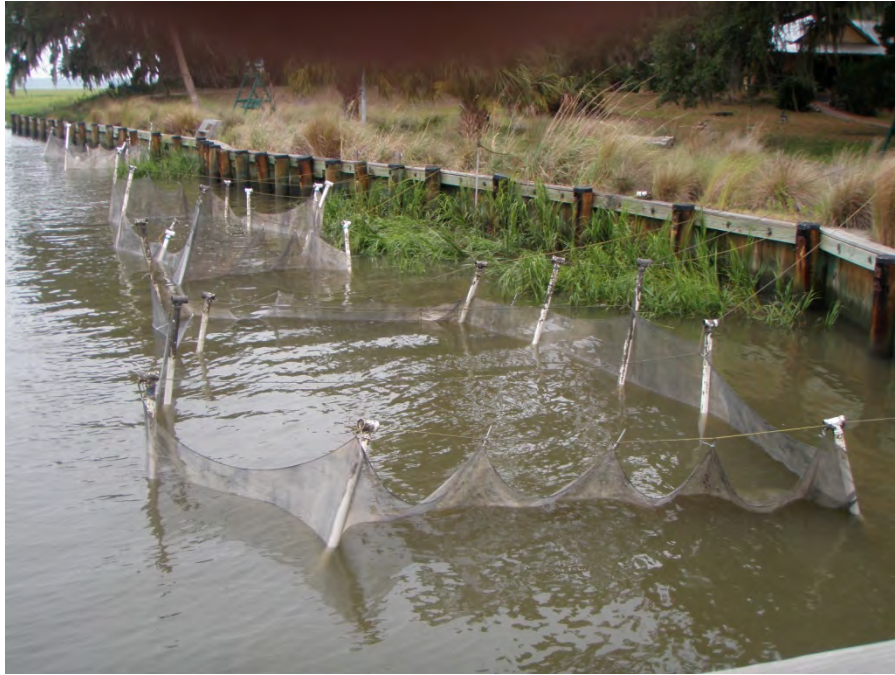
**Figure 31. Bottomless lift nets after deployment, at high tide, prior to construction of the living shoreline.**

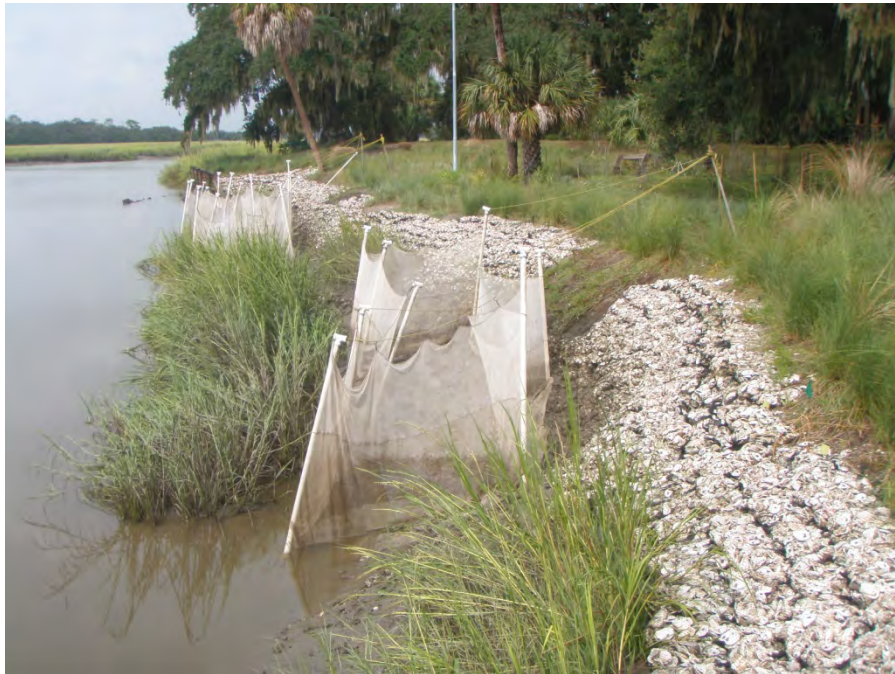
**Figure 32. Bottomless lift nets after deployment, at low tide, after construction of the living shoreline.**

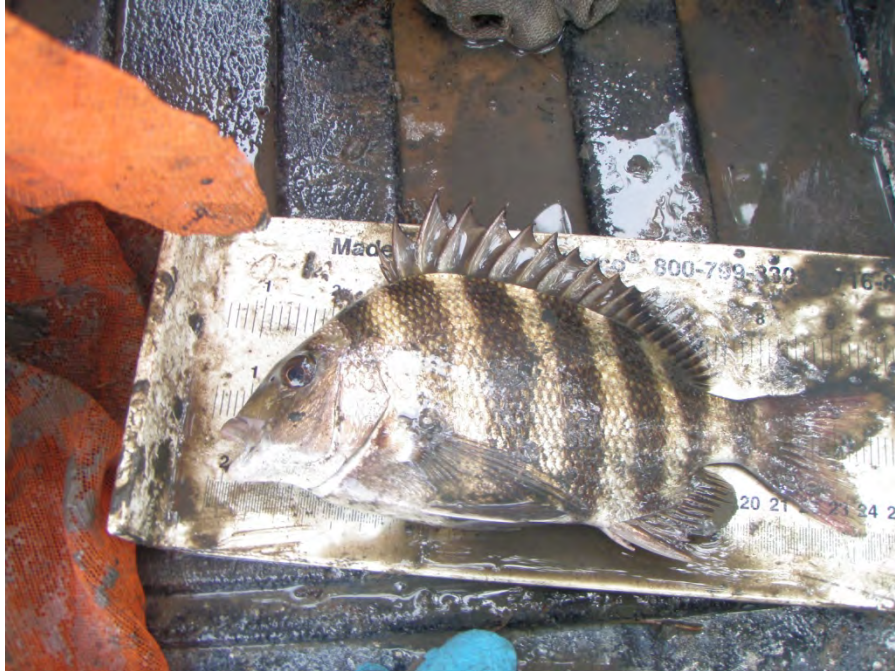
Figure 33. Sheepshead (*Archosargus probatocephalus*) capture in bottomless lift nets after construction of the living shoreline.

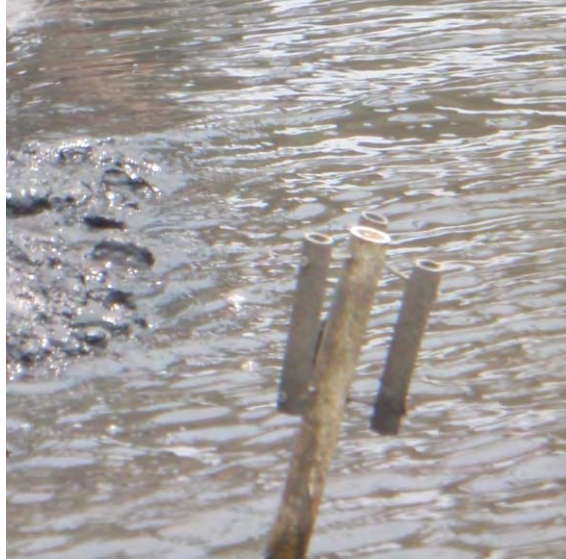
**Figure 34. Spat collector used monitor oyster spat at living shoreline site prior to construction, Little St. Simons Island, GA.**

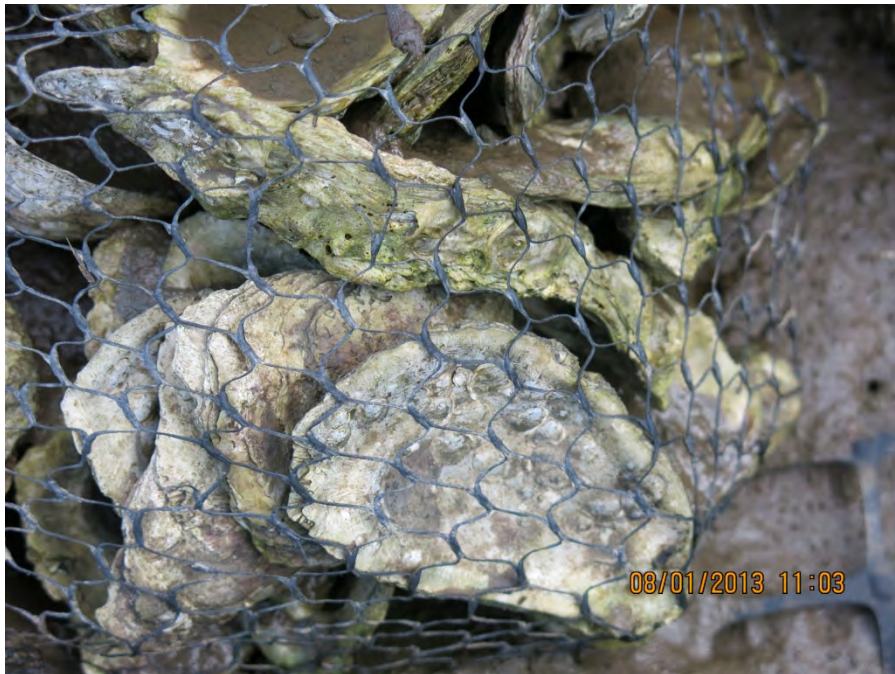
**Figure 35. Oyster spat on bagged oysters used at the living shoreline, Little St. Simons Island, GA**

After construction of the living shoreline live oysters were found on each transect and that density was greatest on the lower quads (at the base of the reef) with 20.4 oysters per 0.25 m<sup>2</sup> and decreased as you moved toward the upland with 10.7, and 3.2 oysters, respectively. The mean length of oysters was 20.5 mm (N=380) and ranged from 8.6 - 50.0 mm (Table 10). We did have less *spartina* present with stems only found in 2 quads with stem densities of 1 and 5 (Table 11). The mean height of *spartina* was 236.0 mm. We did measure *spartina* in the patches planted on the shell slope and found *spartina* and found that it had a mean density of 26.1 stems per 0.25m<sup>2</sup> with an mean height of 362.2 mm. No barnacles or mussels were observed in the any of the 0.25m<sup>2</sup> quadrants. The reef will be continued to be monitored for two more years to track oyster recruitment, density, size, and mortality.
