**AERIAL PHOTOGRAPHIC INTERPRETATION OF
THE HISTORICAL CHANGES IN
NORTHERN BISCAYNE BAY, FLORIDA:
1925 TO 1976**

Peter Wayne Harlem

**SEA GRANT TECHNICAL BULLETIN NO. #40
DECEMBER, 1976**

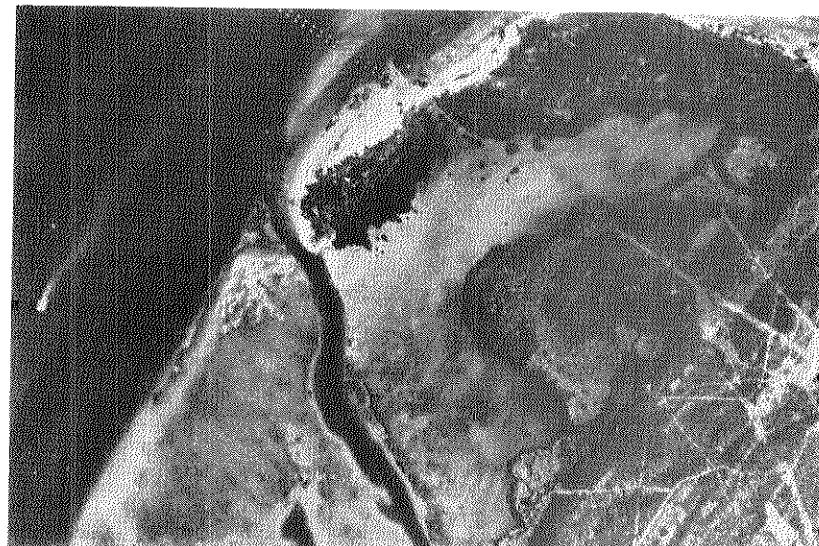
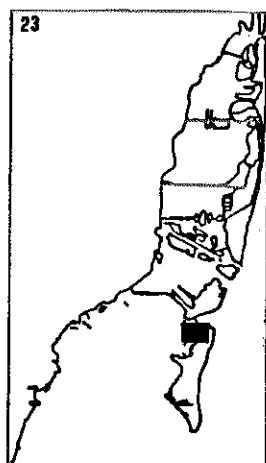
Figure 23. 1945-1951-1976 sequence of the north end of Key Biscayne. The development of Crandon Marina can be seen (USGS, C-1616; USGS, 3625; Fla. Dept. Transportation, PD 1638-20-22).

- e) Dredged marinas are basins dredged to provide anchorage for boats or ships with drafts in excess of natural bottom depths (Figure 23). Actually few bayshore marinas are dredged for boat usage, since most marinas are built in previously dredged borrow pits which reduces construction costs. One feature, possibly unique to Biscayne Bay is the abandoned Pan American Airway Dinner Key seaplane landing strip. This large, shallow rectangular dredge hole is in part used as Dinner Key Marina. For a description of the landing strip as planned see the United States Army Corps of Engineers' report dated 1932 (Figure 22a).

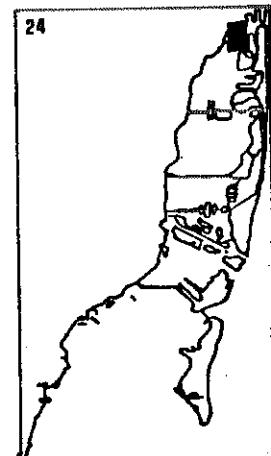
Figure 24. 1940-1973-1976 sequence from Area I. Benthic vegetation increases significantly on both sides of the abandoned waterway (1). The long row of spoil islands seen in 1940 is not seen in later photos. Note the dense vegetation growing on the submerged portions of the two small spoil islands (2) in 1976 (see Figure 33) (USGS, CJF-15-02; Fla. Dept. Transportation, PD 1274-14-13; Fla. Dept. Transportation, PD 1628-21-35. Thin vertical black lines are artifacts).

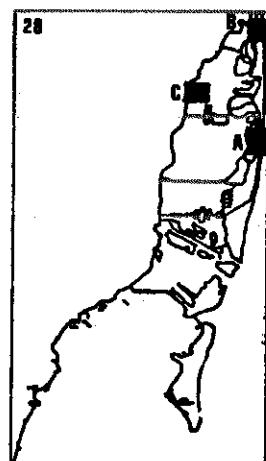
Figure 28. A: Oblique 1925 view shows the clearing of upper Miami Beach. Indian Creek is in the background. Trees are believed to be very tall black mangroves (*Avicennia*) (Hoyt, WP9401). B: Bakers Haulover circa August 1935 shows the fan-shaped tidal delta that formed after the cut was opened in 1925. Portions of the delta are colonized by benthic plants (arrows) (Hoyt, ATL126). C: 1976 view of boat waves acting on a spoil island (arrows). Note the pattern of wave refraction (Fla. Dept. Transportation, PD 1638-21-35).
