**CURRENT METER OBSERVATIONS
OF THE CIRCULATION IN GRAND TRAVERSE
BAY OF LAKE MICHIGAN:
MOORING METHODS AND INITIAL RESULTS**

By
RICHARD G. JOHNSON
and
EDWARD C. MONAHAN

Department of Meteorology and Oceanography
College of Engineering
The University of Michigan

Sea Grant Technical Report #18

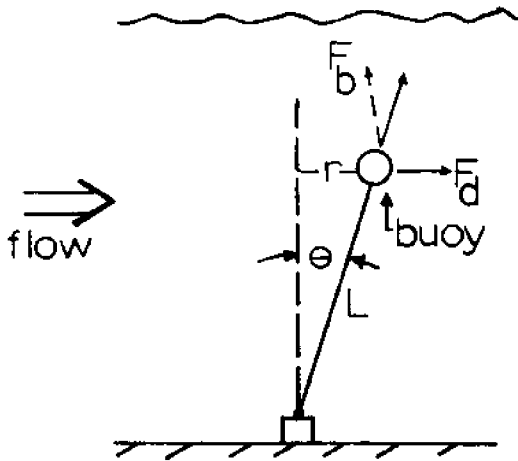
FIGURE 7 - Drag Force Calculations

assume $F_d = F_r$

$$F_d = (\rho C_d A V^2) / 2$$

$$F_r = F_b r / L$$

$$\therefore \rho C_d A V^2 = 2 F_b r / L$$

$$\theta = \sin^{-1} F_d / F_b$$

The necessary calculations are given in Figure 7. Table 1 presents angles of deviation (θ) for various array lengths (L) and net buoyancy values (F_b). Note that for a given array length angle of deviation decreases with increased buoyancy; and that for a given buoyancy the angle of deviation increases as the length of the array increases. Thus, one must determine whether buoyancy or mooring length is the determining factor in a particular situation. In the Grand Traverse Bay cases, mooring length was the determining factor and the least possible buoyancy and anchor weight were sought such that the array would be held within the desired 5° of the vertical. For a mooring length of 70 feet, 100 pounds of net buoyancy in the SABA satisfied this criterion.
