## A FEASIBILITY PILOT PROJECT FOR A METHOD OF OPEN WATER FISH FARMING

FINAL REPORT

Report No. OI-72-78-1

June 1, 1972

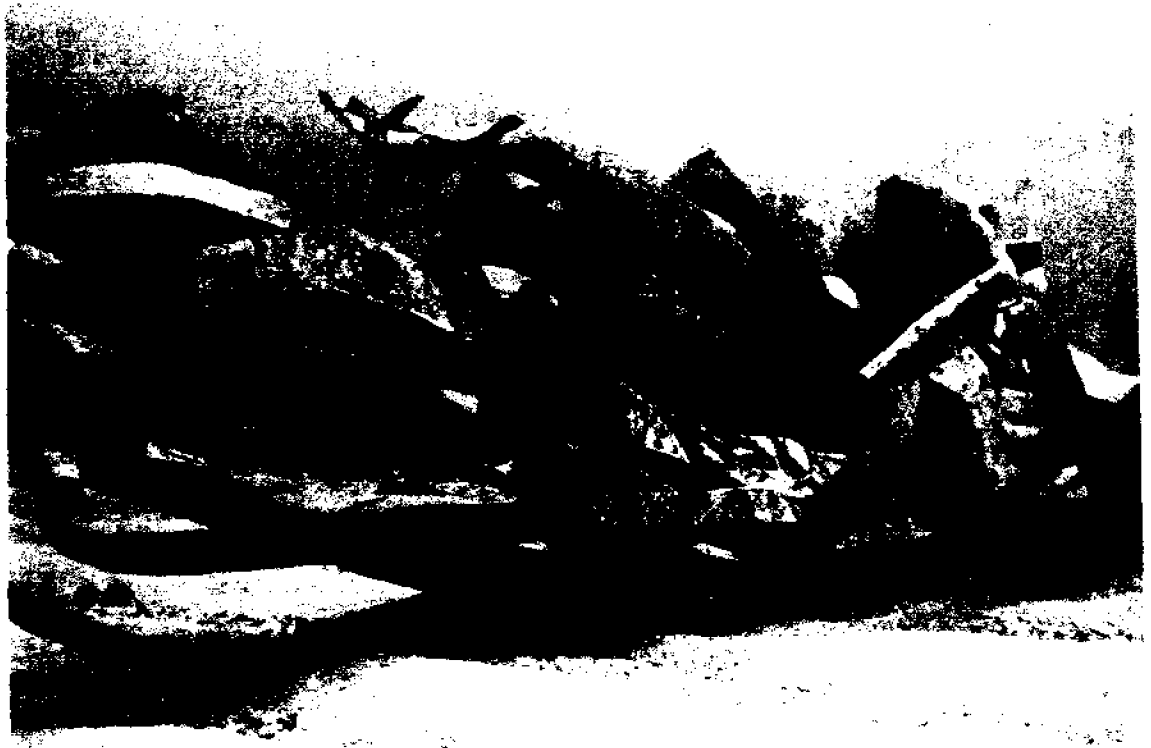
Fig. 4 Tyvek fronds showing algal accumulation.

The olefin plastic seemed to be a considerable improvement over smooth polyethylene. Its textured surface tends to hold a reservoir of algae (Fig. 4), partially protected from grazing, even from the very selective grazing of the sea hares. Its opaque quality did not seem to inhibit growth though our sample was small enough that ambient light from the sides might have induced growth were a full dense bed might inhibit growth deep in the bed. It seemed somewhat less brittle than the polyethylene after exposure to seawater, and it is extremely light and tough. One can conclude that texture is an important feature of grassbed plastics, and that further checking of available types of

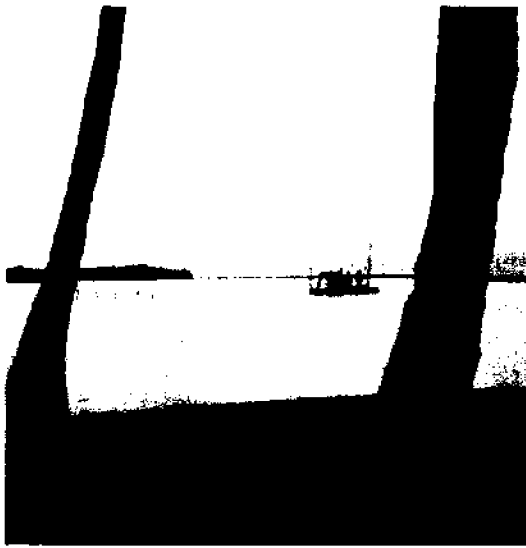
(a) Dredging barge in Ali'i Pond

Fig. 4. Dredging barge, filtration gate, detail of wall construction.

The pond was dredged in a series of arcs. A manually operated system allows a spud to be set in the pond bottom off a rear corner of the barge. The barge, with its dredge head, pivots around the spud. Then the spud is re-set on the opposite rear corner, advancing about 1-1/2 feet with each sweep. The dredging barge, in effect, "walks" across the pond. Dredge spoil is carried by 6000 g/hr to the fill area between the walls. At times excess spoil was available and sold as fill. Manual operation of the spud was later replaced by a motor-driven hydraulic cylinder system.

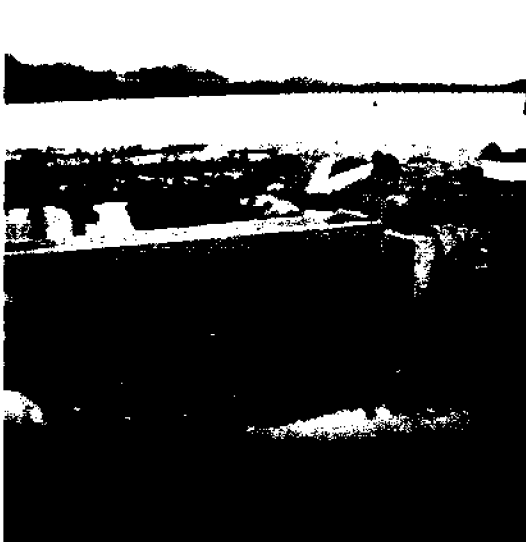
(d) Filtration gate, awai

In the middle of the new dock-road area of the wall, a cement awai and makaha were constructed. Instead of using the ancient method of binding straight saplings vertically on the makaha to keep out predators and competitors, sheets of a special heavy duty plastic screen (Filter X, Cartage Mills, Inc.) for hydraulic filtration were used. This plastic proved to be self cleaning in the tide and is expected to be much more efficient than the sapling barrier in keeping the pond free of unwanted fish. The awai (Fig. 4(c)) (4' h x 8'w x 4'l) is constructed of cast cement, and provided with three slots for plastic screen frames, rubbish grates, and
