CALIFORNIA'S COASTAL NATURAL HAZARDS

*PROCEEDINGS FROM THE CONFERENCE HOSTED BY THE
CALIFORNIA SHORE AND BEACH PRESERVATION ASSOCIATION
AND THE
UNIVERSITY OF SOUTHERN CALIFORNIA
SEA GRANT PROGRAM*

*NOVEMBER 12-14, 1997
SANTA BARBARA, CALIFORNIA*

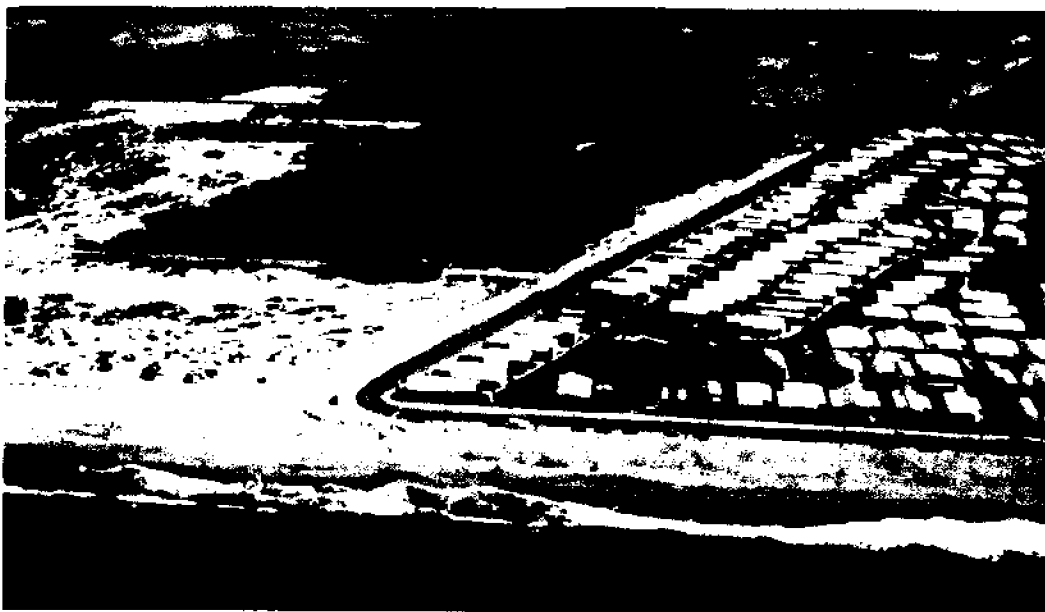
Figure 1. Oxnard Shores, California, 1984, showing loss of dune and truncation of the beach due to construction of buildings and roads.

Beaches and dunes are eliminated to facilitate construction of buildings (Figure 1) (Kuhn and Shepard 1980; Healy *et al.*, 1990), public support infrastructure, such as roads and

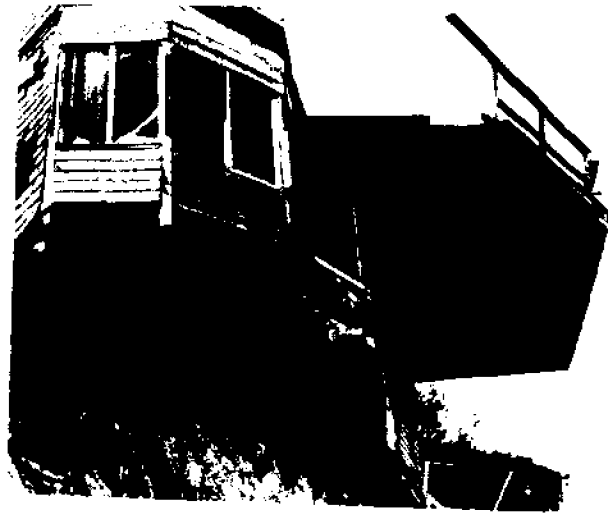
Figure 2a. Construction on eroding coastal bluffs: Marin County

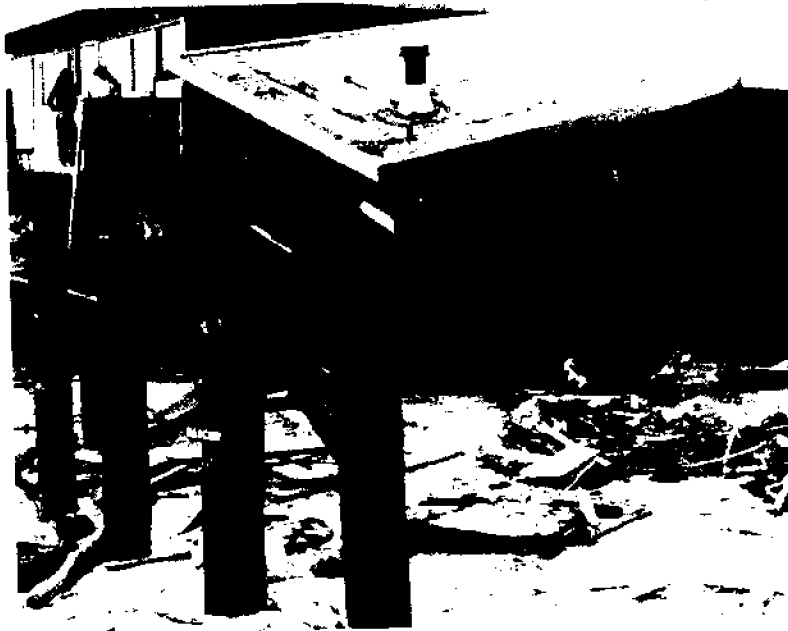
Figure 6. Collapse of a home built on shallow pilings on Rio del Mar Beach, Monterey Bay, during the winter of 1983 due to beach scour.

Damage during the 1983 El Niño winter included undermining of shallow pilings or piers so that homes collapsed onto the beach (Figure 6). Homes on low pilings were also uplifted by waves at high tide and smashed through pilings as they fell. In addition,

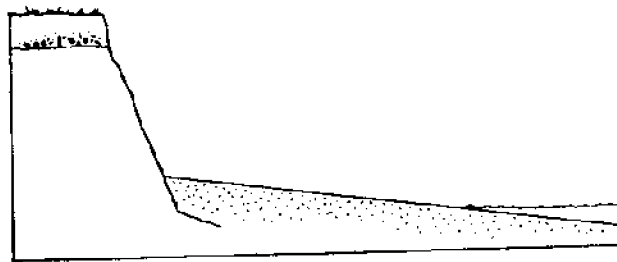
Figure 1. Examples of beach loss through placement of protective structures.

(A) Beach without any coastal protection structures.

- **Impoundment or Placement Loss:** This effect is the most straightforward and predictable. When a structure is built seaward of the base of the bluff, cliff, or dune, well out on the beach profile, a given amount of beach is covered (Figure 14). Thus the effect is immediate beach loss; the extent of the loss being a function of how far seaward and alongshore the structure extends. Along the margin of northern Monterey Bay, California, for example, seawalls were built 100 to 250 feet seaward of the base of the bluff in order to allow homes to be built on the back beach. As a result, from Beach Drive in Rio Del

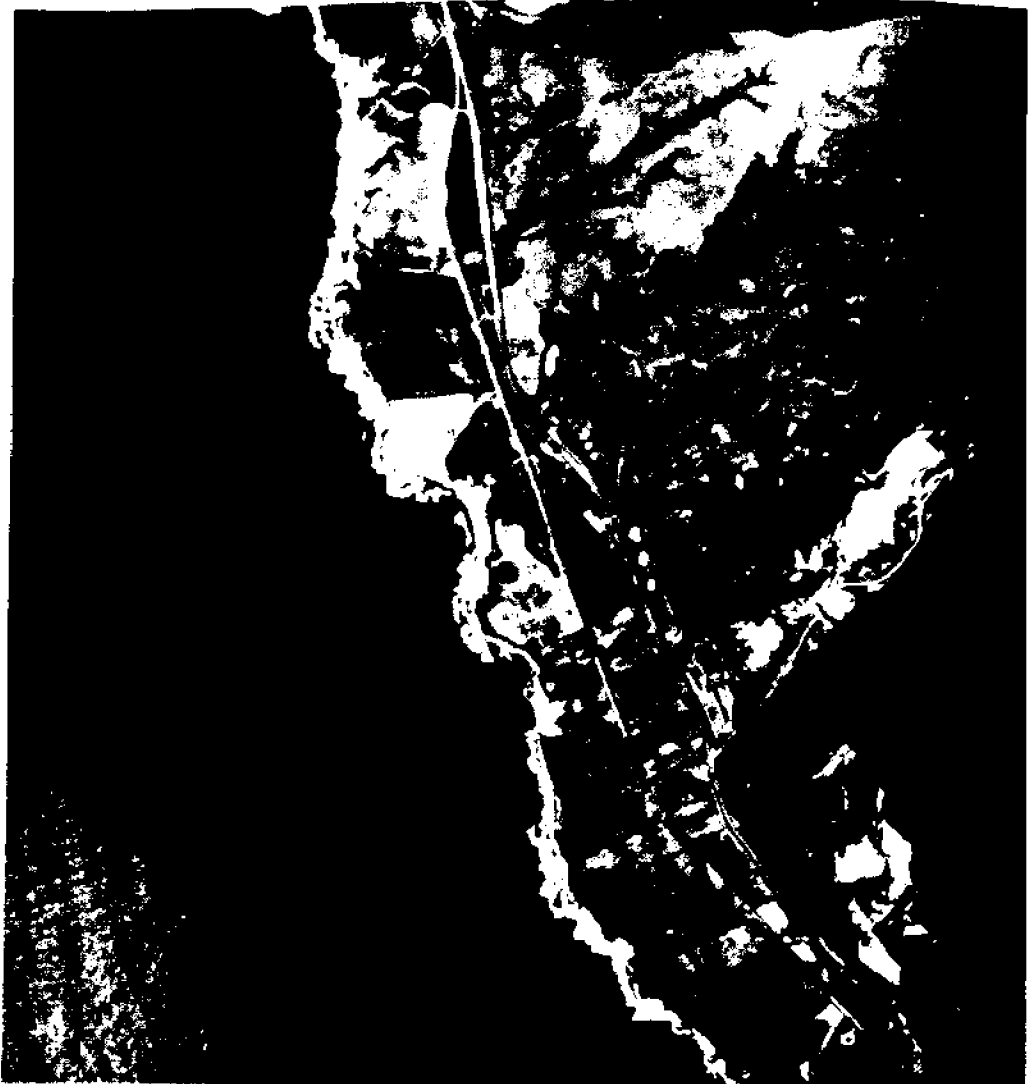
Figure 4b. Vertical aerial photograph showing rocky, irregular pocket beach coastline in Santa Cruz county.

the ribbon of sand and the beach itself, are well studied. Along a pocket beach coastline, however, where there is no apparent ribbon of sand, no continuous sandy beach, and where there are many protrusions and headlands which serve as barriers to movement of sand, the processes of longshore sediment transport are poorly understood.
