**MAINE HEALTHY BEACHES PROGRAM:  
SUMMARY REPORT OF ENHANCED MONITORING AND POLLUTION SOURCE  
TRACKING EFFORTS IN THE NEW SALT RD. TRIBUTARY, GOOSEFARE BROOK  
OLD ORCHARD BEACH, MAINE  
2012-2014**

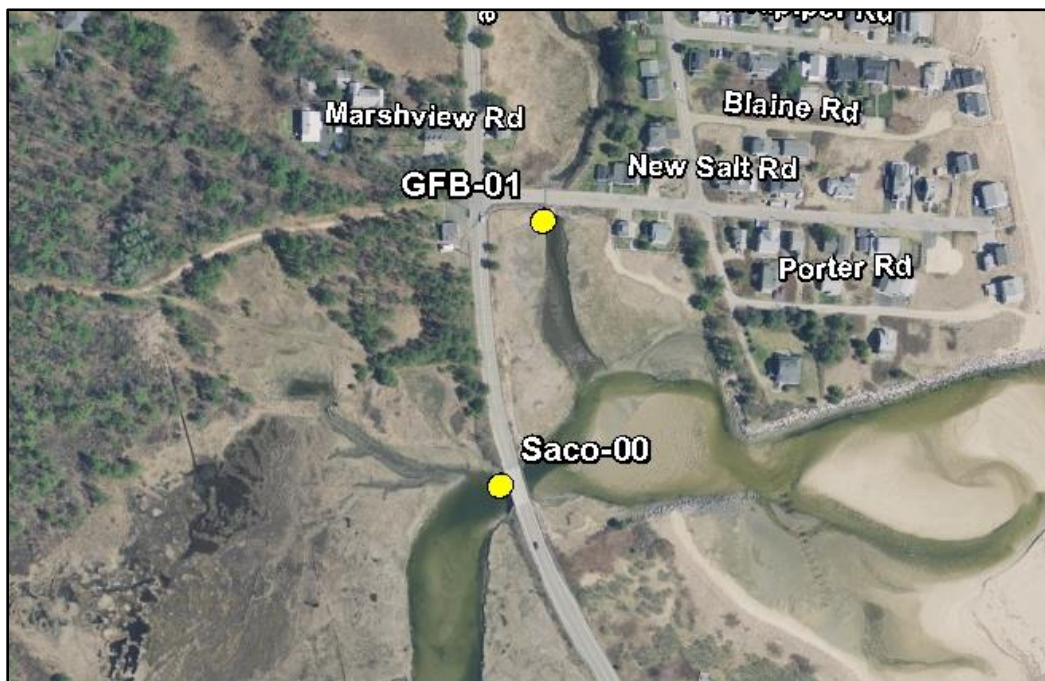
Figure 7. Monitoring stations GFB-01 and Saco-00 located at the mouth of the Goosefare Brook.

- **Mouth of GFB**
  - The apparent trend in the mouth of the brook is higher ENT results on an incoming tide (Figure 8, Table A2) suggesting potential pollution source(s) in the vicinity of the mouth and/or conditions in this area favor persistence and possibly regrowth of ENT. It may also be worthwhile to recheck the area near the tide gate to ensure a tight system (Figure 7).

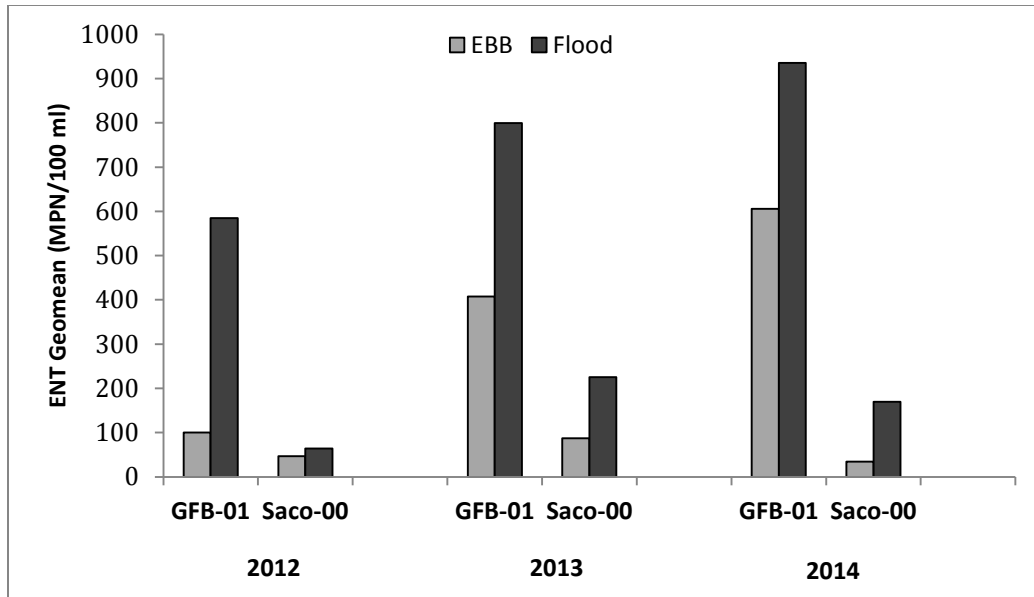
Figure 8. Season-wide ENT geomean results for GFB-01 and Saco-00 weekly samples collected at ebb and flood tidal conditions.

Comparison of ENT geometric mean results (2012-2014) for weekly samples collected during all tidal conditions at two sites (GFB-01 and Saco-00) at the mouth of the brook revealed distinct differences between ebb and flood tidal stages (Figure 7). In all years, ENT geometric mean results were greater during flood (incoming) conditions vs. ebb (outgoing) and in many cases, the flood bacteria values were more than double those observed during ebb conditions. Also, for GFB-01 in particular, the bacteria results during both incoming and outgoing tidal conditions appear to be increasing over time (Figure 8). Given the documented bacteria issues throughout the GFB watershed, it was expected that ebbing tide conditions would result in greater ENT results compared to flood conditions. Presumably, outgoing tides pull water from tributaries (including contaminants from upland areas) compared to incoming tides when ocean waters mix with the brook. Higher flood tide ENT levels suggest potential pollution source(s) in or near the mouth and/or conditions in this area favor persistence and possibly regrowth of ENT.

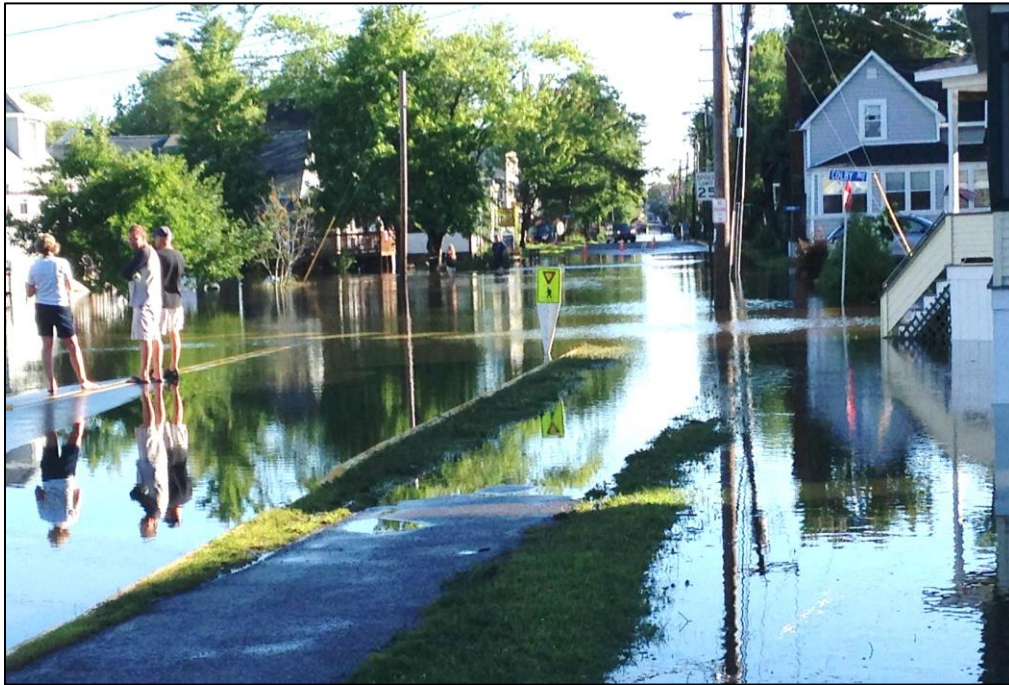
Figure 11. Extent of flooding along West Grand Avenue, Ocean Park following the August 13, 2014 rain event.

On August 13, 2014 nearly 6.5 inches of rainfall fell within a 24-hour period causing flood conditions in several regions throughout southern Maine (Figure 11). As a result, all 7 NSRT sites monitored on this date were flooded and single sample values (SSV) ranged from 1,119-24,200 MPN/100ml with all sites exceeding the ENT single sample safety threshold of 104 MPN/100ml (Figure 12). Given samples were collected during flood conditions, results are likely indicative of multiple sources compounding together under these extreme conditions. Although this event demonstrates impaired water quality, it has little value in highlighting the most

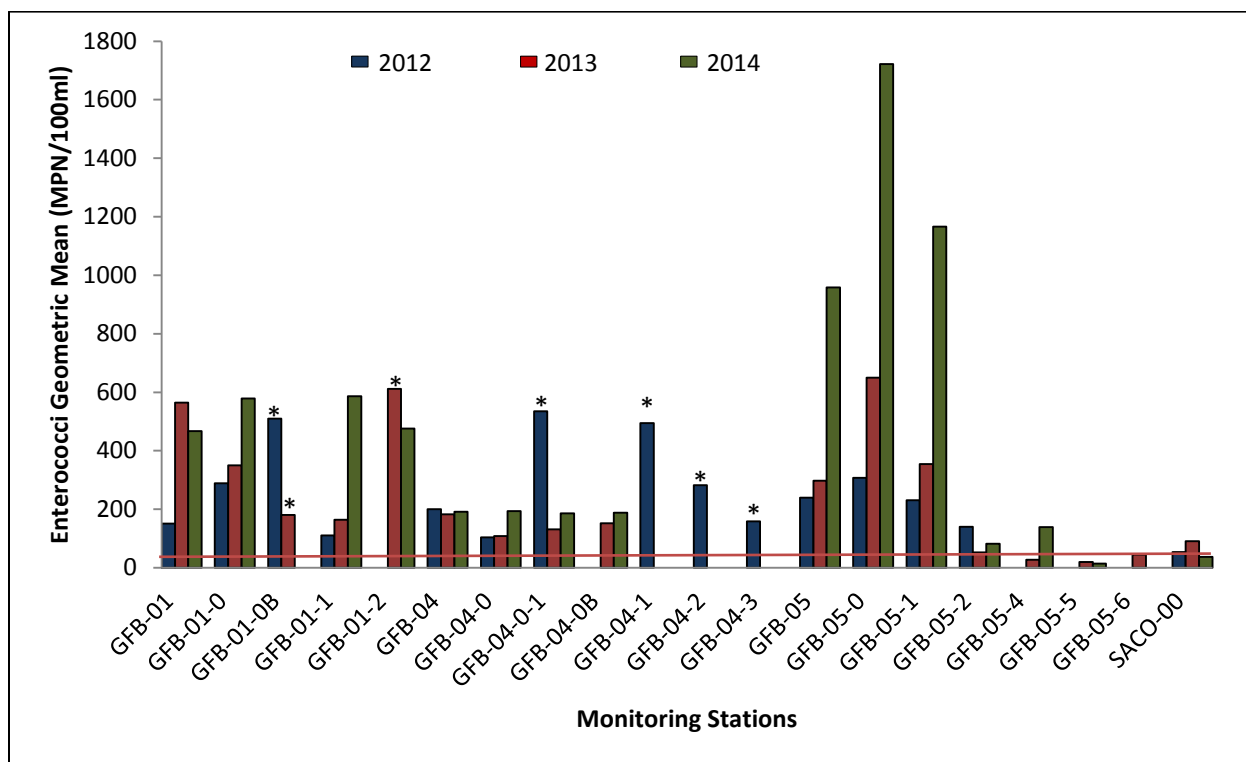
Figure A1. The 2012-2014 ENT geometric mean (MPN/100ml) values by monitoring station in the NSRT as indicated by blue (2012), red (2013), and green (2014) bars. Red solid line indicates safety level of 35 MPN/100ml. Asterisks indicate values based on fewer than 5 samples (mean given rather than geometric mean).

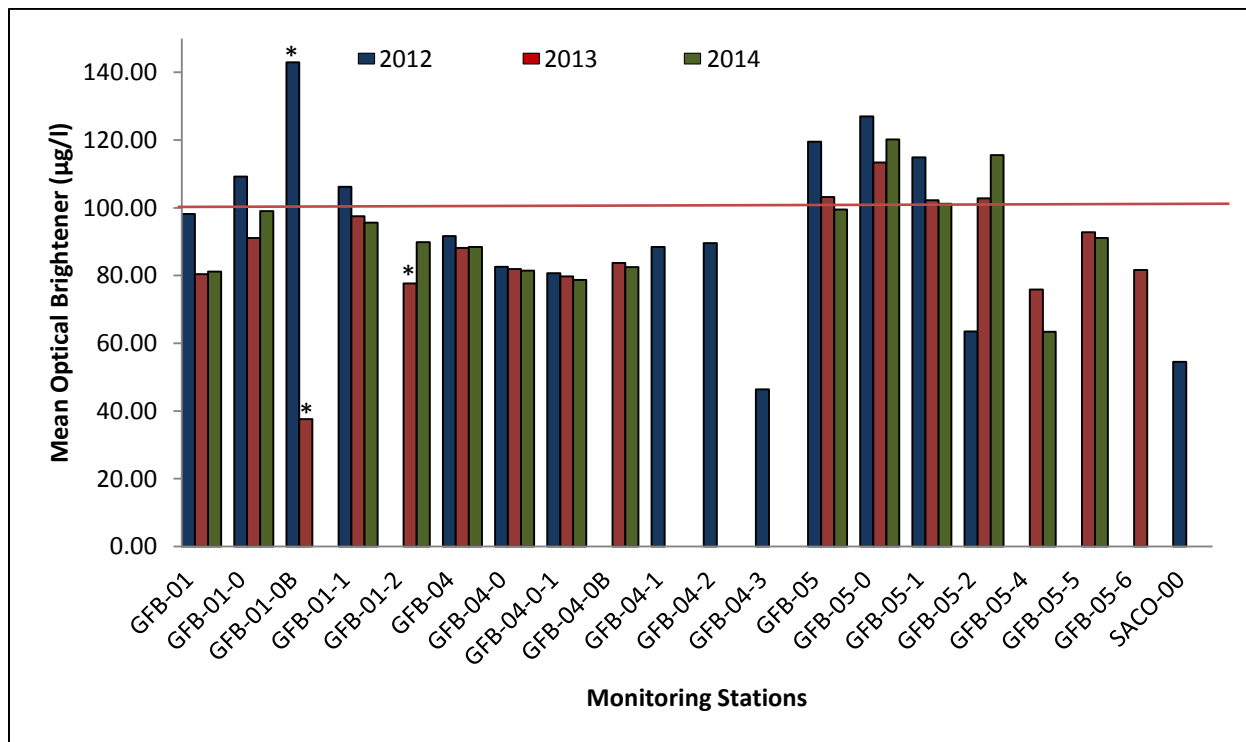
Figure A2. The 2012-2014 mean optical brightener ( $\mu\text{g/l}$ ) concentration by monitoring station in the NSRT as indicated by blue (2012), red bars (2013) and green (2014) bars. Red solid line indicates optical brightener lower threshold (100  $\mu\text{g/l}$ ) indicating the potential for human wastewater contamination. Asterisks indicate values based on fewer than 5 samples.

Combining ENT data from 2012-2014, the overall NSRT geometric mean value of 197 MPN is over five times greater than the EPA threshold of 35 MPN/100ml (Table A1). Additionally, the NSRT-wide geometric mean value increased since monitoring of this area began in 2012, particularly from 2013 (148 MPN/100ml) to 2014 (276 MPN/100ml) (Figure A1, Table A1). These differences are most notable among the sites in the GFB-01 and GFB-05 series. The combined (2012-2014) mean OB value for the NSRT was 91 µg/l, and this parameter has demonstrated very little change over time (Figure A2, Table A1).

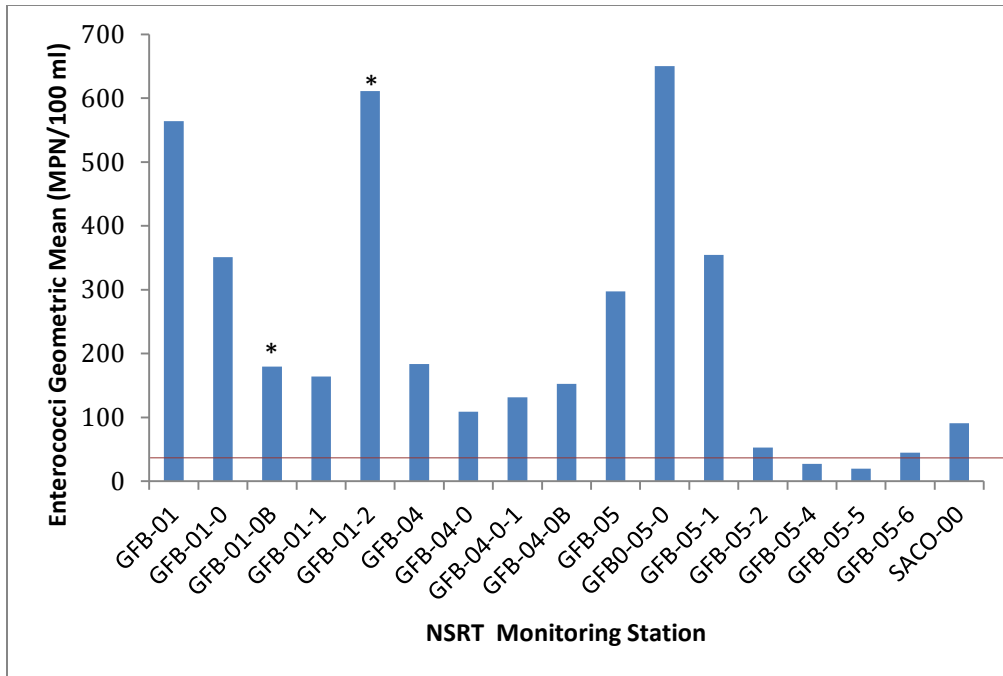
Figure A5. The 2013 geometric mean enterococci (MPN/100ml) values by monitoring station in the NSRT as indicated by blue bars. Red solid line indicates safety level of 35 MPN/100ml. Asterisks indicate values based on fewer than 5 samples.

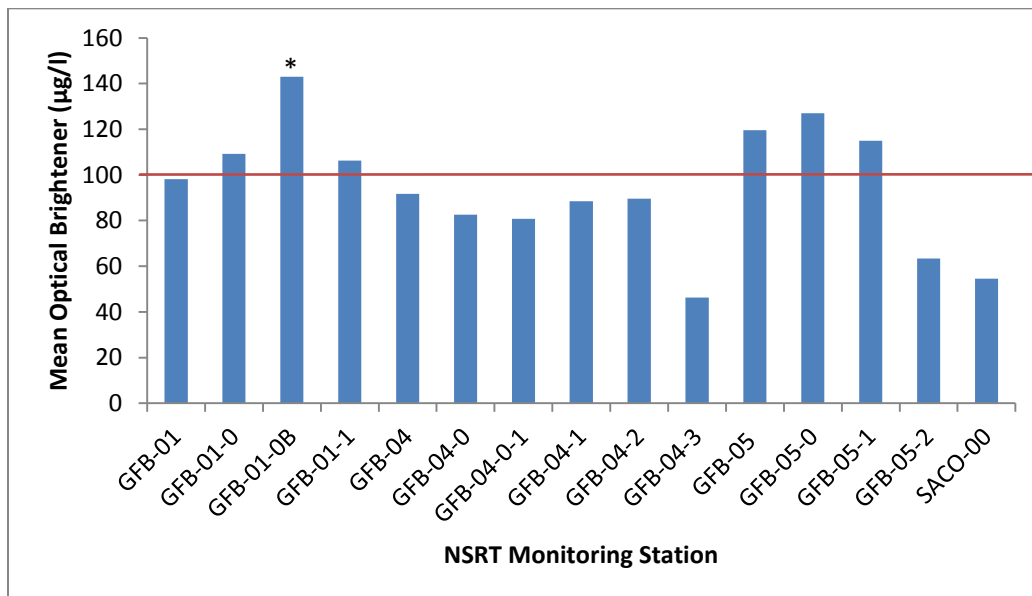
Figure A8. NSRT mean optical brightener (µg/l) concentrations by monitoring station for 2012. Red solid line indicates optical brightener lower threshold (100 µg/l) indicating the potential for human wastewater contamination. Asterisks indicate values based on fewer than 5 samples.
