**MAINE HEALTHY BEACHES PROGRAM:
SUMMARY REPORT OF ENHANCED MONITORING AND POLLUTION SOURCE
TRACKING EFFORTS IN THE NEW SALT RD. TRIBUTARY, GOOSEFARE BROOK
OLD ORCHARD BEACH, MAINE
2012-2015**

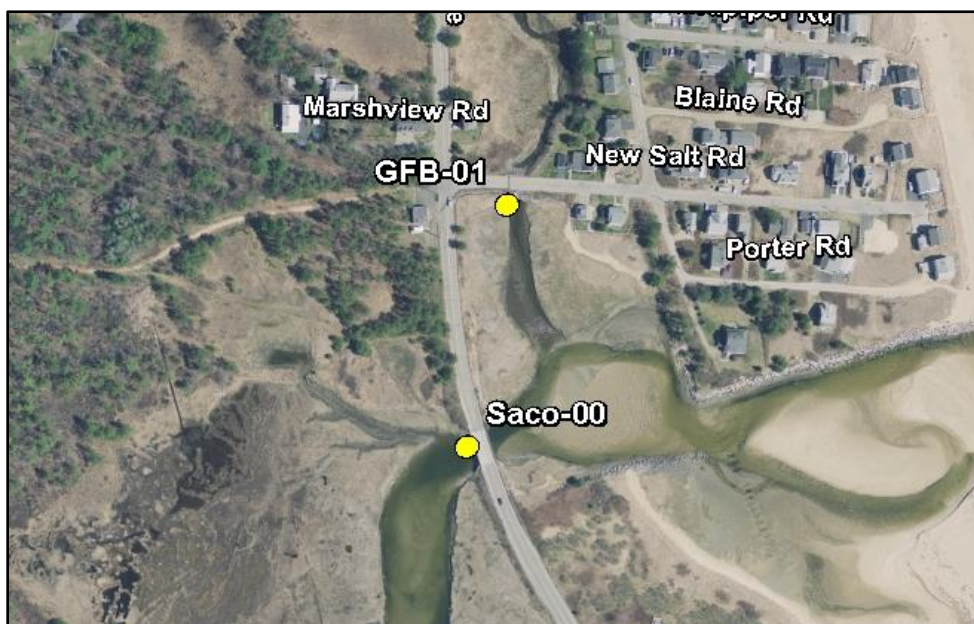
Figure A5. Monitoring stations GFB-01 and Saco-00 located at the mouth of the Goosefare Brook.

- **GFB-01/Mouth of GFB**
 - Although the town has tested the tidegate and areas directly upland, it is recommended to continue investigations at GFB-01-2 where the brook goes underground (in a closed box culvert parallel to Rt. 9) between sites GFB-01-0 (Randall Ave.) and GFB-01-1 (Ancona Ave) (Figure 7).
 - The apparent trend in the mouth of the brook is higher ENT results on an incoming tide (Figure A6, Table A3) suggesting potential pollution source(s) in the vicinity of the mouth and/or conditions in this area favor persistence and possibly regrowth of ENT. It may also be worthwhile to recheck the area near the tide gate to ensure a tight system (Figure A5).
