**MAINE HEALTHY BEACHES PROGRAM
SUMMARY REPORT OF ENHANCED MONITORING AND
POLLUTION SOURCE TRACKING EFFORTS
IN THE WILLARD BEACH WATERSHED
SOUTH PORTLAND, MAINE
2012-2016**

Meagan Sims and Keri Kaczor – Maine Healthy Beaches Program
with assistance from
Fred Dillon – South Portland Stormwater Program Coordinator

July 2017

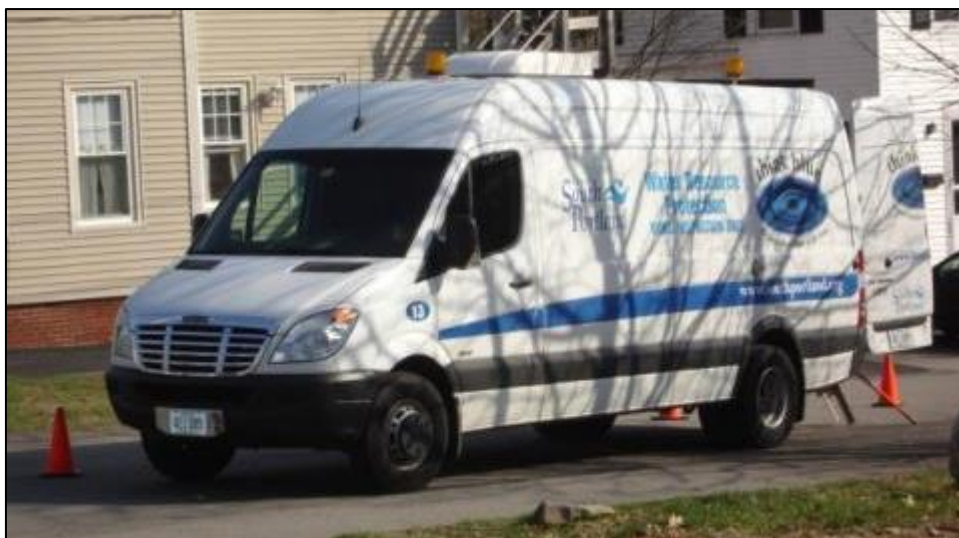
Figure A3. City of South Portland’s closed-circuit television inspection van assessing the condition of the sewer and stormwater systems in the Willard Beach Watershed.

Following the August 2014 discovery of significantly elevated bacteria results in a portion of the separated stormwater system, City staff conducted closed-circuit television inspections in September 2014 to identify potential cross-connections with the public sewer (Figure A4). While no direct connections of sewer service laterals from residences into the separated stormwater system were observed, there were three instances of the public sewer main crossing directly through separated stormwater structures. Subsequent dye testing by City staff identified and eliminated an illicit cross connection between the sewer and stormwater infrastructure at site DM0294 (Figure A5).
