Town of Camden
2012 – Water quality monitoring, testing, and remediation
For Megunticook River, Camden Harbor, and Laite Beach

This report was prepared by Elisabeth Stancioff and Wright Pierce, with review by Keri Kaczor of the UMaine Cooperative Extension, for the Town of Camden under award NOAA CZM NA10NOS4190188 to the Maine Coastal Program from the National Oceanic and Atmospheric Administration, U.S. Department of Commerce. The statements, findings, conclusions, and recommendations are those of the author(s) and do not necessarily reflect the views of the National Oceanic and Atmospheric Administration or the Department of Commerce.

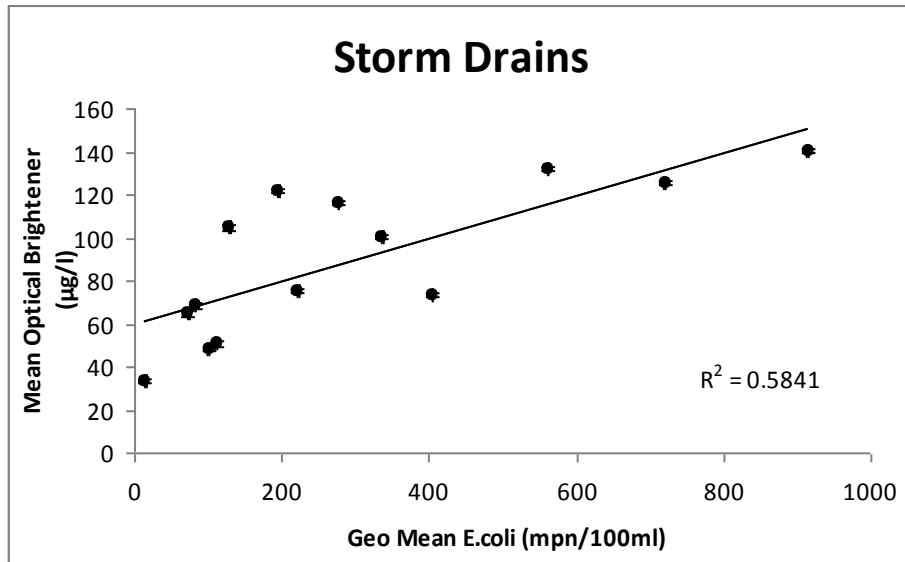
Figure 3. Correlation between bacteria and optical brighteners at all storm drain sites

All of the sites reported an arithmetic mean less than what is considered a high concentration for optical brighteners (200 µg/L). Although none of the mean optical brightener levels were strikingly high, there were some spikes throughout the summer and levels were elevated enough to strongly suggest that human sources could be contributing to the bacterial problem in several of the storm drainage areas. In particular, a few of the sites reported maximum readings greater than the high mark (MSD 1, Wil 1, and Wil 2). Together, with the elevated fecal indicator bacterial levels, human sources of fecal contamination should be suspected at these locations. It should also be noted that these three locations are geographically near each other. Generally speaking, a significant correlation between optical brighteners and bacteria levels was observed at storm drainage sites as demonstrated in Figure 3.

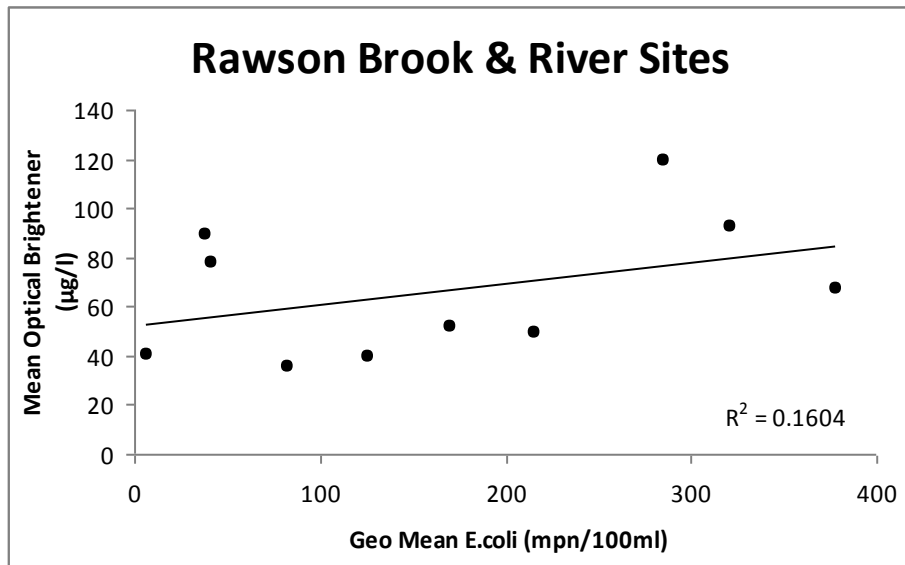
Figure 5. Correlation between bacteria and optical brighteners at Rawson Brook and Megunticook River sites.

Although several of the Rawson brook stations, particularly RB 6, RB 1 and RB 2 showed potentially harmful bacterial levels, there was a relatively low correlation between these numbers and optical brightener levels as illustrated in Figure 5. Elevated bacterial levels and lower optical brightener levels at these sample sites suggest dilution of optical brightener levels (volume of water and proximity to point sources) and/or non-human sources of contamination. The pharmaceutical analysis also indicated a “weak to moderate” human signal at RB 6 and a weak signal at site RB 2.¹⁰ It is likely that the samples taken for the pharmaceutical testing were diluted by the heavy rain that occurred directly preceding the testing, resulting in levels that were lower than they might be on a typical dry day, so human sources should not be entirely ruled out based on the data obtained on that one date. However, upstream from the RB 6 site is a large marshy area, which is likely home to many varieties of wildlife that could be contributing to the problem. (This marsh also makes the stream difficult to access for monitoring purposes.) The geometric mean of 377 MPN/100mL, as well as the numerous instantaneous exceedances, suggests a chronic problem, but it seems unlikely that human sources of

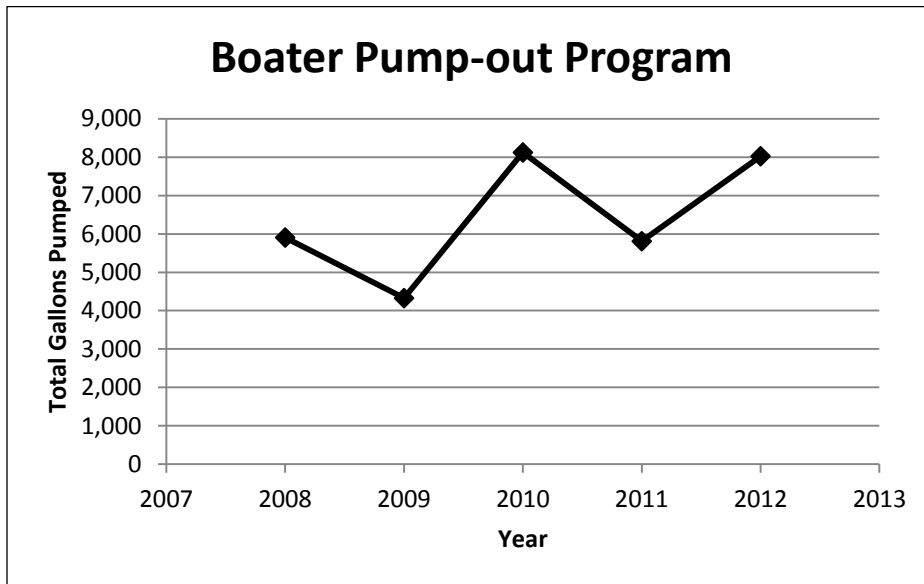
Figure 8. Total gallons of sewage pumped by the Town’s boater pump-out program.

Table 7 summarizes the data from the public boat pump-out program offered by the Town for years 2008 to 2012. The total gallons of sewage pumped per year is also displayed in Figure 8. It should be noted that the Harbormaster believe that marine enthusiasts began installing larger holding tanks in response to DEP moving towards a zero tolerance policy for overboard discharges. As a result, the Town is seeing a fewer number of pump-outs, but a greater average number of gallons pumped per pump-out.
