NOAA Technical Memorandum NOS OR&R 42

Deepwater Horizon Oil Spill: Salt Marsh Oiling Conditions, Treatment Testing, and Treatment History in Northern Barataria Bay, Louisiana (Interim Report October 2011)

Seattle, Washington
April 2013

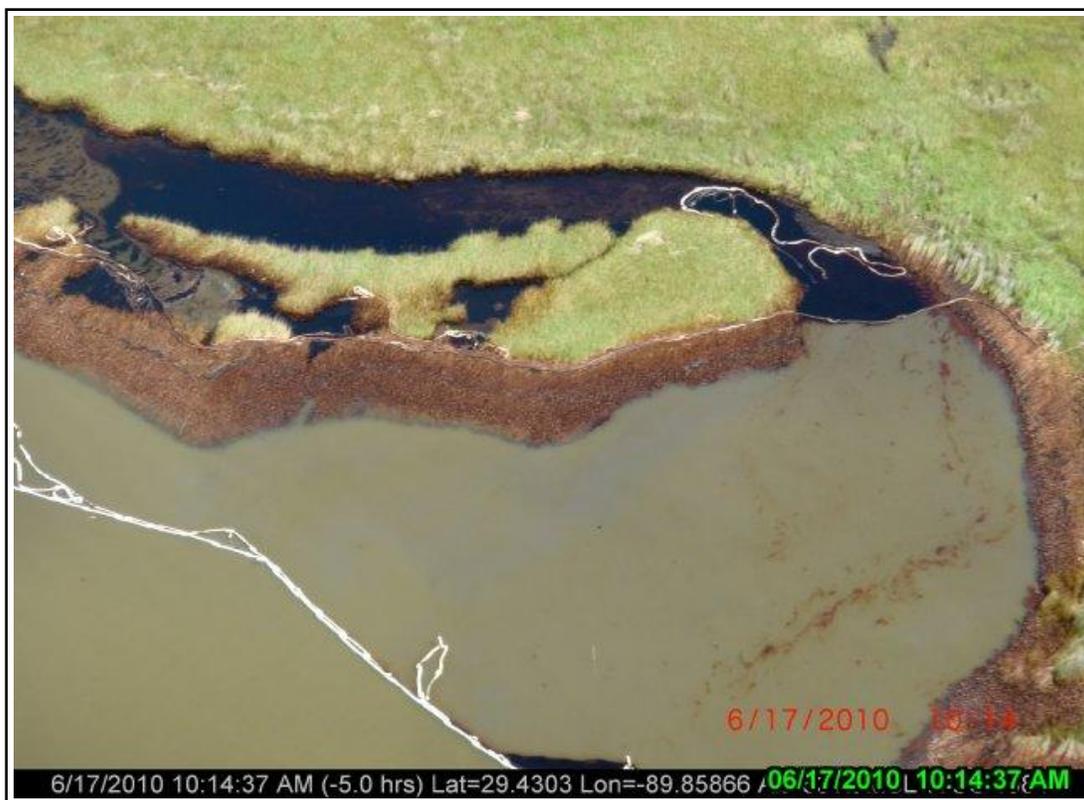
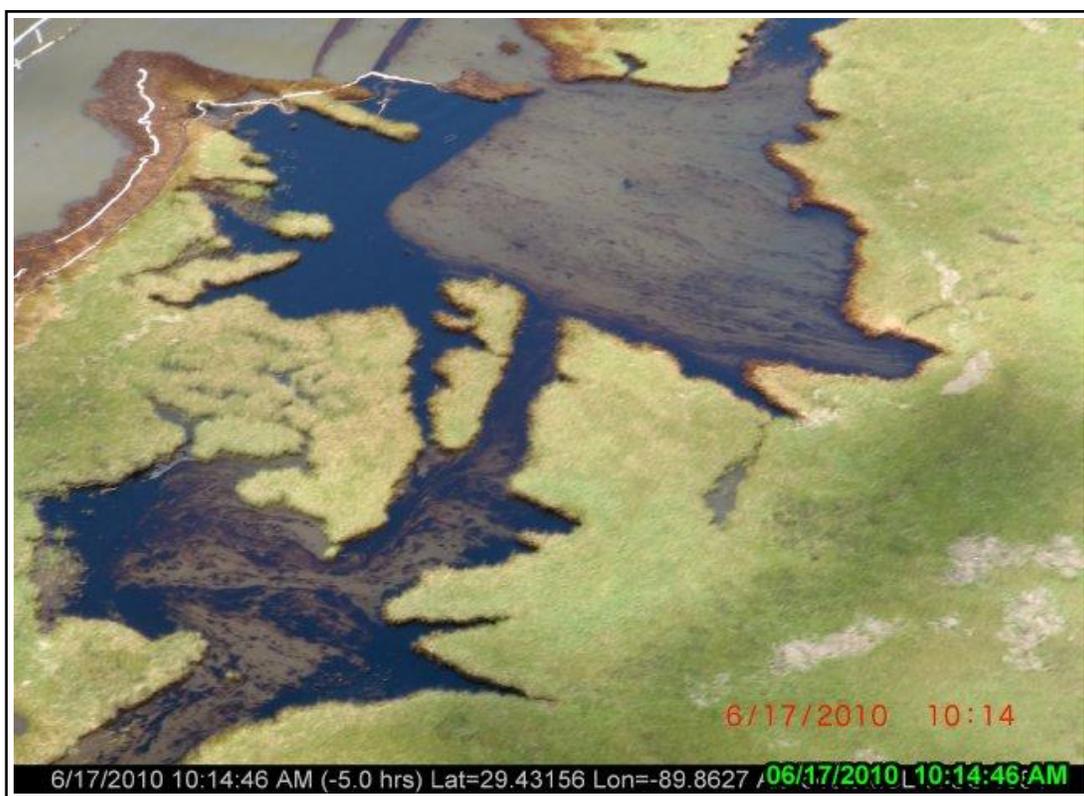
Figure 2. Initial oiling conditions (example), aerial views, Bay Jimmy (Zone I), June 2010.

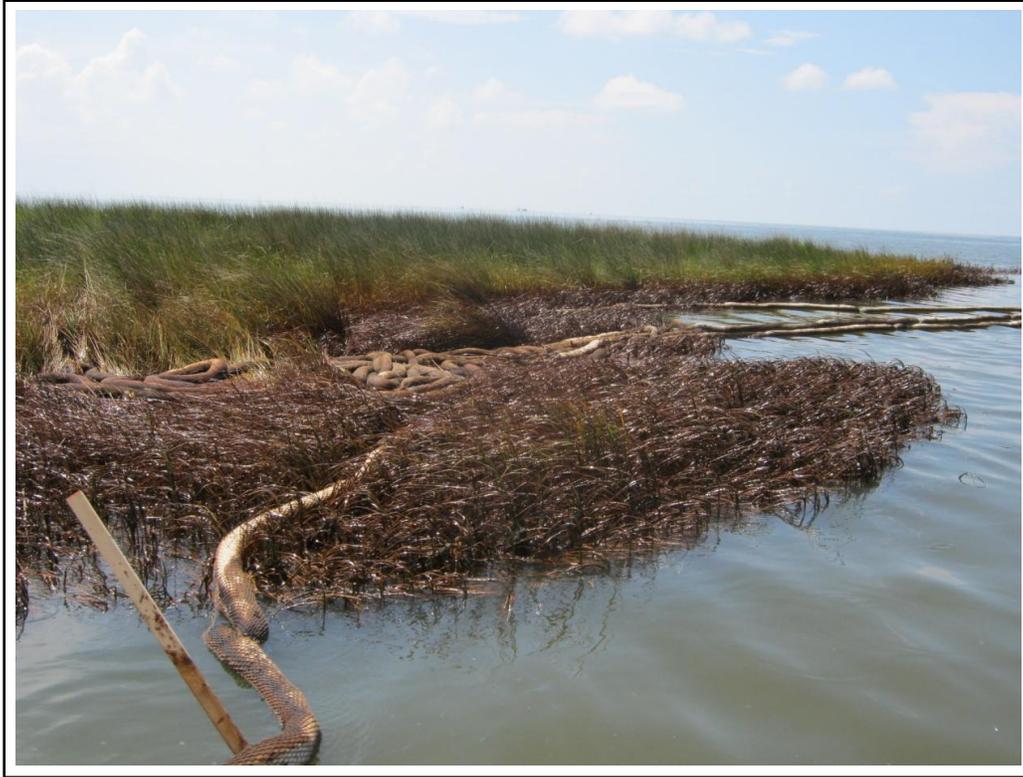
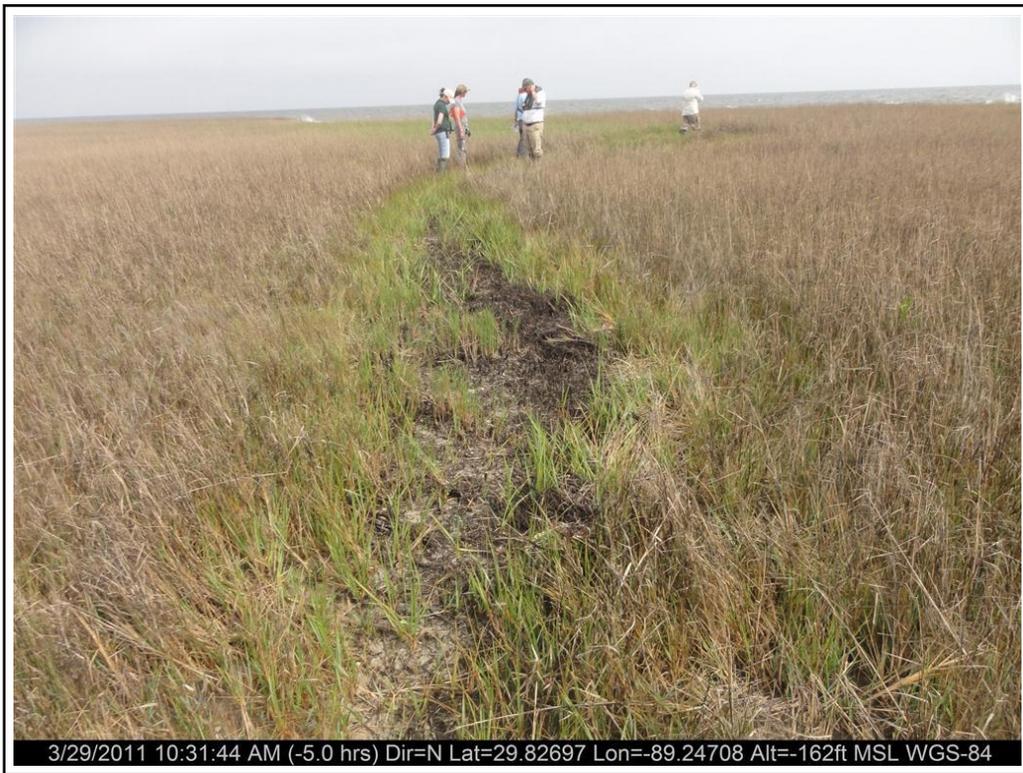
Figure 4. Stranded boom in the marsh. Top: stranded boom and initial oiling in Bay Jimmy (near Zone K), June 2010. Bottom: example of stranded boom scar with accumulated oil, several months following boom removal, Comfort Island, St. Bernard Parish, March 2011.

Hurricane Alex also resulted in large accumulations of stranded boom in these marshes and across the response area, as reported from aerial and ground observations (Figures 3 and 4). Stranded boom in the marshes included hard, sorbent, and snare boom, ranging from relatively clean to heavily oiled. Stranded sorbent boom predominated in the Northern Barataria Bay marshes. Stranded boom in the marshes was also reported regularly prior to this storm.

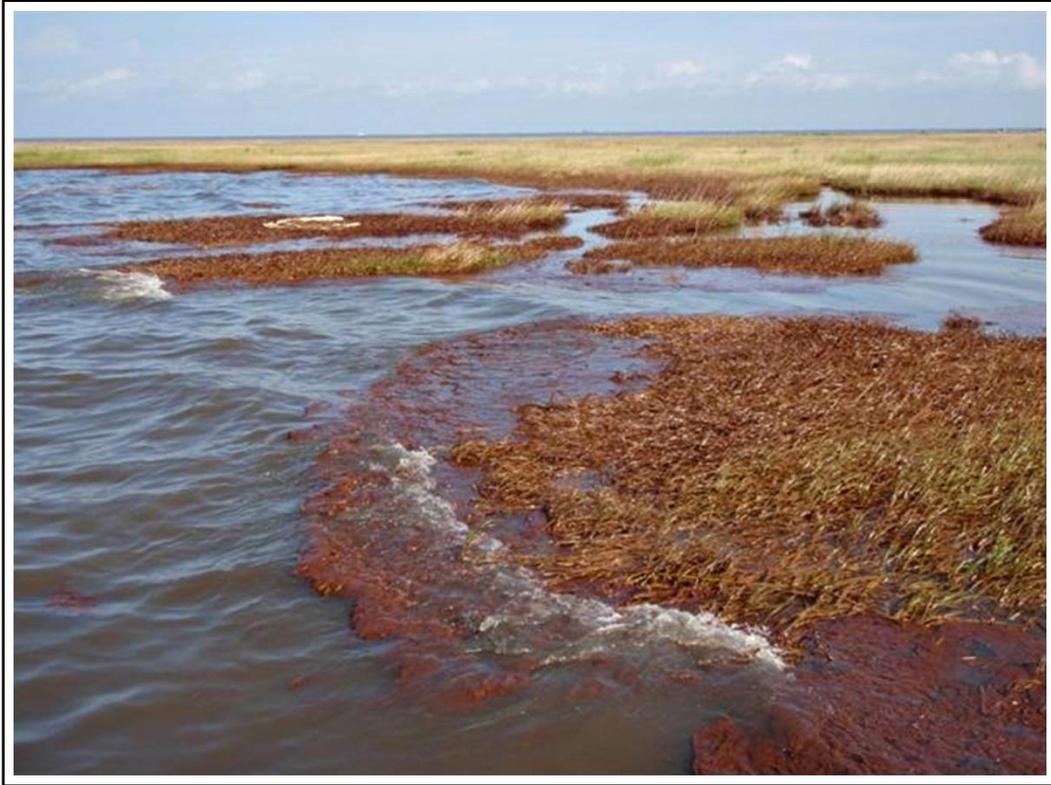
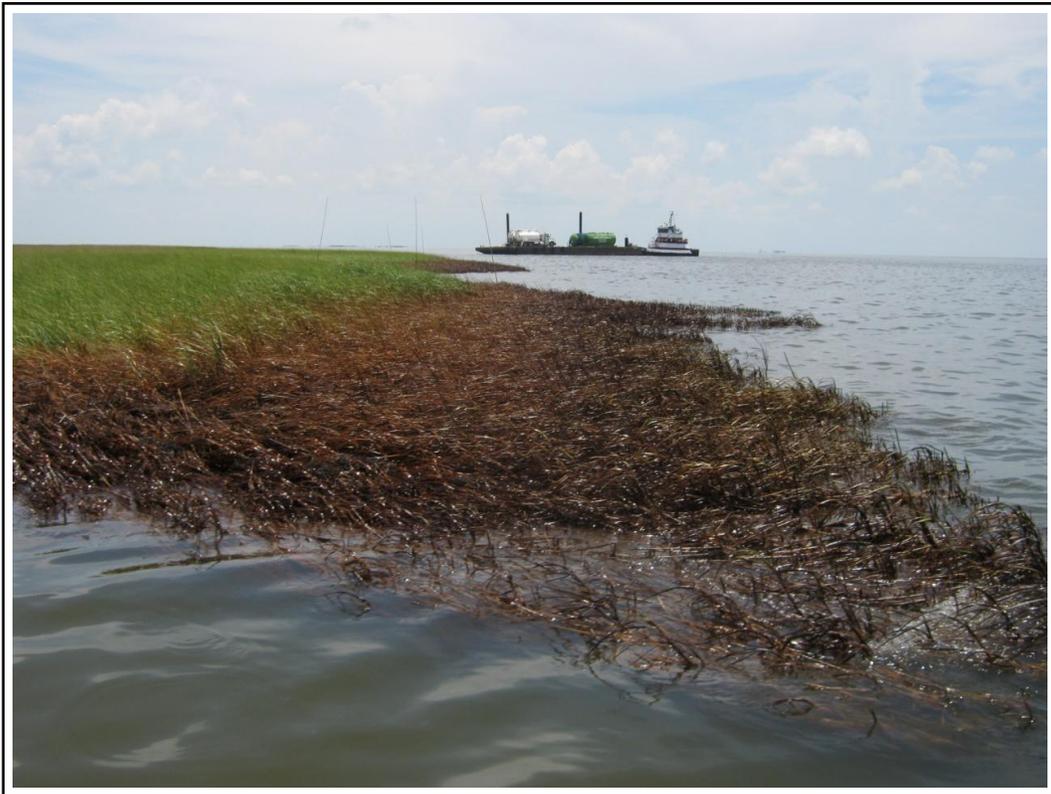
Figure 5. Initial oiling conditions, shoreline views, Bay Jimmy (Zones I and K), June 2010.

SCAT surveys in mid June 2010 (Stage II) documented oiling bands in the Northern Barataria marshes to several meters (m) wide with continuous distribution (91-100%), consisting predominantly of thick (>1 cm) mousse and liquid oil (Figure 5). SCAT surveys in mid July to early August 2010 reported similar conditions, with some weathering of oil coat on the marsh vegetation. Heavily oiled marsh vegetation was also reported as laid over or "flattened" in some locations in late July 2010.

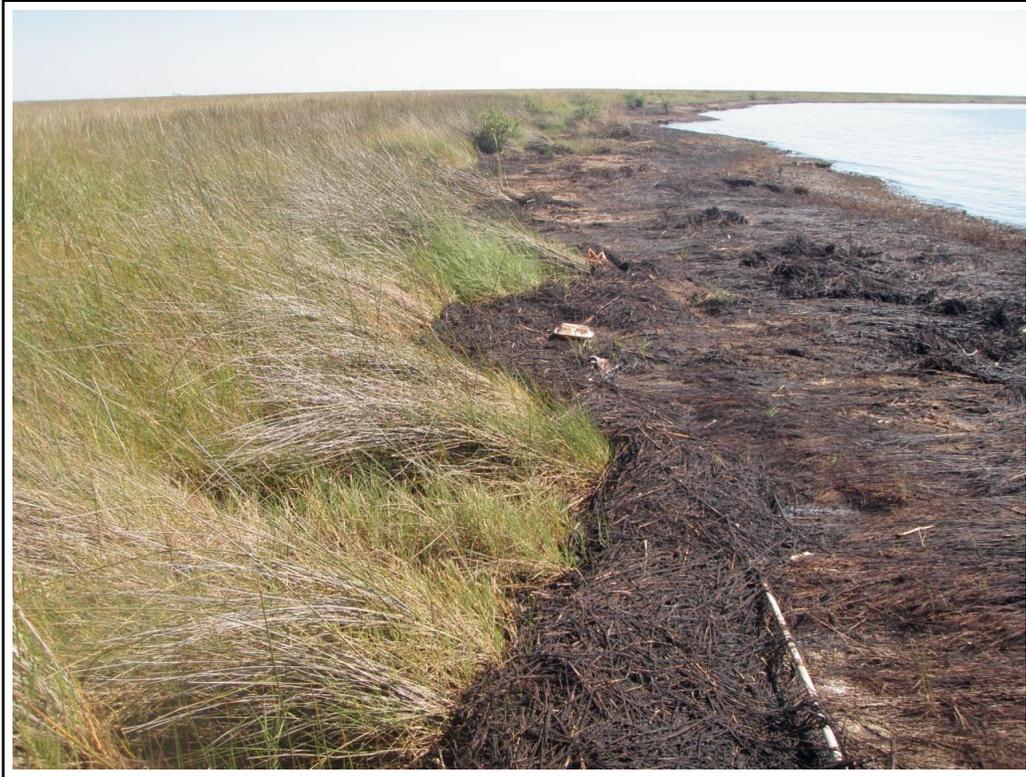
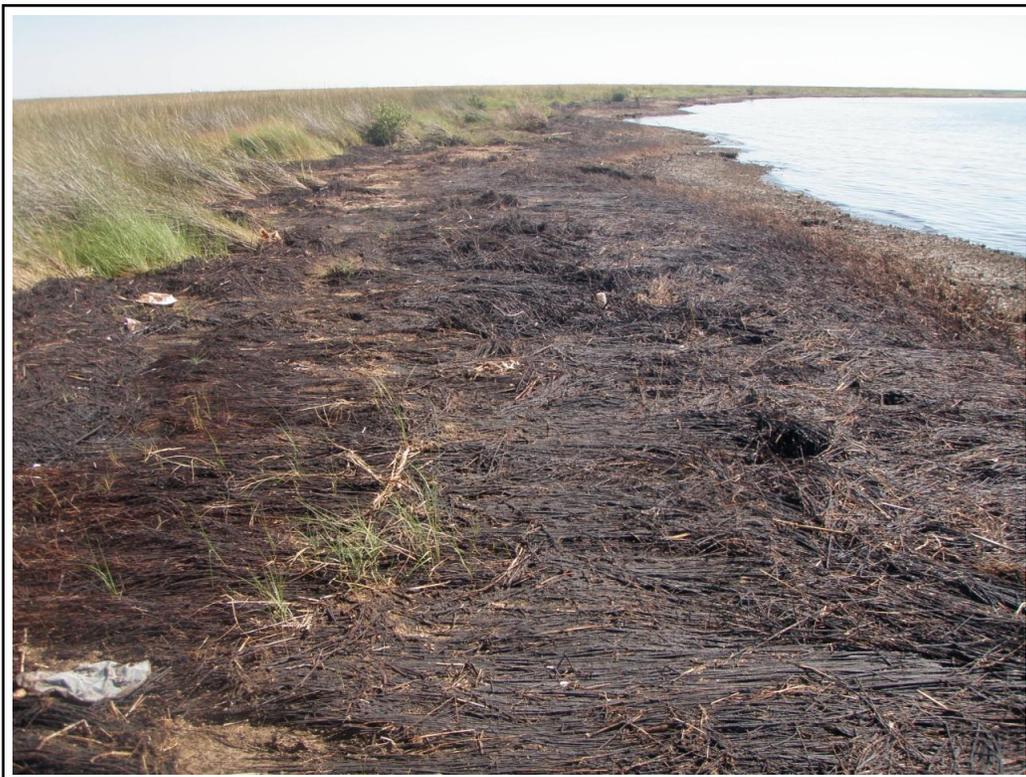
Figure 6. Persistent oiling conditions, heavily oiled wrack and vegetation mat, Bay Jimmy (Zone K), October 2010.

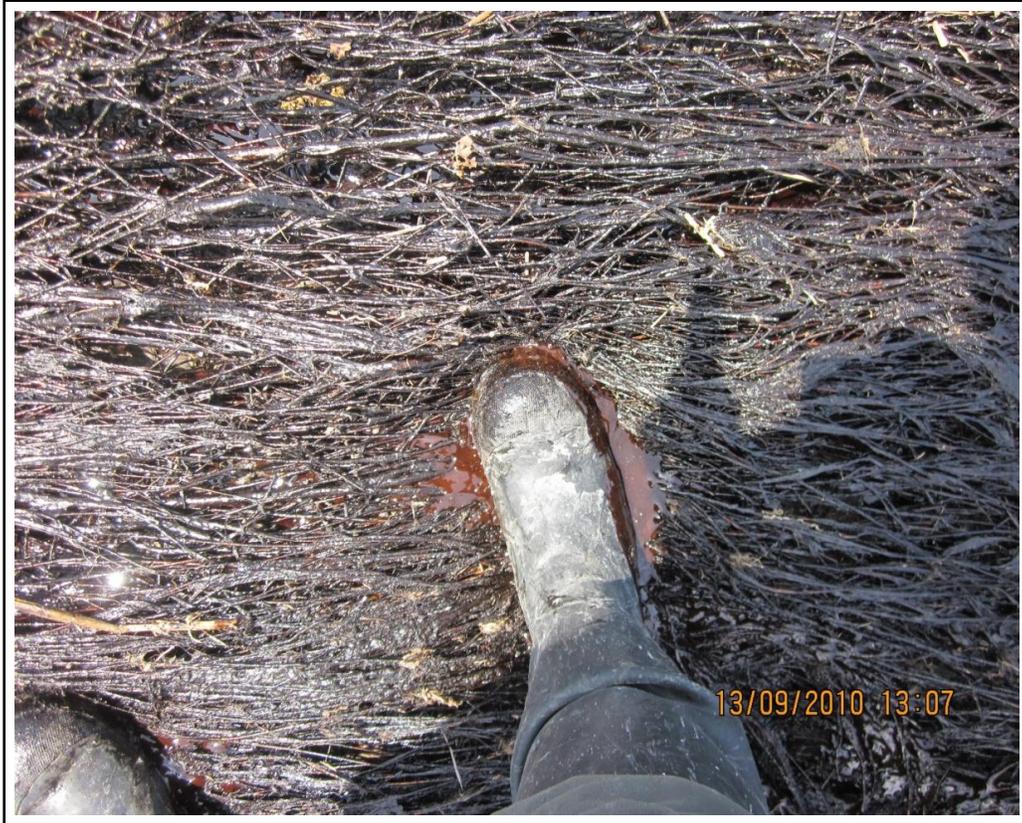
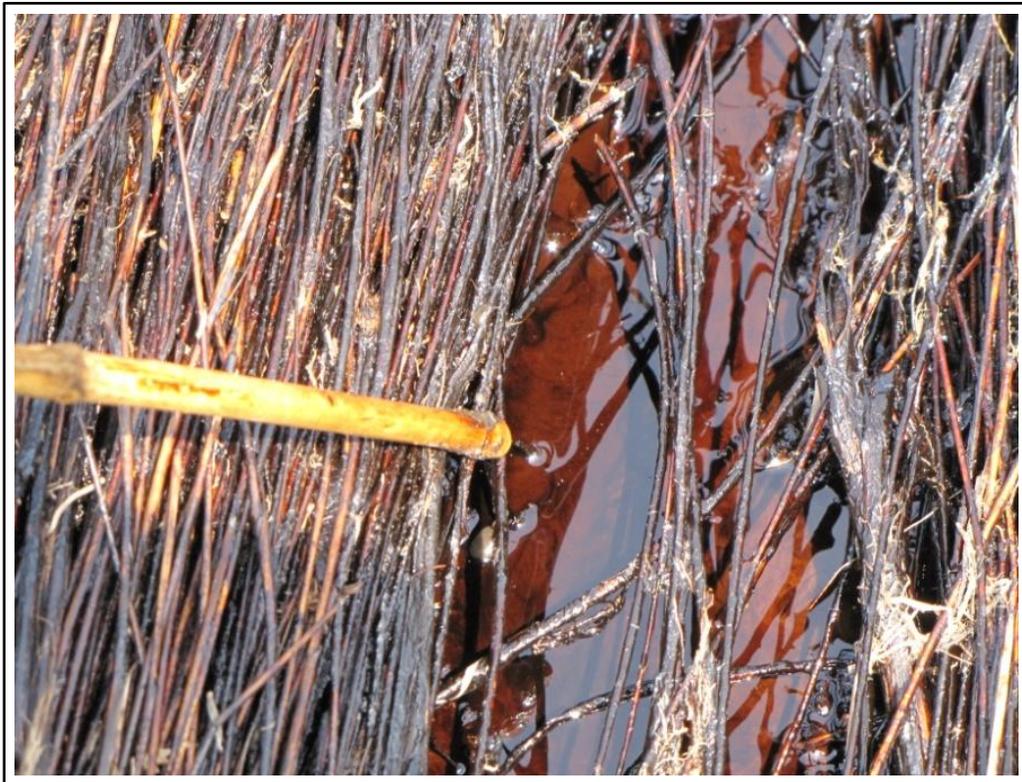
Figure 7. Persistent oiling conditions, pooled mousse under the vegetation mat, Bay Jimmy (Zone K), September 2010.

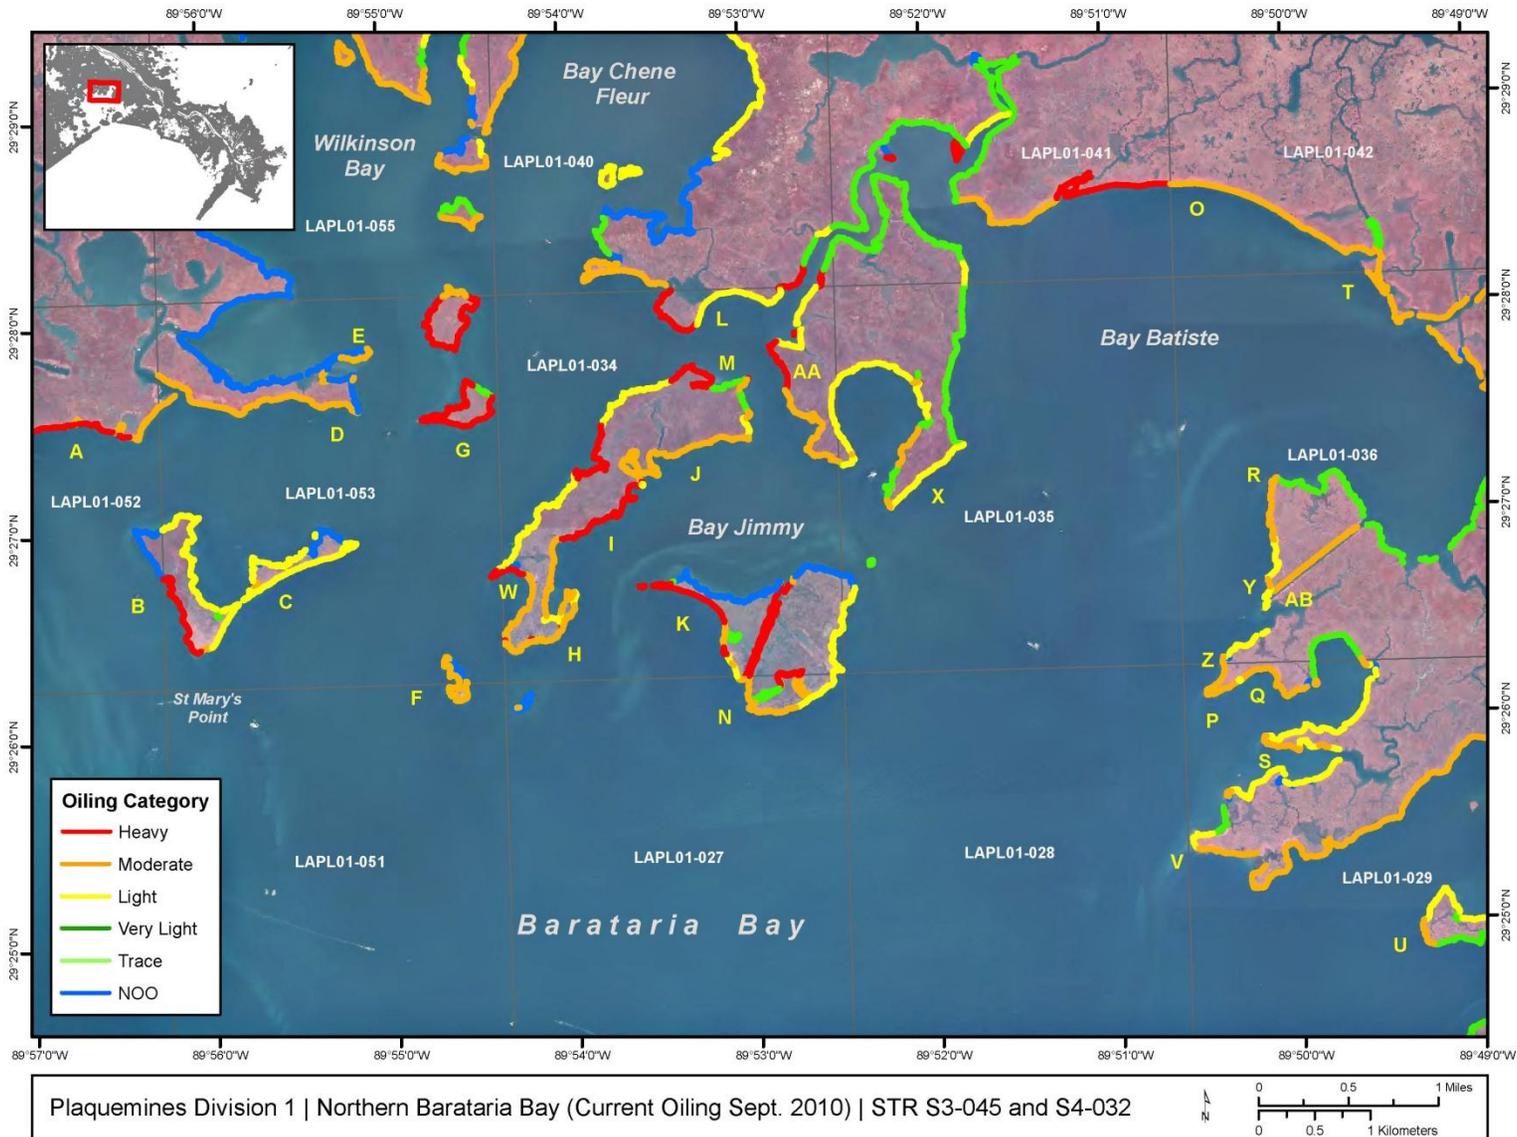
Figure 9. Current oiling summary for Northern Barataria Bay marshes, September 2010. Oiling categories based on oiling width, distribution, and thickness.

miles) and moderate oiling included 19 km (12 miles) in June 2010. The current oiling summary for September 2010 (Figure 9) showed continued heavy oiling on shorelines facing the open bay, but with many prior heavily oiled areas shifting to moderate or lesser oiling categories. Some new heavily oiled shorelines were also documented by this time, as shoreline surveys continued. Additional locations with heavy oiling were documented in continuing surveys under Stage III. Heavy oiling spanned 17 km (11 miles) and moderate oiling included 35 km (22 miles) in September 2010.

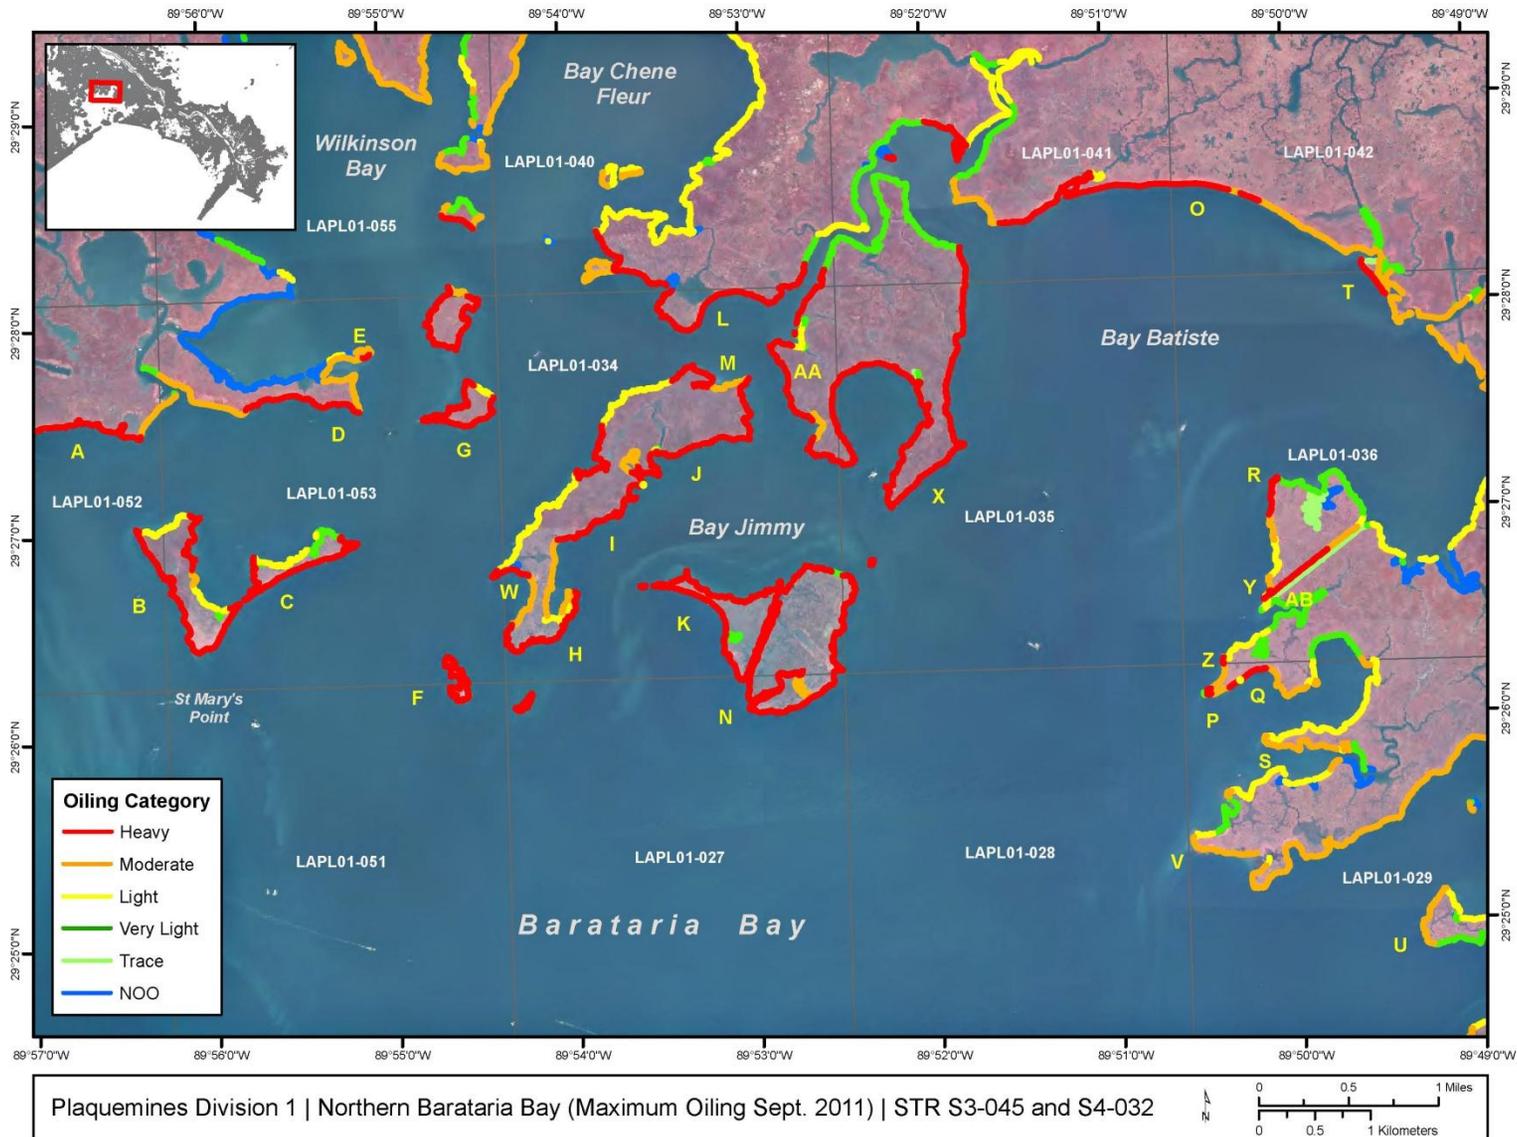
Figure 10. Maximum oiling summary for Northern Barataria Bay marshes, September 2011. Oiling categories based on oiling width, distribution, and thickness.

Maximum oiling conditions (showing the heaviest oiling ever observed along a segment and updated to the present; Figure 10) indicate the total maximum extent of heavy oiling across all surveys throughout the area, including nearly all of Bay Jimmy, large portions of Bay Batiste, most of St. Mary’s Point, and lower portions of Wilkinson Bay. Maximum oiling statistics by category for the Northern Barataria Bay marshes are shown in Table 1. In all, 90% of marsh shorelines in this area were oiled, with 57% of shorelines heavily to moderately oiled (76 km and 48 mi combined).

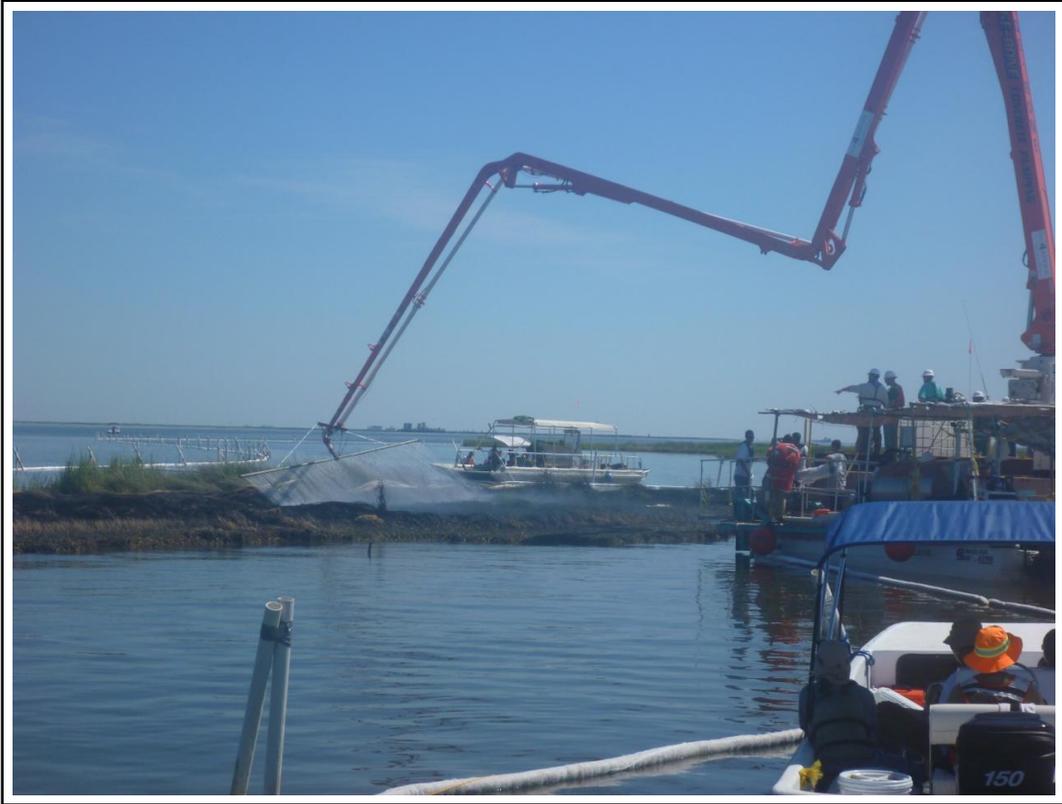
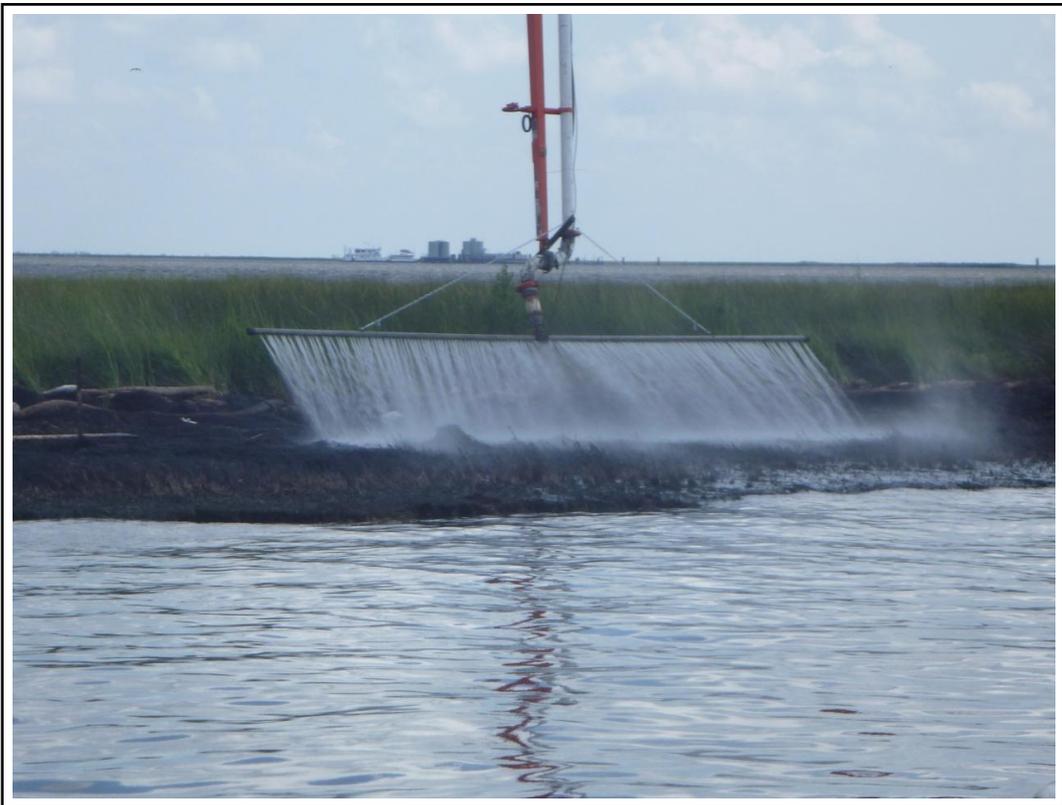
Figure 11. Marsh flushing demonstration in Bay Jimmy, September 2010.

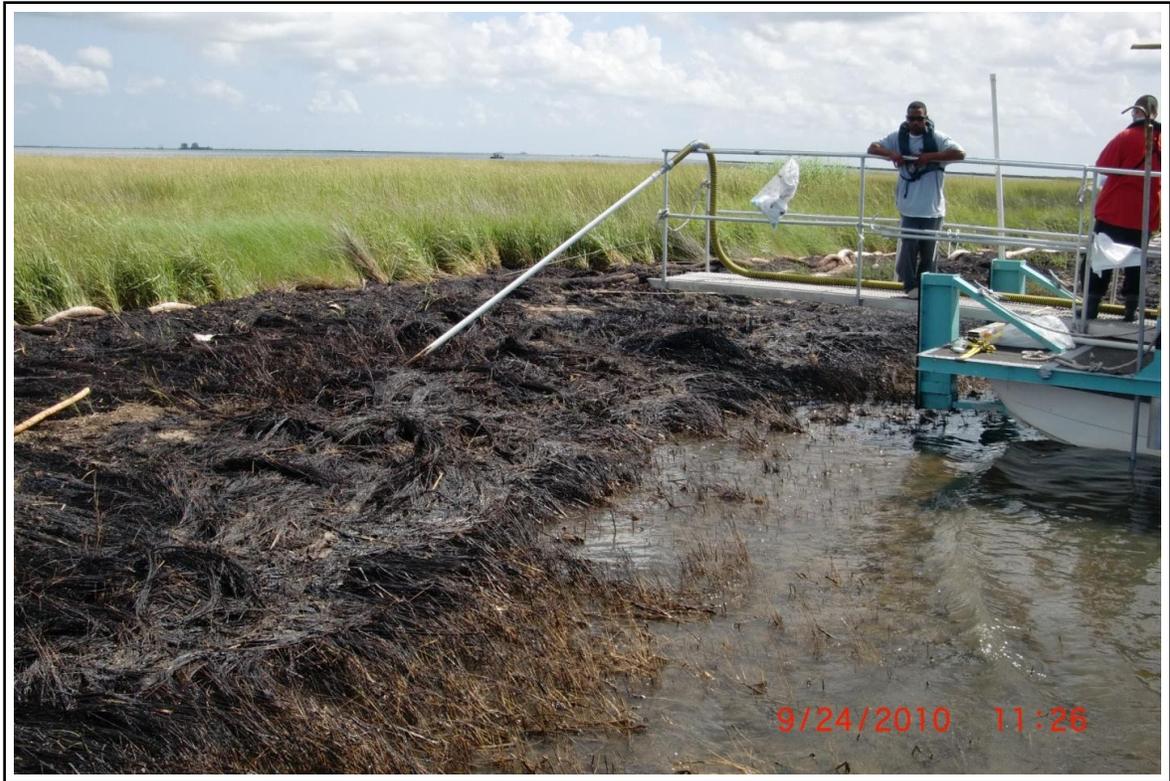
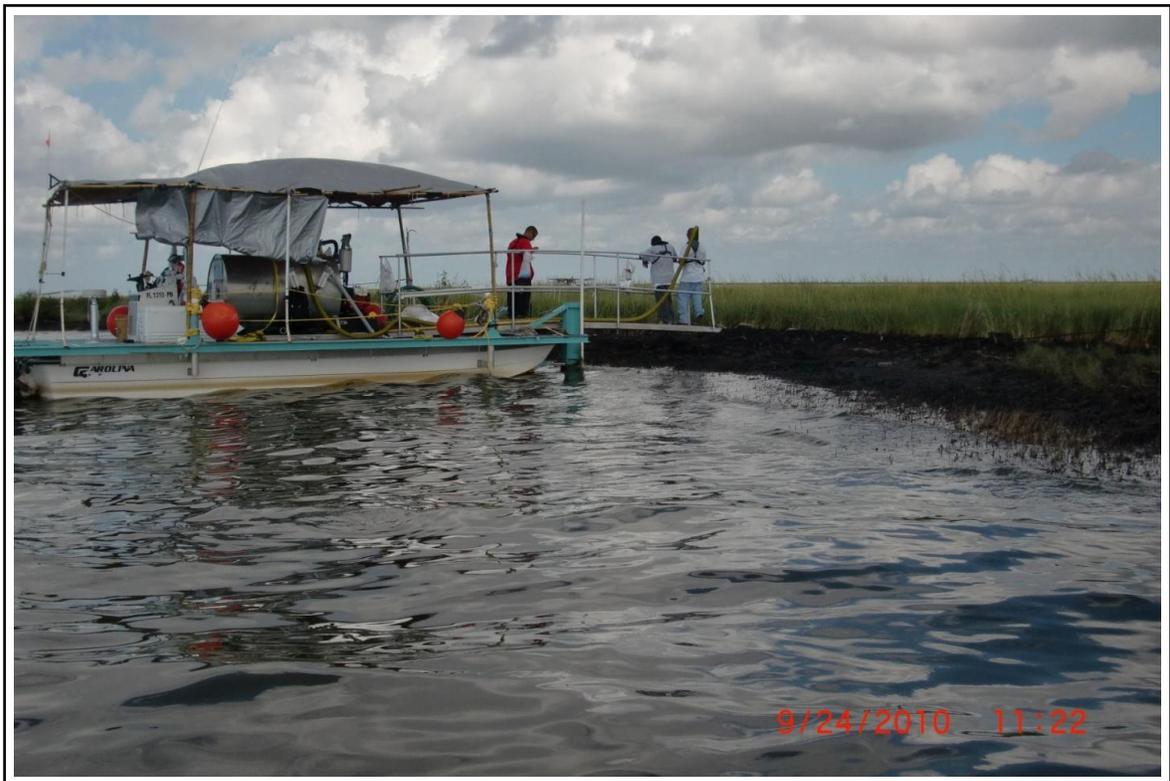
Figure 12. Vessel-based marsh vacuum operations, September 2010.

An early Stage III STR was written to guide pre-existing and on-going vessel-based marsh vacuum operations (Figure 12) that were attempting to remove pooled oil directly from the marsh substrate in Northern Barataria Bay (STR S3-008, issued in mid September 2010). This included pre-STR operations observed during the SCAT survey described above in mid September. The STR provided guidelines for avoiding and minimizing marsh damage during marsh vacuum operations. These operations were controversial, with differing reports on the effectiveness and effects of this method. Large volumes of recovered oil were reported in some cases, but other reports disputed this and also reported potential marsh damage, including the removal of marsh sediments and gouging of the marsh substrate. This STR was ultimately rescinded based on SCAT and Environmental Unit field observations, including the results of the marsh treatment tests described below.

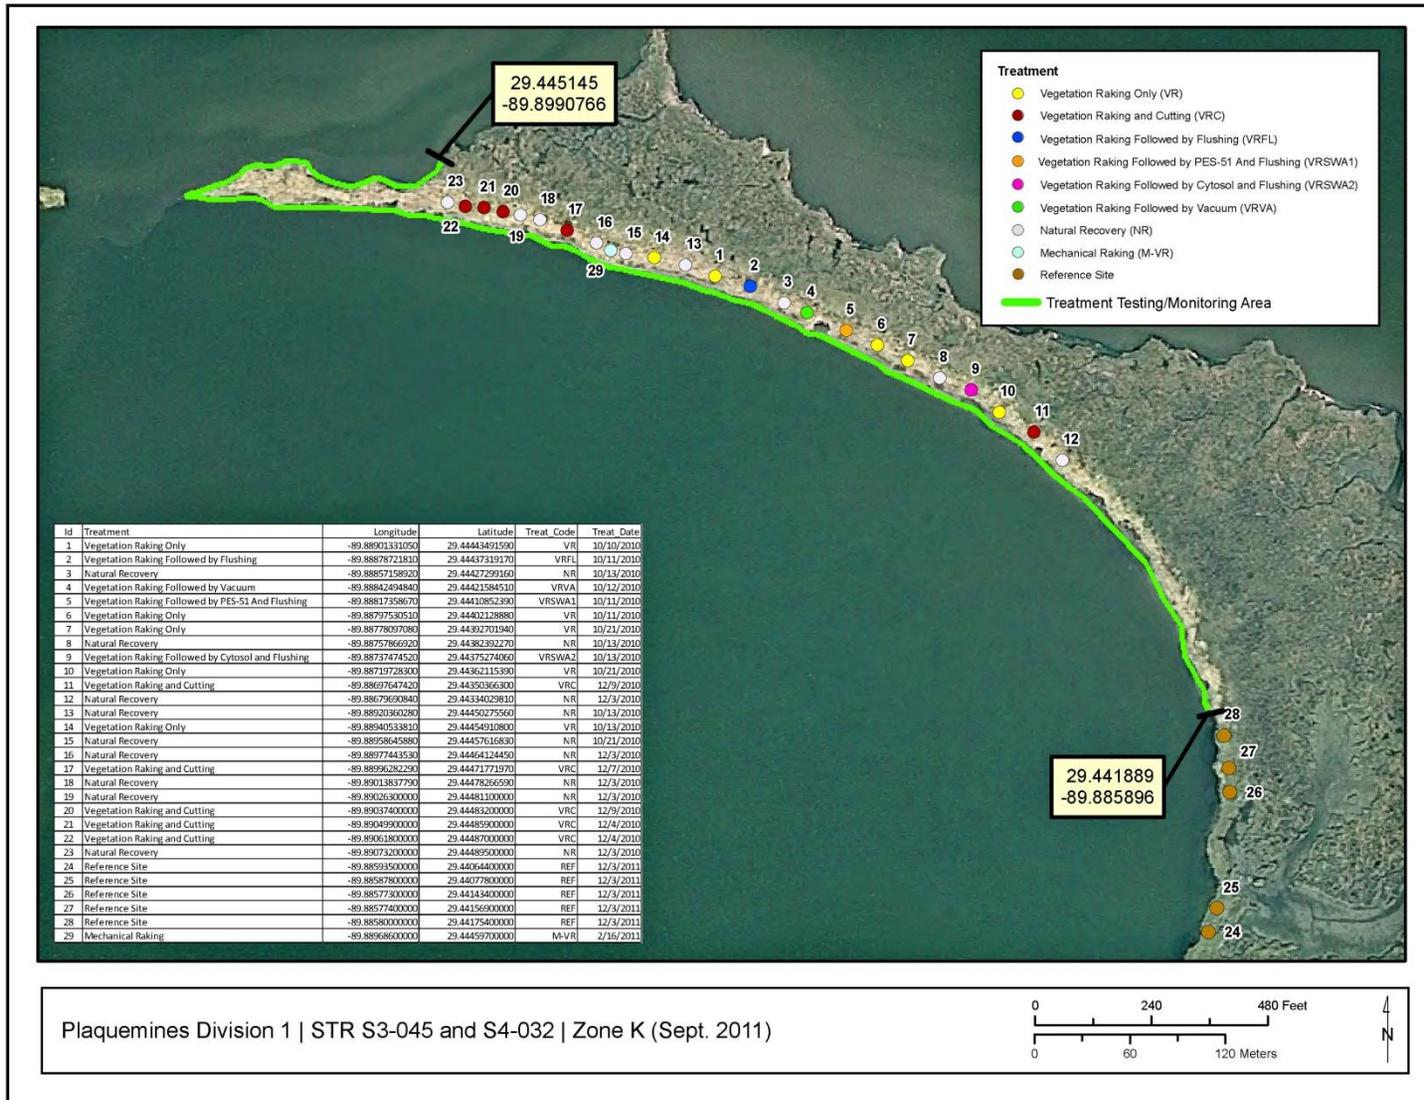
Figure 13. Marsh treatment test plots. Plots 1-10, 12-16, 18-19, and 23 correspond to the October 2010 treatment tests and final natural recovery (no treatment) plots. Plots 11-12 and 16-23 correspond to the December 2010 treatment tests and associated natural recovery plots. Plots 24-28 are reference plots. Plot 29 was a mechanical demonstration plot, February 2011.

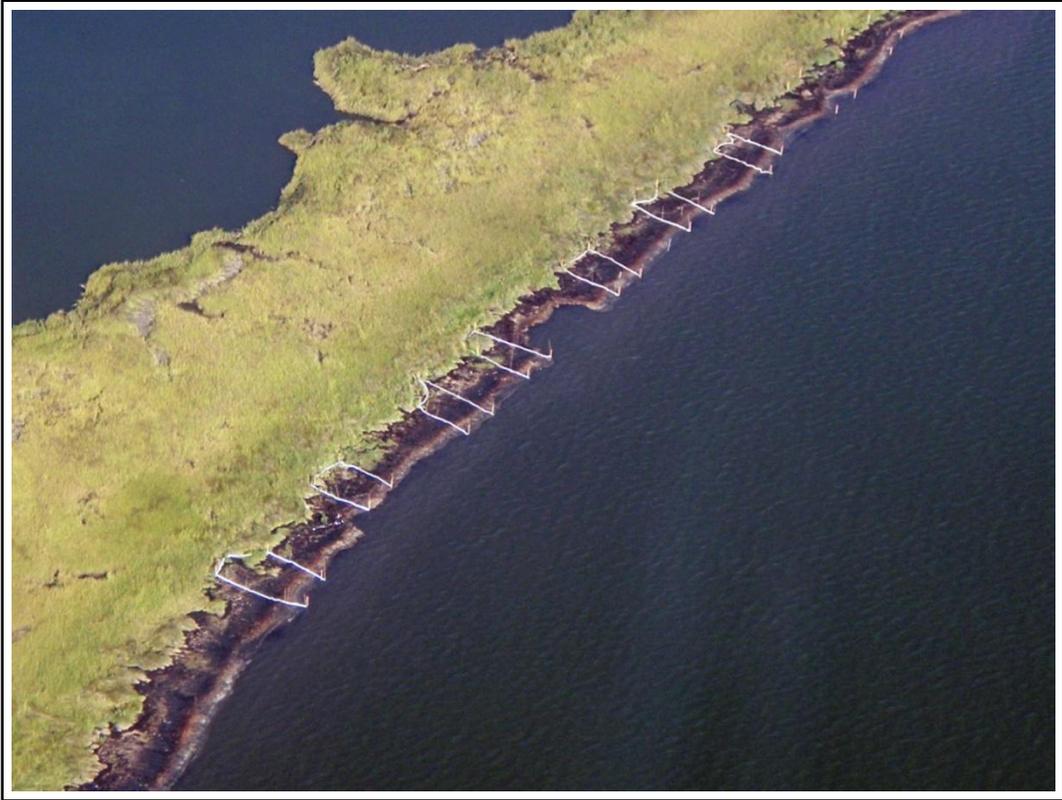
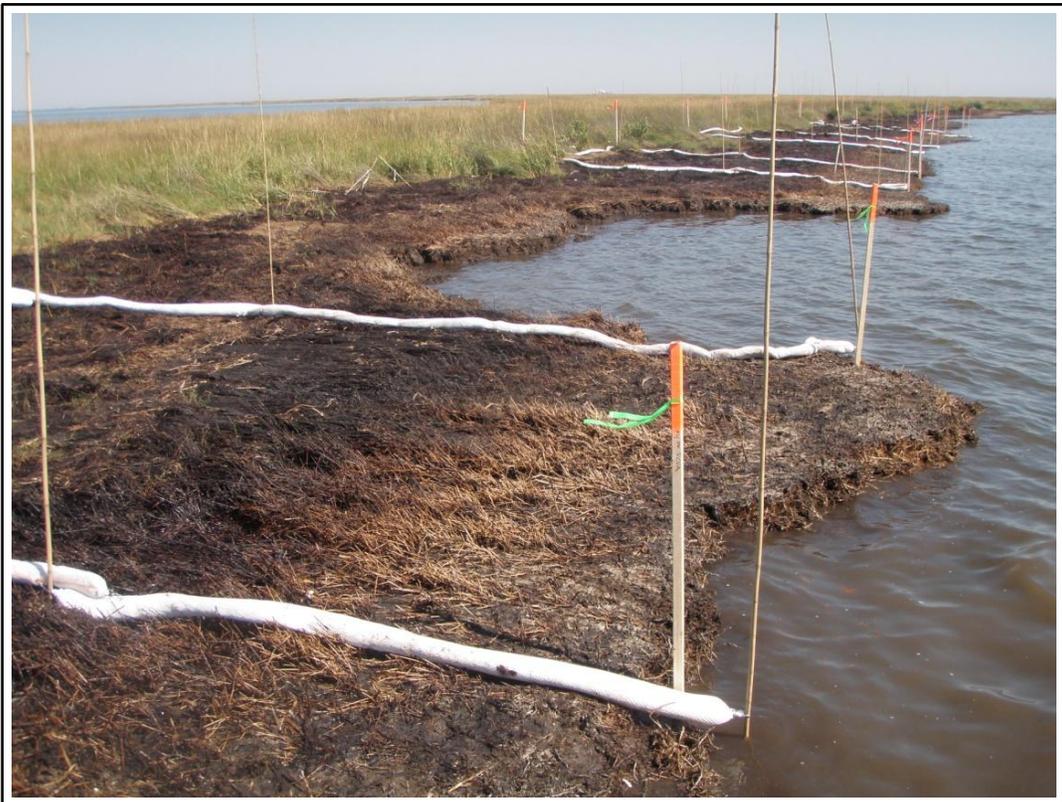
Figure 14. Marsh treatment test plots, aerial and ground views.

Prior to the tests, the plots were marked in the field (Figure 14), and pre-treatment SCAT assessments were performed, including participation by federal, state, BP, and parish representatives. Each plot was also bounded with sorbent boom. Hard boom was placed on the water side of the plots that were scheduled for the flushing and surface washing agent treatments.

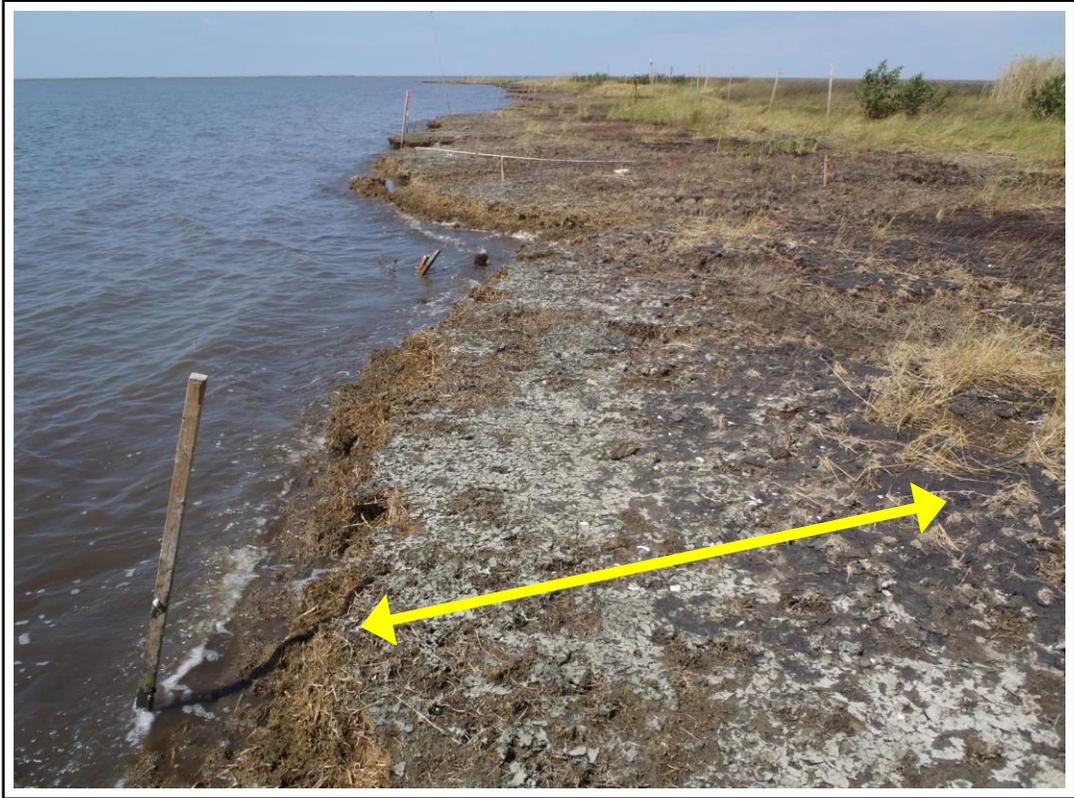
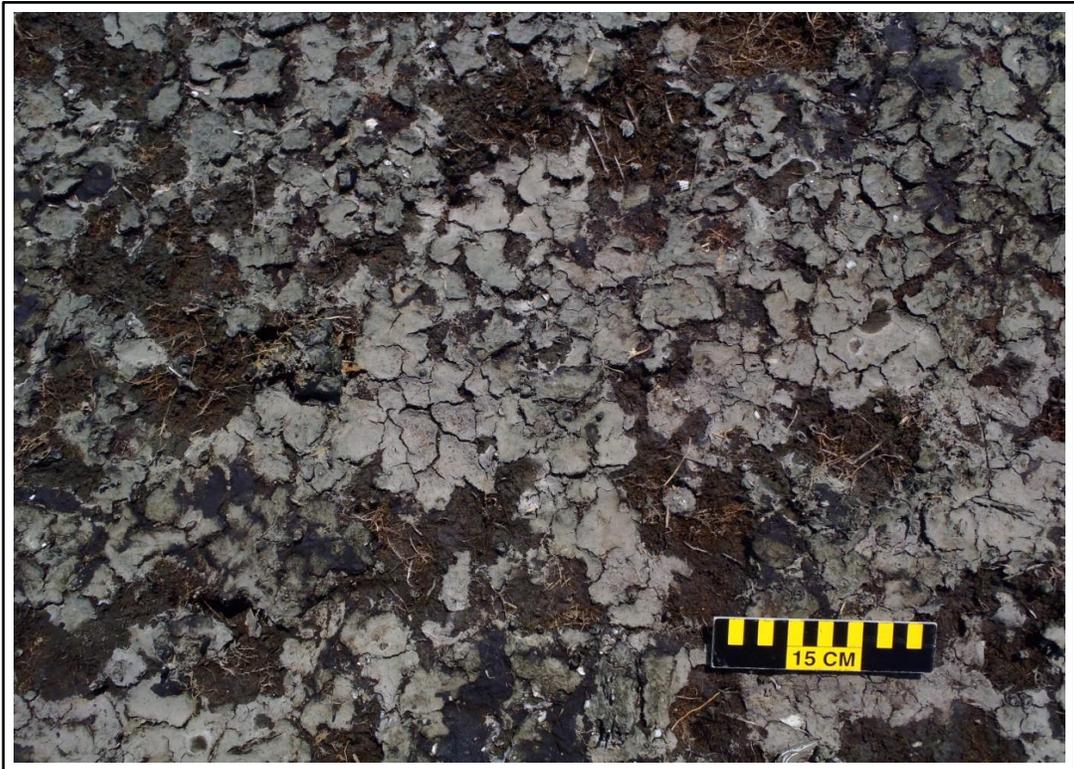
Figure 15. Oiling Zone A, lower marsh edge, surface oil residue with cover thickness, this zone was typically not treated.
