NOAA Technical Memorandum NOS OR&R 42

Deepwater Horizon Oil Spill: Salt Marsh Oiling Conditions, Treatment Testing, and Treatment History in Northern Barataria Bay, Louisiana (Interim Report October 2011)

Seattle, Washington
April 2013

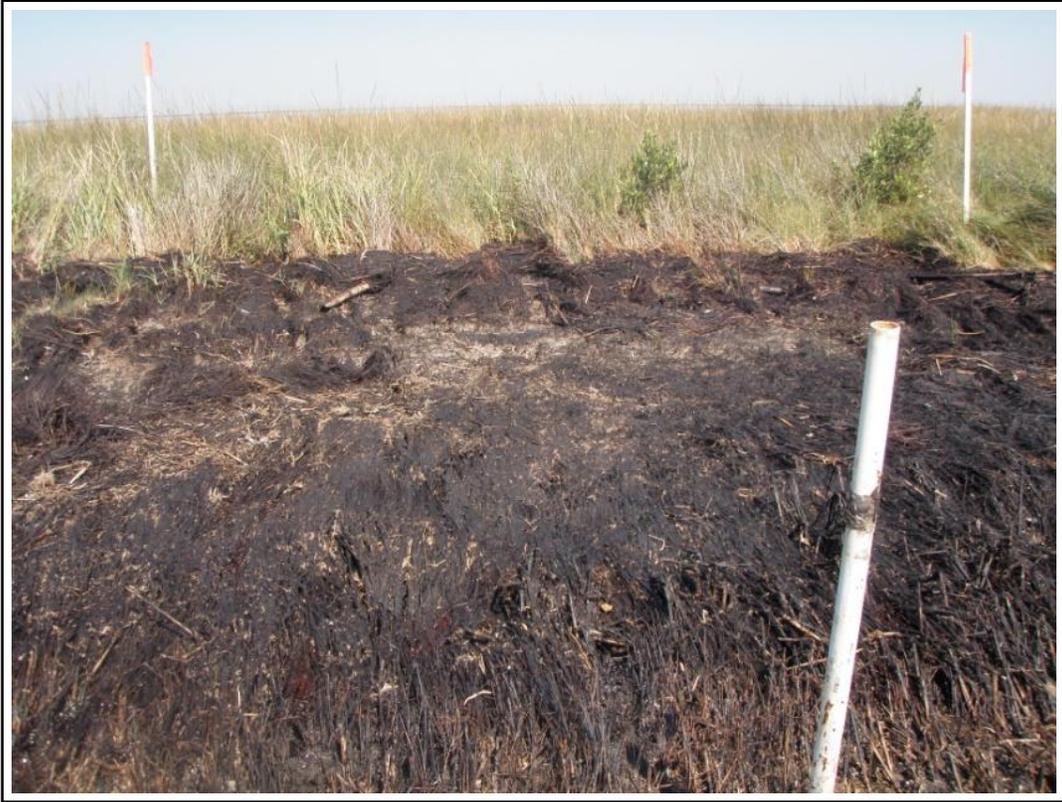
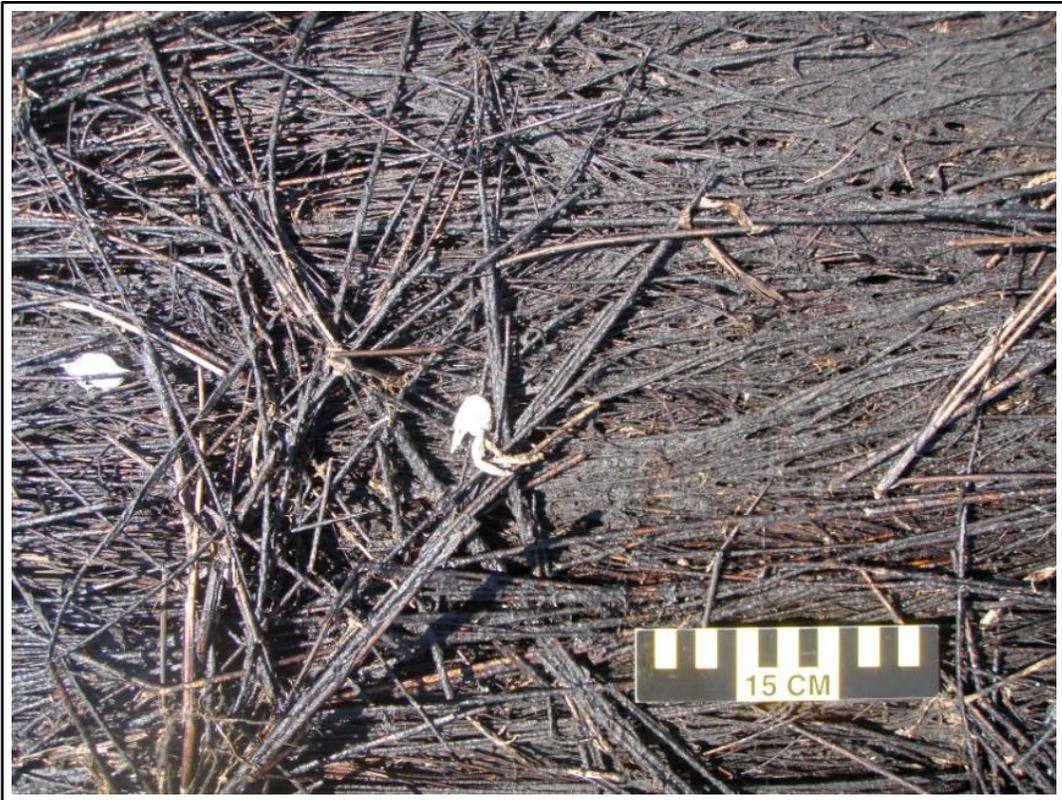
Figure 16. Oiling Zone B, heavily oiled vegetation mats and wrack.

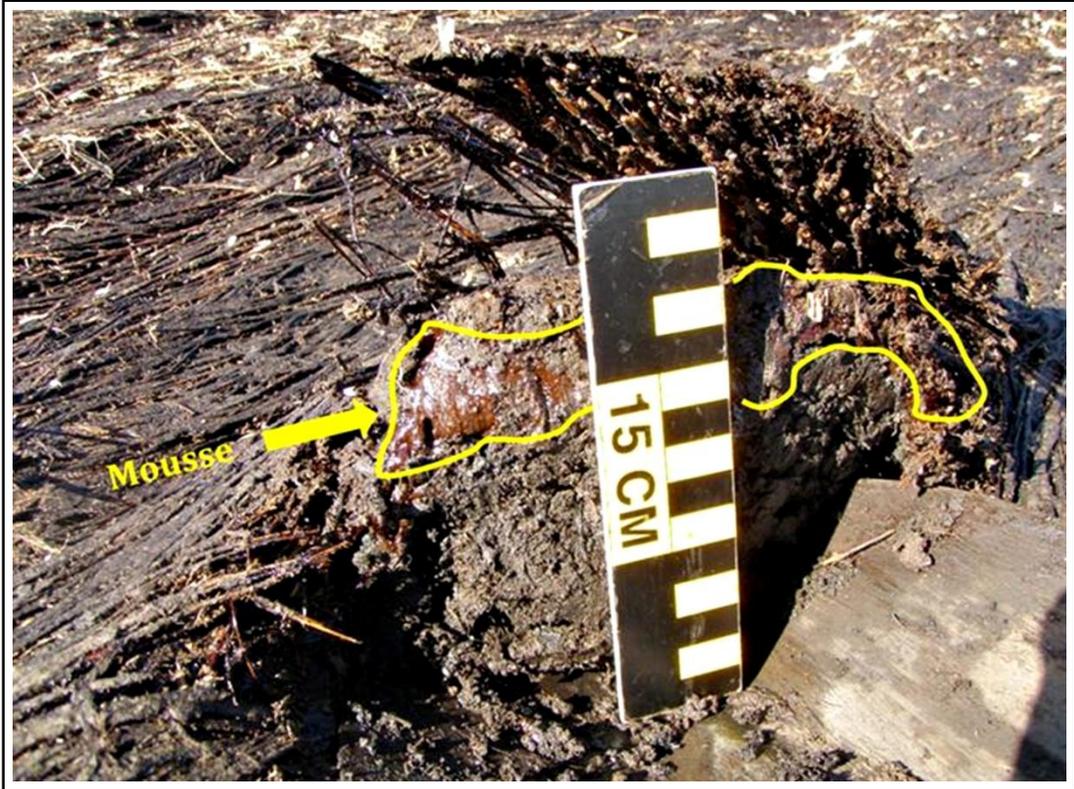
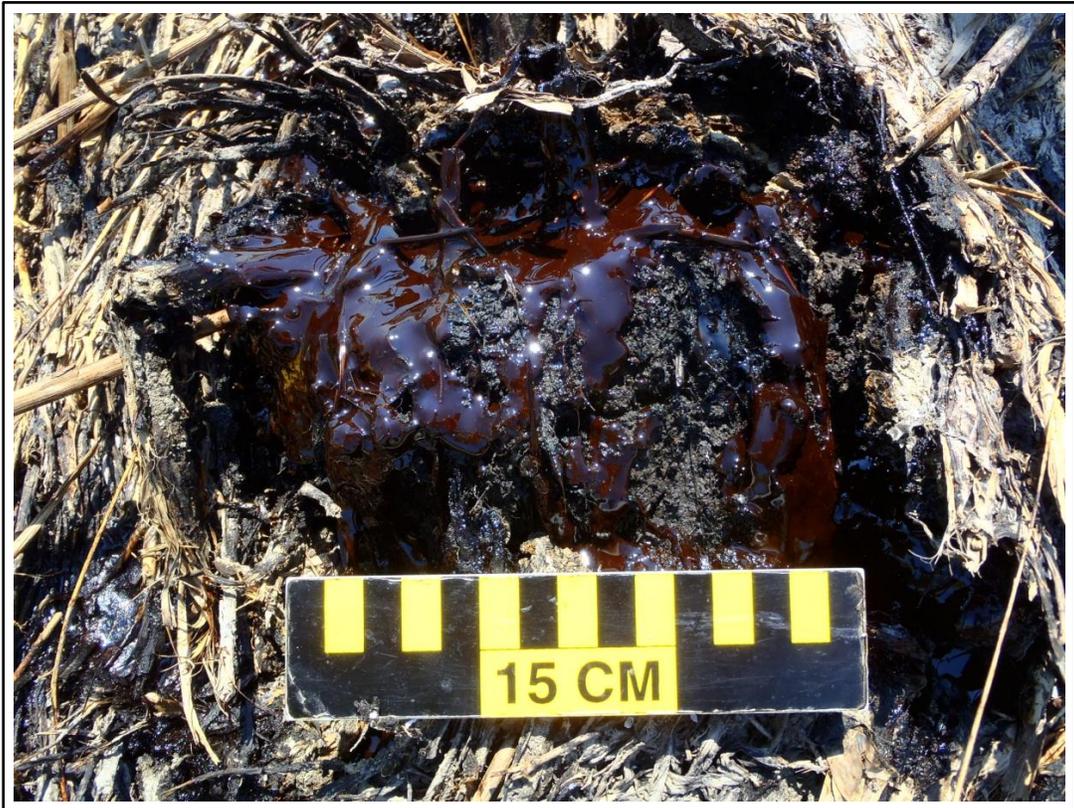
Figure 17. Oiling Zone B, thick mousse trapped under the oiled vegetation mats and wrack.

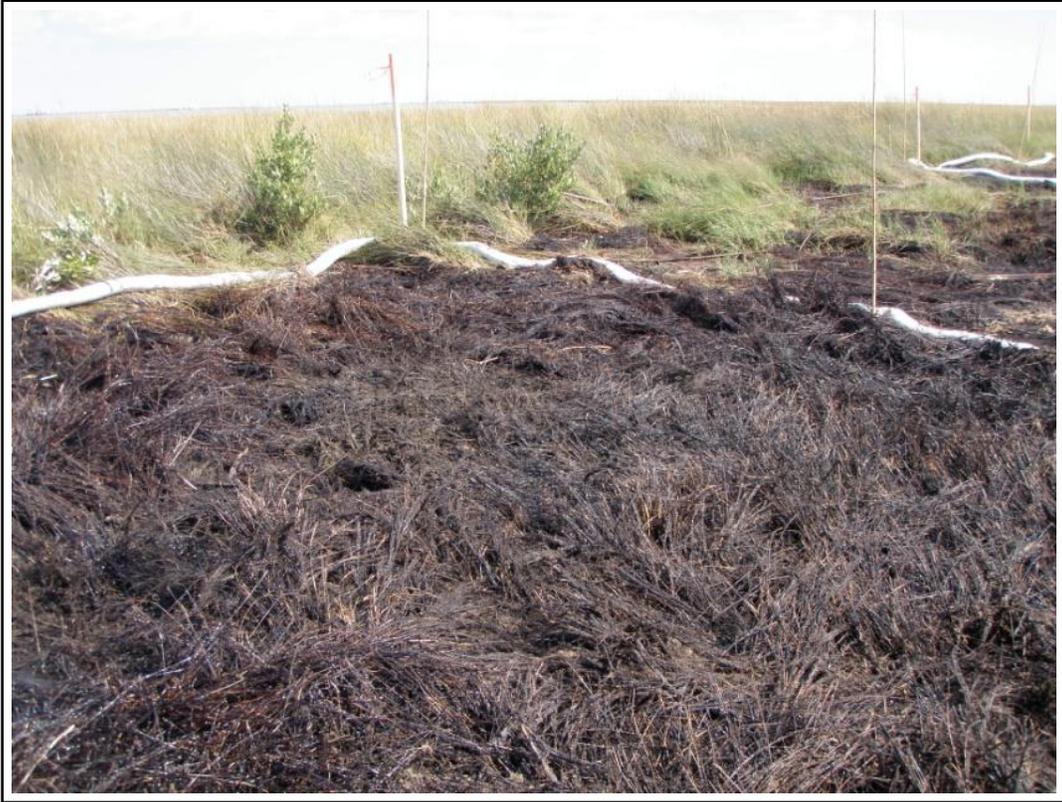
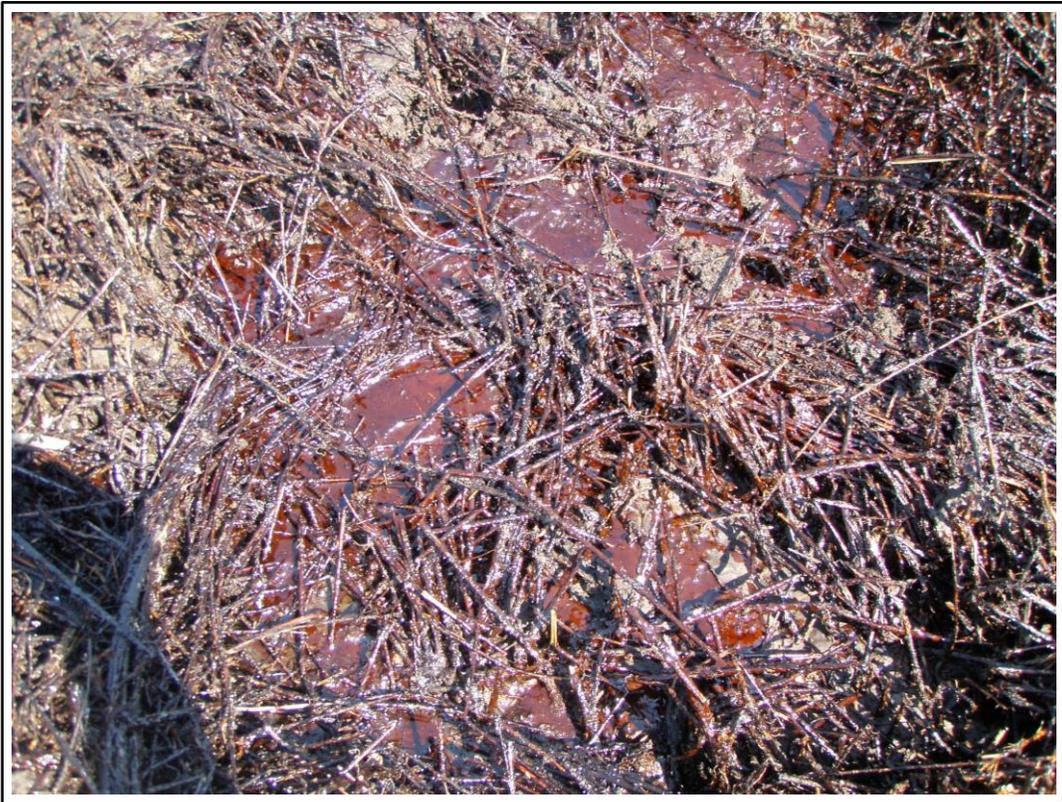
Figure 18. Oiling Zone B, post-raking condition, October 2010.

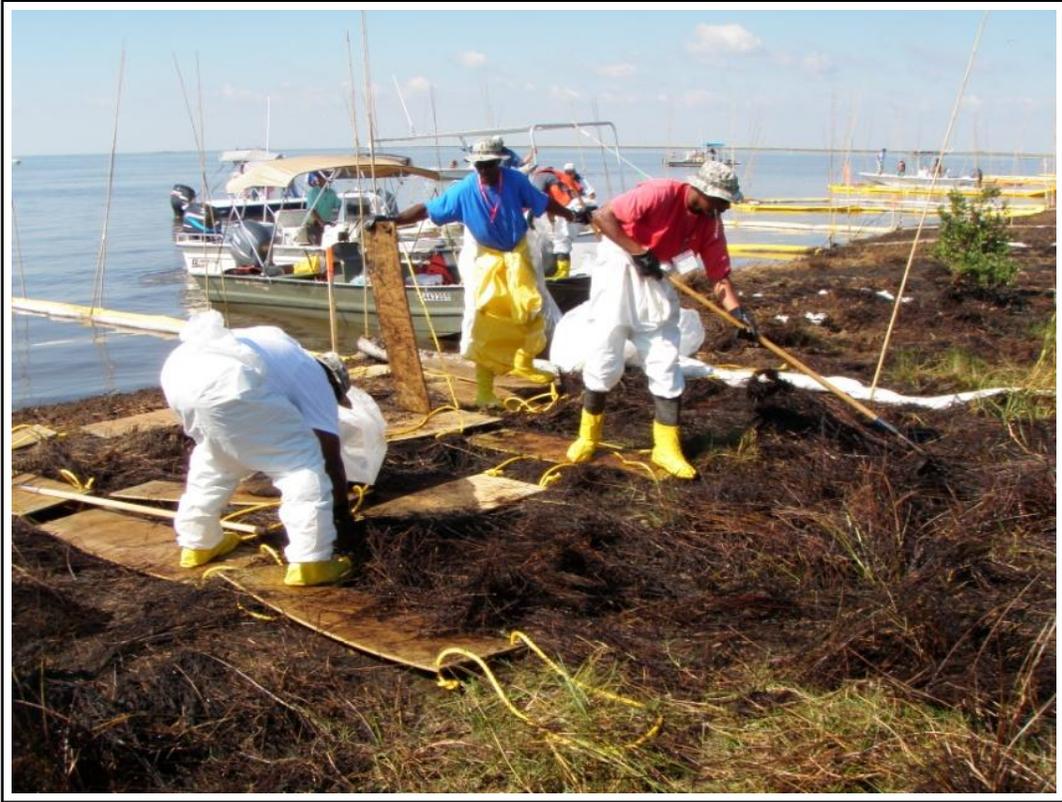
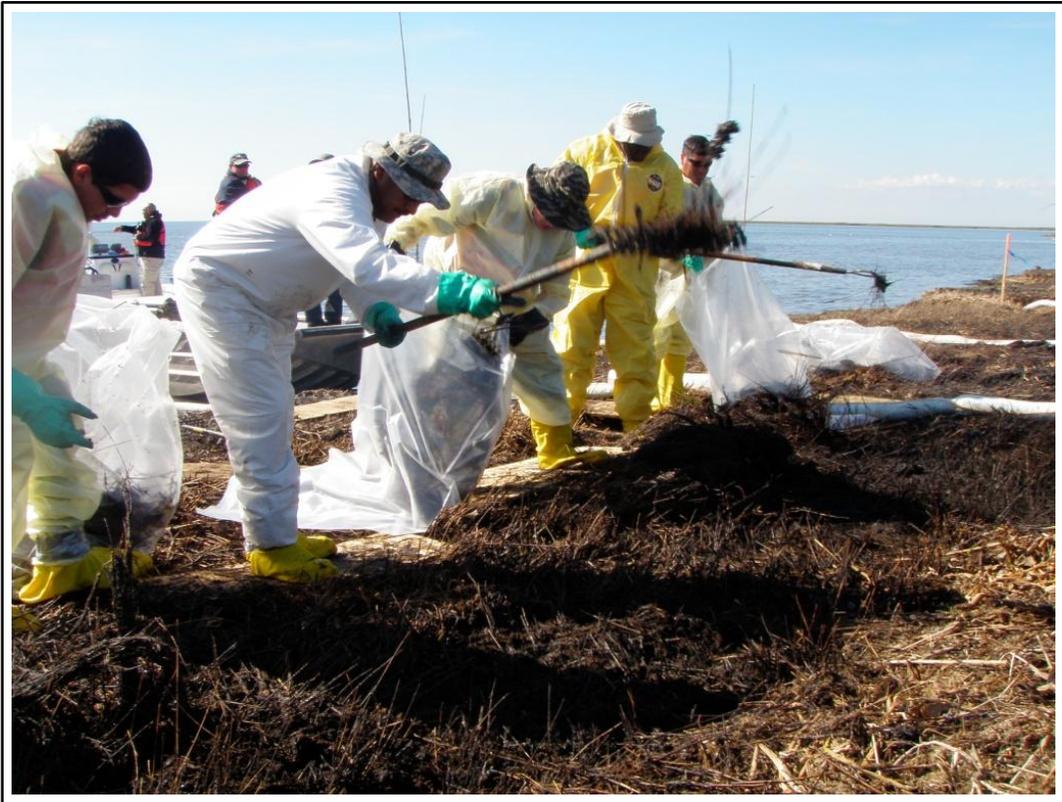
Figure 19. Raking from the walk boards, October 2010.

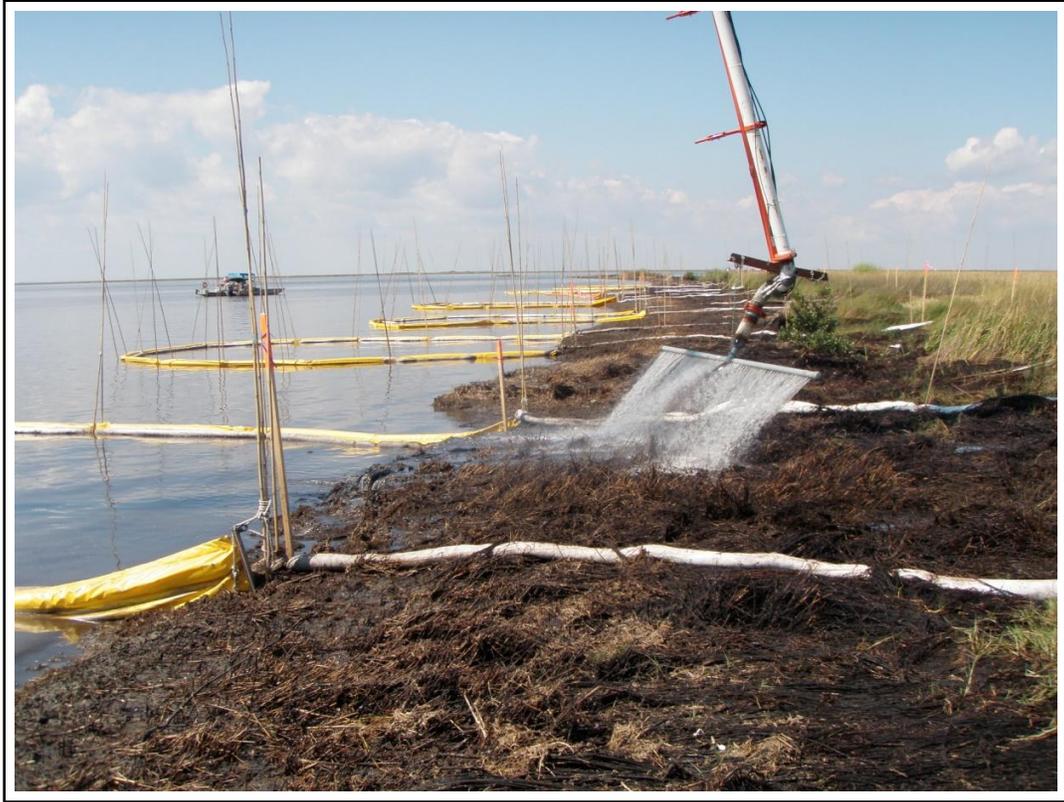
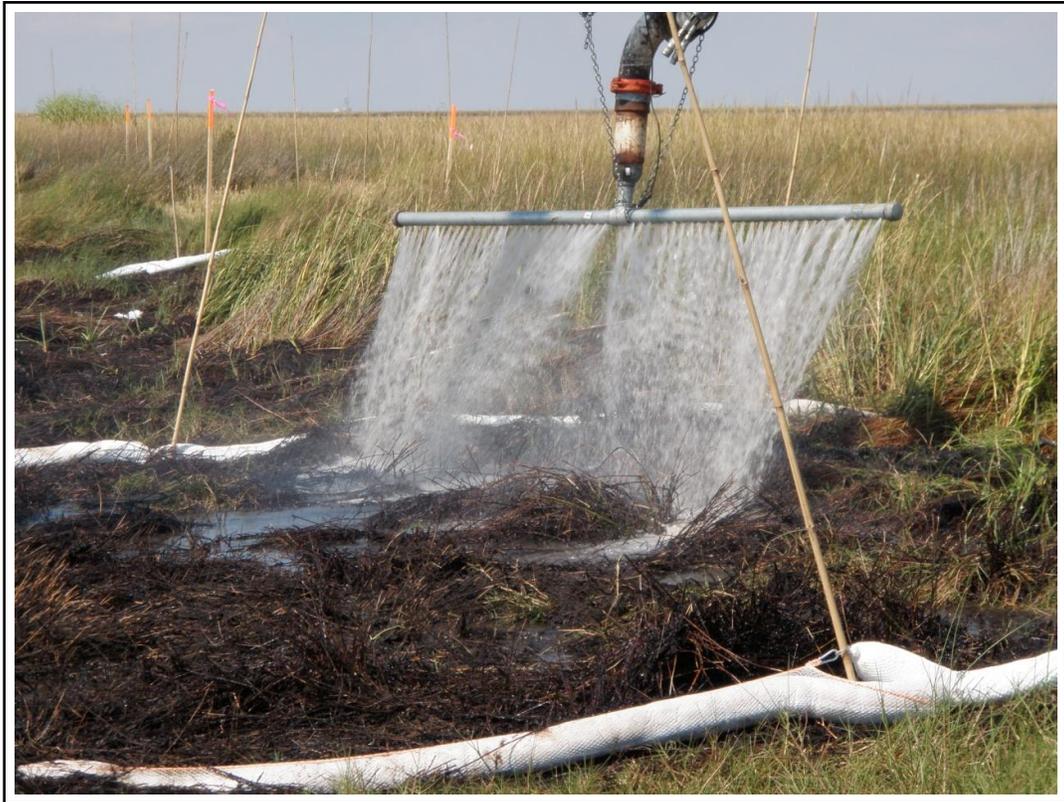
Figure 20. Marsh flushing following raking, October 2010.

Low-pressure flushing following raking mobilized abundant silver sheen to the water surface, covering roughly 80% of the on-water boomed area (Figure 20). More sheen was observed than in prior demonstrations without raking, indicating that the raking had the desired effect of exposing the mousse to treatment and natural flushing and weathering processes; however, the thick mousse layer remained in place. Some scouring of marsh sediments was also observed. Because this secondary treatment method seemed to offer limited gain in treatment effectiveness, low-pressure flushing was not replicated as a treatment.

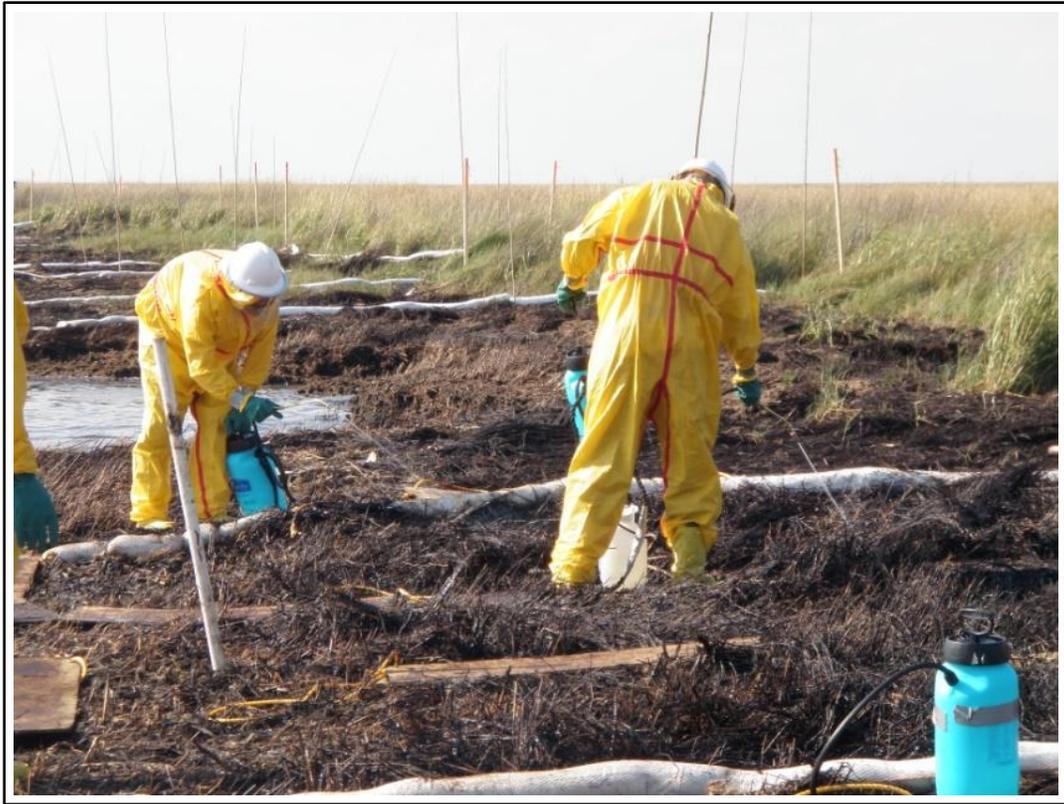
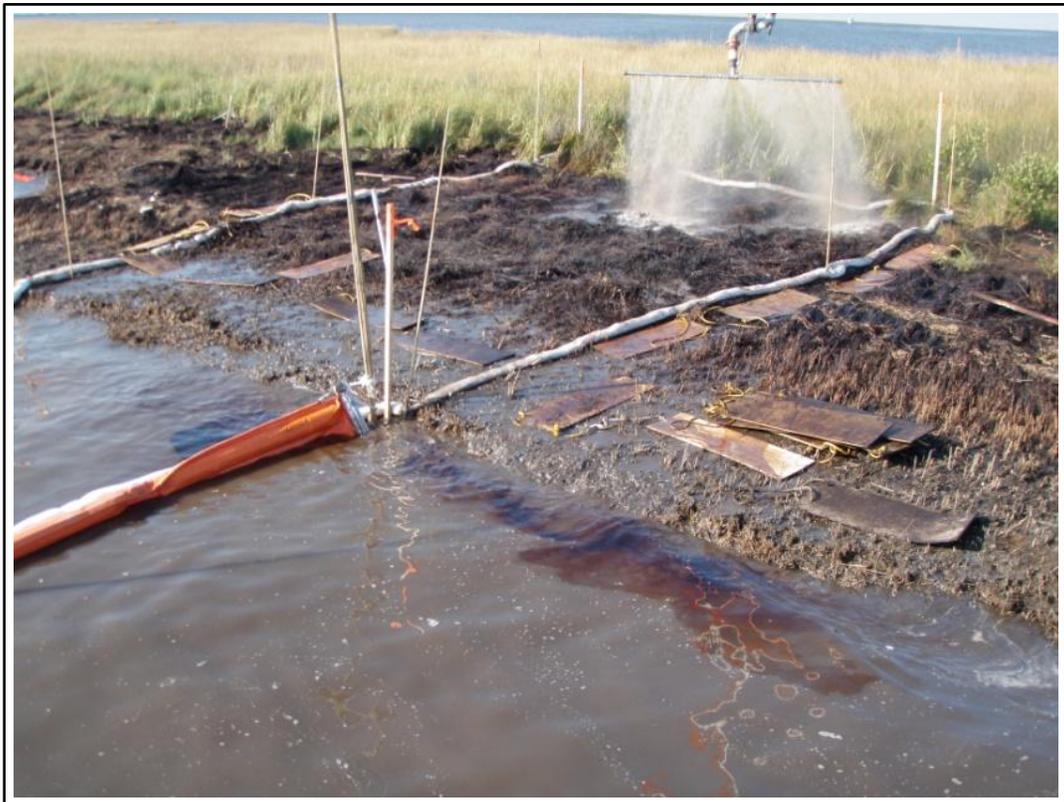
Figure 21. Surface washing agent and flushing following raking, October 2010.

The surface washing agent applications following raking, including PES-51 and Cytosol applied in two different plots, combined with flushing, mobilized a minor amount of liquid oil and mousse to the water surface (Figure 21). The PES-51 application seemed to mobilize a greater amount of oil than the Cytosol, in the form of liquid oil rather than mousse; however, the oil appeared to naturally disperse once it was on the water surface. The Cytosol mobilized what appeared to be mousse mixed with fine organic debris off the marsh. In both cases, the amount of oil released was much less than the amount of oil remaining on the marsh. Scouring of marsh sediments was also observed due to the flushing treatments. Because the surface washing treatments seemed to offer limited gain in treatment effectiveness, they were not replicated further.

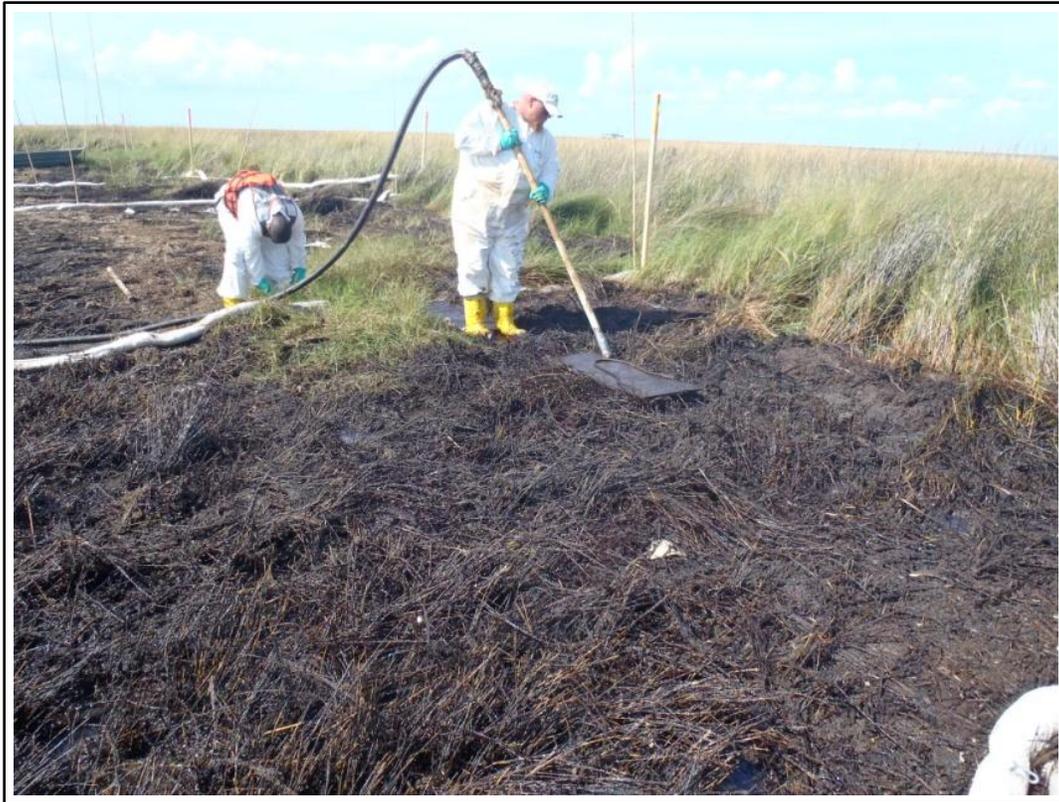
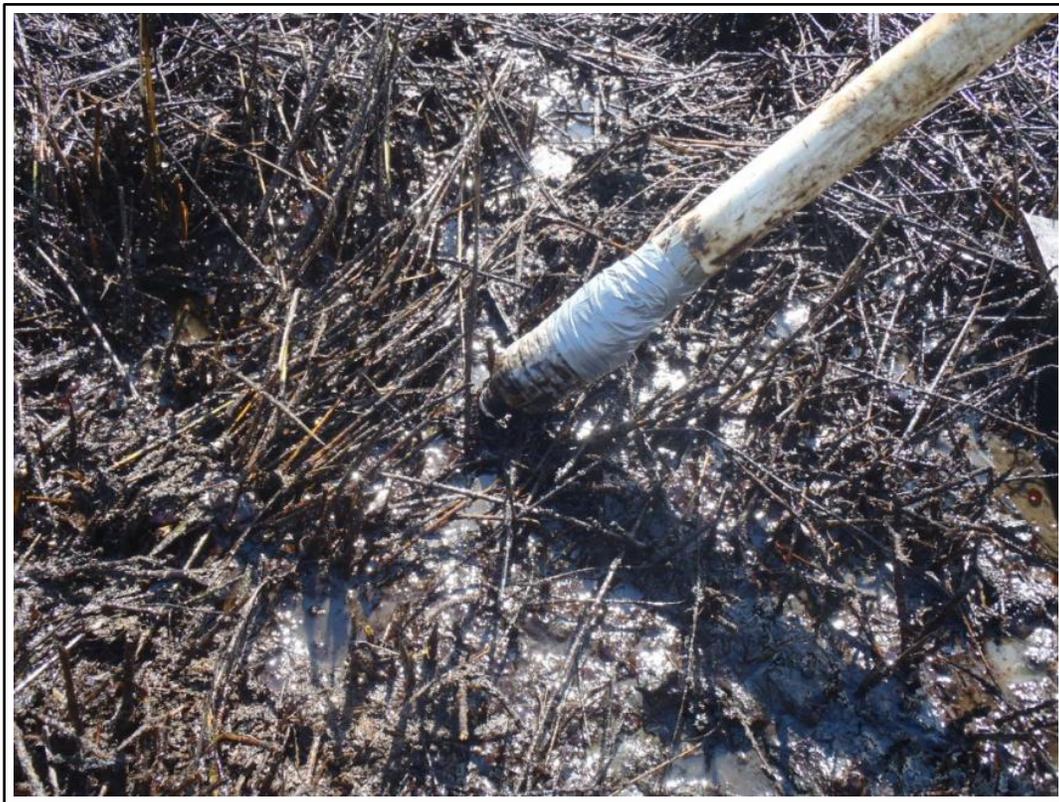
Figure 22. Marsh vacuuming from walk boards following raking, October 2010.

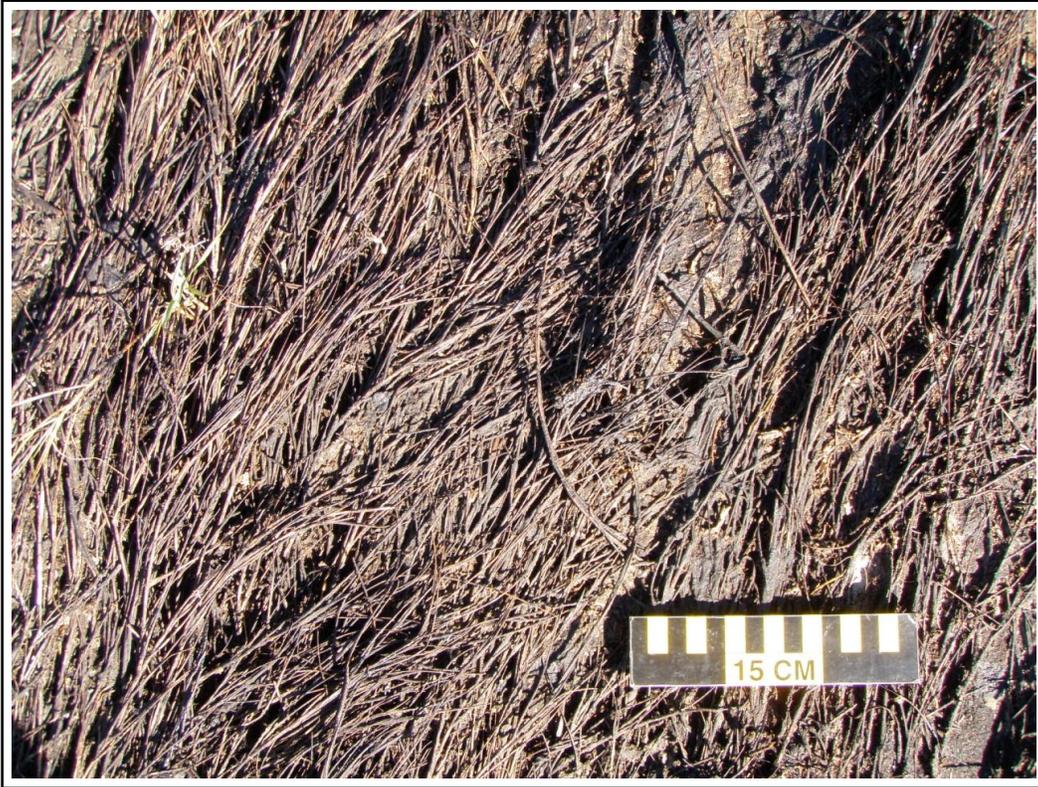
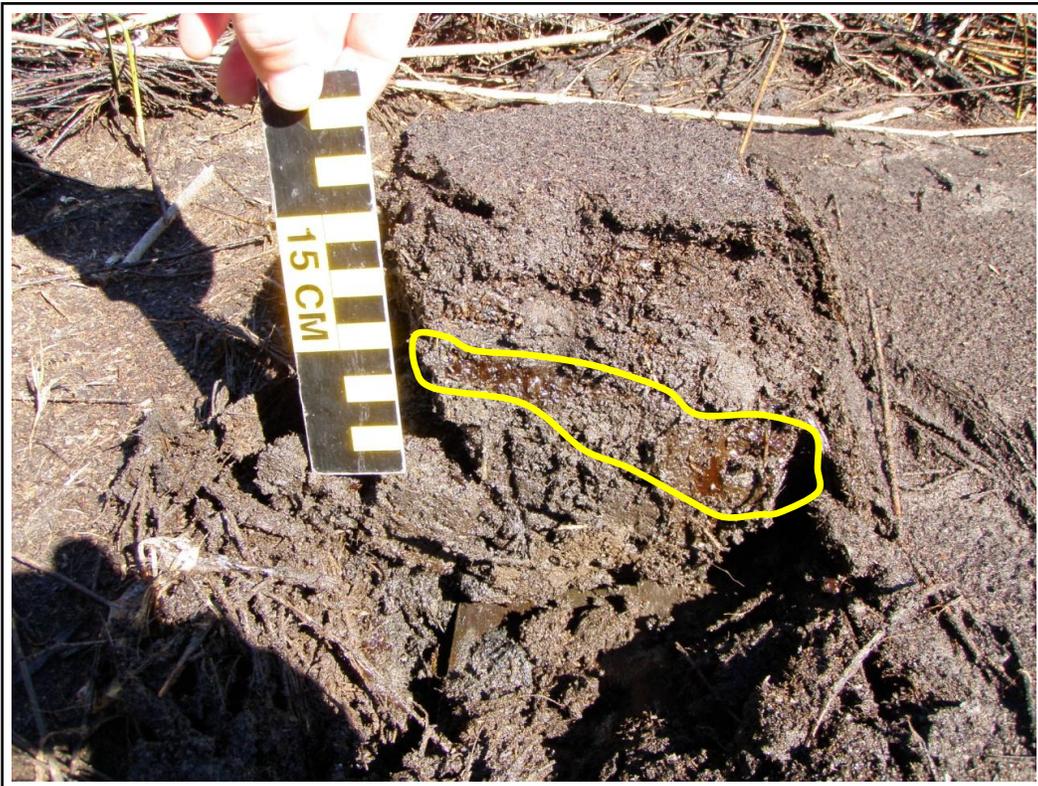
Figure 23. Re-established oiled vegetation mat following raking, thick mousse remains trapped beneath the mat (“coffee grounds” deposited on top of mat in bottom photograph), November 2010.

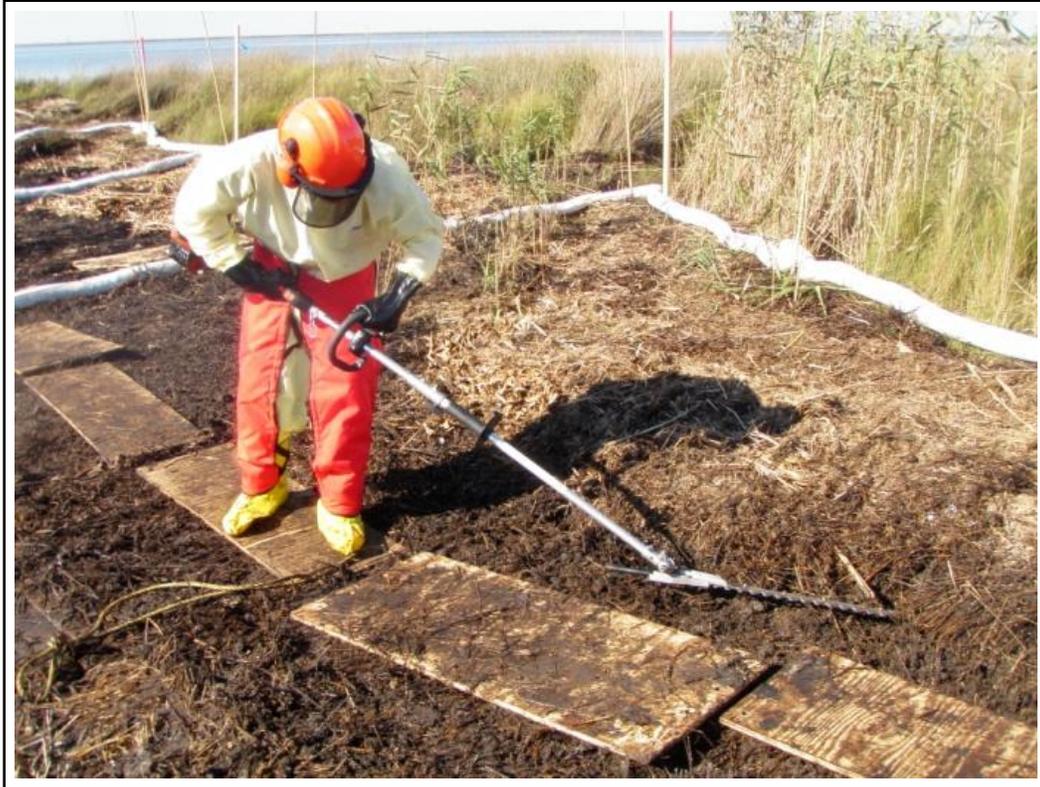
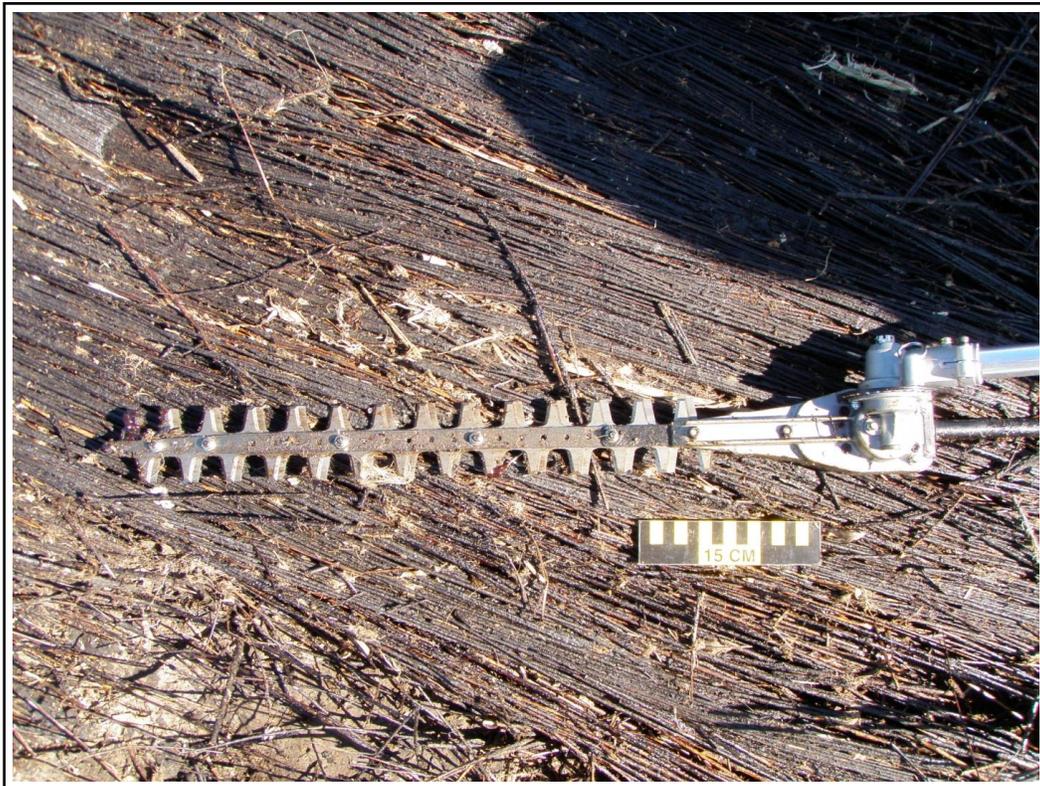
Figure 24. Cutting the oiled vegetation mat with the power hedge trimmer, following intensive raking, December 2010; detail of cutting tool.

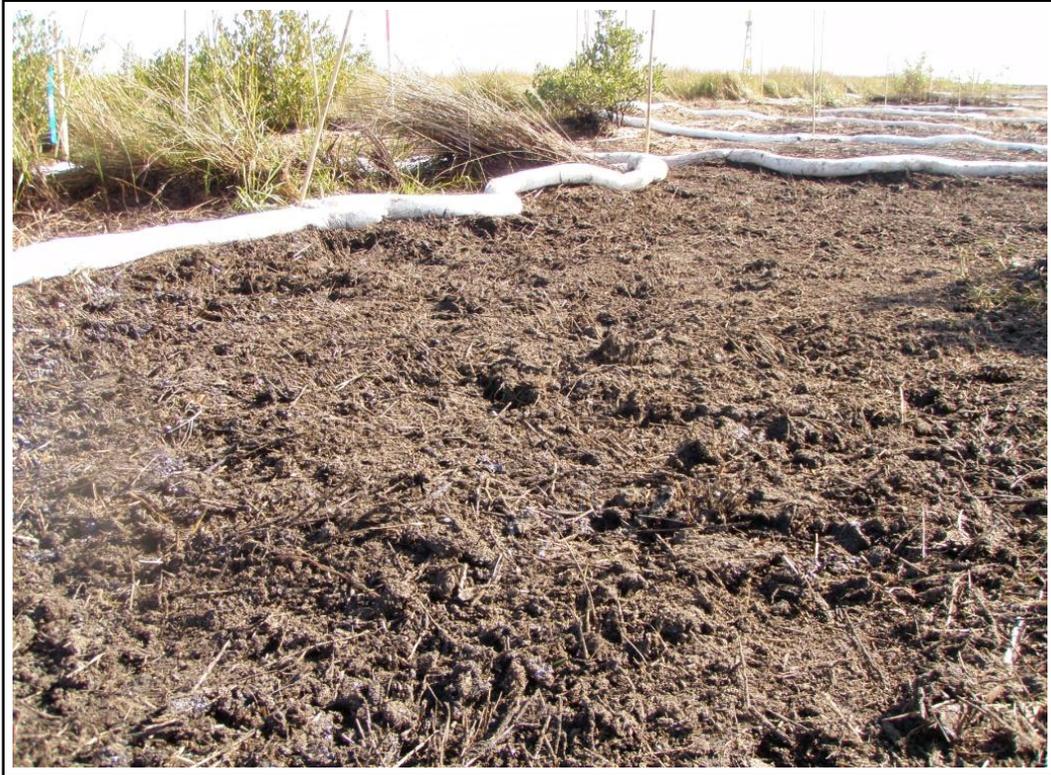
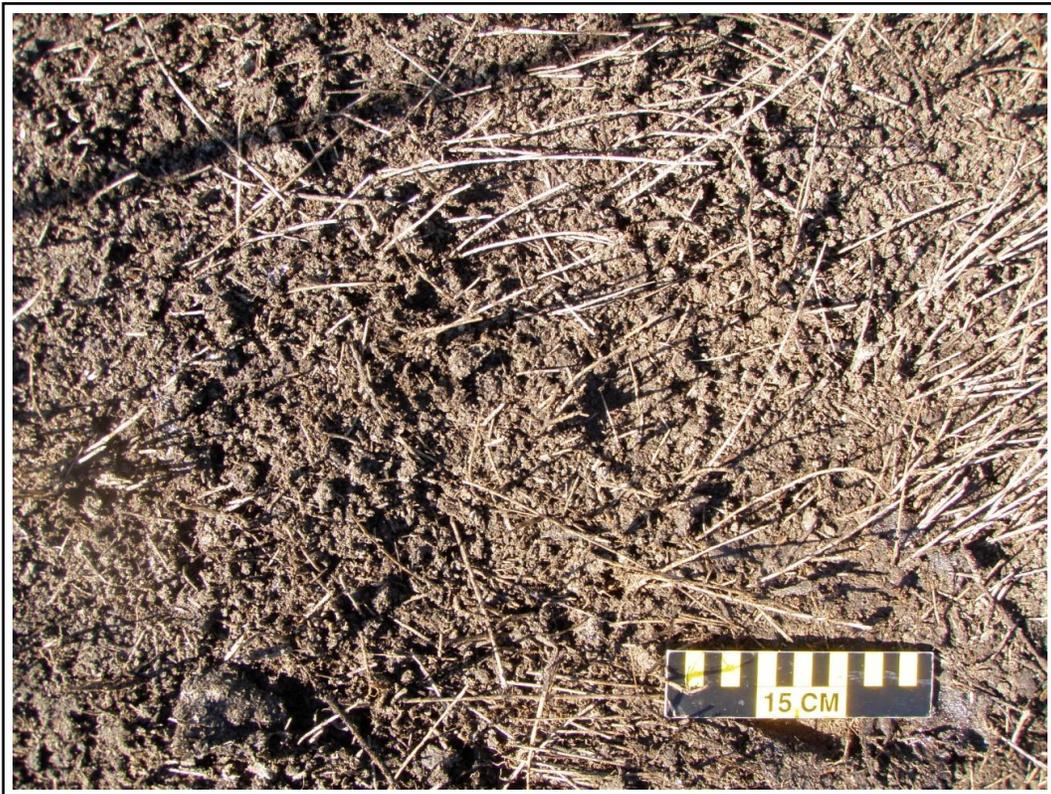
Figure 25. Marsh conditions immediately after raking and cutting, oiled vegetation mats and wrack completely removed, December 2010.

The overall treatment sequence included oiled wrack removal (including cutting the tarry wrack into sections for removal, where needed), aggressive raking of the oiled vegetation mat, cutting the raked vegetation with the hedge trimmer (Figure 24), additional raking and cutting where needed, and light raking as the workers backed their way out of the plots. All work was conducted on walk boards. A short standing stubble of vegetation remained following treatment (Figure 25).

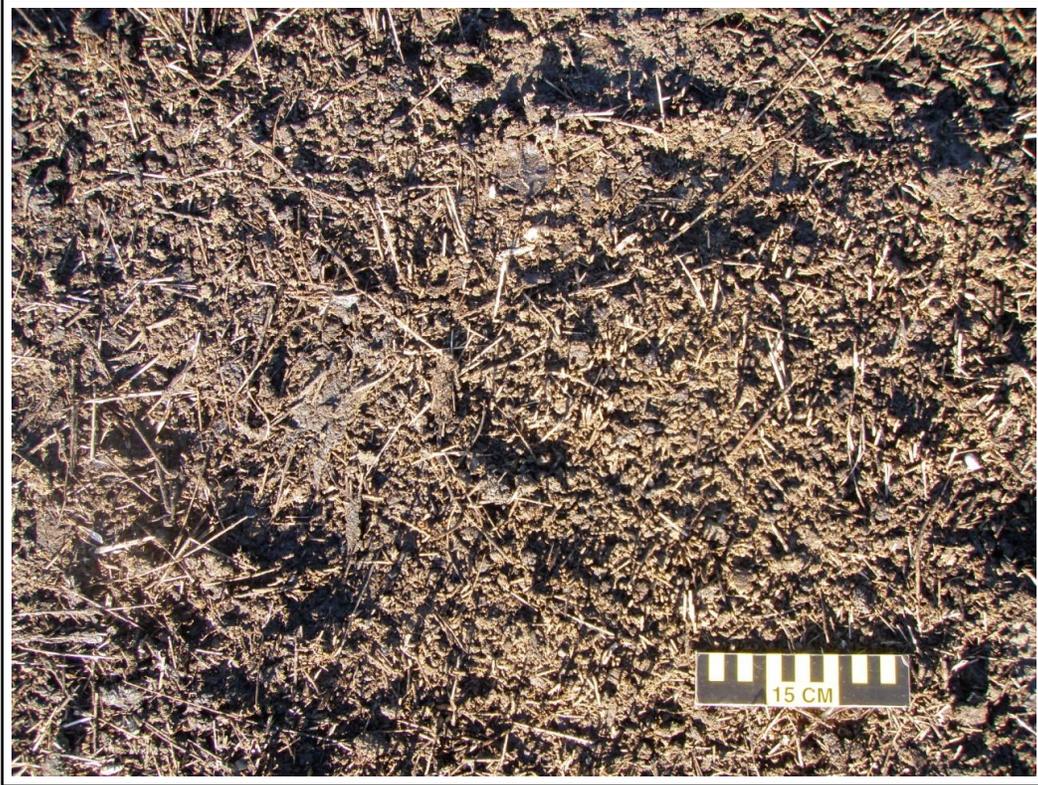
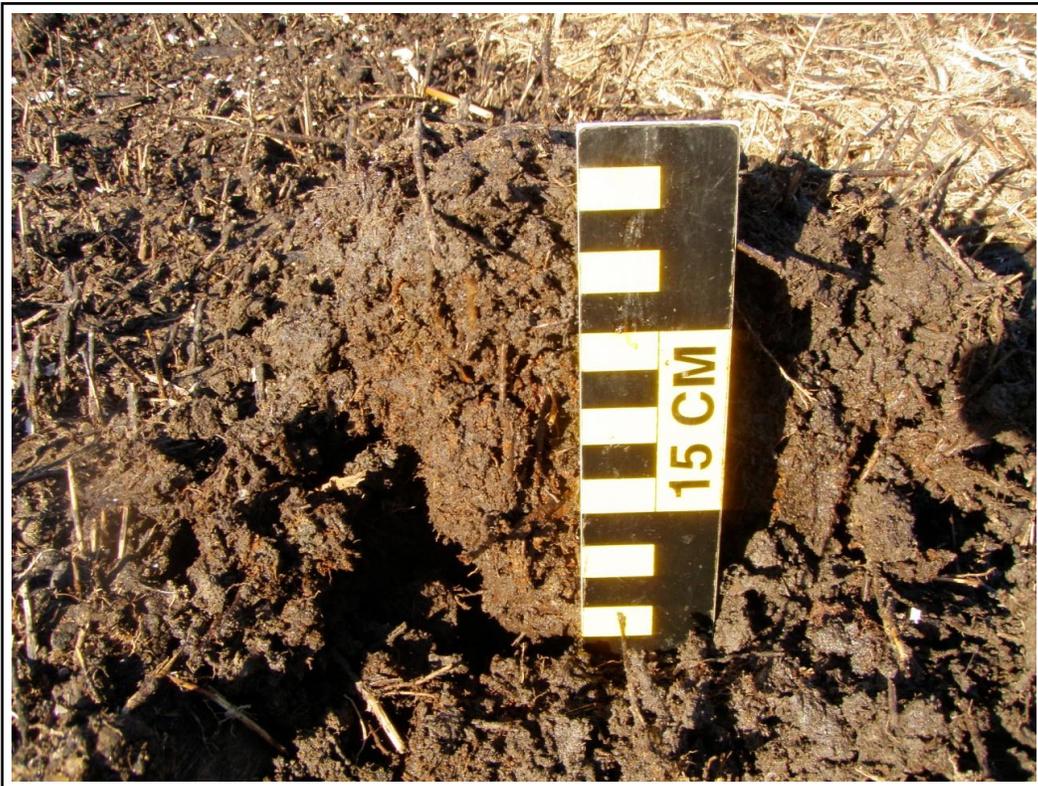
Figure 26. Marsh conditions one month following raking and cutting, plant stubble with surface residue, shovel pit lacking mousse, January 2011.

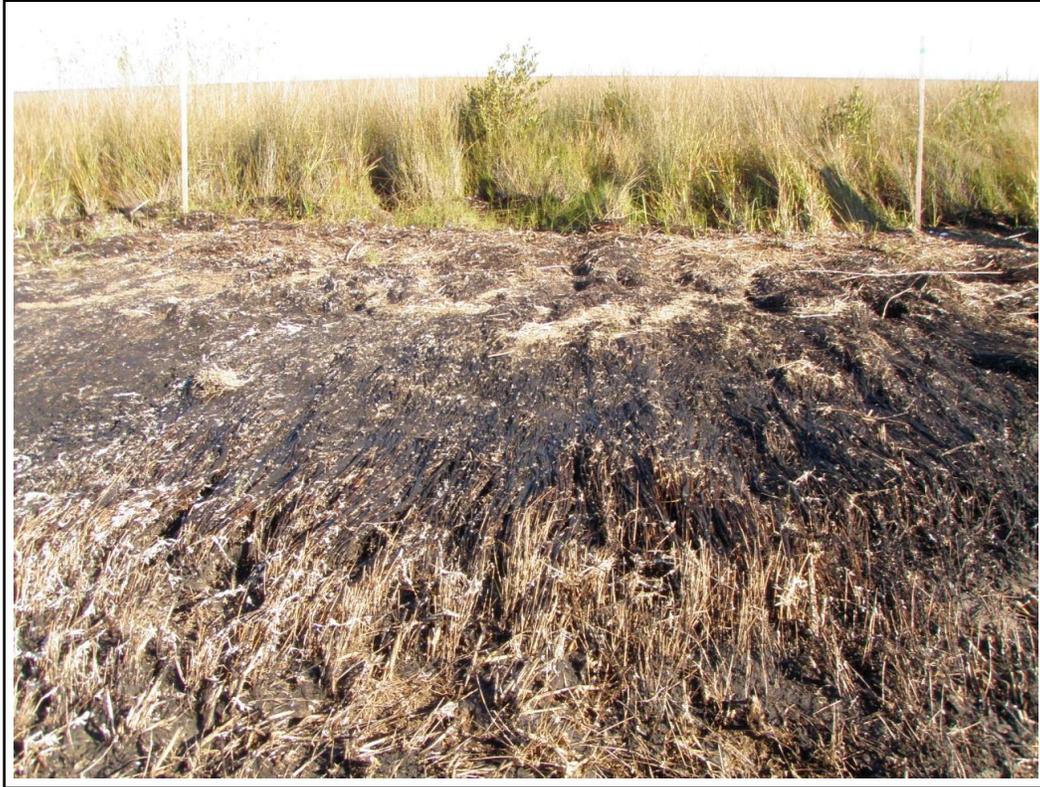
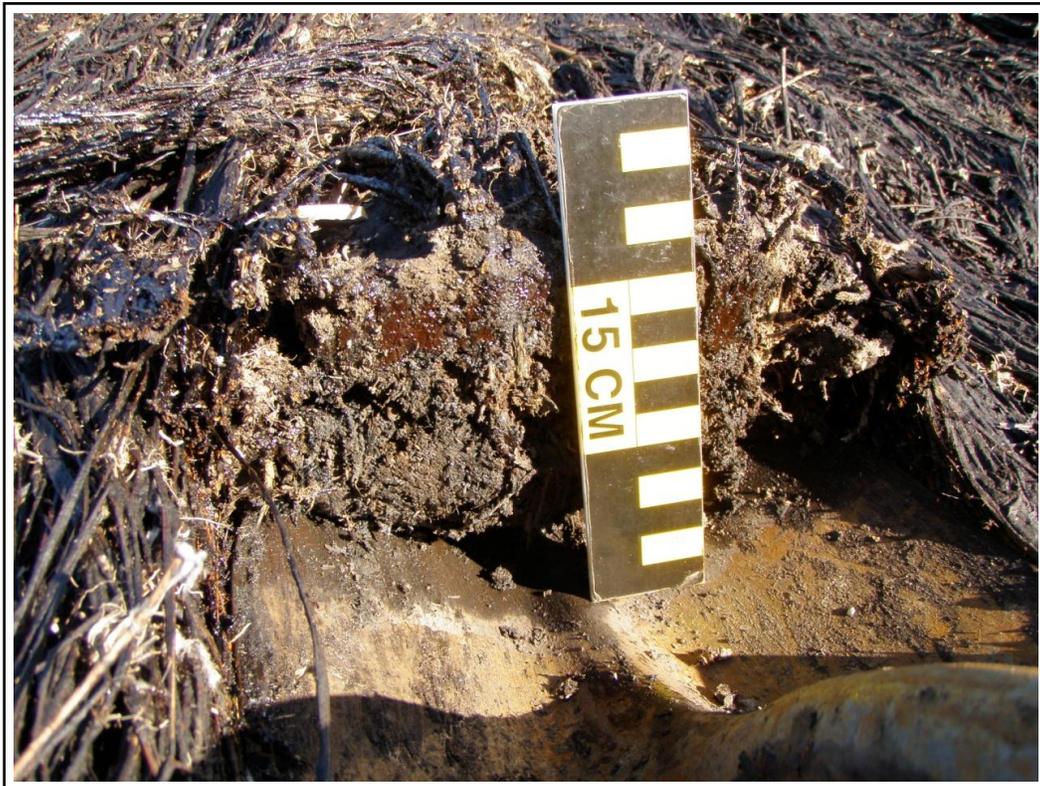
Figure 27. Marsh conditions with natural recovery (no treatment), oiled vegetation mats and thick mousse remain, January 2011.

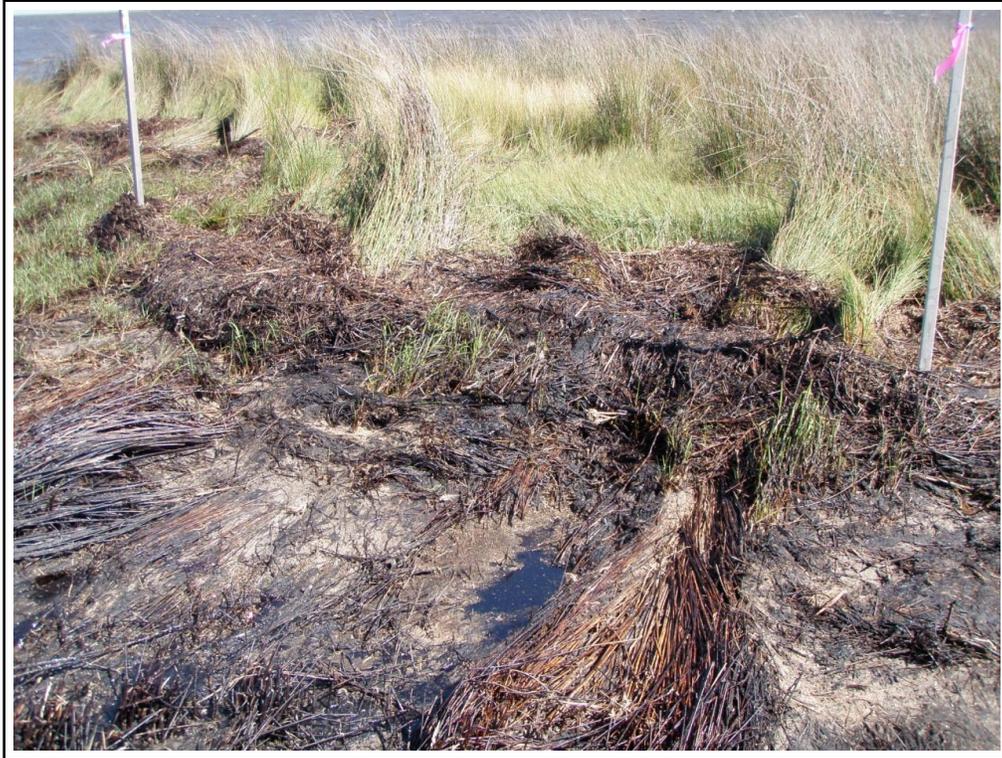
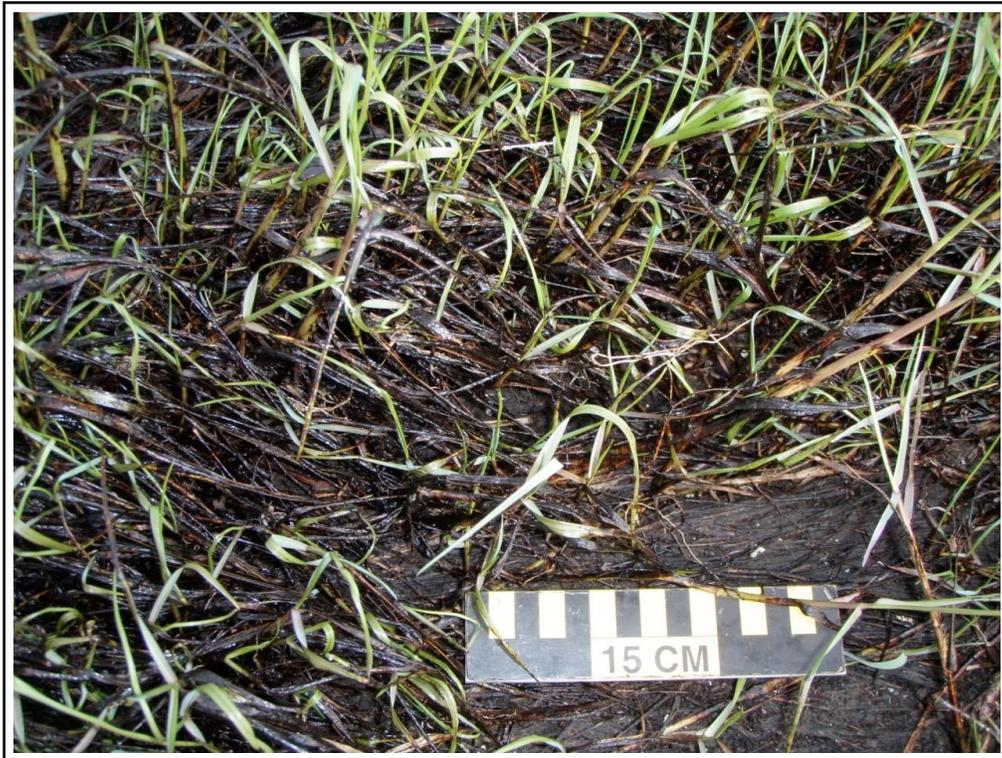
Figure 28. Localized remobilization of oil from the marsh platform, late April storm 2011. Top: new oiled wrack line and re-oiling of portions of the oiled vegetation mat. Bottom: remobilized oil on new vegetation growth within one of the plots (the vegetation survived). Photos from early May 2011.

Two oil re-mobilization events were also documented during the monitoring period. Severe storms coupled with high water levels in late April 2011 generated waves that caused localized re-mobilization of oil from the marsh platform (Figure 28). Monitoring conducted in early May 2011 documented oiling of new vegetation growth in the plots and oil pushed up to several meters further into the marsh by the storm, oiling the existing intact vegetation and establishing a new heavily oiled wrack line. Oil re-mobilization was greater for non-treated areas as compared to treated areas. New oil zones were described for oil on new vegetation growth in the plots, oil on the existing intact vegetation beyond the plots, and the new heavily oiled wrack line. Immediately after the monitoring period, under STR S3-045 (described below), the new oiled wrack line was removed from all areas except the natural recovery plots, limiting further oiling of vegetation and preventing much of the oil from reaching the substrate. In addition, all areas between the existing treatment plots were fully treated under STR S3-045 during May-June 2011. The new oil on the standing vegetation consisted of a coat to stain that persisted for roughly 2-3 months following the storm. The new vegetation growth in the plots generally survived this oiling event.
