NOAA Technical Memorandum NOS OR&R 42

Deepwater Horizon Oil Spill: Salt Marsh Oiling Conditions, Treatment Testing, and Treatment History in Northern Barataria Bay, Louisiana (Interim Report October 2011)

Seattle, Washington
April 2013

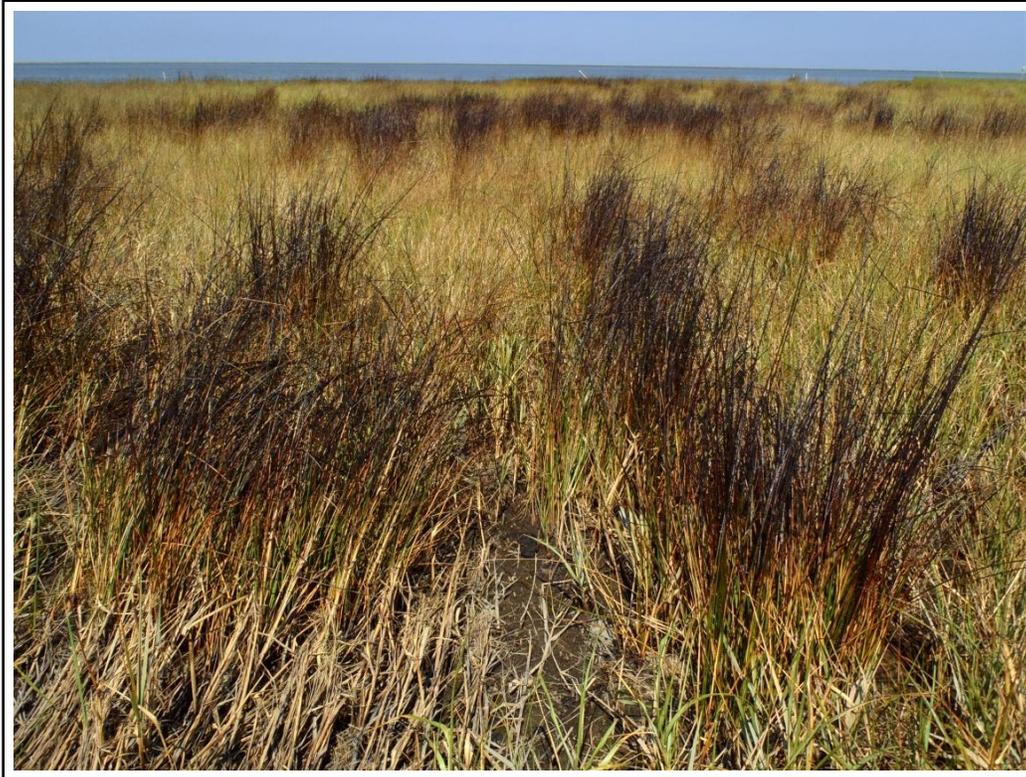
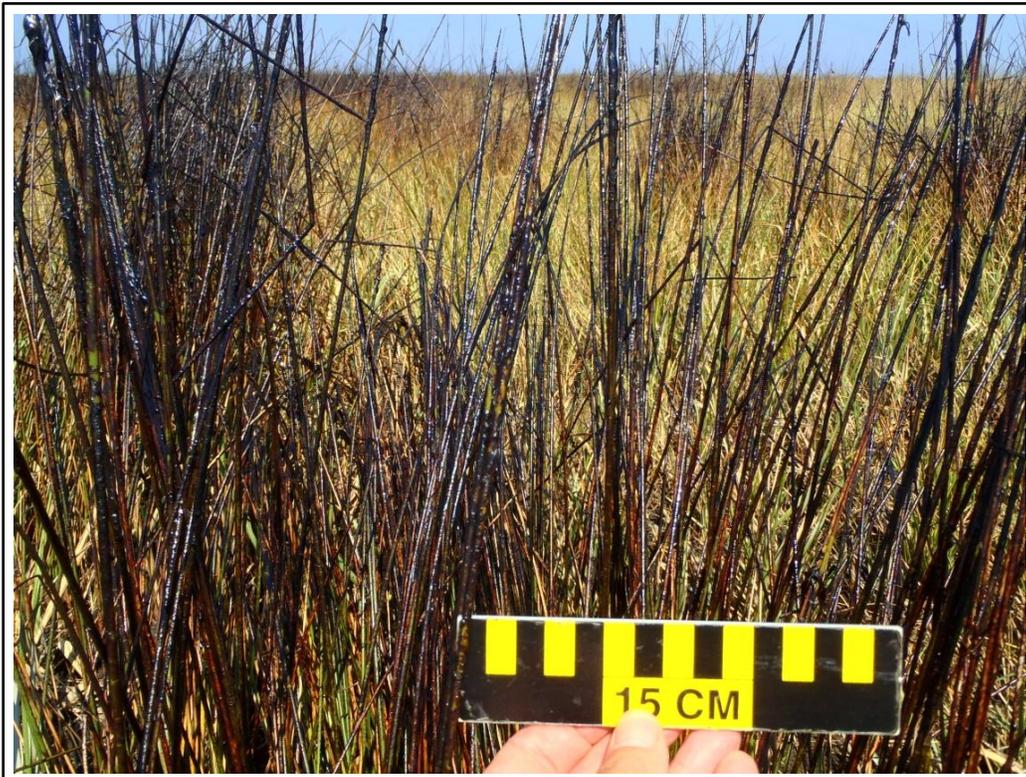
Figure 29. Localized remobilization of oil from the marsh platform, Tropical Storm Lee, September 2011. Oil from a natural recovery plot spread deeper into the marsh, oiling black needlerush, but not other vegetation species or the substrate.

Tropical Storm Lee in early September 2011 resulted in the second localized re-mobilization of oil from the marsh platform. In this case, the western end of the test area appeared to have experienced greater wave energy and oil remobilization, and there was a marked difference in the degree of re-mobilization between the vegetation raking and cutting plots (less to no remobilization) and the natural recovery plots (greater remobilization). There was little to no oil remobilization from the STR treatment areas between the plots. Oil remobilization from several of the natural recovery plots transported oil further into the marsh to tens of meters, oiling relatively patchy stands of *Juncus roemerianus* (black needlerush) vegetation that were not previously oiled (Figure 29). There was little to no oiling of other, more abundant marsh vegetation in the same vicinity, including *Spartina alterniflora* (smooth cordgrass) and *Spartina patens* (saltmeadow cordgrass). An oiled wrack line was not present and no oil was observed on the sediment. Tropical Storm Lee removed nearly all wrack lines, oiled and un-oiled, from the treatment test plots and reference plots.

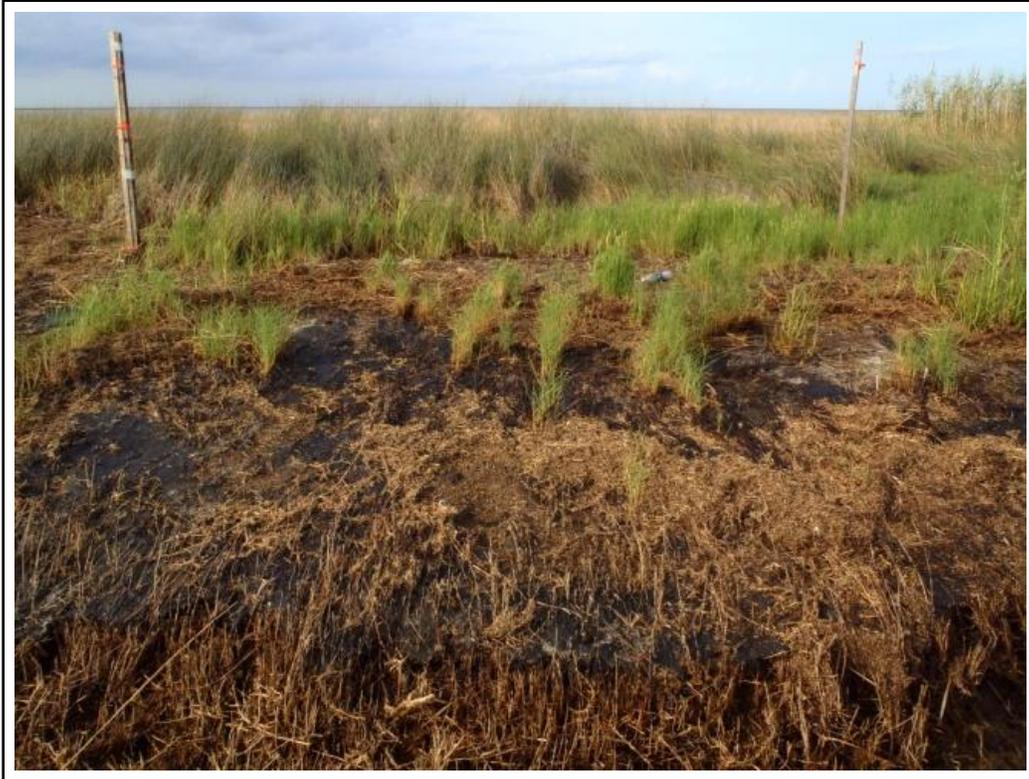
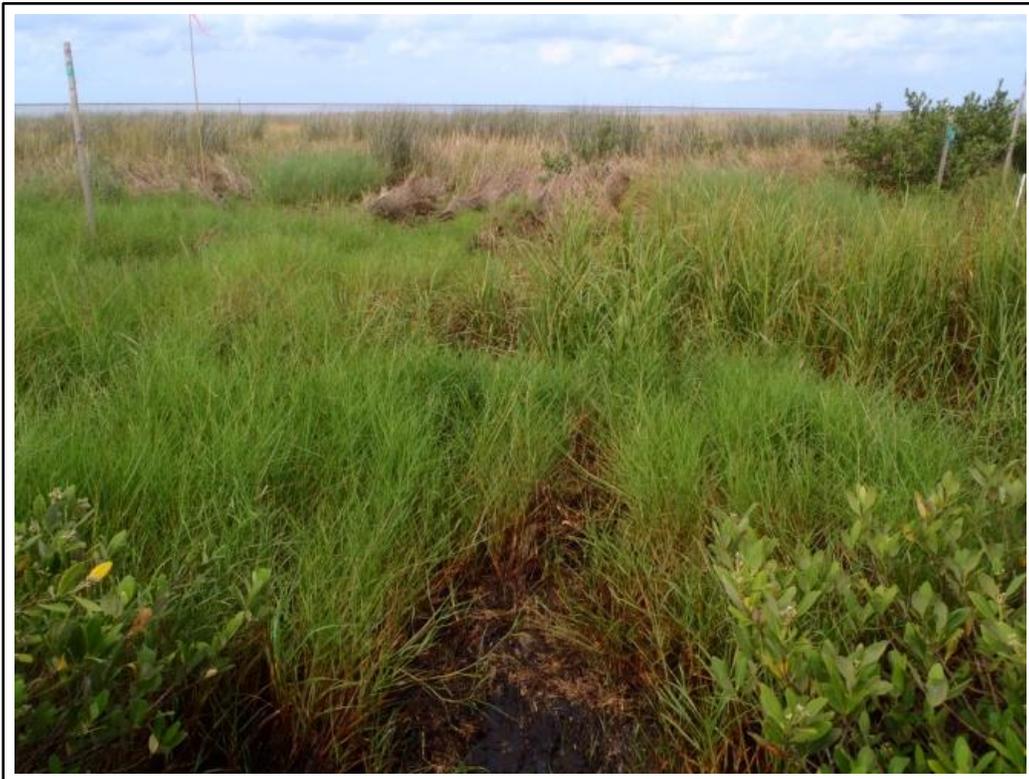
Figure 30. Vegetation response following heavy oiling and treatment tests, August 2011. Top: natural recovery. Bottom: raking and cutting treatment in December 2010.

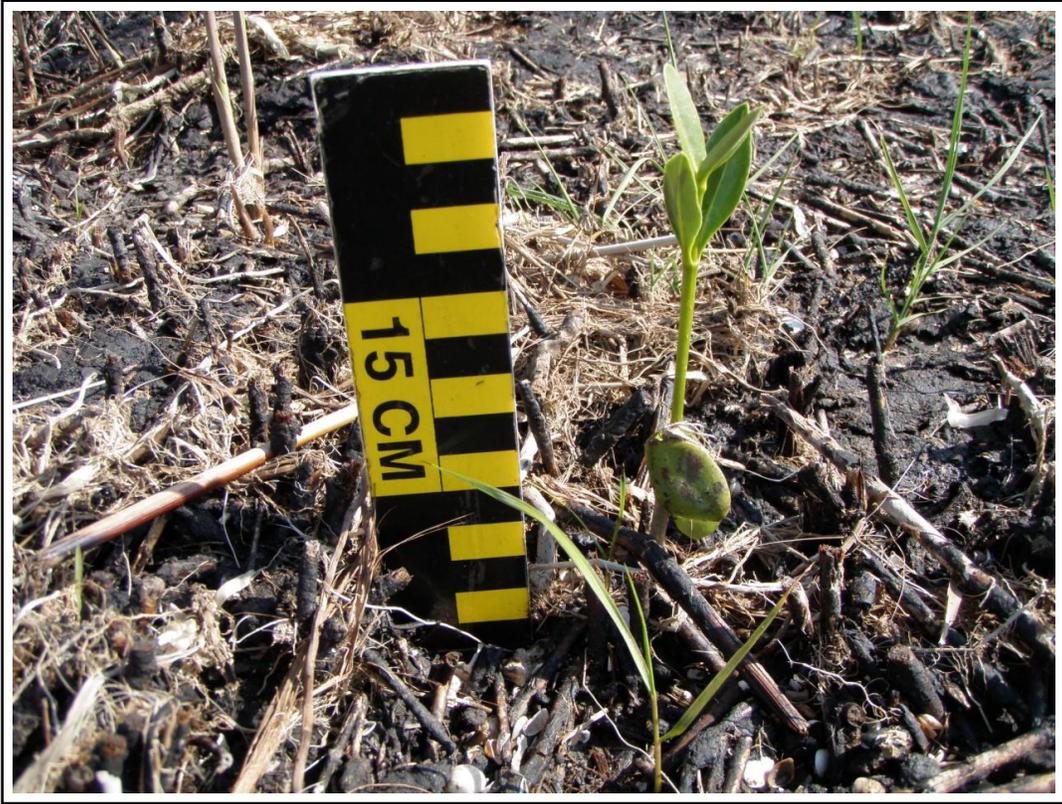
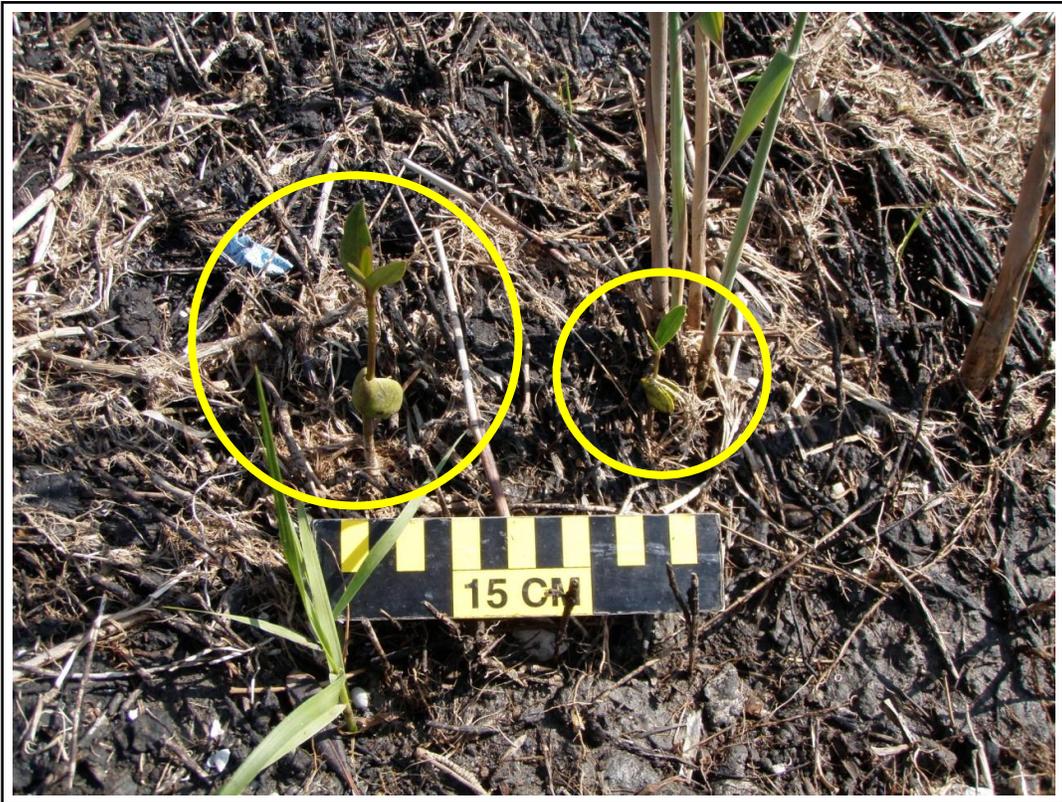
Figure 31. Mangrove seedling recruitment in the raked and cut plots, April 2011.

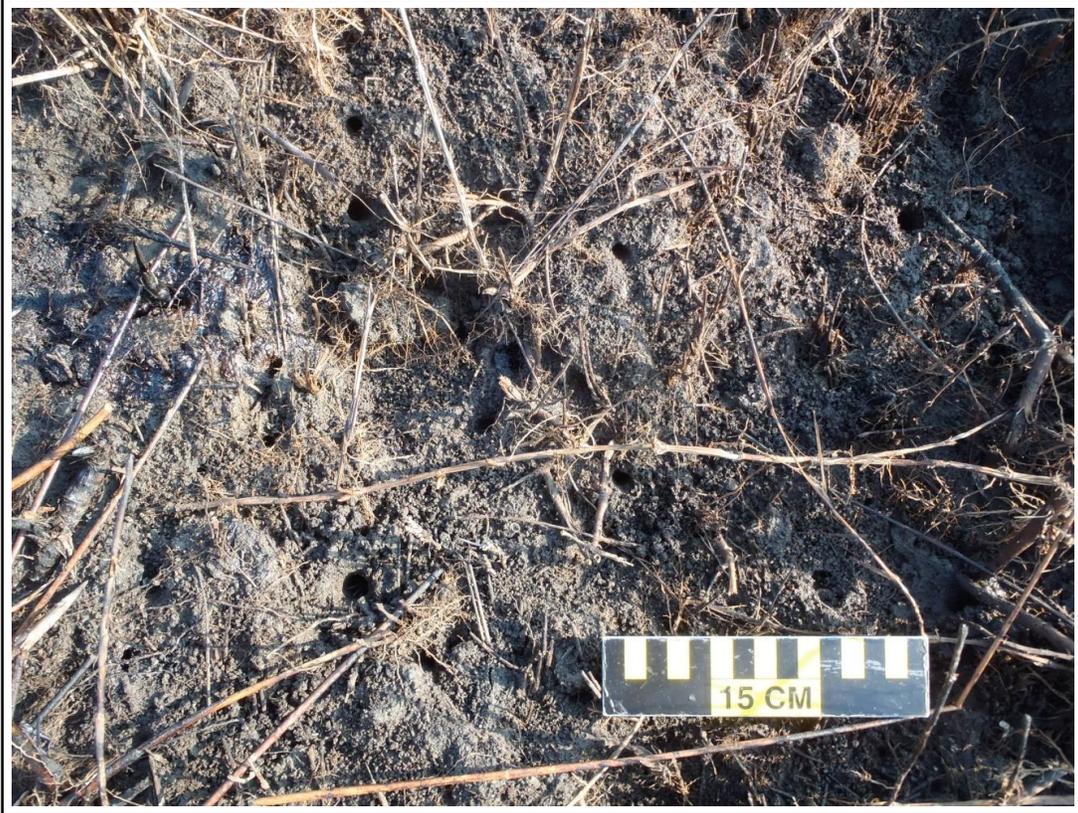
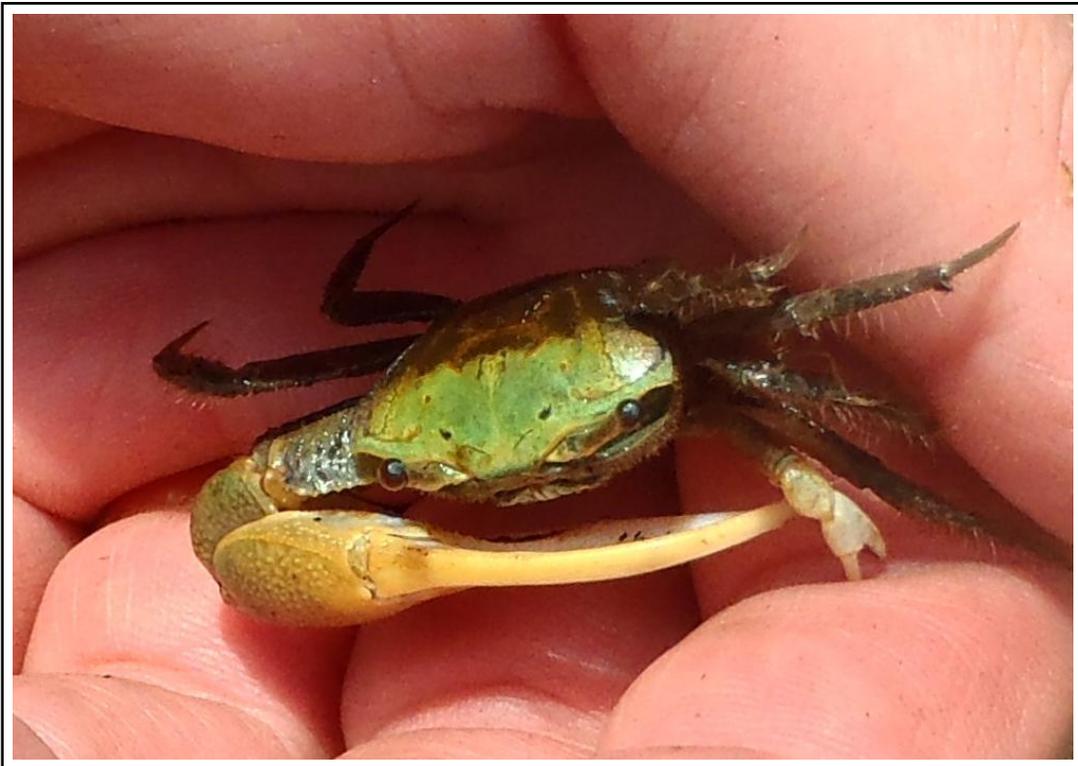
Figure 32. Fiddler crab burrows and a captured individual from the treatment test plots, September 2011.

During the September 2011 monitoring period, fiddler crab burrows (mainly *Uca longisignalis*, Gulf marsh fiddler crab, and *Uca spinicarpa*, spined fiddler crab) (Figure 32) and *Littoraria irrorata* snails were counted in three 0.25 m² quadrats in each plot, one each near the seaward marsh edge, the middle of the plot, and in the former late April 2011 wrack line at or just beyond the upper limit of each plot (near the limit of initial oiling and vegetation impact). The quadrat counts were pooled for purposes of comparison in this report. The vegetation raking and cutting plots and the reference plots, each had similar densities of fiddler crab burrows (Table 5), roughly three times greater than burrow densities in the vegetation raking plots and the natural recovery plots. Marsh periwinkles were nearly absent from all the treatment test plots, but were relatively abundant by comparison in the reference plots. Marsh periwinkles in the test plots were only recorded in low numbers in a few quadrats near the limit of initial oiling and vegetation impact.

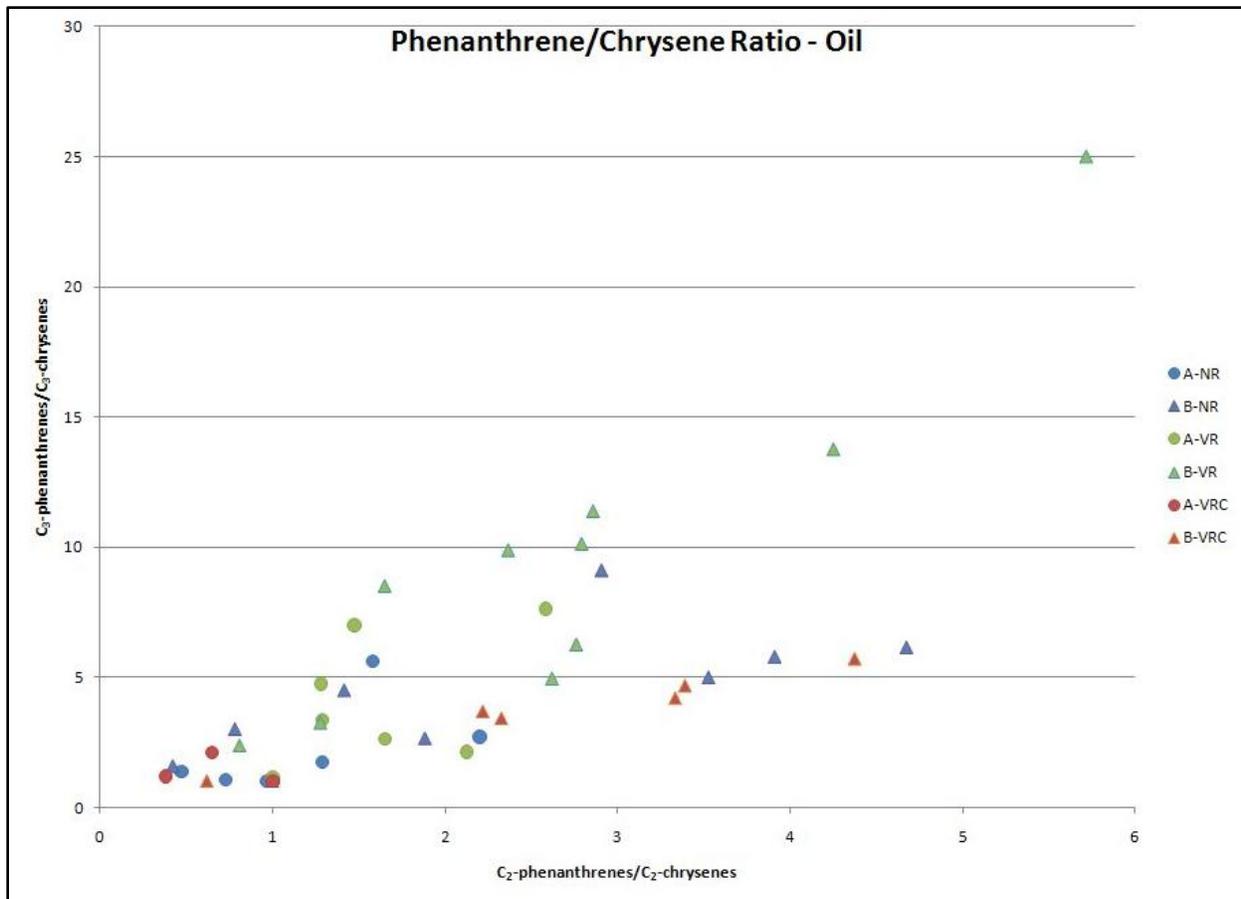
Figure 33. Double-ratio plot of C₂-phenanthrenes/C₂-chrysenes versus C₃-phenanthrenes/C₃-chrysenes for surface oil samples collected in late July/early August 2011, post-treatment. A = Oiling Zone A - exposed surface oil residue on the lower marsh edge, B = Oiling Zone B – thick mousse under vegetation mats/wrack in the middle of the oiled marsh platform (pre-treatment condition). NR = natural recovery (no treatment), VR = vegetation raking, VRC = more intensive vegetation raking and cutting.

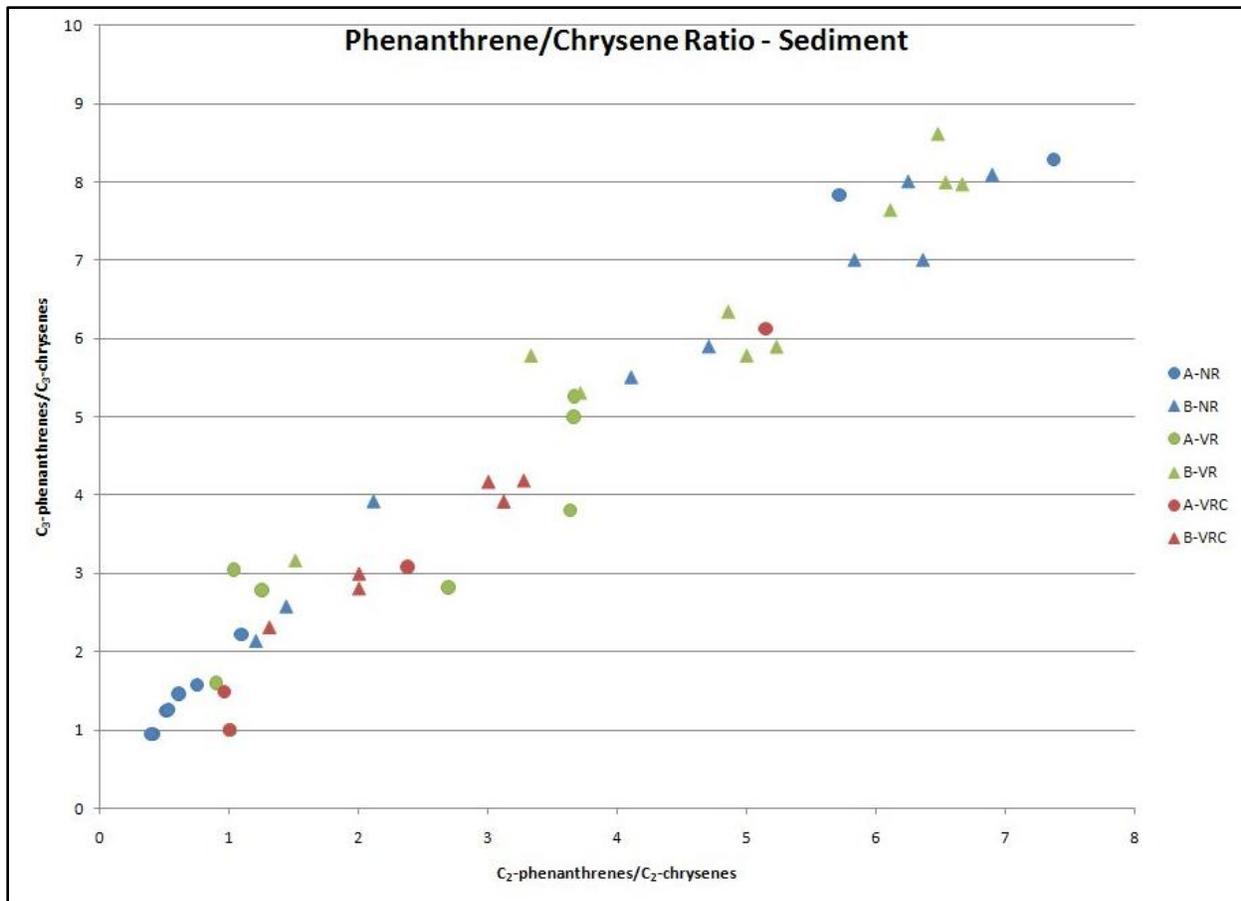
Figure 34. Double-ratio plot of C₂-phenanthrenes/C₂-chrysenes versus C₃-phenanthrenes/C₃-chrysenes in the sediment samples collected in late July/early August 2011, post-treatment. A = Oiling Zone A - exposed surface oil residue on the lower marsh edge, B = Oiling Zone B - thick mousse under vegetation mats/wrack in the middle of the oiled marsh platform (pre-treatment condition). NR = natural recovery (no treatment), VR = vegetation raking, VRC = more intensive vegetation raking and cutting.

Figure 34 shows a similar double ratio plot for the sediment samples. The trend is more linear, but the patterns are the same, as compared to the surface oil samples. That is, the samples from the sediments on the lower marsh edge are more weathered, compared to those from the middle of the oiled marsh platform. However, it seems that the residual oil in the sediments from the vegetation raking and cutting treatment (shown as red triangles) was more weathered (plotted closer to the lower left), than the natural recovery or vegetation raking plots. This is the first chemical evidence showing that raking and cutting improved the rate of weathering in the marsh soils.

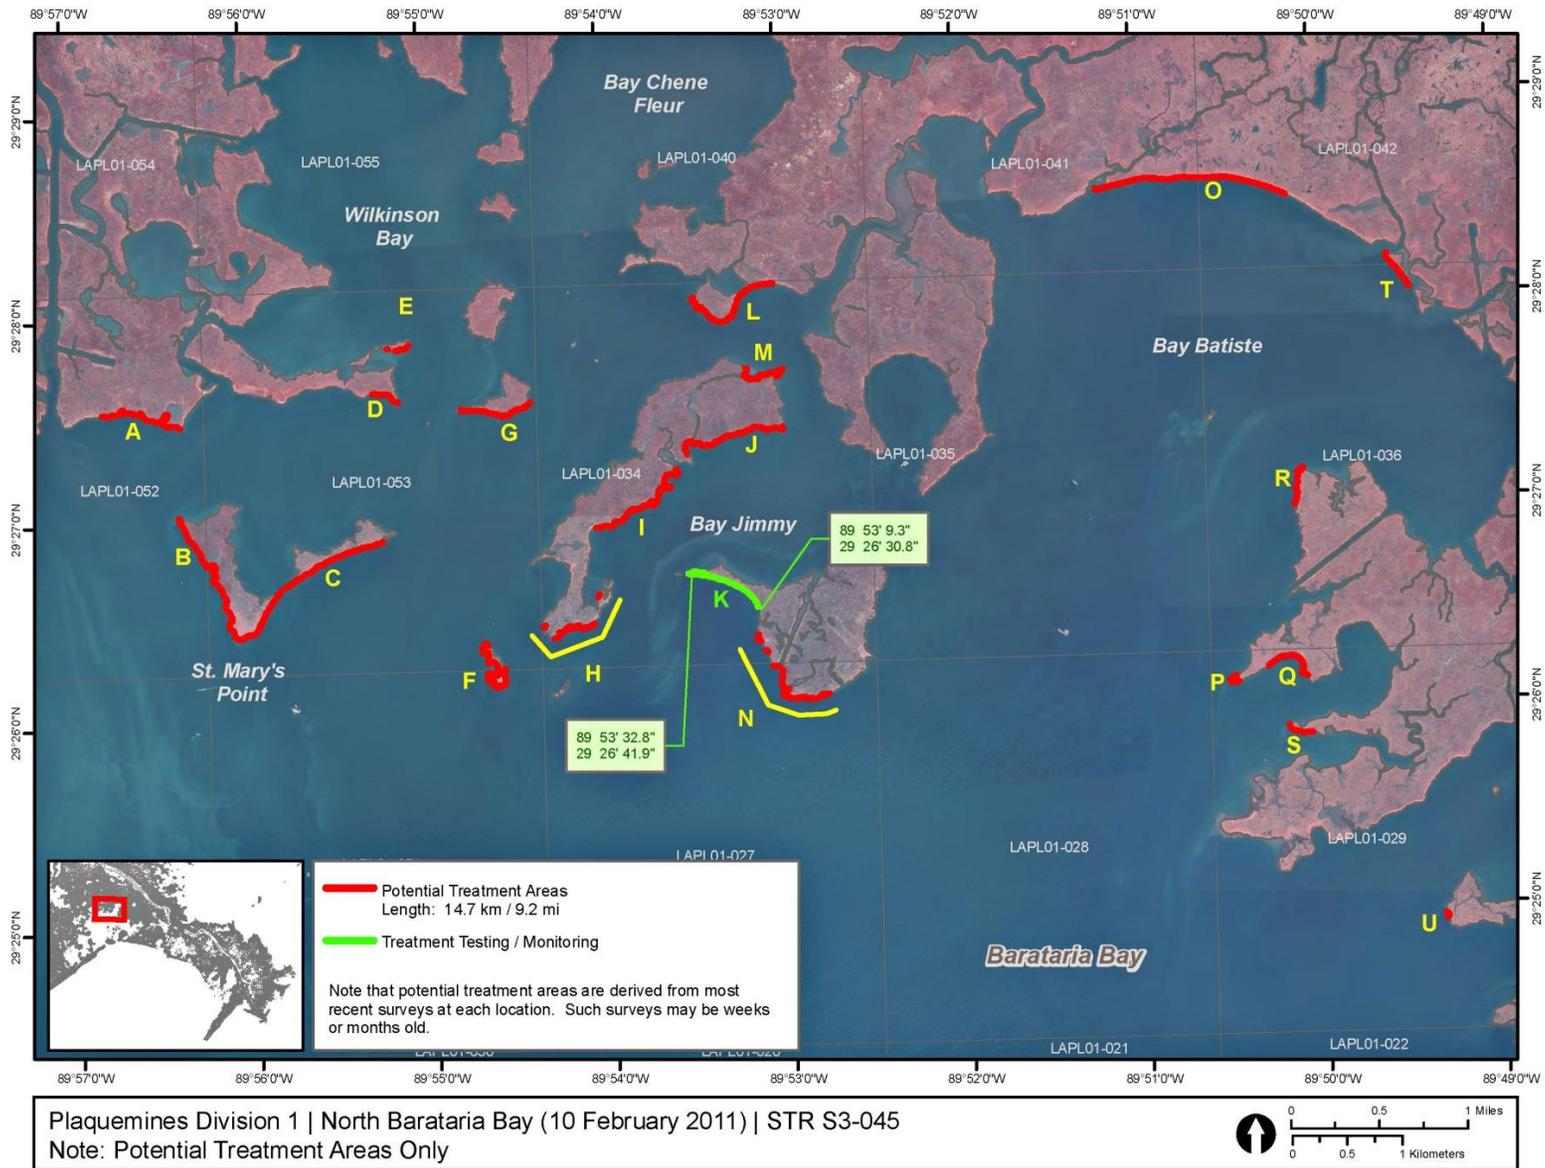
Figure 35. STR S3-045 potential treatment and test areas (zones).

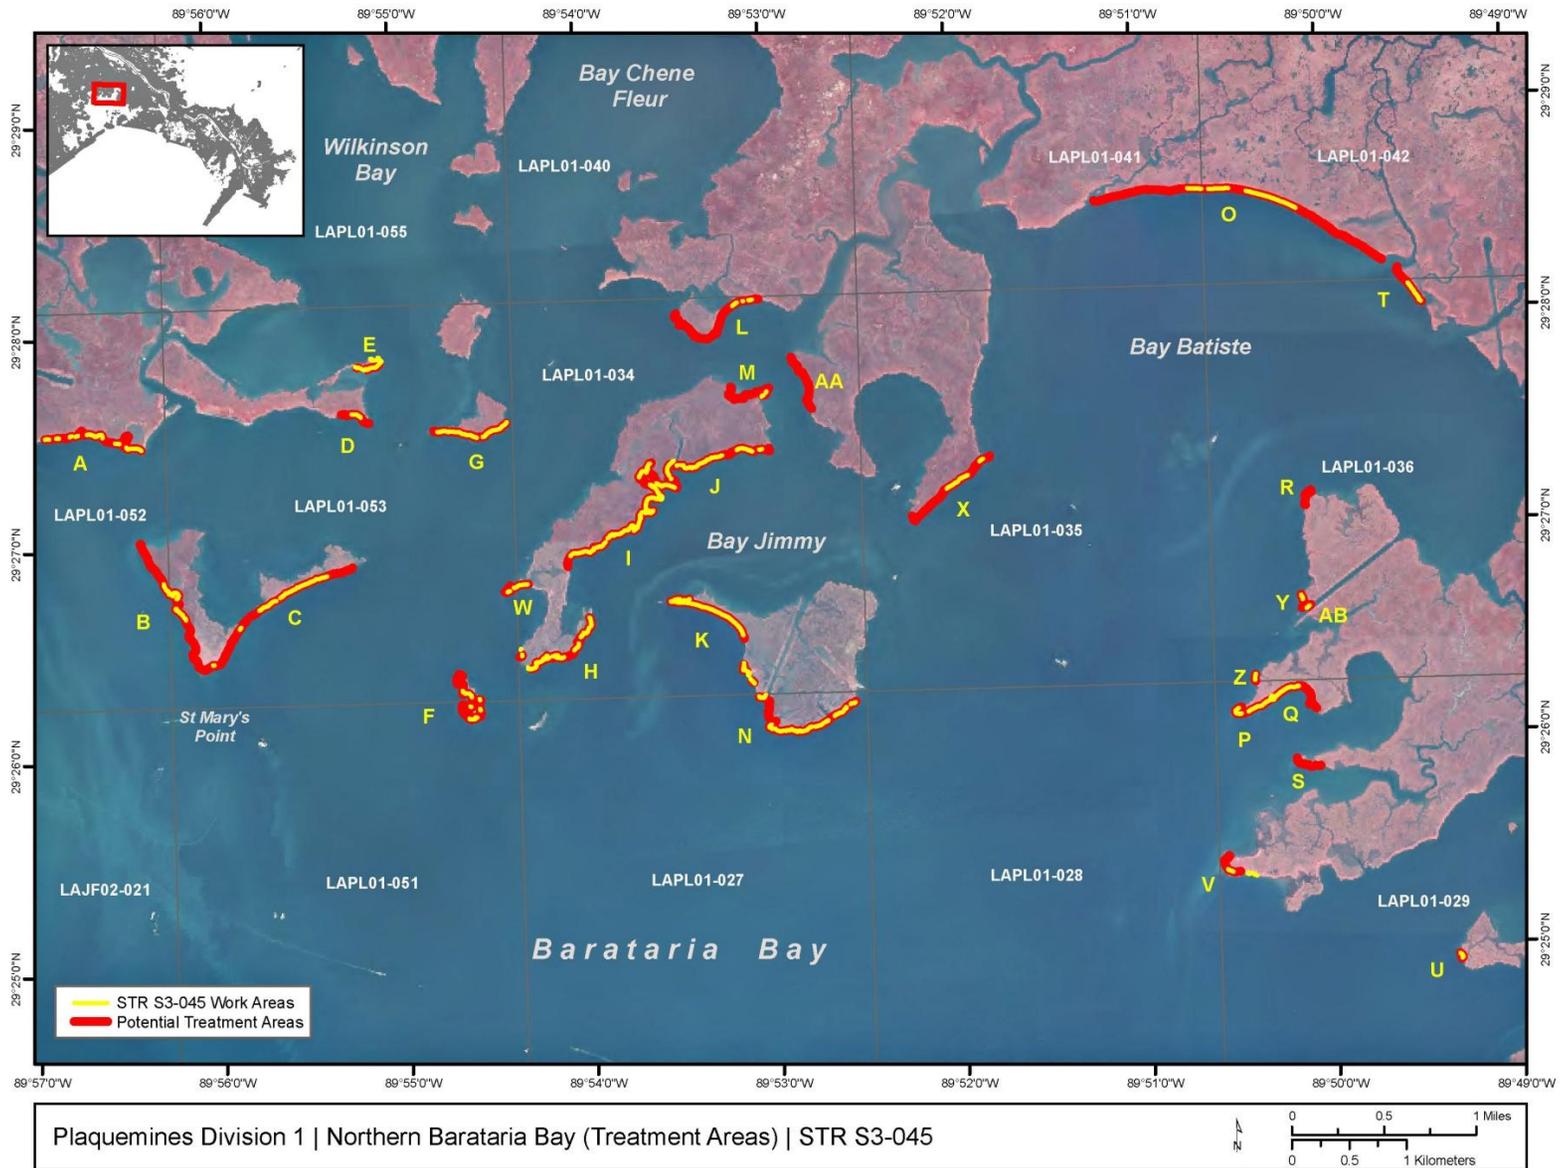
Figure 36. STR S3-045 treatment areas (yellow) and final potential treatment zones (red).

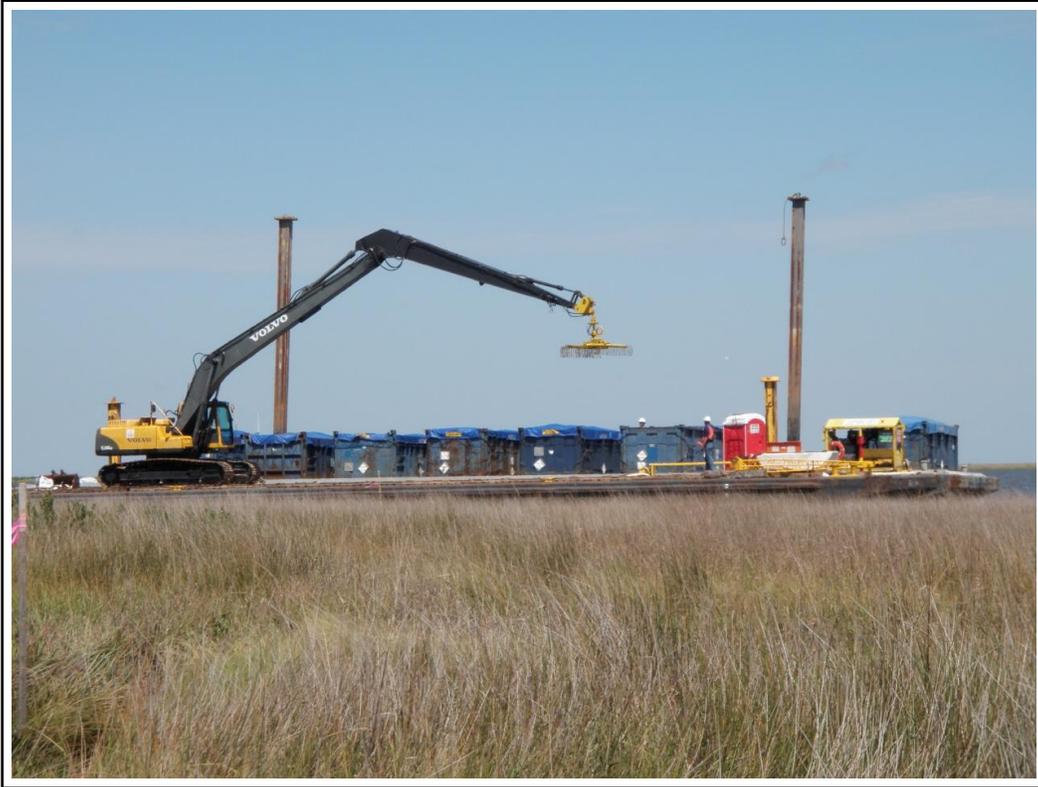
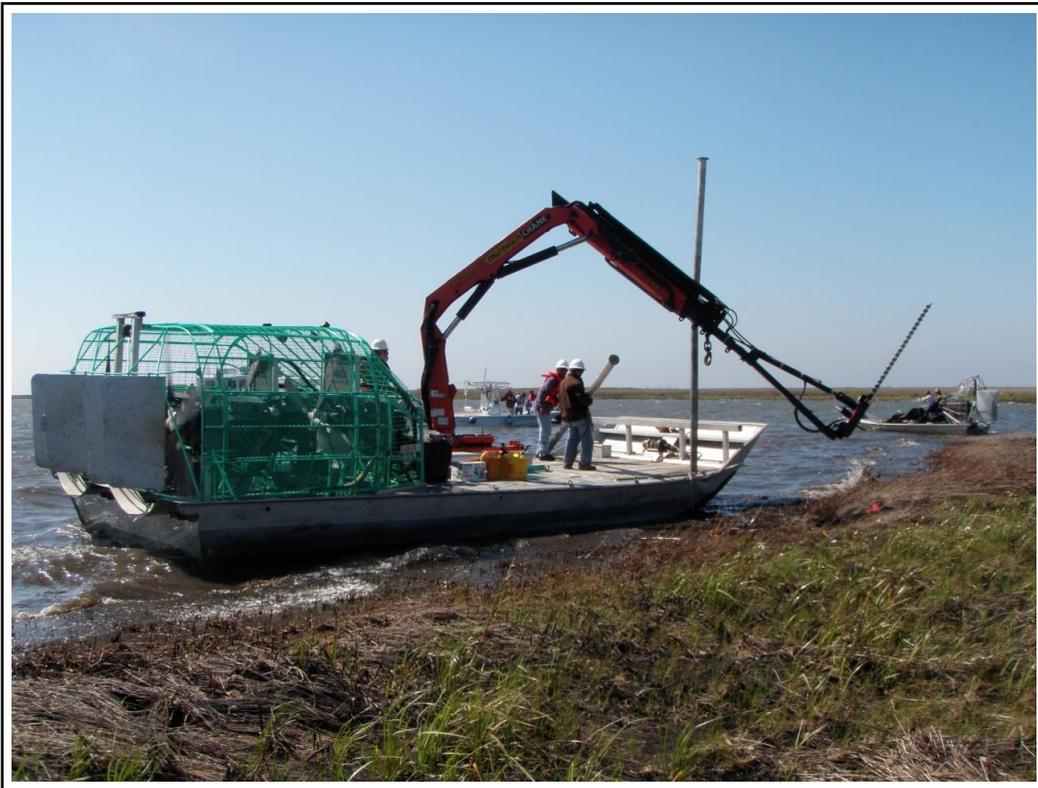
Figure 37. Mechanical treatment platforms. Top: barge, long-reach track hoe with hydraulic grapple, and roll-off containers. Bottom: large airboat with vegetation cutting tool.

Manual treatments were used in all treatment areas and consisted of workers on walk boards applying the STR using hand tools and power hedge trimmers. Mechanical treatments were conducted from April to June 2011. Mechanical treatments included barge-based and large airboat-based platforms positioned in waters adjacent to marsh treatment areas (Figure 36). In each case, mechanical operations used long-reach hydraulic arms coupled with attachments including grapples, rakes, cutting devices, and “squeegees” to conduct marsh treatments (Figure 37). The “squeegee” devices were used to skim thick mousse from the surface of the marsh following the removal of heavily oiled wrack and vegetation mats. Mechanical work was always followed by manual treatment to complete the STR, typically in close succession.

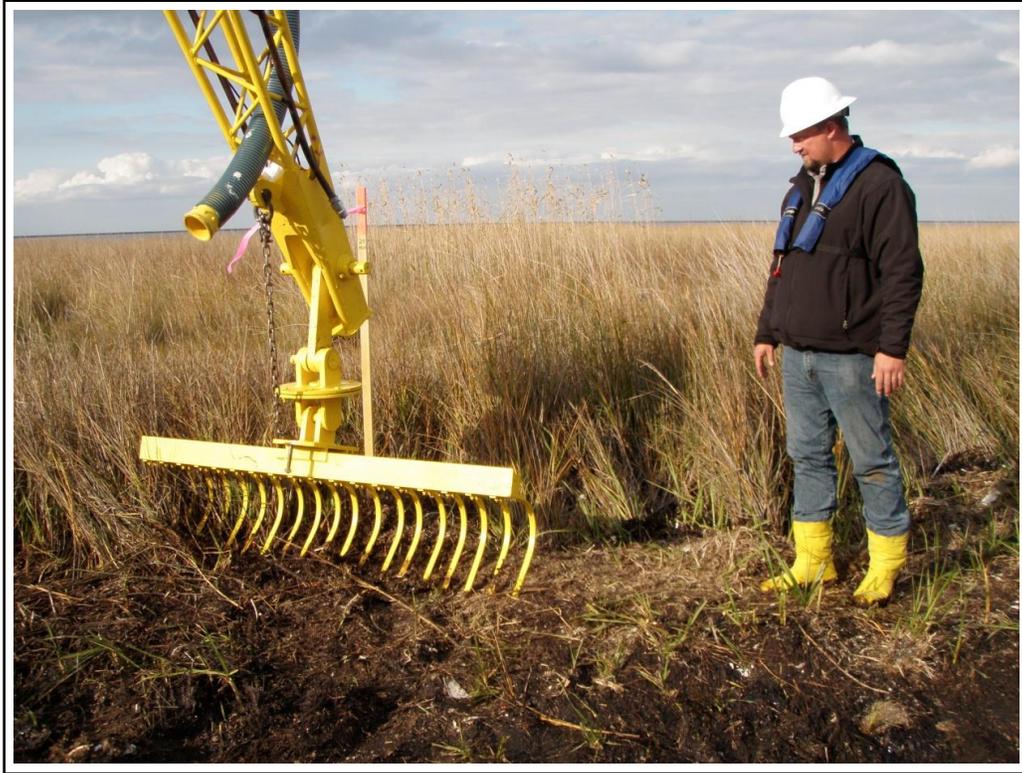
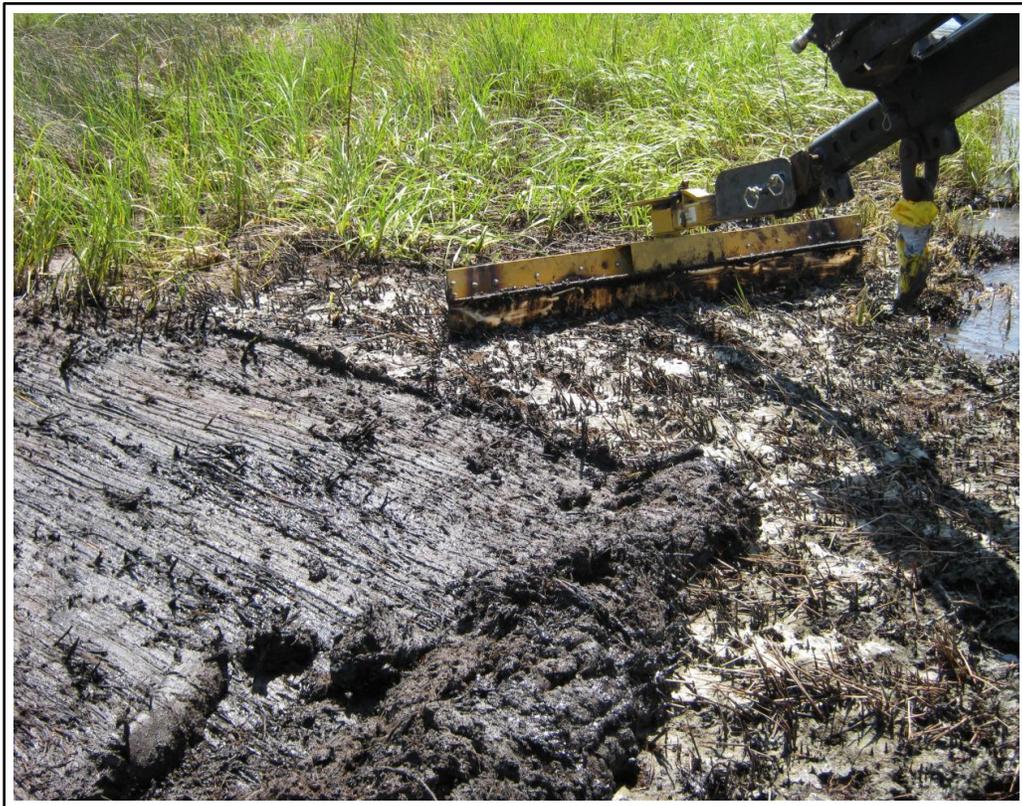
Figure 38. Mechanical tools (examples). Top: raking attachment (barge crew). Bottom: mousse squeegee device (airboat crew).

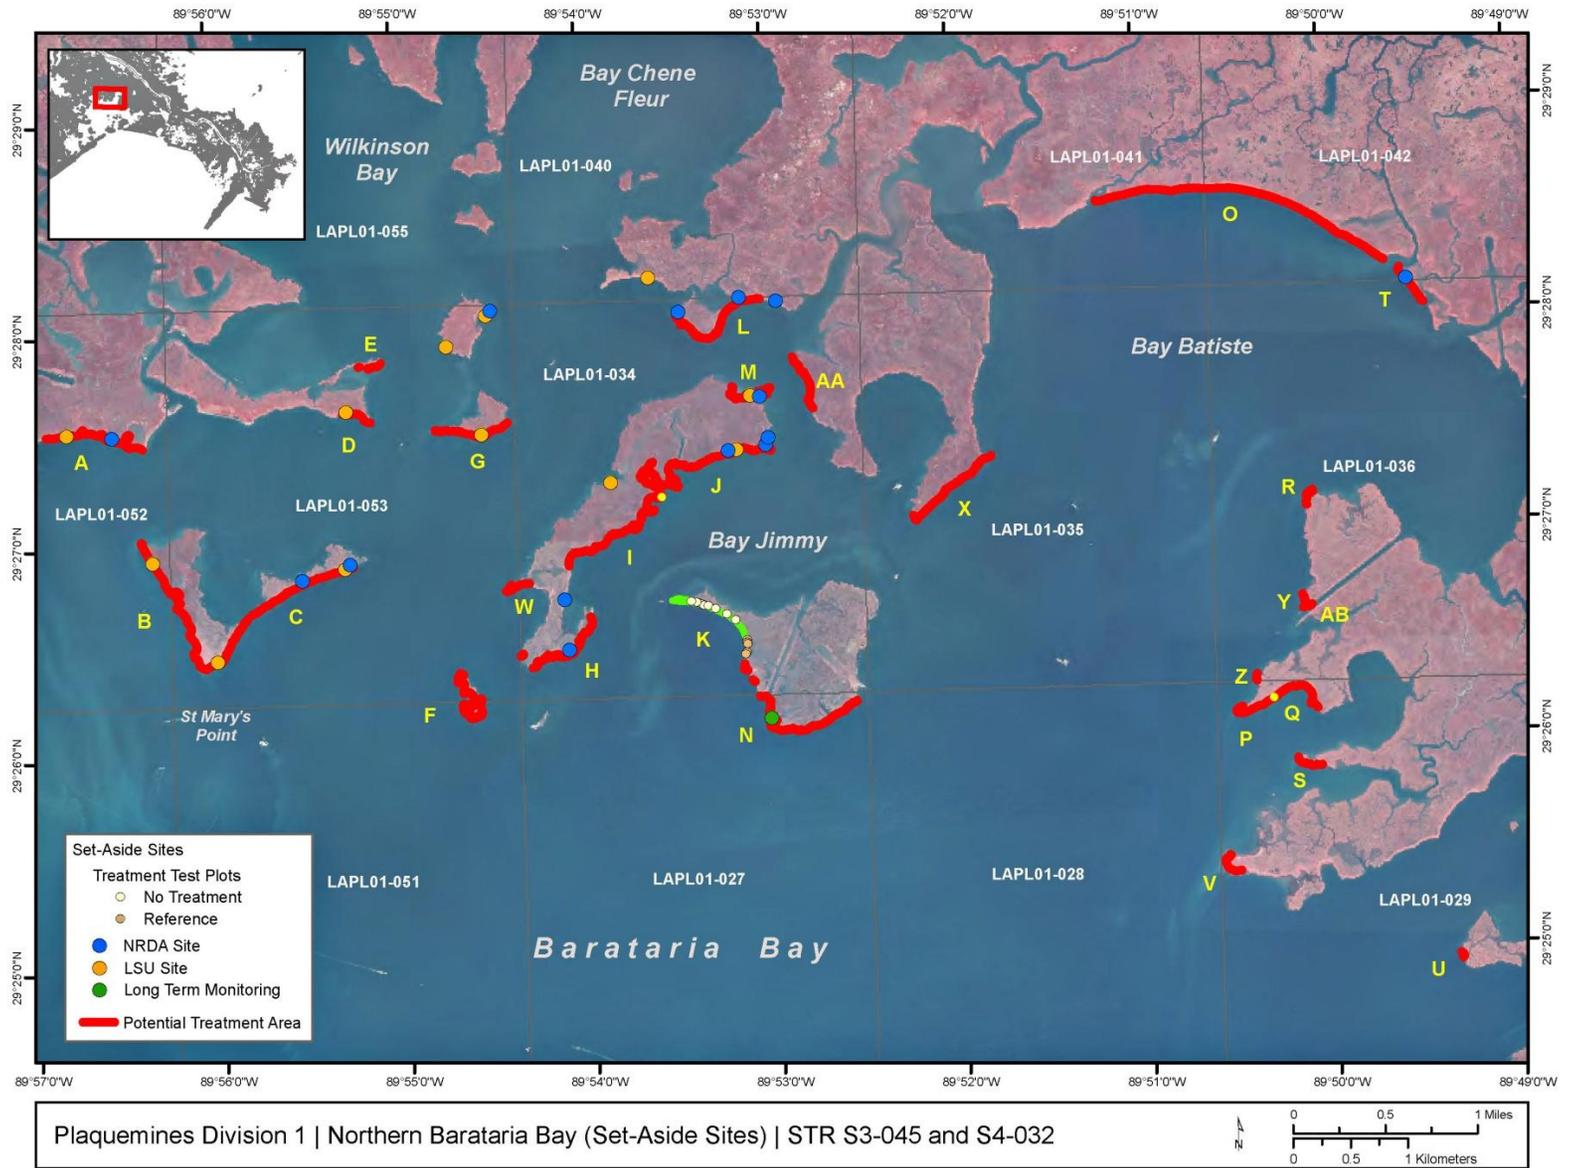
Figure 39. Map of set-aside (no treatment) locations.

The NRDA program had 14 set-aside stations within the STR S3-045 and S4-032 areas that are associated with on-going NRDA studies. Each of the NRDA set-aside stations consisted of 100 m (330 ft) of linear shoreline that were excluded from STR treatments. In addition, the NRDA program has 14 other study sites specifically set-up in treated STR areas (to look at potential treatment effects). The NRDA program also has a number of other study sites established throughout various marsh locations in Louisiana, including other sites in Northern Barataria Bay located outside of STR shoreline segments. NOAA expressed interest in using the set-aside and associated sites for continued monitoring and research at the conclusion of NRDA studies.

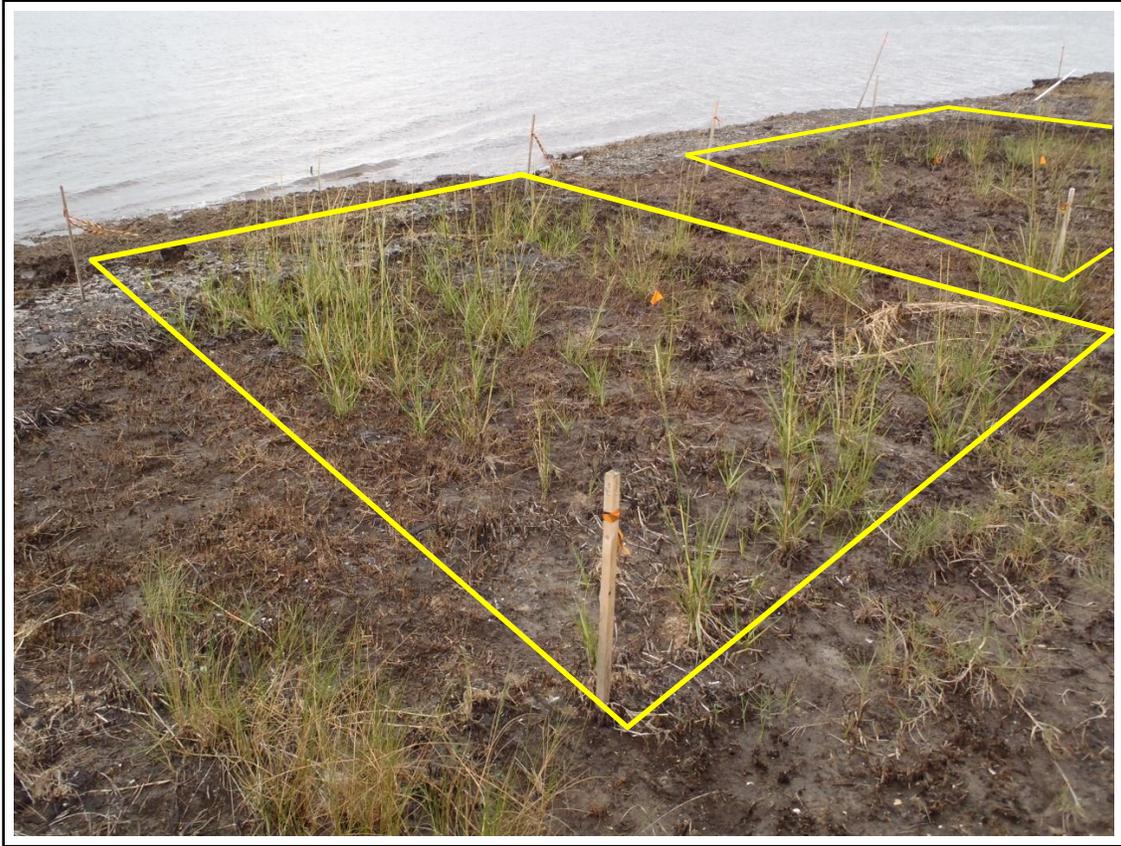
Figure 40. Tulane/NSU marsh planting study plots with planted *Spartina alterniflora* in area treated under STR S3-045, Zone K, November 2011.
