State of Maine's Beaches in 2013

Maine Geological Survey
DEPARTMENT OF AGRICULTURE, CONSERVATION AND FORESTRY
Robert G. Marvinney, *State Geologist*

Open-File No. 13-18

2013

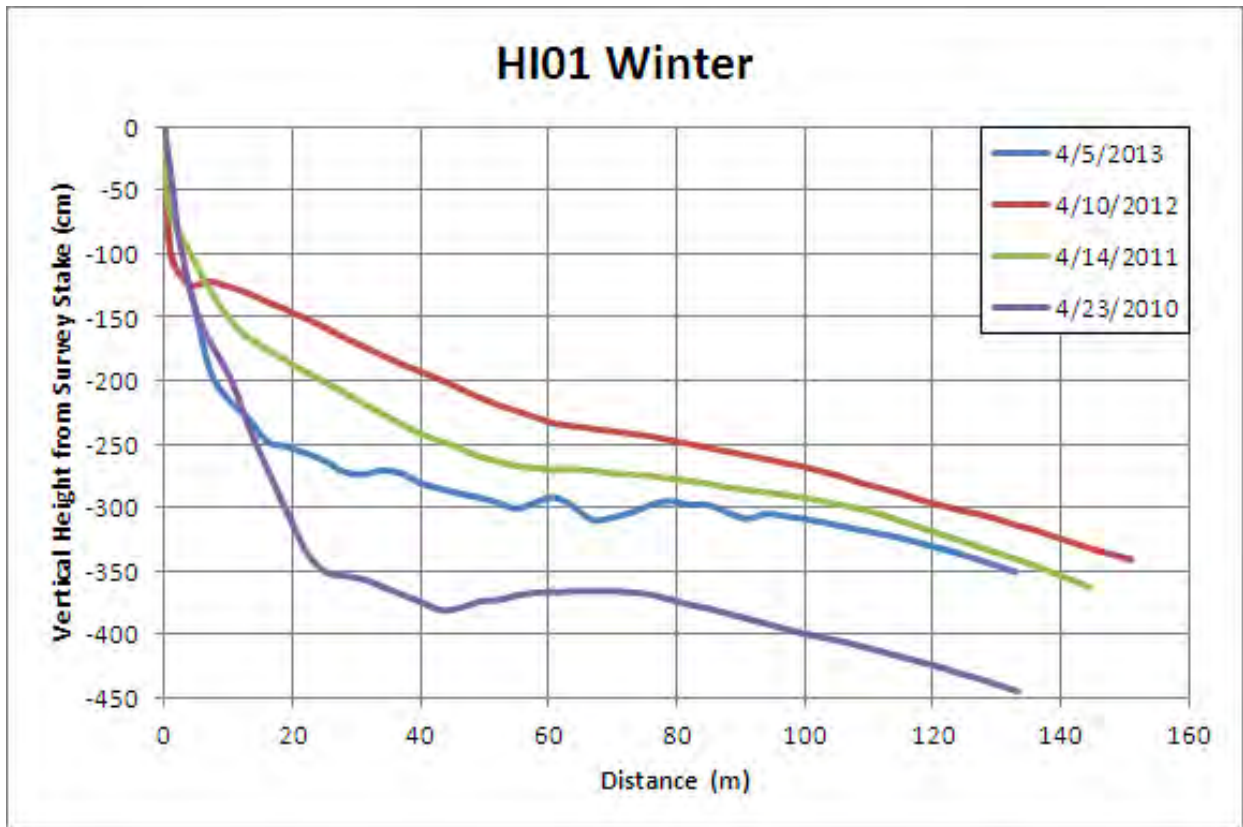
Figure 8. Winter beach profiles for HI01 from 2010, 2011, 2012, and 2013.

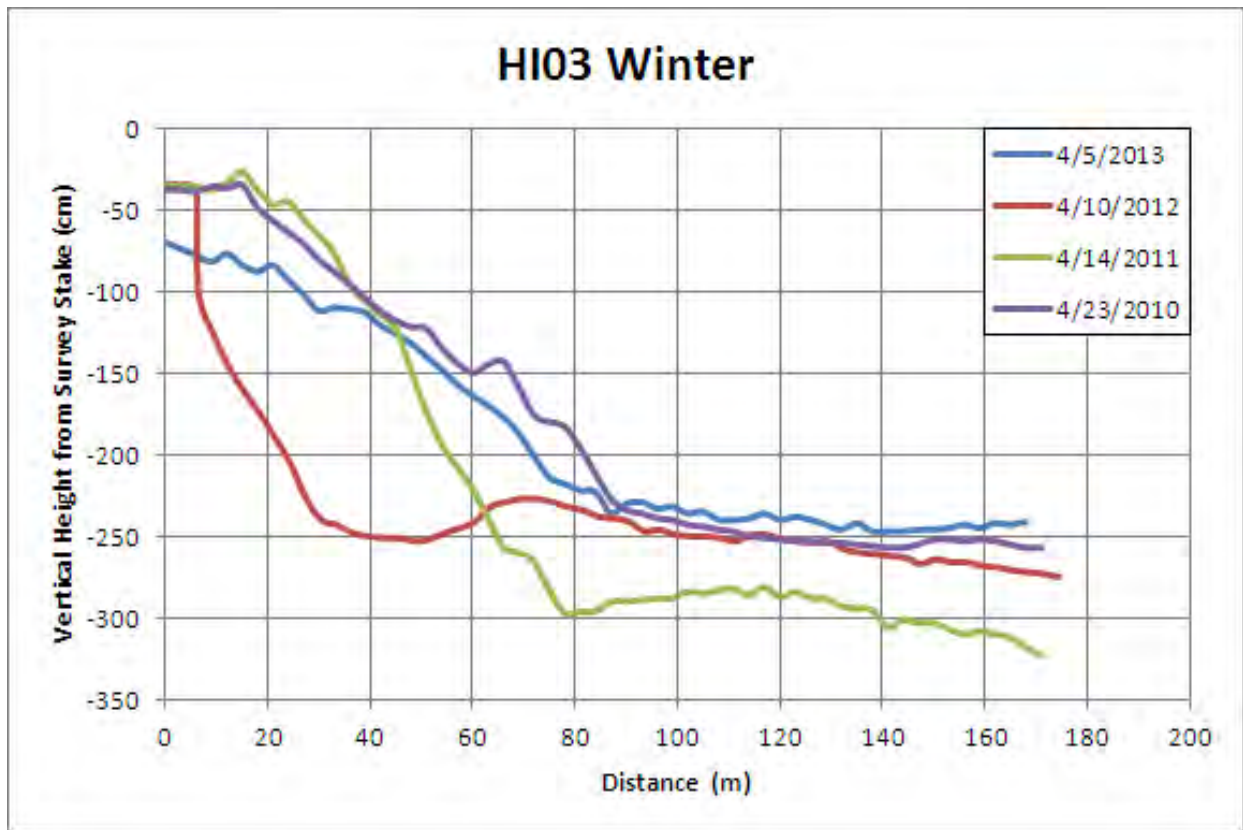
Figure 12. Winter beach profiles for HI03 from 2010, 2011, 2012, and 2013.

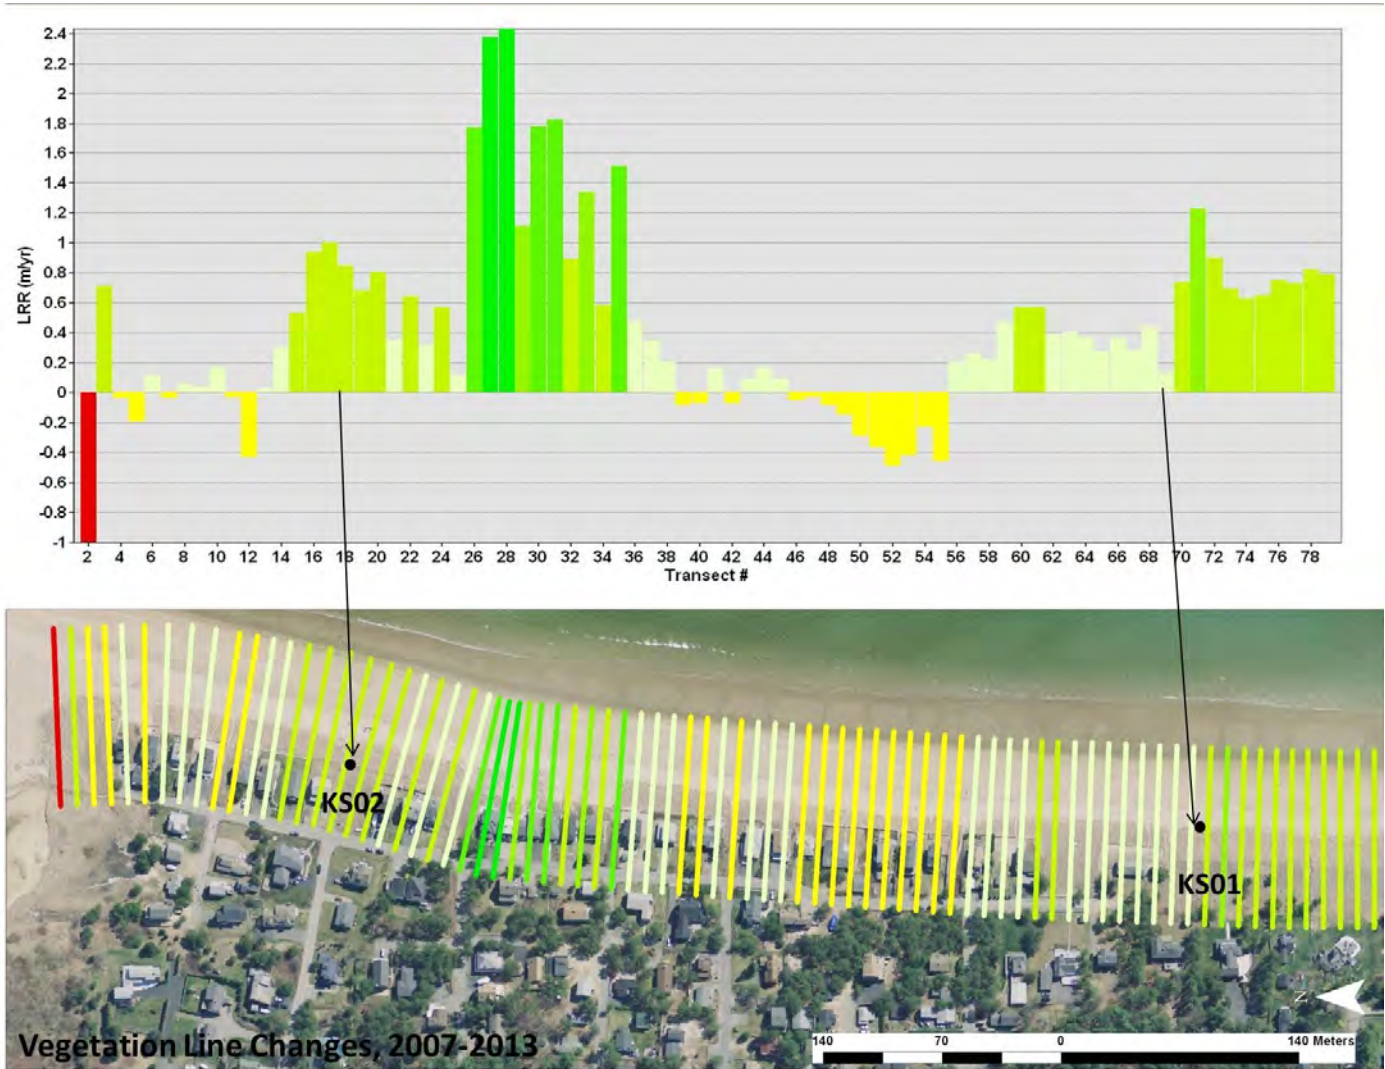
In the northern end of the bay, in the vicinity of the Kinney Shores Profiles, Figure 51 shows MBMAP results. The MBMAP data supports the trends observed at the profiles; that KS01 is undergoing a more erosive phase than KS02.

KS01 is located right where the trend of accretion decreases to about +0.2 to +0.4 m/yr. (in the previous assessment, KS01 was along a stretch of shoreline that had a trend of about +0.6 to +0.8 m/yr.). KS02, on the other hand, has remained at a location where the sand dune has been building, on average, about +0.8 to +1.0 m/yr.

Figure 51. MBMAP shoreline change results for the Kinney Shores area of Saco beaches. Base imagery from Maine OGIS.

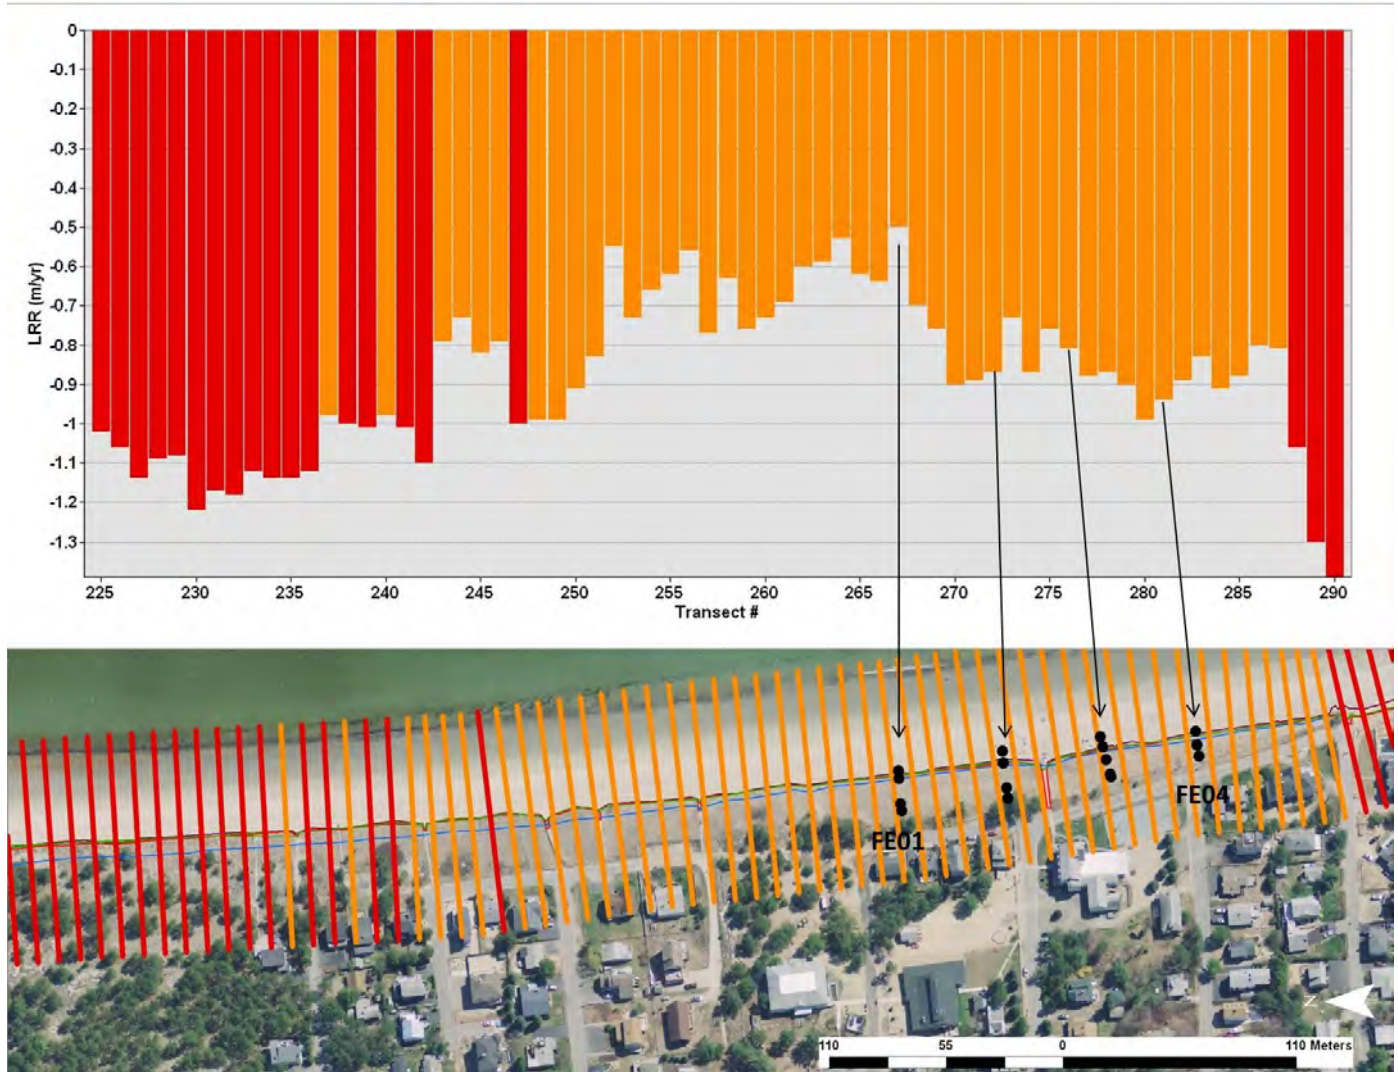
increased, as changes are over -1 m/yr., when in 2011, the shoreline changes in this area were much lower, between -0.2 m/yr. and -0.4 m/yr.

Figure 52. MBMAP shoreline change results for the Ferry Beach area of Saco beaches. Base imagery from Maine OGIS.

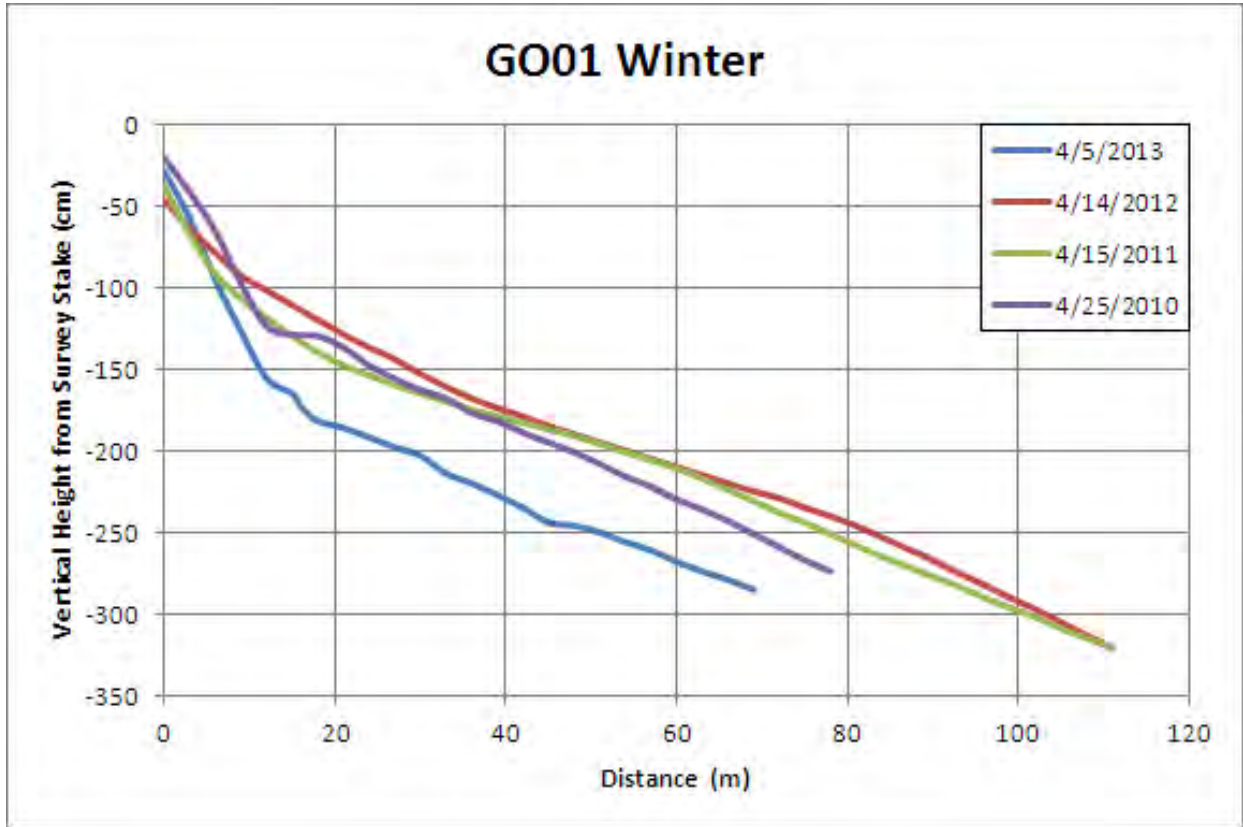
Winter GO01 = F (55). 2011 grade: D. Trend: Worse. The profile is located at the southwestern end of the beach. It received an A and D previously, with erosion in 2011 to below 2007 levels (Figure 64). By 2011, it retreated landward to 15 m, where it remained similar to 2010. In 2012, the sand adjacent to the wall lowered, but the profile built in elevation out to about the 40 m mark. In 2013, it eroded, steepened, and lost around 60 cm in elevation compared with 2012. The winter of 2013 caused extensive erosion of the profile.

Figure 64. Winter beach profiles for GO01 from 2010, 2011, 2012, and 2013.

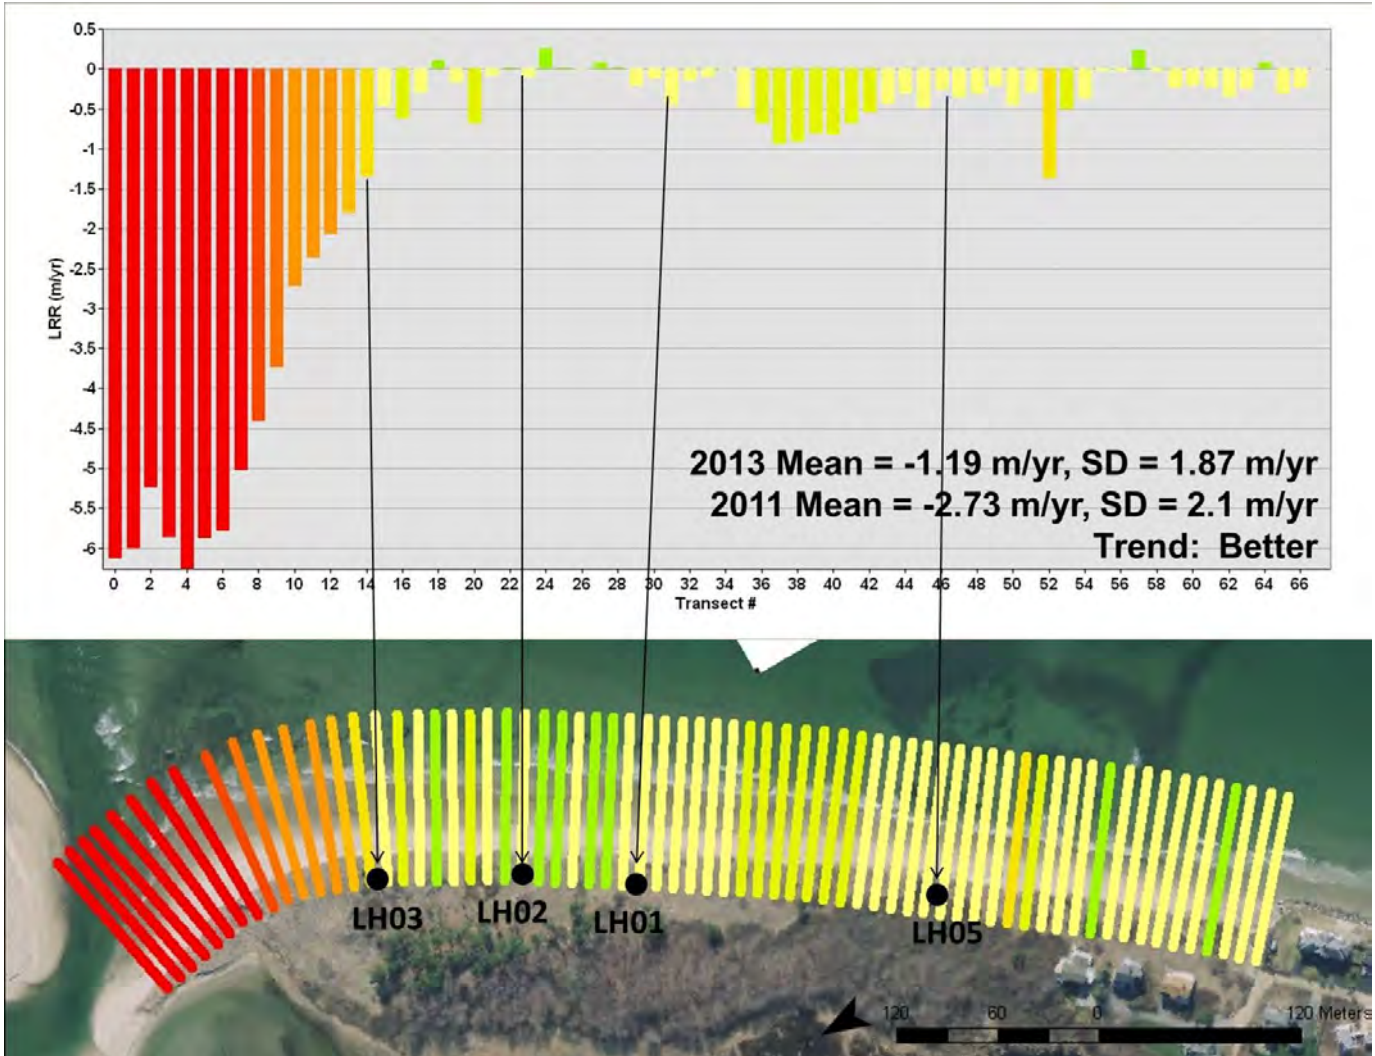
influenced the overall recession rates for the Laudholm Beach section of shoreline. The majority of the profile locations according to MBMAP data were slightly erosive, averaging around -0.5 m/yr. or less (aside from LH03). This trend appears to be reflected by the summer profile shapes at Laudholm Beach, which showed maintenance of the dune positions and not high erosion.

Figure 81. MBMAP shoreline change results for Laudholm Beach, Wells. Base imagery from Maine OGIS.
