State of Maine's Beaches in 2015

Marine Geologist, Maine Geological Survey

Open-File 15-25

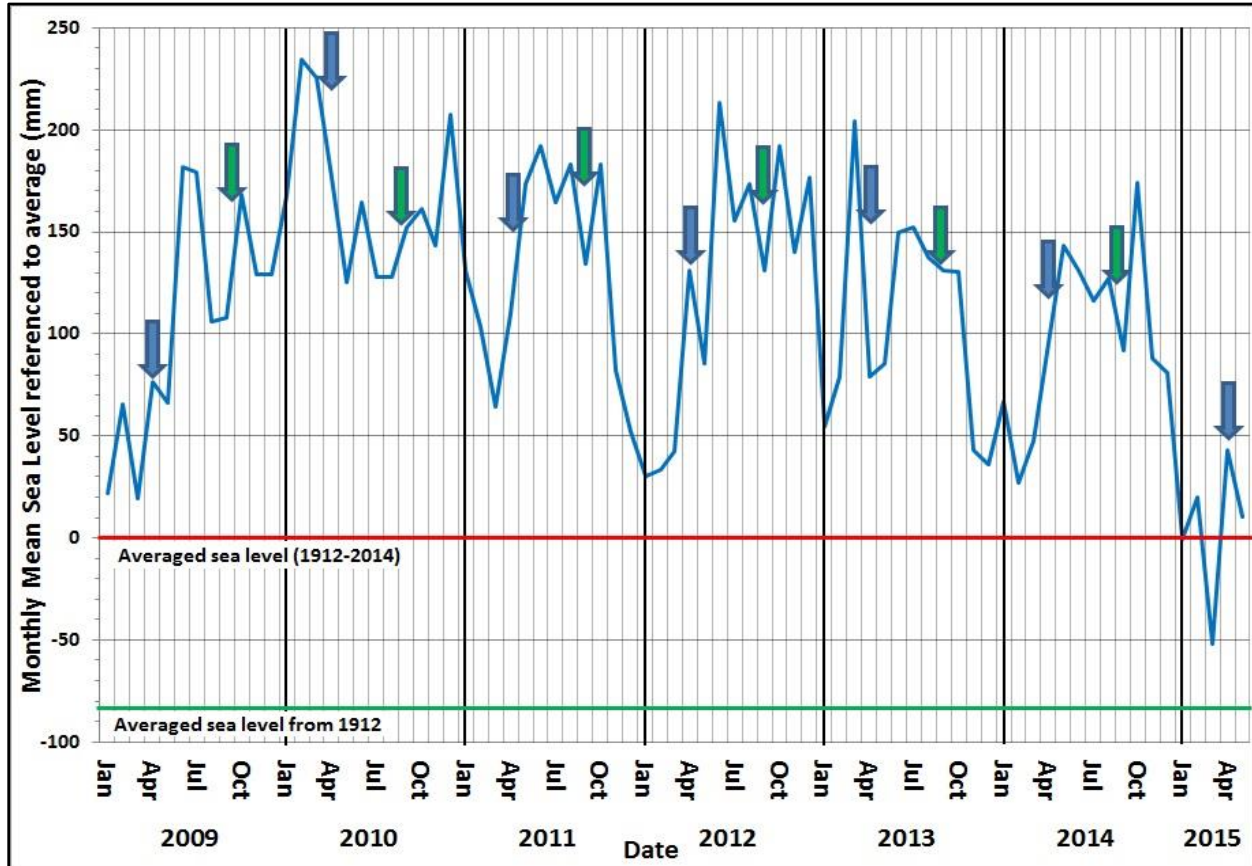
Figure 3. Monthly mean sea levels from January 2009 to May 2015, compared with a shorter-term trend from 1993-2014. Data has been adjusted so that “0” refers to the averaged long-term sea level from the 1912-2014 time period. Approximate times of beach profile data collection for winter (blue arrows) and summer (green arrows) is shown. Data courtesy of NOAA CO-OPS. Figure by P.A. Slovinsky, MGS.

Figure 3 shows monthly mean sea levels at the Portland tide gauge from January 2009 to May 2015. Note how sea levels increased significantly in the summer of 2009, and then spiked in the early winter months of 2010. In fact, the highest sea levels ever recorded for January to April and December occurred in 2010. Since the peak in the winter of 2010, the overall trend has been a slight decrease, but the time period from 2009-2012 accounts for 9 of the highest annualized sea levels recorded since 1912.

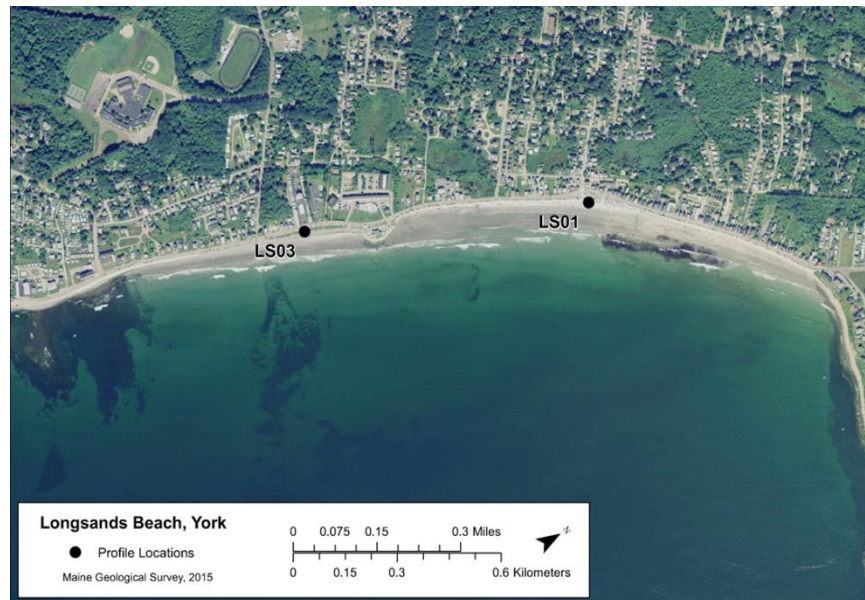
Figure 8. Volunteer profile locations along Long Sands Beach, York. 2013 base imagery from Maine OGIS.

Profile LS01 is located in the northern half of the beach, while LS03 is located at a natural cobble dune and beach area south of the bath house (Figure 8). Figures 9 to 12 show winter and summer shapes for these profiles.

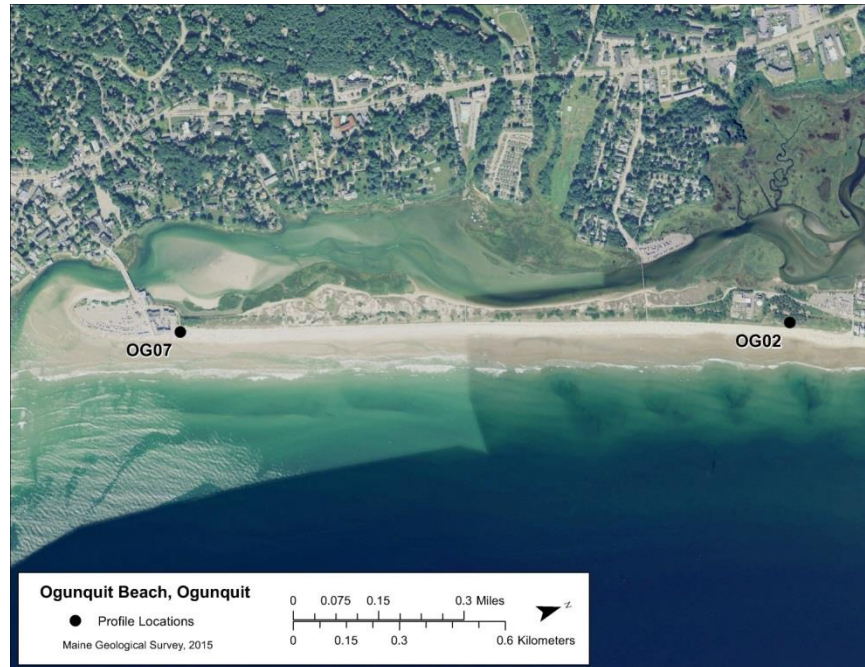
Figure 14. Volunteer profile locations along Ogunquit Beach, Ogunquit. 2013 base imagery from Maine OGIS.

Profiles OG02 and OG07 were available for analysis (Figure 14); OG07 only has winter data from 2012 and 2015 and no summer data. OG02 is located near the treatment plant at the northern end of the beach, and OG07 is located at the seawall at the Norseman hotel. Figures 15 to 17 show seasonal changes at the profiles.

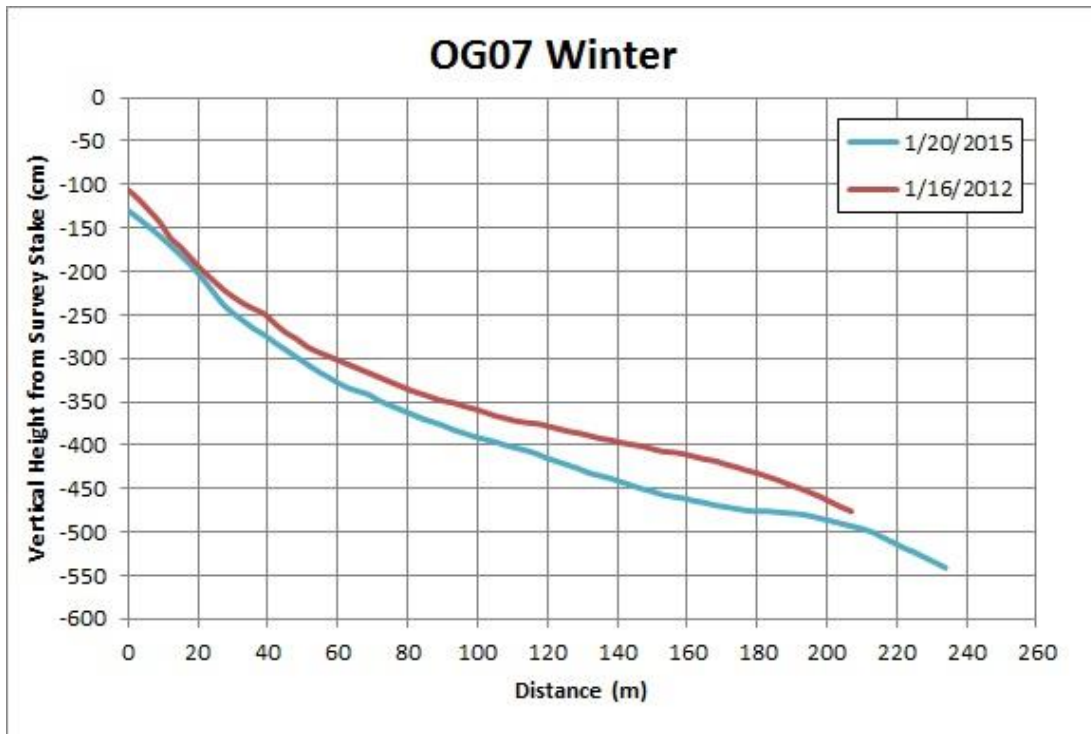
Figure 17. Winter beach profiles for OG07 from 2012 and 2015.

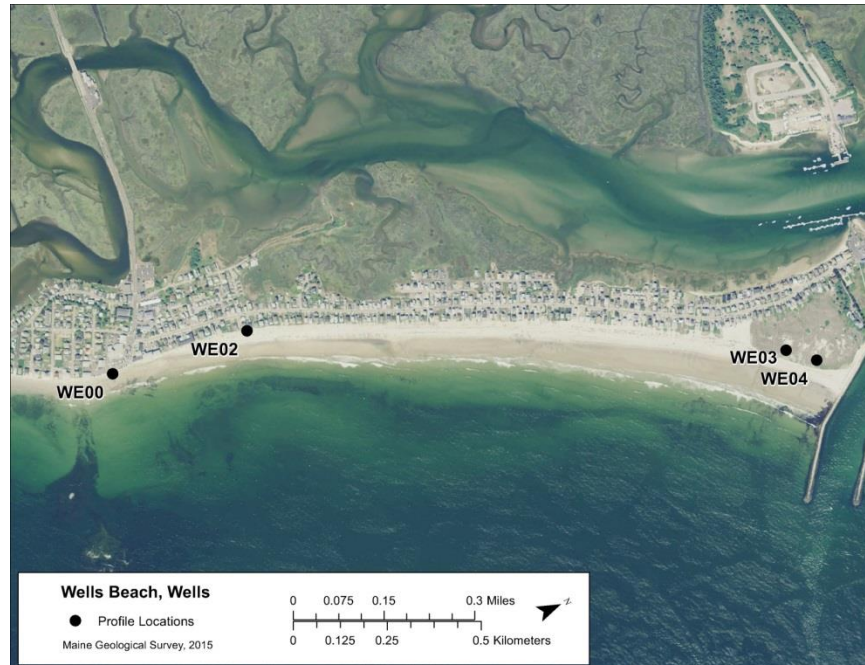
Figure 19. Volunteer beach profile locations for Wells Beach, Wells. 2013 base imagery from Maine OGIS.

Four profiles (WE00, WE02-WE04, Figure 18) were available for analysis. WE00 is just south of Casino Point; WE02 is just north of Casino Point; WE03 is just south of the Webhannet River; and WE04 is directly adjacent to the Webhannet River. Figures 20 to 27 document seasonal changes.

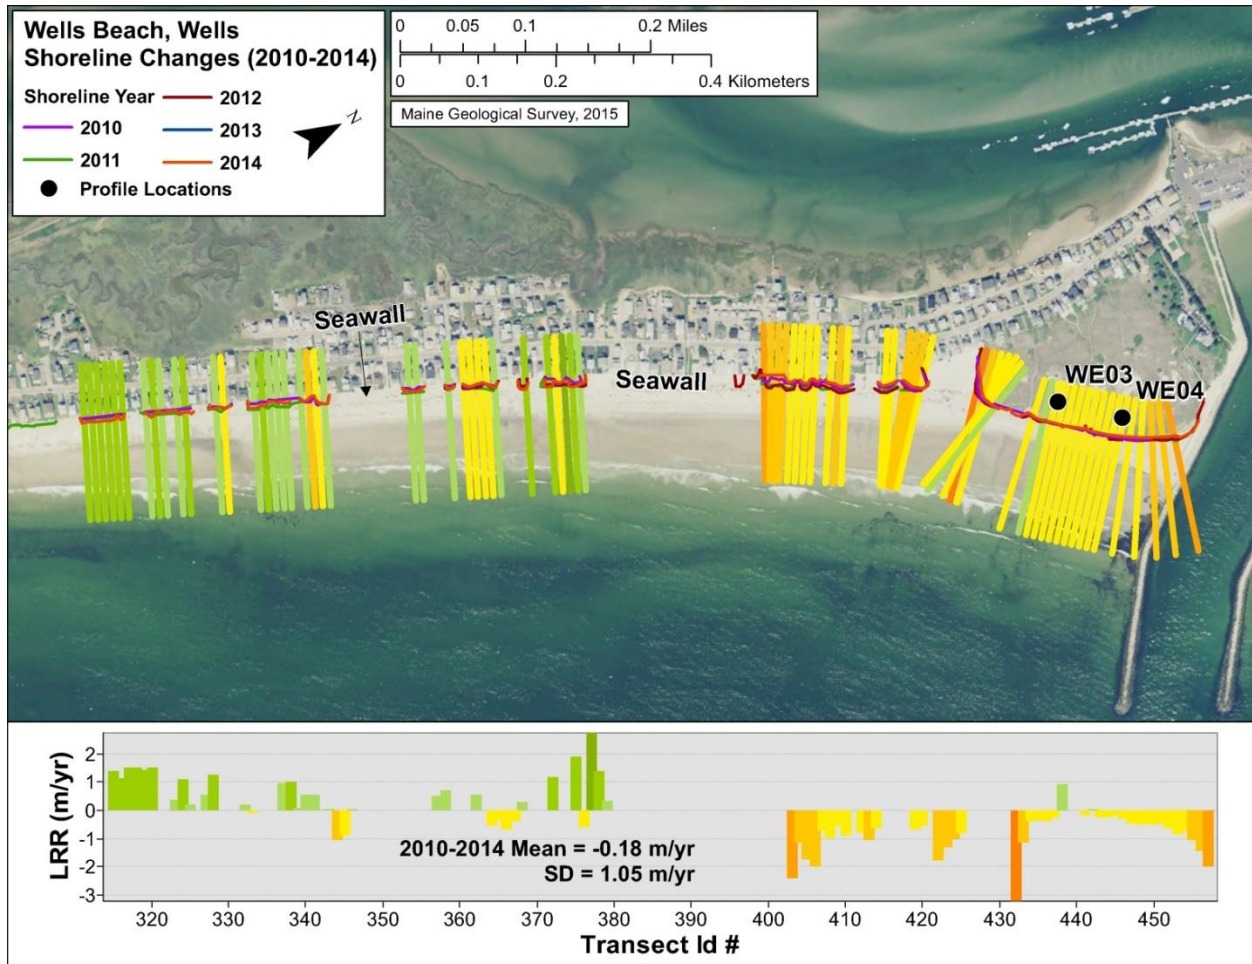
MBMAP data (2010-2012, and 2014) showed two distinct patterns in terms of vegetation line changes along the beach (Figure 28). From transects 310-380, the dune was either stable or growing seaward (an average of +0.6 m/yr), while from transects 405-460, the dune clearly eroded (at an average of -0.8 m/yr). This erosive trend for the northeastern stretch of beach was generally reflected by the summer profile shape at WE04, while WE03 remained relatively stable. The mean shoreline change rate for the entire stretch was **-0.18 m/yr, indicating a relatively stable (yet slightly erosive) trend.**

Figure 28. MBMAP shoreline change results along Wells Beach, Wells. 2013 base imagery from Maine OGIS.

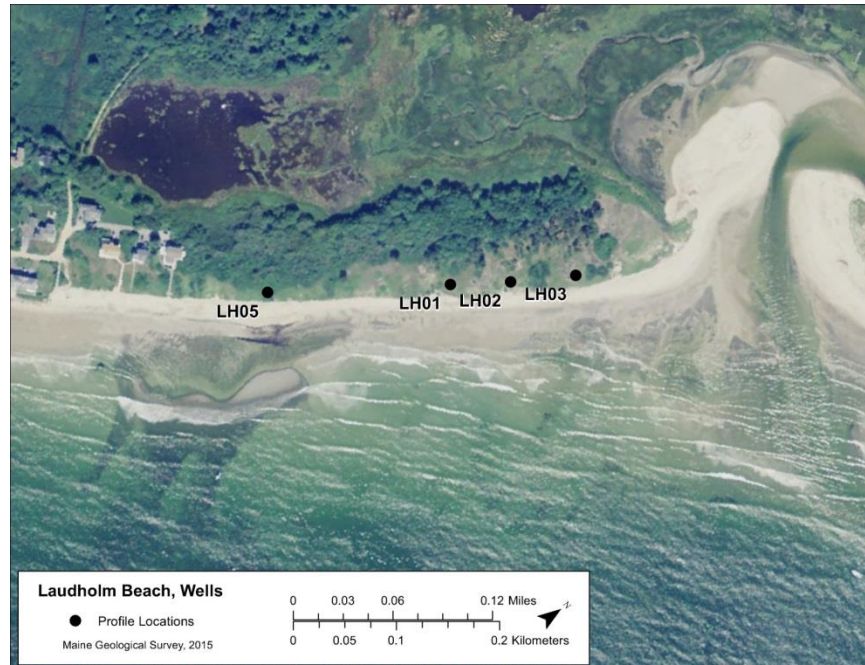
Figure 30. Volunteer beach profile locations along Laudholm Beach, Wells. Base imagery from Maine OGIS.

Four profiles (LH01-03, and LH05) were available for analysis (Figure 30). LH05 is located at the southern end of the beach, nearest to Drakes Island Beach, while LH01 to LH03 extend north along the beach towards the Little River inlet. Figures 31 to 38 show seasonal changes.

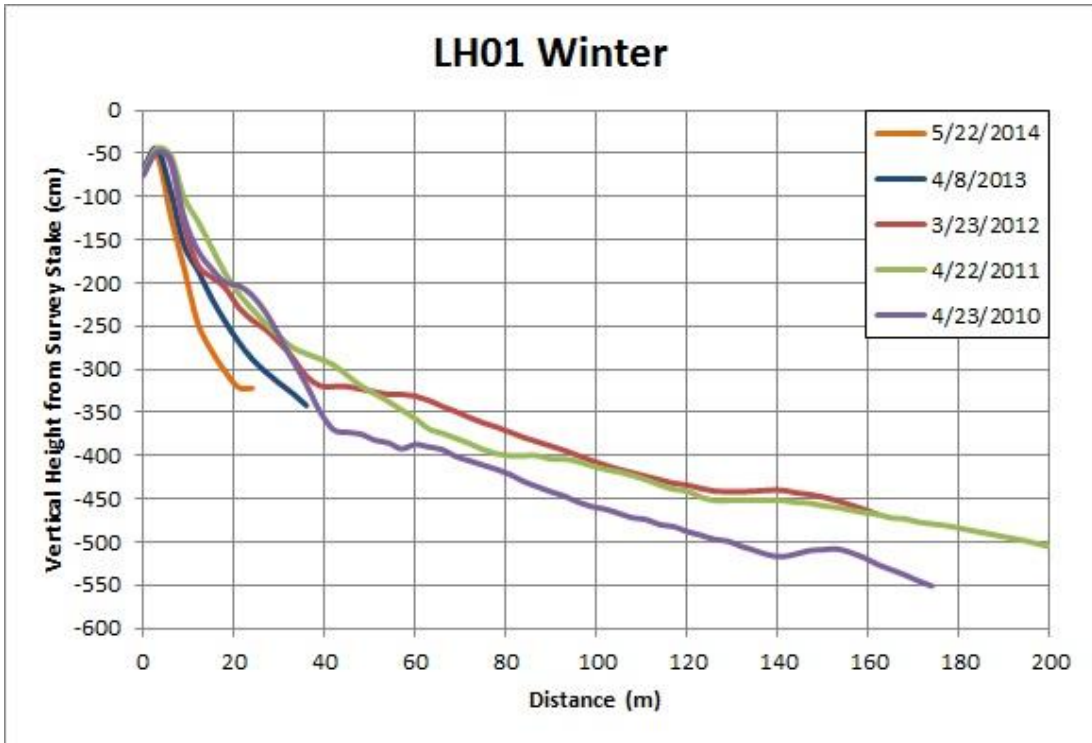
Figure 31. Winter beach profiles for LH01 from 2010 to 2014.

Winter LH01 = D (65). The 2010 profile had a well-defined dune crest and a nice berm at 20 m. In 2011, it had gained sand at the dune, lost some at the berm, but gained sand along the rest of the profile seaward. In 2012, it receded landward at the dune, lost its berm, but gained elevation seaward of 50 m. In 2013, the dune receded and the berm was lost. This continued in 2014, with additional sand lost at the dune, berm, and steepening of the beach. No 2015 data was provided. This profile eroded since 2011.

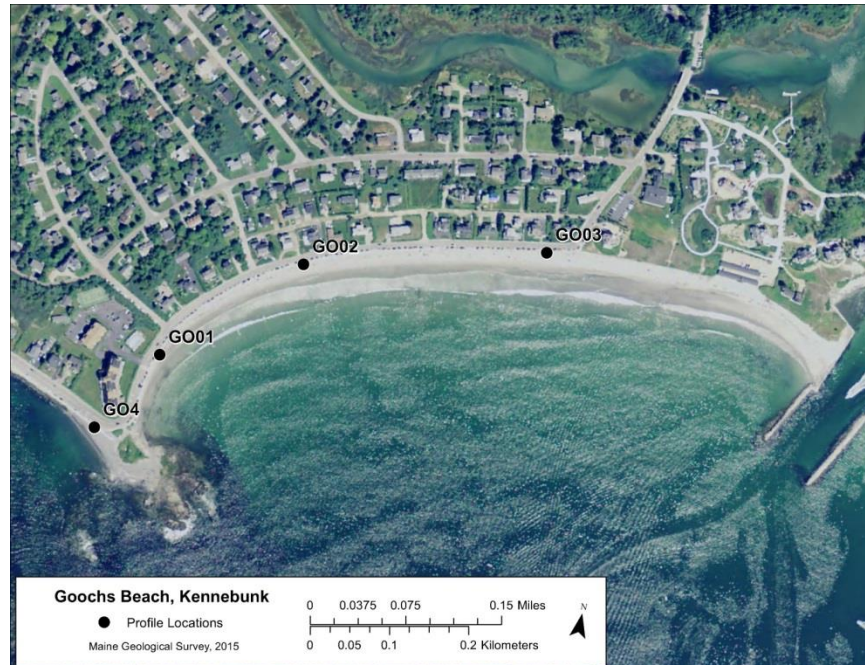
Figure 40. Volunteer beach profile locations at Goochs Beach, Kennebunk. 2013 base imagery from Maine OGIS.

Four profiles (GO01 to GO04, Figure 40) were available for analysis. All are located in the seawall at the beach. GO01 is at the western end of the beach, while GO02 is centrally located. GO03 is the easternmost profile, and GO04 is located at the southeastern end of Middle Beach. Figures 41 to 48 show seasonal changes.

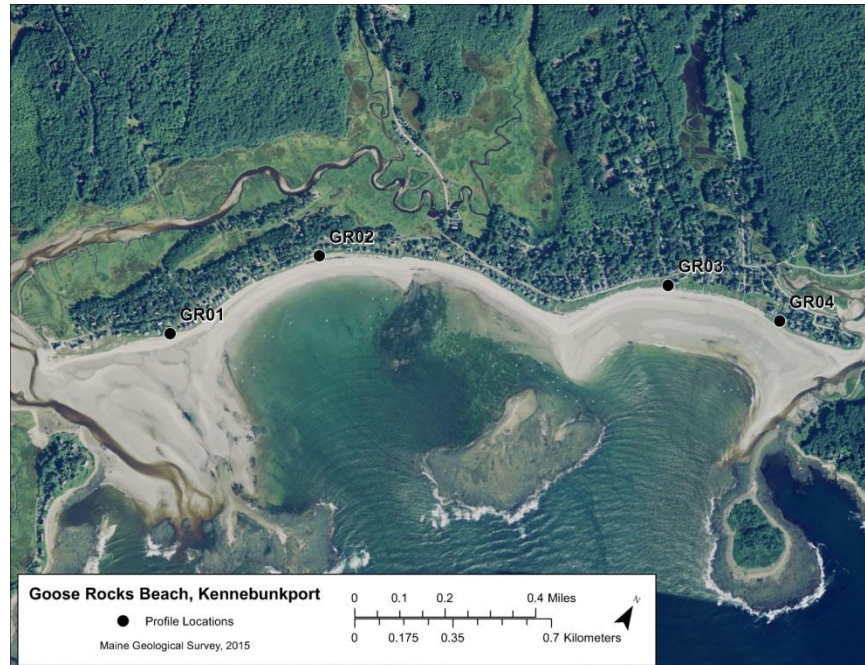
Figure 50. Volunteer beach profile locations for Goose Rocks Beach, Kennebunkport. 2013 base imagery from Maine OGIS.

Four beach profiles (GR01 to GR04, Figure 50) were available for analysis. GR01 is at the south end of the beach, near the Batson River. GR02 is in a small cell in the central portion of the beach. GR03 is in a cove at the north third of the beach GR04 is adjacent to the Little River. Figures 51 to 58 show seasonal changes.

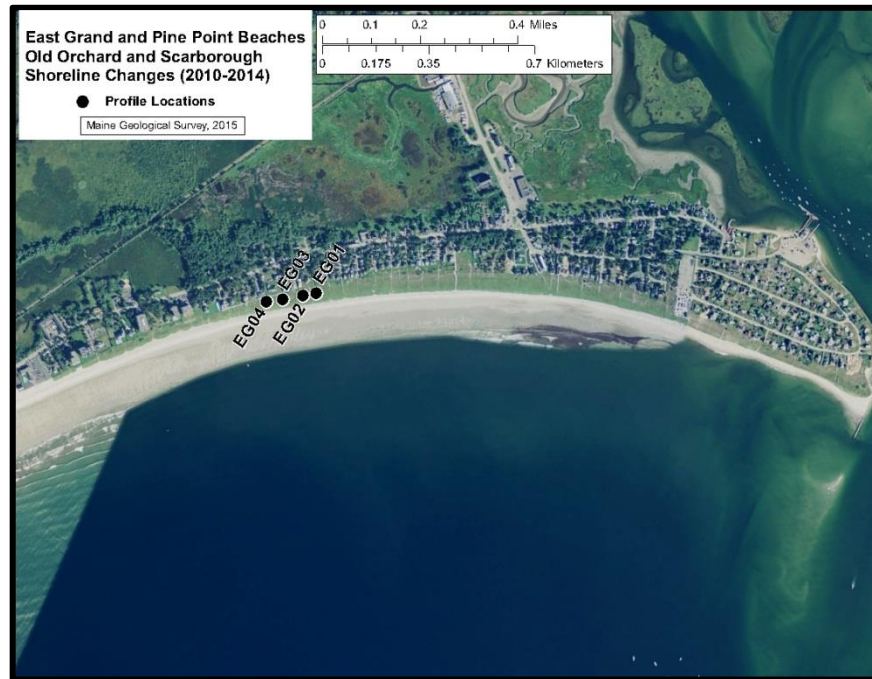
Figure 83. Locations of East Grand Beach volunteer monitoring profiles. Note that only data from EG01 and EG04 are analyzed, since EG02 and EG03 have not had data collected since 2012. 2013 base imagery from Maine OGIS.

Two profiles (EG01 and EG04, Figure 83) were available for analysis with data from 2010 to 2015; these profiles are actually located in Scarborough, not Old Orchard Beach, but are listed as being part of East Grand Beach. Note that profiling at EG02 and EG03 stopped in 2012, so no data will be analyzed. Figures 84 to 87 show seasonal changes.

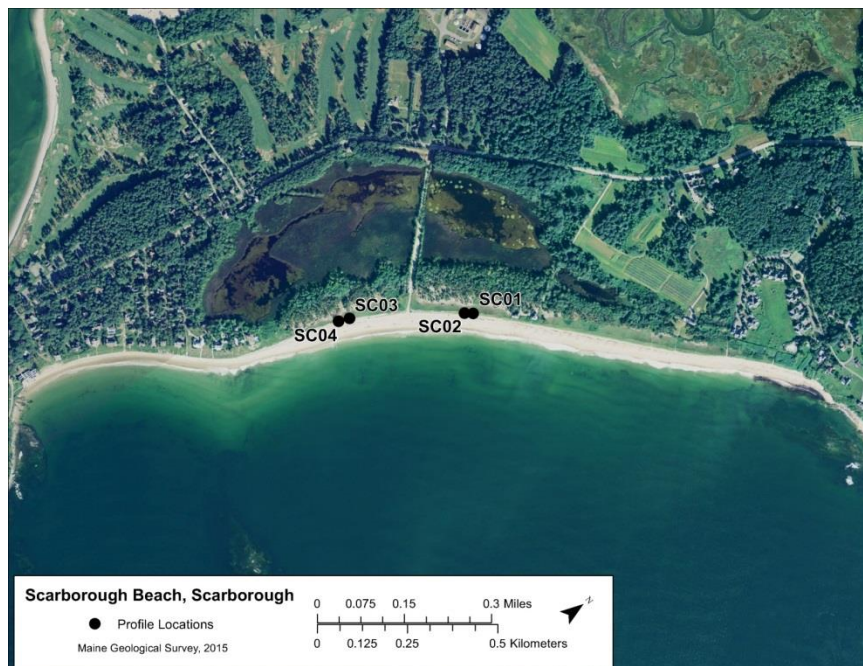
Figure 90. Volunteer beach profile locations at Scarborough Beach, Scarborough. 2013 base imagery from Maine OGIS.

A total of four beach profiles (SC01 to SC04, Figure 90) were available for analysis. *However, only SC01 had 2014 data collected; all other profiles stopped data collection in December 2013, so no recent trends can be analyzed.* SC01 and SC02 are located northeast of the access path, while SC03 and SC04 are located southwest of the access path. Figures 91 to 98 show seasonal changes.

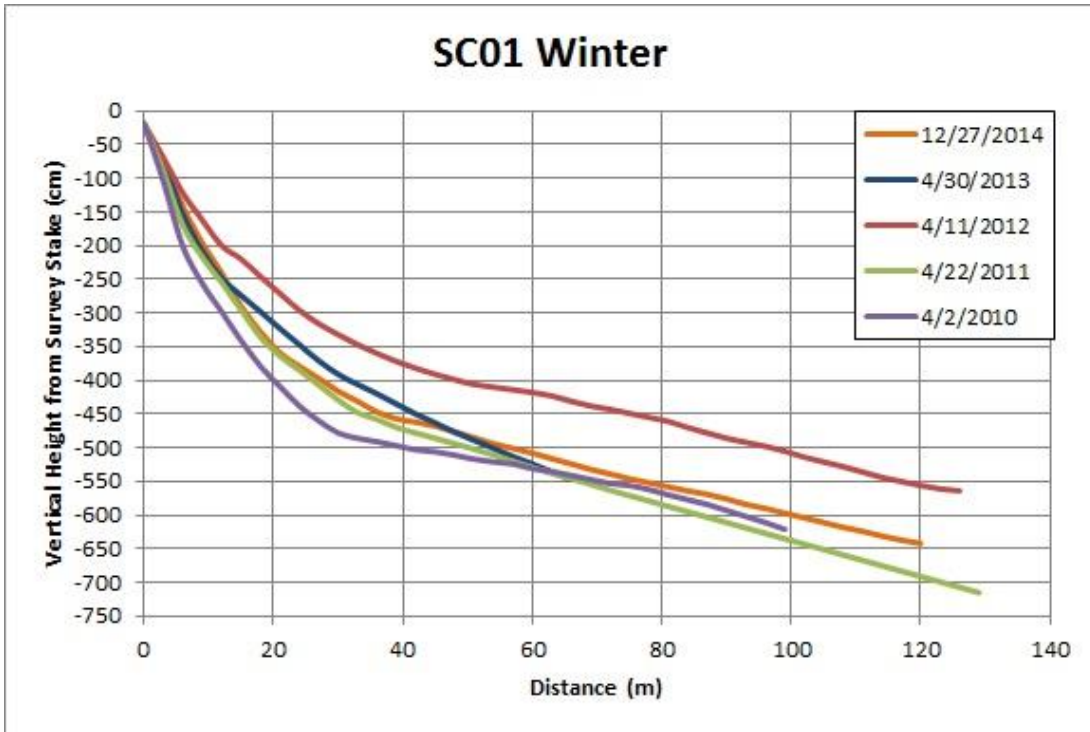
Figure 91. Winter beach profiles for SC01 from 2010 to 2014.

Winter SC01 = C+ (78). In 2010, SC01 had a concave, erosive shape. From 2010 to 2011, SC01 gained elevation along the profile landward of 60 m. Profile growth continued in 2012, with about 100 cm of elevation gain along the profile (to its best shape). It eroded in 2013 but still above 2010 and 2011 shapes. In 2014, it generally showed stability, changing little from the 2013 shape. 2010 was the worst, and 2012 the best years for this profile. It eroded since 2012, but not back to 2010 levels.

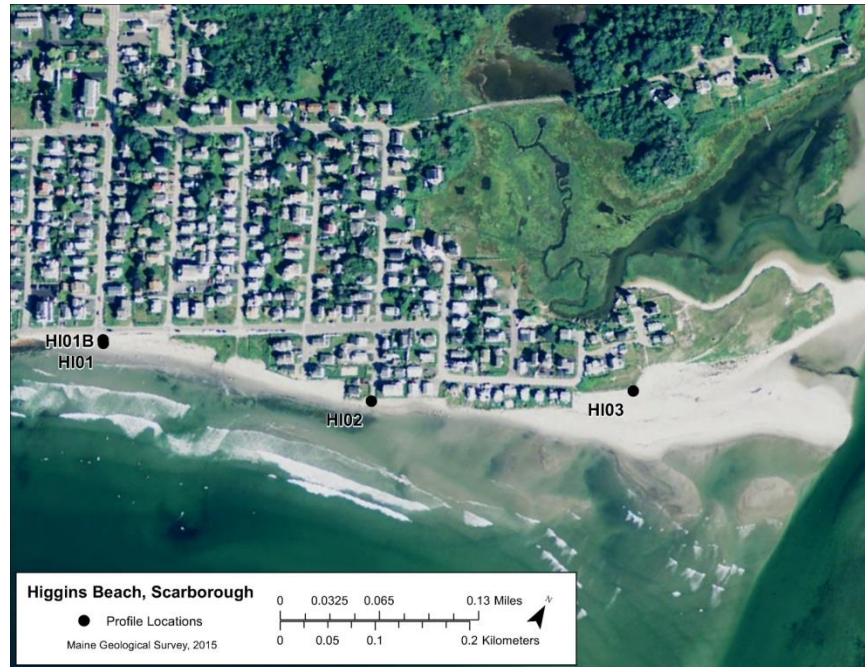
Figure 100. Volunteer profiling locations at Higgins Beach, Scarborough. 2013 base imagery from Maine OGIS.

Three beach profiles (HI01, HI02, and HI03, Figure 100) were available for analysis. HI01 (and HI01B, a backup point) are located in the rip-rap seawall along Bayview Ave. HI02 is located at a small seawall along the central portion of the beach, and HI03 is located in a wall landward of a natural dune area closer to the Spurwink River. Figures 101 to 106 show seasonal changes.

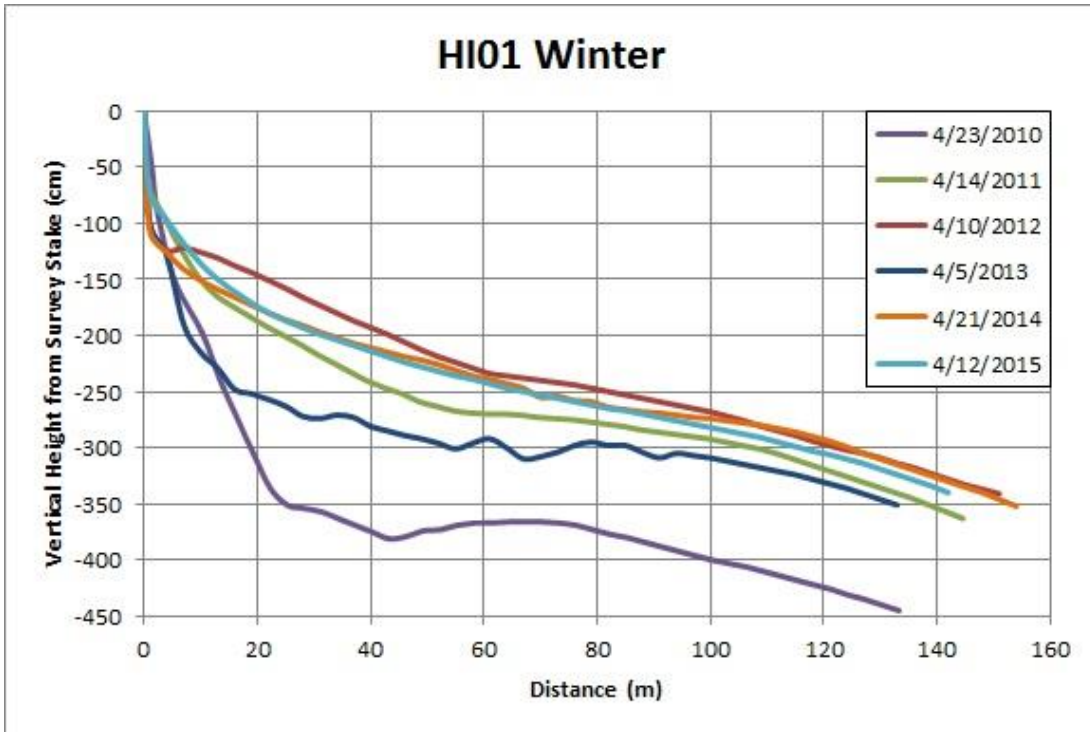
Figure 101. Winter beach profiles for HI01 from 2010 to 2015.

Winter HI01 = B- (82). The 2010 profile was the lowest, most erosive shape, likely eroding down to a historical erosional surface (such as peat). By 2011, it gained about 100 cm of sand vertically along its length. In 2012, this trend continued, with additional growth on the order of 20-40 cm along most of the profile; however, nearest the wall, the beach scoured and lowered. In 2013, HI01 eroded to within about 50 cm of the 2010 shape, and was steeper nearest the wall. In 2014, it remained extremely steep near the wall, but gained about 50-60 cm in elevation on the beach. The 2015 shape regained sand at the wall, and was stable in the beach area of the profile. This profile showed recovery from 2010 to a high in 2012, erosion in 2013, and good recovery in 2014 and stability in 2015. All profiles remained above 2010 levels.
