Monitoring Coastal Boundary along Nueces County Beaches

MASGP-15-034

Task 1. Coastal Jurisdictional Boundary Surveys 2014

Report of Findings

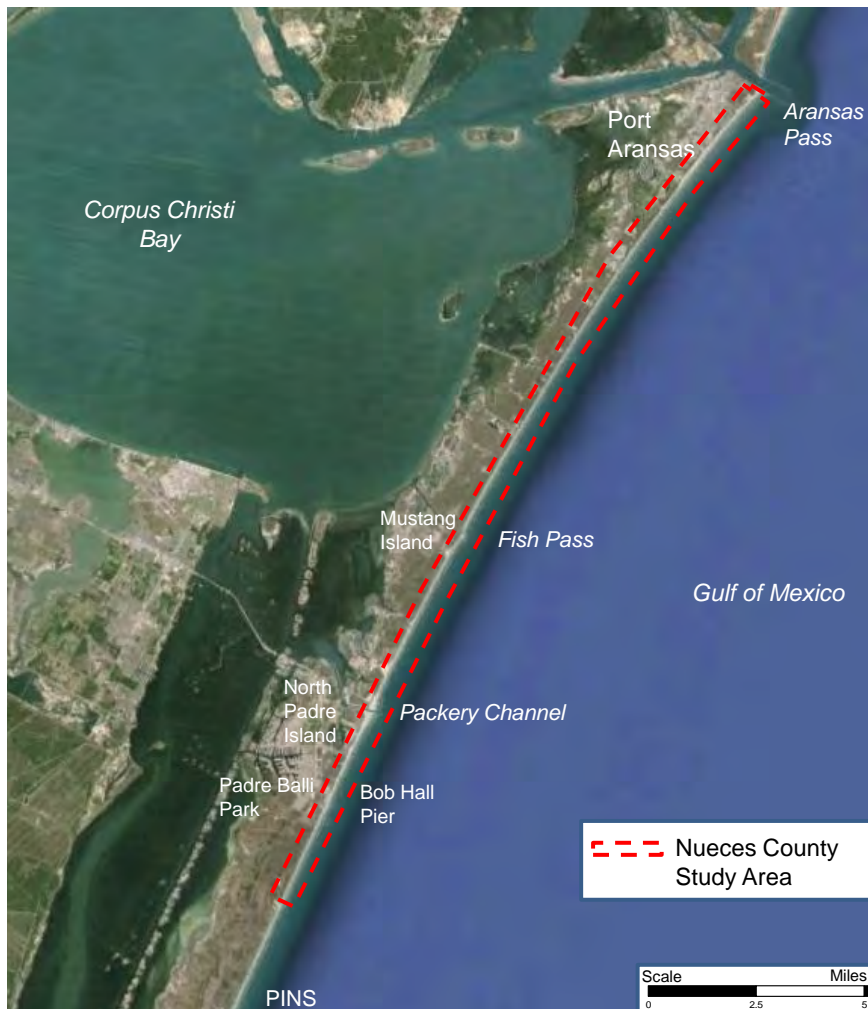
Figure 1. Beach along Mustang and North Padre Island that is located in Nueces County, Texas

Nueces County has been charged with the stewardship of approximately 22 miles of public beach stretching along Mustang and North Padre Islands from Aransas Pass to south of Bob Hall Pier (Fig. 1). This region of the coast has a diverse backshore beach environment including multiple beach access roads, a seawall (North Padre Island Seawall), paved parking (Padre Balli Park) as well as sections of continuous well-established dunes. The features that define the backshore limit of the beach can influence sediment transport across the beach. In addition, three sets of jetties limit and compartmentalize alongshore sediment transport to varying degrees both along the beach as well as in the nearshore. The diversity of backshore features and coastal structures along this stretch of barrier island beach creates a challenging environment for coastal resource managers. The maintenance and management of beaches within Nueces County is shared among the cities of Port Aransas and Corpus Christi, the Texas Parks and Wildlife Department (TPWD), and the National Park Service (NPS) as well as Nueces County Coastal Parks.

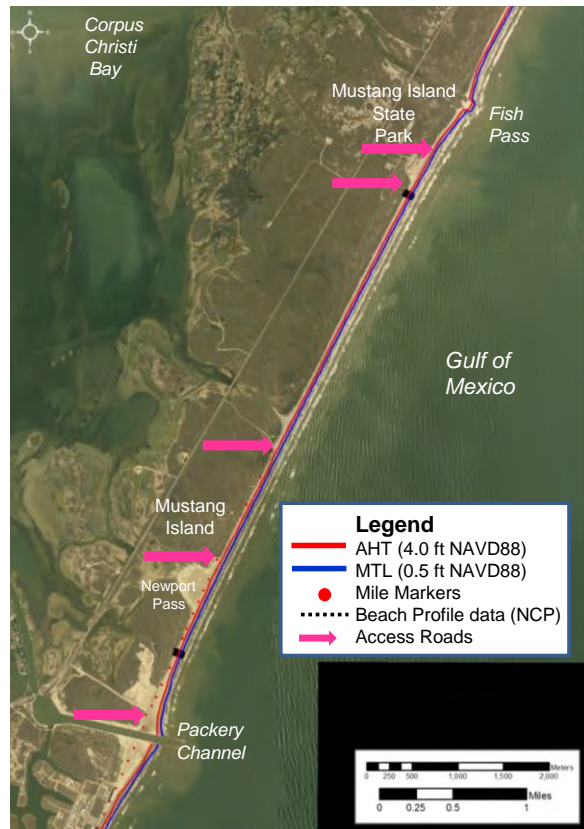
Figure 3. Position of AHT and MTL from Fish Pass to Packery Channel

Review of the data was divided into three regions based on limitations in sediment transport represented by coastal structures; 1) Aransas Pass to Fish Pass (Fig. 2), 2) Fish Pass to Packery Channel (Fig. 3) and 3) Packery Channel to Nueces-Kleberg county line (Fig. 4). Within these regions the review of the baseline positions of AHT and MTL was further subdivided with an emphasis on significant changes in backshore features or other parameters such as park boundaries where the type of beach management, including the lack of sargassum removal, differs significantly. The region from *Aransas Pass to Fish Pass* has large stretches of beach with a nearly continuous duneline. Along this region the duneline is interrupted by 9 access roads along approximately 13 miles of beach with the greatest concentration of access roads within the first 4 miles south of Aransas Pass. From *Fish Pass to Packery Channel* beach maintenance to facilitate vehicular access is limited to a one-mile stretch from Packery Channel to

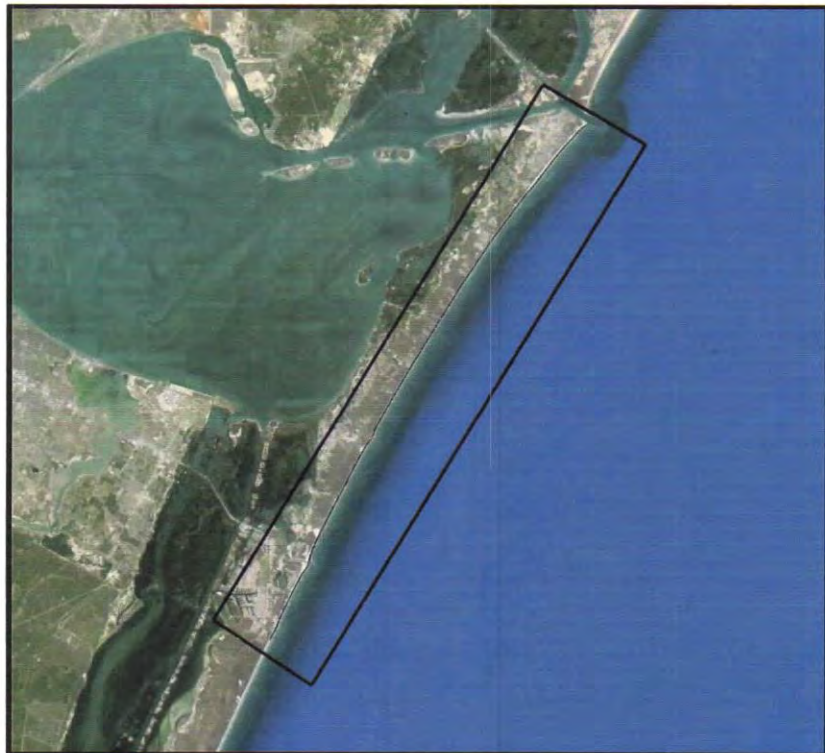
Survey Area (Image from Google Earth)

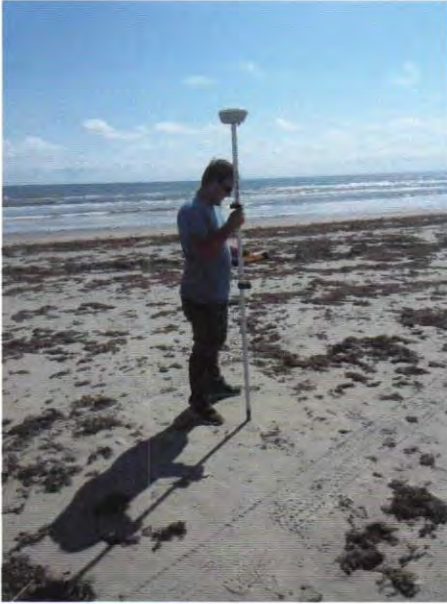
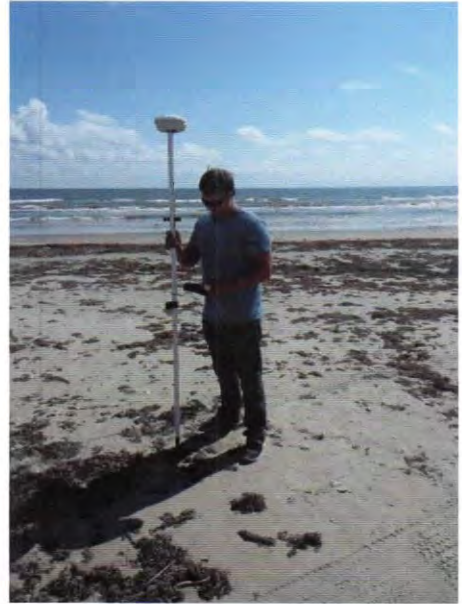
AHT Surveyed Near Upper Extent of Scattered Sargassum Weed
