**Wheat Chaff and Coal Dust:
Underwater Archaeological Investigations
of the Grain Schooners
*Daniel Lyons and Kate Kelly***

**State Archaeology and Maritime Preservation Program
Technical Report Series #06-002**

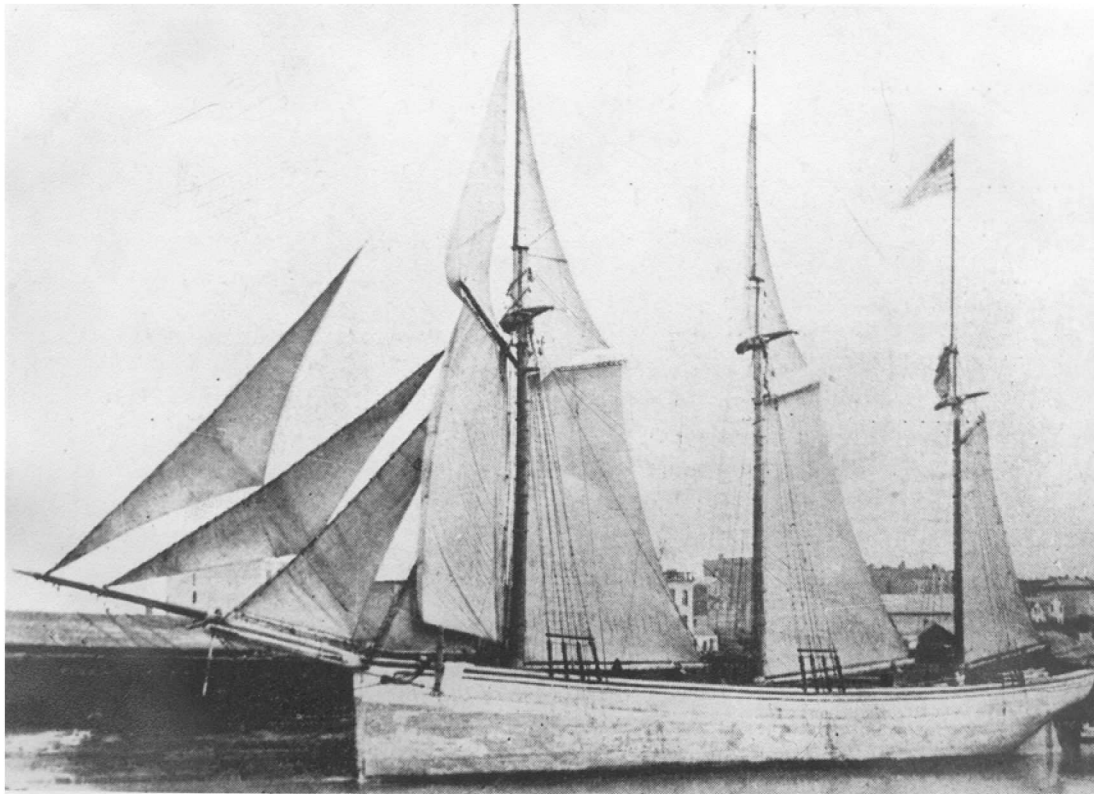
Figure 1. The *M. J. Cummings*, built by George Goble following the *Daniel Lyons*. The two vessels were nearly identical. Historical Collections of the Great Lakes, Bowling Green State University.

The *Daniel Lyons*, official number 6780, slid down the ways at 4:45 P.M. on Monday, 3 February 1873 (Figure 1). Originally scheduled for three o'clock, the launch was a much-anticipated break from the long Oswego winter and the extra hour and forty-five minute wait was worthwhile. The large amount of pageantry and celebration that accompanied the *Daniel Lyons*' launch marked the height of Oswego's shipbuilding era. The twenty-fifth of thirty-four ships built by George D. Goble, Jr., the *Daniel Lyons* was Oswego's first three-masted schooner (*Oswego Daily Palladium* 1873a, 1906). Built by the Goble & MacFarlane Shipyard for owners Daniel Lyons and George Goble, she was 142.5 feet in length, 26 feet in beam, 11 feet deep, and 318 gross tons (*Daily News* 1873a). The *Lyons*' hull lines were based on Goble's previous two-masted schooners *Nassau* and *Madeira*, but built to larger dimensions with an additional mast. Her construction cost was \$27,000, and her insurance rating was A1 (*Oswego Daily Palladium* 1873a).

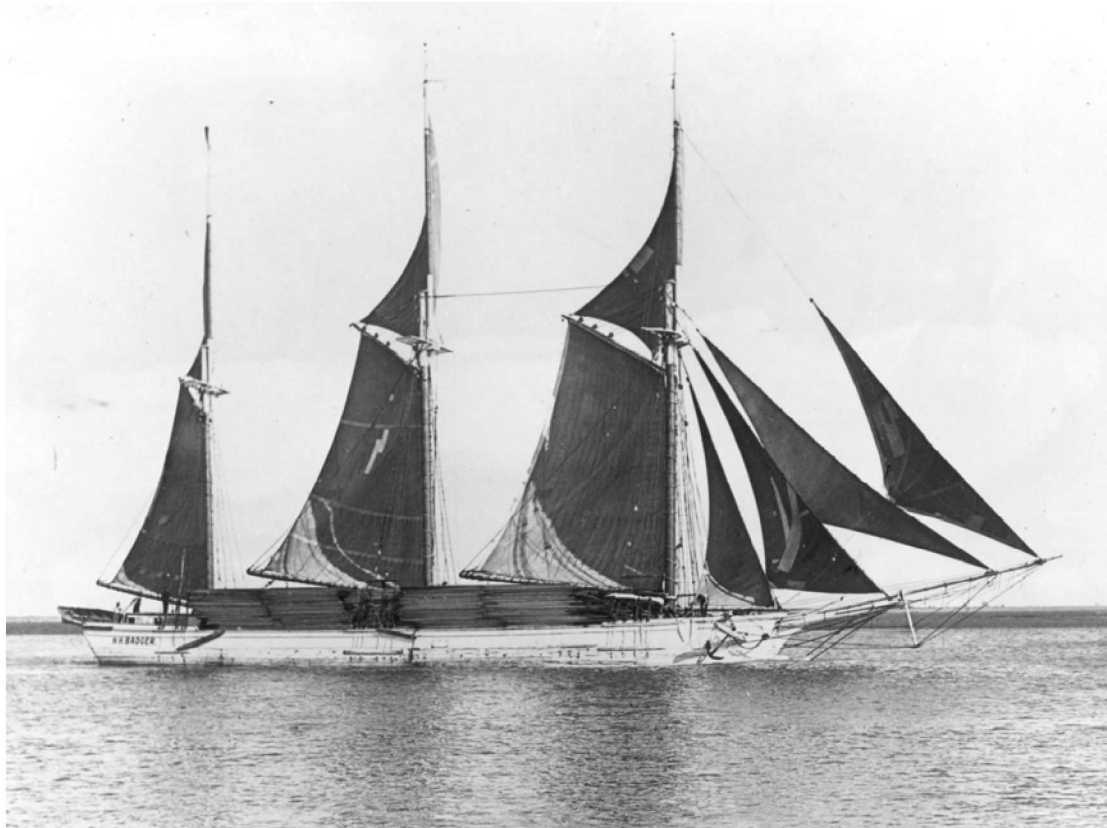
Figure 2. The *Kate Gillett* after her 1882 rig change from two to three masts, and name change to *Horace H. Badger*. Historical Collections of the Great Lakes, Bowling Green State University.

Aboard the *Lyons*, Madden saw the red and green running lights of the schooner *Kate Gillett* (Figure 2) about a mile north of the *Lyons*. The *Kate Gillett* was a two-masted schooner 129 feet in length, 30.16 feet in beam, and 9.66 feet in depth. Built in 1867 by J.J. Miller in Conneaut, Ohio, the *Kate Gillett* was heavily laden with fence posts from Cedar River, Michigan, bound for Chicago (Board of Marine Inspectors 1871). The *Kate Gillett*'s mate was also at the helm as the two vessels converged.

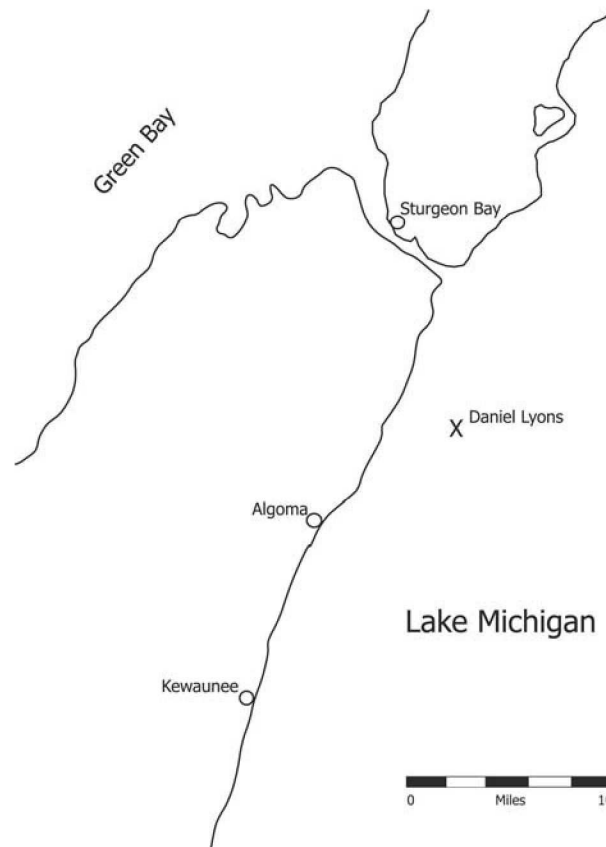
Figure 3. *Daniel Lyons* wreck site northeast of Algoma, Wisconsin.

The *Daniel Lyons* survey was designed as a Phase II predisturbance archaeological survey of the shipwreck nine miles northeast of Algoma in Kewaunee County (Figure 3) (44° 40.241' N, 087° 17.712' W). Predisturbance surveys involve the documentation of the site as it lays, with no excavation or artifact retrieval. Diagnostic artifacts that may indicate the site's age or identification are measured, sketched, photographed, and left in place. Predisturbance surveys have very little impact on a site, and are relatively inexpensive compared to Phase III excavations. The *Daniel Lyons* was selected for survey for the information it could provide on Great Lakes schooners and the grain trade.

The *Daniel Lyons* lays in 110 feet of water, somewhat broken up, but with nearly all hull structure and rigging represented. Bottom temperatures ranged from 40-42° Fahrenheit, with visibility varying from 40 to 100 feet. To maximize both bottom time and safety, all dives were conducted using 34% Nitrox as a bottom gas and 100% oxygen as a decompression gas. All divers utilized redundant SCUBA systems with manifolded tanks with an isolation manifold.

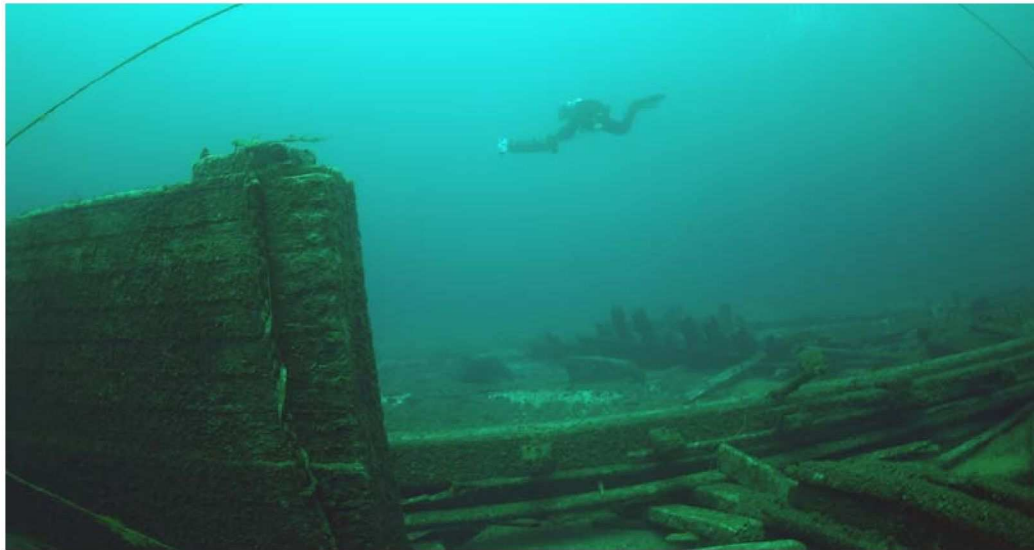
Figure 4. Capturing digital images for *Daniel Lyons* photo mosaic with DPV. Photo by Tamara Thomsen.

On 21 June 2005, WHS archaeologists and volunteers video-recorded the site to gather digital images used in constructing a digital photo mosaic. Images were gathered with a Sony 3 CCD Megapixel Handycam in a Light & Motion Bluefin underwater housing attached to the nose of a Silent Submersion UV-26 Diver Propulsion Vehicle (DPV) (Figure 4). With the DPV in a horizontal position, the camera was aimed directly at the bottom. A bubble level was mounted on the camera housing to aid the diver piloting the DPV in keeping the camera at right angles to the bottom at all times. In this manner, the DPV pilot “flew” the DPV and camera over the *Daniel Lyons* site approximately 20 feet above the lakebed, continuously recording video. Lanes were close enough to allow an overlap of video footage of several feet between lanes, ensuring the entire wreck site was recorded without gaps. Four hundred twenty-three successive, overlapping still images were captured from the digital video. These images were then hand-assembled in Adobe Photoshop 7.0 and printed in a scale of one inch equals four feet (1 in. = 4 ft.) (Figure 5). Because of large variations in site relief, scale errors were introduced into the mosaic through varying lens-to-wreck distances. The wide-angle lens (necessary to gather as much data as possible in a limited bottom time) introduced additional parallax error at the lens’s periphery. These errors made site plan production directly from the photo mosaic problematic. Hull structures in the photo mosaic, therefore, needed to be checked for accuracy and any errors corrected. A few wreck details were missing or blurred in the mosaic, requiring further on-site correction.

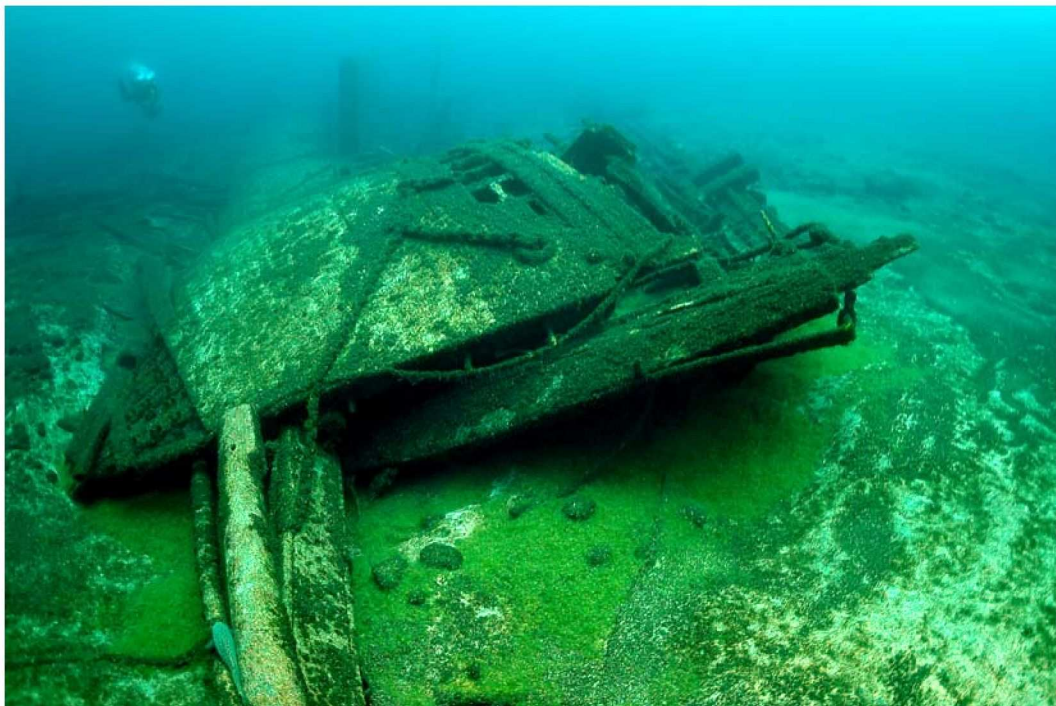
The *Daniel Lyons*' bow is the site's most visually impressive feature (Figure 7). Before toppling to port, the bowsprit and jib boom dislodged from their location atop the stempost and split the bow in two along the stempost's starboard side, coming to rest atop the keelson. The jib boom is 53 ft. 6 in. in length and tapers slightly toward its tip, measuring 1 ft. 3-5/8 in. in diameter at its base and 11 in. in diameter at its center. Jib stays were fastened to the jib boom with two iron rings that are located 3 ft. 2 in. and 11 ft., respectively, from the jib boom's tip. Twenty-two feet from the jib boom's base is an iron ring that still fastens the jib boom to the end of the bowsprit. A 6 in. tenon protrudes from the base of the jib boom that secured the jib boom to the bowsprit by a mortised wooden block that remains intact atop the bowsprit. The bowsprit lays beneath the jib boom and extends 25 ft. 6 in. from bow. The bowsprit continues beneath the starboard side hull, which lays somewhat flattened over the bowsprit, stempost, and deadwood. A tangle of wire rigging lays around the bowsprit, as well as a sail gaff, complete with jaws, that lays immediately to starboard of the jib boom.

Figure 7. *Daniel Lyons*' bow. Note diver in upper left. Photo by Tamara Thomsen.

The canaller's bluff bow is readily apparent. The stempost is 7 in. sided by 2 ft. 2 in. molded, and is rabbeted to accept the outer hull planking. Its leading edge is protected with a stem iron that is beginning to separate at the stempost's upper end. The stem iron has a 90 degree bend at its top that hooks onto and partially covers the top of the stempost's uppermost surface. The starboard bow's outer hull planking is 6 in. wide and 2-3/8 in. thick, and is intact with the exception of the foot of the bow. The starboard knighthead remains fastened to the outer hull planking's leading edge. The lower 4 ft. of 6 starboard cant frames are visible where the outer hull planking is absent. Square frames aft of the cant frames are absent, having broken above the turn of the bilge and are now obscured beneath the outer hull planking.

An 8 in. diameter hawse pipe remains intact, centered 6 ft. from the railcap and 4 ft. from the bow. The starboard anchor chain runs through the hawse pipe and lays in a small loop atop the starboard side hull before ending in the sand. Neither anchor is present, having been salvaged in 1985 by local divers and fisherman (Milwaukee Public Library n.d.). Six bulwark stanchions are visible where the bulwark planking is missing, measuring 6 in. sided and 9-5/8 in. molded, spaced 2 ft. on center. Eight feet aft of the bow is an iron open chock that is fastened atop the railcap.

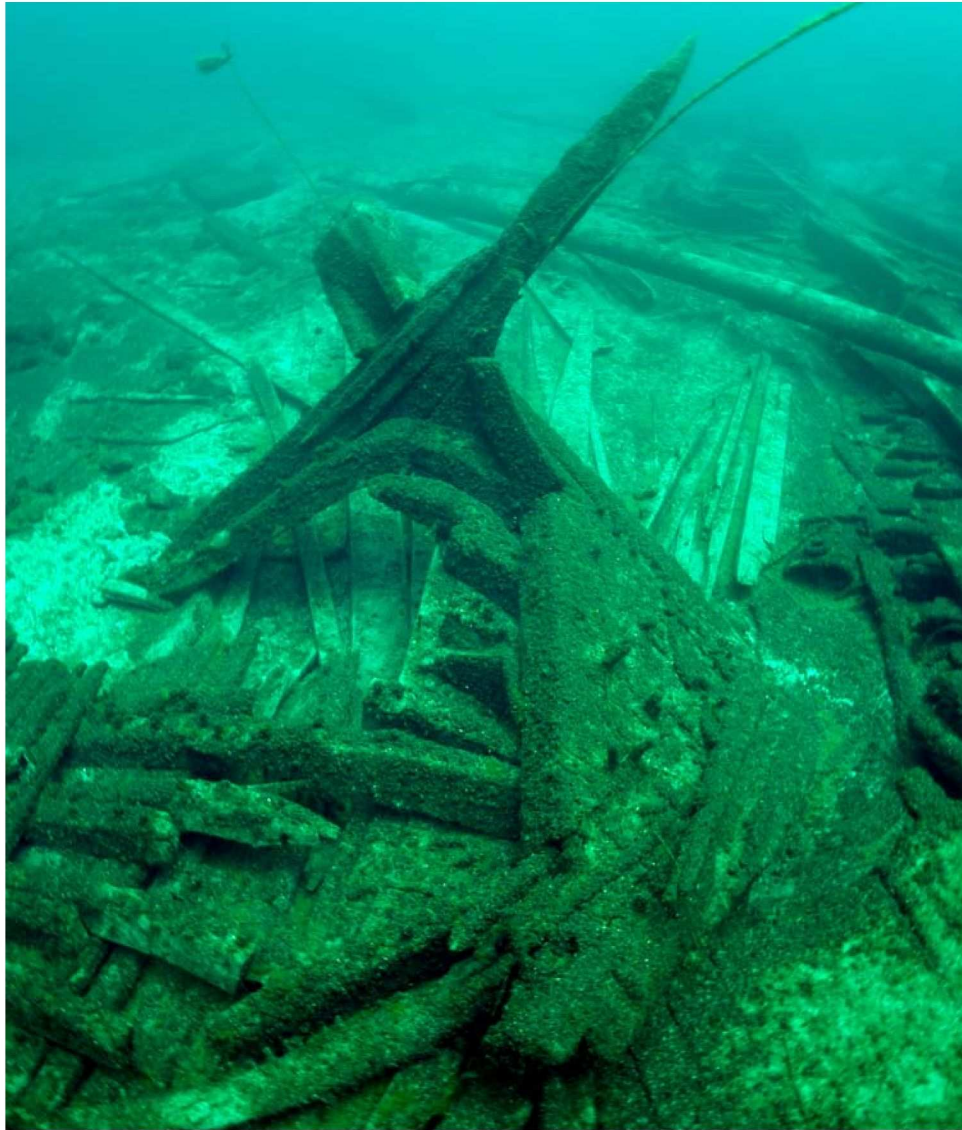
Immediately aft of the starboard side's collision damage lays the stern, complete with a fragment of the keel, keelson, deadwood, cant frames, outer hull planking, and fashion timber (Figure 8). The keel is broken 7 ft. aft of the mizzenmast step, and the large stern structure now lays approximately 40 feet north of its former location, likely the result of an entanglement with fishing nets. The broken keel section is 10 ft. 6 in. in length. A filler piece rides atop the keelson. Three deadwood timbers ride atop the filler piece, between the filler and the inner post. Cant frame fragments are extant on the starboard side, fastened to the deadwood with iron bolts. Fragments of outer hull planking are extant on the starboard cant frames as well as over the port side's keel / stern post interface. The stern post is 16 ft. 7-1/4 in. long, 10-1/4 in. sided by 10-1/2 in. molded. The stem post's aft surface is recessed to accept the rudder post. An inner post is attached to the stern post's forward edge, and measures 1 ft., 5-3/8 in. molded. The inner post runs from the keel to the underside of the fashion timber. The fashion timber is 18 ft. in width, and rises ten feet above the lakebed in its current position.

Figure 8. Stern section with keel, deadwood, cant frames, outer hull planking, and fashion timber. Mizzenmast step and keel is visible in upper right. Photo by Tamara Thomsen.

Historical accounts indicate the *Daniel Lyons* rolled onto her port side before she sank bow first. Archaeological evidence, however, suggests the *Daniel Lyons*' stern struck the bottom first. The *Daniel Lyons*' aft sections are far more broken than her forward sections. Additionally, her keel is broken seven feet aft of the mizzenmast step. This suggests that the *Daniel Lyons* sank stern first, breaking her keel upon collision with lakebed, which subsequently fractured the entire stern from the main hull. It is not likely the collision with the *Kate Gillett* caused the keel break, as it is farther aft than where the *Gillett* struck the *Lyons*.

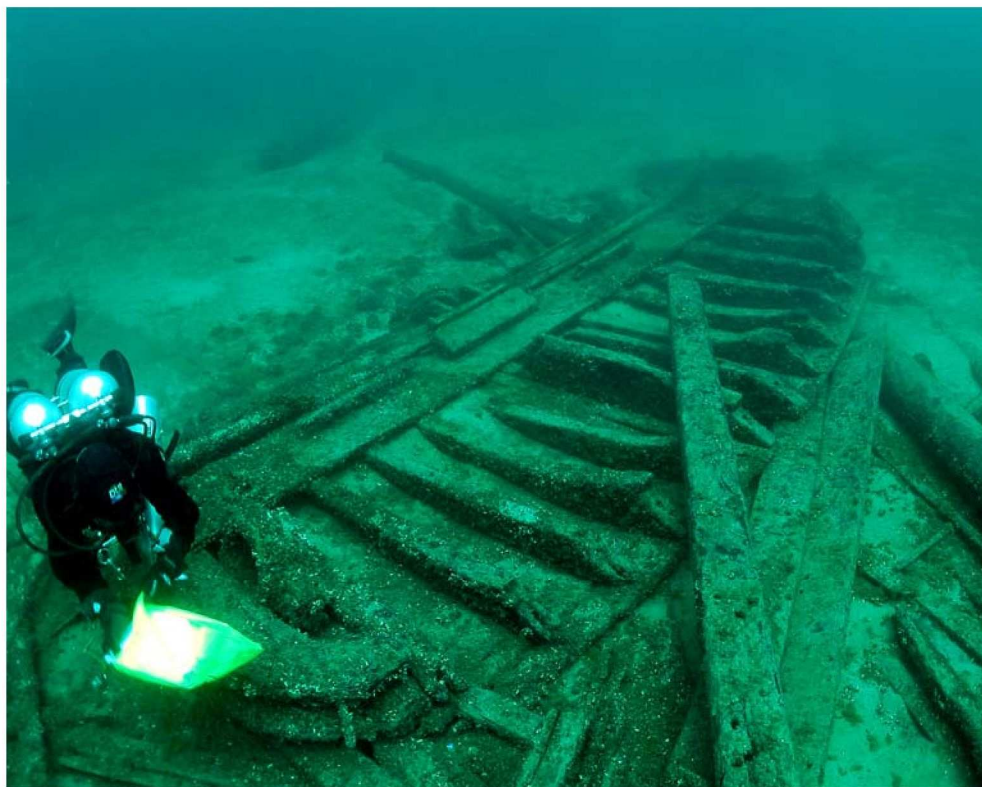
The intact transom lays abaft of the keel. The transom has no counter and has overall dimensions of 18 ft. 10-3/4 in. wide and 7 ft. 6 in. tall (Figure 9). The transom's outboard ends retain the side counter timbers that originally fastened to the fashion timber's ends. Two post timbers remain extant, each 6 ft. in height. There are five horn timbers on either side of the post timbers that measure (from the post timbers outboard) 6 ft., 5 ft. 6 in., 5 ft. 3-5/8 in., 4 ft. 9-5/8 in., and 4 ft. 4-3/4 in. in height. The horn timbers vary in sided dimension from 4-3/4 in. to 6 in., and vary in molded dimension from 6-5/8 in. to 7-1/4 in. Both the post and horn timbers are cut to join with the fashion timber, fastened with iron bolts. A single-sheave mizzen sheet block remains attached above the post timbers. The two outermost horn timbers retain iron rings attached near their upper ends. Stern knees at the top of either side's counter timber measure 2 ft. 1-1/4 in. along both the arm and body and 1 ft. 4-3/4 in. at the throat.

Figure 9. WHS research diver documenting the transom. Photo by Tamara Thomsen.

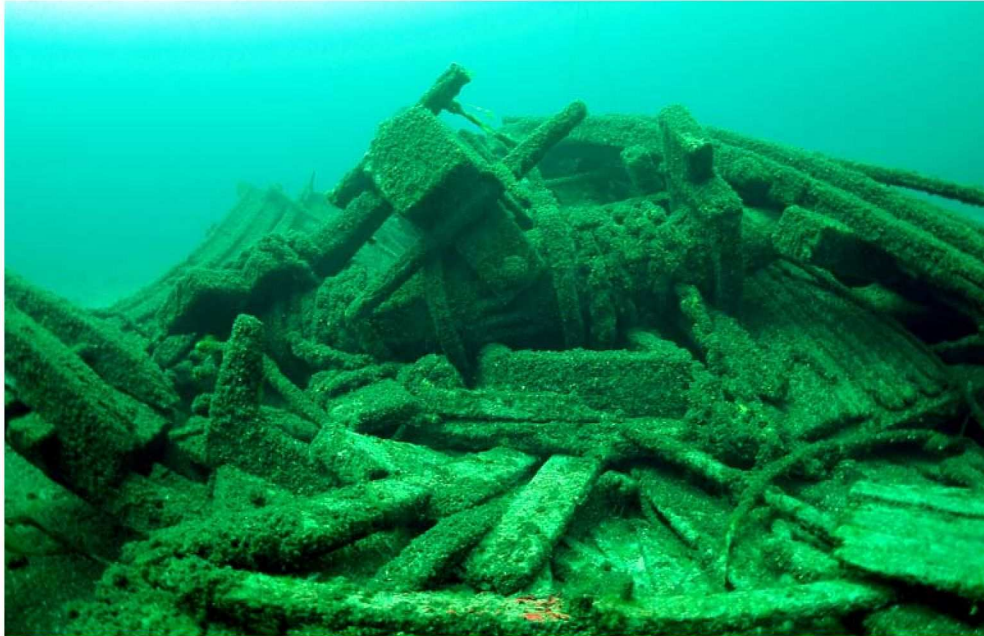
The sampson post has fallen towards the port quarter, and the windlass now rests atop the forecastle companion way (Figure 10). The forecastle companion way is 3 ft. square on the outside of the combing. The combing is 10-3/4 inches tall on its inside edge, and 3-5/8 in. thick. The sampson post (or pawl bitt) formerly rose 6 feet above the main deck and is 1 ft. 4-3/4 in. square. The windlass pawl remains attached to the sampson post, and is 1 ft. wide, 1 ft. 7-1/4 in. long, and 5/8 in. thick. The windlass is 11 ft. 10-3/4 in. wide; circumference measurements could not be obtained due to the anchor chains, sampson post, and other hull structure and debris covering the windlass. The windlass' pawl rim teeth are 3-5/8 in. apart on center. Two purchase rims are 1 ft. 10-3/4 in. apart, each rim 3-5/8 in. wide. The crosshead remains attached to the forward side of the sampson post, complete with two purchase rods connecting the crosshead to the purchase rims' ratcheting mechanism. To weigh anchors, two hand levers were inserted in either side of the crosshead and two crewmen then worked the hand levers up and down, ratcheting the purchase rims and revolving the windlass. The pawl locked the windlass and kept it from reversing rotation between purchases. The anchor chain whelps are 2 ft. 8-3/8 in. wide and covered with four turns of the anchor chain on either side of the windlass. Outboard of either whelp is a 4 in. cheek piece that held the windlass to the carrick bitts. The windlass was supported by two carrick bitts 4 in. sided and 1 ft. 3-5/8 in. molded.

Each bitt is braced by a standard knee that measures 4 ft. on deck and 2 ft. 8-3/8 in. along the carrick bitt. A fragment of the windlass strongback that joined the sampson post to the carrick bitts is extant on sampson post's aft surface.

Figure 10. Sampson post, windlass and forecastle companion way. Photo by Tamara Thomsen.

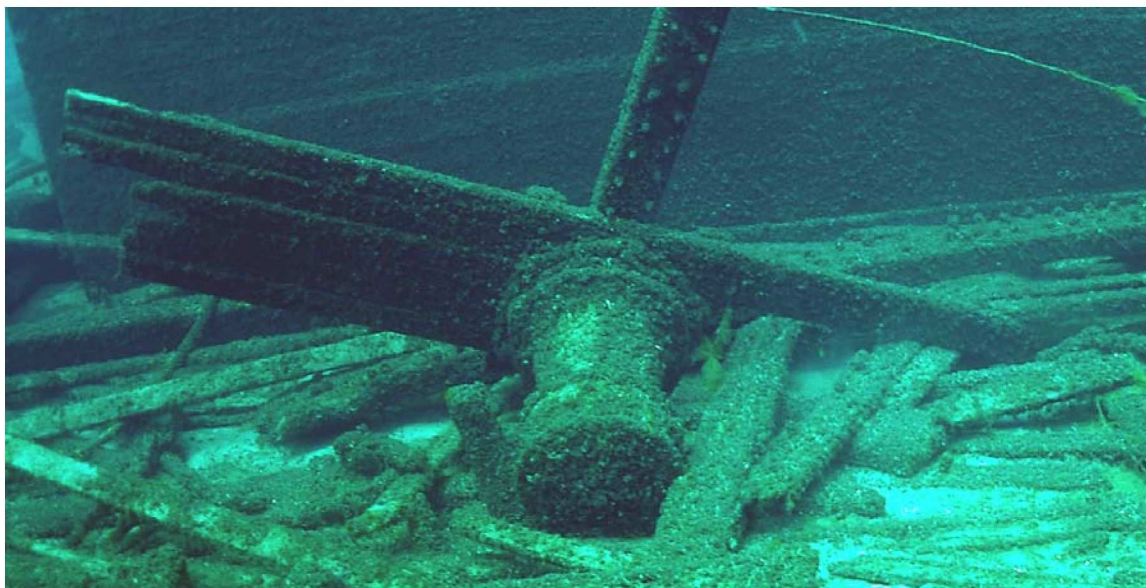
Immediately forward of the centerboard winch lays an inverted capstan with an attached deck beam and 6 capstan partners (Figure 12). The capstan is heavily encrusted with zebra mussels that obscure many finer details. The capstan is 3 ft. 4-3/4 in. tall overall. The pawl rim rises 8 inches above the capstan partners. The capstan's barrel is 1 ft. 8 in. tall with vertical whelps spaced 8 in. on center. The drum head is 1 ft. tall and 2 ft. 2 in. in diameter. Handspike holes are 2 in. square and spaced on 1 ft. centers around the drum head. The capstan's data plate was absent and no patent dates were visible.

Figure 12. Inverted capstan mounted atop capstan partners and deck beam. Photo by Tamara Thomsen.

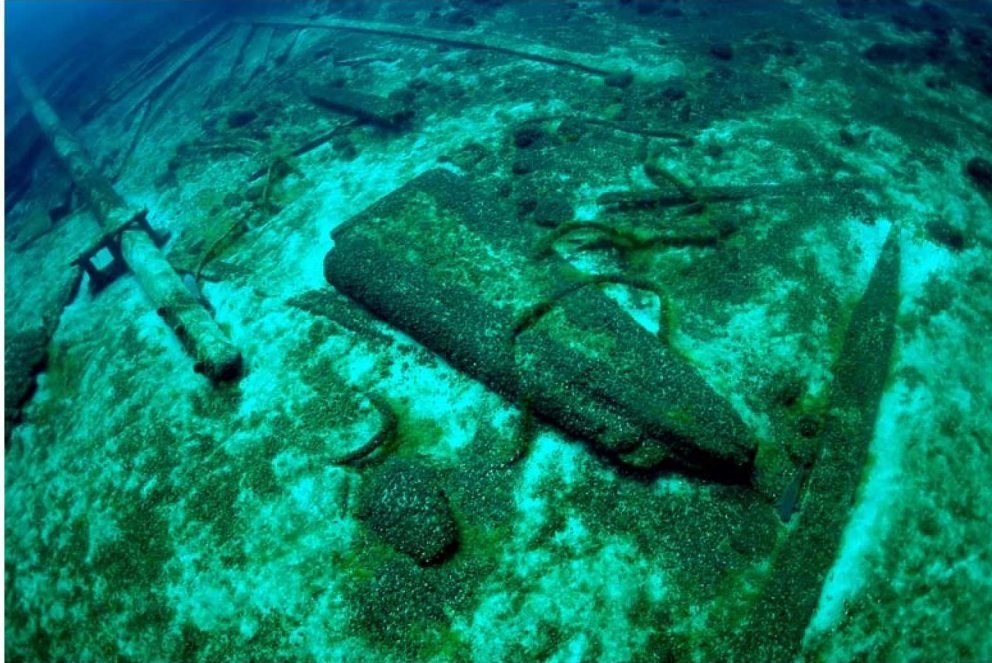
The rudder lays near the mizzenmast's masthead, off the hull's starboard quarter (Figure 13). The rudder blade is 9-5/8 in. wide and 11 ft. 6-3/8 in. tall. The base of the rudder blade is 3 ft. 4 in. long. An iron reinforcing strap protects the rudder's underside and trailing edge. The rudder post is 9-5/8 in. in diameter, but is broken 1 ft. below the top of the rudder blade. The rudder lays amidst a tangle of wire rigging on the lakebed.

Figure 13. The *Daniel Lyons*' rudder. The mizzen masthead and trestle tree are visible to the left. Photo by Tamara Thomsen.

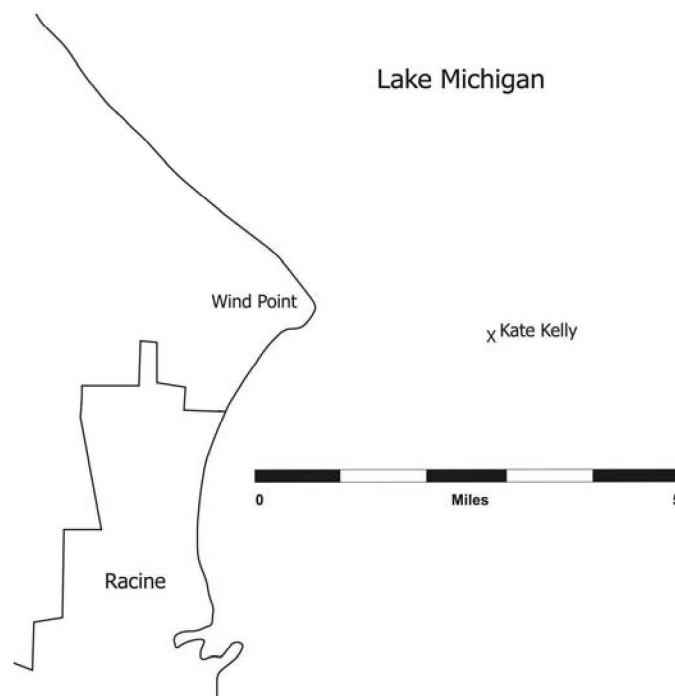
Figure 14. *Kate Kelly* wreck site off Wind Point, Racine, Wisconsin.

The *Kate Kelly* survey was designed as a Phase II archaeological survey of the shipwreck two miles east of Wind Point in Racine, Wisconsin (Figure 14) ($42^{\circ} 46.684' \text{ N}$, $087^{\circ} 43.509' \text{ W}$). Predisturbance surveys involve the documentation of the site as it lays, with no excavation or artifact retrieval. Diagnostic artifacts that may indicate the site's age or identification are measured, sketched, photographed, and left in place. Predisturbance surveys have very little impact on a site, and are relatively inexpensive compared to Phase III excavations. The *Kate Kelly* was selected for survey for the information it could provide on Great Lakes schooners and the grain trade.

On 20 June 2003 a permanent mooring was emplaced off the wreck's starboard bow, anchored with a 2,000 lb. deadweight mooring block placed by the University of Wisconsin – Milwaukee's R/V *Neeskay*. The *Kate Kelly* lays in 55 feet of water, mostly broken up, but with large hull sections intact and associated gear remaining. Bottom temperatures ranged from 42-58° Fahrenheit, with visibility varying from 20 to 40 feet. Underwater archaeological fieldwork was coordinated by WHS underwater archaeologists Russ and Cathy Green. The majority of the fieldwork was conducted by volunteers from the Great Lakes Shipwreck Research Foundation, Inc. during the 2002 and 2003 field seasons.

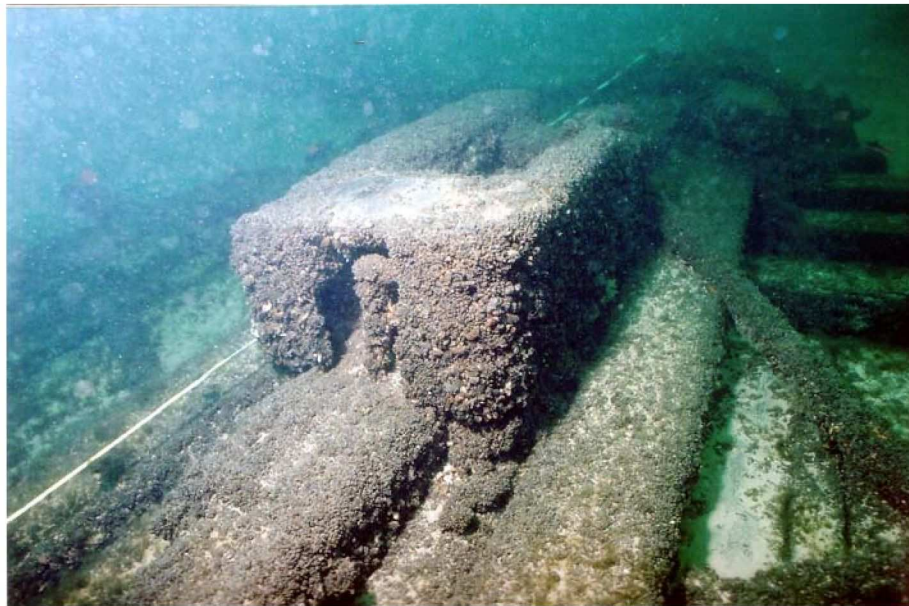
The foremast step is located 15 ft. 4 in. from the bow (Figure 16). This mast step is 4 ft. long by 2 ft. wide, and is fastened to the keelson with iron bolts and clinch rings. The mainmast step is located 65 ft. 2 in. from the bow, but few structural components of the step remain intact. Two pumps shaft holes for the stern bilge pump are visible through the keelson 90 ft. from the bow.

Figure 16. Foremast step. Photo by Tamara Thomsen.

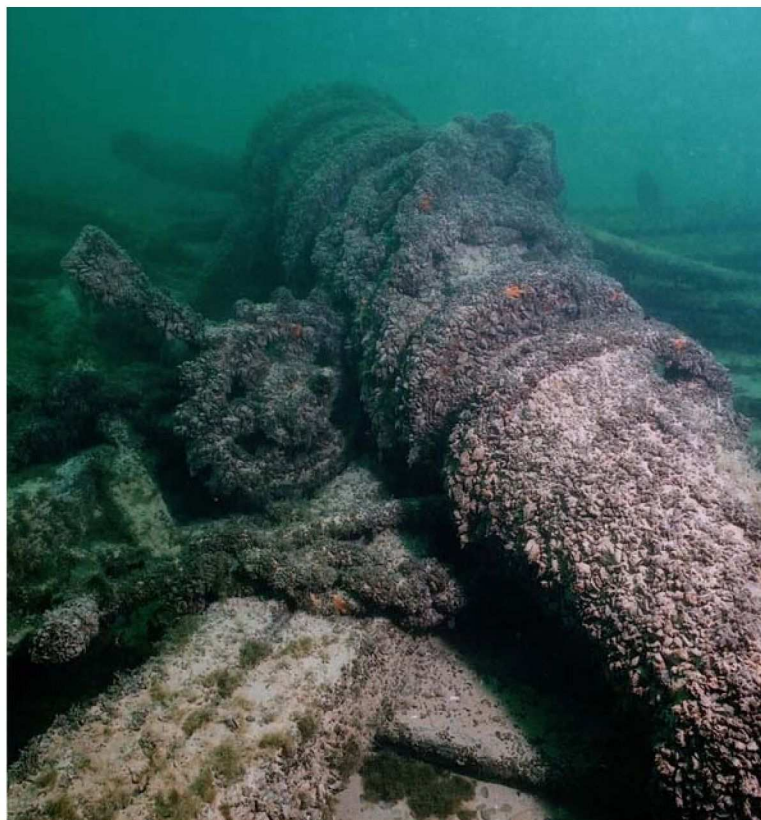
The *Kate Kelly*'s port and starboard bow separated at the stem post and lay adjacent to one another off the lower hull's port side. The windlass lays atop the port side bow fragment, which lays ceiling up on the lakebed. The port bow retains the port side knighthead, four cant frames, seven square frames, as well as a section of railing and ceiling planking. Forward of the port side bow, a large tangle of wire rigging lays partially buried in the lakebed.

Figure 17. *Kate Kelly*'s windlass with pinion gear and hand lever. Photo by Tamara Thomsen.

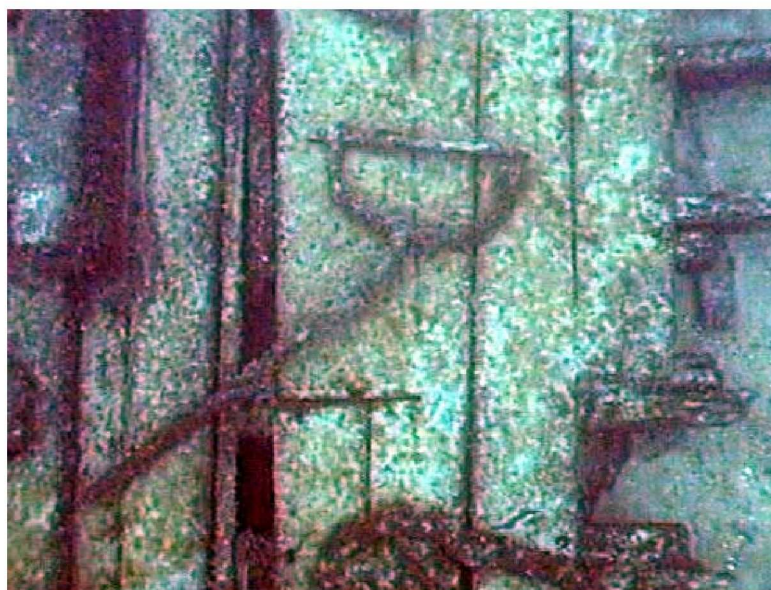
Figure 18. The windlass' hand lever, one of two used to manually weigh anchors, lays to the port side of the foremast step. Photo by Great Lakes Shipwreck Foundation, Inc.

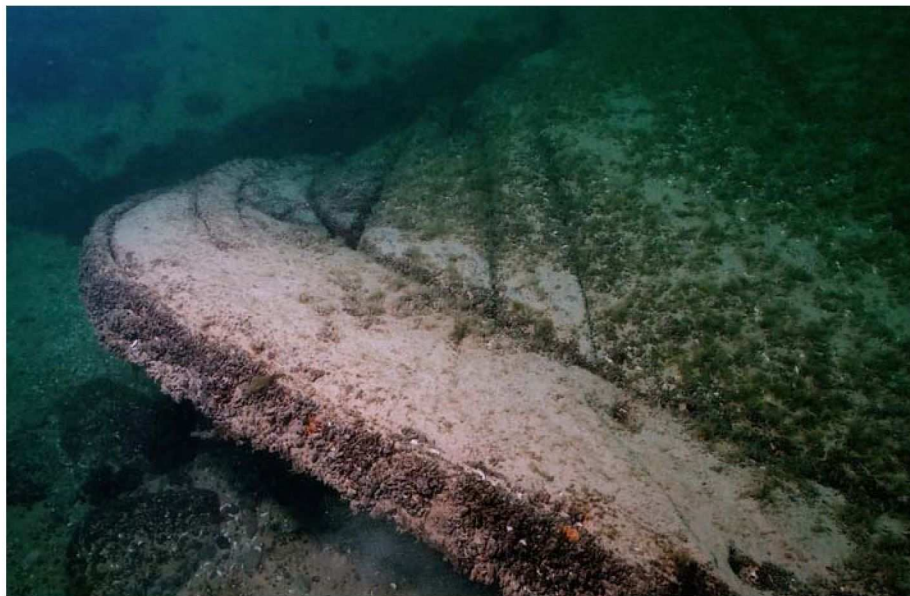
The starboard bow fragment lays just aft of the port bow, and lays ceiling down. There is no evidence of the bowsprit or figurehead. A stem iron, stem post, stem apron, and 12 frames remain attached to the starboard bow. Much of the outer hull planking is extant, with 25 planks remaining from the bulwarks to beneath the turn of the bilge. Outer hull plank width varies from 6 to 10 in. Four extant cant frames are 7 in. sided with a 10 in. space. Square frames vary from 8 to 9 in. sided, with spacing varying from 1ft. 3-5/8 in. to 1 ft. 6 in. A 1 in. thick stem iron protects the stempost's leading edge, and wraps around the foot of the bow to continue along the keel. The stem post / keel joint is reinforced by a curved iron brace that is 1 ft. 9 in. long by 3 in. wide, secured with five peened iron bolts that are $\frac{3}{4}$ in. in diameter (Figure 19). Remnants of the wire bobstays and their anchors remain attached to the stempost, as well as remnants of the forestays fastened to the outer hull planking.

Figure 19. Foot of the starboard bow, showing the stempost, stem iron, and iron reinforcement strap. Photo by Tamara Thomsen.

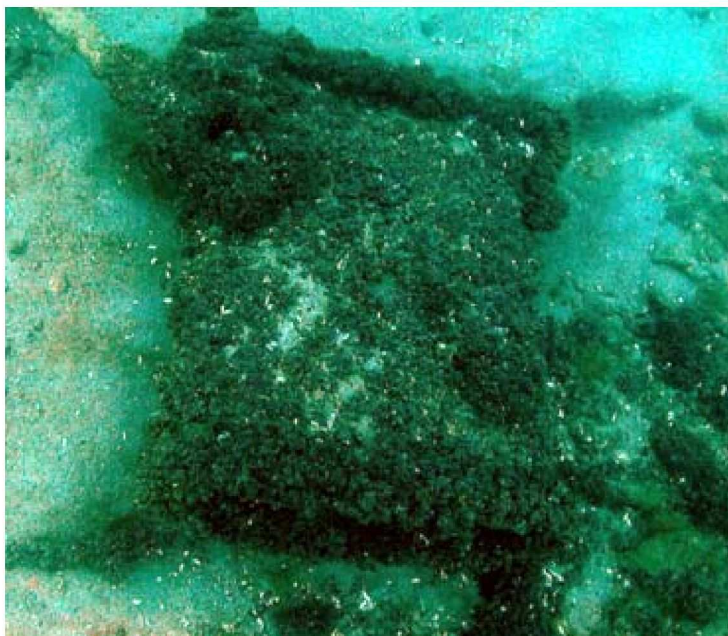
Several pieces of the *Kate Kelly*'s deck gear lay in a debris field around the forward hull sections. A double-acting, cast iron bilge pump lays in the sand 30 ft. forward of the lower hull section, obscured by a large colony of zebra mussels (Figure 20). Between the lower hull section and the port side bow is the donkey engine's winching drum (Figure 21). The drum is 16 ft. in length with a 5 in. diameter gypsy head on either end of the drum. Each gypsy head has a wide slot cut into the end; the slots on either end are parallel with one another. The drum's main gear is 3 ft. 4 in. in diameter with 1-1/2 in. square teeth on 3 in. centers. A smaller 10 in. diameter gear is centered on the drum shaft. A fragment of the donkey engine's boiler lays 14 ft. aft of the port side bow (Figure 22). A lumber port cover lays 15 ft. off the stern of the main wreckage.

Figure 20. The bilge pump, heavily encrusted with zebra mussels, lays forward of the bow. Photo by Great Lakes Shipwreck Research Foundation, Inc.

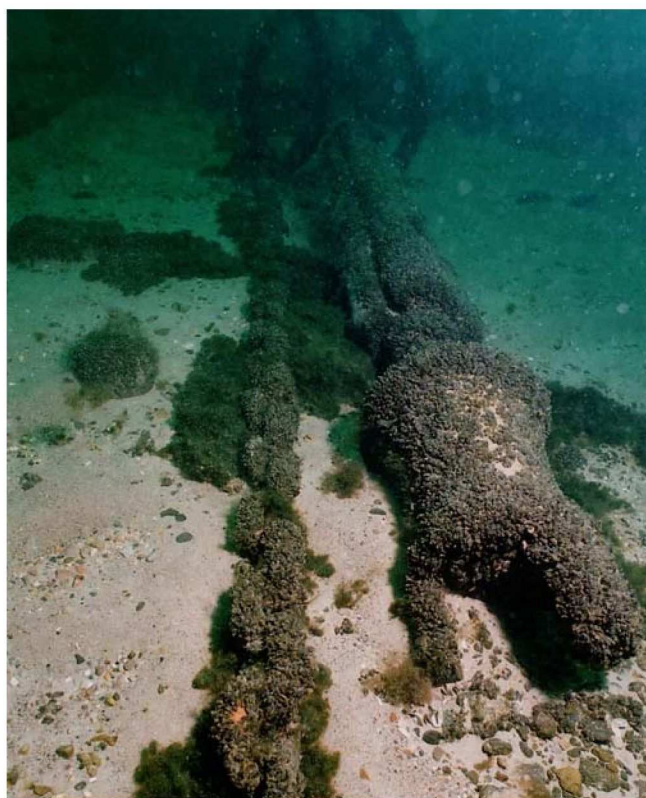
Figure 21. *Kate Kelly*'s winch drum and gear from the donkey engine. Photo by Tamara Thomsen.

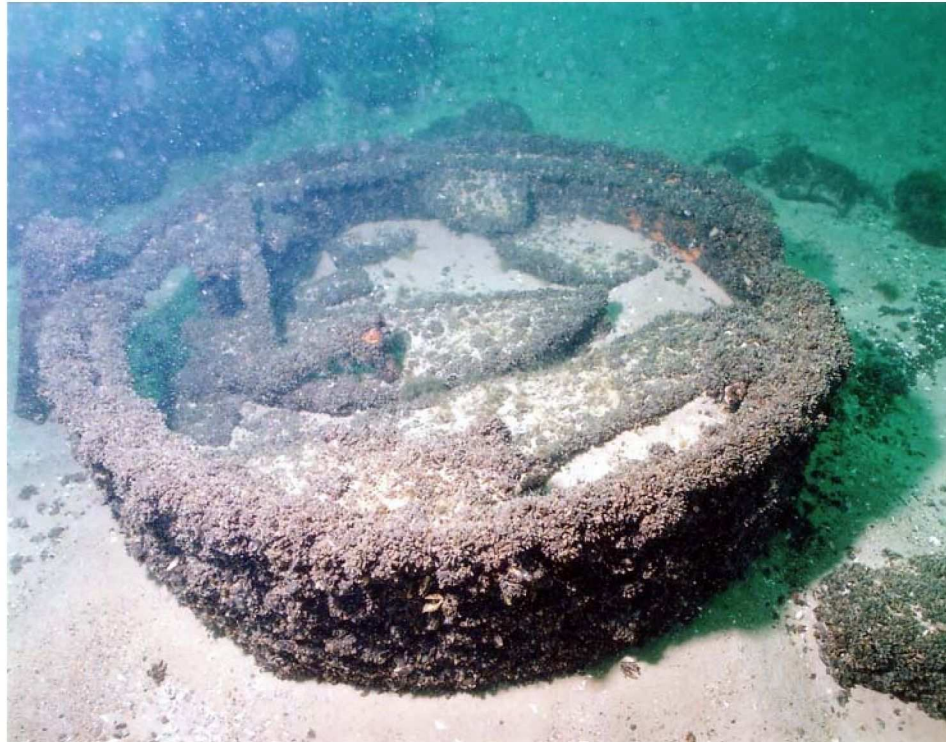
Figure 22. Donkey boiler fragment. Photo by Tamara Thomsen.

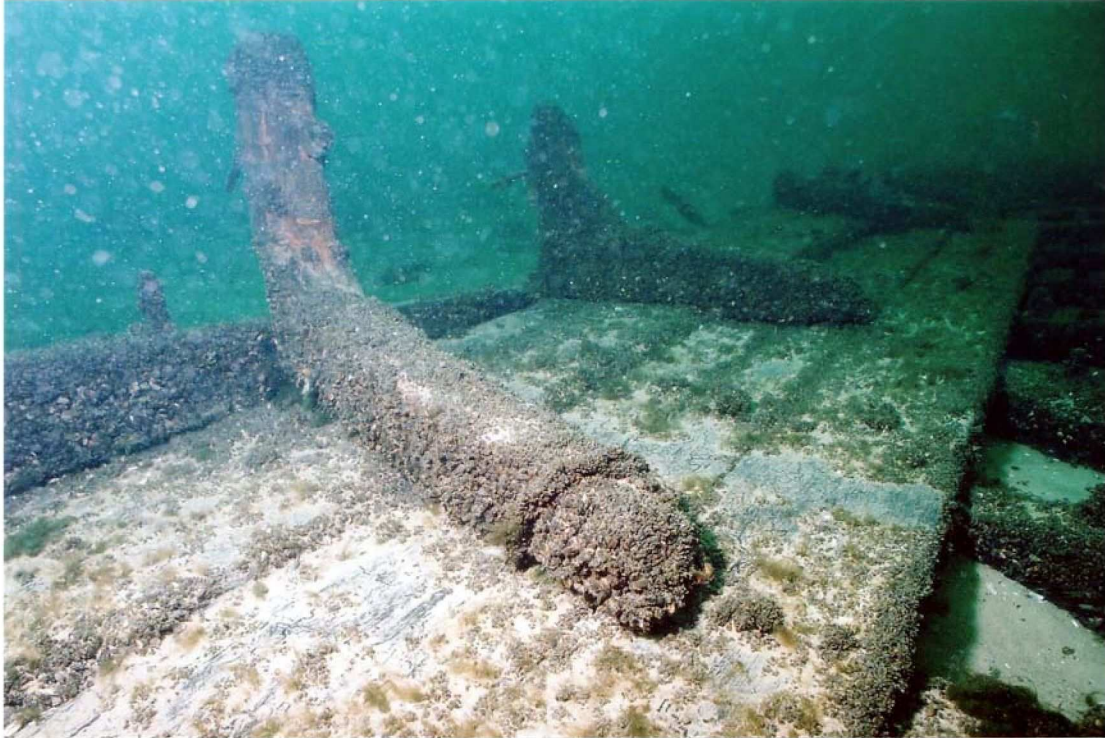
A large disarticulated hull section lays 250 feet off the main hull's port quarter. This section lays ceiling down on the lakebed, and measures 45 ft. 3 in. long by 10 ft. 2 in. tall. Fourteen outer hull planks are extant, 2 in. thick and varying in width from 6 to 8 in. Frames are spaced on 24 in. centers. It was impossible to determine whether this section was from the port or starboard side. A section of pipe 3 ft. 6 in. long and 3 in. in diameter is wedged between the outer hull planks nearest the main hull section.

Figure 23. Hanging knees on disarticulated hull side. Note iron reinforcing strap on bottom of hanging knee. Photo by Tamara Thomsen.
