New Hanover Banks: Then and Now

NEW HANOVER BANKS: THEN AND NOW
A GUIDE TO THE NEW HANOVER COUNTY BEACHES

SEA GRANT PUBLICATION UNC-SG-77-14 December 1977

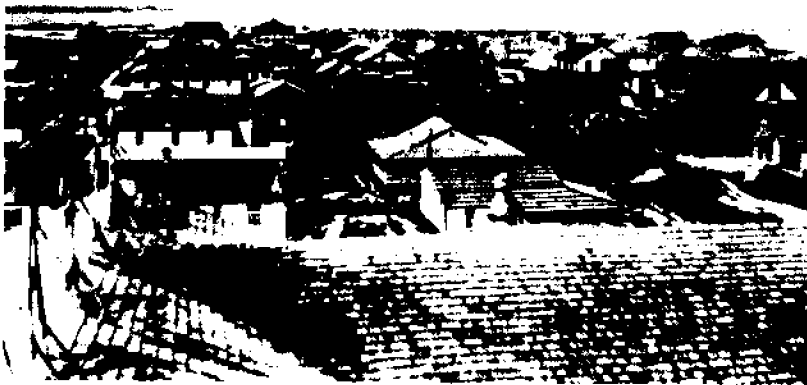
FIGURE 6. Northern section of Wrightsville Beach in the early 1920's. This photograph shows the island is already developed with many rows of cottages across the dune and grassland surface. Moores Inlet is visible in center of photograph. Moores Inlet, a major inlet at this time, has had a complex history of migration and closure. In the 1920's the inlet was as far south as Salisbury Street and Mercer's Pier. Shell Island is seen in the upper portion of the photo. (D. H. Barnett collection)

Parking meters and the median are located where the gorge of Moore's Inlet existed in 1920 (Figure 6). After the inlet migrated to the north, Mercer's Pier was built during the early 1940's. It has been rebuilt several times following destruction by coastal storms.

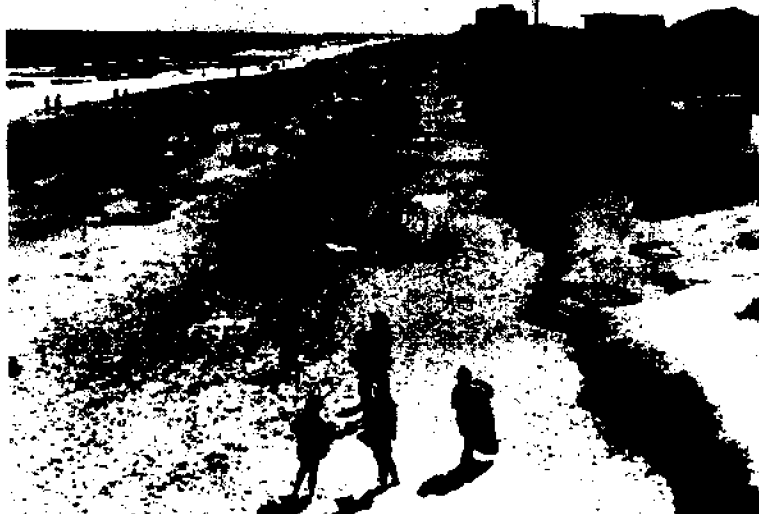
FIGURE 7. Artificial dune line south of Mercer's Pier, Wrightsville Beach. Note scarping and undercutting of artificial dune. Material comprising the "dune" consists of coarse shells and fine sand. Only the upper berm remains from the original 1965 Corp of Engineers Hurricane Protection Project. Station One Condominium is in the background.

The sloping section of the upper beach immediately in front of the lifeguard stand is the result of the recent grading (1976) of the artificial dune and berm. Note that the pilings in the fill material directly in front of the steps of Mercer's Pier are being undermined. You can see that the supports are exposed and abundant blackened oyster shells are strewn about the toe of the dune. Again note the relatively poor vegetation development on the berm and foredune (Figure 7 and 8).

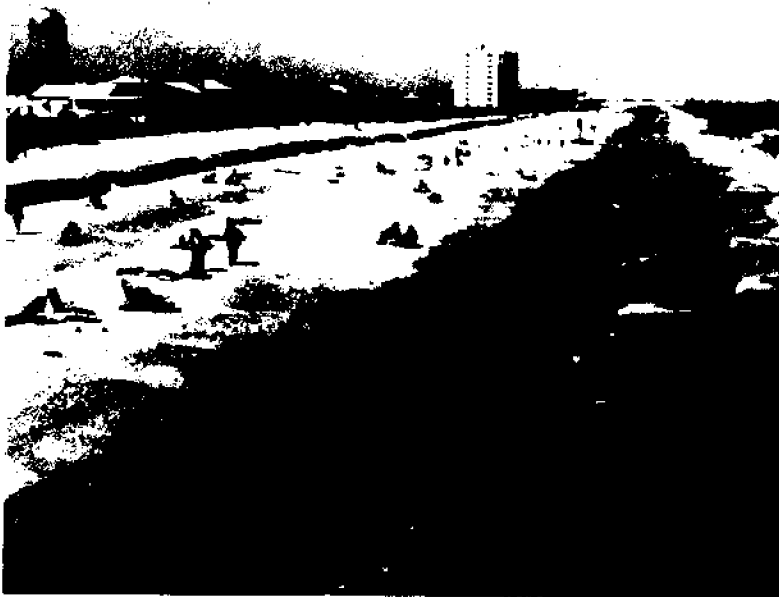
FIGURE 8. Artificial dune line north of Mercer's Pier, Wrightsville Beach. Note the position of the Holiday Inn and houses further north with respect to the scarped dune line. Coarse material on the beach face is derived from winnowing of fill material.

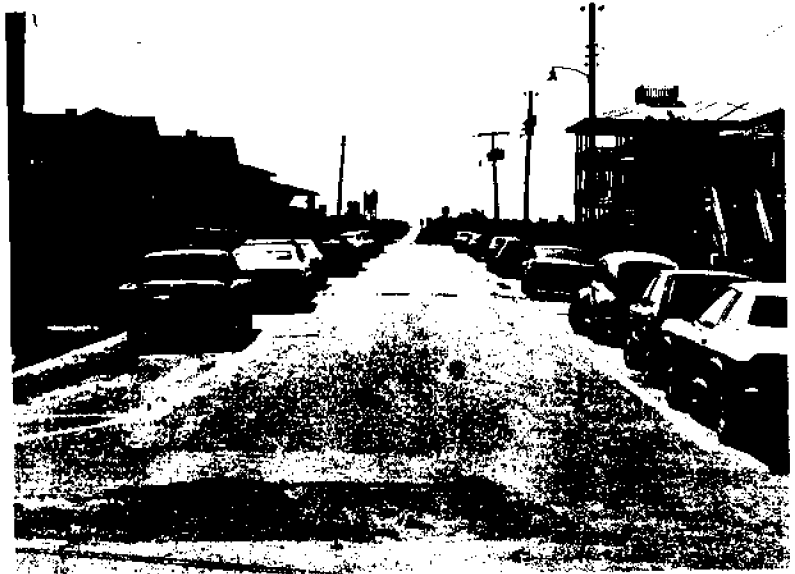
FIGURE 9. Typical side street, Wrightsville Beach, perpendicular to North Lumina Avenue. The artificial dune is seen in the background. Streets such as these will in time of a hurricane act as conduits for water and washover sediment.

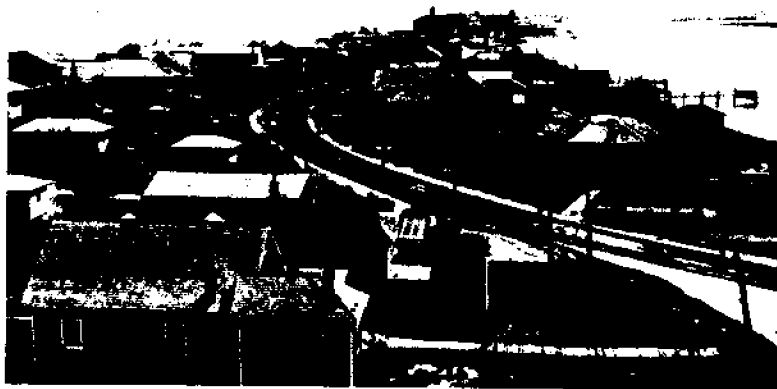
FIGURE 10. View looking south of Station #1 (Newells), Wrightsville Beach (ca 1920). Note the narrowness of the southern section of Wrightsville Beach. Cottages and hotels line the island from sound to ocean side. Tracks of the early trolley were laid within the dune swales. The old road bed of the early railroad underlies south Lumina Avenue. Banks Channel is seen on the right in the photo. Dredge spoil from this channel provided the material for construction of Waynick Blvd. and the artificial berm and dune (1965). (D. H. Barnett collection)

- 8.7 STOP 4. STATION ONE. *Park your vehicle south of Newell's or close to Station One. Again parking may be a problem. Directly west of here on the sound was the original footbridge that connected the Banks with the Hammocks (Harbor Island). The original bathhouses were located on the footbridge. Station One in the days of early beach development was the northern limit of Ocean View Beach, the first stop of the electric trolley on the Ocean View Railroad (Figure 10). It is now one of the newest condominiums.*

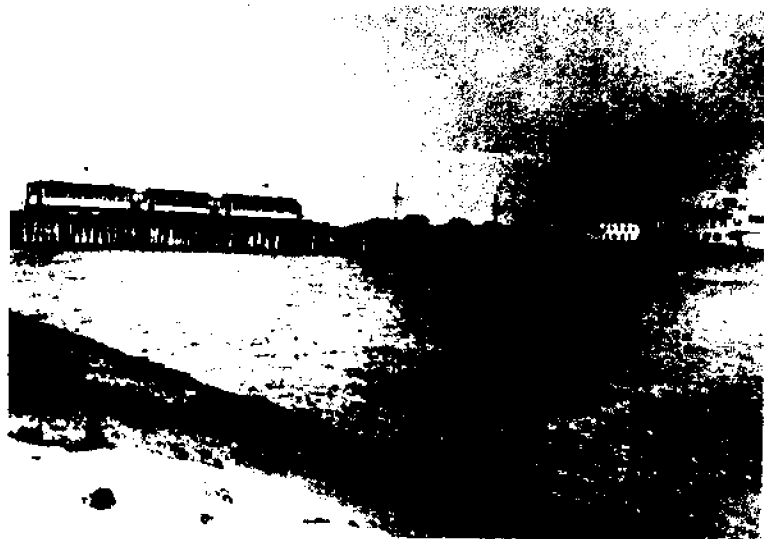
Figure 11. Early Banks Channel trestle, Wrightsville Beach. Trolley cars carried summer visitors to Wrightsville Beach (ca. 1920). The large hotel at right of photo is the Oceanic. The original timbers of the trestle were driven in 1889. The structure connected the Hammocks (Harbor Island) and Wrightsville Beach. (D. H. Barnett collection)

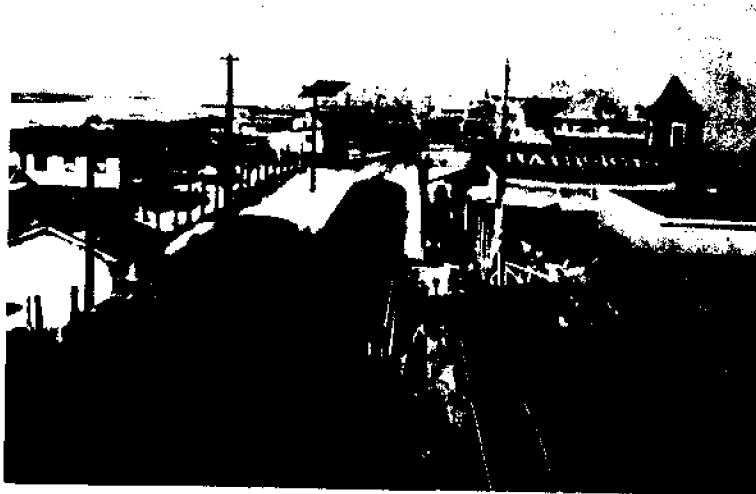
FIGURE 14. Station #7 (Lumina), Wrightsville Beach.
View is looking north along old electric trolley line.
Note the close spacing of the beach cottages, hotels
and bath houses even at this early date.
(D. H. Barnett collection, ca 1925)

The original Ocean View Railbed extended the length of South Lumina Blvd. from Station #1 (Newells) to Station #7 (the Lumina) (Figure 14). Just south of the Crystal Pier the first groin was installed on the Beach in 1923. Since the late 1800's the beach and dune line had eroded enough to warrant attention. The section south of the Lumina to the present location of Masonboro Inlet developed at a later date as the railbed was extended.

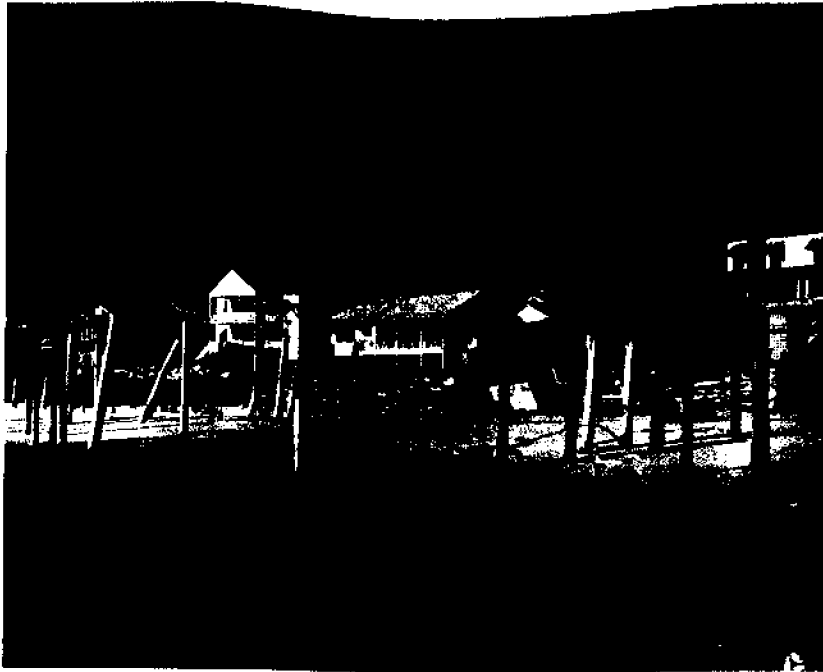
FIGURE 15. Aftermath of Hurricane Hazel (1954), Wrightsville Beach. Wreckage and pilings are remnants of the first two rows of beach cottages. The photograph was taken near the foot of Fayetteville Street. Hazel piled up water on the streets 8 feet above normal high tide. (E. Helms collection)

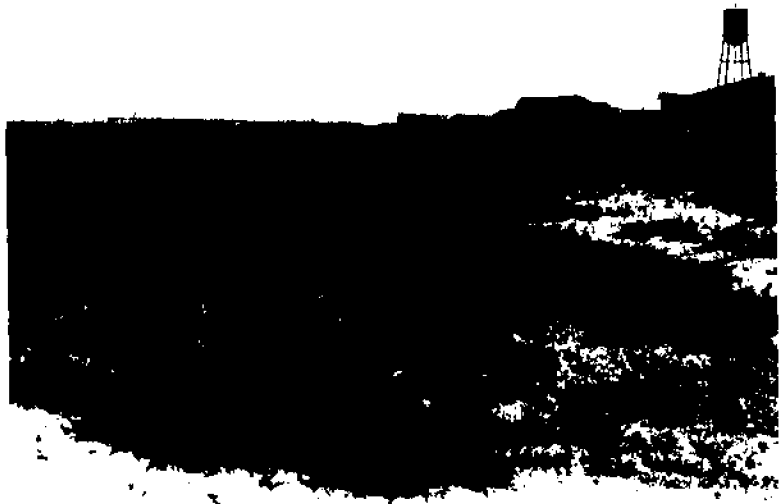
FIGURE 16. Hurricane Protection Project, Wrightsville Beach. This view is south from the Blockade Runner Motel. The swale (arrow) in front of the houses on the right was the beach before the project was undertaken. The houses are those left standing after Hurricane Hazel in 1954. A row further seaward was obliterated by the storm.

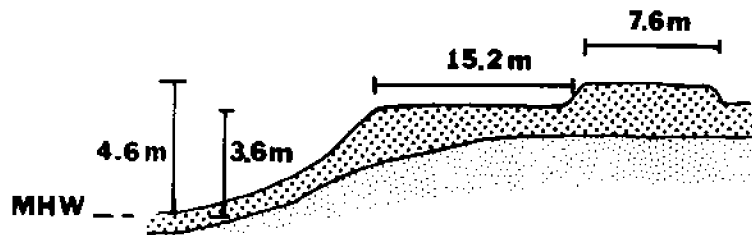
FIGURE 17. A diagrammatic representation of the beach-berm Project for Wrightsville and Carolina Beaches. The plan called for 2 large berms with fill material added seaward to approximate the natural slope of the beach.

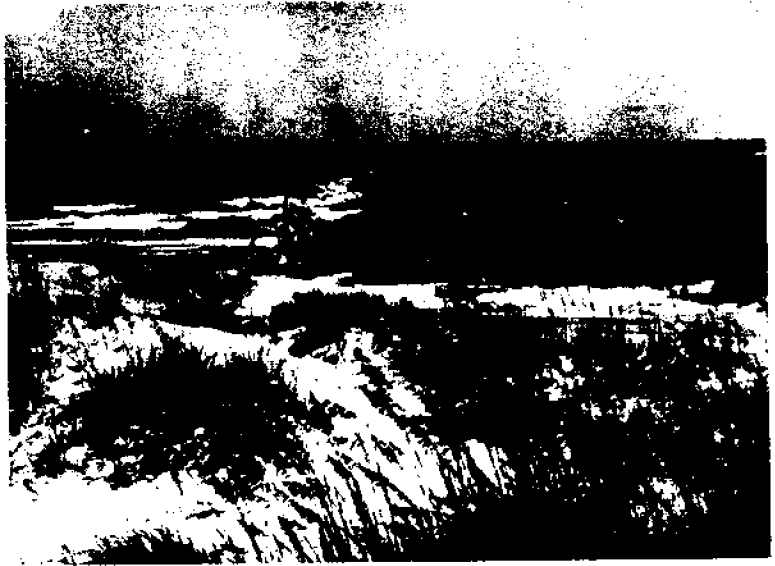
FIGURE 18. The Wier Jetty at Masonboro Inlet. The jetty built as part of the Masonboro Inlet stabilization project has served to impound sand on the updrift side (left). As a result of this impoundment the southern end of Wrightsville Beach is slowly prograding. The inlet channel has shifted and is generally migrating toward the rock wall. Plans call for a second jetty to be constructed on Masonboro Island in an effort to stabilize the channel.

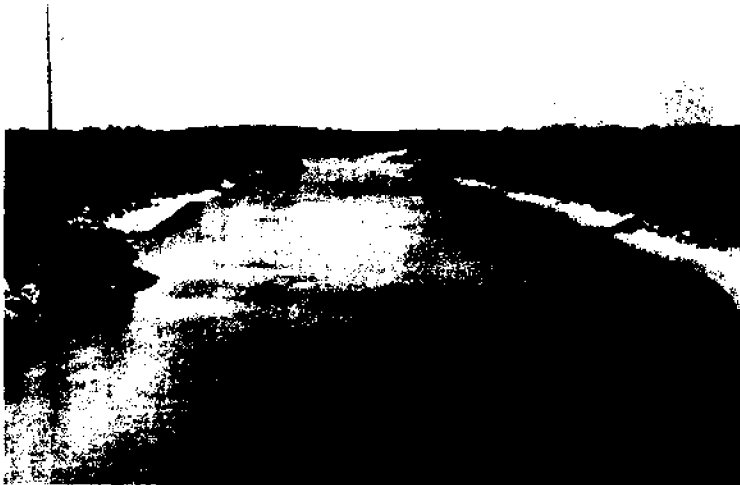
FIGURE 19. Snow's Cut and the Cape Fear River. This view is from atop the Inland Waterway Bridge. Coquina limestone outcrops in this cut along both banks. This late Pleistocene deposit was used in the early development of Carolina and Kure Beaches as a building material.

You are now passing over Snow's Cut, a land cut across the narrow peninsular section of New Hanover County. The cut is named after a major with the U. S. Army Corps of Engineers who was stationed in Wilmington and headed the dredging operation at Federal Point in the early 1930's. The earlier highway was located to the west. It was completed in 1929. During the late 1950's, the low swing bridge over U. S. 421 was replaced by the existing high rise bridge. To the left is Carolina Beach extension and the ocean. To the right is the Cape Fear River (Figure 19).

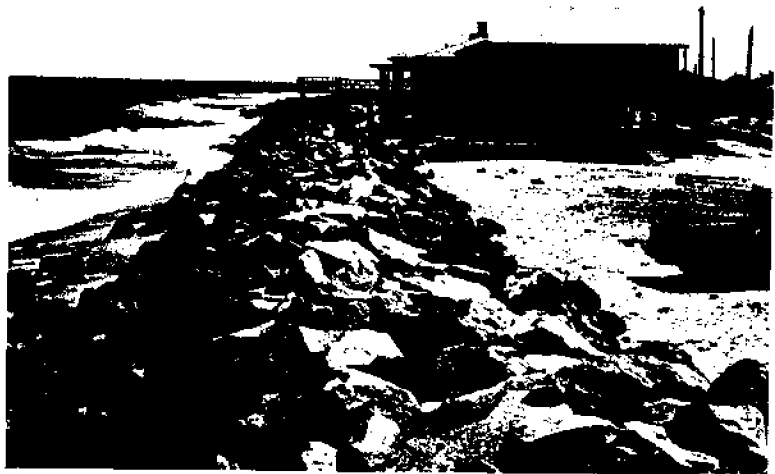
FIGURE 21. Beach stabilization project, Carolina Beach. This view is looking south from the pier on the northern extension of Carolina Beach. The beach has had an expensive record of beach stabilization projects (see text). The granite boulders that comprise the 2050' long seawall were emplaced between 1970 and 1973.

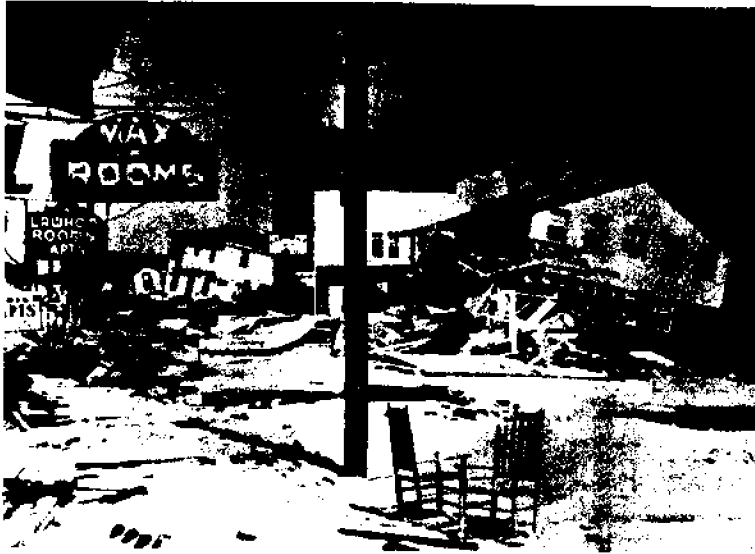
FIGURE 22. Damage caused by Hurricane Hazel (1954) at Carolina Beach. Damage by Hurricane Hazel was estimated at 17 million dollars. Note houses, sand, and rubble deposited by storm surges accompanying the hurricane. (A. Newton collection)

"Cottages nearest the ocean were smashed to pieces or lifted intact from their foundations and hurled against nearby cottages. The ocean face only was ripped from many cottages, while others had both front and rear ripped off, leaving only the shell. Boardwalks and piers were torn apart, with piles being twisted off. Sand, washed inland, was deposited 3 and 4 feet deep in the streets."

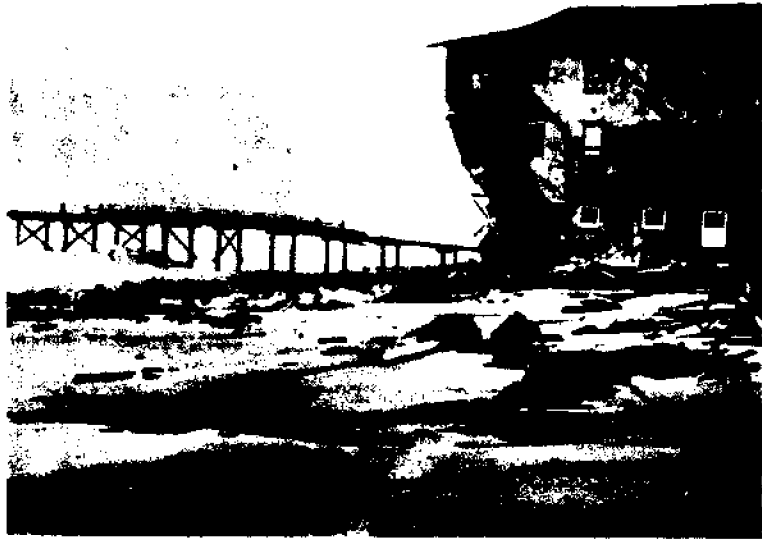
FIGURE 24. Breakers Hotel, Wilmington Beach. This portion of the mainland beach suffered severe damage. Red brick rubble from the Breakers now lines the shoreline at Fort Fisher. (A. Newton collection)

Hurricane Hazel destroyed the first brick hotel, the Breakers, built on the shoreline in 1924. It was located at the corner of Ocean Blvd. and South Carolina Ave. (Figure 24). The debris and piles of rubble from

the Breakers Hotel were hauled to Fort Fisher to help curb the erosion there.

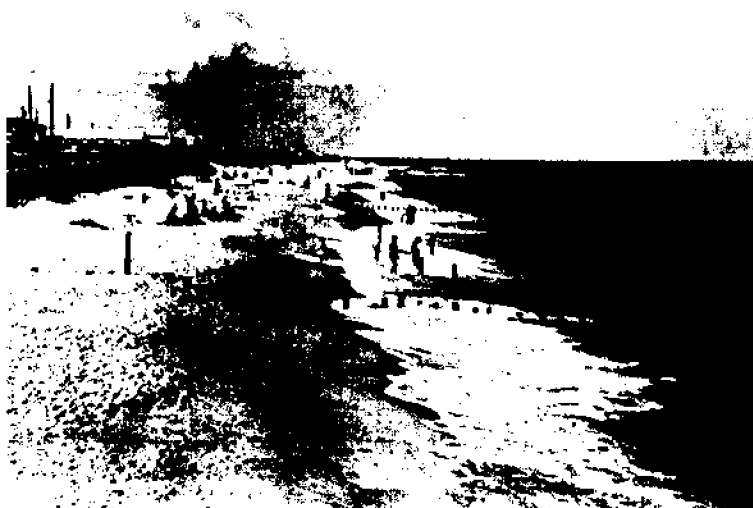
FIGURE 25. Groins and bulkhead, Kure Beach. Note bulkhead, remnants of groins and condition of berm. Hurricane Hazel (Oct. 1954) removed one row of houses from this section of the mainland and unearthed a relict stump forest.

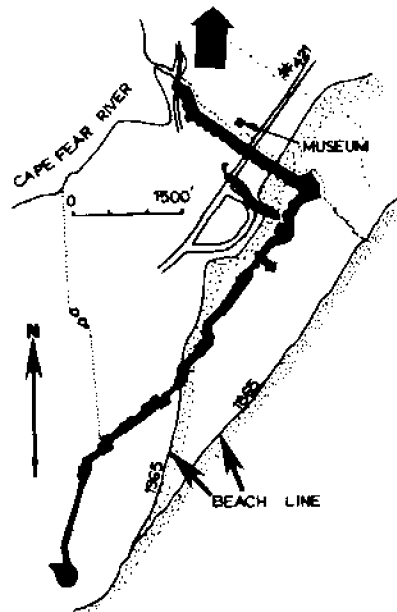
FIGURE 26. Map of Fort Fisher showing the location of the 1865 and 1965 shorelines. (Modified from Division of Archives and History Pamphlet 90M-6/75).

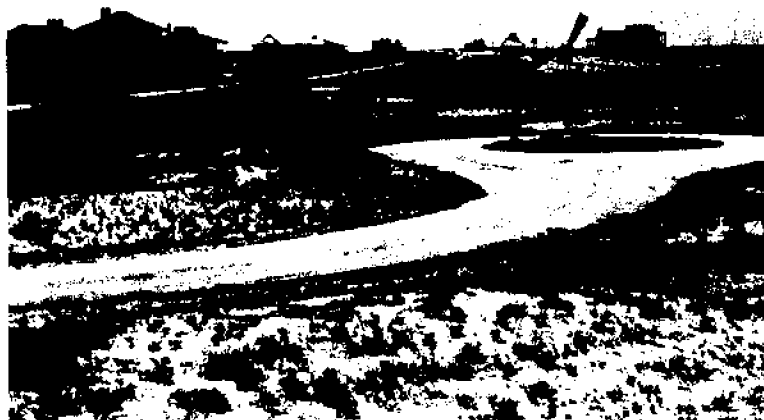
FIGURE 30. View looking south, Figure Eight Island. The large dunes (arrow) mark the location of Mason Inlet in 1938. Notice the sparse vegetation. The area shown in the photograph is primarily fill material pumped onto former low sandy flats. Emplacement of the fill provided elevated sites for home construction and created navigable waterways for homeowners.

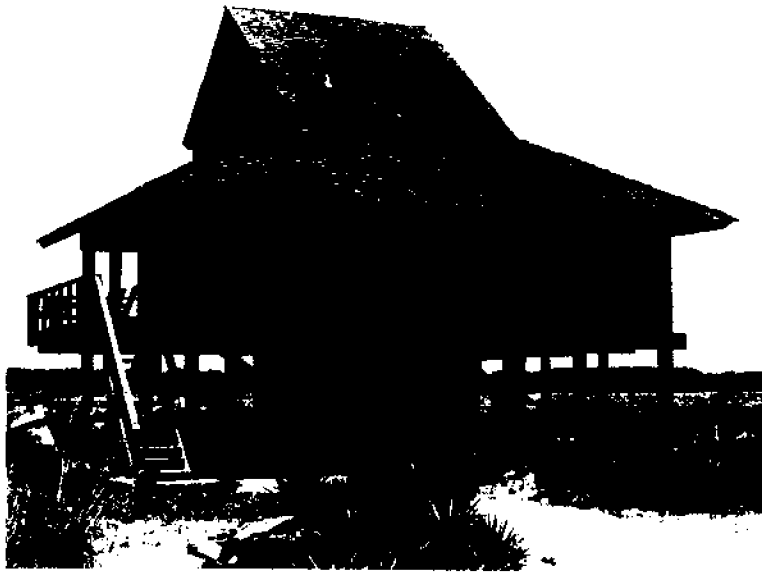
FIGURE 31. The Bay house. The Bay house is an example of a well-constructed beach home. It is built so that the pilings are continuous from the ground through the second story. In more poorly constructed buildings, the upper story is attached to the tops of pilings, allowing strong winds and/or waves to literally 'rip the house from its foundation'.

The developers of Figure 8 Island placed a large amount of fill on the beach berm to help stabilize the former inlet area. Houses placed here are now 4.3 m (14 feet) above mean sea level. In general, the combination of factors present on this end of the island make it a poor area for development. It is doubtful that the pumped-fill buildup will prevent washover. Perhaps it is appropriate that the less "exclusive" cottages are at this end of the island. Examples of good construction can be found, however, such as the cottage on the right at the corner of Beach Road and Jib which has external stilt posts that extend through the upper level. (Figure 31).
