By Stanley R. Riggs and Dorothea V. Ames  
Published by North Carolina Sea Grant

## DROWNING THE NORTH CAROLINA COAST: Sea-Level Rise and Estuarine Dynamics

**ON THE FRONT COVER.** *Pre-Hurricane Isabel photograph of the lower portion of sediment bluff that occurs along the Chowan River estuary western shoreline. The red star, on the satellite image inside the back cover, indicates the specific site location. This bluff is approximately 75 feet high and consists of a lower clay bed that is about 30 feet thick (to the top of this photograph), with an overlying sand bed that is 45 to 50 feet thick. Because bluff shorelines normally erode at average rates between  $-2.0$  and  $-2.5$  ft/yr (Table 8-1-3) and because the lower sediment bank is composed of clay, there is no sand beach preserved on the eroded wave-cut scarp and platform (Fig. 4-2-1). Notice the red dotted line along the wave-cut scarp and compare this to the respective location on the post-Hurricane Isabel photograph on the back cover. Photograph was taken in August 2003. See the back cover for the post-Hurricane Isabel photograph of the same site and inside back cover for a satellite image showing the site location an

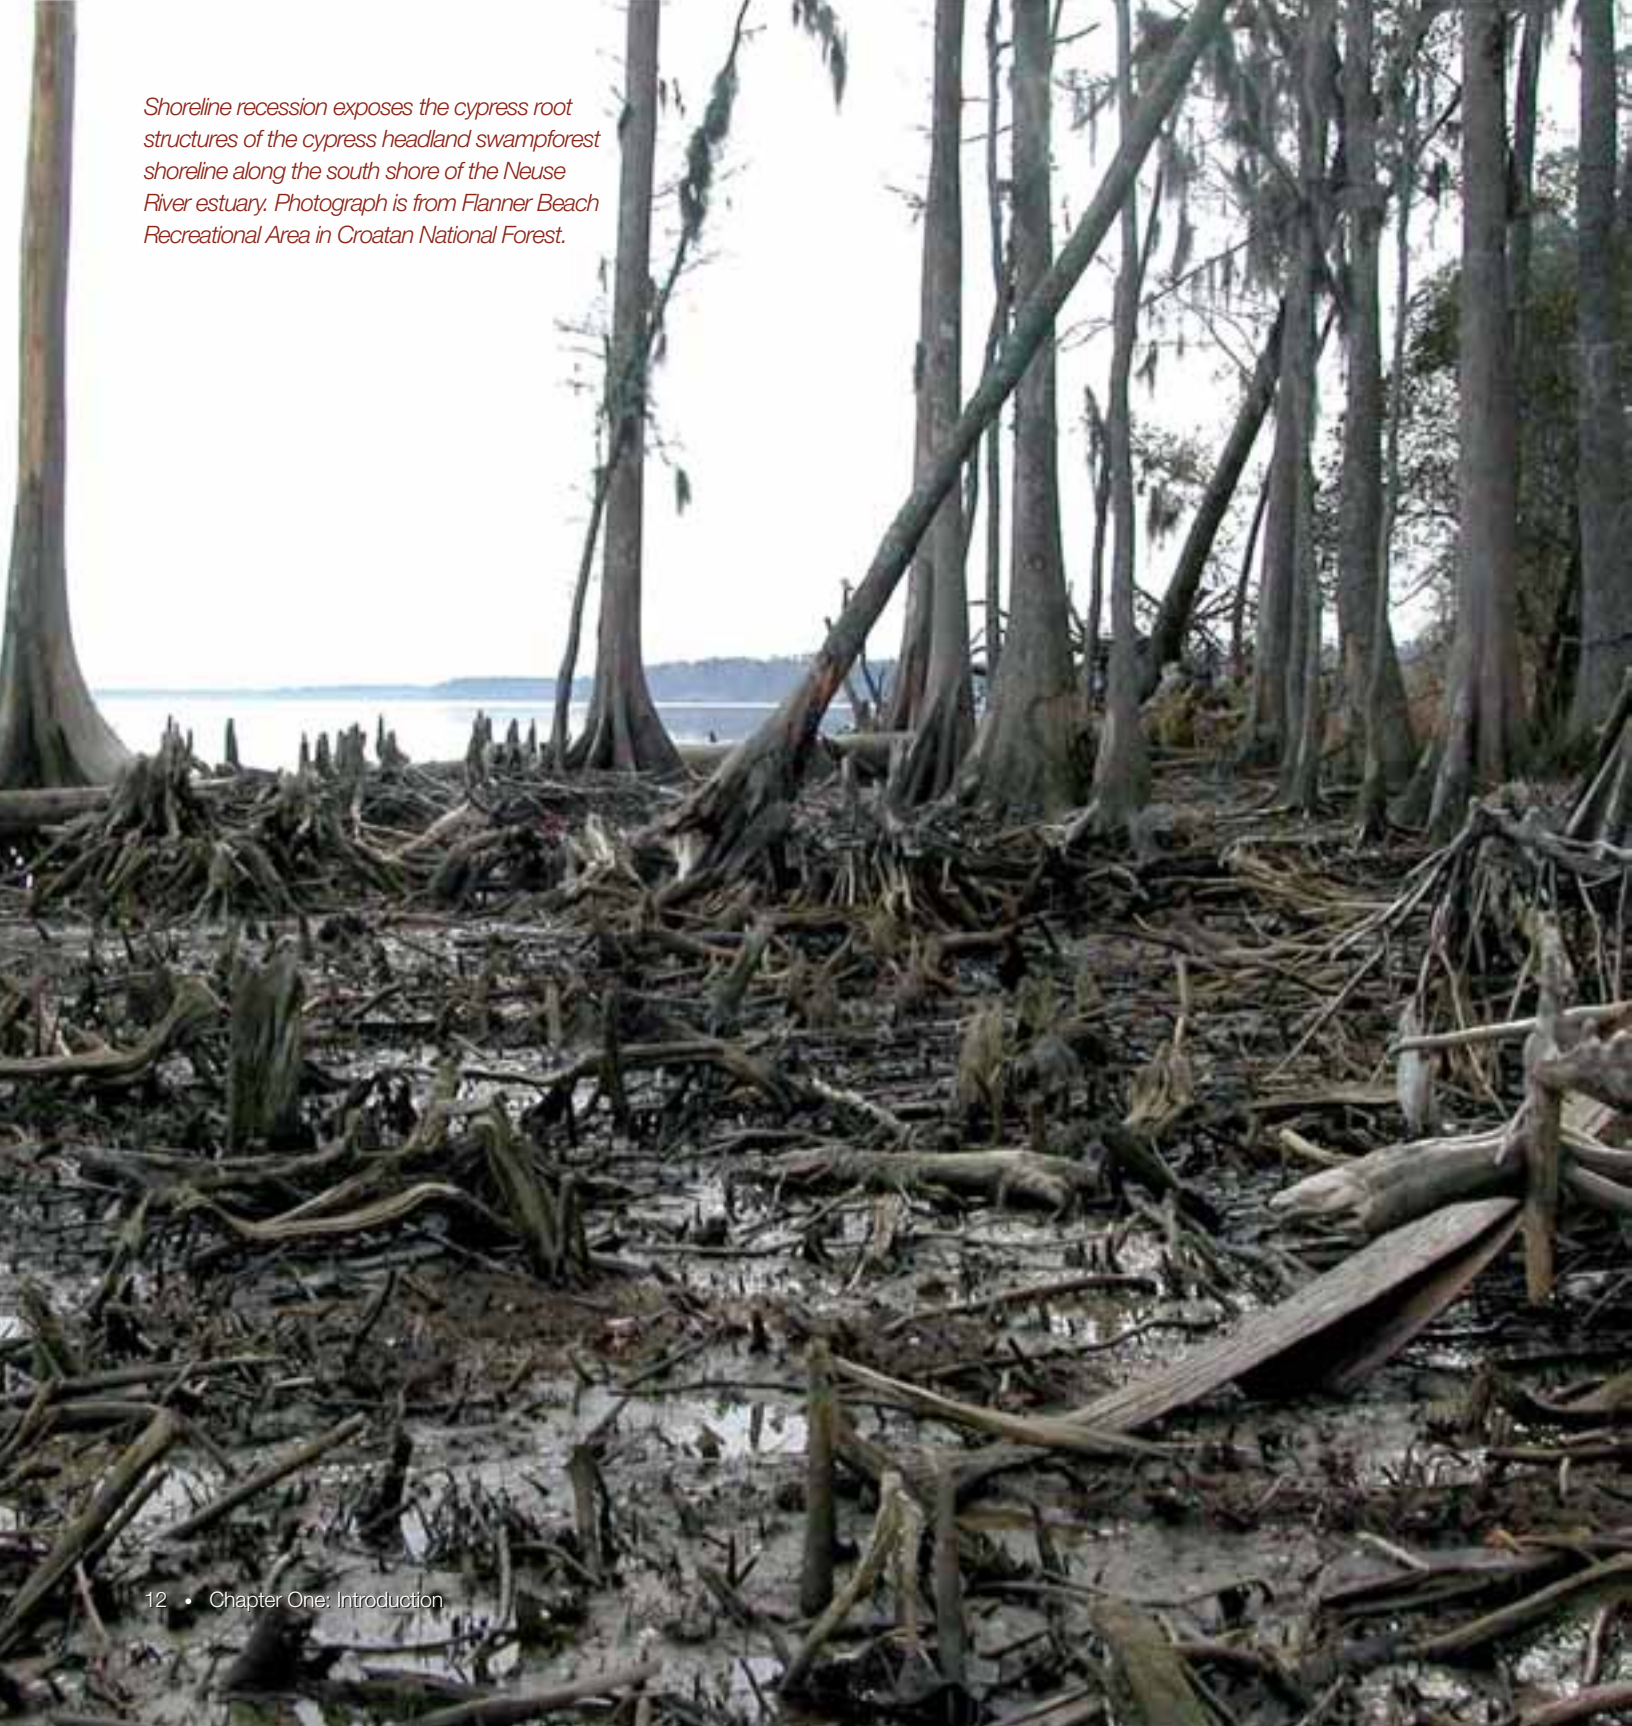
*Shoreline recession exposes the cypress root structures of the cypress headland swampforest shoreline along the south shore of the Neuse River estuary. Photograph is from Flanner Beach Recreational Area in Croatan National Forest.*

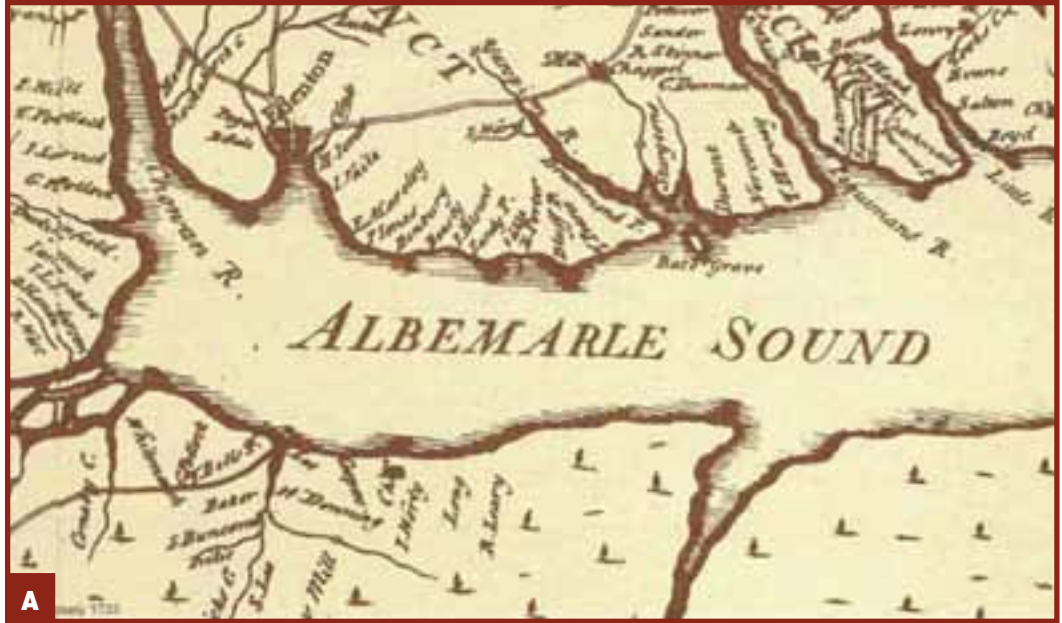
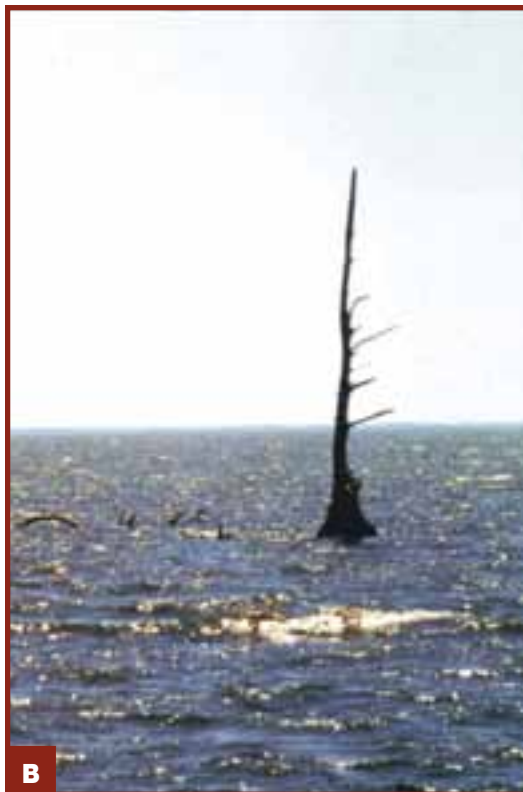
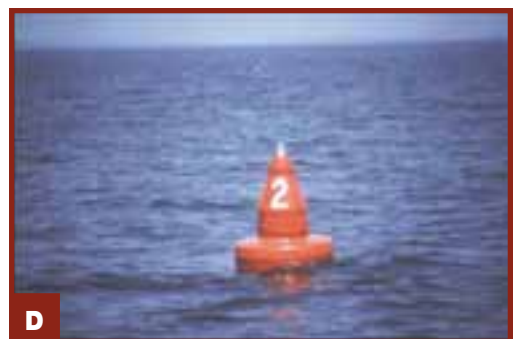
**FIGURE 1-1-1.**

**Panel C.** Portion of the National Oceanographic and Atmospheric Administration (NOAA) Nautical Chart 12205, Page E, 1976, showing the former location of Batts Grave. The area shaded in blue represents less than 6-foot water depth. The area outlined in red is the former location of Batts Grave, which is the seaward extension of Drummond Point as indicated by the dashed red lines. As sea level rises, water floods onto the land, and wave energy causes the shoreline to recede by erosion.

**Panel D.** Photograph in the early 1990s showing the red buoy that marks the shallow shoal remnants of Batts Grave.

In 1975, Bellis et al. used the demise of Batts Island in the Albemarle Sound to demonstrate ongoing estuarine shoreline erosion in direct response to the intimately coupled processes of wave action and rising sea level. This island, which occurred about 0.75 miles offshore of Drummond Point at the entrance to Yeopim River, first appeared on the 1657 Comberford map (Cumming, 1938) as Hariots Island. The island subsequently became the home of Captain Nathaniel Batts, the first Virginian to settle in the Albemarle region and the Governor of “Roan-oak.” The island is referred to as Batts Grave on the 1733 Moseley map (Cumming, 1966) (Fig. 1-1-1A). In 1749 the island consisted of 40 acres occupied by houses and orchards (Powell, 1968). Bellis et al. (1975) estimated that the island was about 10 acres in size on an 1849 U.S. Coast and Geodetic Survey bathymetric survey map. By the early 1970s, a lone cypress skeleton marked the total demise of the island as indicated on the 1976 nautical chart (Fig. 1-1-1B, 1C). By the early 1990s, only a red buoy marker reflected the presence of shallow shoals (Fig. 1-1-1D).

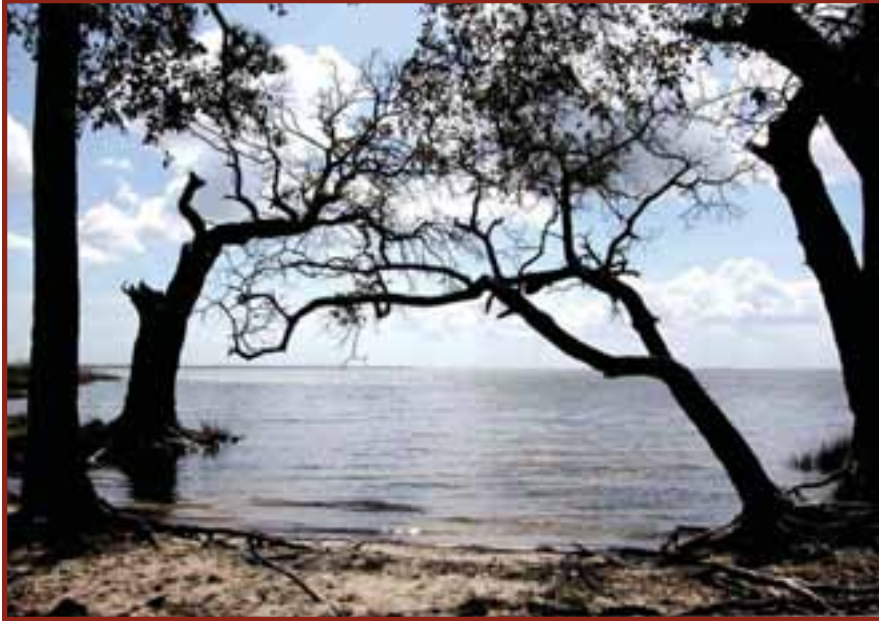
**FIGURE 1-1-2.** *A beautiful and serene coastal system on a clear and calm summer day produces the general public perception of estuarine shorelines. However, a closer look along most shorelines suggest other forces and processes at work over annual- to decadal-time scales and during short-term, high-energy storms when few people experience the shoreline. Notice that the shoreline in the foreground has receded, leaving a large oak tree to slowly drown offshore, and wave erosion at the shoreline has exposed the roots of two trees. These clues attest to the systematic rise in sea level that slowly moves upward and landward, eroding a shoreline as the former land surface is drowned. This photograph of a low sediment bank shoreline occurs along the back-barrier portion of Nags Head Woods.*

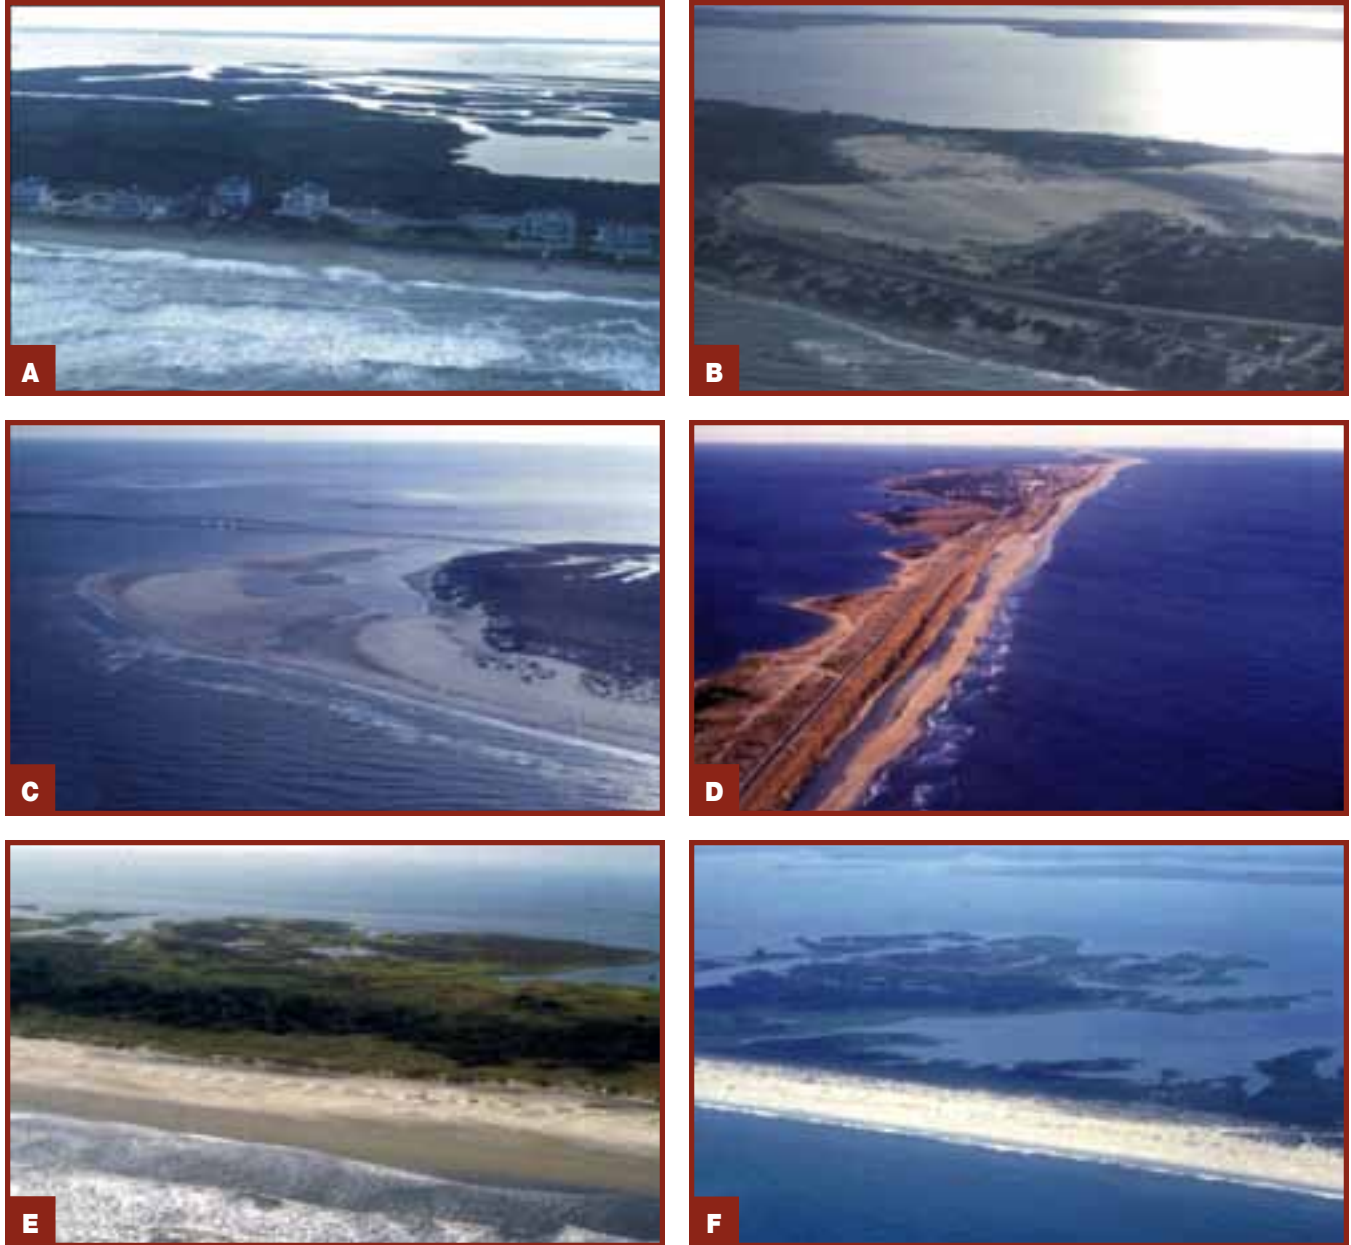
**FIGURE 3-3-1.** Oblique aerial photographs of back-barrier estuaries in the Northern Province. **PANEL A.** Photograph of Currituck Banks (1998) shows the back-barrier marshes and marsh shorelines that formed on the flood-tide delta of an historic inlet into Currituck Sound. This marsh shoreline erodes only slightly due to the shallow waters and moderate fetch of Currituck Sound. The Currituck County mainland is in the distance. **PANEL B.** The very wide barrier island at Nags Head (1991) contains Jockey's Ridge State Park. This back-barrier shoreline is open to the extremely large fetch of Albemarle Sound to the northwest, causing this stretch of low sediment bank shoreline in Roanoke Sound to be severely eroded. Roanoke Island is in the distance. **PANEL C.** This photograph (1991) looks through Oregon Inlet to the extensive, barely emergent sand flats associated with the inlet's flood-tide delta. If Oregon Inlet closed, these sand flats would quickly revert to salt marsh similar to Figure 3-3-1A. The vast Pamlico Sound extends southwest into the distance. **PANEL D.** The very narrow, overwash dominated barrier island segment (1991) between

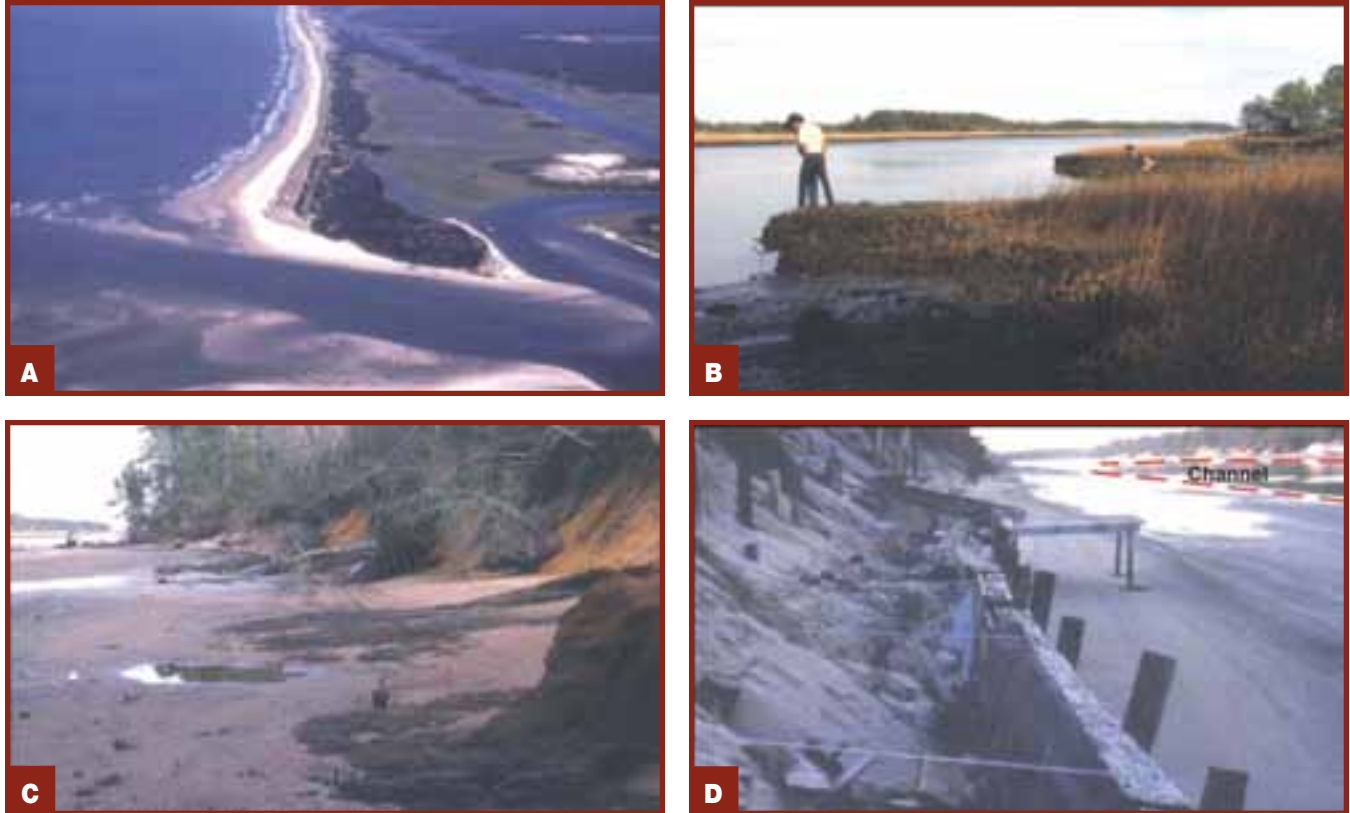
**FIGURE 3-3-4.** Photographs of shoreline erosion along the Intracoastal Waterway (ICWW) channel. **PANEL A.** Oblique aerial photograph of the east side of Onslow Beach and Browns Inlet in Figure 3-3-3 showing the ICWW cutting through the estuarine marsh (light green-colored vegetation) behind Onslow Beach in the foreground and the Pleistocene subaerial headland (dark green-colored vegetation) in the background. Notice the string of old, high and circular dredge spoil piles and the active, irregular-shaped dredge disposal site along the left side of the ICWW and covered with upland vegetation (dark green-colored). **PANEL B.** Photograph of the eroding estuarine marsh shoreline along the ICWW at low astronomical tide. Notice that at this tide level, boat wakes will erode the soft peat beneath the tough modern marsh root mass, producing a severe undercut peat block that will ultimately break off. **PANEL C.** Photograph of an eroding low to high sediment bank shoreline along the ICWW at low astronomical tide. Shoreline erosion will not take place during this tide level as the wave energy is expended on the very broad strandplain beach. However, during high tide, the boat wakes break directly on the base of the wave-cut cliff, severely eroding the bank with the ultimate failure of large slump blocks and associated trees. Notice the Pleistocene iron-cemented sandstone in the foreground that is slightly more resistant to the erosional process. **PANEL D.** Photograph similar to Panel C with a desperate, but unsuccessful effort to stop the erosional process. Assuming that the steps in the background are four feet wide, this shoreline has receded approximately 100 feet since the ICWW was cut in the 1930s, resulting in an erosion rate of about 1 to 2 feet per year.

Many of these southern trunk estuaries are partially cut off from the back-barrier estuaries as a result of human activities. Construction of the ICCW and associated navigational channels resulted in an extensive network of dredge-spoil piles that have greatly modified the water flow (Figs. 3-3-3, 3-3-4A). In addition, some trunk estuaries, such as the North River, have bridges that act as partial dams and restrict current flow. These changes have dampened the oceanic influence, resulting in estuaries that are not as well mixed as the back-barrier estuaries and with a significantly decreased influence of salt water and regular astronomical tides. Consequently, the waters grade over short distances — from high-brackish salinity on the ocean side, to low-brackish and fresh water away from the coast.

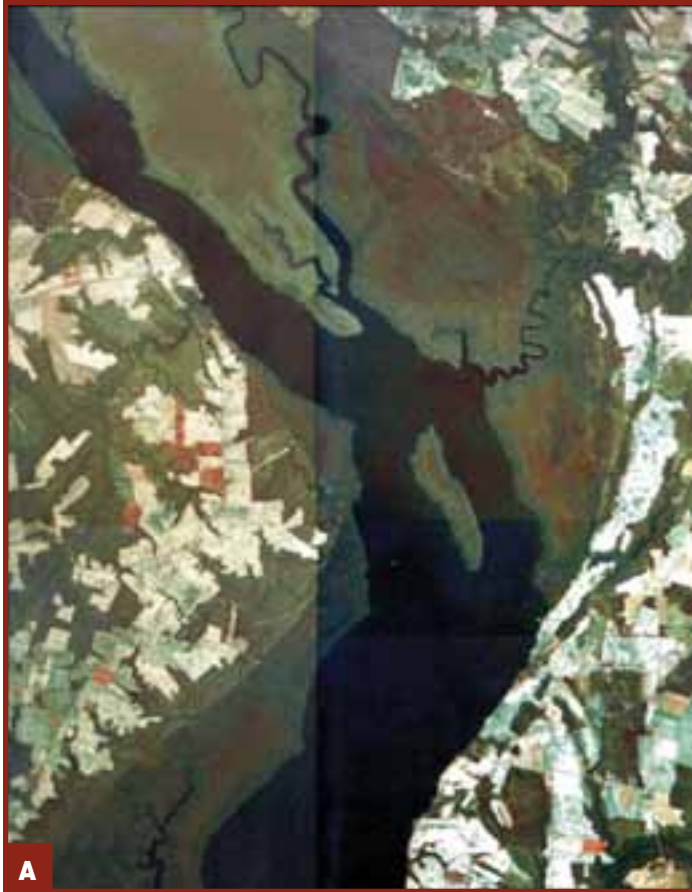
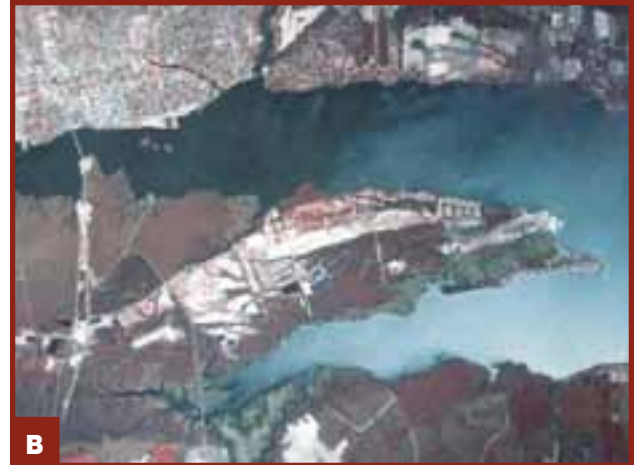
**FIGURE 3-4-1.** Two infrared aerial photograph mosaics of the riverine-estuarine transition zone. Photographs were flown by the High Altitude Program of the U.S. Department of Agriculture. See Figure 2-1-3 for the location of these panels. **PANEL A.** Aerial photograph (4/1/1982) of the Chowan River. Notice that the swampforest shoreline of the floodplain is being eroded by the systematic drowning of the swampforest vegetation in response to ongoing sea-level rise. **PANEL B.** Aerial photograph (3/29/1982) of the Tar-Pamlico rivers. Notice that the swampforest shoreline of the floodplain is being eroded by the systematic drowning of the swampforest vegetation in response to ongoing sea-level rise.

The transition zone from river to estuary (Fig. 3-4-1) occurs in a broad zone where the river valley reaches sea level and is flooded by estuarine waters. Within this broad transition zone, riverine processes give way to estuarine processes. Due to the low sloping land in the Northern Province, coastal flooding occurs far upstream, producing the deeply embayed estuarine system. Considering all of the trunk estuaries and associated tributaries that have been flooded by sea level, North Carolina has over 3,000 miles of estuarine shoreline within the Northern Province alone (Fig. 2-1-3).

etc.) and occur within the fresh water, riverine floodplains of the uppermost portions of trunk and tributary estuaries (Fig. 3-4-1). As sea level rises, the lower portions of riverine floodplains become permanently flooded, causing the shrubs and trees to become stressed and die by drowning and producing a swampforest shoreline (Fig. 4-3-1). The vegetation that is least tolerant of flooding dies off first, leaving the most tolerant, the elegant cypress, to stand as lonely sentinels in open water beyond the shoreline (Fig. 4-3-2). This produces one of the most characteristic and beautiful sights within the North Carolina estuarine system. Ultimately,

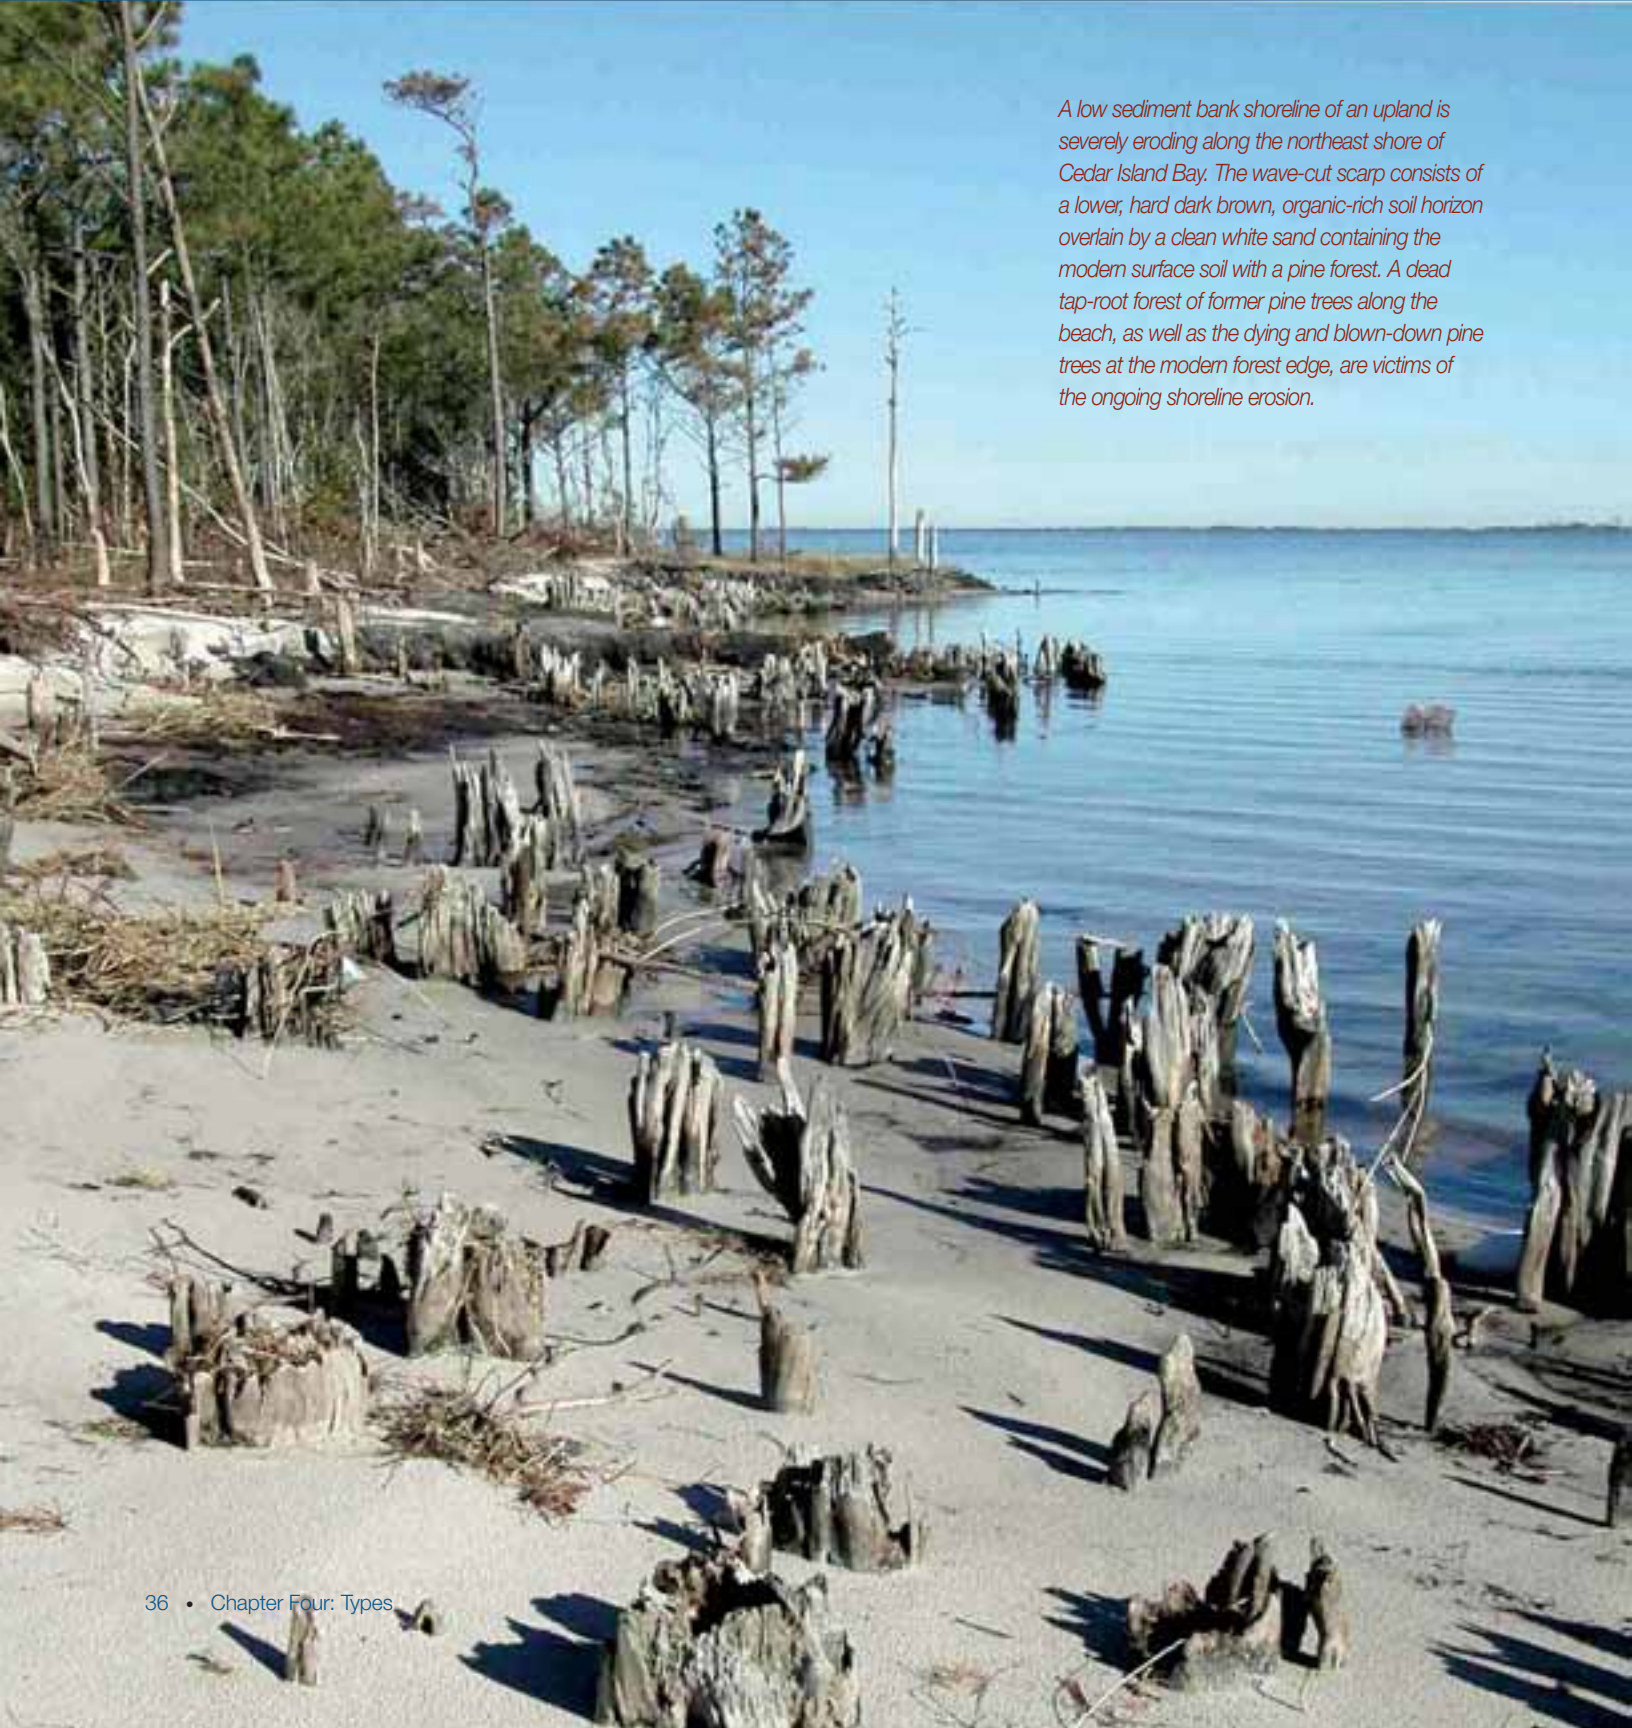
*A low sediment bank shoreline of an upland is severely eroding along the northeast shore of Cedar Island Bay. The wave-cut scarp consists of a lower, hard dark brown, organic-rich soil horizon overlain by a clean white sand containing the modern surface soil with a pine forest. A dead tap-root forest of former pine trees along the beach, as well as the dying and blown-down pine trees at the modern forest edge, are victims of the ongoing shoreline erosion.*

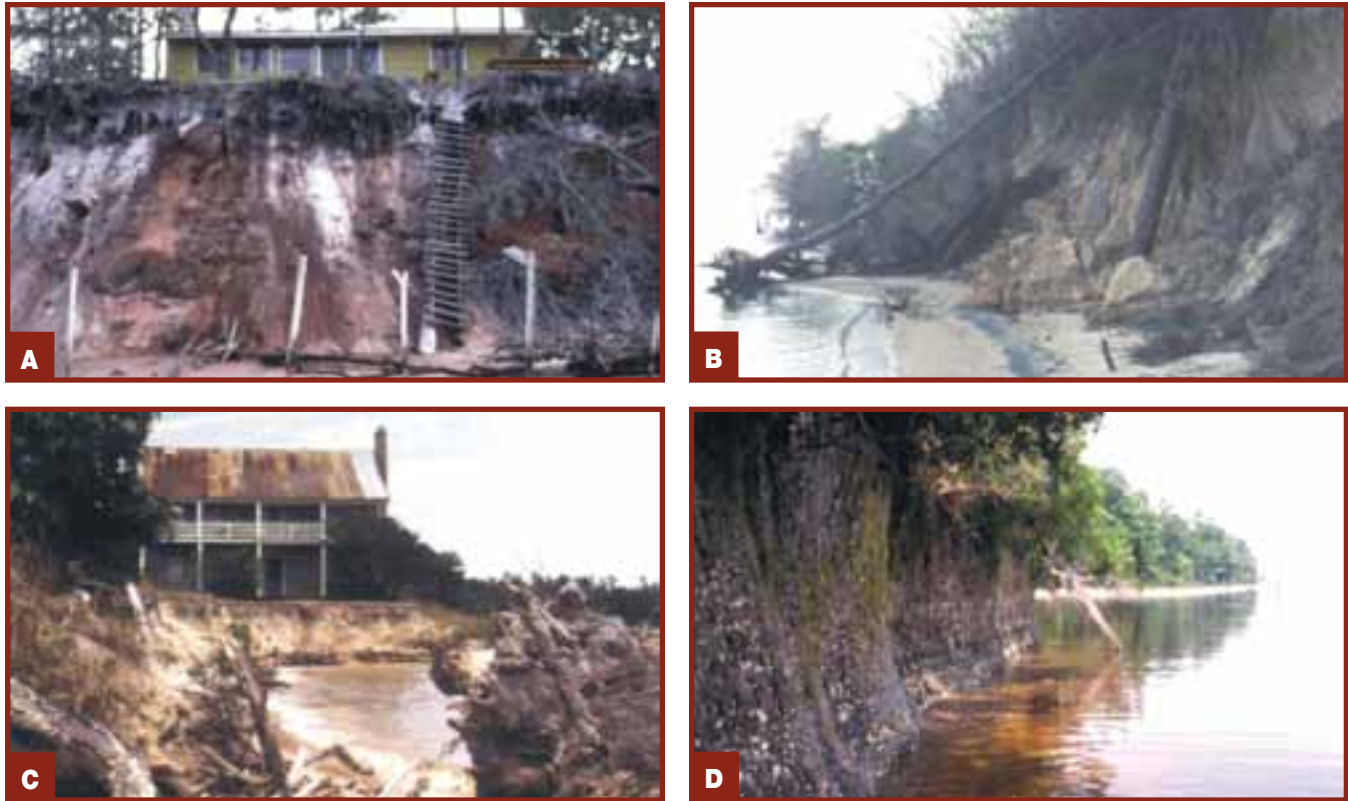
**FIGURE 4-2-2.** Photographs of eroding bluff and high sediment bank estuarine shorelines. **PANEL A.** A bluff sediment bank is actively eroding due to the sand composition of the bluff. The wave-cut scarp is dominated by continuous slumping and reworking into an extensive strandplain beach. **PANEL B.** A high sediment bank shoreline is actively eroding. Notice that erosion was not taking place at the time of the photograph when winds were not blowing, and water level was normal. Large slump blocks, with trees on top, have collapsed onto the beach and are being reworked into a strandplain beach. The trees ultimately will be laid down and act as natural groins to help trap and hold the beach sands in place. **PANEL C.** A high sediment bank shoreline is actively eroding, as indicated by the location of the colonial farmhouse, which was probably not built on the waters edge. Notice that the size of strandplain beach decreases as the wave-cut scarp height and sand volume decreases. **PANEL D.** This high sediment bank shoreline is composed of a very tight, fossiliferous, blue mud and consequently is eroding very slowly. Since this is a slowly receding mud bank, there is not an adequate source of sand to build a strandplain beach.

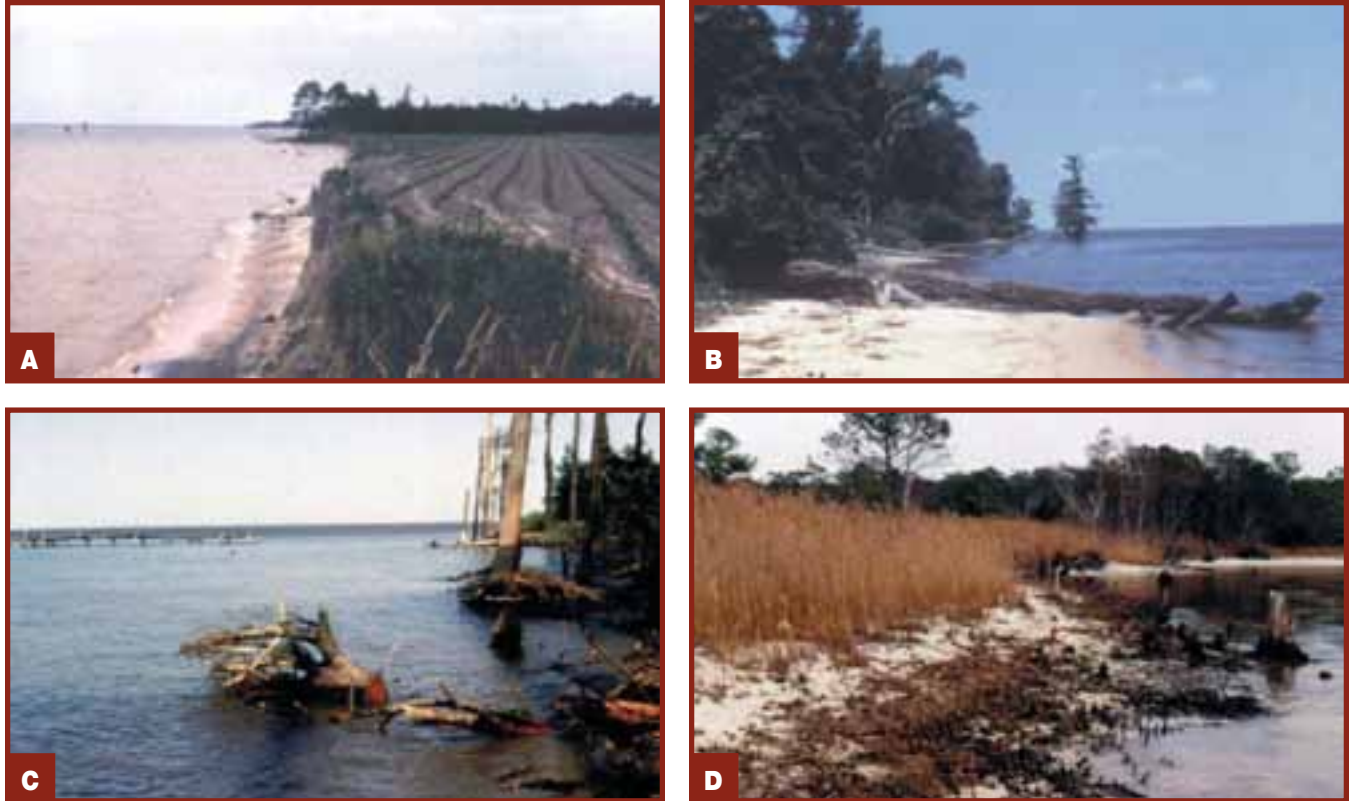
**FIGURE 4-2-3.** Photographs of low sediment bank shorelines. **PANEL A.** An actively eroding low sediment bank. The size of the strandplain beach has decreased significantly as the height of the wave-cut scarp has decreased (see Figure 4-2-2). Notice that the rate of erosion is so high that the tractor turning area has been eliminated since the crop was planted. **PANEL B.** A segment of low sediment bank that is stabilized by a heavy growth of vegetation. The sand that forms the strandplain beach was derived from adjacent properties after the banks were cleared for development. Notice how the amount of sand dramatically diminishes into the background and the role of tree trunks as natural groins in trapping and holding the beach sand. **PANEL C.** An actively eroding low sediment bank that is too small to produce a wave-cut scarp and there is no sand available in the bank to produce a strandplain beach. Consequently, the muddy sediment is slowly washed out from around the trees, leaving the pine forest ghosts and their many stumps standing in shallow water. **PANEL D.** A low sediment bank that is being converted to a freshwater marsh in response to the ongoing rise in sea level. The soil upon which the pines and live oak were growing has been buried by a thin layer of peat produced by the freshwater grasses. Ongoing shoreline recession produced minimal amounts of sand for development of a minor strandplain beach and has left stumps exposed in the shoreface.

mud, there probably won't be any sediment from which to build a beach (Fig. 4-2-3D). In this case, the wave-cut platform will consist of indurated rock or compacted clay that is exposed directly to wave action.

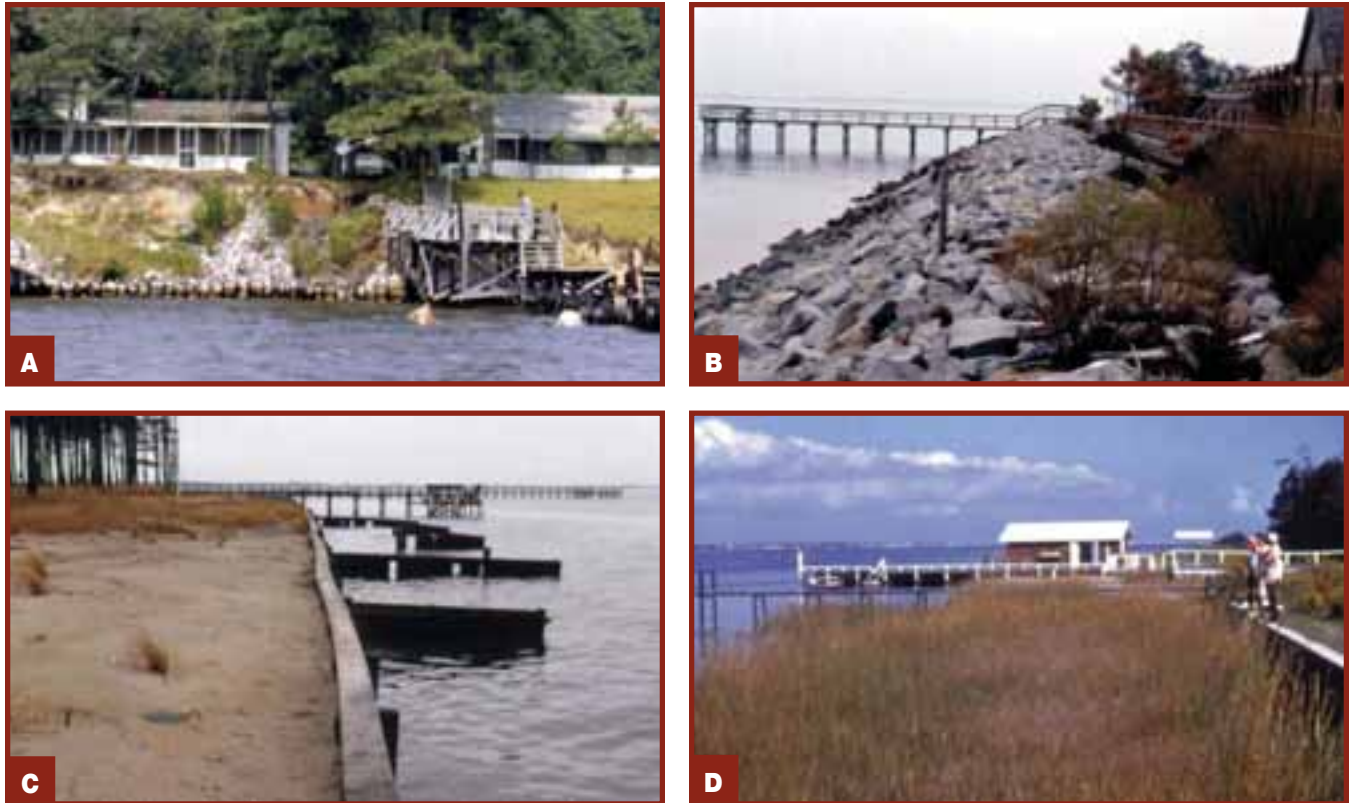
**FIGURE 4-2-4.** Photographs of human-modified sediment bank shorelines and no sand strandplain beaches. **PANEL A.** A high sediment bank shoreline with multiple efforts to stop the erosion using combinations of rock rip-rap, rock revetments and wooden bulkheads. **PANEL B.** A massive rock revetment protects the high, sediment bank at the Lost Colony on the north end of Roanoke Island. **PANEL C.** A wooden bulkhead in concert with a small groin field protects a low sediment bank on the northwest end of Roanoke Island. **PANEL D.** A concrete bulkhead protects a low sediment bank in Bogue Sound. A fringing marsh grass, planted in front of the bulkhead, baffles the wave energy and has trapped some sediment to build up a shallow platform for marsh development. Photo is from North Carolina Sea Grant, N.C. State University.

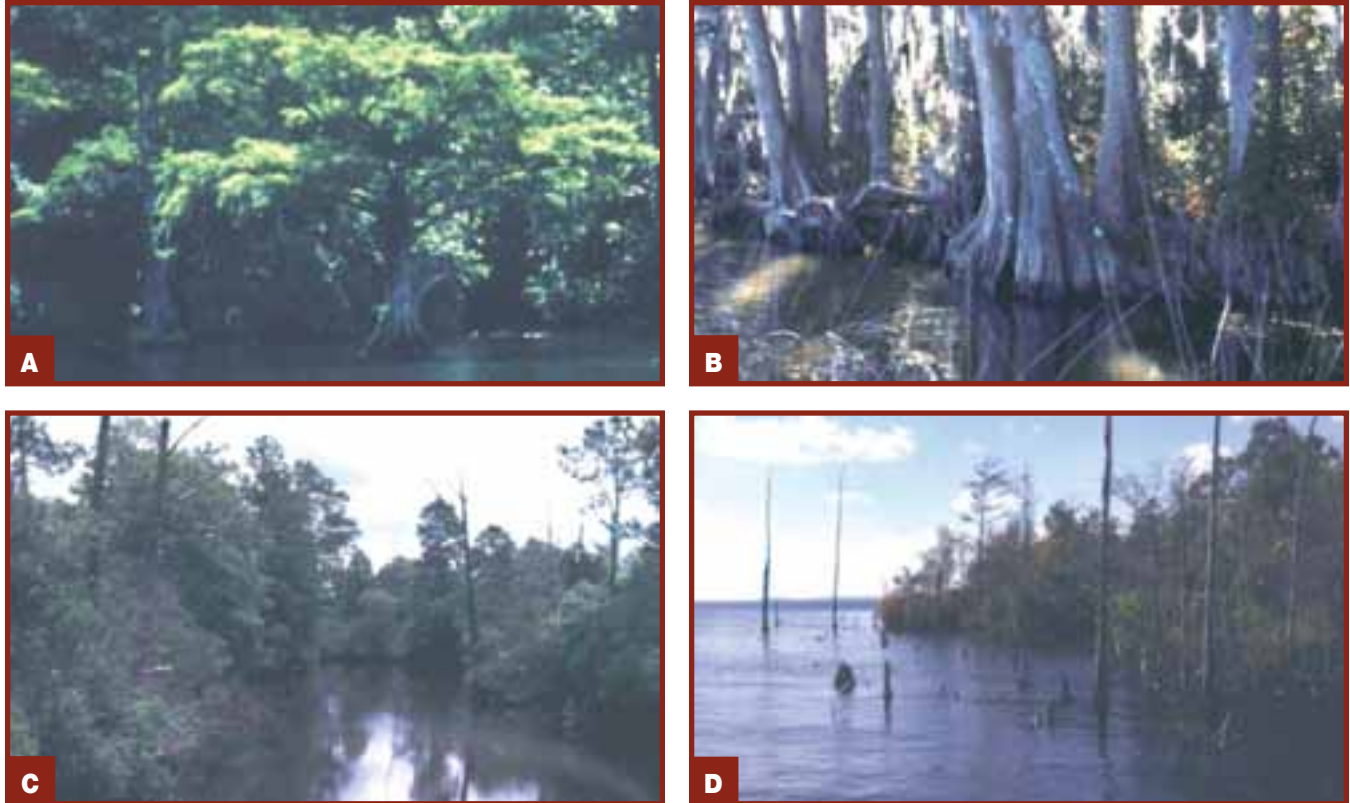
**FIGURE 4-3-3.** Photographs of vegetatively bound swampforest shorelines in the headwaters of small tributary estuaries and outer estuaries where the receding shoreline has intersected pocosin swamp forests. **PANEL A.** A vegetatively bound swampforest shoreline that displays little to no shoreline recession taking place. **PANEL B.** Estuarine shoreline dominated by a massive bulkhead like zone of cypress trees that effectively protects the shoreline from day-to-day erosional processes. **PANEL C.** The estuarine headwaters of a tributary stream are heavily dominated by vegetation. Rising sea level is causing a change in vegetation from less wet to more wet adapted species, as evidenced by the scattered and still-standing dead pine trees. **PANEL D.** Photograph of a pocosin swampforest shoreline where the receding shoreline has intersected a swamp system perched on a low, upland area. Wave action erodes out the enclosing peat sediment, leaving the ghost trees and stumps standing out in the shallow waters. This type of shoreline occurs primarily in the lowland regions of the outer estuaries in Currituck, Dare, Hyde, Tyrrell, Pamlico and Carteret counties.

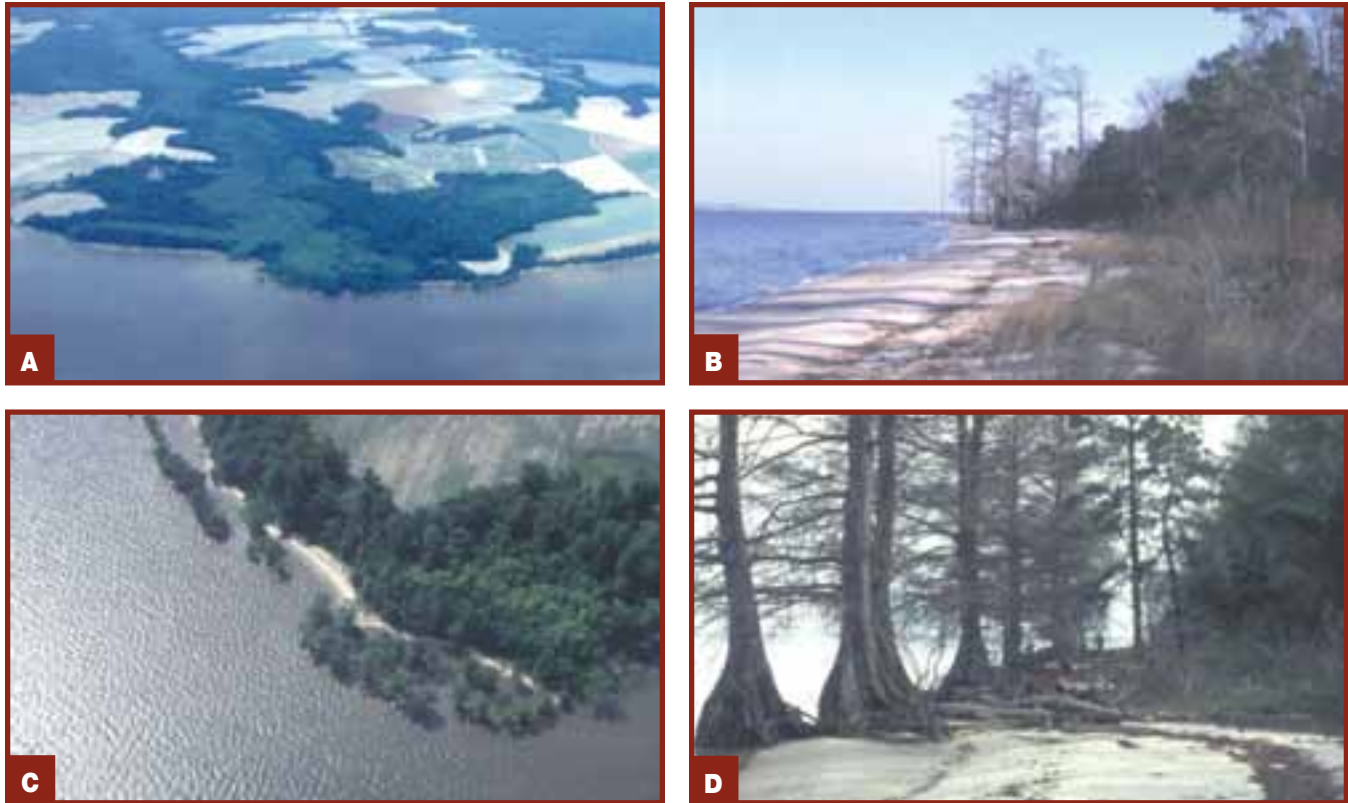
**FIGURE 4-3-4.** Photographs of shorelines dominated by cypress headlands and cypress fringes. **PANEL A.** An oblique aerial photograph showing the differential erosion rates of a tributary stream and associated swampforest floodplain as it enters Albemarle Sound and the adjacent sediment bank shorelines. The swampforest vegetation drowns and recedes at slow rates, leaving the cypress standing in the shallow waters as the adjacent sediment bank shoreline recedes more rapidly. **PANEL B.** A ground view of a similar cypress headland in the Neuse River estuary. The cypress form a headland that acts as a large-scale groin trapping an extensive strandplain beach in front of the eroding sediment bank in both the upstream and downstream segments. **PANEL C.** An aerial photograph looking vertically down upon an eroding sediment bank shoreline with a cypress fringe in front of the eroding bank in the Chowan River. **PANEL D.** Ground view of a similar cypress fringe fronting a bluff shoreline in the Chowan River. The cypress helped trap sand and build the strandplain beach, as well as partially protecting the adjacent bluff on the right side of the photo. The protection has allowed a significant growth of vegetation that further protects this shoreline.

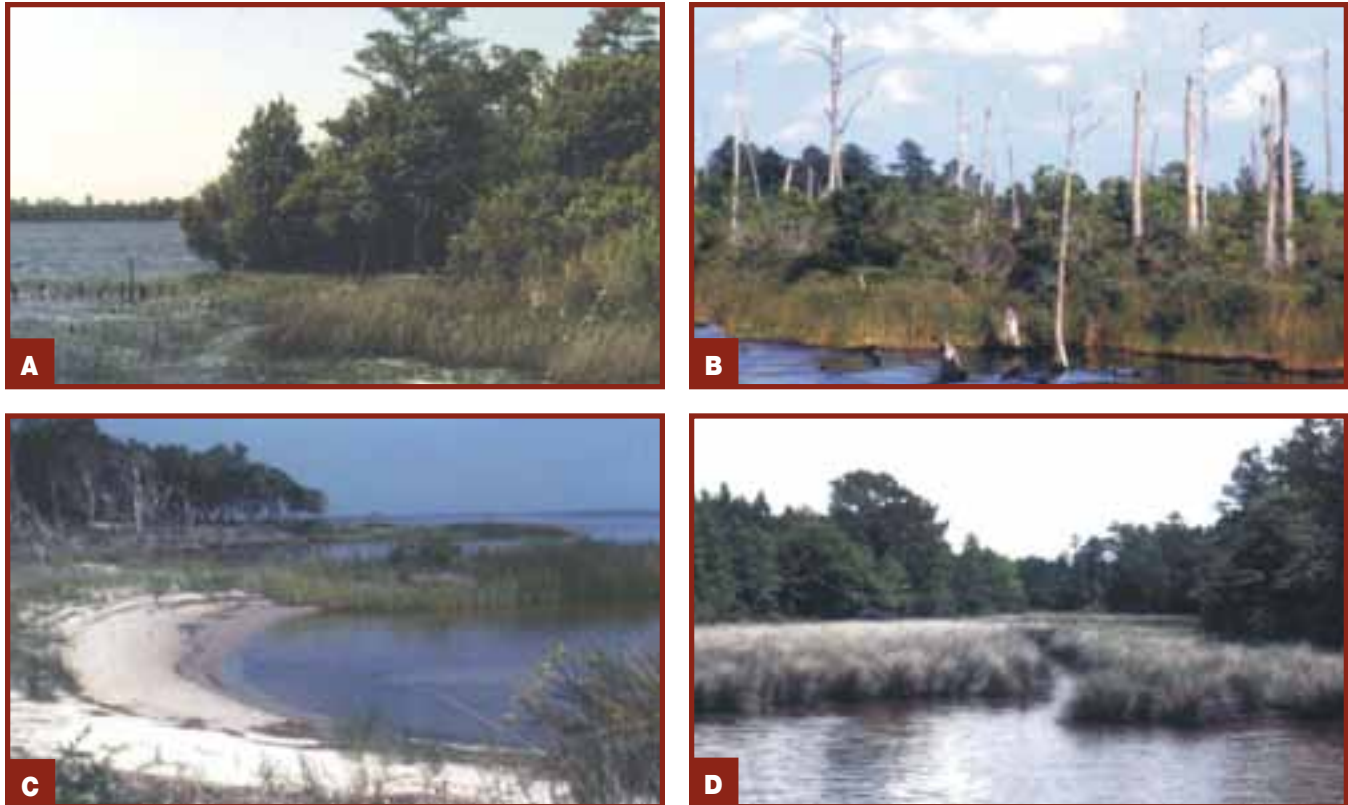
**FIGURE 4-3-6.** Photographs of fresh to brackish, irregularly flooded, fringing marsh shorelines. **PANEL A.** A highly vegetated, low sediment bank shoreline with a fringing marsh composed of freshwater grasses. **PANEL B.** A highly vegetated, very low, sediment bank shoreline with a fringing marsh composed of freshwater grasses. The effects of ongoing sea-level rise are obvious as the old-growth pine are stressed and ultimately die by drowning and are systematically replaced by more water-tolerant transition zone shrubbery and finally by the marsh grasses. **PANEL C.** The low sediment bank shoreline, dominated by upland vegetation, is fronted by a broad strandplain beach, with a fringing marsh composed of *Spartina* sp. and transition zone plants. The sand that forms the beach was derived from an eroding shoreline in back of the photograph. Notice the interdependence between the cusped geometry of the beach and growth of marsh grasses. The marsh grows on the shallow sands on cusp edges, which in turn traps additional sediment, causing the increased growth of the cusped structures. **PANEL D.** The shallow waters of this tributary estuary developed a wide fringing, brackish water marsh composed of *Juncus roemerianus*. The fringing marsh has completely filled the shallow perimeter platform to the channel, which is the original stream channel that concentrates the water flow and is too deep for growth of the marsh grass.
