By Stanley R. Riggs and Dorothea V. Ames  
Published by North Carolina Sea Grant

## DROWNING THE NORTH CAROLINA COAST: Sea-Level Rise and Estuarine Dynamics

**ON THE FRONT COVER.** *Pre-Hurricane Isabel photograph of the lower portion of sediment bluff that occurs along the Chowan River estuary western shoreline. The red star, on the satellite image inside the back cover, indicates the specific site location. This bluff is approximately 75 feet high and consists of a lower clay bed that is about 30 feet thick (to the top of this photograph), with an overlying sand bed that is 45 to 50 feet thick. Because bluff shorelines normally erode at average rates between  $-2.0$  and  $-2.5$  ft/yr (Table 8-1-3) and because the lower sediment bank is composed of clay, there is no sand beach preserved on the eroded wave-cut scarp and platform (Fig. 4-2-1). Notice the red dotted line along the wave-cut scarp and compare this to the respective location on the post-Hurricane Isabel photograph on the back cover. Photograph was taken in August 2003. See the back cover for the post-Hurricane Isabel photograph of the same site and inside back cover for a satellite image showing the site location an

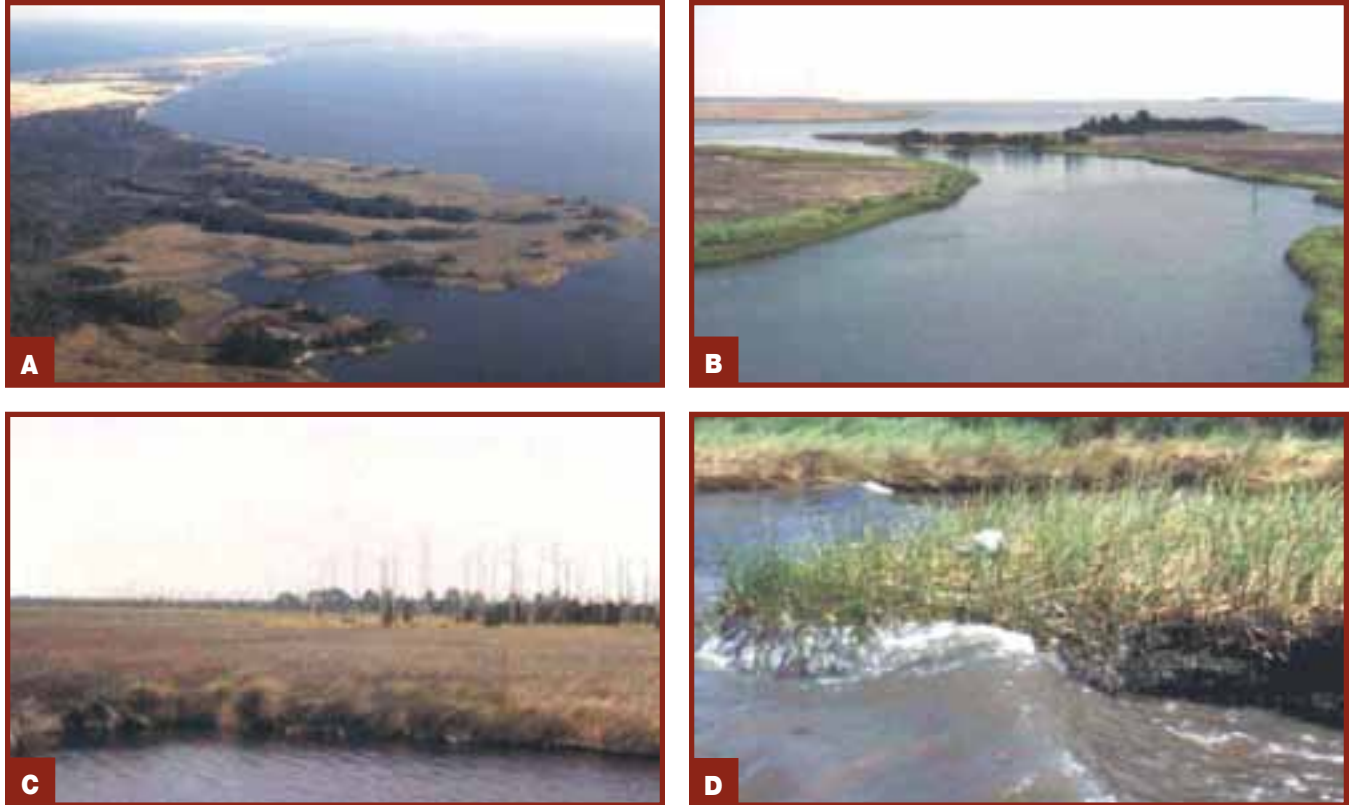
**FIGURE 4-3-7.** Photographs of low brackish, irregularly flooded, and wave-dominated, platform marsh shorelines of the Northern Province. **PANEL A.** An oblique aerial photograph shows the broad platform marsh composed of *Juncus roemerianus* encroaching upon the back side of the high and wide barrier island behind Nags Head Woods. Notice the elongate ridges and small circular hammocks scattered through the marsh and characterized by dark green upland vegetation. These hammocks are the high points on the paleotopographic surface that is being drowned and buried by the marsh in response to ongoing sea-level rise. Jockey's Ridge, an active back-barrier sand dune, is visible in the distance. **PANEL B.** An oblique aerial photograph shows a portion of the broad expanse of *Juncus roemerianus* marsh in the Cedar Island National Wildlife Refuge. Notice 1) the bright green rim of *Spartina alterniflora* marsh grass that forms the outer zone adjacent to the waterway and 2) hammocks in the marsh characterized by dark green upland vegetation. **PANEL C.** Ground-view photograph of a broad *Juncus roemerianus* platform marsh at mean water level. The marsh shoreline in the foreground has a 3- to 5-foot deep vertical erosional scarp below the water with an extensive undercut just below the water surface. Notice in the distance the obvious effects of ongoing sea-level rise as all the older growth pine became stressed and died by drowning and have been replaced by more water-tolerant transition zone shrubbery. **PANEL D.** A close-up view of an eroding platform marsh shoreline. The surging wave energy erodes the softer peat below the exposed peat ledge, which consists of a dense root mass of the modern *Spartina alterniflora*. As the undercut becomes more extensive, the surface root mass begins to move with each wave until a large block finally breaks off (see Figure 4-3-5).

root mat (Fig. 4-3-7D). With continued undercutting, the overhang surges with each wave until large undulating peat blocks finally break off, supplying eroded organic detritus and large peat blocks to the adjacent estuarine floor (Fig. 4-3-5). Erosion of marsh peat shorelines is one of the major sources of fine organic detritus that forms the organic-rich mud sediments within the estuarine central basins.

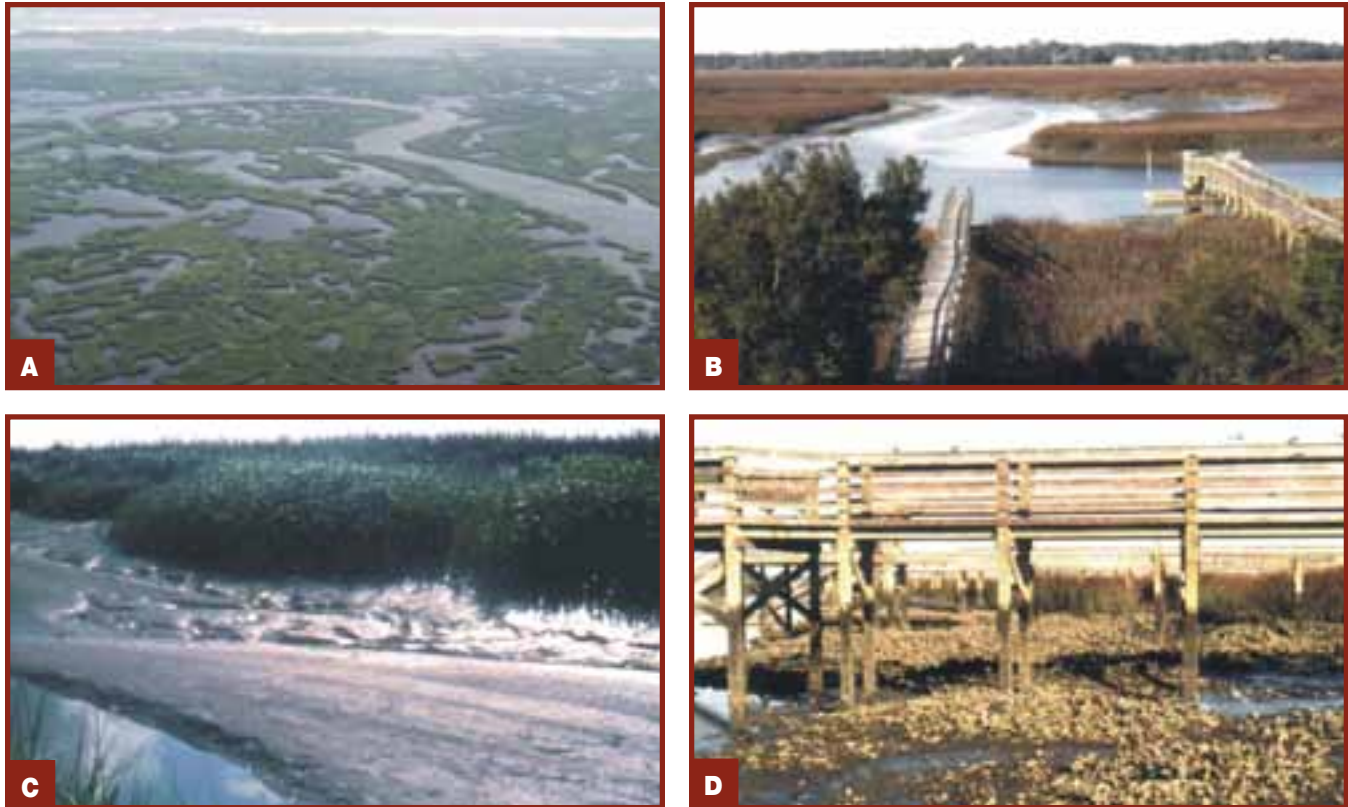
**FIGURE 4-3-8.** Photographs of high-brackish, regularly flooded marsh shorelines and associated tidal mud flats of the Southern Province. **PANEL A.** An oblique aerial photograph of the extensive *Spartina alterniflora* marsh that fills Topsail Sound behind the simple overwash barrier island in the distance. Since the photo was taken at summer high tide, the marsh grass is very green, the tidal creeks are totally filled with water, and all mudflat environments are submerged. **PANEL B.** Groundview of an extensive *Spartina alterniflora* marsh that fills the sound behind Sunset Beach. Since the photo was taken at winter low tide, the marsh grass is very brown, the tidal creeks are almost empty, and the vast mudflat environments are well exposed. **PANEL C.** A close-up view of the *Spartina alterniflora* marsh, associated mudflats and tidal channel in the previous panel. **PANEL D.** A close-up view of the abundant oyster reefs that occur on the mudflats and extend into the lower portion of the marsh in the previous panels. None of these oysters are edible due to high pollution levels resulting from extensive development and associated stormwater runoff and septic discharge.

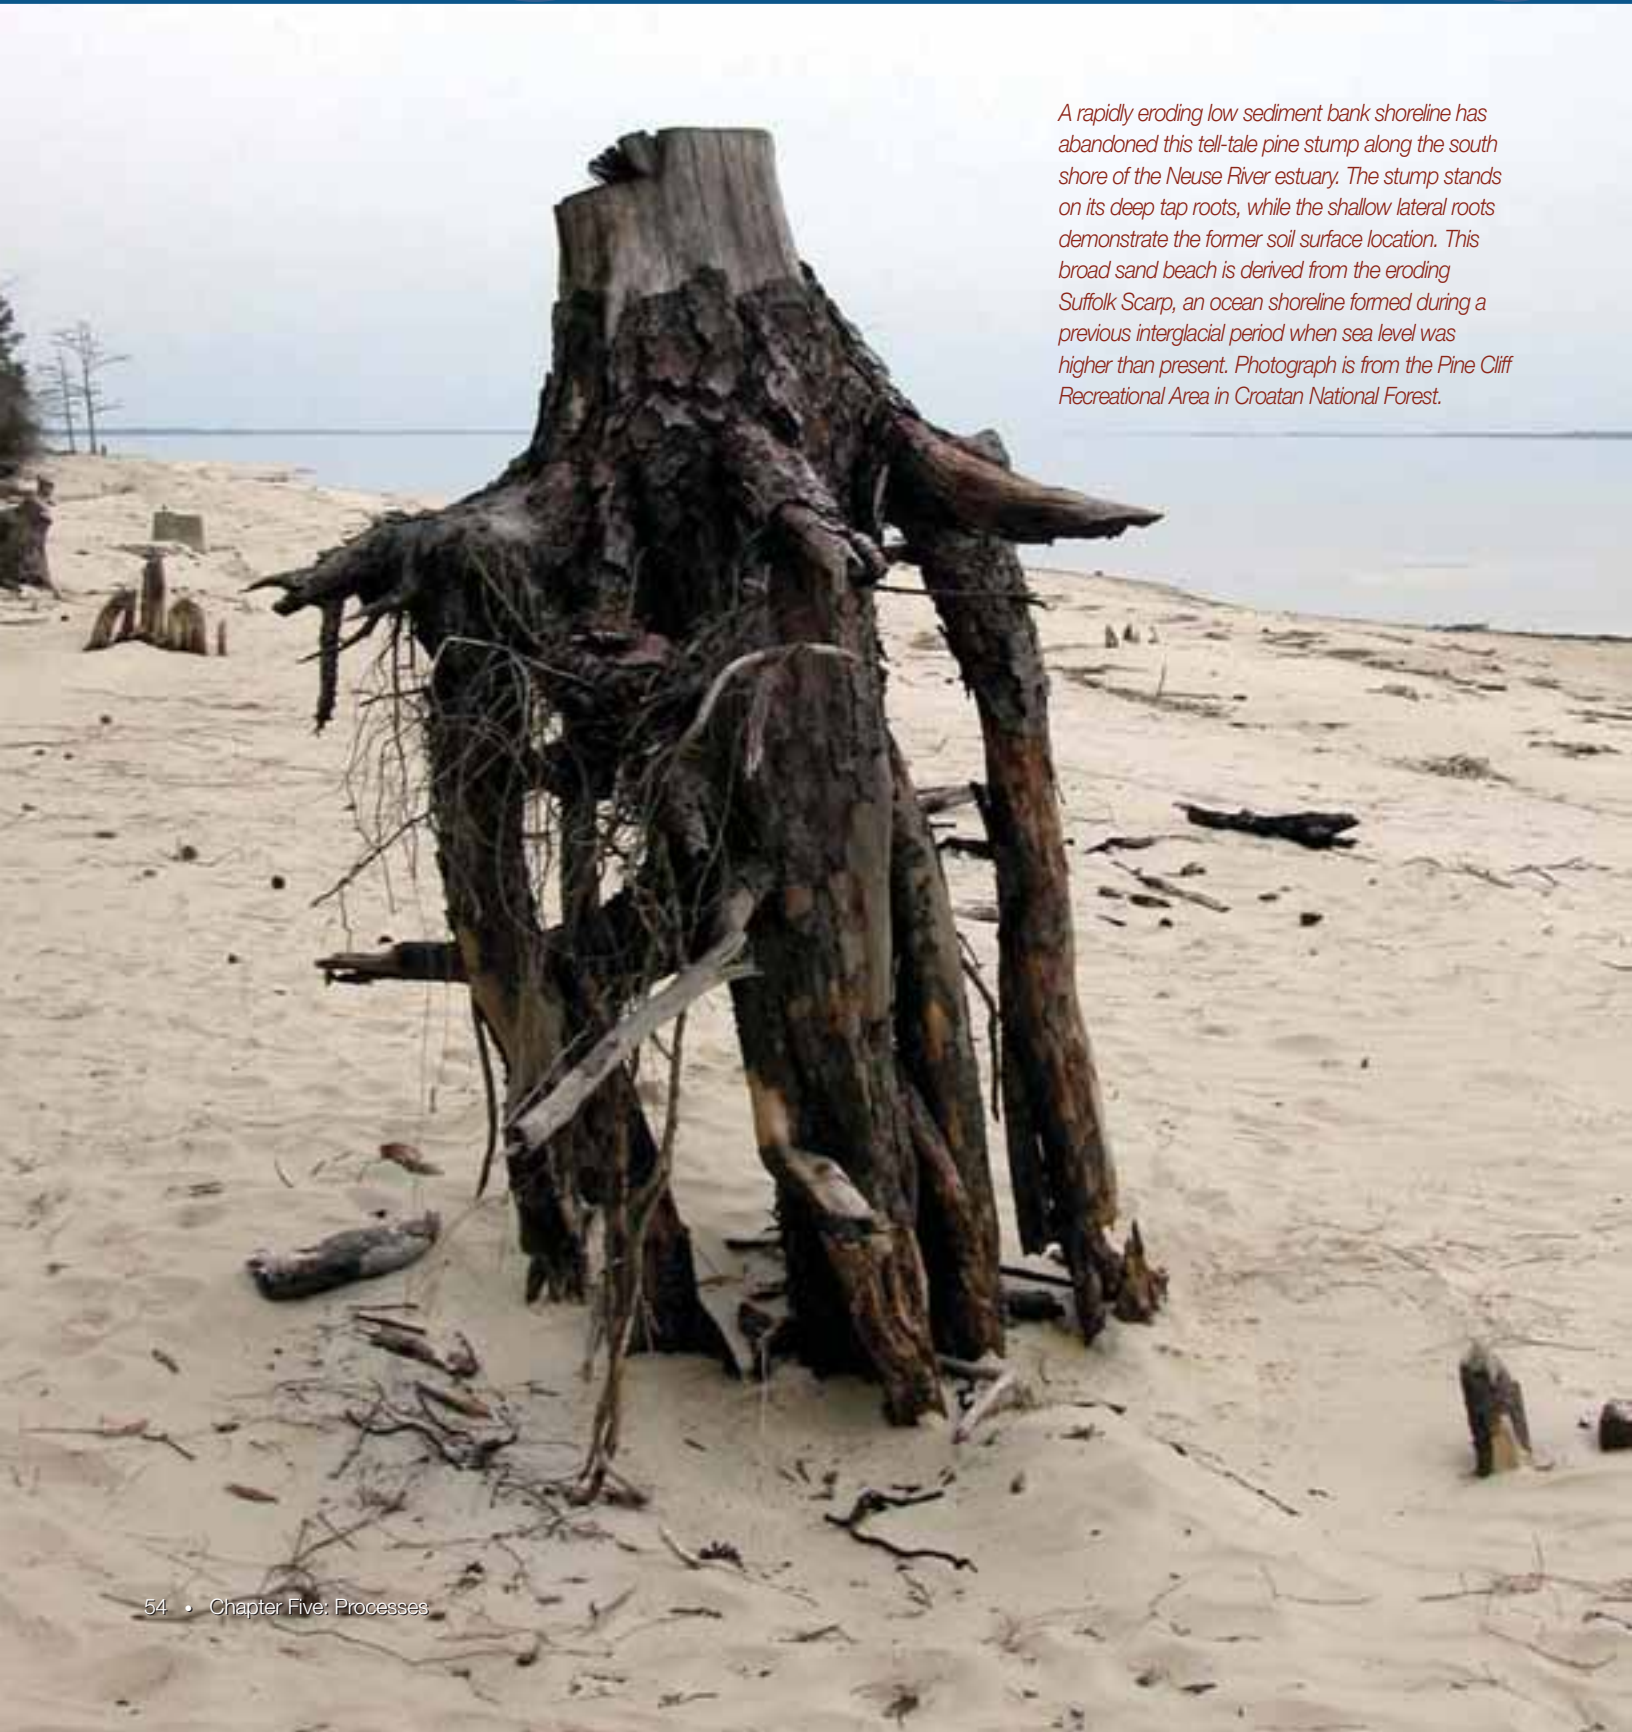
*A rapidly eroding low sediment bank shoreline has abandoned this tell-tale pine stump along the south shore of the Neuse River estuary. The stump stands on its deep tap roots, while the shallow lateral roots demonstrate the former soil surface location. This broad sand beach is derived from the eroding Suffolk Scarp, an ocean shoreline formed during a previous interglacial period when sea level was higher than present. Photograph is from the Pine Cliff Recreational Area in Croatan National Forest.*

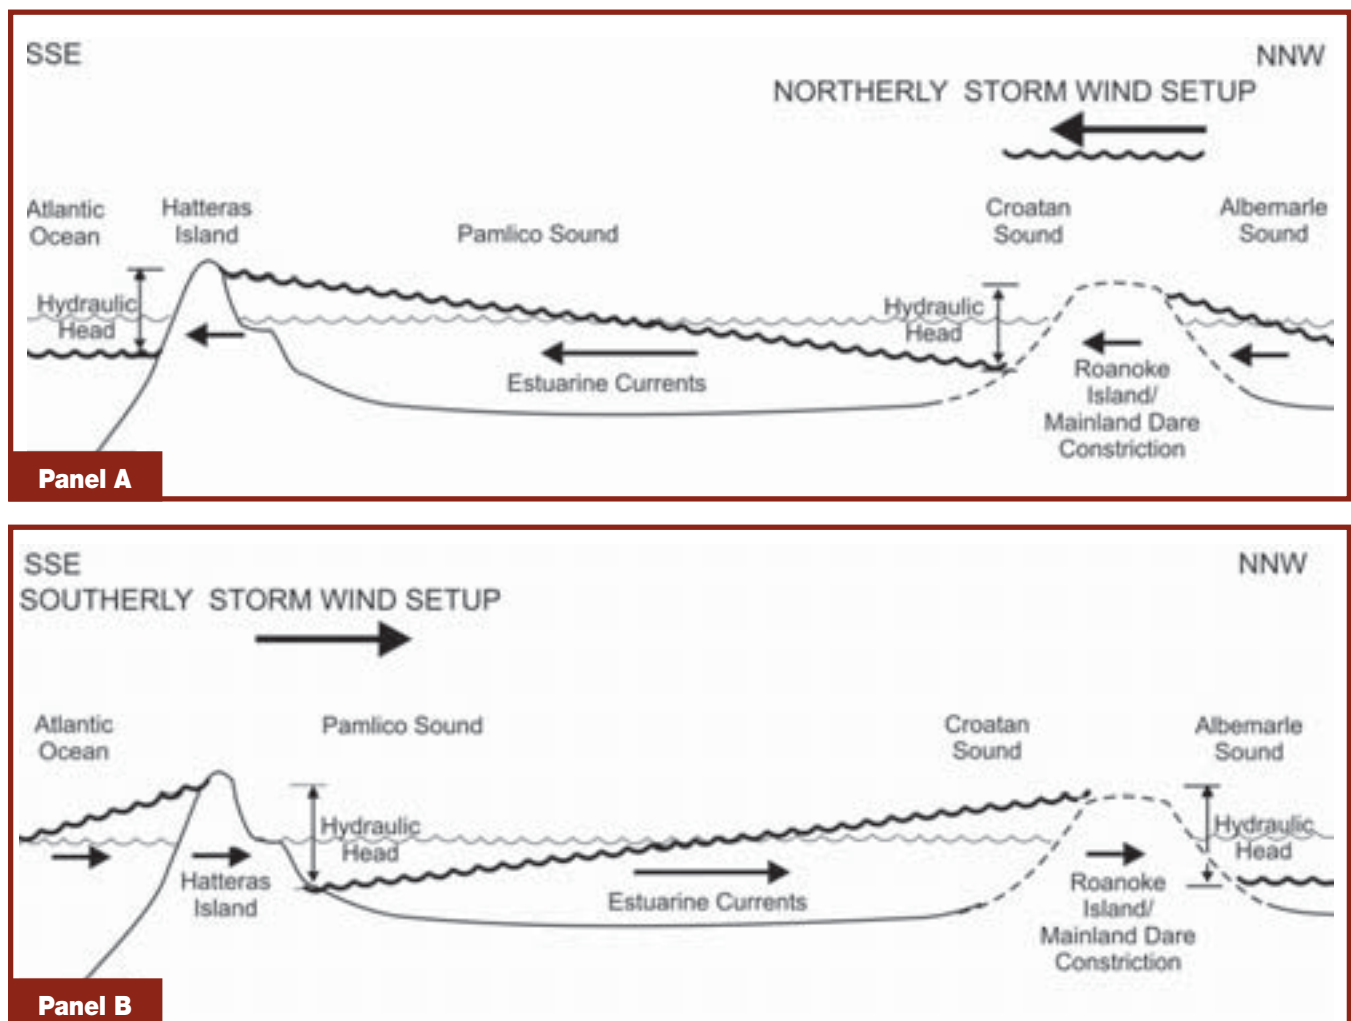
**FIGURE 5-2-1.** Model of estuarine storm tides in the North Carolina sounds that form in response to different storm events. Wave energy superimposed upon both high- and low-storm tides is the primary process driving estuarine shoreline recession. This model is based upon the physical oceanographic studies of Pietrafesa et al. (1986), Pietrafesa and Janowitz (1991), and Lin (1992). **PANEL A.** High-storm tides occur along southern shores in response to events dominated by northeast, north, or northwest wind directions, whereas low-storm tides occur along the northern shores. **PANEL B.** High-storm tides occur along the northern shores resulting from events dominated by winds from the west, southwest, or south wind directions, whereas low-storm tides occur along the southern shores.

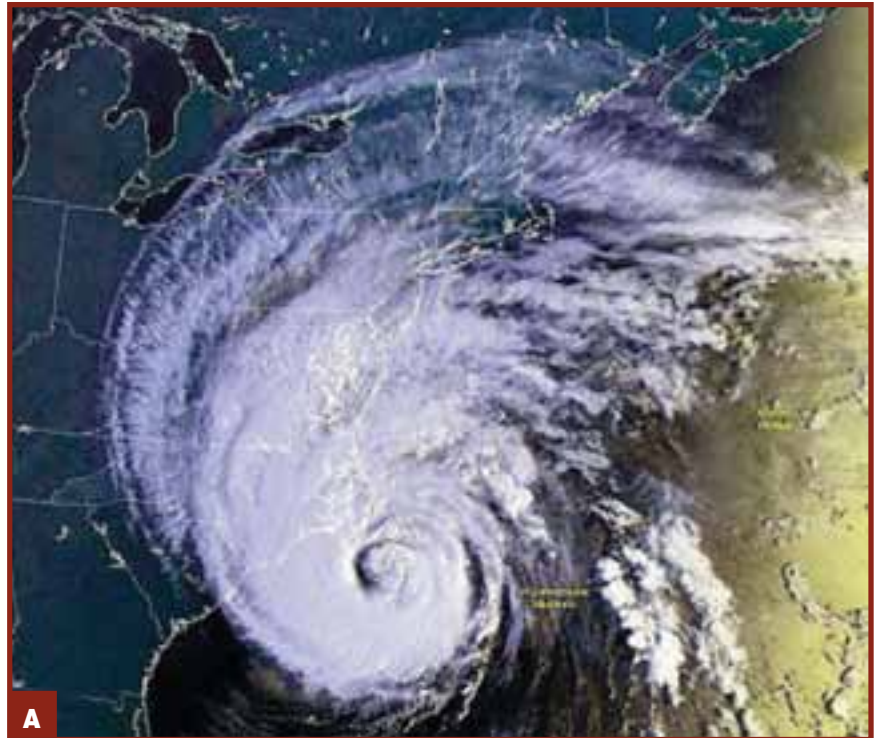
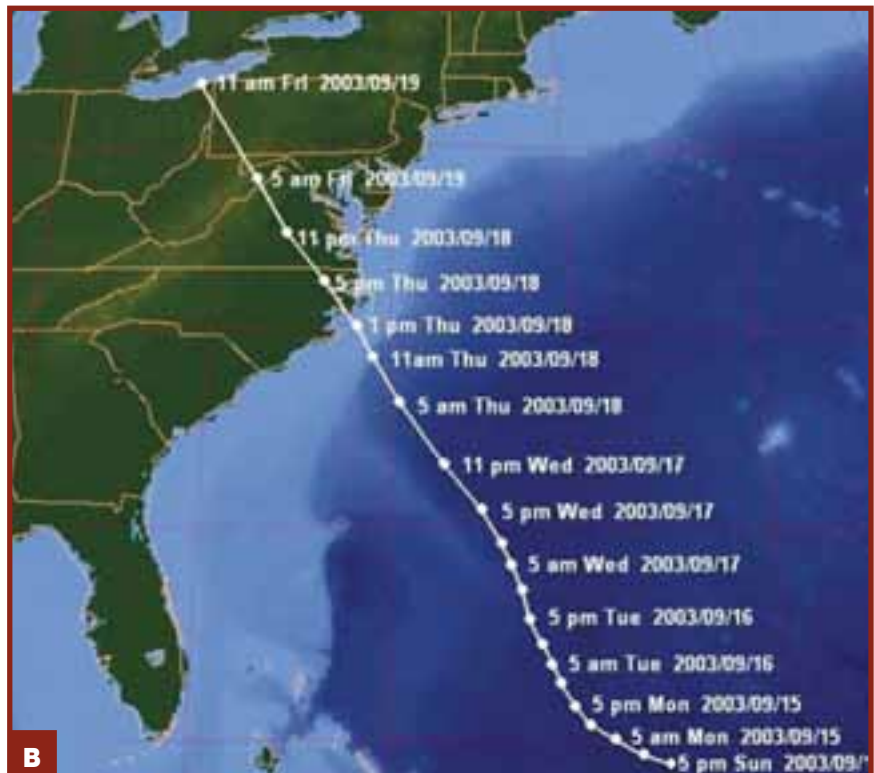
**FIGURE 5-2-2. PANEL A.** Satellite image of Hurricane Isabel as it approached the North Carolina coast as a minimal category 2 storm on September 18, 2003. **PANEL B.** The track of Hurricane Isabel as it came ashore in the vicinity of Ocracoke Inlet and tracked inland along a northwest course. Both images are from the U.S. National Weather Service Web site at N.C. State University, Dept. of Marine, Earth and Atmospheric Sciences, Raleigh, NC.

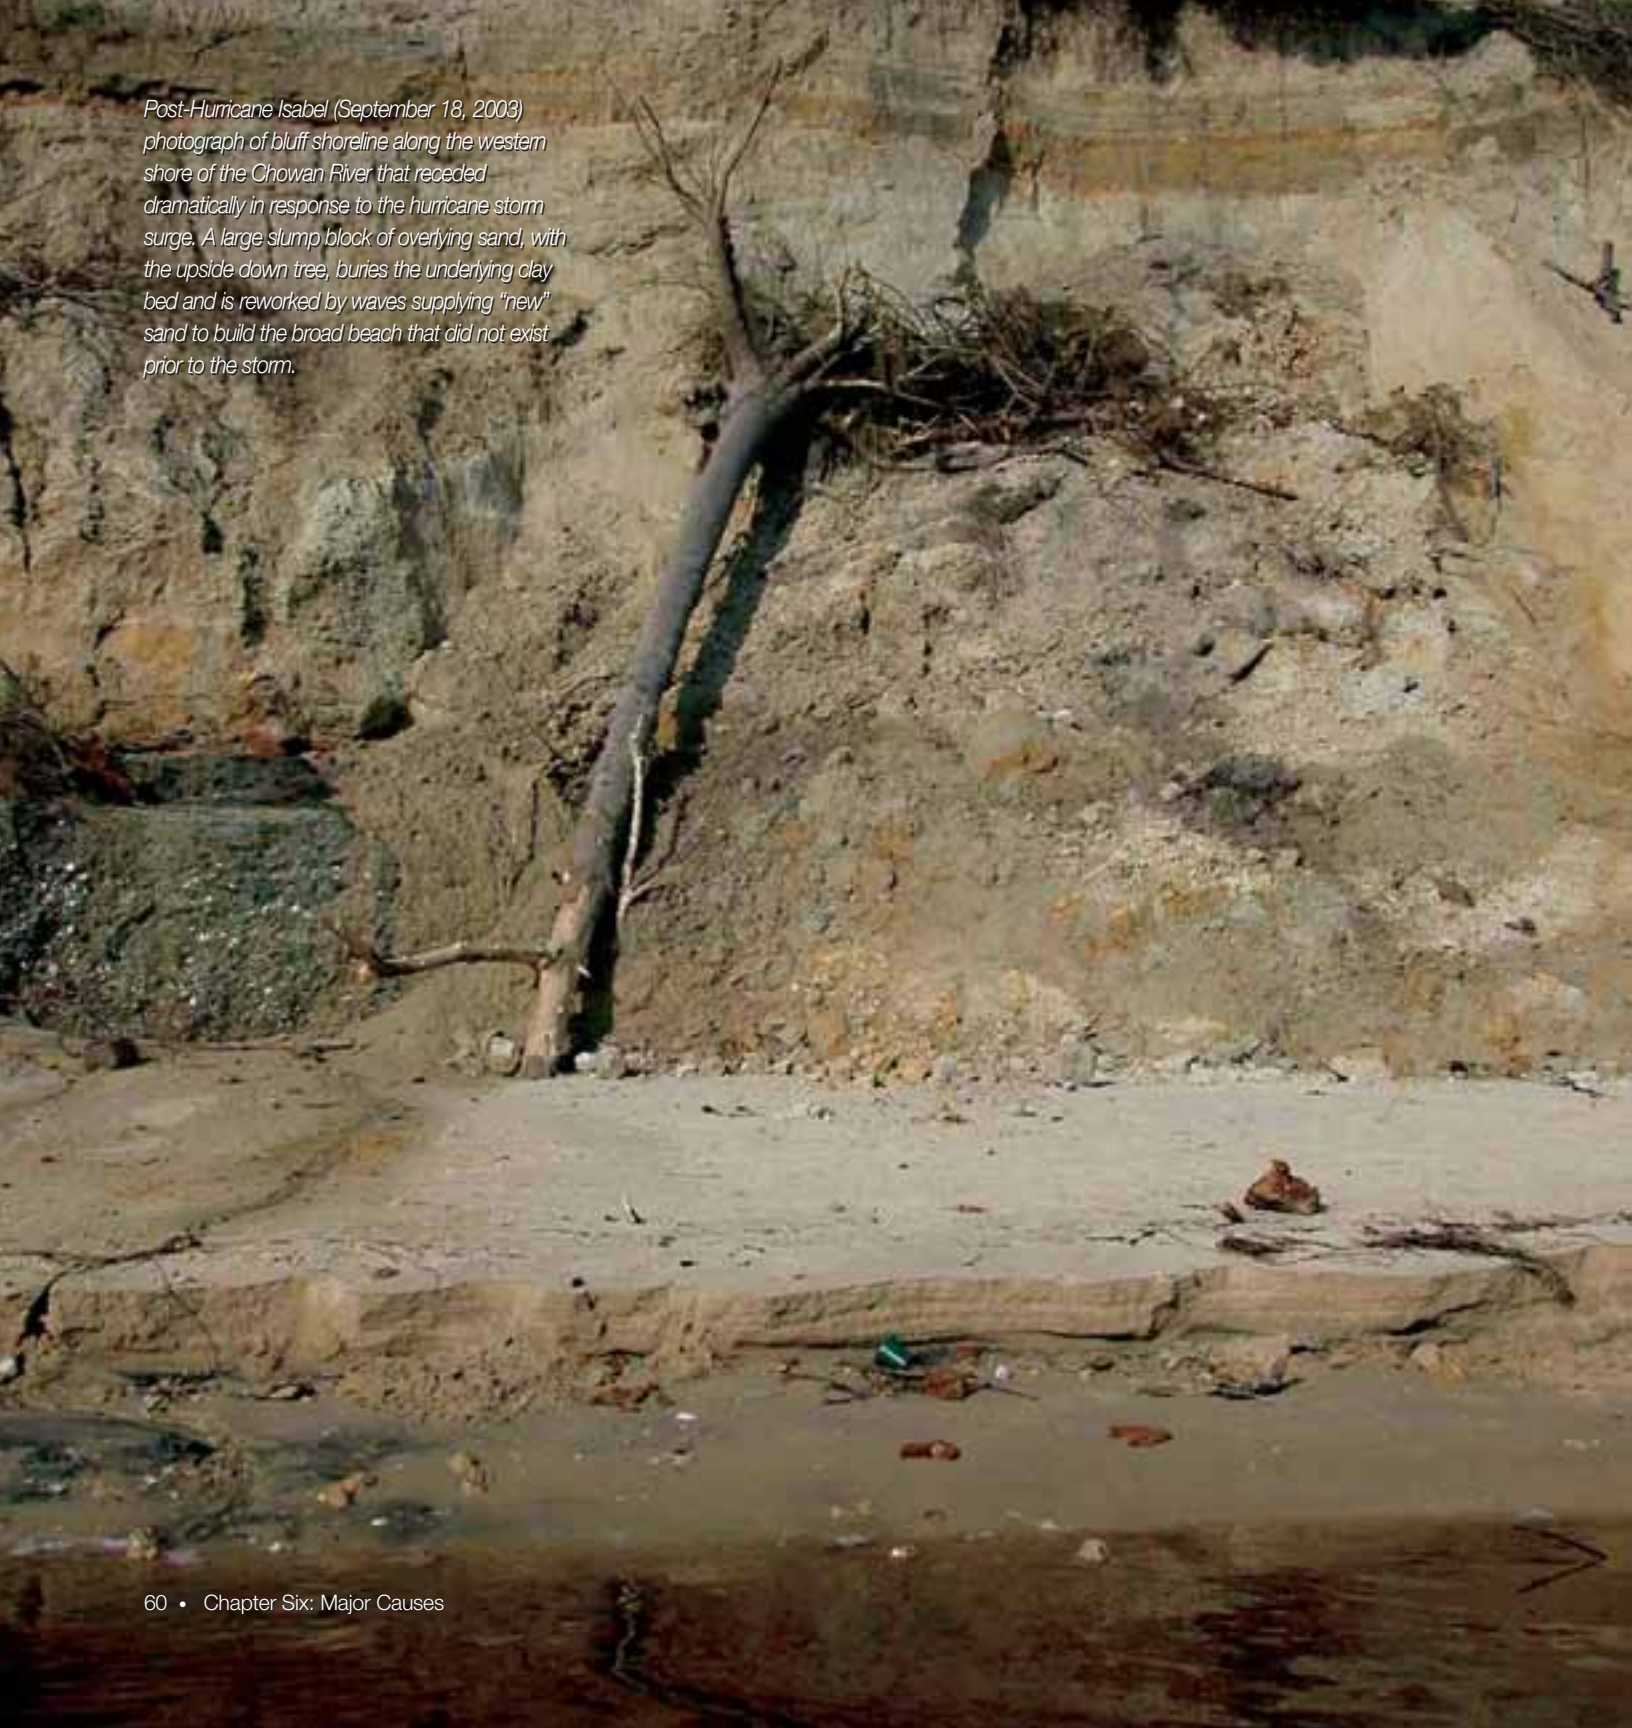
*Post-Hurricane Isabel (September 18, 2003) photograph of bluff shoreline along the western shore of the Chowan River that receded dramatically in response to the hurricane storm surge. A large slump block of overlying sand, with the upside down tree, buries the underlying clay bed and is reworked by waves supplying "new" sand to build the broad beach that did not exist prior to the storm.*

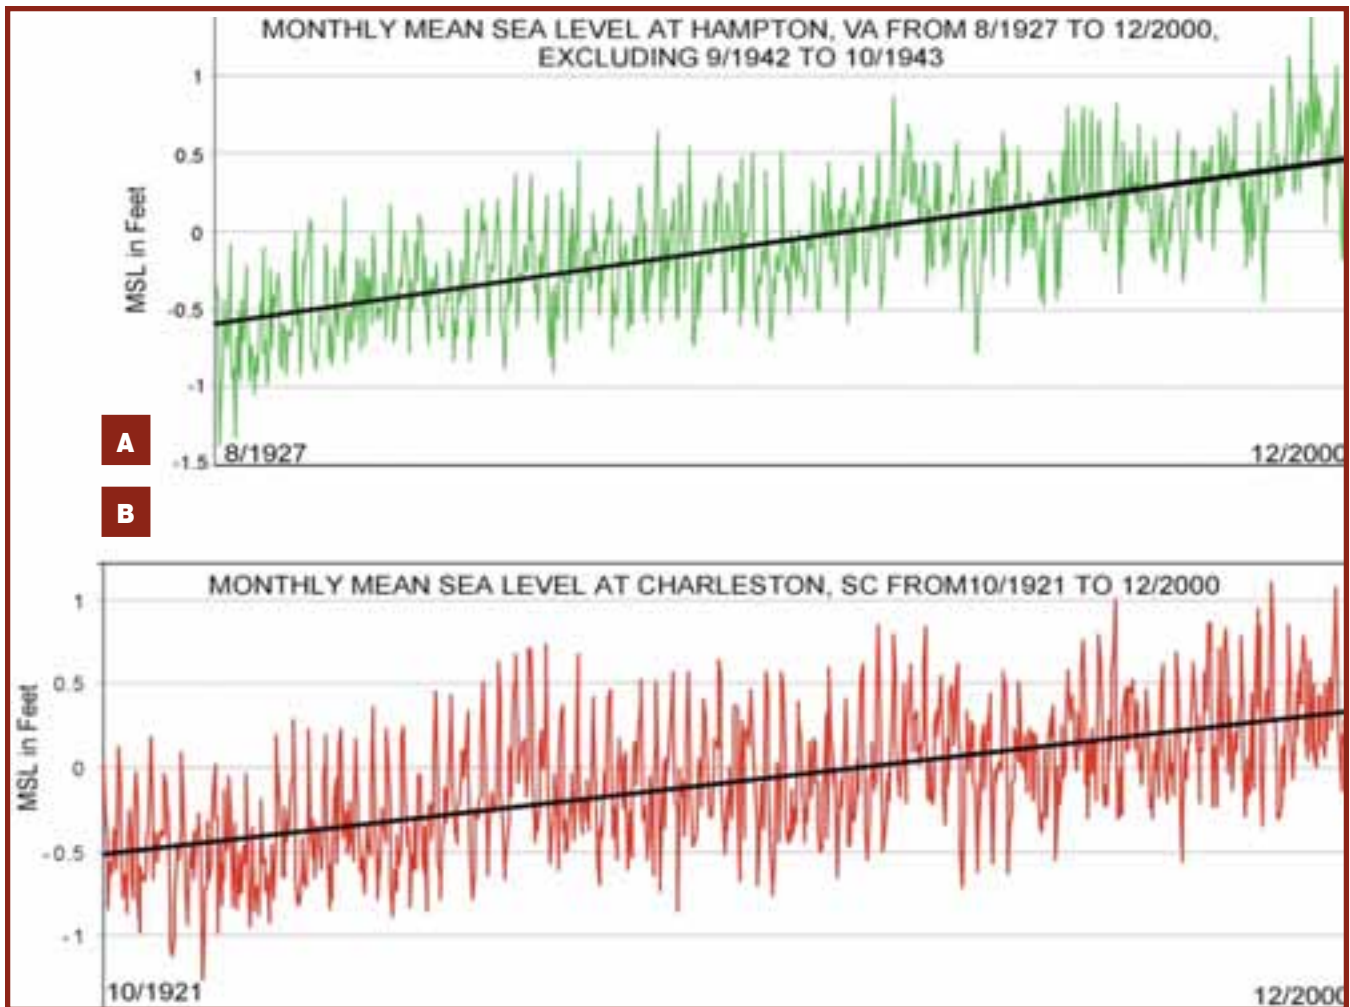
**FIGURE 6-3-2.** Tide gauge data from Hampton, Va., and Charleston, S.C., demonstrate the rate of ongoing sea-level rise. The plotted data are monthly averages of mean sea level that extend from August 1927 and October 1921, respectively, to December 2000. The heavy line through each plot is the graphical representation of the trend data obtained by regression analysis, showing the net rise in sea level during this time period. Similar tide-gauge data developed at Duck, N.C., by the U.S. Army Corps of Engineers only goes back to 1980, but in a 20-year time period, the data suggest a slightly higher rate of sea-level rise of about 1.5 ft/100 yrs for the Albemarle Sound coastal region. The two sets of tide-gauge data in Figure 6-3-2 are from the National Oceanographic and Atmospheric Administration (NOAA) National Water Level Observation Network ([www.co-ops.nos.noaa.gov/data\\_res.html](http://www.co-ops.nos.noaa.gov/data_res.html)). **PANEL A.** Tide-gauge data for Hampton, Va., suggest sea level has been rising at the rate of 1.16 ft/100 yrs in this region since 1927. **PANEL B.** Tide-gauge data for Charleston, S.C., suggest sea level has been rising at the rate of 1.01 ft/100 yrs in this region since 1921.

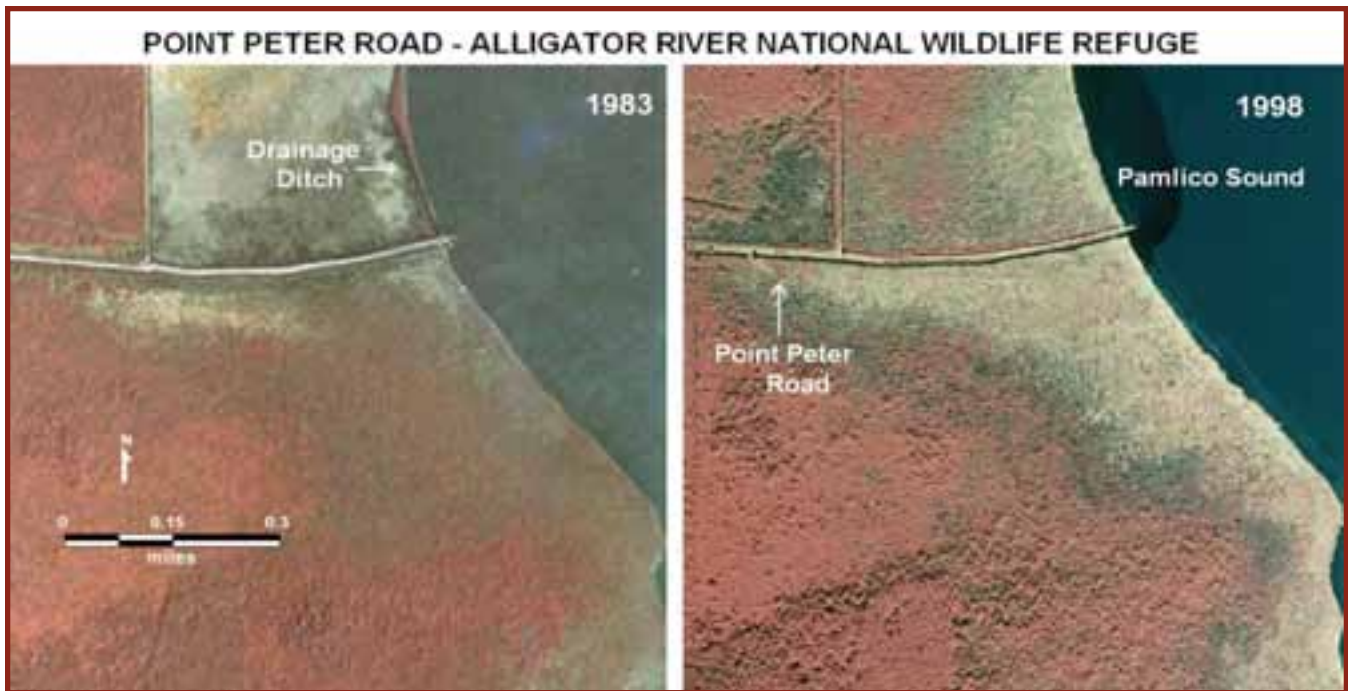
**FIGURE 6-3-3.** Due to the extremely low land elevation in the Point Peter Road area of the Dare County mainland (U.S. Fish and Wildlife's Alligator River National Wildlife Refuge), ongoing sea-level rise is having a dramatic effect. The site, on the western shores of Pamlico Sound between Manns Harbor and Stumpy Point, displays marsh expansion at the expense of a pocosin swamp forest. These winter infrared aerial photographs display the marsh grasses (not photosynthesizing) as a pale gray-green color. In contrast, the nondeciduous swampforest trees and scrub-shrubs (photosynthesizing) display a red color. During the period from 1983 to 1998, marsh expansion ranges from about 0.1 to 0.5 miles inland. This dramatic change in the 15-year period is the evolutionary response to ongoing sea-level rise. The 1983 aerial photograph was flown by the High Altitude Program of the U.S. Department of Agriculture. The 1998 aerial photograph is a Digital Orthophoto Quarter Quadrangle from the U.S. Geological Survey.

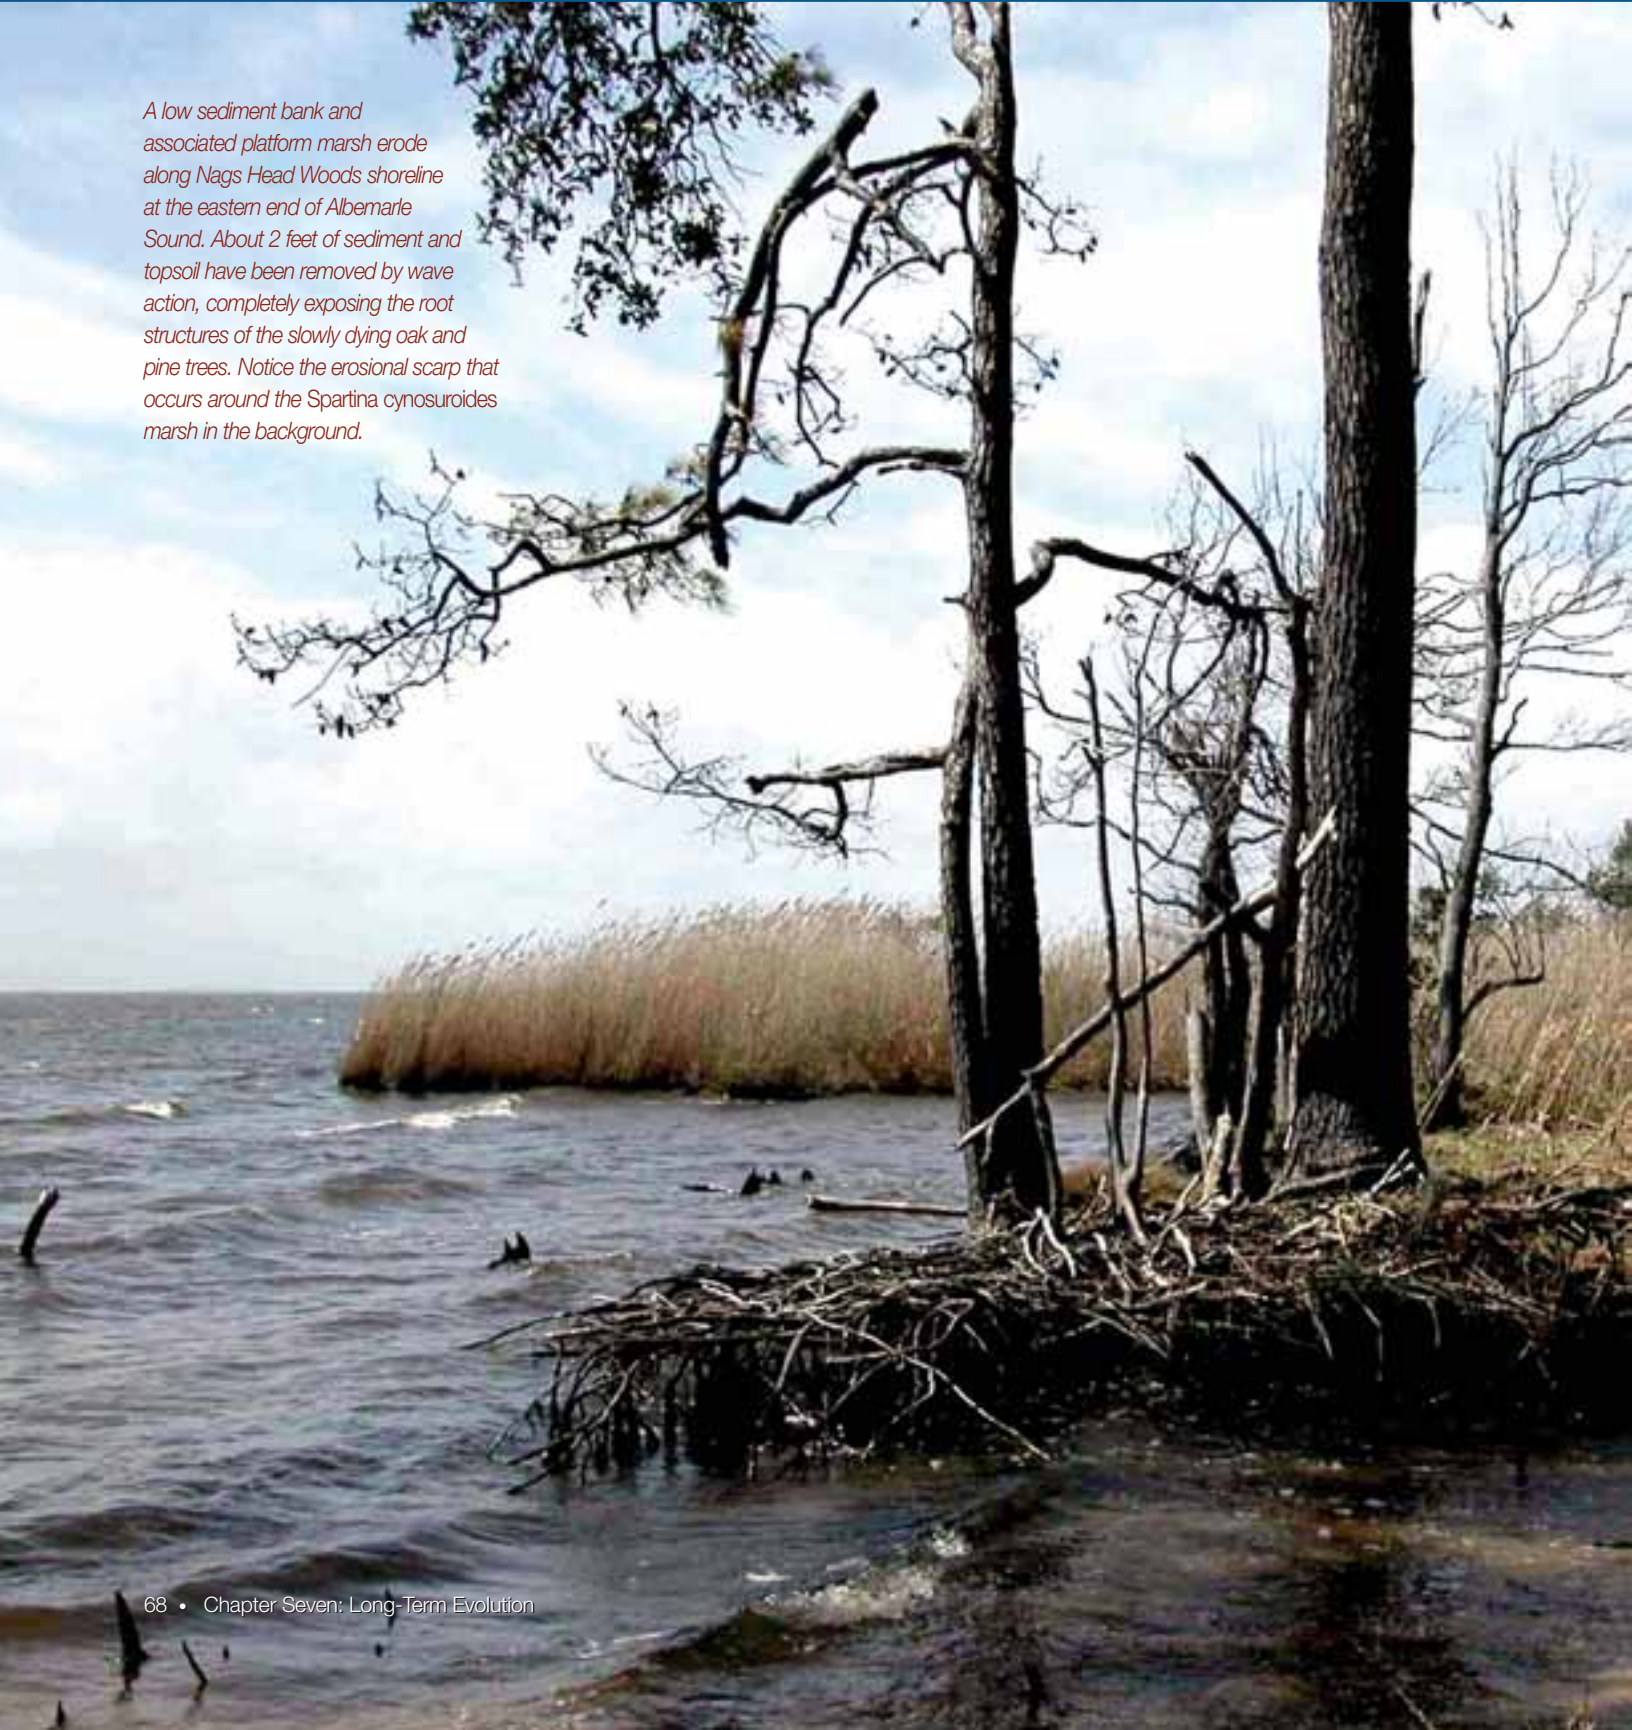
*A low sediment bank and associated platform marsh erode along Nags Head Woods shoreline at the eastern end of Albemarle Sound. About 2 feet of sediment and topsoil have been removed by wave action, completely exposing the root structures of the slowly dying oak and pine trees. Notice the erosional scarp that occurs around the *Spartina cynosuroides* marsh in the background.*

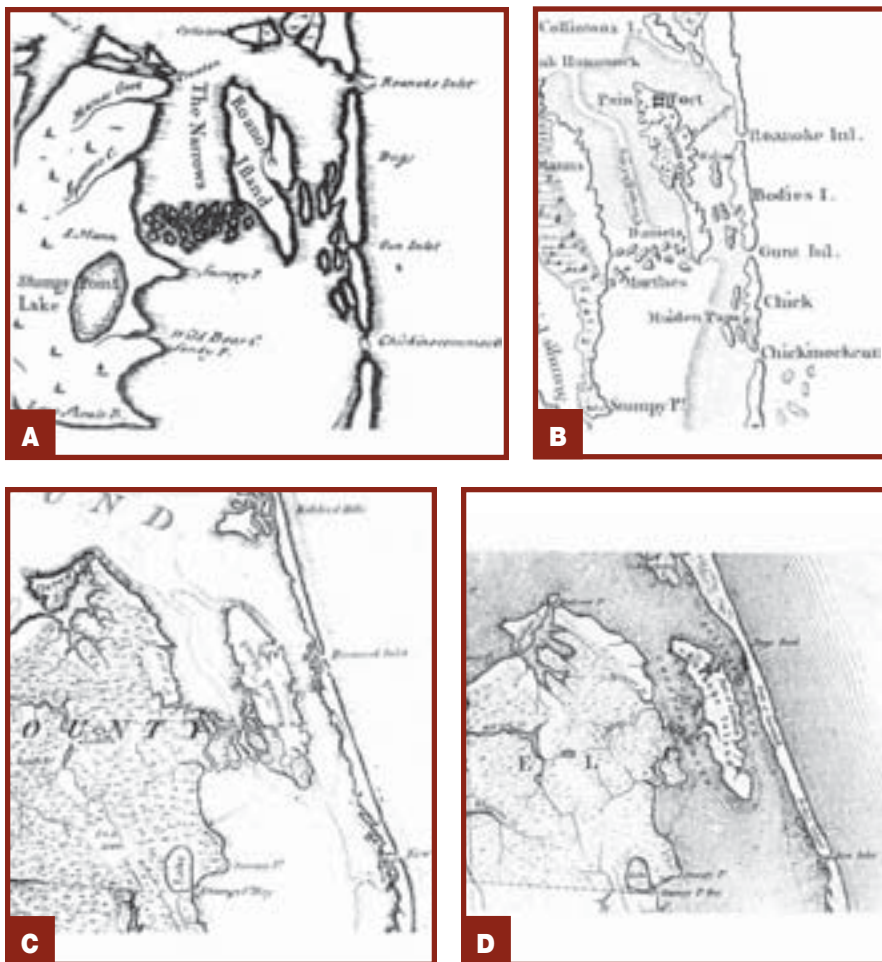
**FIGURE 7-1-1.** Historical maps depicting the evolutionary changes for Croatan Sound and the opening of Roanoke Marshes between Croatan and Pamlico sounds. Notice the dramatic changes in inlet location through the barrier islands, the habitat changes within Croatan Sound due to current scour, and the slow dissection of Stumpy Point Lake by the receding shoreline. Maps are not to the same scale. **PANEL A.** Map of Moseley dated 1733. **PANEL B.** Map of Collet dated 1770. **PANEL C.** Map of Price and Strother dated 1808. **PANEL D.** Map of MacRae and Brazier dated 1833. All four maps are from Cumming (1966).

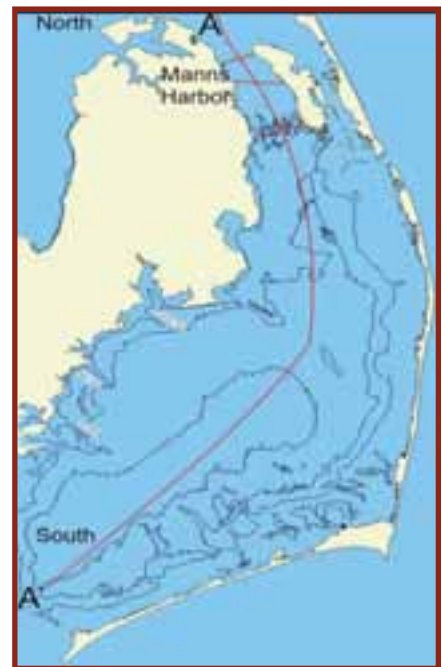
**FIGURE 7-1-2.** The A-A' longitudinal cross section (above panel) is drawn along the channel of Pamlico Creek on the south, across the interstream divide at Roanoke Marshes, through the channel of Croatan Creek, and into the Roanoke River on the north. This section shows the general antecedent or paleotopography of the Pleistocene surface and thickness of Holocene sediment that infilled the channel in response to estuarine flooding by rising sea level during the past 10,000 years. Figure is modified from Riggs et al. (2000).

through the remnants of the Roanoke Marshes and into Croatan Sound. Today, the former Roanoke Marshes area is almost as deep as the rest of Croatan Sound (Fig. 7-1-2).

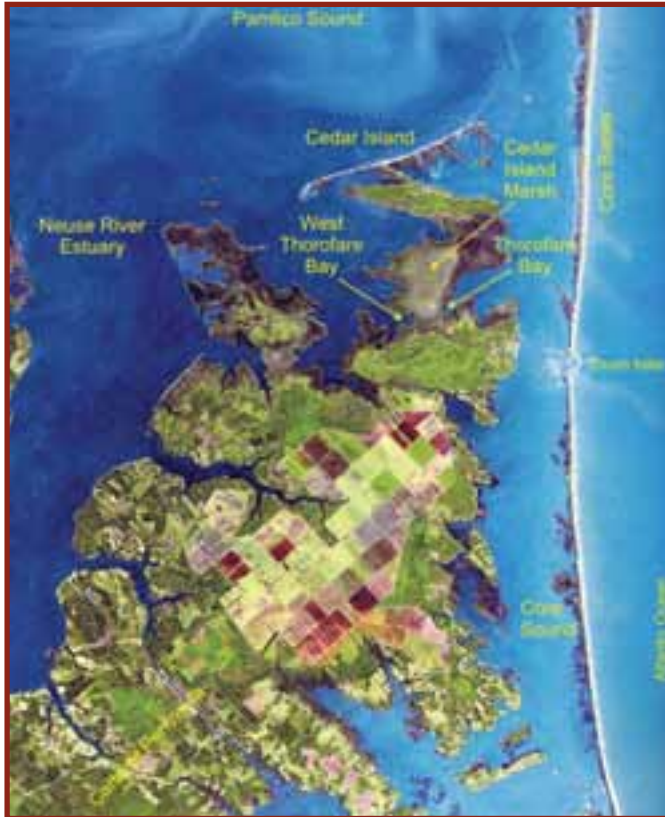
**FIGURE 7-1-5.** Portion of a satellite image (EOSAT from SPACESHOTS, Inc.) of the Cedar Island area showing the modern process of drowning across the Carteret Peninsula interstream divide. The vast Cedar Island *Juncus roemerianus* marsh (gray color) occurs on the interstream divide between West Thorofare and Thorofare bays. With continued flooding due to rising sea level and shoreline erosion, the marsh will rapidly disappear and eventually form an open Thorofare Sound. This is a modern analog for the transition of Croatan Creek to Croatan Bay and finally Croatan Sound.

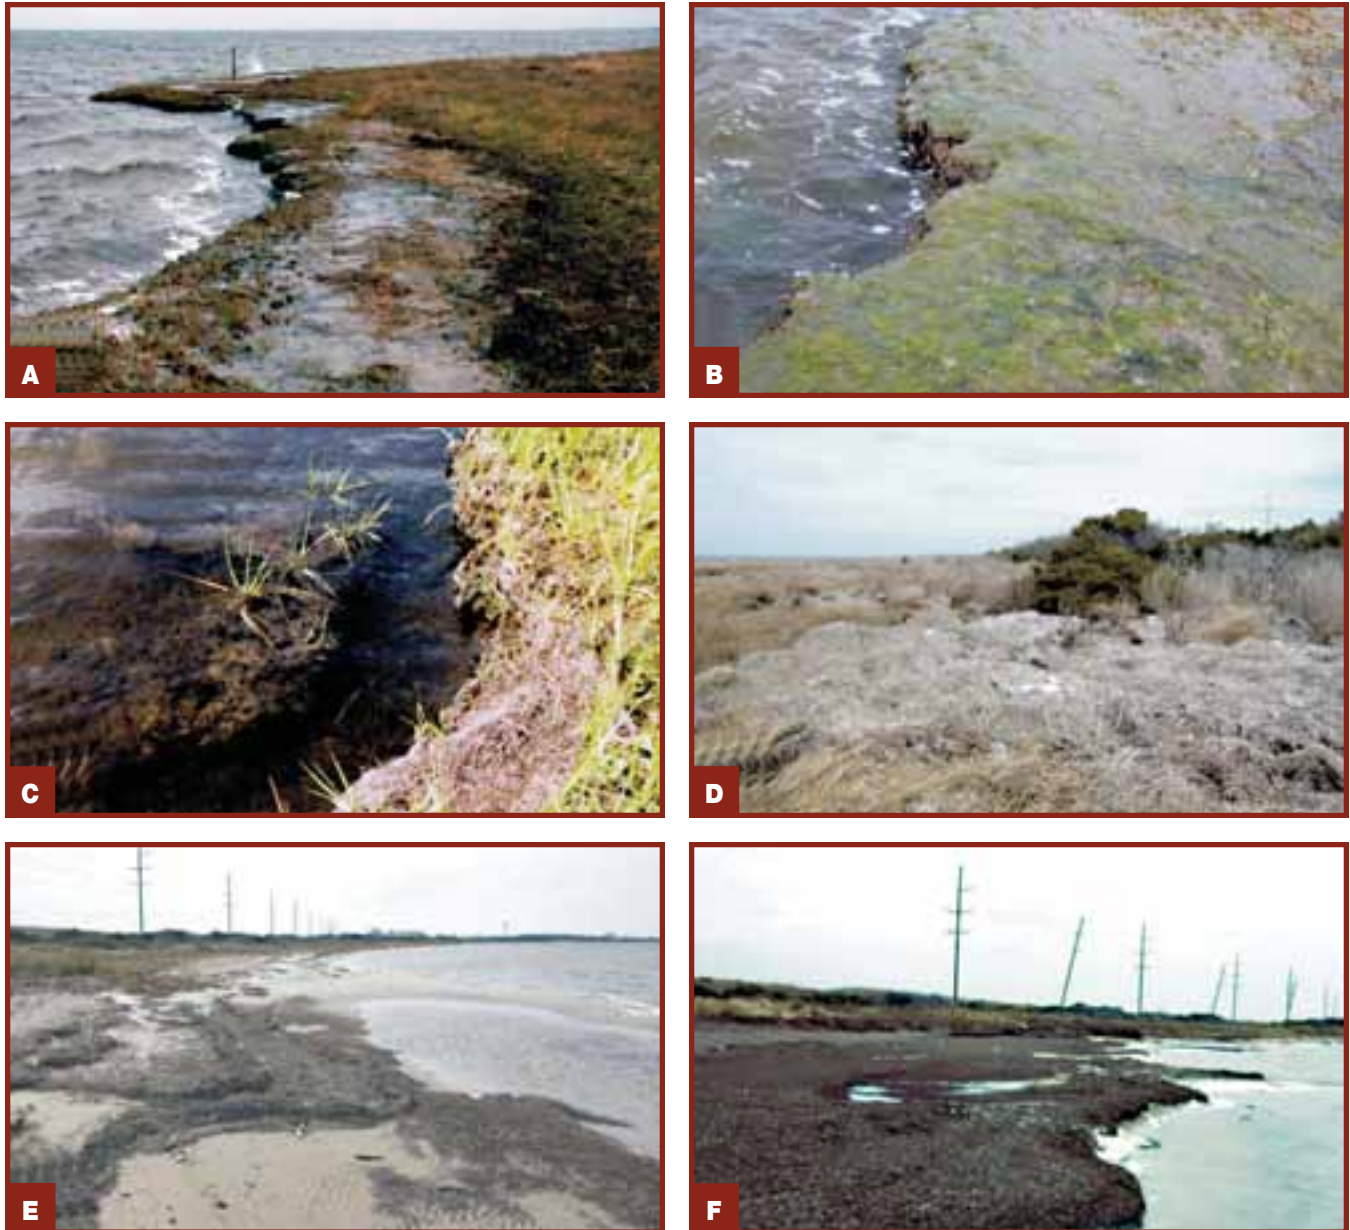
**FIGURE 8-2-1.** Photographs of the Hatteras Overwash site. **PANEL A.** Looking east along the north side of the eroding marsh platform. The outer zone has been totally stripped of marsh grass during winter storms. **PANEL B.** Close-up of the peat surface in the outer zone that has been stripped of marsh grass and is now dominated by green algae. **PANEL C.** Close-up of the outer edge of eroding marsh platform with a large eroded peat block lying in the adjacent shallow waters. The marsh grass is *Spartina alterniflora*. Photograph is from Murphy (2002). **PANEL D.** Looking east along the inner zone of the marsh platform and the adjacent zone of scrub-shrub that occupies the higher elevation of a more recent overwash fan. Notice the extensive accumulation of wrack along the inner zone of the *Juncus roemerianus* marsh platform. **PANEL E.** Looking west along the strandplain beach associated with an overwash fan that occurs to the immediate west of the marsh platform. Notice the minor amounts of dead submerged aquatic vegetation (SAV) that has accumulated locally on this summer beach. **PANEL F.** Same location as Panel E, but now the fall strandplain beach is covered with an extensive accumulation of dead SAV.
