By Stanley R. Riggs and Dorothea V. Ames  
Published by North Carolina Sea Grant

## DROWNING THE NORTH CAROLINA COAST: Sea-Level Rise and Estuarine Dynamics

**ON THE FRONT COVER.** *Pre-Hurricane Isabel photograph of the lower portion of sediment bluff that occurs along the Chowan River estuary western shoreline. The red star, on the satellite image inside the back cover, indicates the specific site location. This bluff is approximately 75 feet high and consists of a lower clay bed that is about 30 feet thick (to the top of this photograph), with an overlying sand bed that is 45 to 50 feet thick. Because bluff shorelines normally erode at average rates between  $-2.0$  and  $-2.5$  ft/yr (Table 8-1-3) and because the lower sediment bank is composed of clay, there is no sand beach preserved on the eroded wave-cut scarp and platform (Fig. 4-2-1). Notice the red dotted line along the wave-cut scarp and compare this to the respective location on the post-Hurricane Isabel photograph on the back cover. Photograph was taken in August 2003. See the back cover for the post-Hurricane Isabel photograph of the same site and inside back cover for a satellite image showing the site location an

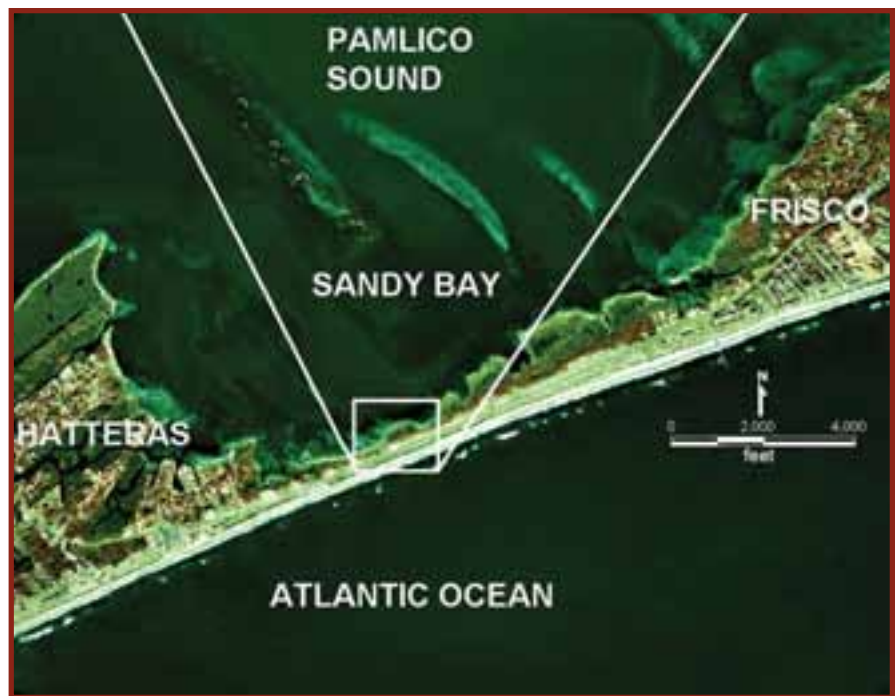
FIGURE 8-2-2. The Hatteras Overwash site 1998 Digital Orthophoto Quarter Quadrangle (DOQQ), with digitized shorelines for 1962 and 1998.

The 1998 DOQQ (Fig. 8-2-2) for the Hatteras overwash site shows the digitized shorelines for 1962 and 1998. The marsh platform had an average shoreline erosion rate of  $-0.5$  ft/yr for the period from 1962 to 1998 (Table 8-2-1), while the strandplain beaches within the adjacent coves actually accreted sediment at the average rate of  $+0.8$  ft/yr. The rates ranged from an accretion rate of  $+3.0$  ft/yr to a recession rate of  $-0.5$  ft/yr. The low net erosion rates, as compared to other sites, are related to the extremely shallow water of Sandy Bay, with abundant surficial sand

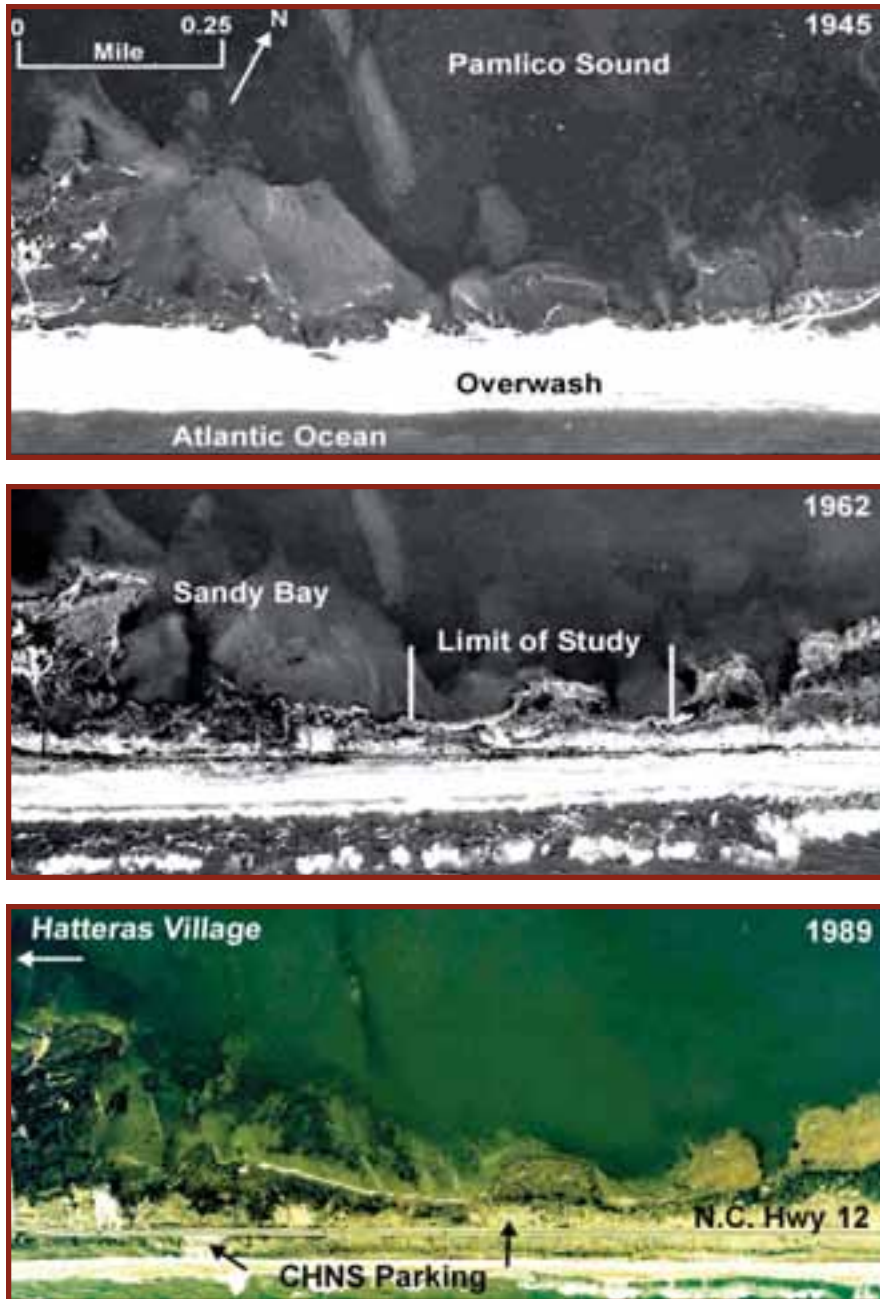
**FIGURE 8-2-3.** The Hatteras Overwash site aerial photograph time slices from 1945, 1962, and 1989. The 1945 photo predates construction of N.C. Hwy. 12 and regular maintenance of the associated barrier-dune ridges. Consequently, this barrier segment is dominated by active overwash processes. However, in the 1962 post-Ash Wednesday storm photograph, the overwash is significantly diminished in magnitude. The difference probably reflects the presence of an elevated N.C. Hwy. 12 roadbed and reconstruction of the associated barrier-dune ridge. The 1989 photo shows no overwash due to a major barrier-dune ridge with increased vegetation growth along the landward side.

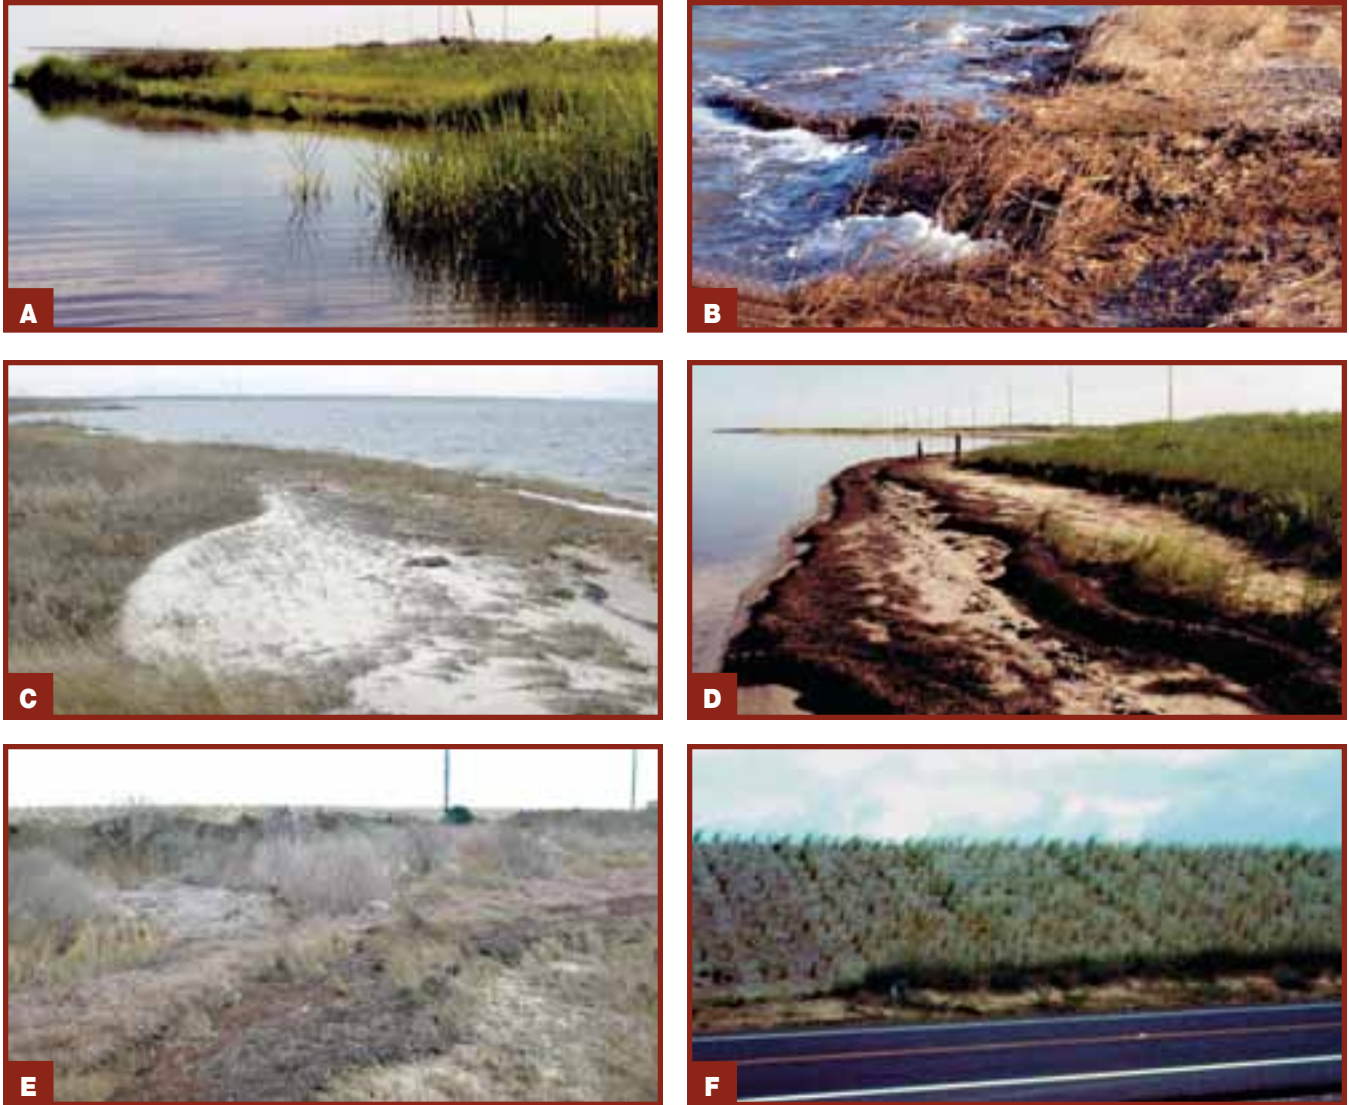
**FIGURE 8-2-4.** Photographs of the Buxton Inlet site. **PANEL A.** Summer photograph looking north along the backside of the marsh platform with *Spartina alterniflora* in bright green and *Juncus roemerianus* in dark green colors. **PANEL B.** Winter photograph looking north along the backside of the marsh platform, with the marsh grasses partially eroded off the peat surface. Notice the scarped outer marsh edge and the irregular geometry to the marsh shoreline due to active shoreline erosion processes. **PANEL C.** Winter photograph looking south along the marsh platform. Notice that there is some sand available to form a high-water sand berm on top of the marsh platform. **PANEL D.** Summer photograph looking north along the backside of the marsh platform. Notice the abundant sand available to form a major strandplain beach in front of and temporarily protecting the outer-scarped marsh. Also, notice the dead submerged aquatic vegetation (SAV) that formed wrack berms at three different previous water levels. Photograph is from Murphy (2002). **PANEL E.** Winter photograph looking east across the inner portion of the marsh platform, the narrow scrub-shrub zone, and the newly constructed barrier-dune ridge on the east side of the new N.C. Hwy. 12. Notice the beach berm in the lower right hand portion of the photo that is composed of a lower sand component and two upper SAV wrack components. Also, behind the wrack berms is an irregular patch of rafted wrack within the transition zone vegetation. **PANEL F.** Looking east at the newly constructed and vegetated barrier-dune ridge built to protect the post-Hurricane Dennis (1999) relocated N.C. Hwy. 12. These structures eliminate the overwash and inlet processes that built this portion of the barrier island and are necessary for maintaining the island for the long term. Without overwash and inlet processes supplying sand to the estuarine side, estuarine erosion rates increase, causing the barrier island to narrow through time.

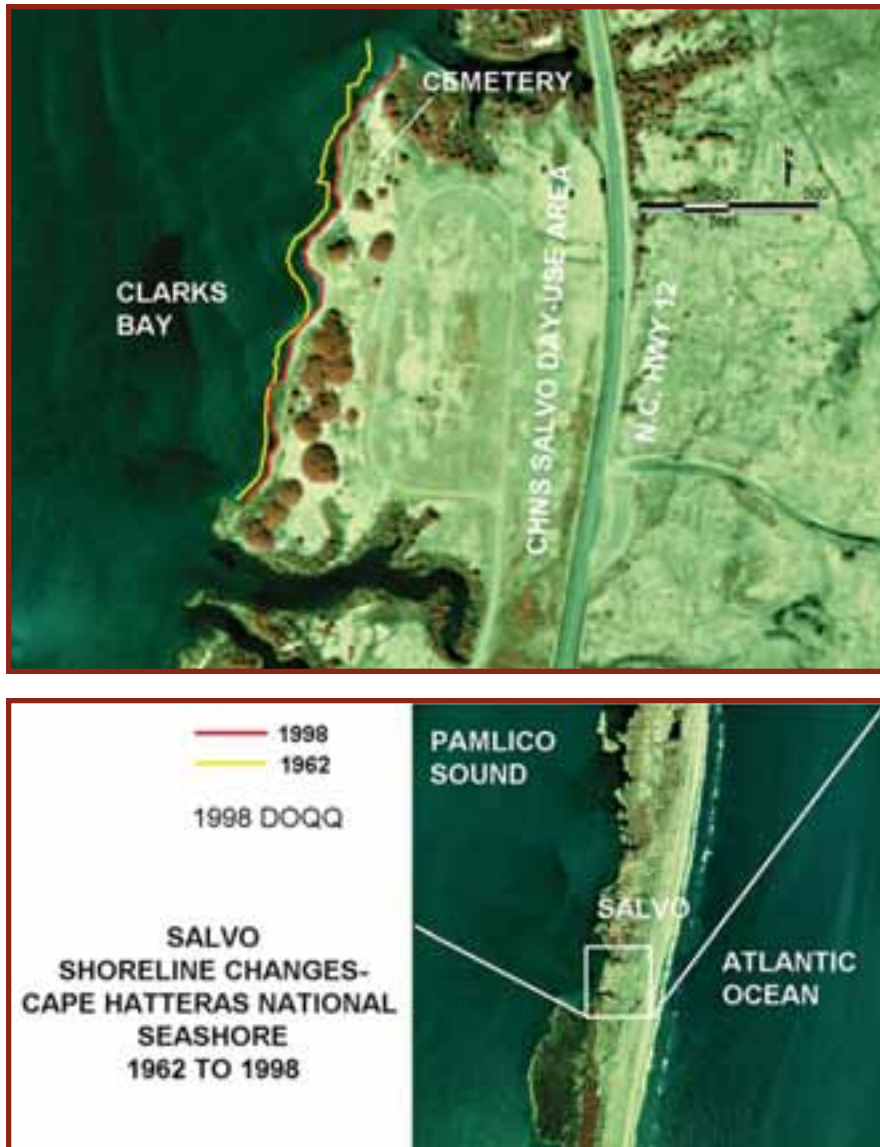
**FIGURE 8-2-9.** The Salvo Day-Use site 1998 Digital Orthophoto Quarter Quadrangle (DOQQ) with digitized shorelines for 1962 and 1998.

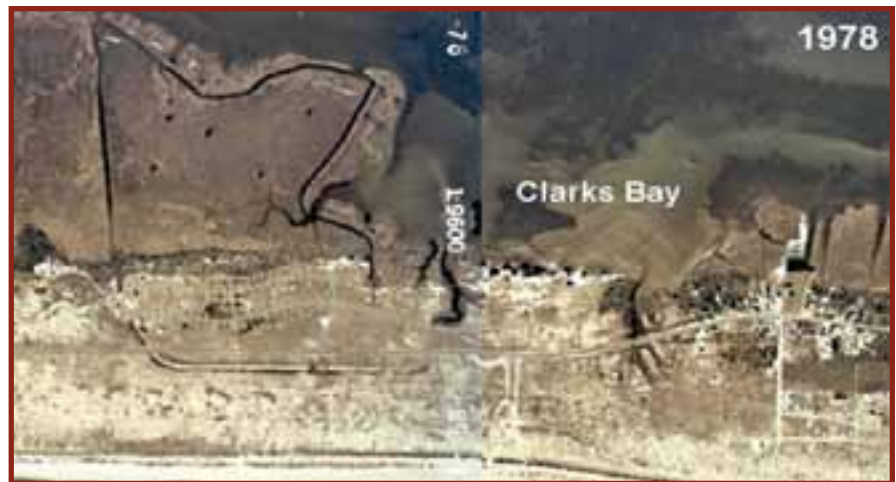
**FIGURE 8-2-10.** The Salvo Day-Use site aerial photograph time slices from 1962, 1978 and 1983. In the 1962 photograph, notice that — even though N.C. Hwy. 12 and associated barrier dune ridges were in place prior to the Ash Wednesday nor'easter storm — the old overwash pattern was re-established as the cross-island water flowed into Pamlico Sound through the existing channel structures on either side of the study area. The ongoing process of estuarine shoreline erosion through time is obvious along the outer edge of the impoundment in the upper left portion of the photo sequence (1962 to 1983). By 1998 (Fig. 8-2-9) ongoing shoreline recession had eroded through the adjacent dike and exposed an ever-increasing length of the north-south ditch to the open waters of the Pamlico Sound.

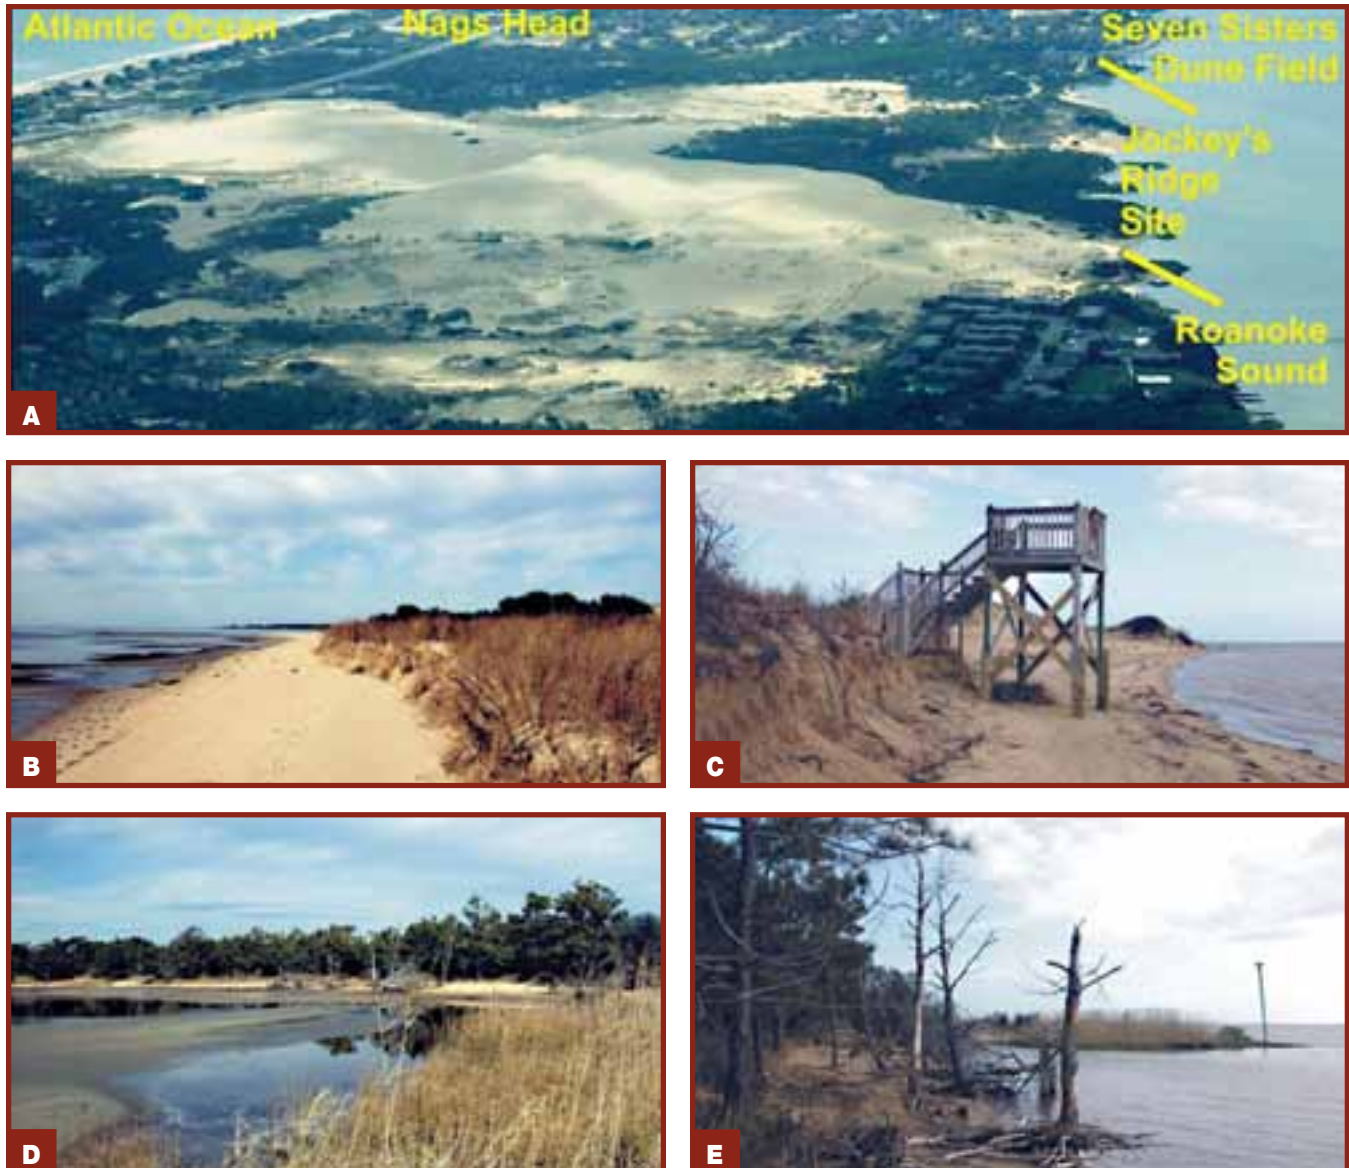
**FIGURE 8-2-11.** Photographs of Jockey's Ridge site. **PANEL A.** An oblique aerial photograph showing Jockey's Ridge State Park and the irregular geometry of the estuarine low sediment bank shoreline. Photograph is from the Field Research Facility of the U.S. Army Corps of Engineers. **PANEL B.** Looking north along the eroding low sediment bank shoreline composed entirely of sand and covered with various types of grass vegetation. The low wind tide has exposed the extremely broad and well-developed strandplain beach that consists of an upper portion occupied during high wind tides and a lower portion occupied during low wind tides. Notice the grassed slump blocks that have collapsed in front of the wave-cut scarp. **PANEL C.** Close-up view looking south along the eroding low sediment bank shoreline and associated upper strandplain beach. Rapid recession of the wave-cut scarp has required the observation platform, which was sitting on top of the low sediment bank, to be repiled and braced. Notice the exposed roots in the wave-cut scarp. **PANEL D.** Photo during a low wind tide from a marsh headland and looking east into a cove. The shoreline is a low sediment bank covered generally by pine trees and a very broad and well-developed strandplain beach. **PANEL E.** Photo looking southwest from inside the cove towards the marsh headland of Panel D. The abundant dead pine trees on the nearshore and strandplain beach demonstrate the active rates of shoreline recession.

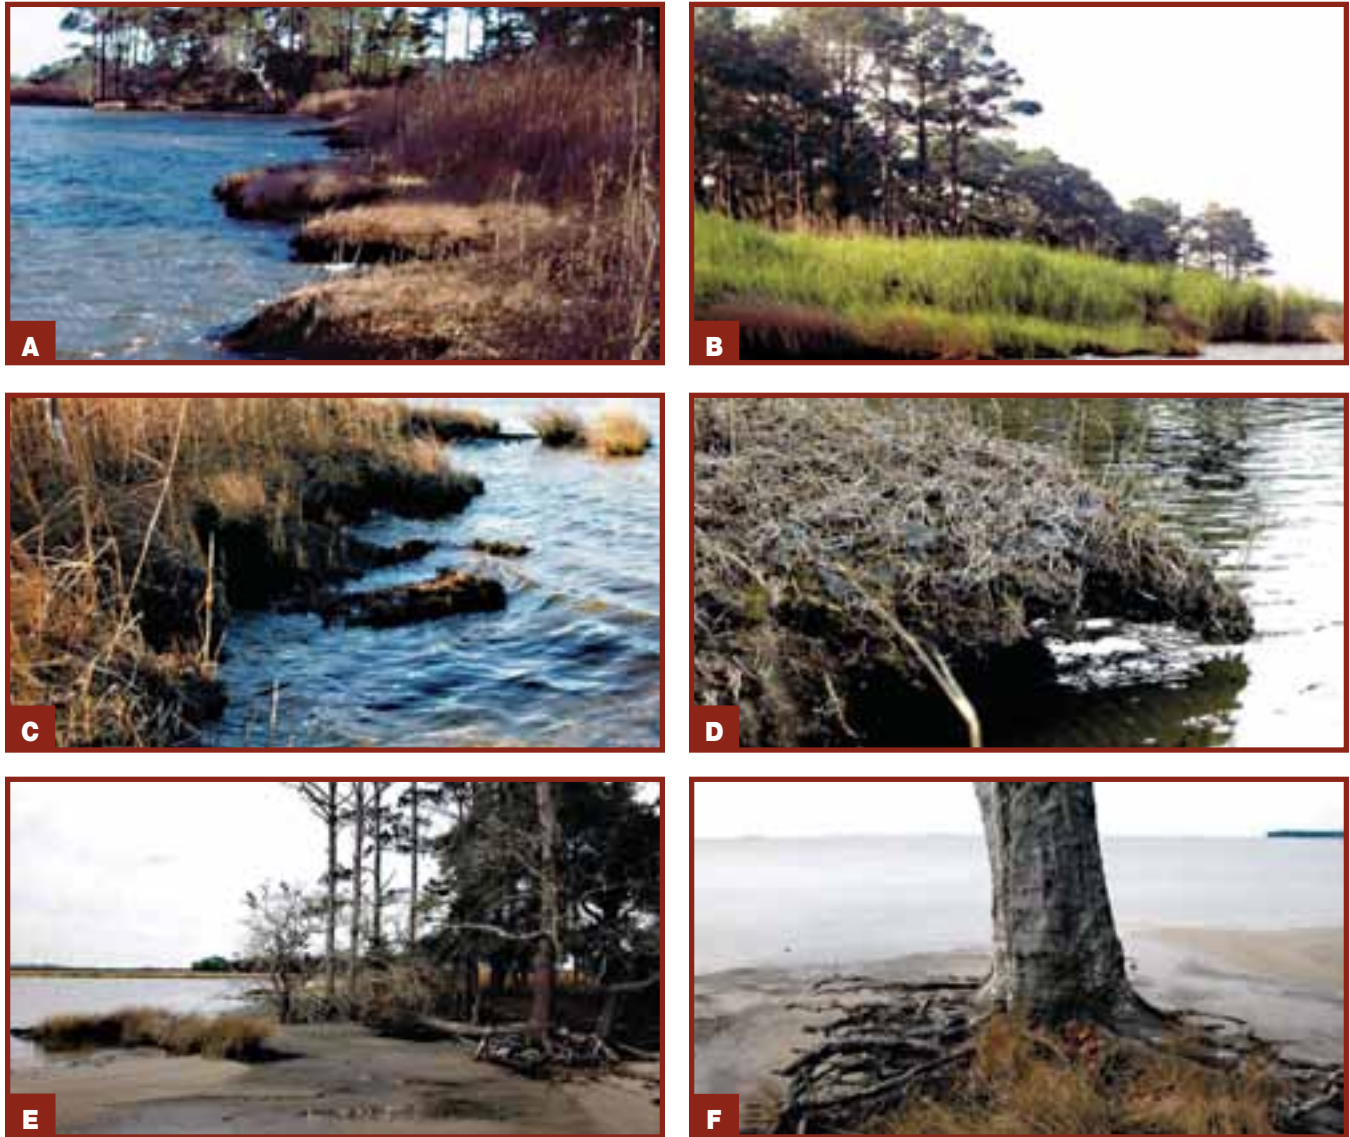
**FIGURE 8-2-16.** Photographs of Nags Head Woods site. **PANEL A.** Winter photograph looking northeast along the eroding edge of a narrow marsh platform towards a small segment of low sediment bank dominated by a maritime forest of pine trees. Notice the irregular erosional geometry of the marsh peat shoreline. **PANEL B.** Summer photograph looking the opposite direction to Panel A, southwest along the eroding edge of a narrow marsh platform that fronts an upland region dominated by a maritime forest of pine trees. The outer zone of marsh grass is a mixed assemblage of *Spartina patens* and *Juncus roemerianus*, while the inner zone of tall grass is *Spartina cynosuroides*. **PANEL C.** Close-up winter photograph looking southwest along the eroding edge of a marsh platform. Notice the two large eroded peat blocks sticking out of the water just to the right of the eroding shoreline. **PANEL D.** Close-up view of an eroding marsh peat headland along the shoreline in Panel C during a low wind tide. The deeply undercut modern root zone slopes steeply into the water. A subsequent storm, with a high wind tide and wave action, will cause the overhanging block to break off and produce an offshore peat block as is seen in Panel C. **PANEL E.** Close-up view of low sediment bank shoreline that occurs in the distance in Panel A. The low wind tide has exposed the rippled sand flats of the lower portion of the strandplain beach. Notice the many trees with the root structures exposed by the erosional processes. **PANEL F.** Close-up view of a dead live oak tree on the lower portion of the strandplain beach. The entire root system has been exposed through the erosion of the upland soil.

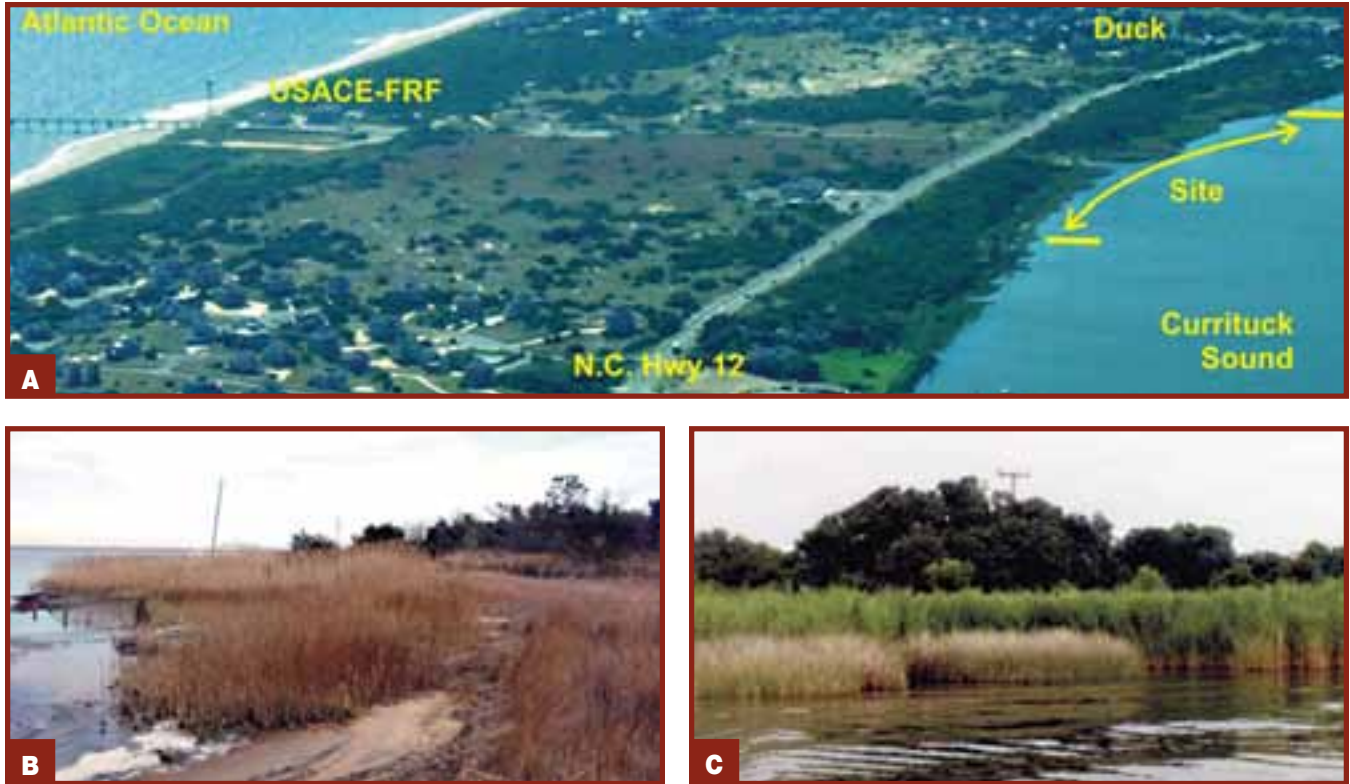
**FIGURE 8-2-18.** Photographs of the Duck Field Research Facility site. **PANEL A.** An oblique aerial photograph showing the densely vegetated character of the estuarine shoreline at the Duck site. The narrow, outer and lighter green colored zone is marsh grass. Whereas, the darker zone between the marsh and N.C. Hwy. 12 has dense scrub-shrub growing on top of the low sediment bank. Oblique aerial photograph is from the Field Research Facility of the U.S. Army Corps of Engineers. **PANEL B.** Winter photograph looking north along the strandplain beach towards the eroded low sediment bank scarp in the distance on the right side of the photo. Notice the fringing marsh consisting primarily of *Juncus roemerianus* in the foreground and *Phragmites australis* in the background. In the middle of the strandplain beach is a wrack berm composed of dead marsh grasses. **PANEL C.** Summer photograph looking east across the shoreline to the upland scrub-shrub. The shorter grass in the foreground is *Juncus roemerianus* with *Phragmites australis* in the background.

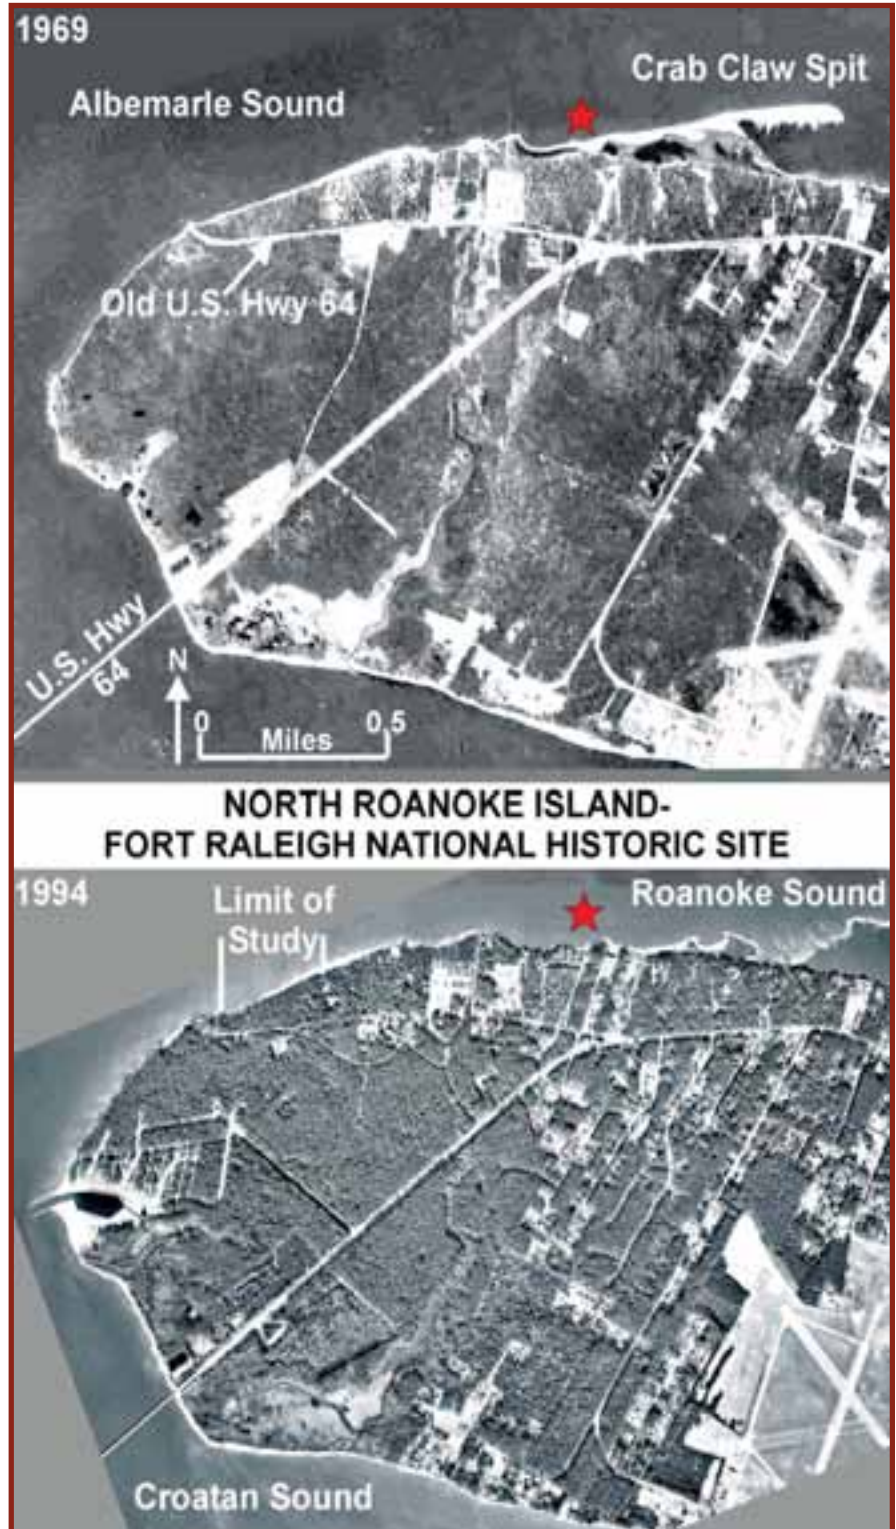
**FIGURE 8-3-4.** The North Roanoke Island site aerial photograph time slices from 1969 and 1994. Crab Claw Spit formed over time from high rates of sediment bank erosion on the north end of Roanoke Island and the associated long-shore currents driven by northwest storms. However, during the latter part of the 20th century, the amount of sediment feeding Crab Claw Spit rapidly diminished as most of the north end of Roanoke Island was stabilized (Fig. 8-3-1A). Loss of the sediment source led to destabilization, breakup and rapid eastward migration of the Spit remnants as demonstrated in the 1994 photo. As the Spit moves, shorelines formerly protected behind the Spit become re-exposed to open water and increased rates of shoreline erosion. The red star marks the same spot on both photographs.

the northeast portion of Roanoke Island. The sand to build Crab Claw Spit came from erosion of the northern shoreline and subsequent longshore transport in response to strong northwest winter winds. Notice that by 1994 Crab Claw Spit has largely broken down, and portions have migrated further to the southeast. This dramatic breakup and spit migration is a direct response to loss of the sediment source resulting from hardening most of the northern shorelines (Fig. 8-3-1A and Table 8-3-2).

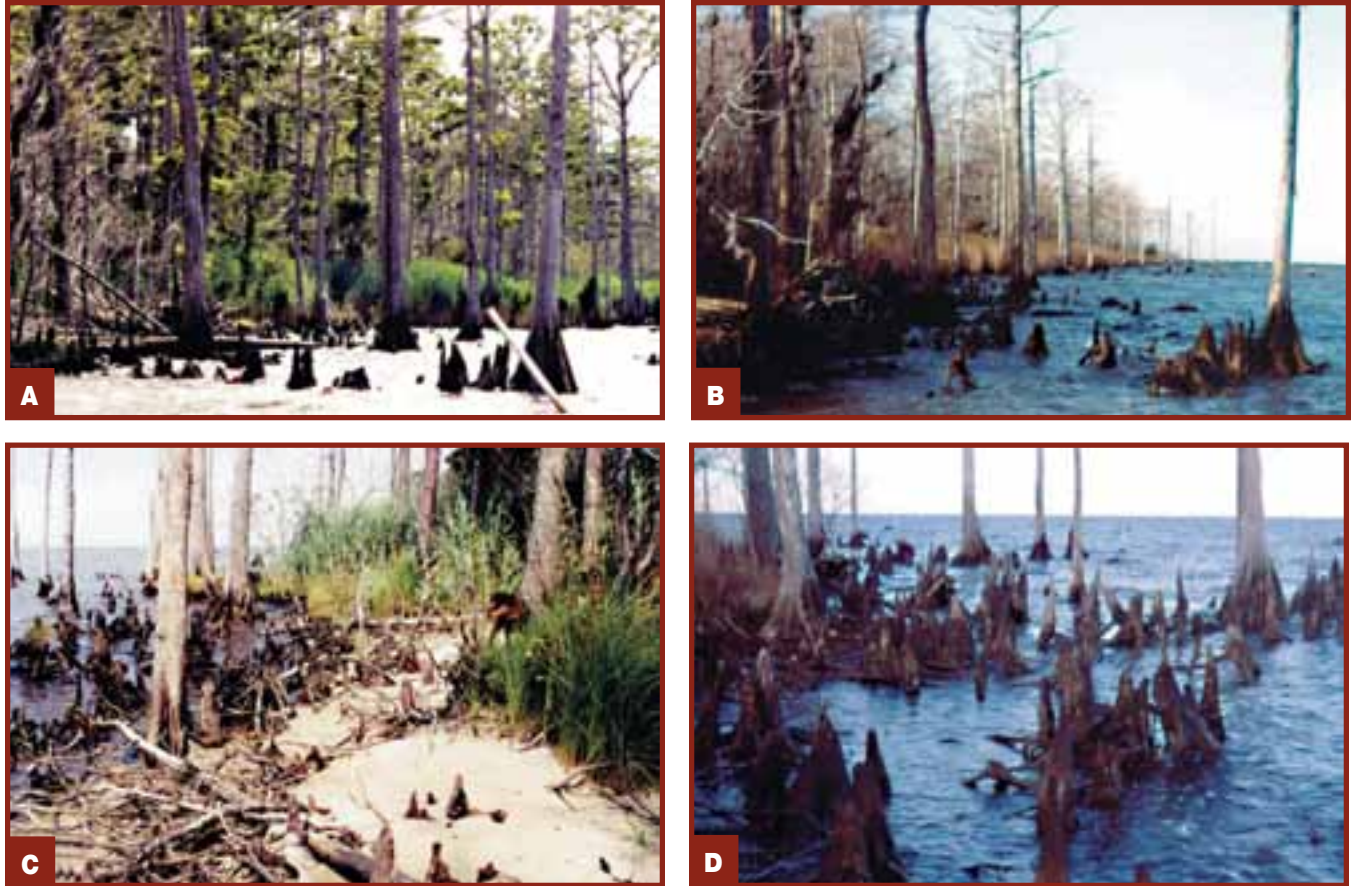
**FIGURE 8-3-5.** Photographs of the Woodard's Marina site. **PANEL A.** Summer photograph looking south into the three common zones that characterize swampforest shorelines. The photo is taken from within the ghost swamp forest of Zone 3 and backed by the dense growth of *Spartina cynosuroides* that characterizes the middle Zone 2 and represents the shoreline. Behind the marsh grasses is the dense and living swamp forest of Zone 1. **PANEL B.** Winter photograph looking west along the swampforest shorelines from the same general location as Panel A. **PANEL C.** Close-up photo of the shoreline (Zone 2) characterized by a small sand berm, which supports the dense growth of *Spartina cynosuroides*. Photograph is from Murphy (2002). **PANEL D.** Close-up photo of the cypress trees and associated knees that are the last survivors within Zone 3 as the shoreline of Zone 2 moves landward.

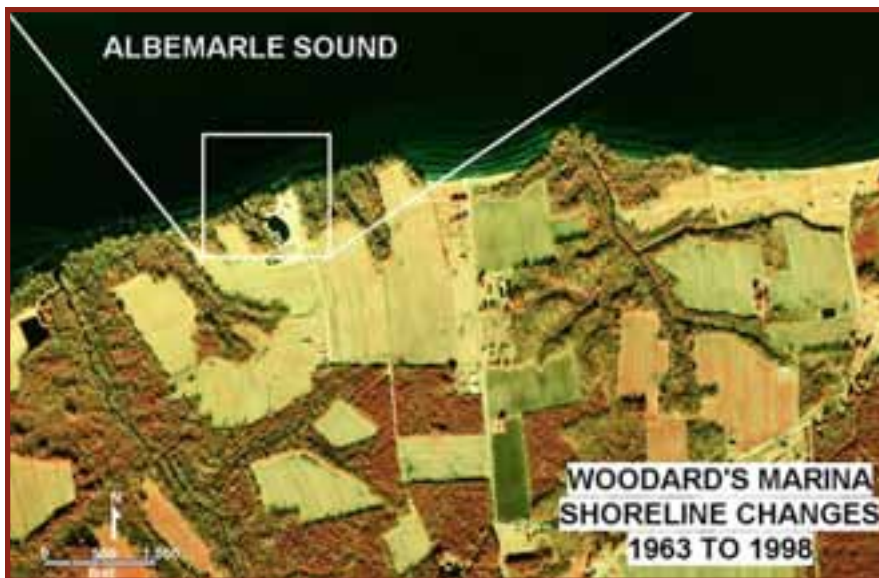
**FIGURE 8-3-6.** The Woodard's Marina site 1998 Digital Orthophoto Quarter Quadrangle (DOQQ) with digitized shorelines for 1963 and 1998.

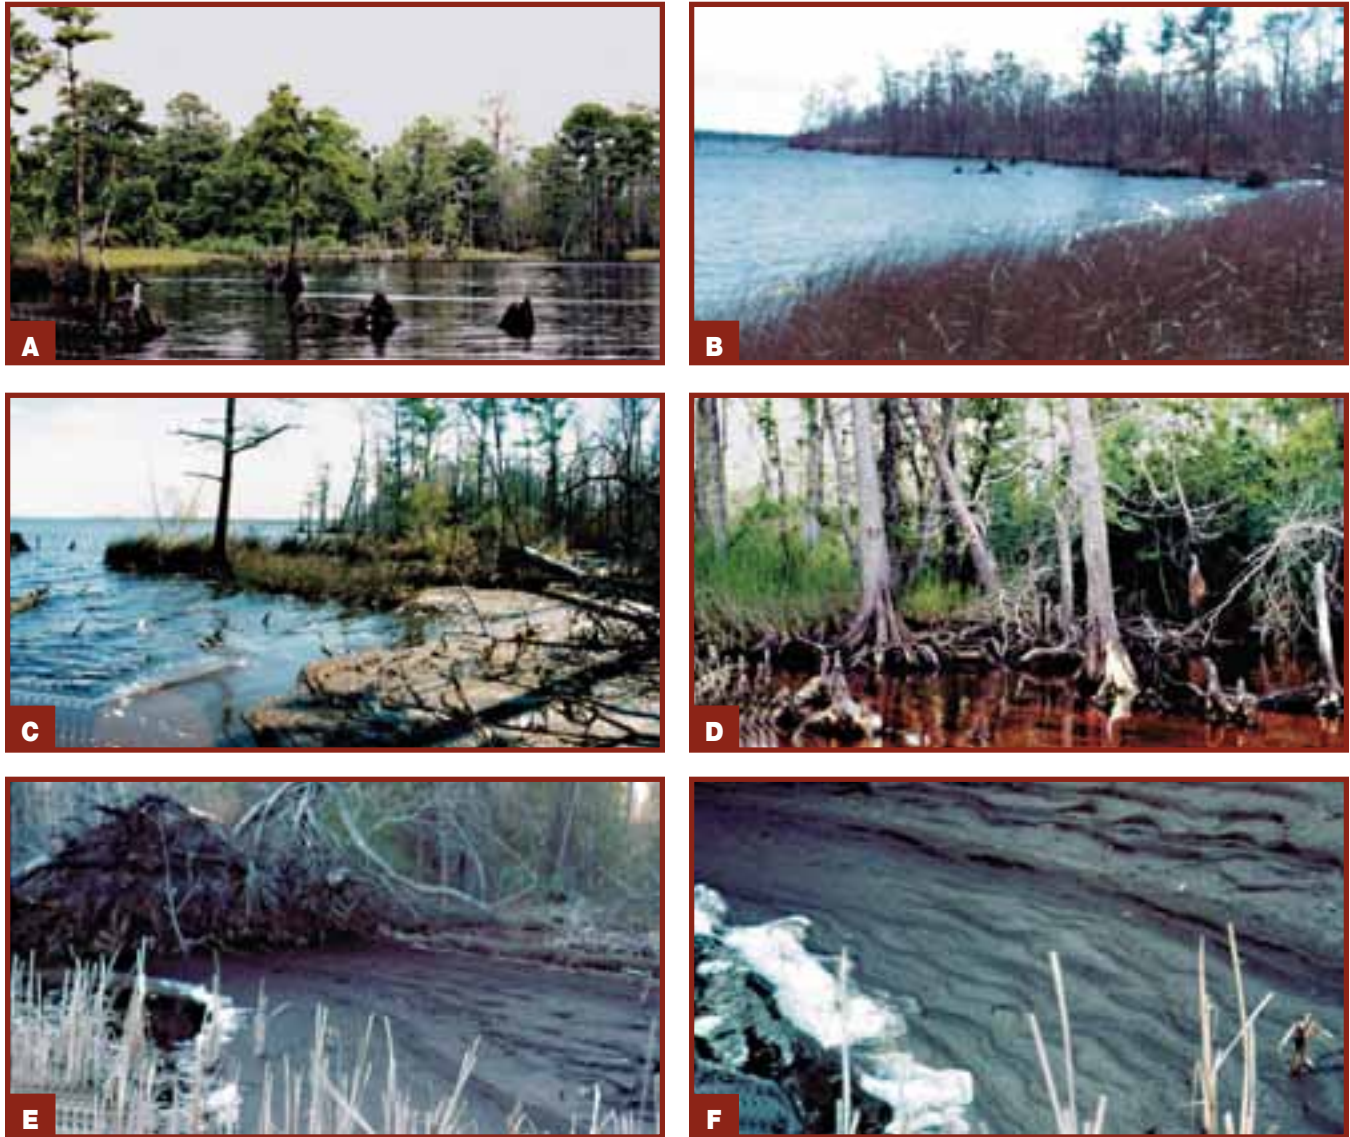
**FIGURE 8-3-8.** Photographs of the Grapevine Landing site. **PANEL A.** Summer photograph looking north along the swampforest shoreline of the Alligator drowned river estuary. This swampforest shoreline has been extensively modified by natural processes, resulting in a broad shoreline zone of marsh and strandplain beaches. The photo shows the southern portion of the study area, the landing (pier) in the center and the northern portion of the study area in the distance. **PANEL B.** Winter photograph looking south across the southern portion of the study area from the pier. The outer zone of marsh grass is generally *Juncus*, whereas the inner zone occurring within the swamp forest is generally *Spartina cynosuroides*. **PANEL C.** Close-up of strandplain beach within a cove formed by a small headland of stumps and covered with *Juncus* marsh grass. Photograph is from Murphy (2002). **PANEL D.** Close-up of an eroded section of swamp forest with the root systems exposed and *Spartina cynosuroides* marsh grass within the existing swamp forest. Photograph is by M. Murphy. **PANEL E.** Close-up of a strandplain beach within a cove formed by a headland of swampforest trees that have been recently uprooted. The strandplain beach consists of a thin, basal bed of quartz sand burying the eroded peat substrate. The denser quartz sand has been buried by a one-foot thick accumulation of very light organic detritus. **PANEL F.** Close-up of the depositional and erosional sediment structures produced in the organic detritus layer on the strandplain beach during the last falling wind tide. The coffee-colored water is visible at the bottom left corner of the photo.

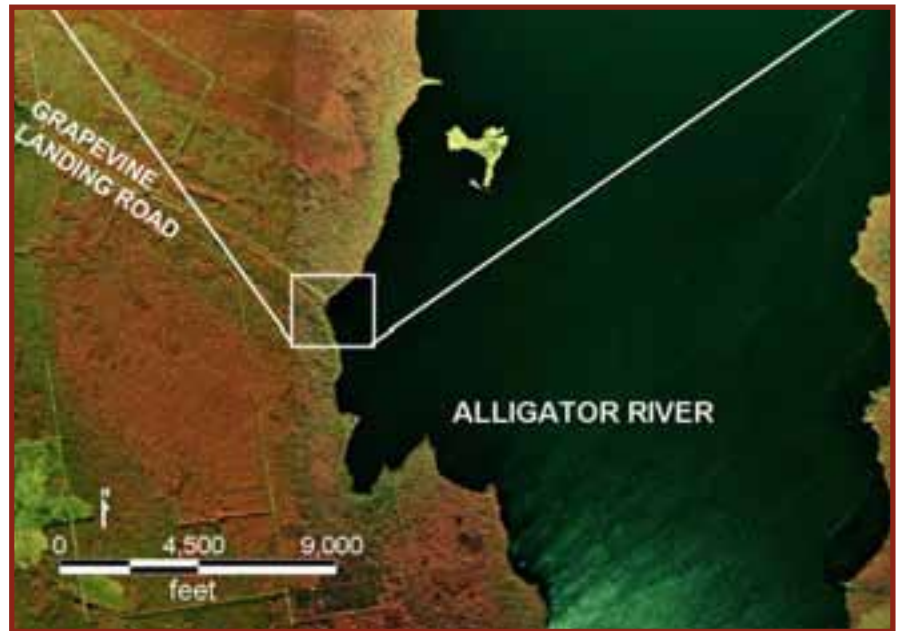
**FIGURE 8-3-9.** The Grapevine Landing site 1998 Digital Orthophoto Quarter Quadrangle (DOQQ) with digitized shorelines for 1981 and 1998.

The 1998 DOQQ (Fig. 8-3-9) shows the location of digitized estuarine shorelines for 1981 and 1998. During this period, the Grapevine Landing site had an average shoreline recession rate of  $-1.9$  ft/yr, with a range from

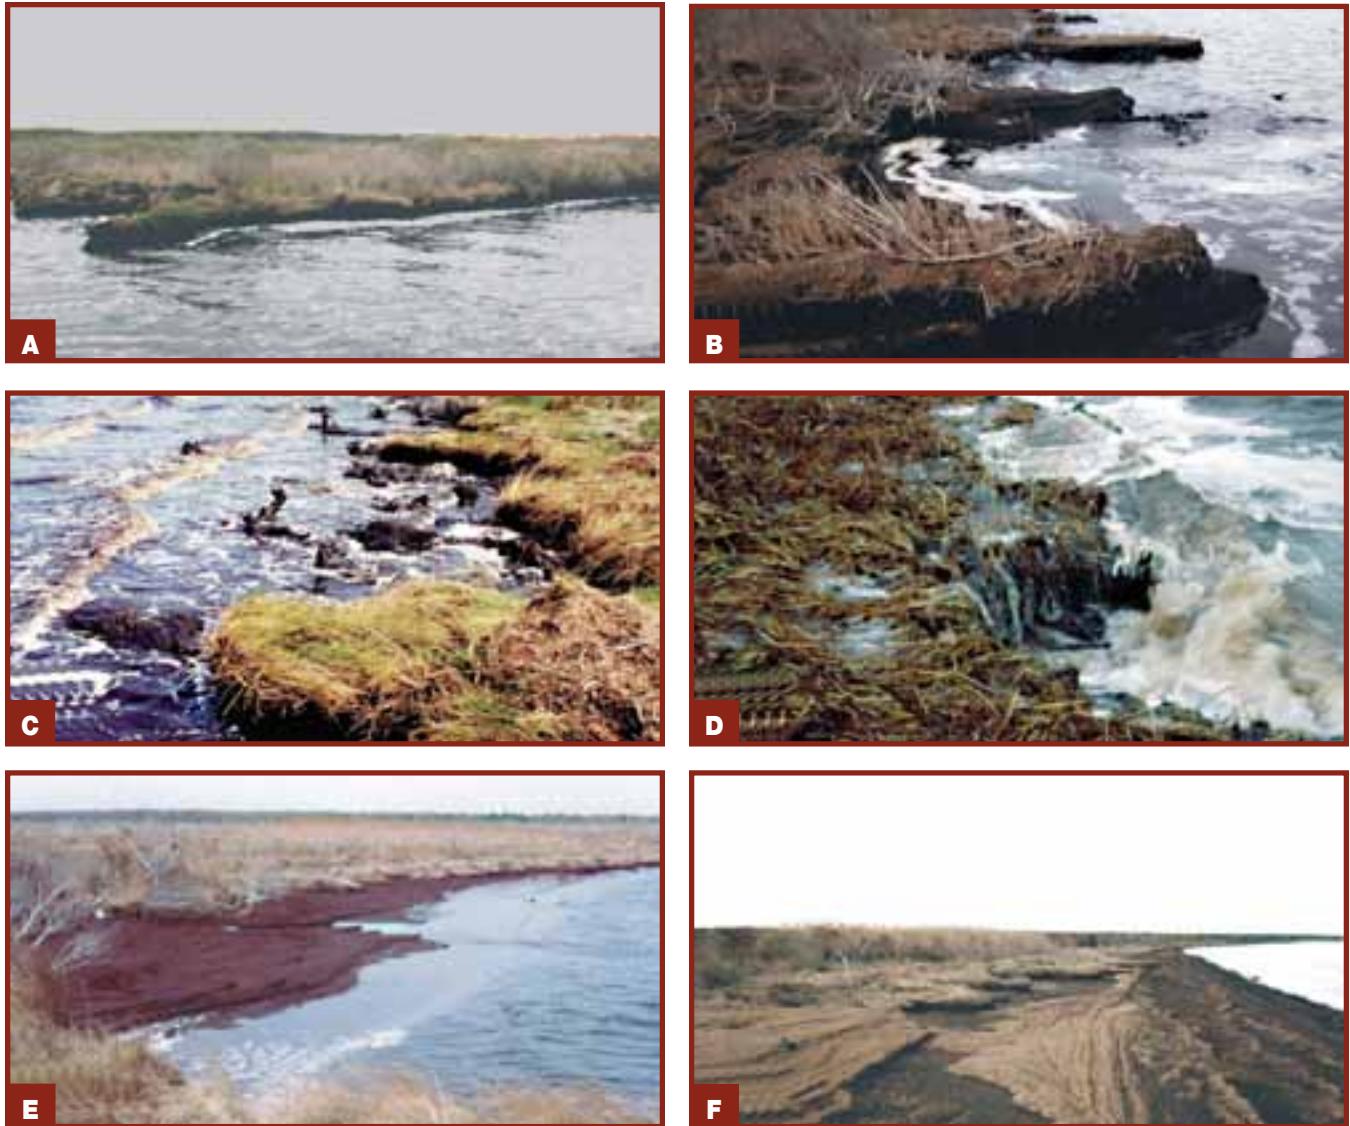
**FIGURE 8-3-10.** Photographs of the Point Peter Road site. **PANEL A.** Winter photograph looking west at the former freshwater, swampforest shoreline that has recently evolved into a fresh- to low brackish-water transition zone with marsh vegetation. Today, the vegetation is dominated by *Spartina patens*, *Cladium*, *Baccharis*, and *Myrica*. **PANEL B.** Close-up of the highly irregular eroding geometry of the peat shoreline. The small headlands are held up either by modern *Baccharis* and *Myrica* stumps that occur at the shoreline as it recedes or by larger stumps and logs that occur in the lower portions of the eroding peat bank. **PANEL C.** Close-up of the irregular peat shoreline displaying the tops of the abundant, large, eroded peat blocks that litter the nearshore area. Notice the irregular wrack berm on top of the *Spartina patens* marsh. **PANEL D.** Close-up view of erosional wave action that causes the upper and overhanging modern root-bound layer to oscillate as the softer, decomposing under layer is actively eroded away. **PANEL E.** Similar photo to Panel A, but with a small strandplain beach composed totally of organic detritus eroded out of the underlying peat bed. The presence and extent of this organic detritus is extremely variable and dependent upon the season and storm patterns. Notice how the irregular erosional geometry of the original peat shoreline can be seen on the landward side of the strandplain beach. **PANEL F.** Winter photograph looking north from the same location as Panel E. Now, the entire eroding peat shoreline is buried beneath an extensive strandplain beach composed totally of organic detritus. This detrital accumulation is over 3 feet thick at the water's edge and extends some distance seaward below the water's surface. Notice the beautifully detailed, and small-scale depositional and erosional sediment structures that are preserved on this beach as the water rises and falls in response to the wind tides.

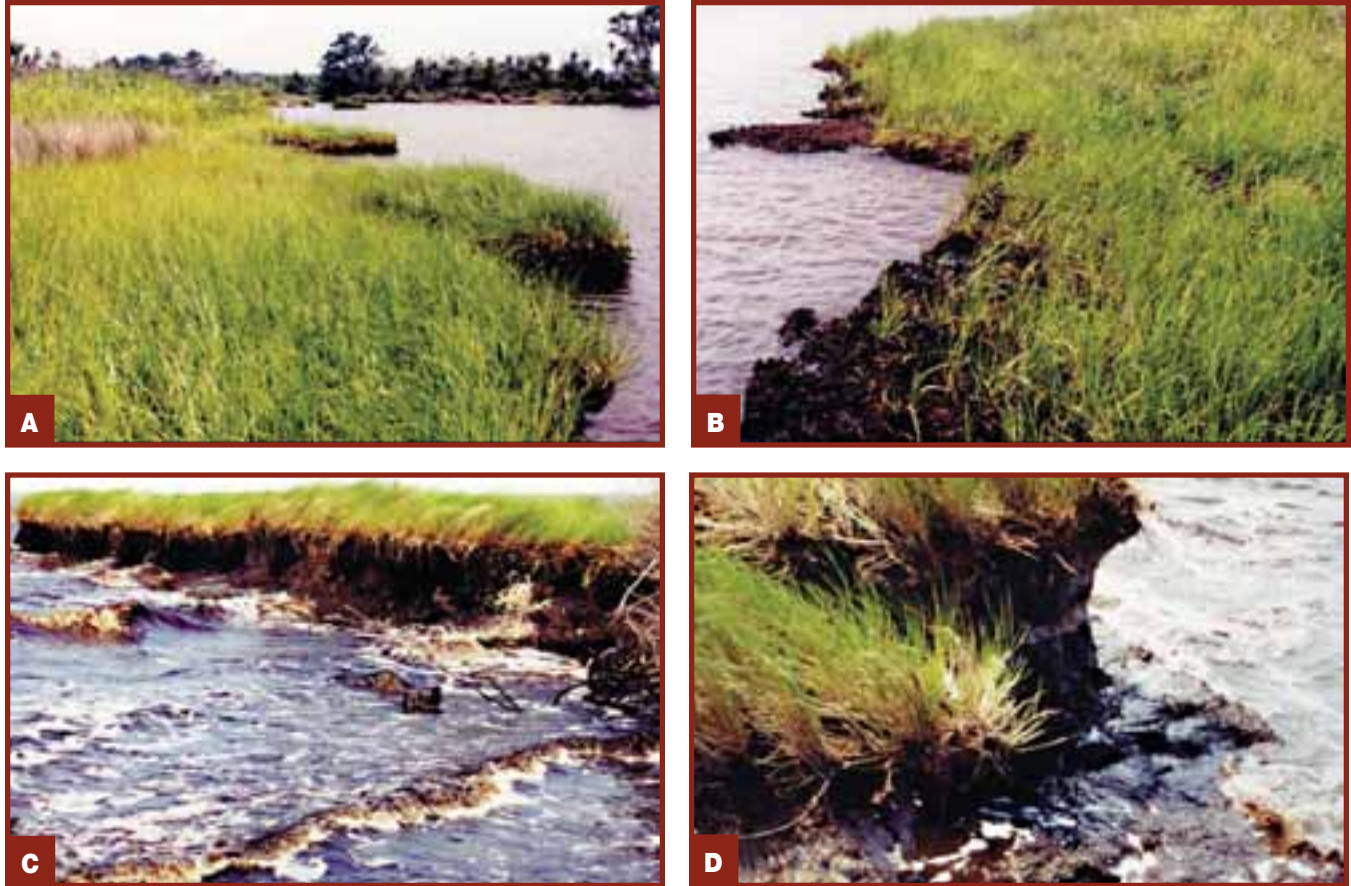
**FIGURE 8-3-13.** Photographs of the North Bluff Point site. **PANELS A and B.** Summer photographs looking northeast (A) across the Outfall Canal to the upland vegetation on the far spoil bank and looking southwest (B) along the outer edge of the marsh platform. The outer zone of this platform marsh consists of *Spartina alterniflora* that grades landward into a dense growth of *Spartina cynosuroides*. The latter grass is growing on a slightly elevated zone of spoil that was deposited along the outside of the impoundment ditch as indicated on Figure 8-3-14. Notice the highly irregular shoreline geometry of the rapidly eroding marsh peat shoreline. Photographs are by M. Murphy. **PANELS C and D.** Close-up photographs of the irregular marsh peat shoreline. The peat is about 6 to 7 feet thick at this point, with the wave-cut scarp eroded to depths of 2 to 4 feet below the water surface. Thus, the bottom of the estuary is still in the soft peat. The estuarine floor gently slopes away from the land to 6- to 7-foot water depth where the peat has been totally eroded away and the underlying tight clay forms the estuarine floor. Notice the dark coffee color of the water.
