By Stanley R. Riggs and Dorothea V. Ames  
Published by North Carolina Sea Grant

## DROWNING THE NORTH CAROLINA COAST: Sea-Level Rise and Estuarine Dynamics

**ON THE FRONT COVER.** *Pre-Hurricane Isabel photograph of the lower portion of sediment bluff that occurs along the Chowan River estuary western shoreline. The red star, on the satellite image inside the back cover, indicates the specific site location. This bluff is approximately 75 feet high and consists of a lower clay bed that is about 30 feet thick (to the top of this photograph), with an overlying sand bed that is 45 to 50 feet thick. Because bluff shorelines normally erode at average rates between  $-2.0$  and  $-2.5$  ft/yr (Table 8-1-3) and because the lower sediment bank is composed of clay, there is no sand beach preserved on the eroded wave-cut scarp and platform (Fig. 4-2-1). Notice the red dotted line along the wave-cut scarp and compare this to the respective location on the post-Hurricane Isabel photograph on the back cover. Photograph was taken in August 2003. See the back cover for the post-Hurricane Isabel photograph of the same site and inside back cover for a satellite image showing the site location an

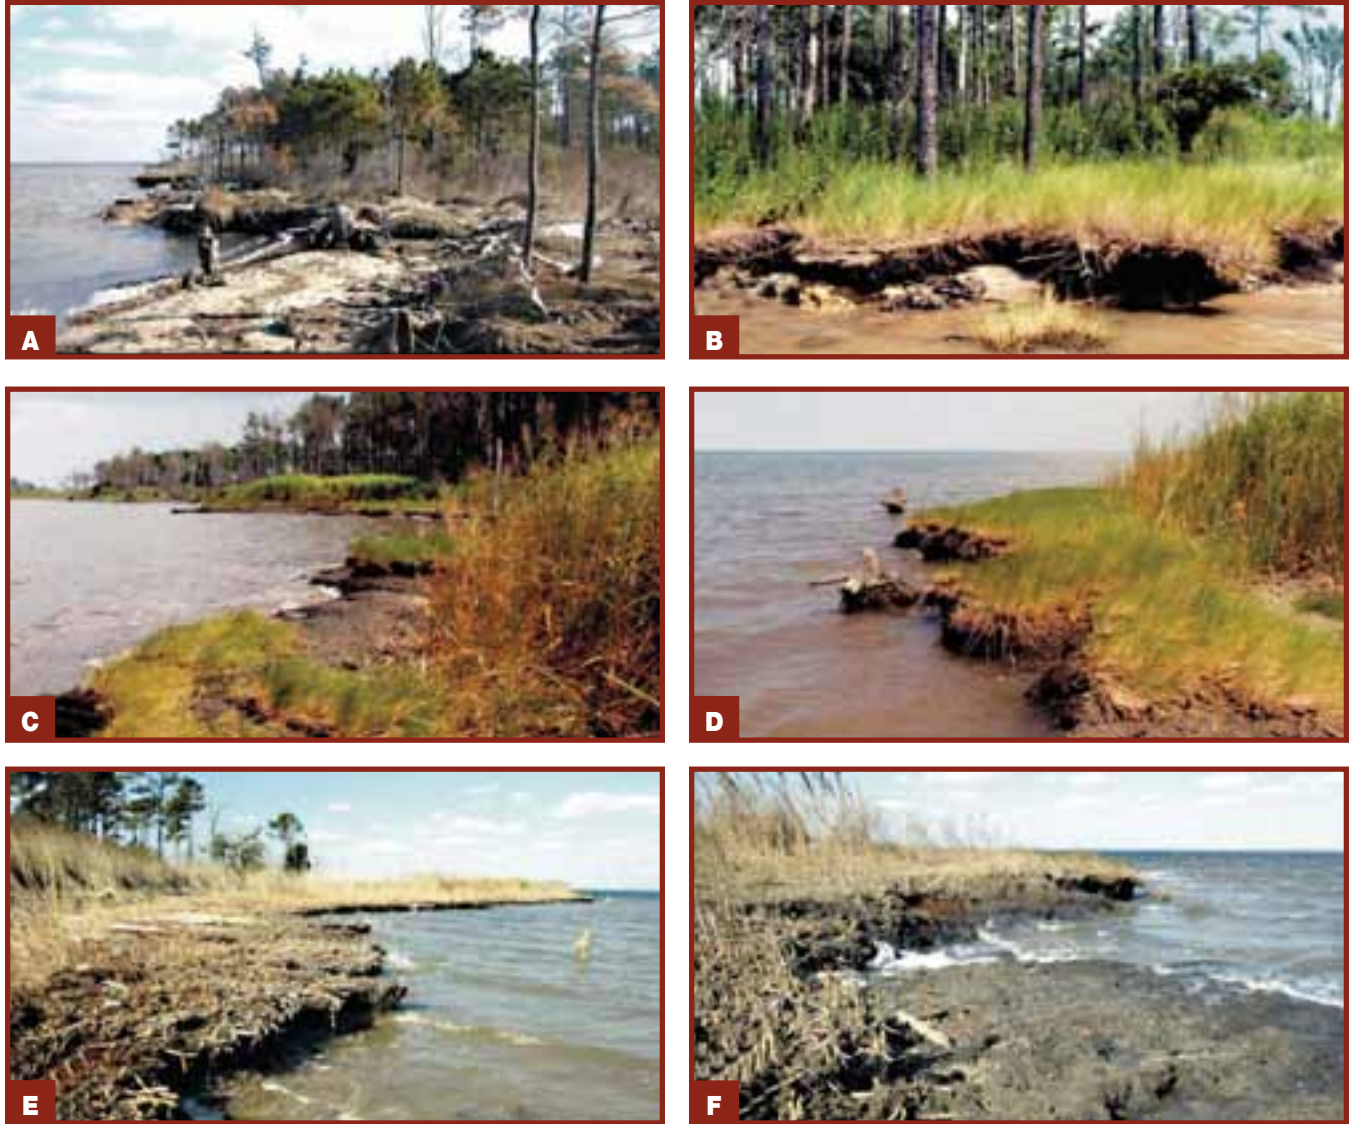
**FIGURE 8-3-17.** Photographs of the Lowland site. **PANEL A.** Winter photograph looking northeast within the cove and along a low sediment bank shoreline with *Spartina patens*, scrub-shrub and pond pine growing on the upper surface. Notice the small strandplain beach that occurs only within the apex of the cove. **PANEL B.** Close-up of the wave-cut scarp eroded into the low sediment bank overlain by a thin pocosin peat containing a cover of *Spartina patens* in the foreground and pond pine with transition zone scrub-shrub in the background. The sediment bank is composed of a Pleistocene, tight, slightly sandy clay. This is the source of the limited sand forming the small strandplain beach in Panel A. **PANEL C.** Summer photograph looking east along the narrow marsh platform in front of the mineral soils, with their wetland woods consisting predominantly of scrub-shrub, bay trees and pond pine. The marsh platform is composed of organic peat that is forming on top of and pinches out onto the mineral soil that forms the shoreline in Panel B. Photograph is by M. Murphy. **PANEL D.** Summer close-up of the marsh platform dominated by a narrow outer zone of *Spartina patens* adjacent to the water and an inner zone of *Spartina cynosuroides* that is growing on a very thin and slightly raised sand and wrack berm. Photograph is by M. Murphy. **PANEL E.** Winter photograph looking northwest along the marsh platform shoreline within the cove. Notice the thick roots of *Spartina cynosuroides* that extend out to edge of the eroding marsh peat where the plants have been stripped off by wave action. **PANEL F.** Close-up of the wave-cut scarp and wave-cut platform eroded into the marsh peat. In the foreground, the tight, root-bound, upper surface has been eroded off in a stair-step fashion. Whereas, in the background, this root-bound surface is being undercut forming an overhang.

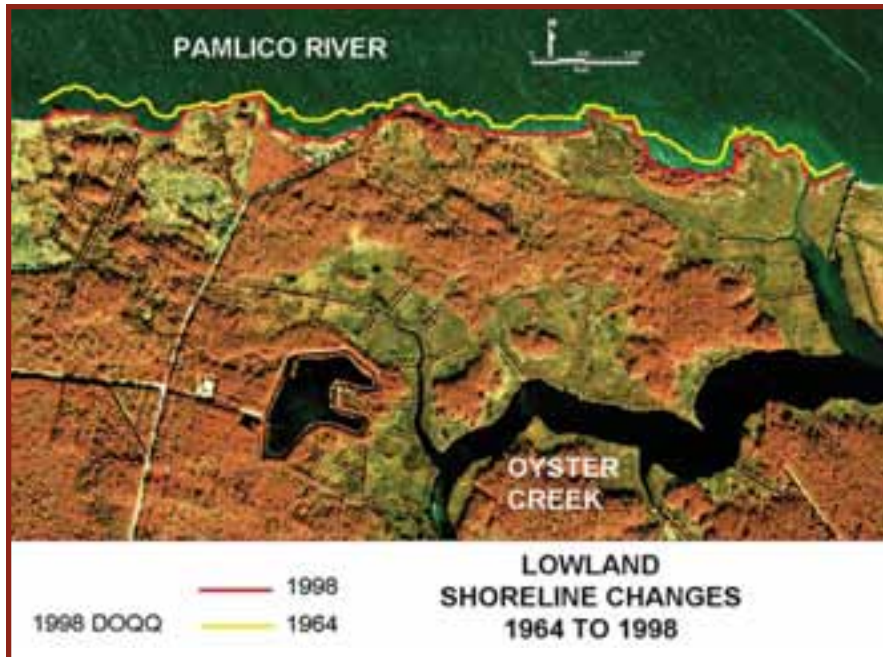
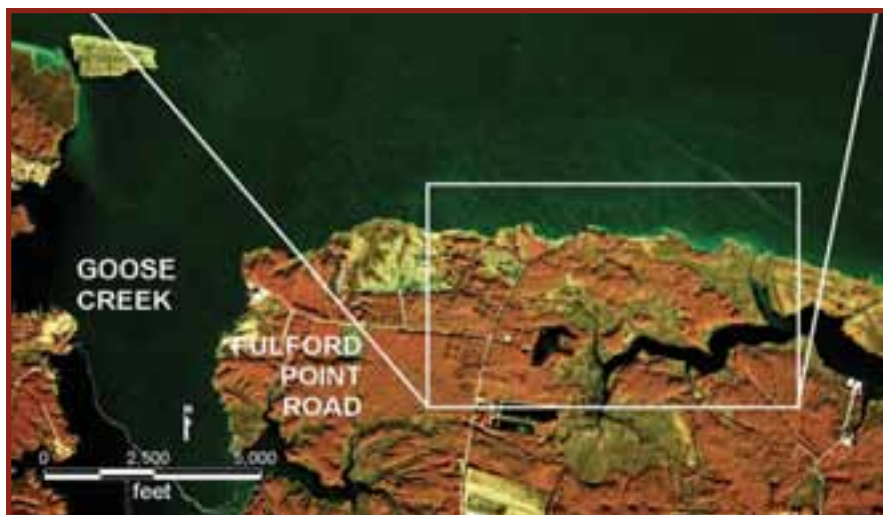
**FIGURE 8-3-18.** The Lowland site 1998 Digital Orthophoto Quarter Quadrangle (DOQQ) with digitized shorelines for 1964 and 1998.

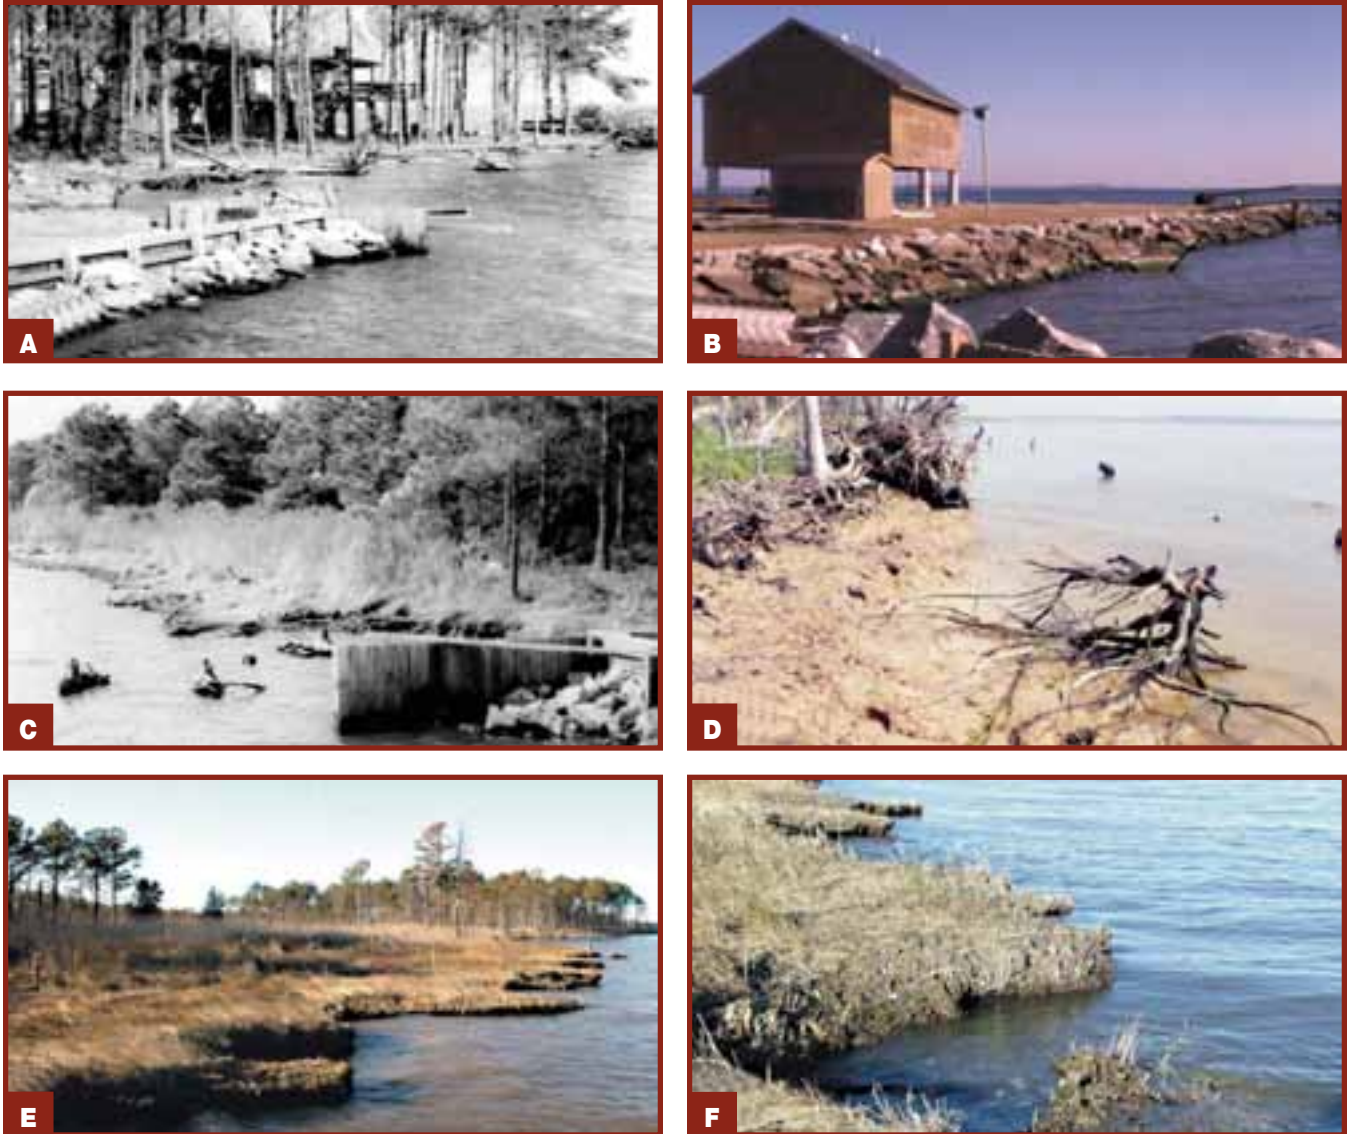
**FIGURE 8-4-1.** Photographs of the Wades Point site. **PANEL A.** September 1979 photograph looking east towards the eroding Wades Point and a former beach cottage located on the nonhardened low sediment bank shoreline with upland pine vegetation. Photo is from Hardaway (1980). **PANEL B.** A January 2001 photograph from about the same location as Panel A. Notice the hardened shoreline, lack of upland vegetation, and a relatively new beach cottage. **PANEL C.** September 1979 photograph looking west along the low sediment bank shoreline of the Pamlico River. Photo is from Hardaway (1980). **PANEL D.** Close-up of the wave-cut platform eroded into the low sediment bank shoreline indicated in Panel E. The shoreline is composed of tight Pleistocene clay, with the absence of a strandplain beach due to lack of sand in the eroding clay sediment. Also, the shallow root systems of the upland vegetation are totally excavated as demonstrated by the trees along the shoreline. **PANEL E.** January 2003 photograph looking north along the platform marsh shoreline of the Pungo River from Wades Point. The marsh interior is dominated by *Juncus roemerianus*, with a narrow outer perimeter marsh dominated by *Spartina patens*. Locally, there is a narrow and mixed zone of *Phragmites australis* and *Spartina cynosuroides* growing on a thin sand and wrack berm that parallels the shoreline. Notice the highly irregular erosion pattern of the marsh peat in the foreground and the upland area and associated low sediment bank shoreline in the distance (see Panel D). **PANEL F.** January 2003 close-up photograph of the eroding platform marsh shoreline. Notice the large peat block in the near-shore that has recently broken off the shoreline.

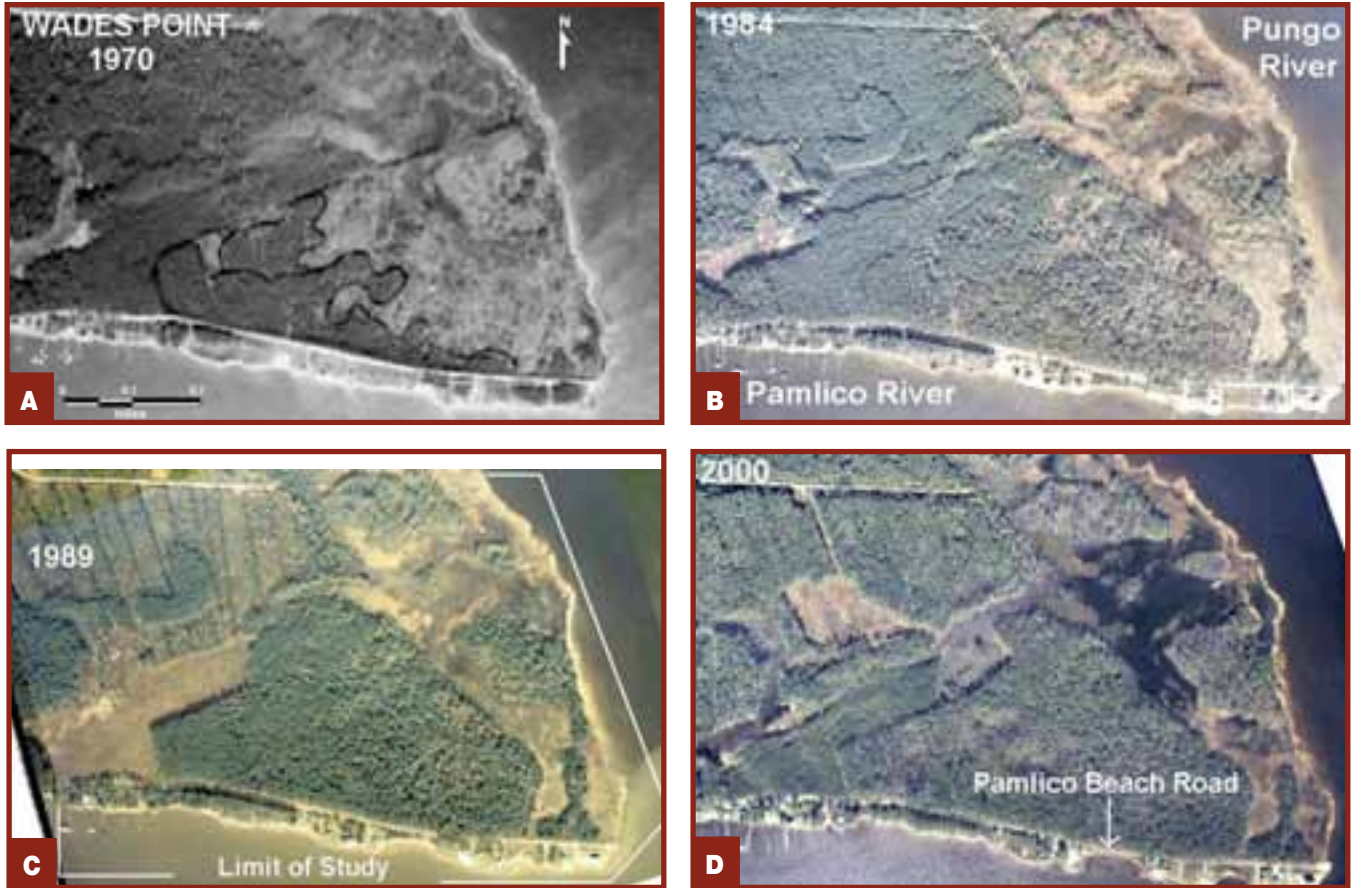
**FIGURE 8-4-3.** The Wades Point site aerial photograph time slices from 1970, 1984, 1989 and 2000. The rate of shoreline recession is obvious along the Pamlico River shoreline through time. Compare the fairly straight and unmodified shoreline and shore parallel to Pamlico Beach Road in 1970 with the 2000 aerial photograph. Notice the sequence and effect of shoreline hardening upon the erosion process.

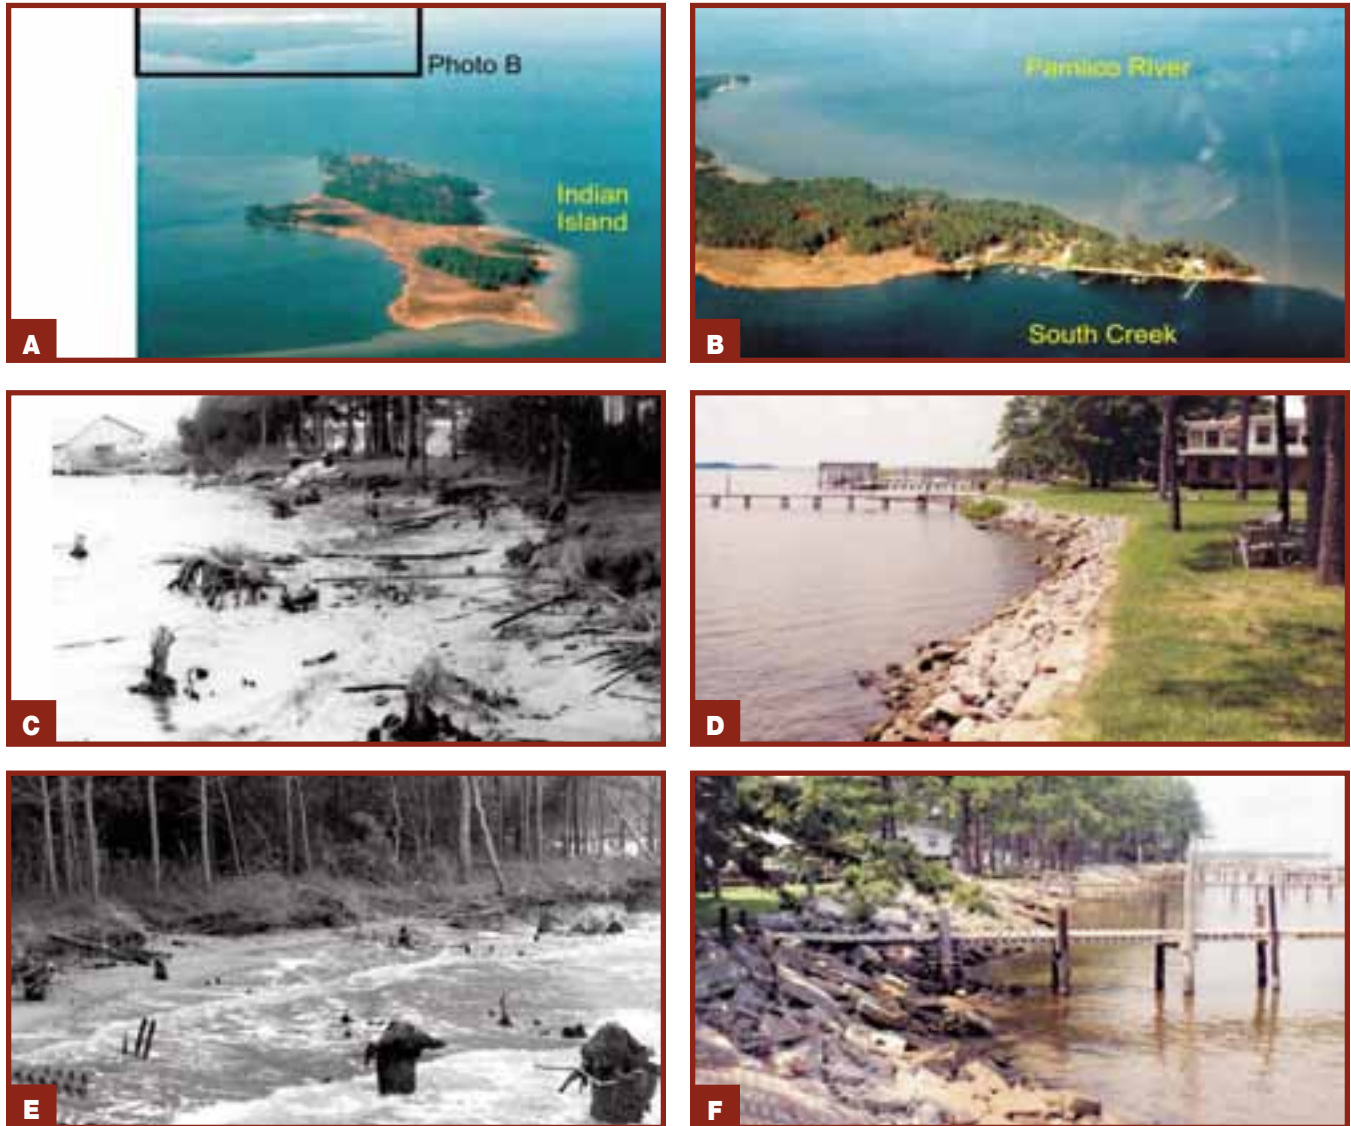
**FIGURE 8-4-4.** Photographs of the Hickory Point site. **PANEL A.** Oblique aerial photograph (December 1991) looking west across Indian Island and Hickory Point with Pamlico River to the right and South Creek to the left. Indian Island and Hickory Point are high areas along the interstream divide between the two water bodies. Indian Island has become separated from Hickory Point by rising sea level and associated shoreline erosion. **PANEL B.** Oblique aerial photograph (December 1991) of the study area at Hickory Point showing the marsh shoreline in the left foreground, modified low sediment bank shoreline along both sides of the Point, and unmodified low sediment bank shoreline along the wooded, curved coast in the upper left. **PANEL C.** A 1979 photograph along the South Creek low sediment bank shoreline prior to human modification. Notice the small pine stumps left in the near shore as the shoreline recedes and the beach cottage in the upper left corner that is collapsing into South Creek. Photograph is from Hardaway (1980). **PANEL D.** A 2001 photograph in approximately the same location as Panel C, showing the human-modified, low sediment bank shoreline. Notice that the rock and rubble revetment along the South Creek shoreline is slightly smaller scale than along the Pamlico River shoreline in Panel F. Photograph is from Murphy (2002). **PANEL E.** A 1979 photograph of a typical low sediment bank shoreline with a dense growth of small pine trees. The long pine tap root holds the stumps in place in the near-shore as the shoreline recedes. Minor sand derived from the erosion of the Pleistocene, slightly sandy clay bank results in a thin and ephemeral strandplain beach. Photograph is from Hardaway (1980). **PANEL F.** A 2001 photograph looking west along the human-modified, low sediment bank shoreline of the Pamlico River. Photograph is from Murphy (2002).

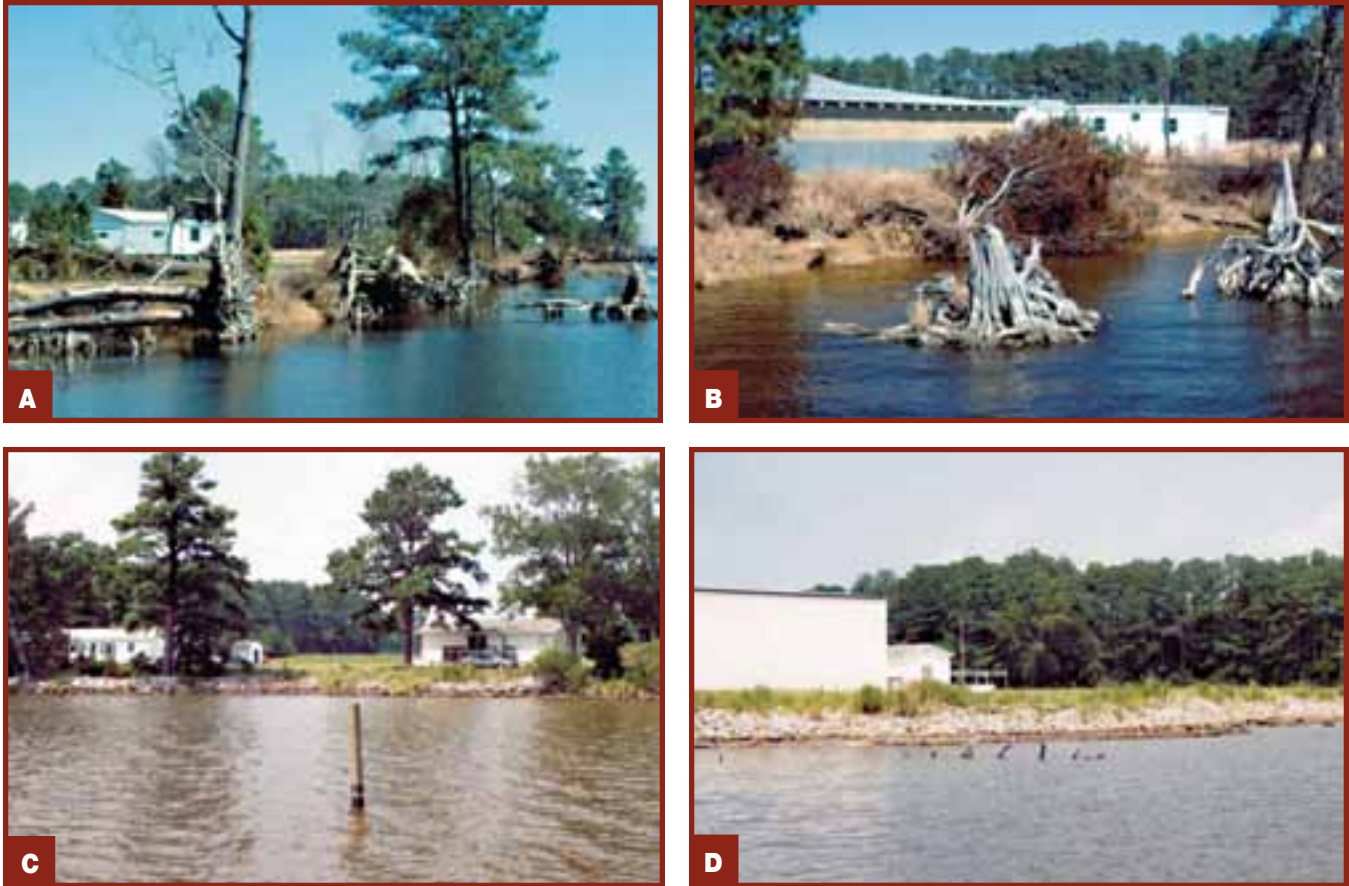
**FIGURE 8-4-7.** Photographs of the Pamlico Marine Lab site. **PANELS A and B.** March 1978 close-up photographs of the unmodified and eroding, low sediment bank shoreline of the Pamlico Marine Lab site. Panel A is on the western side, and Panel B is on the eastern side of the lab. Notice the large trees lying along the bank and the stumps in the near shore, reflecting the receding shoreline. The area has been generally cleared for the lab, leaving only a few trees along the bank. **PANELS C and D.** August 2001 photographs of the modified low sediment bank shorelines of the Pamlico Marine Lab site. Panel C is on the western side, and Panel D is on the eastern side of the lab. The rock revetment has temporarily stopped the shoreline recession. Photographs are from the pier by M. Murphy.

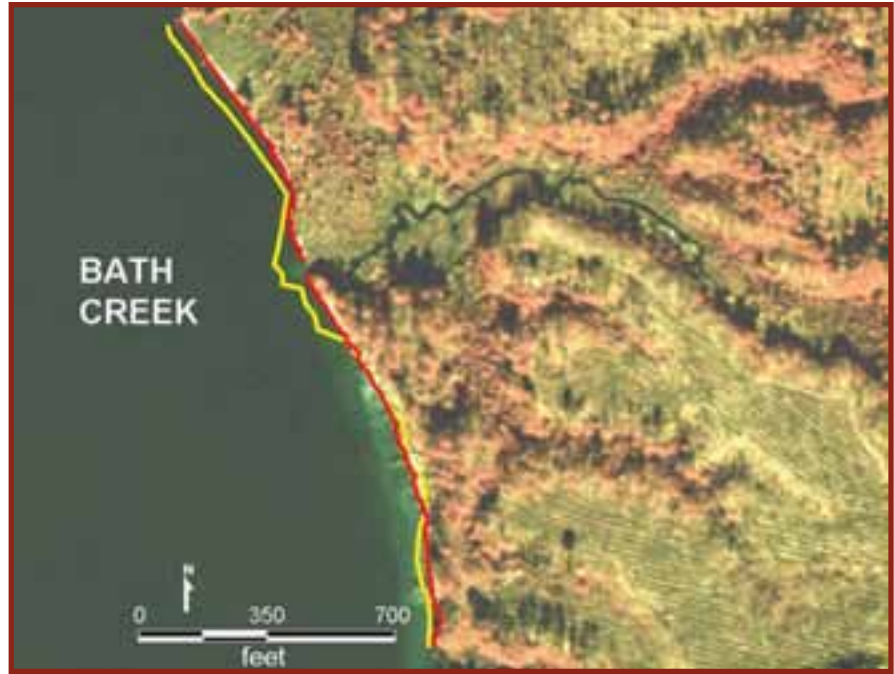
**FIGURE 8-4-9.** The Bayview site 1998 Digital Orthophoto Quarter Quadrangle (DOQQ) with digitized shorelines for 1970 and 1998. Notice the small drainage system that flows west off the upland to form a small cypress headland in the middle of the study area.

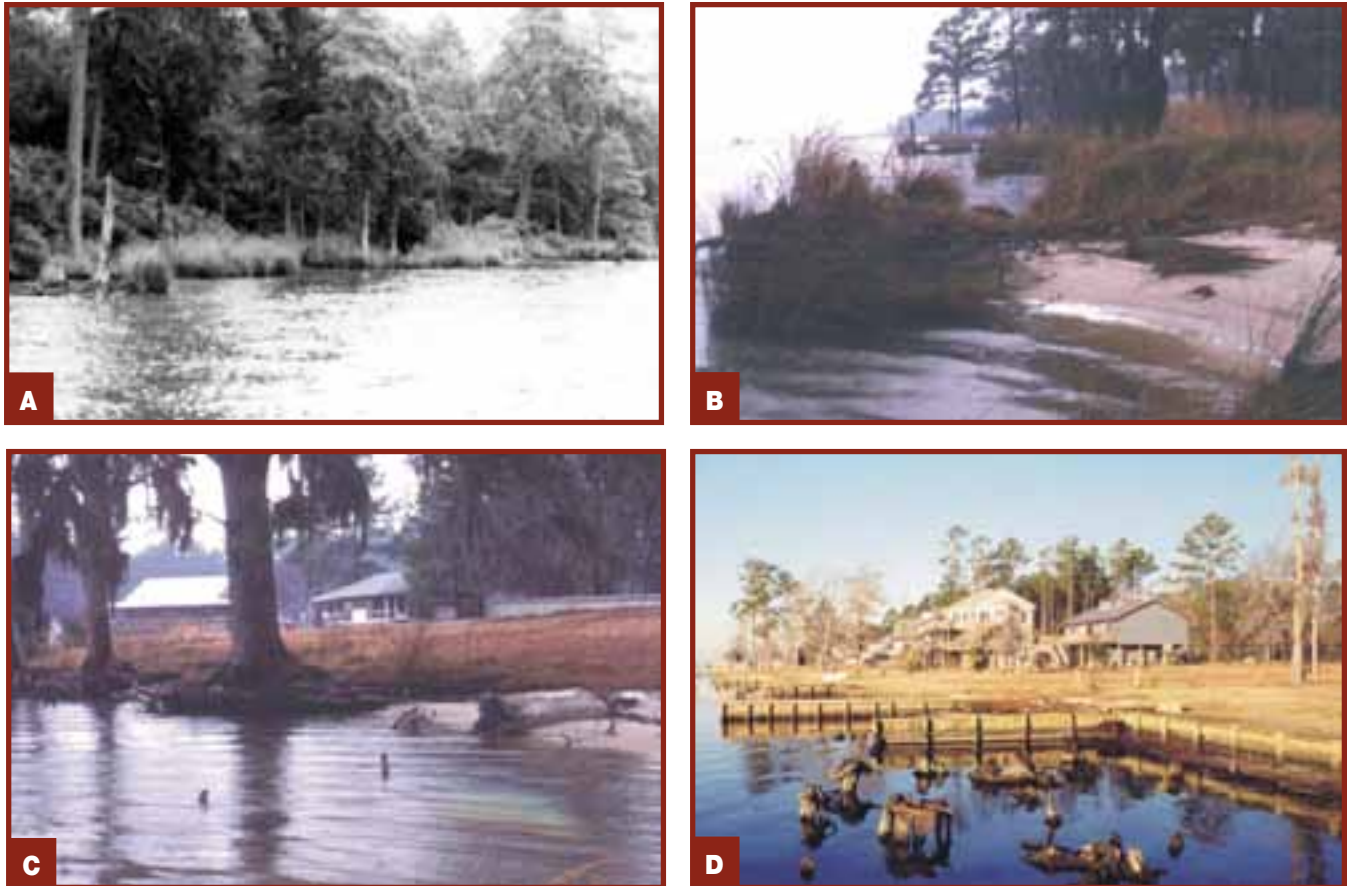
**FIGURE 8-4-10.** Photographs of the Camp Leach site. **PANEL A.** A July 1977 photograph looking east along the undeveloped eastern portion of the study site on the Pamlico River north shore. The low sediment bank occurs behind a narrow zone of dense *Juncus roemerianus* and cypress growing on a peat substrate up to 2 feet thick. Photo is from Hardaway (1980). **PANEL B.** A January 1977 photograph looking west along a portion of the study site utilized by Camp Leach. Notice the *Juncus roemerianus* headlands with small coves containing thin strandplain beaches lapping up onto the low sediment banks. **PANEL C.** A January 1977 photograph of the low sediment bank shoreline in front of Camp Leach. Notice that the root system of the large shoreline trees have been severely exposed by the slow erosion processes. No marsh grass occurs within this high-use area. However, there are local strandplain beaches scattered in the small coves along the shoreline. **PANEL D.** A January 2001 photograph in approximately the same area as Panel C. The low sediment bank in this development has now been extensively bulkheaded with the elimination of marsh headlands and shoreline trees. Notice that no strandplain beaches exist in front of bulkheads.

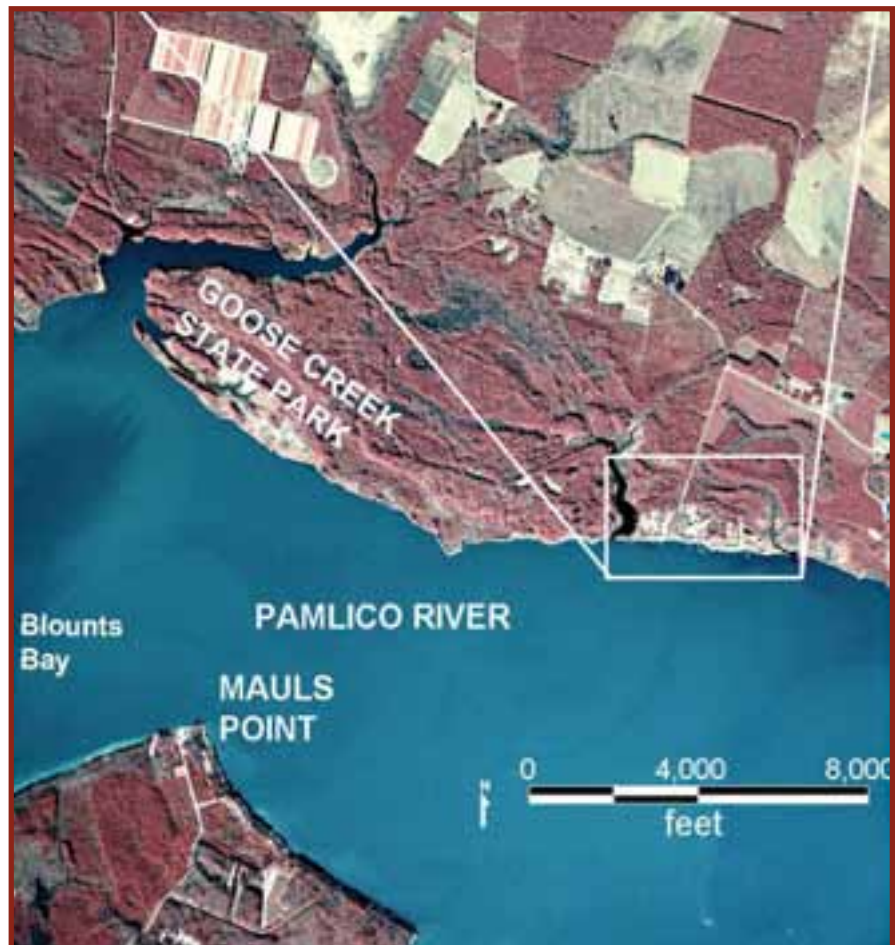
**FIGURE 8-4-11.** The Camp Leach site 1998 Digital Orthophoto Quarter Quadrangle (DOQQ) with digitized shorelines for 1970 and 1998.

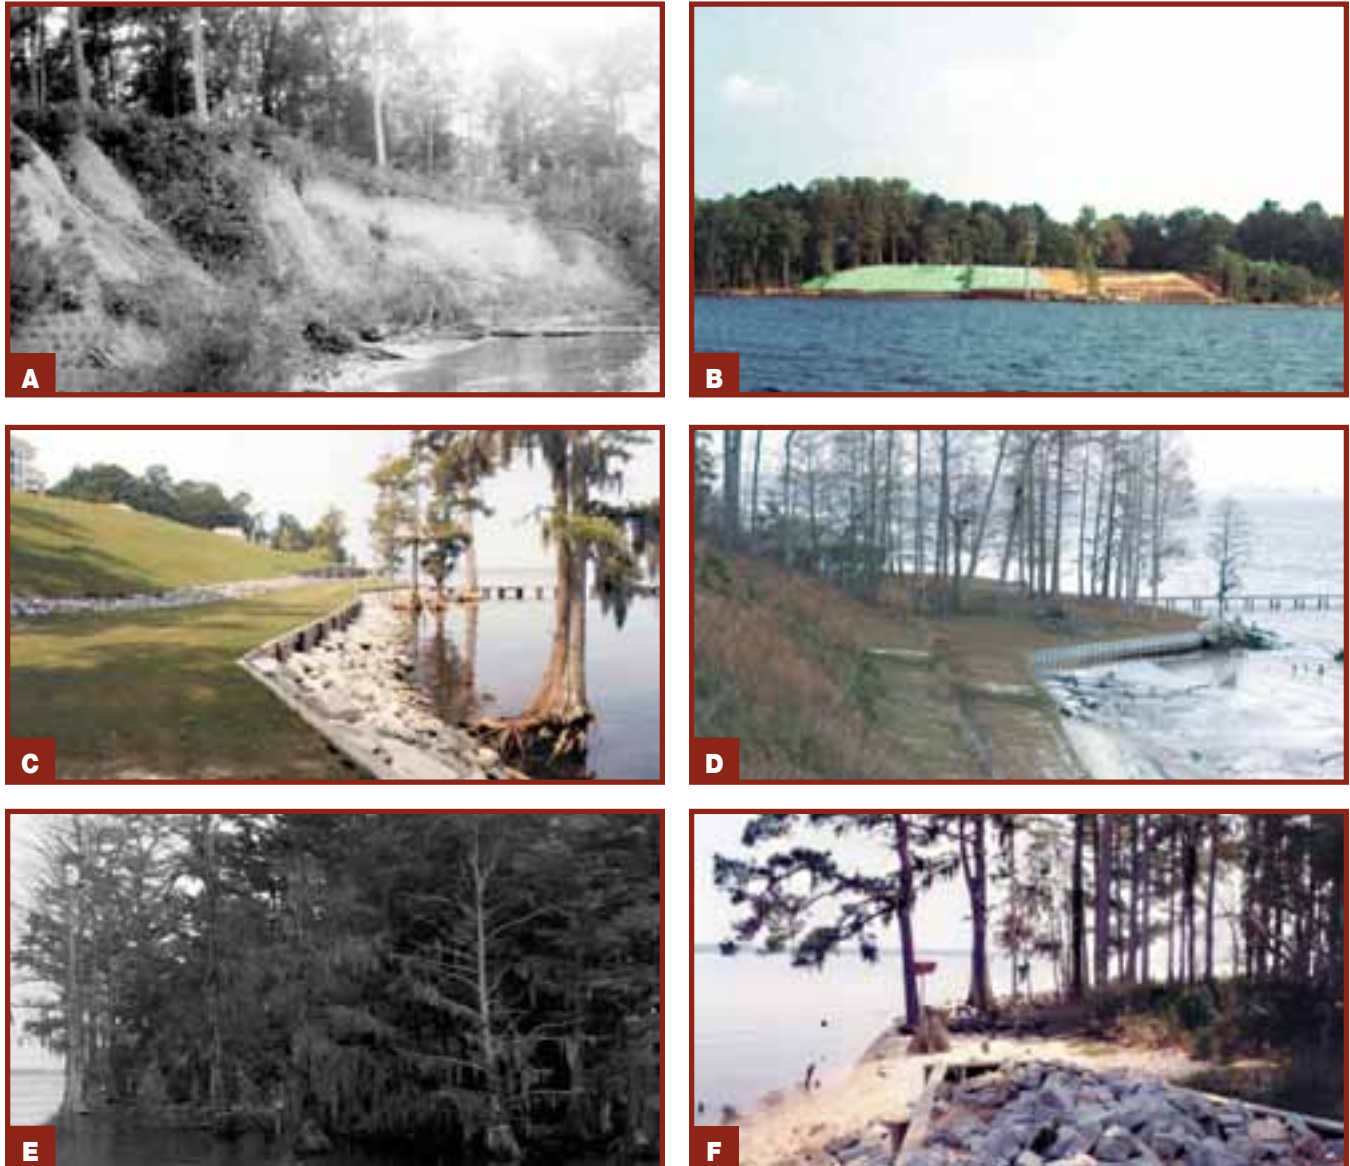
**FIGURE 8-4-12.** Photographs of the Mauls Point site. **PANEL A.** A July 1977 photograph looking southwest along the unmodified bluff at Mauls Point. Notice the overhanging modern root mass, the tree debris along the shoreline, and the strandplain beach in front of the wave-cut bluff. Photograph is from Hardaway (1980). **PANEL B.** An August 1998 photograph of the bulldozed and bulkheaded bluff that occurs in Panel A. A portion of the modified bluff has been seeded and covered with landscape fabric. **PANEL C.** An August 2001 close-up photograph of the modified bluff pictured in both Panels A and B. Notice the lack of a strandplain beach in front of the steel bulkhead and rock revetment. Photograph is from Murphy (2002). **PANEL D.** A January 2003 photograph of the modified cypress headland that occurs off of a small creek dissecting the upland and associated bluff on the southwest side of the study site (see Fig. 8-4-14). The local occurrence of sand in front of the bulkhead that formed in response to a bulkhead failure and associated gullyng just below the bottom of the photograph. **PANEL E.** A 1979 photograph of the swampforest shoreline along the cypress headland that occurs at Mauls Point, on the northeast side of the study site. Photograph is by S. Hardaway. **PANEL F.** An August 2001 photograph of the same location as Panel E. The rock is the northeast end of the revetment in Panel C. Notice how the swamp forest has been thinned and the occurrence of a small strandplain beach. Photograph is from Murphy (2002).

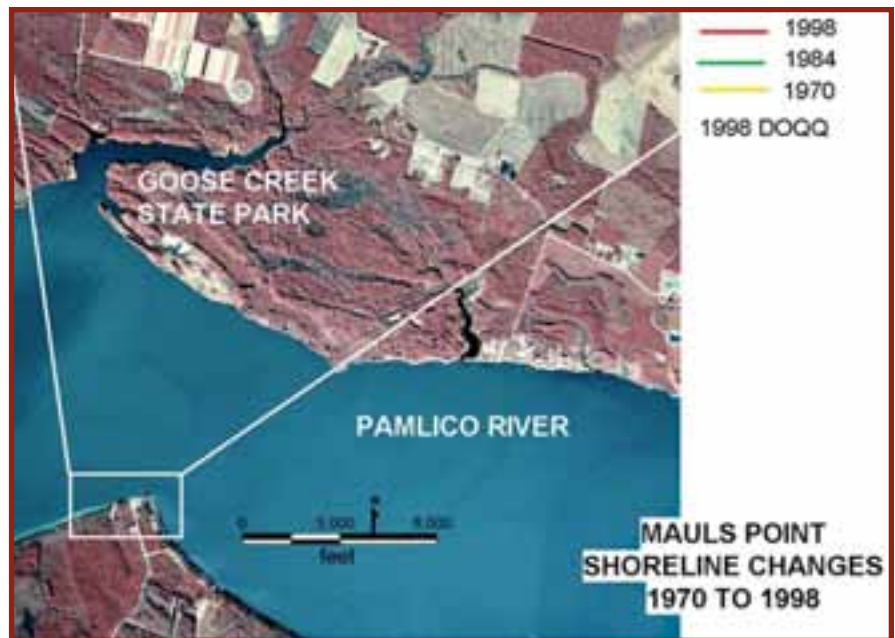
**FIGURE 8-4-13.** The Mauls Point site 1998 Digital Orthophoto Quarter Quadrangle (DOQQ) with digitized shorelines for 1970, 1984, and 1998.

The 1998 DOQQ (Fig. 8-4-13) shows the location of digitized estuarine shorelines for the period between 1970 and 1998. This site was a natural bluff shoreline for the period from 1970 to 1984 with an average rate of shoreline recession of  $-2.9$  ft/yr (Table 8-4-1) and a range in erosion rates from  $-0.6$  to  $-3.1$  ft/yr. The period from 1984 to 1998 represented mixed conditions when the natural bluff was severely modified by bulldozing and bulkheading. This resulted in a slight net shoreline loss for this period of  $-0.2$  ft/yr with an average range from  $-2.6$  to  $+2.6$  ft/yr (Table 8-4-1). Due to the amount of sediment bulldozed onto the bluff shoreline, the adjacent modified low sediment bank to the southwest displayed average accretion rates of  $+0.8$  ft/yr.

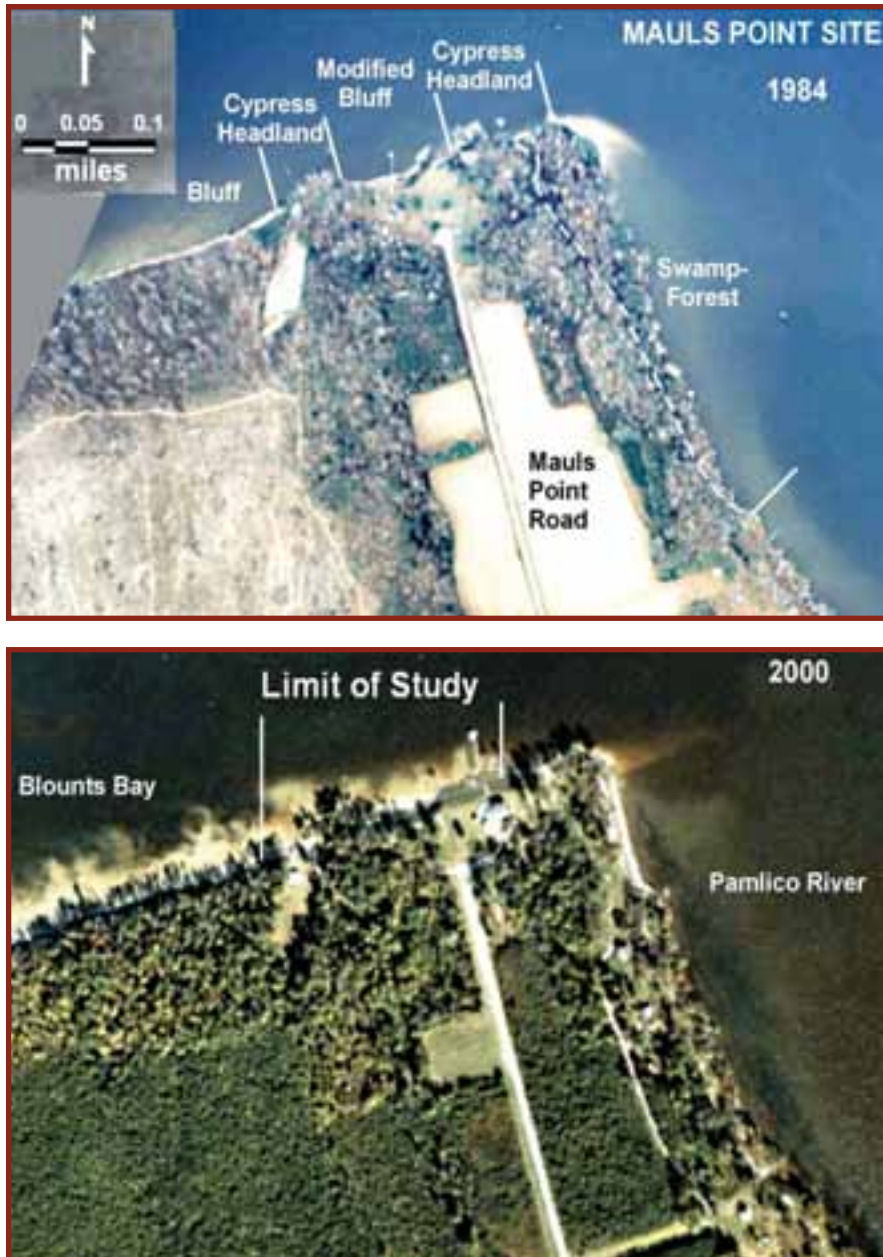
**FIGURE 8-4-14.** The Mauls Point site aerial photograph time slices from 1984 and 2000. Mauls Point Road runs north along an interstream high between two small drainages that parallel the road. The drainage on the northeast side of the road has been intersected by the Pamlico River, creating a wide swampforest shoreline along the Pamlico River side and forms a cypress headland at Mauls Point (Fig. 8-4-12, Panels E and F). The bluff shoreline occurs where Blounts Bay intersects the interstream divide at the end of the road (Fig. 8-4-12, Panels A, B, and C). Another small swampforest shoreline forms a cypress headland that extends into the water where the drainage on the southwest side of the road flows into Blounts Bay (Fig. 8-4-12, Panel D).

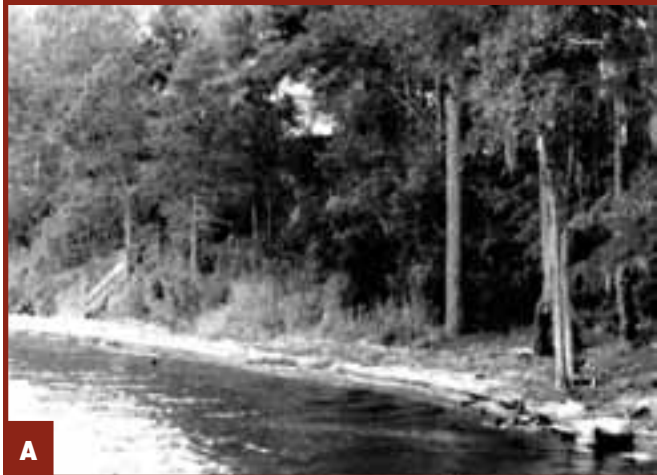
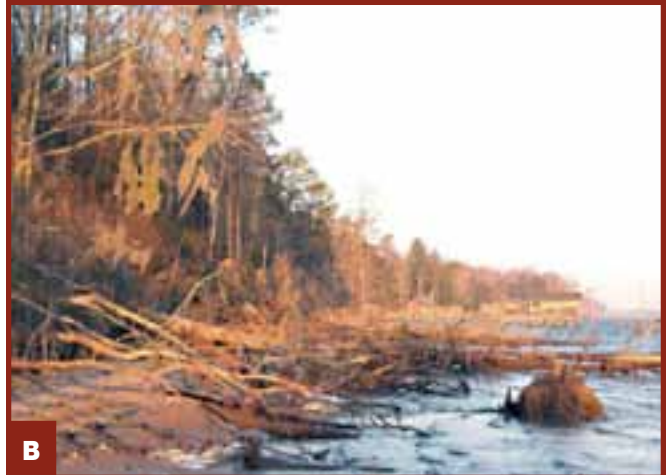
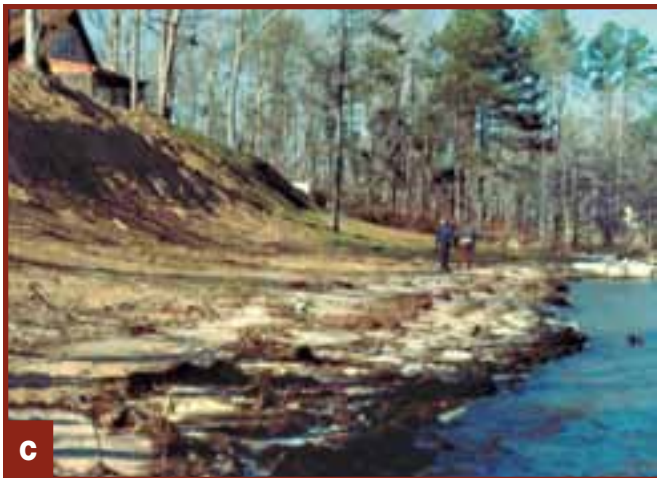
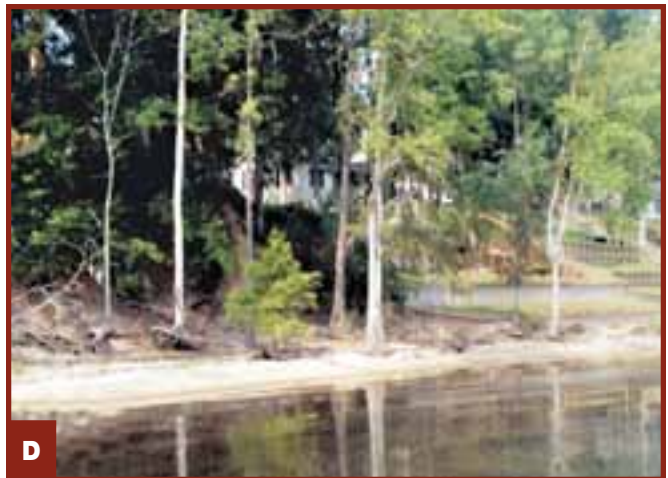
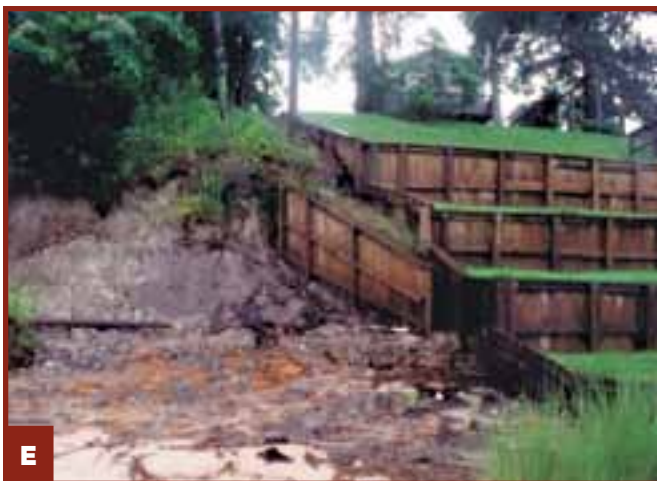
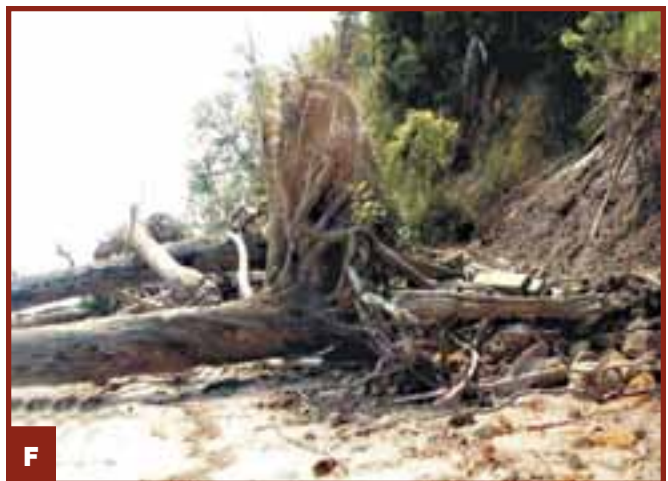
**FIGURE 8-4-15.** (PAGE 138) Photographs of the Bay Hills site. **PANEL A.** A July 1977 photograph looking east along a highly vegetated, natural bluff shoreline. The lack of an erosional cut-bank, slump blocks and tree and shrub debris indicate that this bluff is not eroding on a year-to-year scale. This moderately stable bluff shoreline has a modest slope that can develop a significant vegetative cover to protect the bluff through small storms and the short term. Photograph is by S. Hardaway. **PANEL B.** A January 2003 photograph along the same portion of Bay Hills that locally displays steeper erosional bluff segments and wider strandplain beaches with abundant tree debris. Portions of this shoreline were destabilized by a series of very high storm tides (up to +10 feet above mean sea level) that impacted the upper Pamlico River area between 1996 and 1999. Thus, normally stable shorelines in semiprotected areas with small fetches do erode. This happens during extreme storm events when the shoreline recedes in large pulses. **PANELS C, D and E.** Panel C is a January 1977 photograph looking west along a modified bluff shoreline. The bluff was bulldozed in 1975 to form a 1:1 sloped ramp behind a low sediment bank shoreline. Both the bulldozed bluff and low sediment bank have, in most cases, been extensively bulkheaded as demonstrated in the 2001 photographs in Panels D and E. Much of this extreme bulkheading was done since the high storm tides of the 1996-1999 hurricanes destabilized and severely eroded the bluffs. Notice that the natural bluff shoreline in Panel D still has a strandplain beach. Photograph in Panel D is from Murphy (2002), and Panel E is by Murphy. **PANELS E and F.** Panel E is a close-up view of the Pleistocene, tight blue clay that crops out along the lower 15 feet of the bluff shoreline. An easily erodable, unconsolidated sand bed overlies the clay bed. The former readily slumps onto the beach carrying the vegetative cover with it, as demonstrated in Panel F. This stratigraphic combination produces bluffs with an overall lower slope that can generally develop more stable vegetative covers. Panel F is from Murphy (2002).

for about 2,440 feet to the west and 1,300 feet to the east of Bay Hills Drive. About 2,990 feet of this shoreline is generally a bluff that has been extensively developed and modified by bulldozing and bulkheading. Whereas, 750 feet of bluff shoreline located east of the developed bluff remains in its natural condition. The 1970 aerial photograph shows a small stream

dissecting the bluff and flowing into Chocowinity Bay west of Bay Hills Drive. A nice example of a cypress headland occurs where this stream floodplain enters the bay.

The natural bluff rises 25 to 30 feet above mean sea level with a very tight blue Pleistocene clay cropping out in the lower 15 feet of the bluff. The basal clay grades upward into a 5- to 10-foot-thick unit of muddy fine sand and an upper 7-foot-thick unit of iron-stained clayey sand and soil. The vegetative cover above the bluff is hardwood forest. The upper sandy portion of the natural bluff slumps onto the beach and is reworked by waves to produce a 20- to 30-foot-wide strandplain beach littered with logs and stumps. The shoreline itself is eroded into the lower clay unit, forming an erosional clay platform that continues riverward under the strandplain beach and onto the estuarine floor.

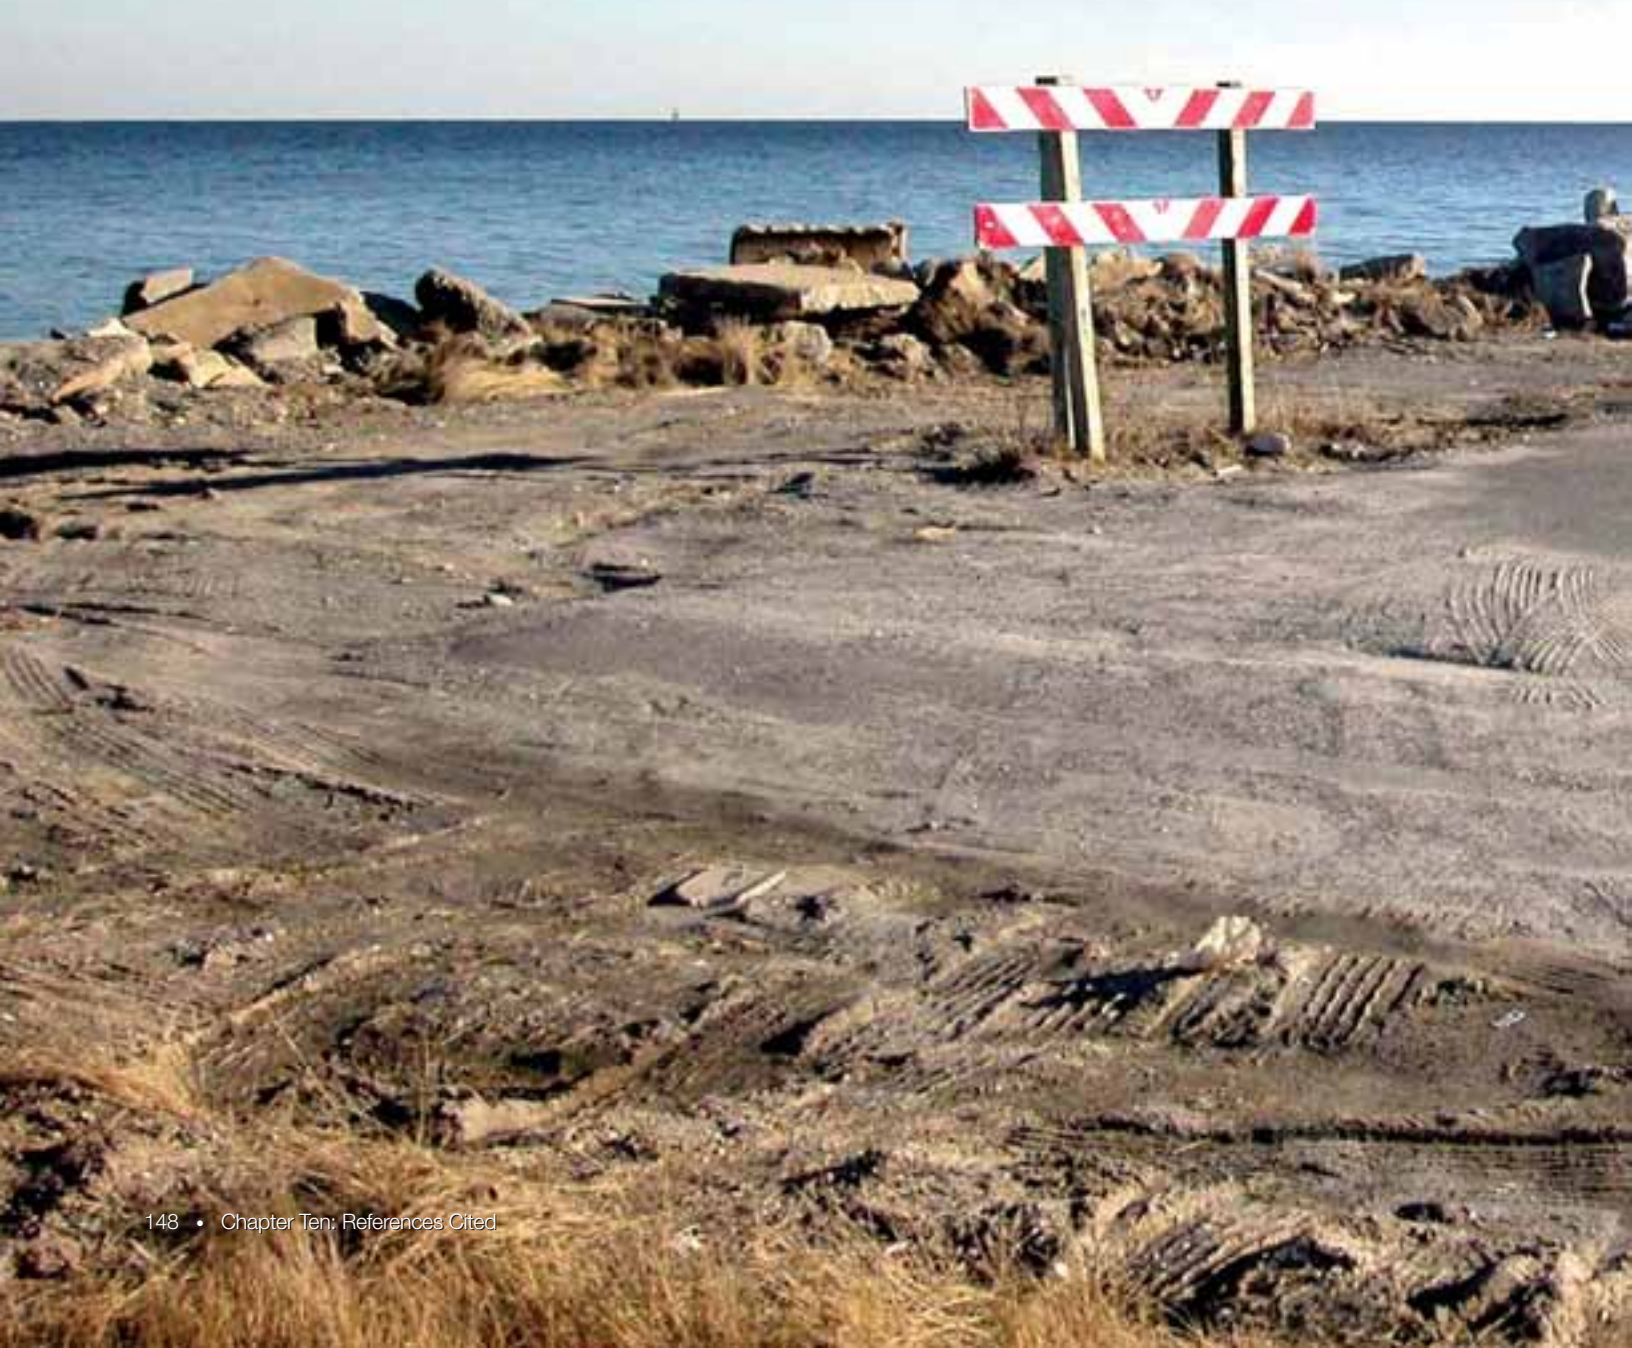
*An actively "going-to-sea" state road at Wades Point, the high-energy confluence of the Pungo and Pamlico river estuaries.*
