By Stanley R. Riggs and Dorothea V. Ames  
Published by North Carolina Sea Grant

## DROWNING THE NORTH CAROLINA COAST: Sea-Level Rise and Estuarine Dynamics

**ON THE FRONT COVER.** *Pre-Hurricane Isabel photograph of the lower portion of sediment bluff that occurs along the Chowan River estuary western shoreline. The red star, on the satellite image inside the back cover, indicates the specific site location. This bluff is approximately 75 feet high and consists of a lower clay bed that is about 30 feet thick (to the top of this photograph), with an overlying sand bed that is 45 to 50 feet thick. Because bluff shorelines normally erode at average rates between  $-2.0$  and  $-2.5$  ft/yr (Table 8-1-3) and because the lower sediment bank is composed of clay, there is no sand beach preserved on the eroded wave-cut scarp and platform (Fig. 4-2-1). Notice the red dotted line along the wave-cut scarp and compare this to the respective location on the post-Hurricane Isabel photograph on the back cover. Photograph was taken in August 2003. See the back cover for the post-Hurricane Isabel photograph of the same site and inside back cover for a satellite image showing the site location an

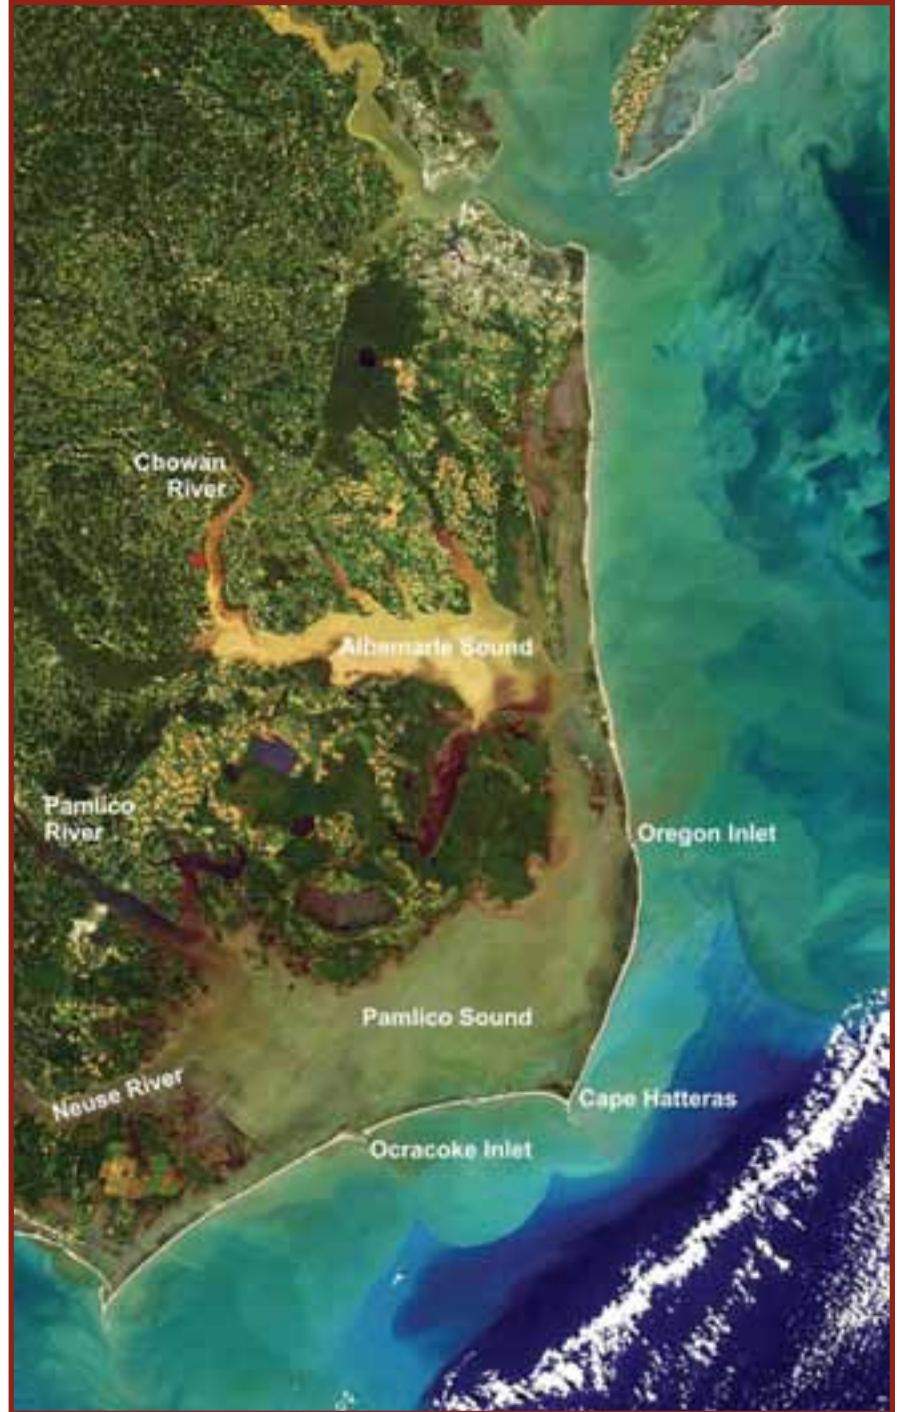
**AT RIGHT.** A post-Hurricane Isabel MODIS Level-1B satellite image taken on September 19, 2003 of northeastern North Carolina showing the Albemarle and Pamlico sounds coastal system. The eye of the storm came ashore in the vicinity of Ocracoke Inlet and traveled northwest to the mouth of the Albemarle Sound and west of the Chowan River estuary. The eastern portions of all estuaries are slightly muddy. However, the lower Chowan River and Albemarle Sound are extremely muddy. The bright tan color is due to an incredibly large volume of suspended clay sediment in the water column. This sediment load is the direct consequence of severe erosion of sediment bank shorelines that are extensive in the upper Albemarle Sound and lower Chowan River (Riggs, 2001). Sand from the eroded shorelines formed beaches while the mud sediment components remained suspended in the water column. Slightly muddy waters within Pamlico Sound reflect the vast areas dominated by organic shorelines that are composed dominantly of marsh and swampforest peat with only minor low sediment bank shorelines. Notice that there is no suspended sediment in the Neuse and Pamlico river estuaries due to the northeasterly location of the storm track. See the front and back covers for the pre- and post-Hurricane Isabel photographs of the shoreline site indicated by the red star on this satellite image. Satellite image is from MODIS Image Gallery, Liam Gumley, Space Science and Engineering Center, University of Wisconsin-Madison.

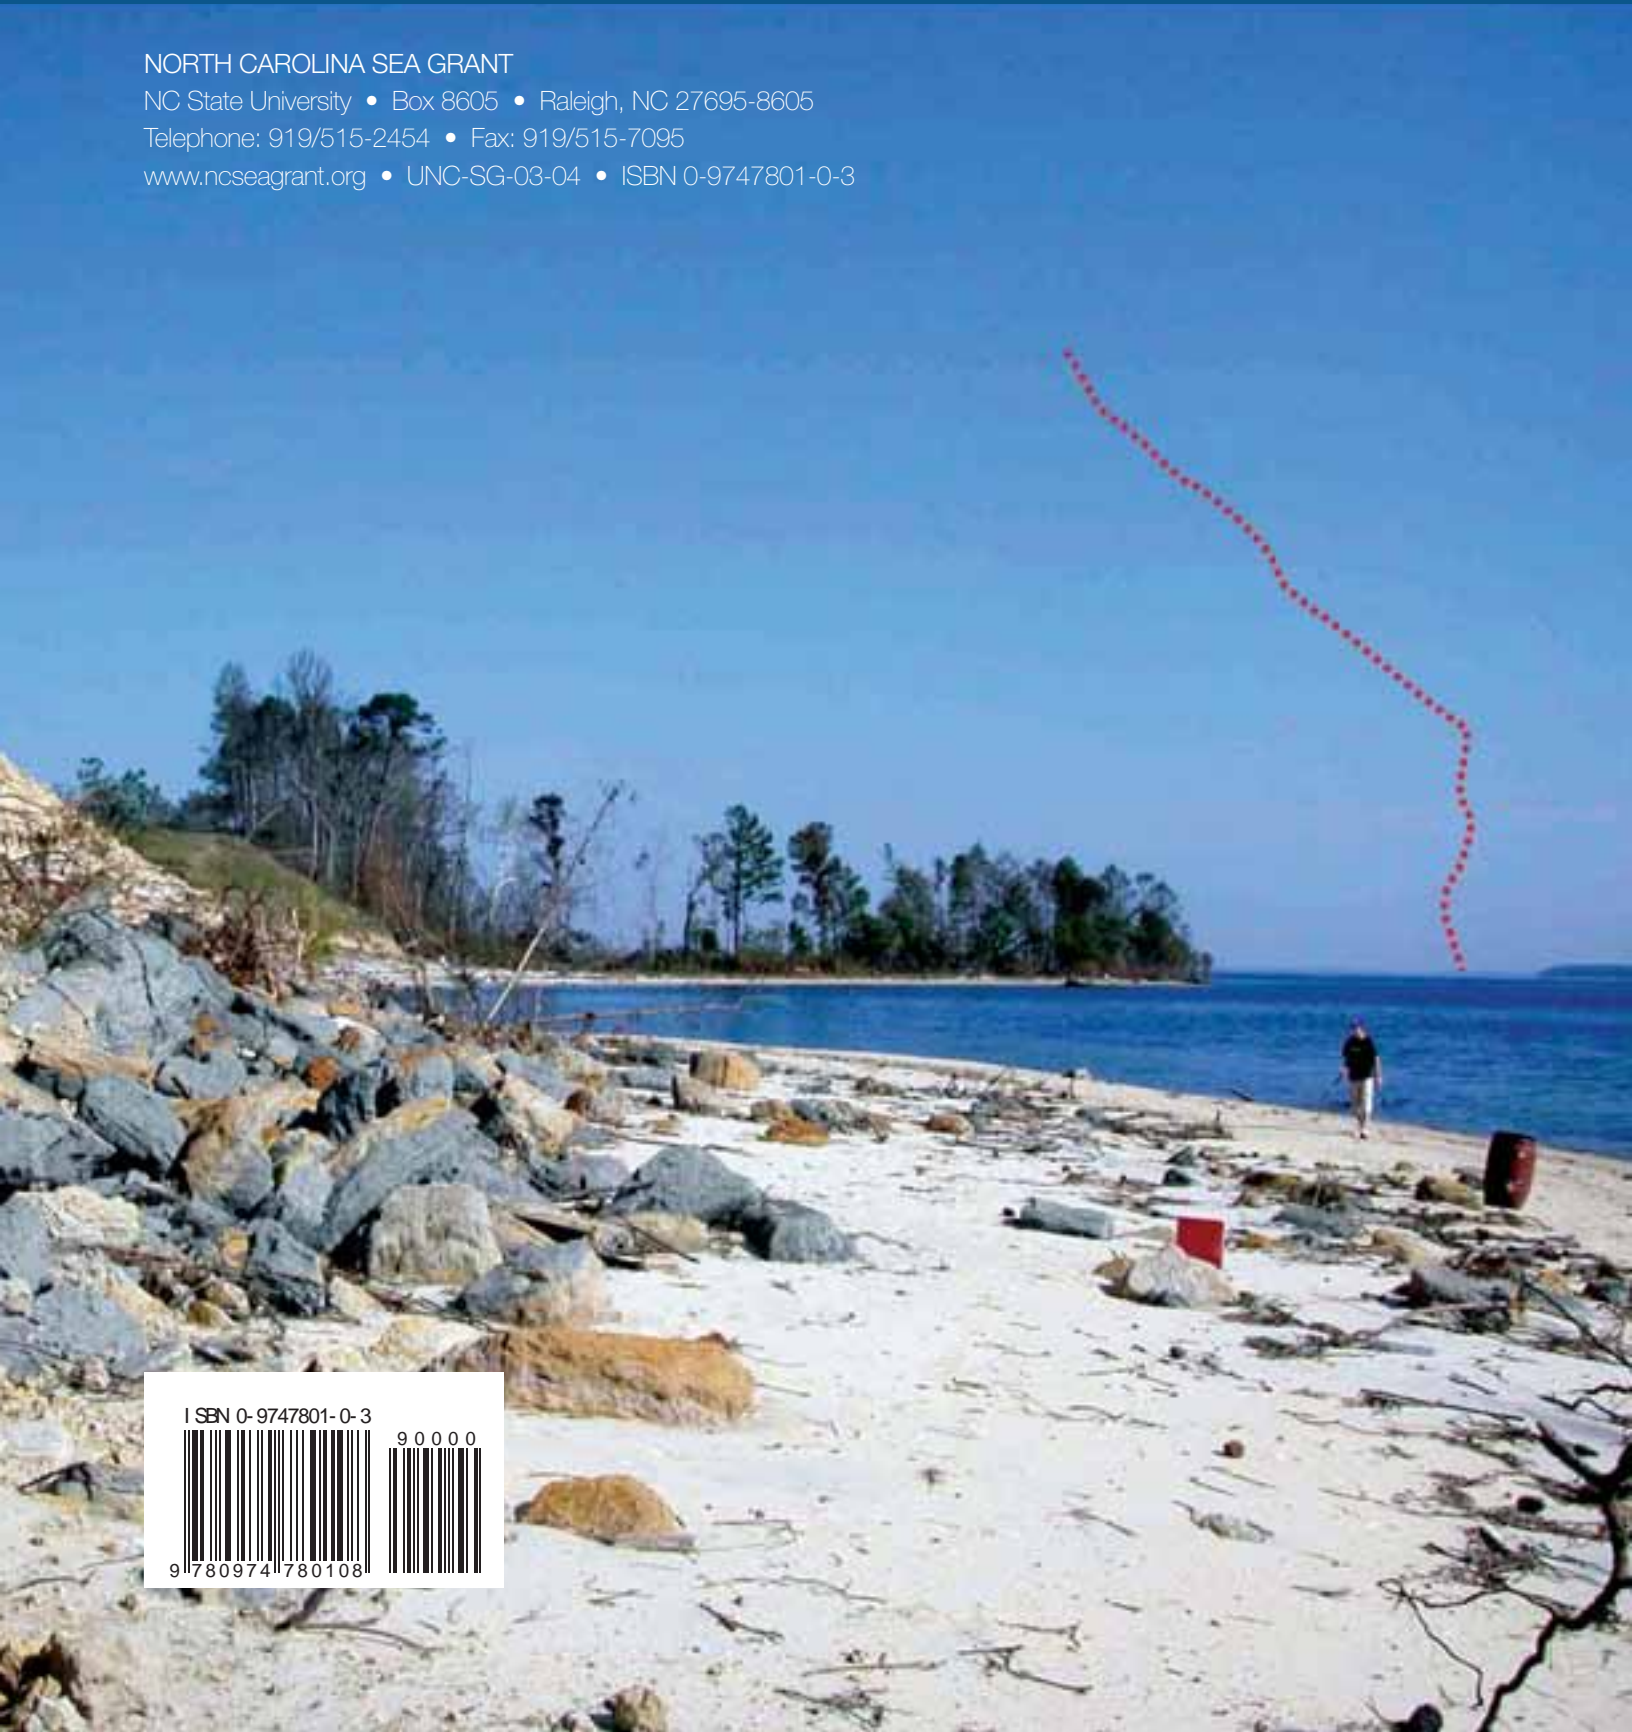
**ON THE BACK COVER.** *Post-Hurricane Isabel photograph taken from about the same location along the bluff shoreline as the front cover photograph. The red dotted line is the approximate location of the pre-Hurricane Isabel shoreline. Hurricane Isabel, a small category 2 storm, came ashore on September 18, 2003, with the eye of the storm on a northwest path that was located just west of the Chowan River estuary. Quiet water flood marks in the vicinity of the photograph suggest about a 5- to 8-foot storm surge occurred in the Chowan River with estimated 80 mph sustained winds and gusts up to 95 mph. The consequence was an average bluff shoreline recession of about -50 feet (range from about -30 to -80 feet) for the several segments of accessible bluff shoreline (person for scale = 5 feet tall). Notice that the clay bed on the front cover thinned dramatically into the bluff and changed to a more erodable sandy clay (large eroded blue blocks on the beach). As the waves eroded the basal clay bed, great volumes of rain saturated sands cascaded down the scarp as great slumps. Slumping of the overlying sands was accentuated by winds that blew out the overhanging trees. The slumped sediments were subsequently reworked by waves into a broad sand beach. Photograph was taken on October 6, 2003. See the front cover for the pre-Hurricane Isabel photograph of the same site and page 152 for a satellite image showing the site location and post-Hurricane Isabel, sediment-laden, estuarine water conditions.*
