Scow Schooners: A Regional Analysis

Final Report and Documentation

Final Report: Project Number 2020-002

**WISCONSIN
HISTORICAL
SOCIETY**

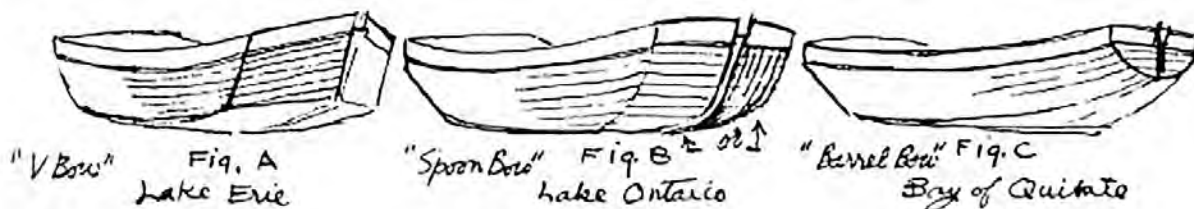
Figure 1. Various scow bow structures (Loudon Wilson).

Despite occasional disputes over identification, scows have several unique characteristics which can be used to differentiate them from conventional vessels. These traits are most easily understood when analyzing the hull. Scow hulls are boxy with a flat bottom and vertical sides, connected by a hard chine, or a nearly ninety-degree angle at the bilge. Conventional sailing vessels, whether flat-floored or with deadrise, possessed a soft chine, or a smooth, rounded edge.

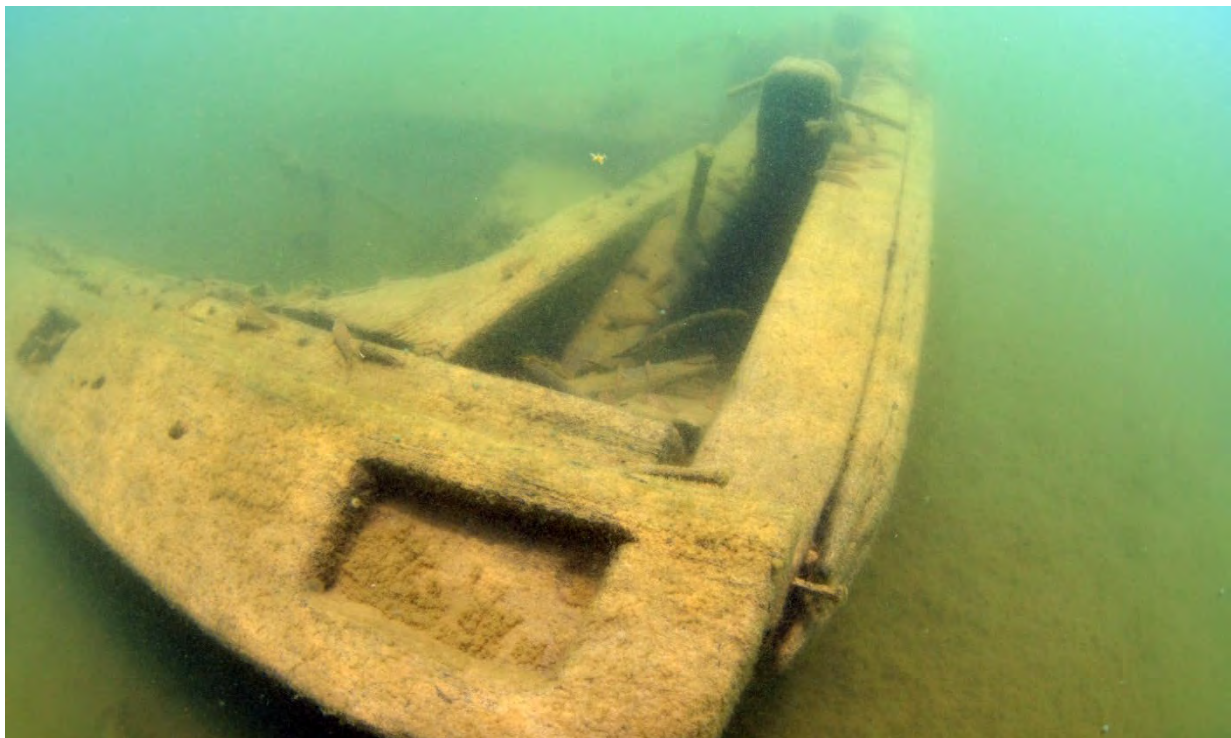
Figure 9. The port side bow of *Alaska* (Wisconsin Historical Society).

The *Alaska* has a boxy, spoon-shaped bow with athwartship planking. To the outside of the bow frames, the vessel's bow ramp appears flat and athwartship planked. King post hull construction was noted. The king posts measured 0.4 feet sided and 0.4 feet molded. Structural members of the vessel's floor, possibly the vessel's chine stringers, located outbound of the stringers that would have rested alongside the chine, measure 0.6 feet wide by 0.8 feet thick on the port side and 0.8 feet square on the starboard side. The difference in measurements could likely be the results of the vessel's extensive repairs. Several pieces of athwartship bottom planking were observed beneath the stringers (Kiefer et. al 2015). The centerboard trunk was badly damaged; it is unclear if it was deployed at the time of sinking.

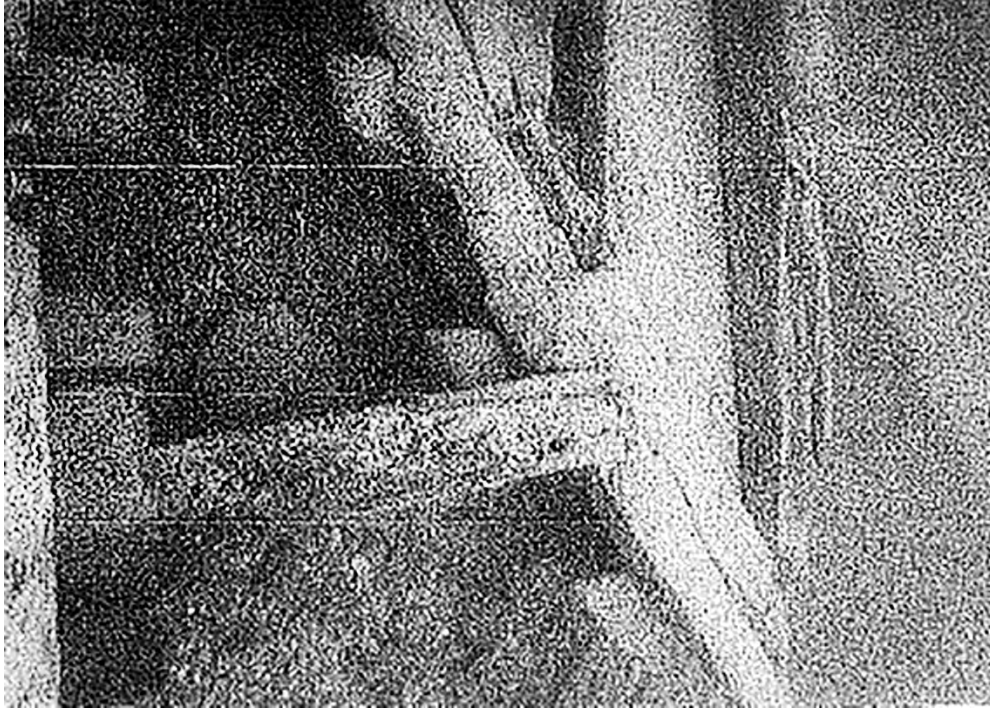
Figure 13. Image of *Forest*'s port side bow construction (Wisconsin Historical Society).

The vessel's deck clamp measures 1.79 feet wide and 0.3 feet thick, with a deck shelf fastened over it. Three ceiling planks remain attached to the frames below the deck shelf, and measure 0.92 feet wide. The ceiling, shelf, and clamp are fastened with drift bolts that measure 0.06 feet in diameter. This construction method is typical of many gunnel-built scows, although no evidence of a chine log was mentioned on the site. Single bulwark stanchions, measuring 0.4 feet square, extend above the deck shelf (Cooper 1989). Other scows that were built with double frames, such as *Success*, tended to be through bolted like traditional schooners. No evidence of the bottom hull of *Forest* was located on the site, so it could not be determined if the vessel was longitudinally or cross-planked.

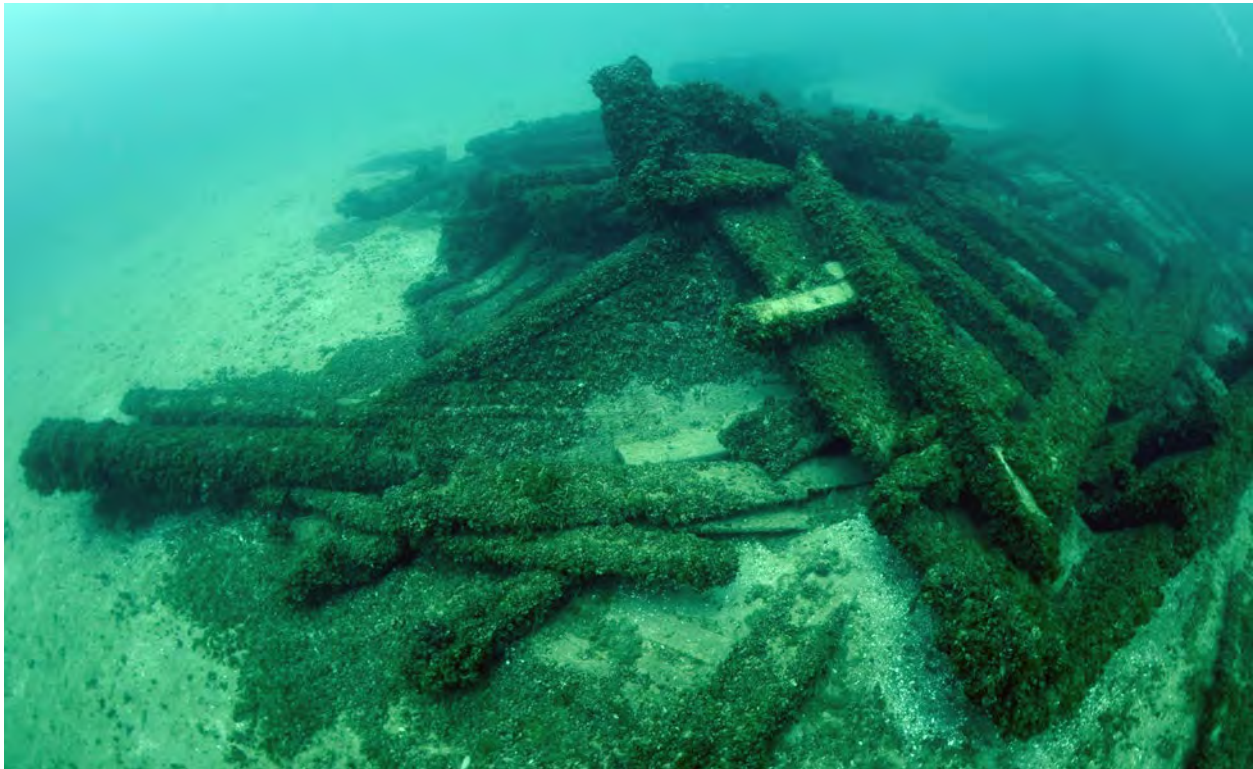
Figure 17. Flattened stern of *I.A. Johnson* showing cross planking and floor stringers/keelsons (Wisconsin Historical Society).

As is typical in scows, the vessel's keel and keelson structure lies within the bilge, allowing the vessel to draw a shallow draft, which facilitated the *I.A. Johnson's* work in shallow, near-shore waters. Due to the accumulation of sand in the vessel's hull, it was not possible to determine if the *I.A. Johnson* was equipped with any sister keelsons, but aft of the centerboard trunk, the keelson appears to have two rider keelsons sitting atop the keelson.

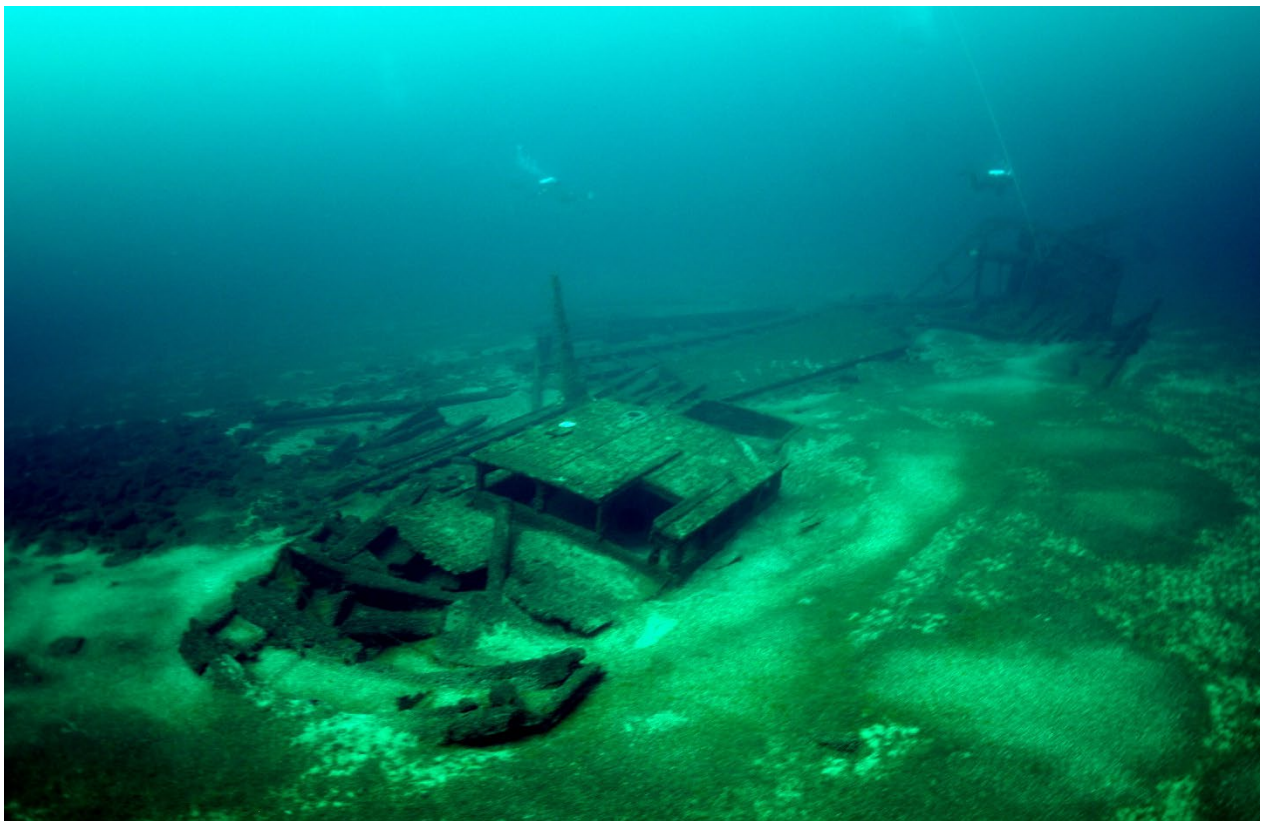
Figure 21. *Ocean Wave*'s stern, looking forward (Wisconsin Historical Society).

Much of the transom and stern ramp's inner planking is missing. Transom outer hull planking measures 4-1/4 in. wide and 1-1/2 in. thick and continues below deck level, onto the cross-planked stern ramp. Both the vessel's port and starboard sides have fallen outward from the hull. The exposed portion of the starboard side is longitudinally-planked with three visible planks (Meverden and Thomsen 2006).

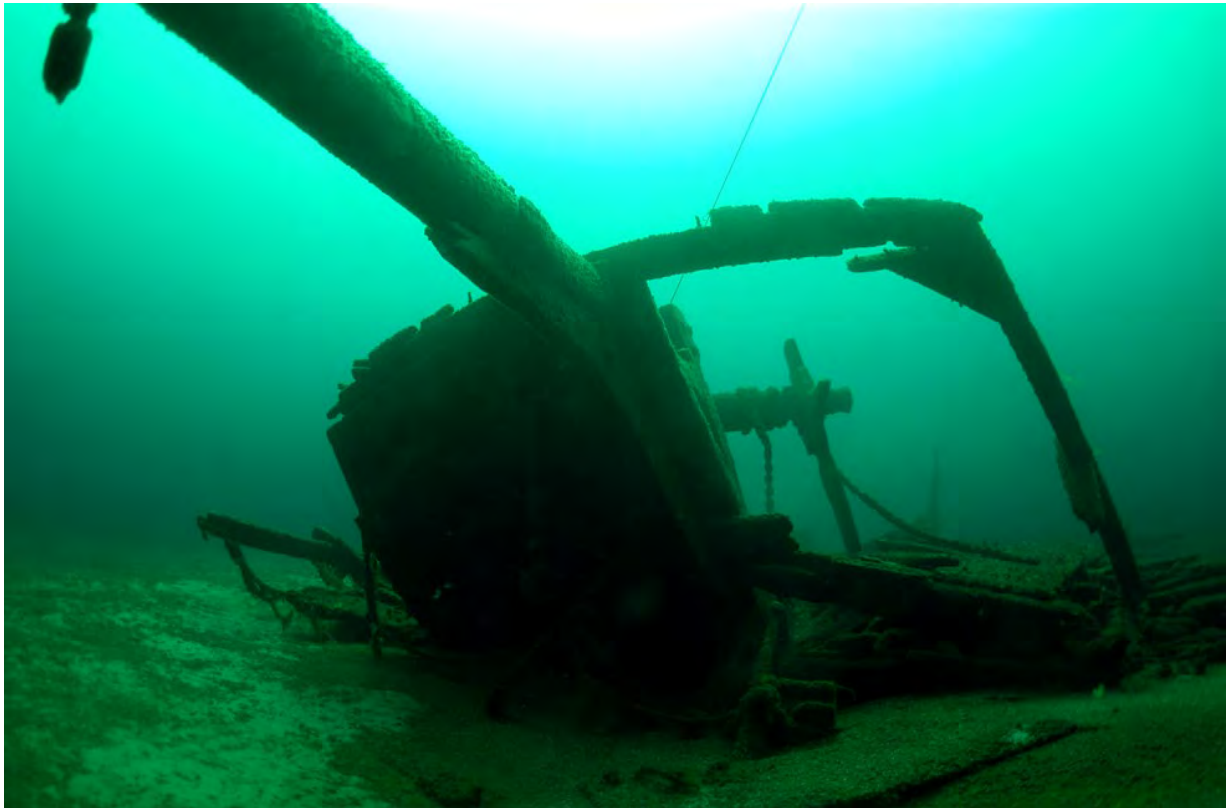
Figure 22. Cross-planked bow of *Ocean Wave* (Wisconsin Historical Society).

Ocean Wave's bow is cross-planked. There is no evidence of a hard chine-type edge between the bow and hull bottom. The bow curves towards the vessel's bottom with no visible transition.

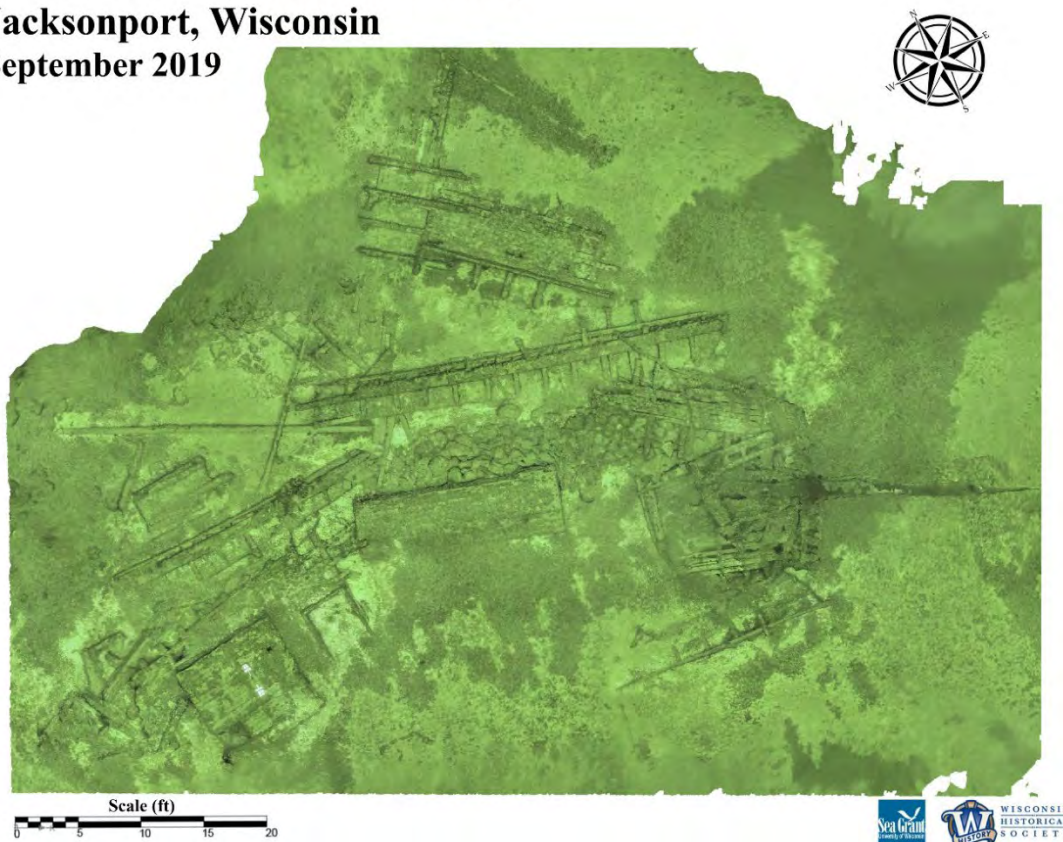
Figure 23. Orthomosaic of the *Ocean Wave* site (Tori Galloway).

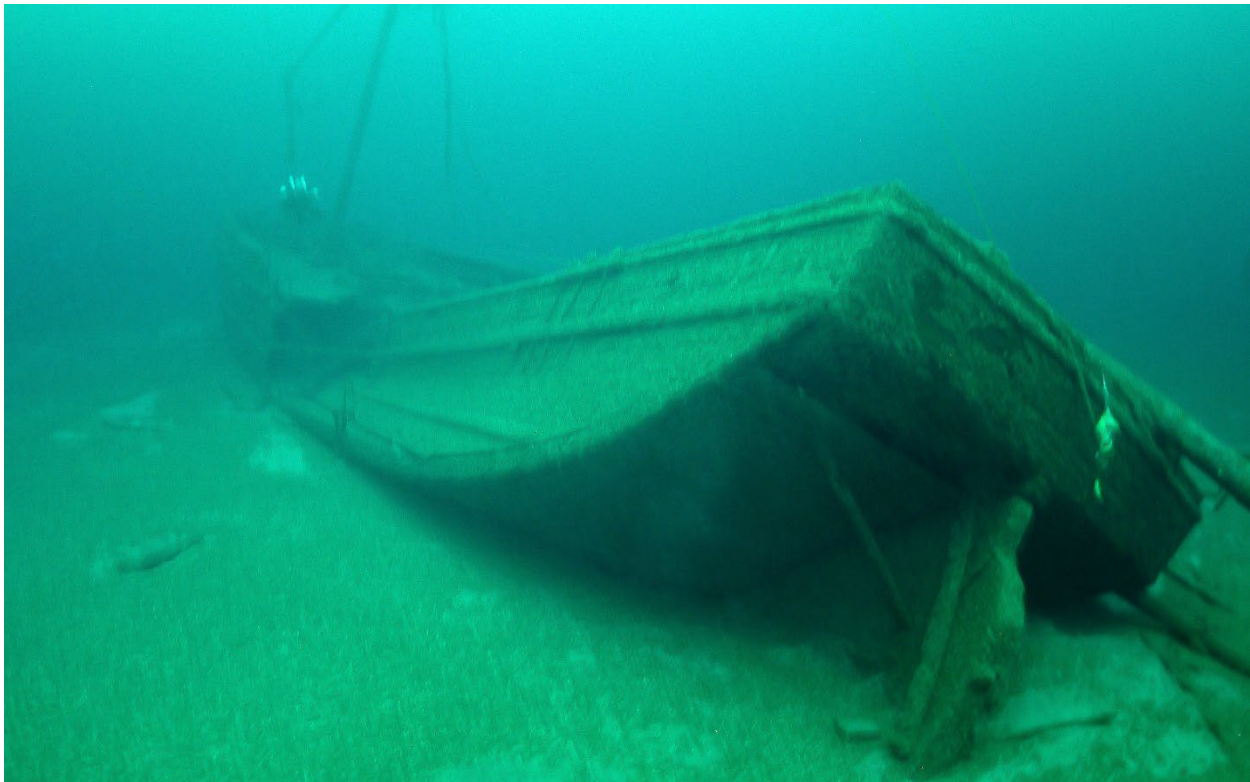
Figure 26. Image of *Silver Lake*'s sharp rise of the stern ramp (Wisconsin Historical Society).

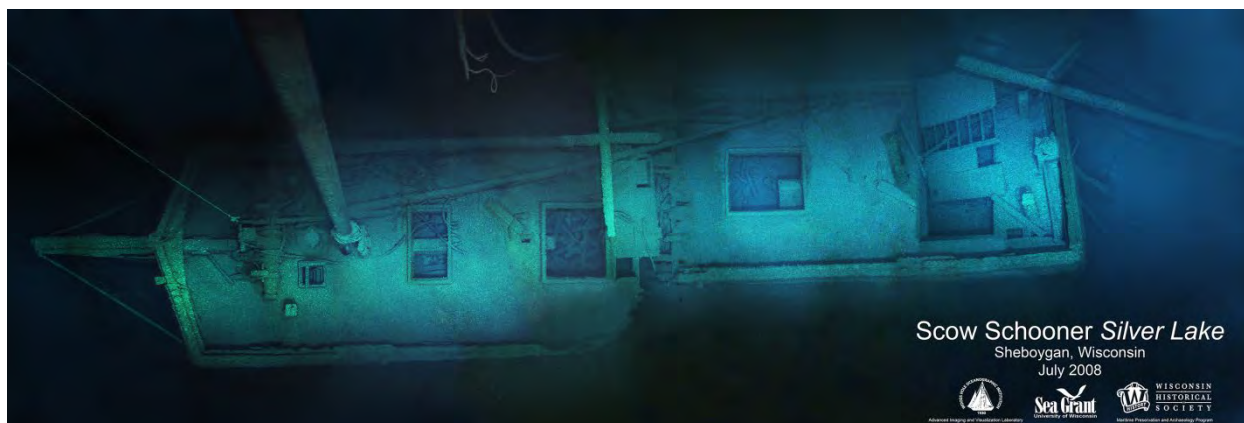
Figure 27. Photo mosaic of *Silver Lake* site (Woods Hole Oceanographic Institution).

The hull’s sides are constructed of longitudinal planks that are 0.65 feet high by 0.45 feet thick. The planks are edge-bolted together and into the chine log, measuring is 0.5 feet wide by 0.9 feet tall. The joint between side hull planks is caulked. Side planks are fastened to the top of the chine log flush with the log’s outside edge so that the chine log forms the turn of the bilge. A sister chine log, 0.6 wide by 0.65 feet tall, is fastened to the inside of the chine log. The sister log serves as both a reinforcement and as a chock, upon which the ends of the athwartship ceiling planks are supported and fastened. The ceiling planks are 0.15 feet tall by 0.75 feet wide and abut the inside edge of the chine log with the tops of the ceiling planks flush with the top of the chine log (Thomsen and Meverden 2011b).

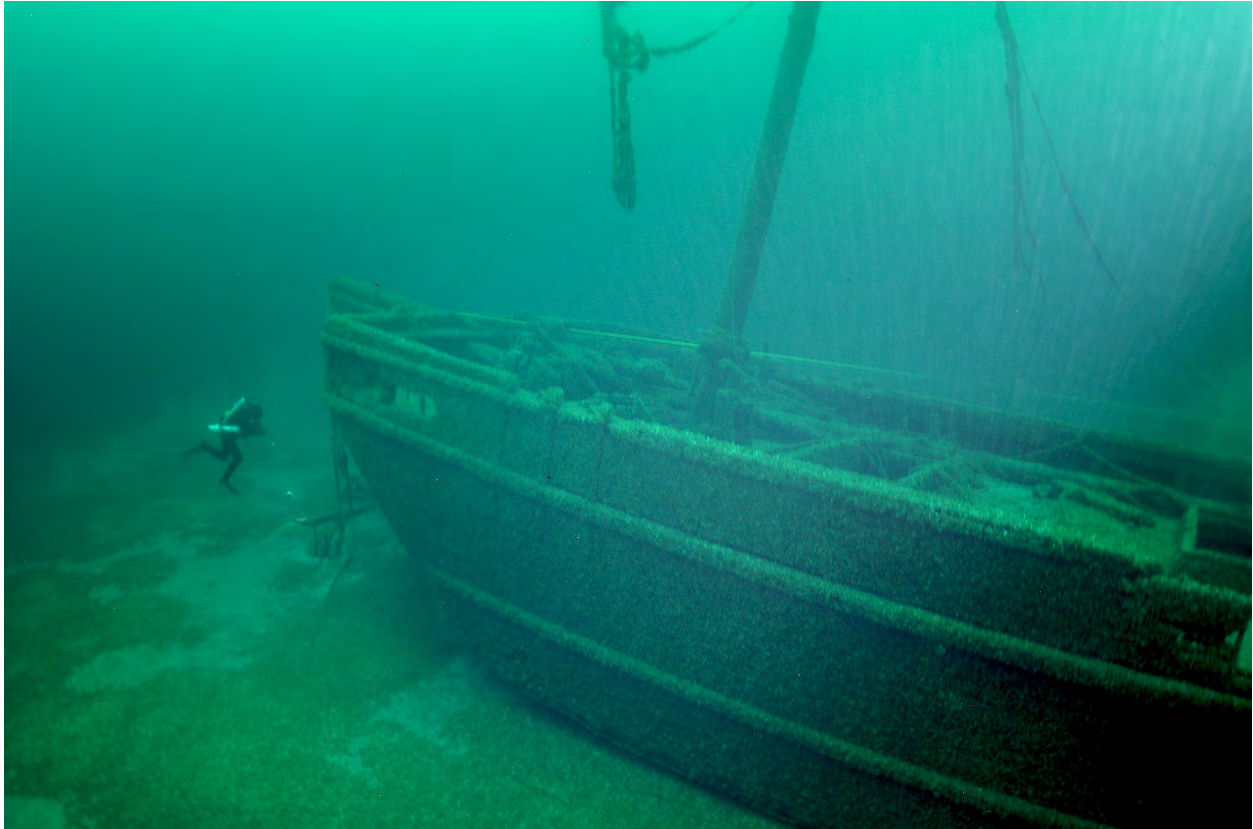
Figure 28. The V-bow of *Silver Lake* (Wisconsin Historical Society).

fouling from deck cargo. Like the forward centerboard, the aft does not have a dedicated winch mounted on deck level, but instead was raised and lowered via the ship's rigging. Likewise, the chain also passes through a wooden box that is 0.55 feet wide and 0.9 feet long, which rose 4.7 feet above deck level (Thomsen and Meverden 2011b).

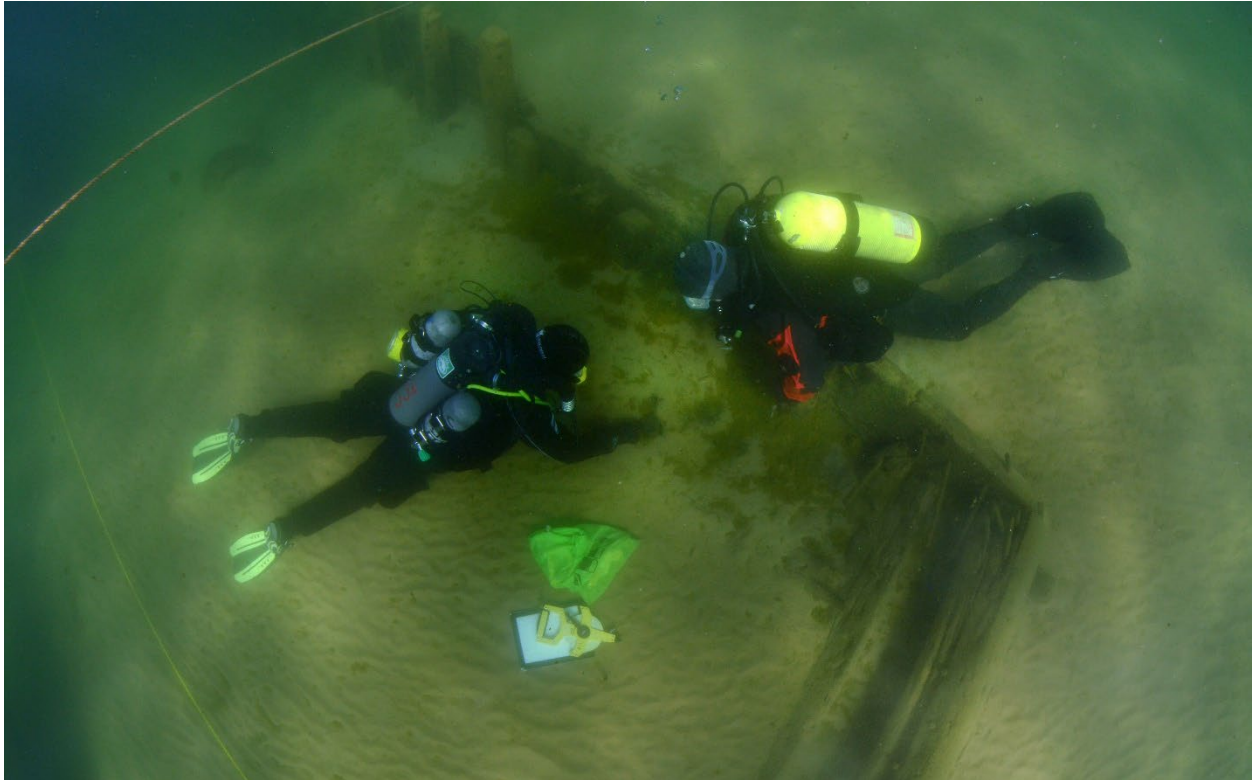
Figure 29. Two archaeologists investigate the double frames of *Success* near the vessel's bow (Wisconsin Historical Society).

Unlike traditional scow schooners of the Great Lakes, *Success* was not built with a series of king posts spaced throughout the length of the ship but was instead constructed in a manner closely resembling regular schooner construction. *Success* had double frames with futtocks measuring 0.55 feet and 0.45 feet wide, and 0.45 feet thick. Although many of the futtocks of each frame have been broken or damaged, evidence of their fasteners and their placement is visible along the interior of the hull planking, where the planking is grooved to fit the timber. The frames are spaced irregularly. A 25-foot-long section of the ceiling planking on the port side lies 57.0 feet from the sternpost; it measures 0.4 feet wide, 0.1 thicker than the outer hull planking, a method of construction common throughout the Great Lakes region. The hull structure is through-bolted and peened from the interior of the ceiling planking (Zant and Thomsen 2015).

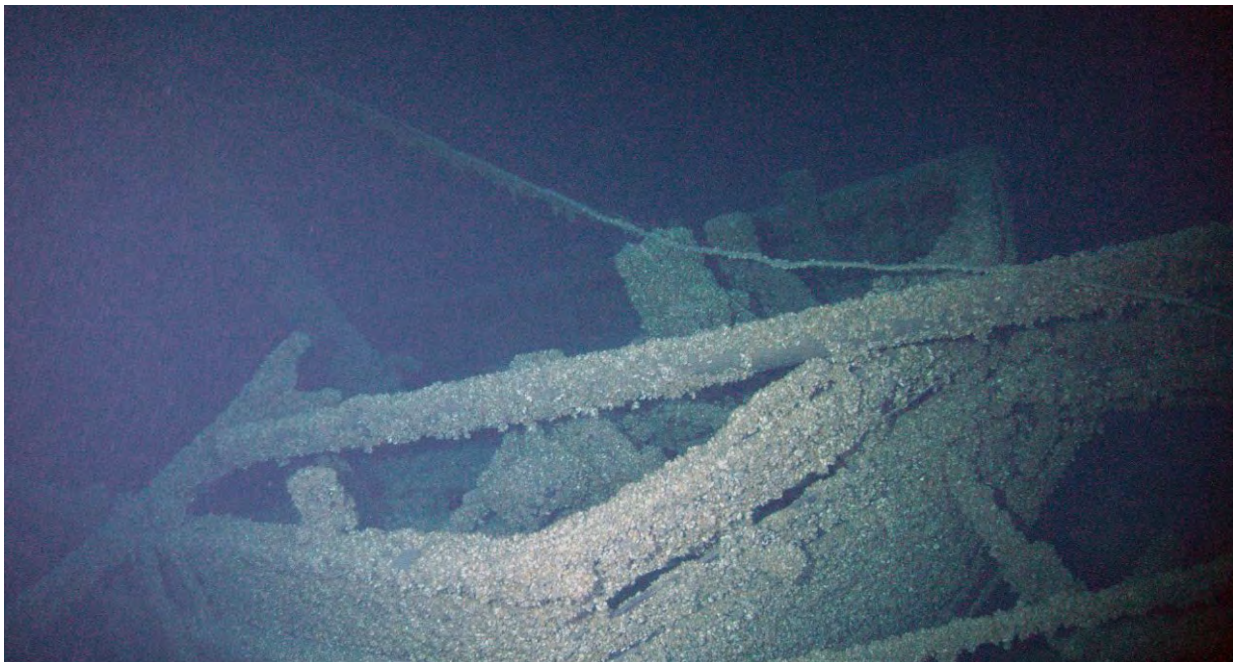
Figure 32. ROV image of *Tennie and Laura*'s V-bow (Marine Imaging Technologies).

The vessel's bow ramp is cross-planked, joined to the longitudinal side-planking by framing timbers. The bow curves upward sharply from the bottom and appears to be constructed of two separate panels. These panels are joined together to create a v-shaped bow that extends 1.6 feet forward of the framing timbers, where it connects at the stempost and is reinforced by a breasthook (Meverden and Thomsen 2007).

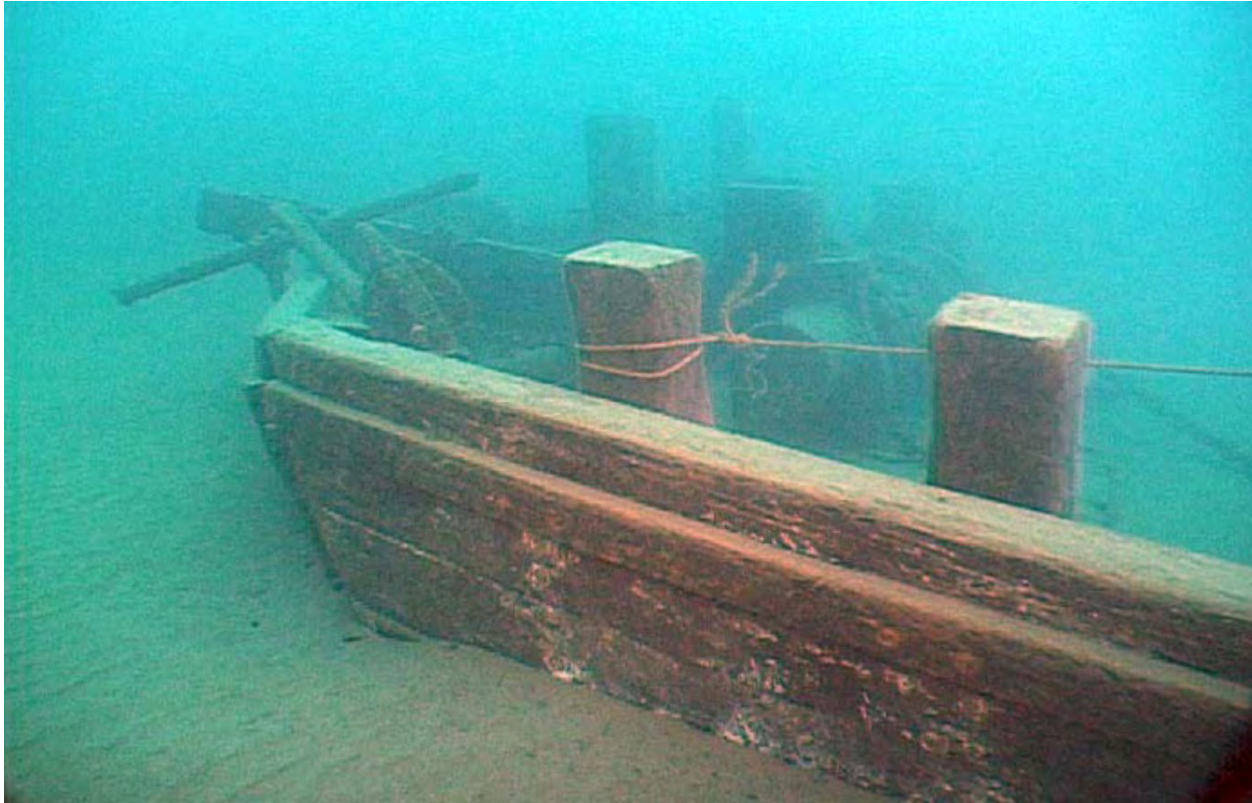
Figure 33. Bow and port side of *May Flower* (Ken Merryman).

The *May Flower's* outer hull planks are 0.65 feet wide by 0.3 feet thick and are edge bolted together with iron bolts. Although buried in the sand bottom and difficult to distinguish, it appears that the hulls sides and bottom are joined with a chine log that is mortised to accept the king posts. The bulwark stanchions are fastened to the forward side of the king posts and are 0.55 feet square with a space of 2.5 feet between stanchions (Meverden and Thomsen 2011).
