**IMPACT OF HURRICANES ON  
PINELLAS COUNTY, FLORIDA, 1985**

Richard A. Davis, Jr. and Margaret Andronaco

Department of Geology  
University of South Florida  
Tampa, Florida 33620

TECHNICAL PAPER NO. 51  
May 1987  
Price \$3.00

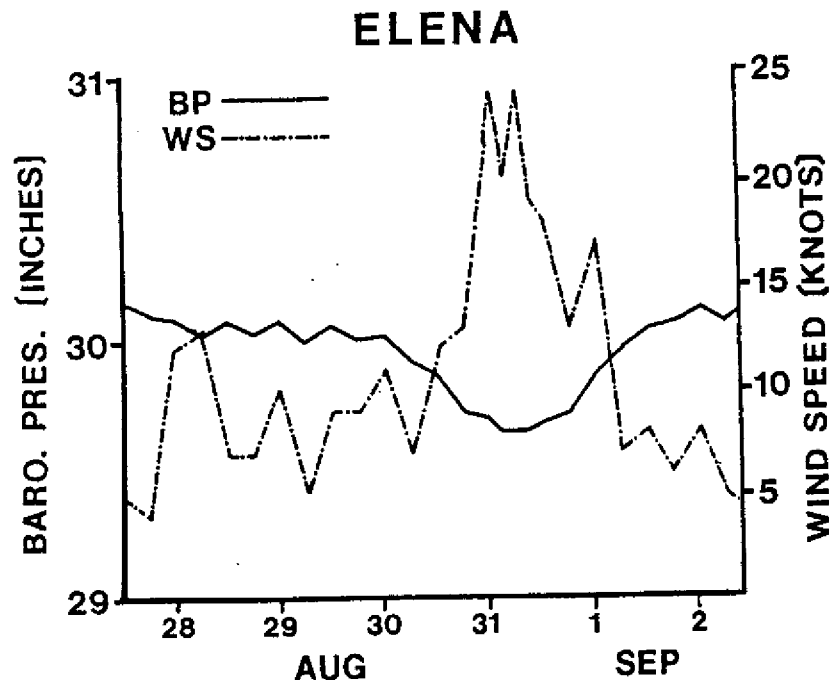
Figure 5 - Plot of barometric pressure and wind speeds recorded at the Tampa airport during the passage of Hurricane Elena.

Weather conditions in the Pinellas County area included a minimum barometric pressure of 1003 mb and maximum winds of 24 knots at the National Weather Station in Tampa (figure 5). The strongest winds in this area were from the south and southwest, the directions of persistent winds during passage of the storm.

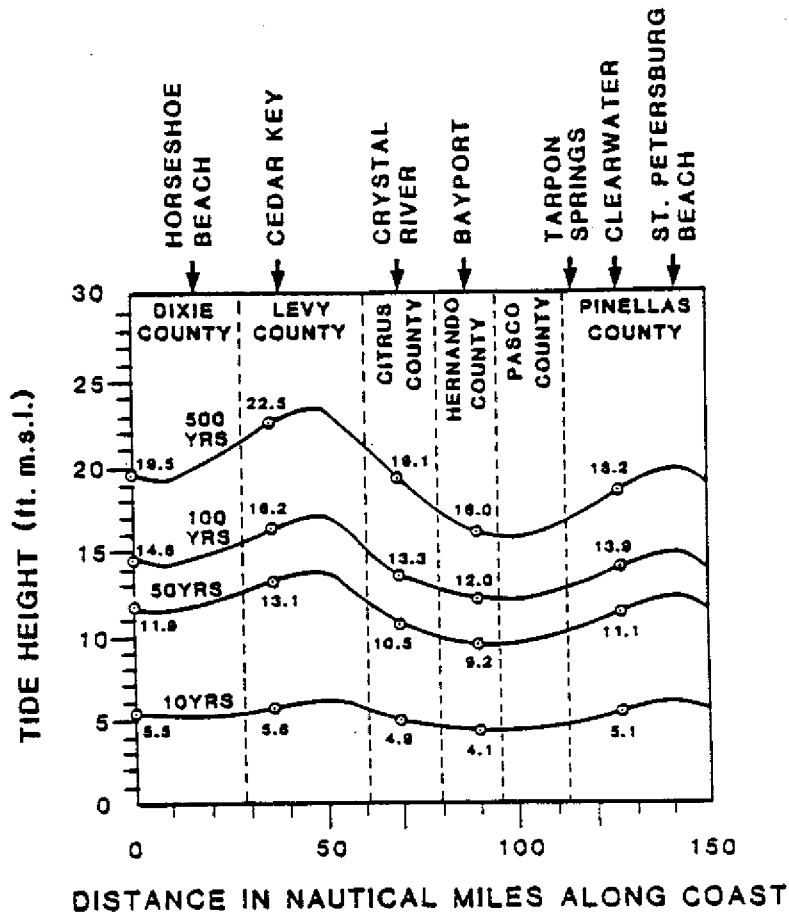
Figure 8 - Storm recurrence curves for the northeastern Gulf Coast including Pinellas County. Note that Hurricane Elena was only about a once in 10 yr storm. (from Hine et al, 1986.)

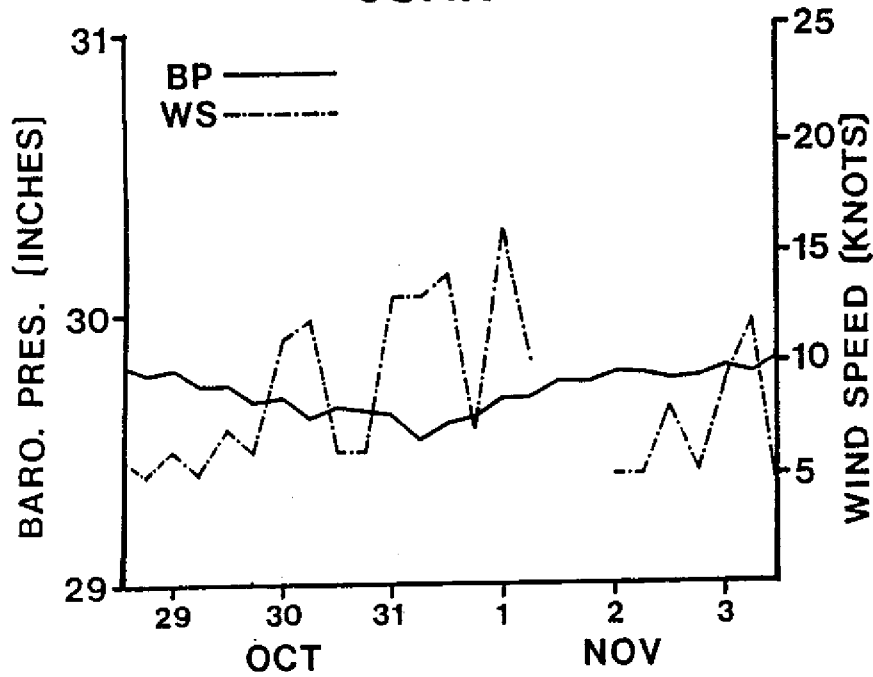
Figure 11 - Plot of barometric pressure and wind speed from the Tampa airport during the passage of Hurricane Juan.

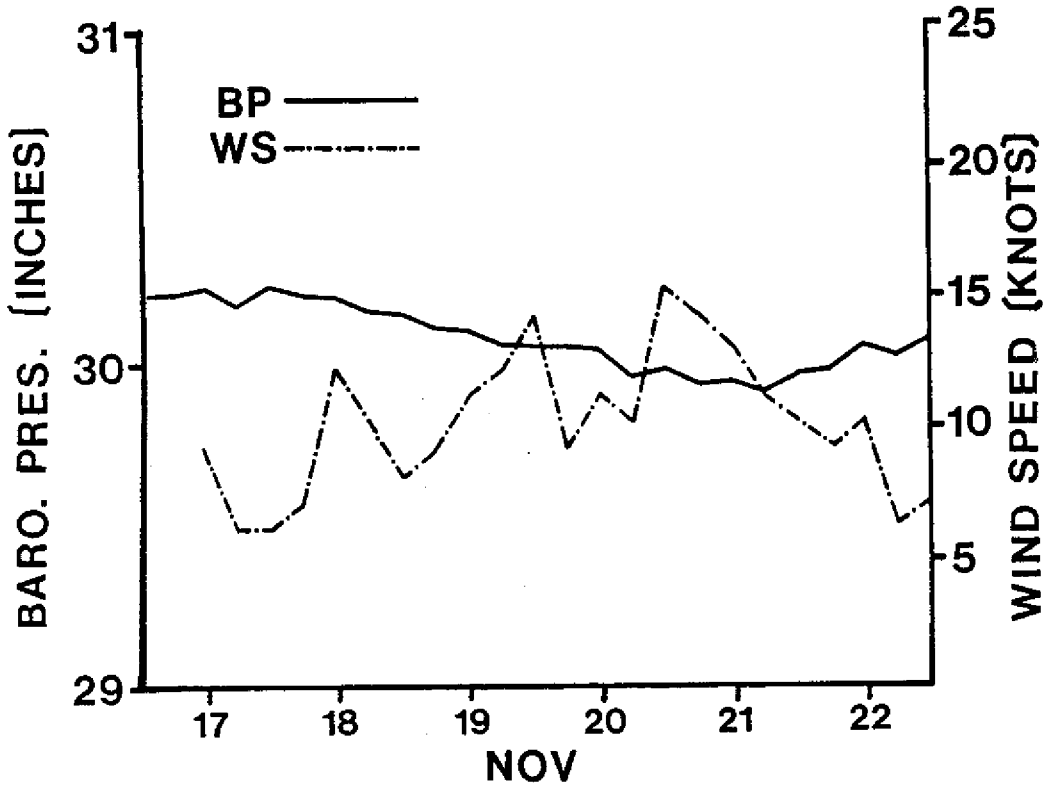
Figure 13 - Barometric pressure and wind speed data from the Tampa Airport during the passage of Hurricane Kate.
