The Causes of  
**EROSION TO  
SILETZ SPIT,  
Oregon**

Paul D. Komar  
C. Cary Rea

OREGON STATE UNIVERSITY  
SEA GRANT COLLEGE PROGRAM  
Publication no. ORESU-T-75-001

DECEMBER 1975

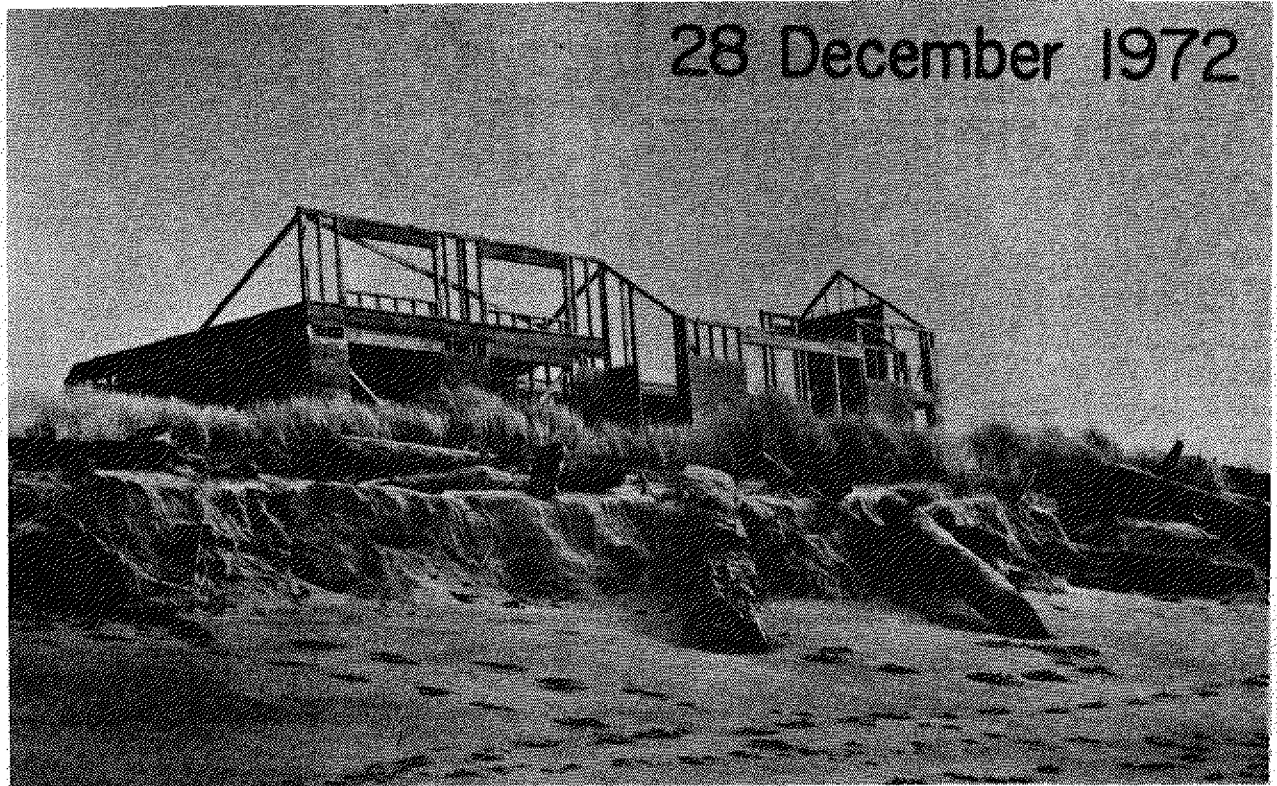
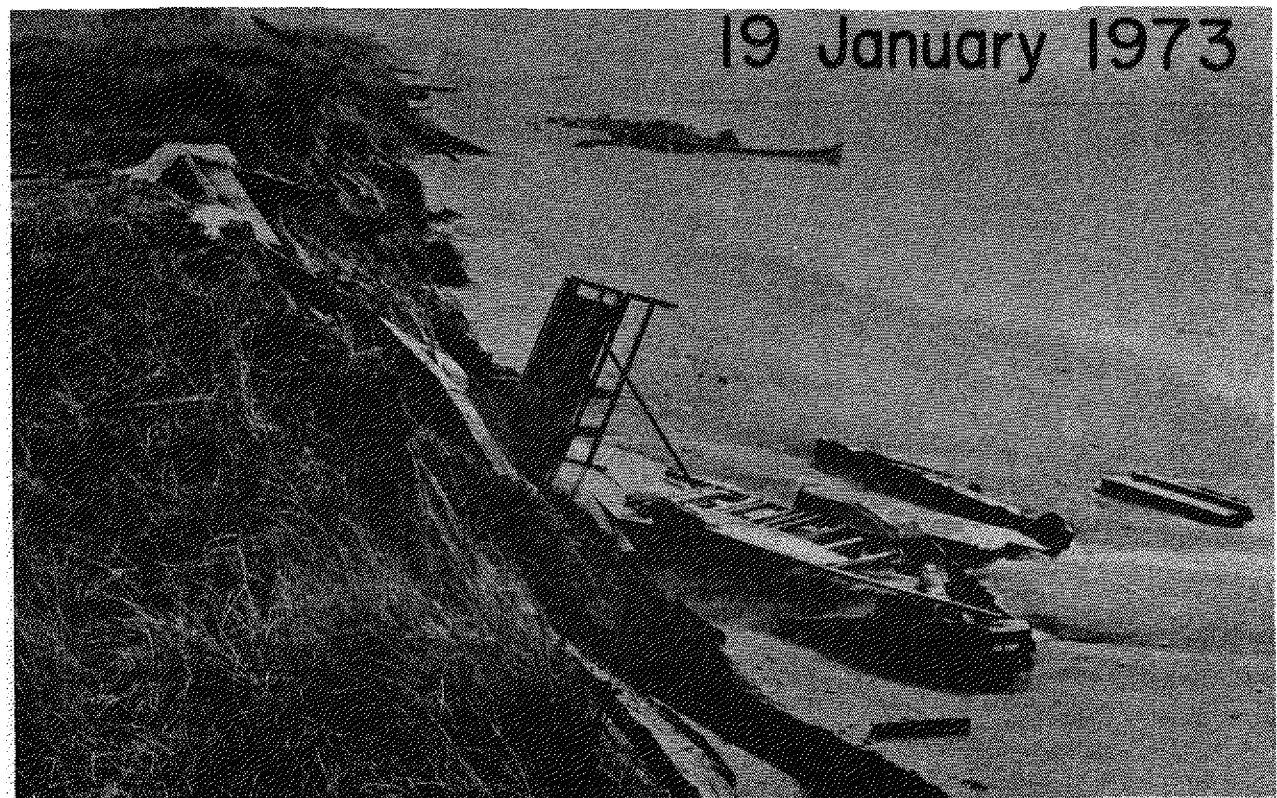
Fig. 2. Erosion and destruction of the house under construction on lot 226 of Siletz spit.

The severest episode of erosion occurred during the winter of 1972-73. One partially built home was destroyed (Fig. 2) and others had to be protected by riprap on three sides (Figs. 3 and 4). The worst erosion took place along a 650 meter (2100 feet) stretch of the central spit, opposite the artificial lagoons cut into the bay-side of the spit. Fig. 5 diagrams the erosion to the base of the foredunes, the maximum recession amounting to 30 meters (199 feet) in a three-week period. Individual homeowners placed riprap in front of their properties, but vacant lots left unprotected continued to erode. This flank erosion in the empty lots made it necessary for the houses to be protected on their sides as well. The group of three houses ended on a promontory supported by riprap (Figs. 3, 4 and 5).

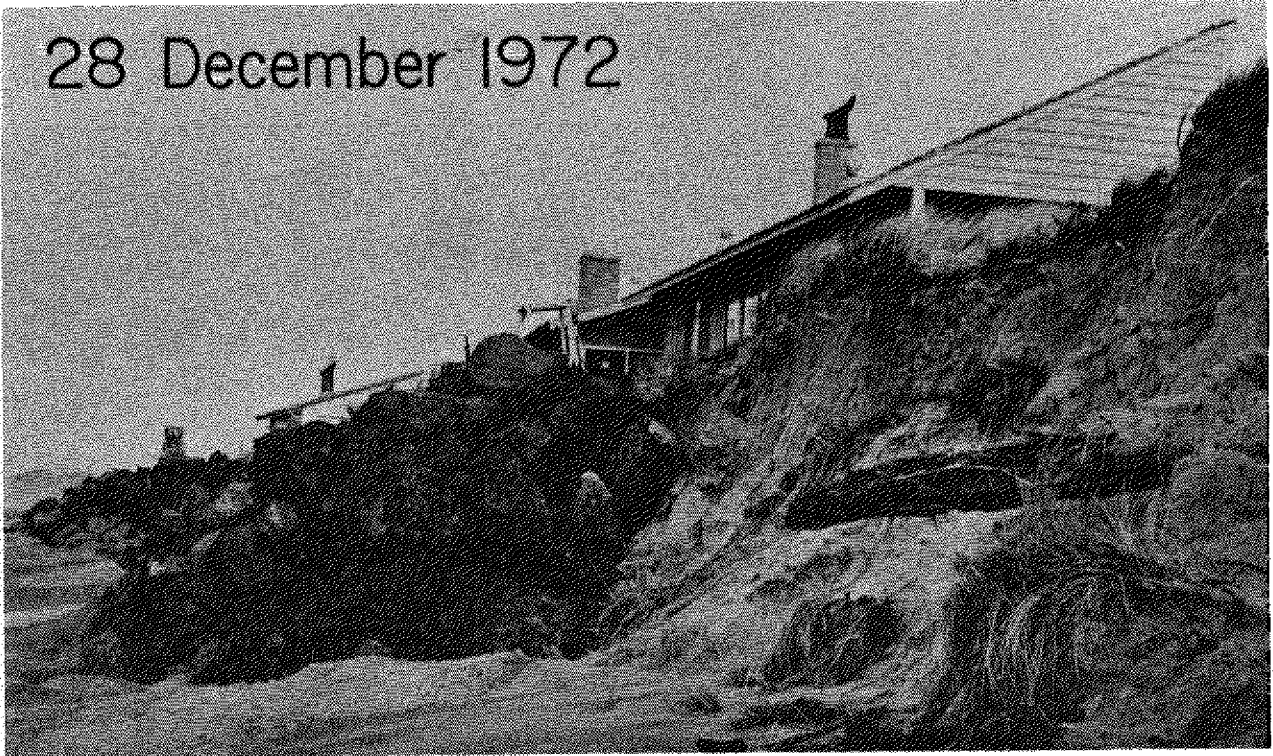
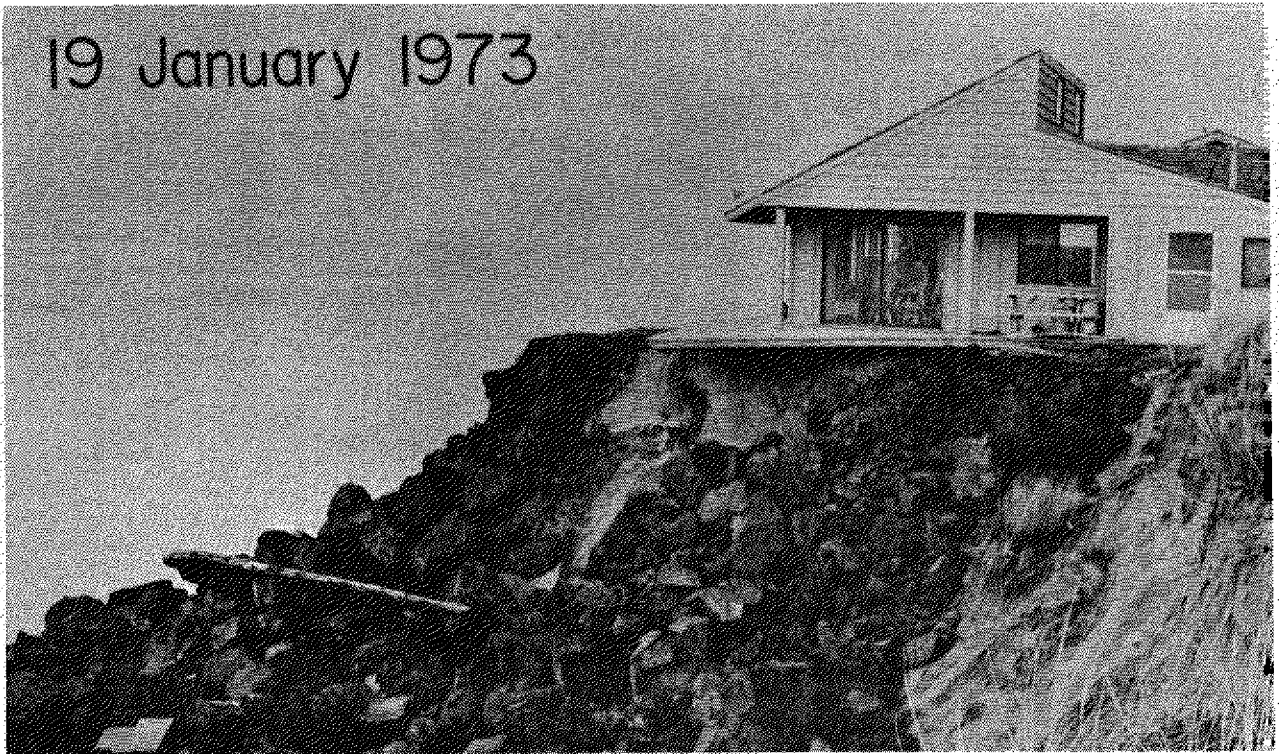
28 December 1972

19 January 1973

Fig. 3. Erosion around the house on lot 229-A. In the upper photo rapid erosion required the placement of riprap in front of the home. But no riprap was installed in the adjacent vacant lot so erosion continued along the side as seen in the lower photo.

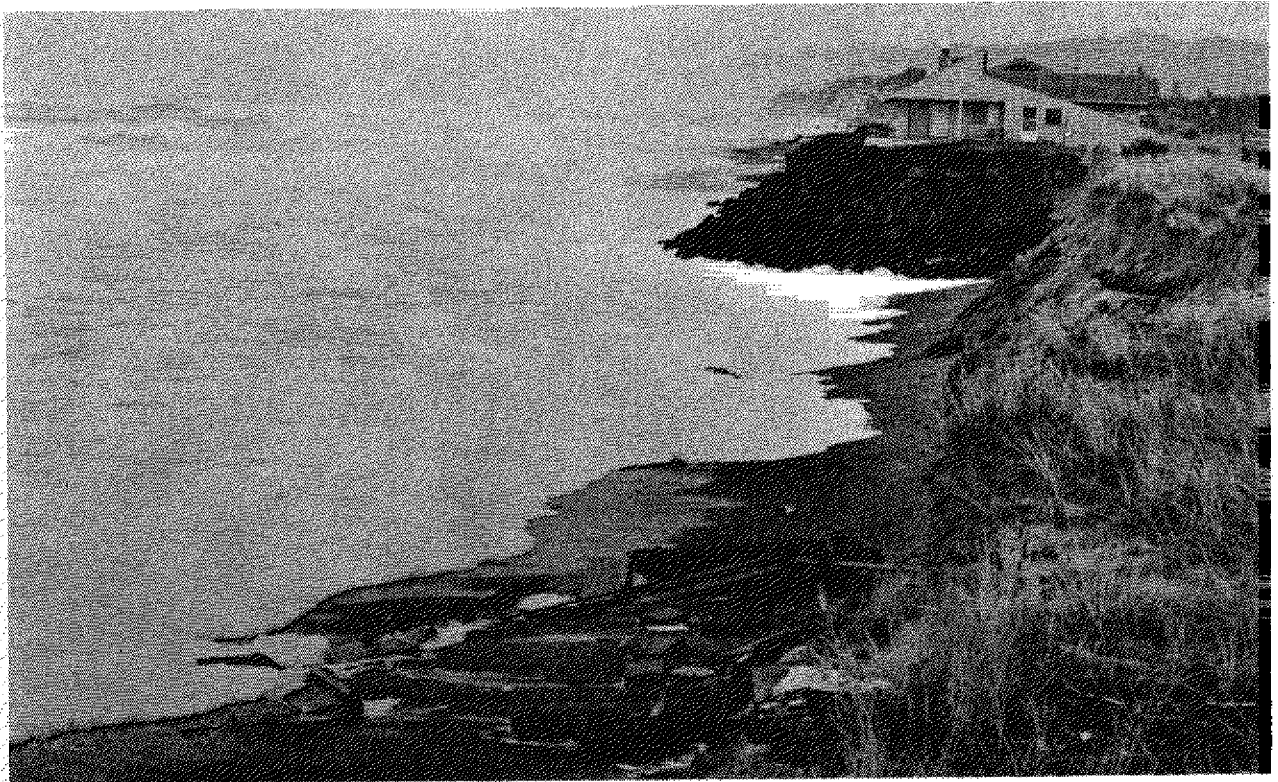
Fig. 4. View showing both houses of Figs. 2 and 3.

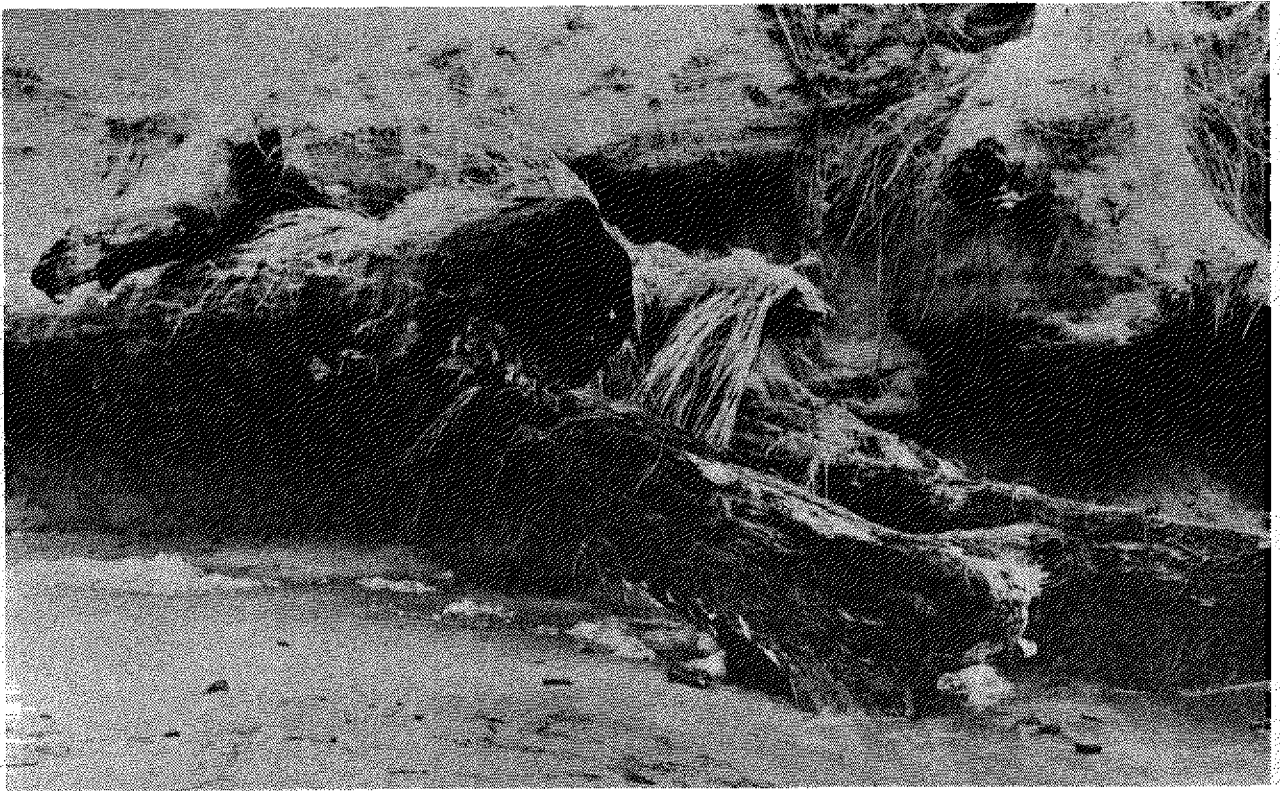
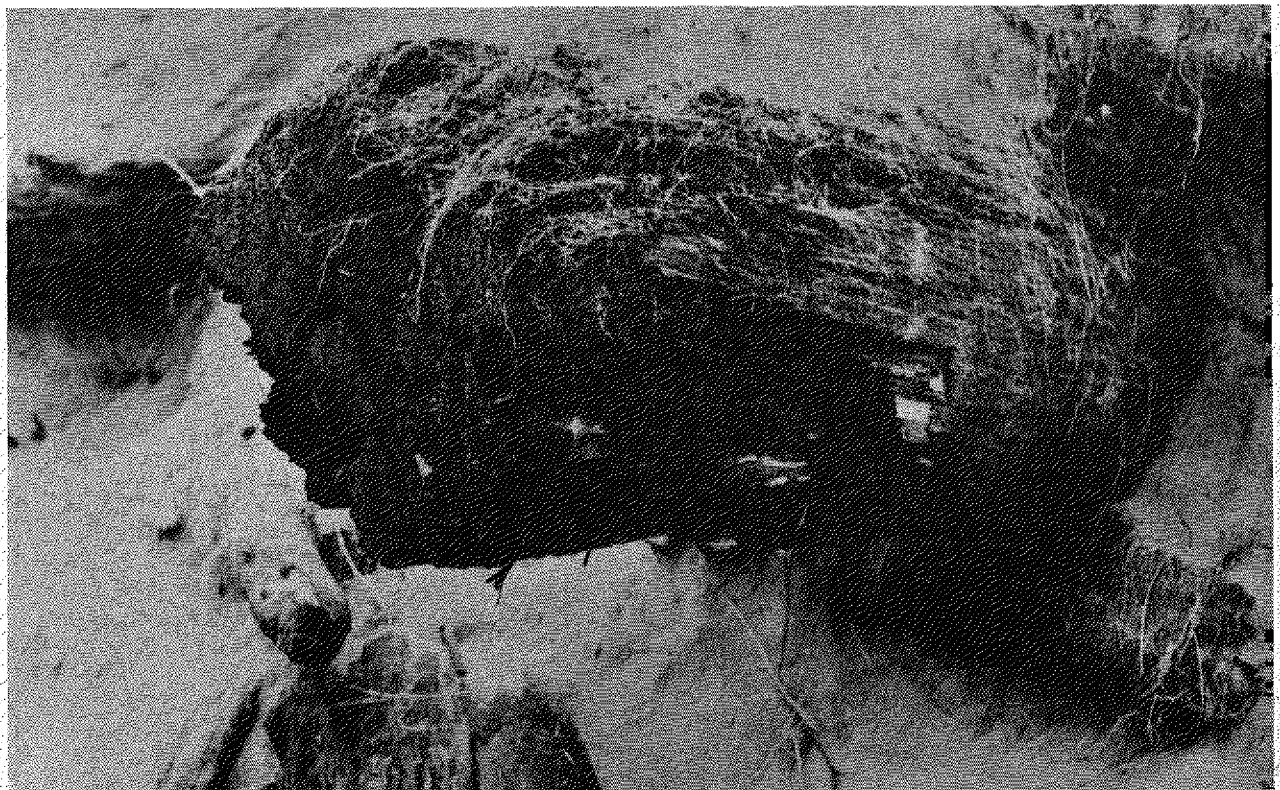
Fig. 6. Logs exposed within the eroded dune bluff, many of which had been sawed.

Erosion of the dunes on the spit exposed numerous drift logs, many of which had been sawed (Fig. 6). This indicates an association with logging in the Oregon coast area. The main influx of settlers and logging started about 1895. Sawed logs within the spit indicate that the portion of Siletz Spit on which the houses had been built must have suffered previous erosion, sometime after 1895. After that early erosion the dunes must have built back out and become re-established.

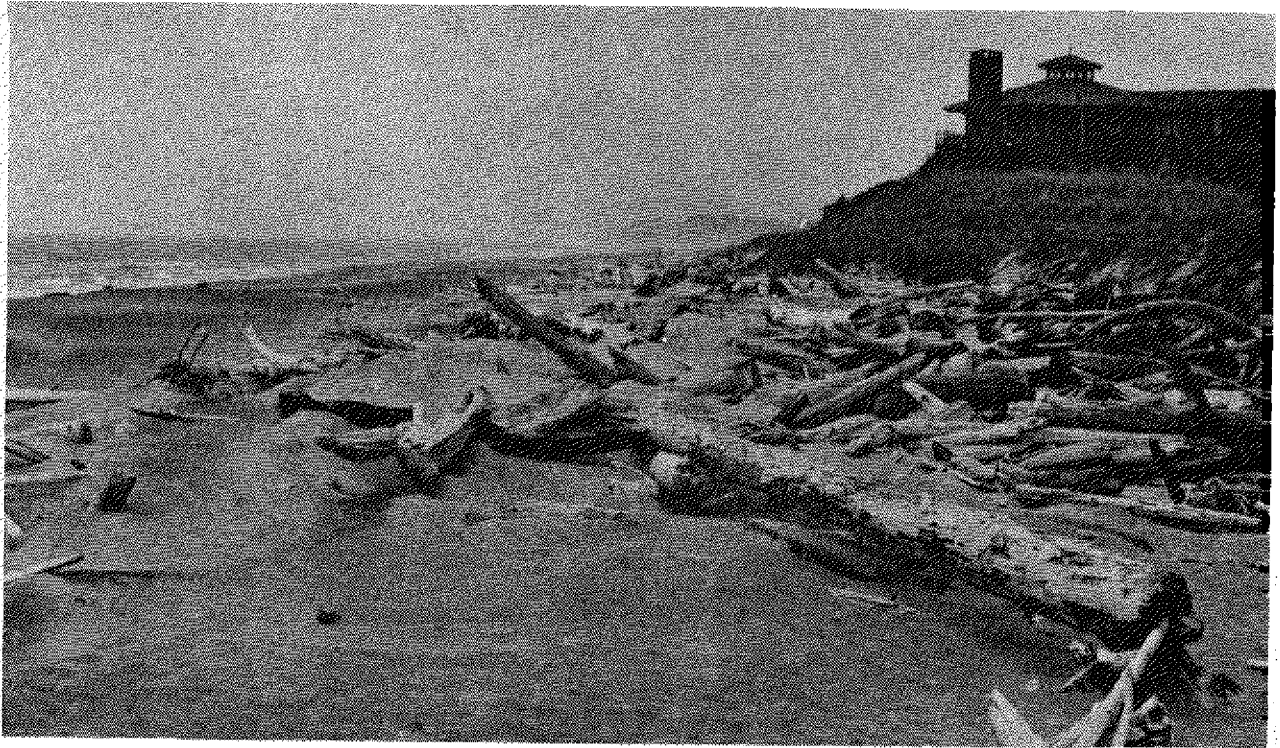
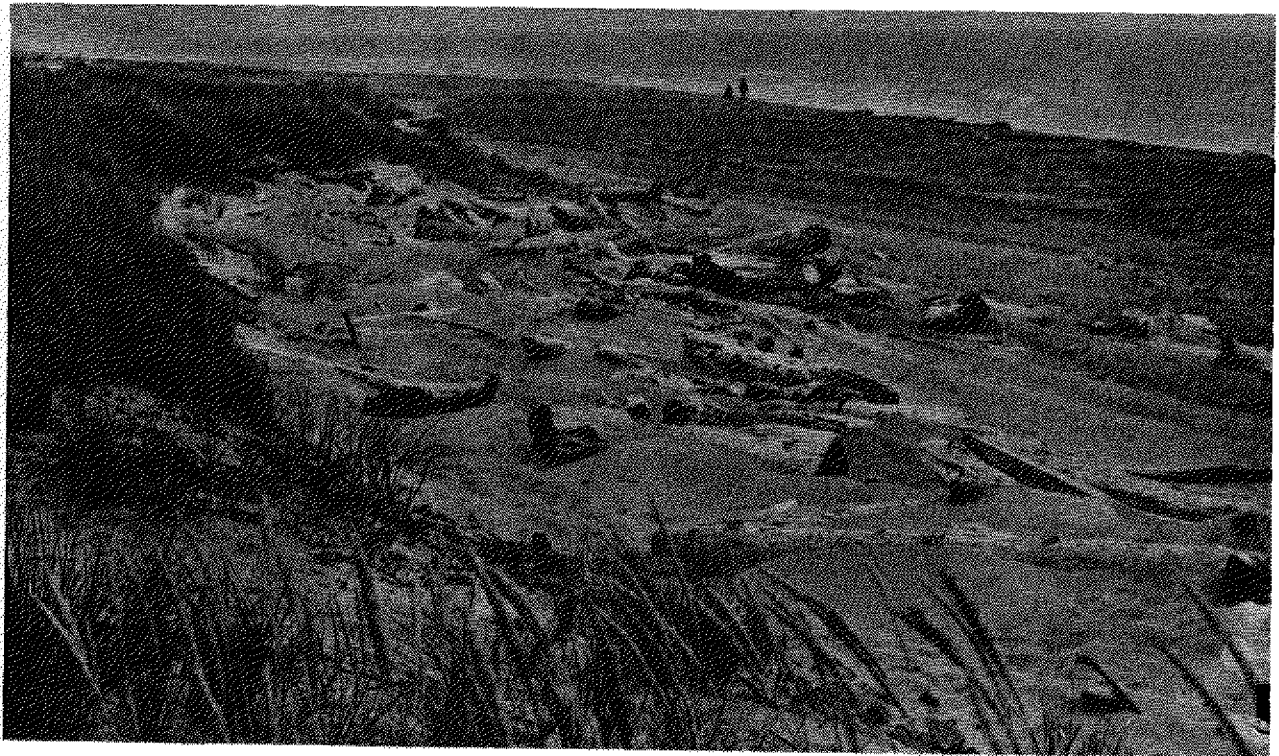
Fig. 7. Logs deposited within small embayments into the foredunes, trapping sands and helping to re-establish the foredunes. The upper photo is the park area which was extensively eroded in 1971 through 1973. The lower photo shows a smaller embayment near the northern end of the spit at a more advanced stage of dune formation.

The following sequence of events as revealed by the aerial photographs is typical of many cycles of erosion and accretion of the foredunes on Siletz Spit: (1) high waves eroded a vertical scarp in the seaward edge of the foredunes, (2) subsequent high tides deposited drift logs at the base of the scarp, (3) lower energy waves during the summer built a wide beach, (4) the logs behind the beach trapped sand that was either blown off the beach or washed there by the waves at high tide, (5) wind-blown sand continued to accumulate around the logs, sometimes aided by dune grasses, until the foredunes were re-established (Fig. 7 illustrates these processes), (6) erosion again occurred to repeat the cycle.

This study also demonstrates that drift logs play an important role in the natural rebuilding of the foredune areas (Fig. 7). Large-scale removal of the logs for any purpose may be harmful.

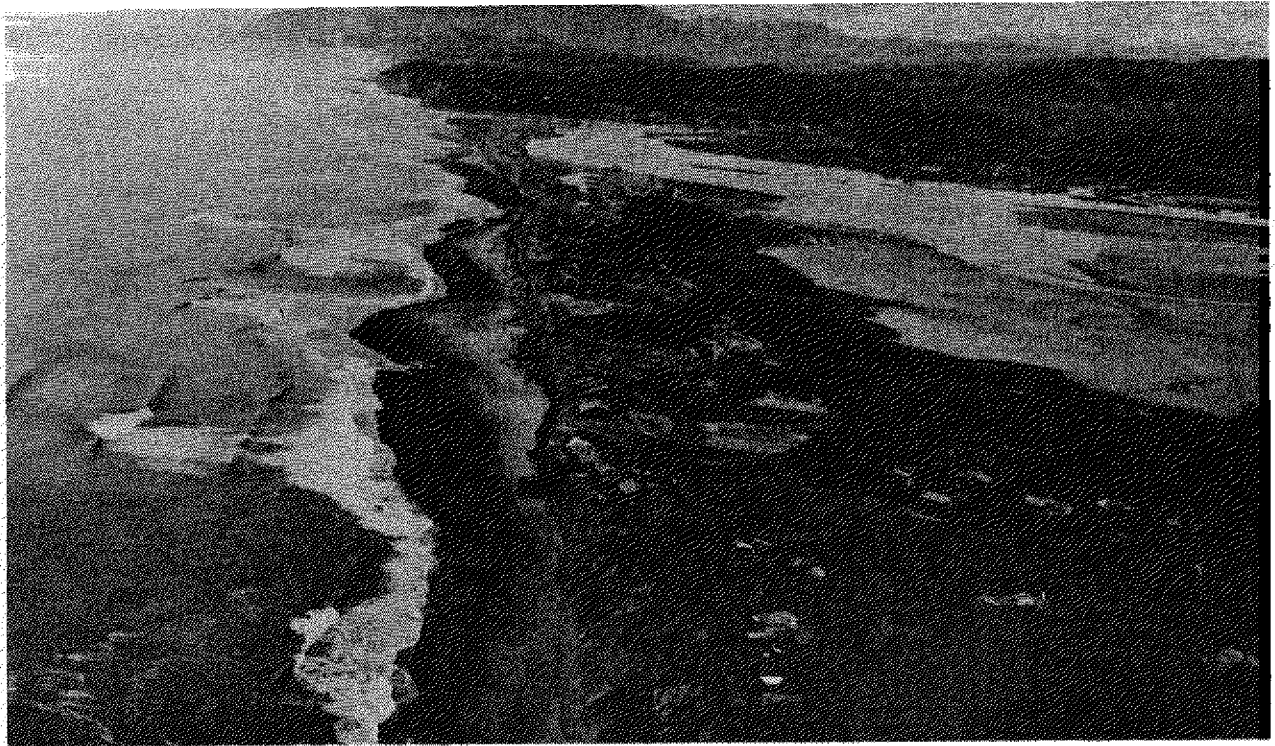
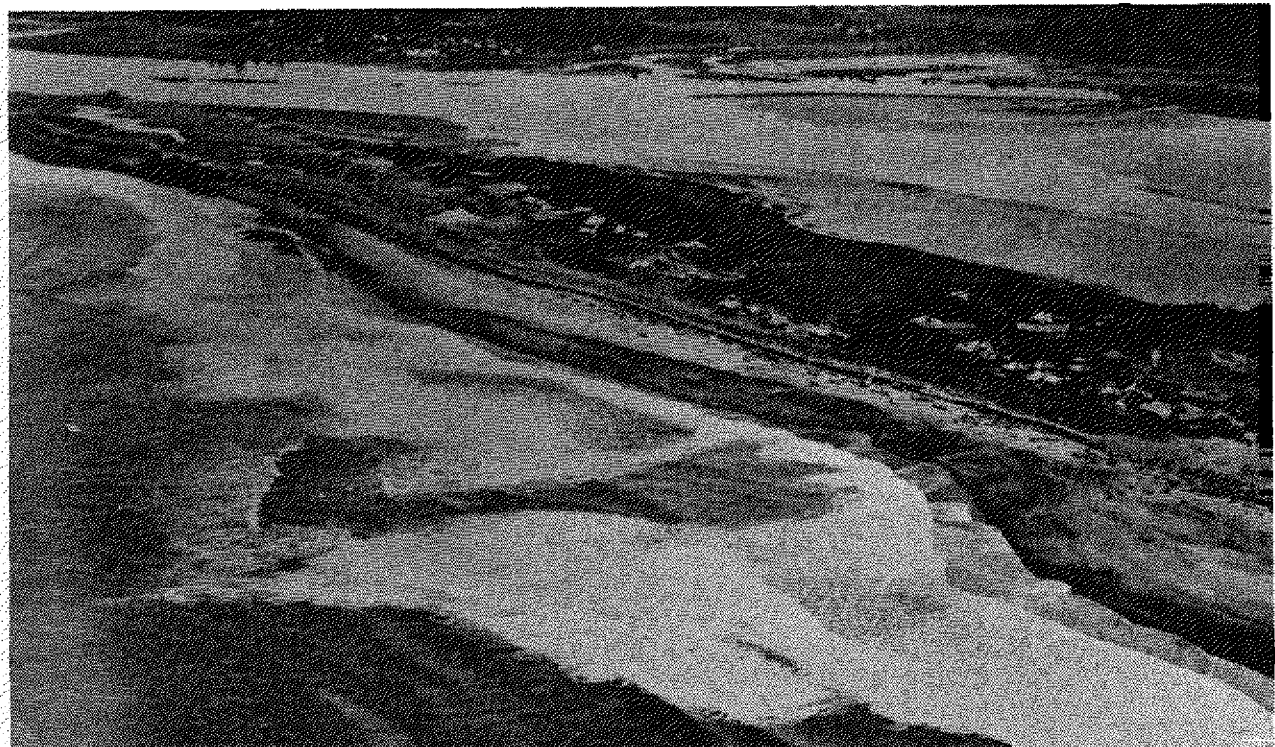
Fig. 8. Irregular shoreline of bays and cusps due to the presence of rip currents, one of which is shown in the lower photograph. These photographs were obtained on February 8, 1973, soon after the erosion occurred. Note that the bay that comes closest to the dunes is at mid-spit, opposite the homes on the riprap promontory.

The shoreline along Siletz Spit is typically very irregular (Fig. 8) due to rip currents carrying sand offshore. Rip currents hollow out small bays on the beach with large cusps between them. At the time of erosion in 1972-73 a strong rip current was situated in one position for most of the winter. This rip current hollowed out a large embayment on the beach, entirely removing the portion of the beach above high tide level so that the wave swash was able to reach the dunes. The loose sands, offering no resistance to the waves, were easily eroded away.

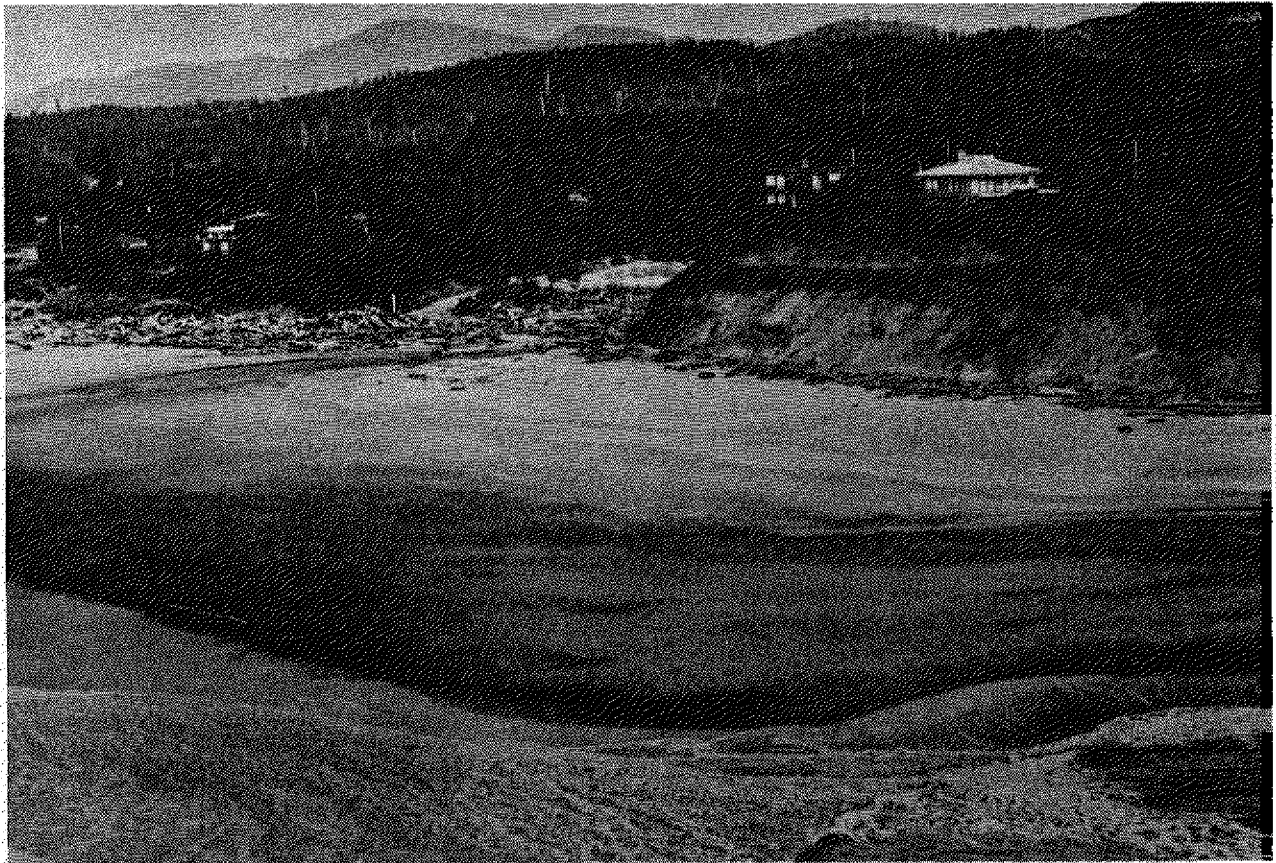
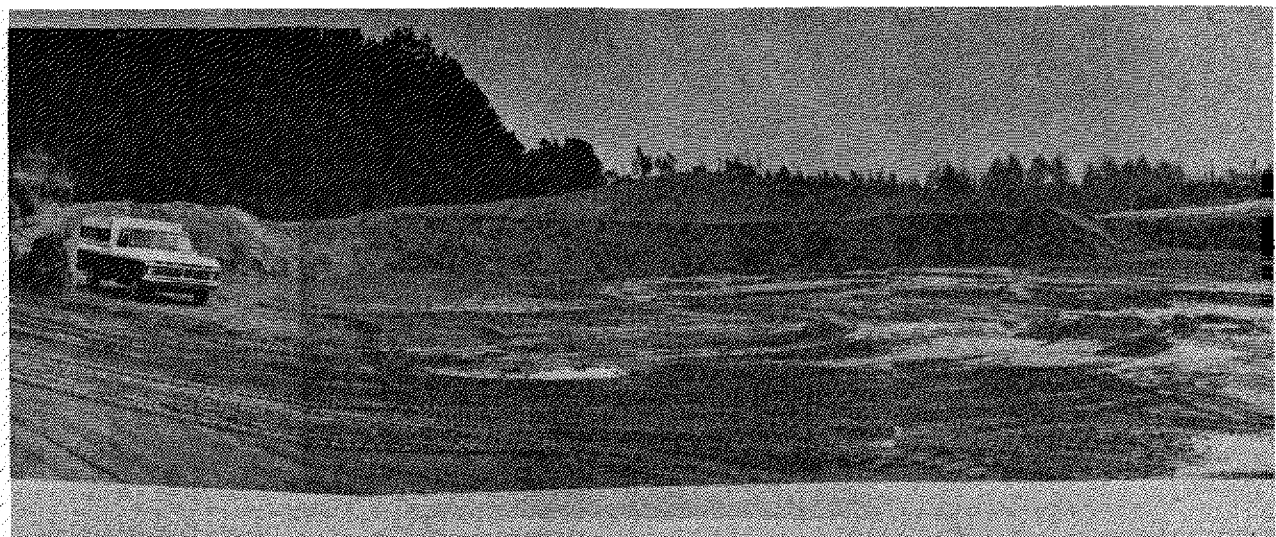
Fig. 9. Sand mining from the beach at School House Creek, south of Siletz Spit. Sand was removed from the beach at low tide, shown in the upper photo, and piled just inland, shown in the lower photograph. This shows only a portion of the volume removed in a single year. Note the erosion to the sea cliffs in the upper photograph.

The erosion of 1972-73 was more severe than previous episodes of erosion (at least back to 1939); it cut back farther into the dunes. This may have been due to sand mining operations removing sand from the beach just to the south of the spit (Fig. 9). Some

84,500 cubic meters (111,000 cubic yards) of sand were removed between 1965 and 1971.

For these reasons, removal of the sand by mining operations probably disrupted the natural budget of beach sand, the balance of sand gains and losses on the beach. With a decreased volume, the beach was not able to protect the coastal property from wave attack, and accelerated erosion resulted. Therefore, although cycles of erosion to Siletz Spit are natural and are known to have occurred prior to beach sand mining, the mining operations aggravated the situation and caused increased erosion. Beach sand mining has subsequently been stopped.

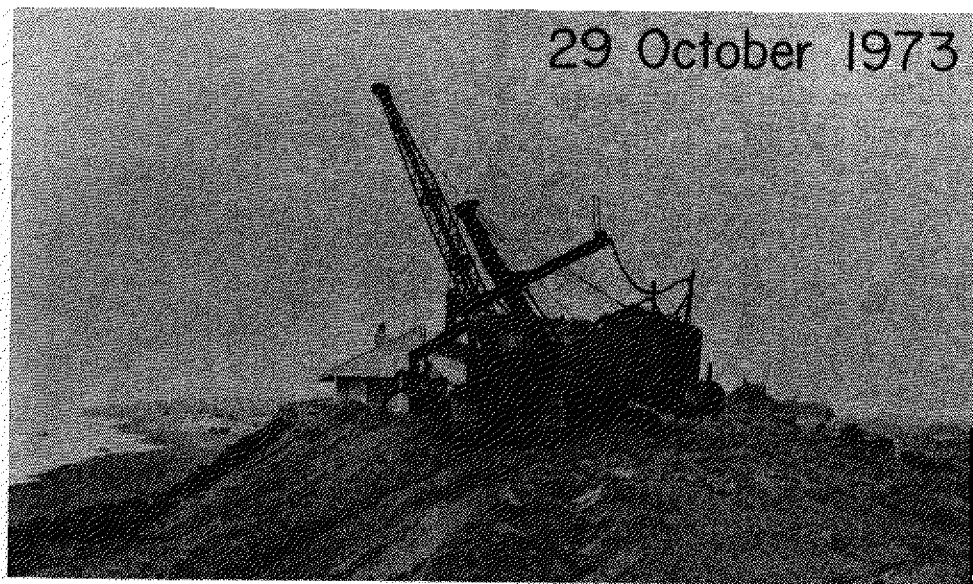
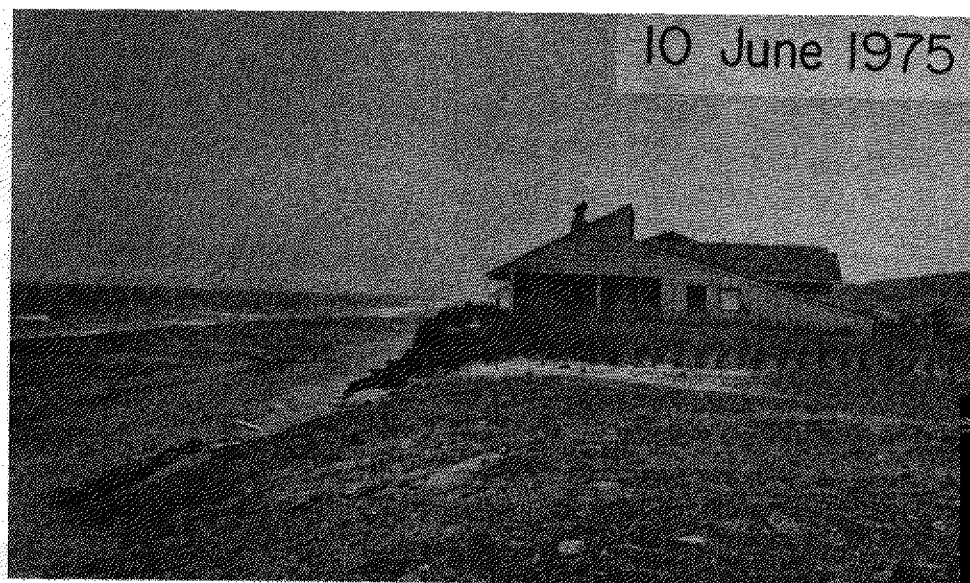
Fig. 10. Restoration of the lots 228 and 229. Compare with Figs. 3 and 4.

Some of the lots that were eroded away in 1972-73 have been subsequently restored

(Fig. 10). These are either not protected or inadequately protected; another winter of intense storms could bring renewed erosion. Even some houses that installed riprap in 1972-73 could be endangered by erosion because their riprap protection failed. In some cases the riprap has partially eroded away, even exposing the dune sands (Fig. 11). This riprap was hastily installed in order to save the houses at the time of severe erosion in 1972-73. Its installation did not follow the normal engineering procedures for riprap construction. Even more important, stones of inferior size were used because of their availability; these are easily washed away by waves.

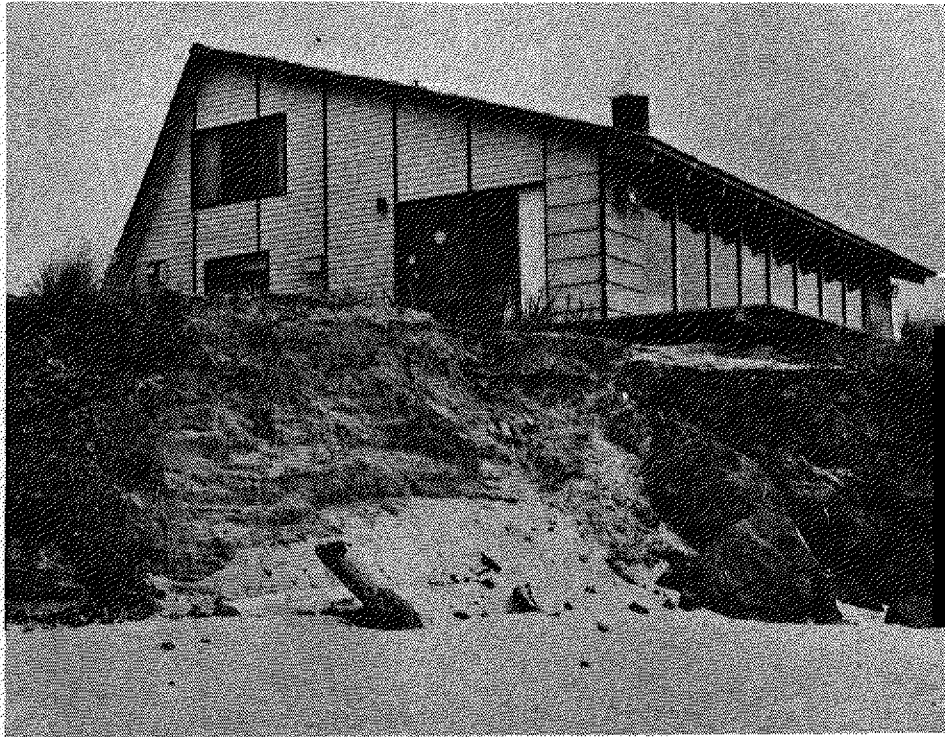
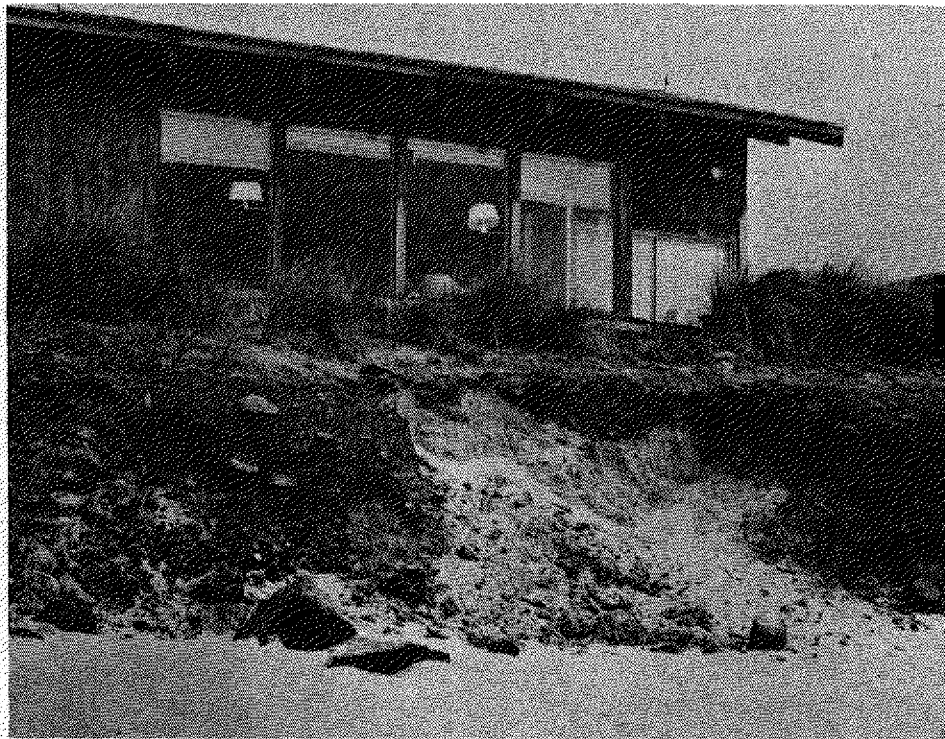
Fig. 11. Erosion of the riprap in front of the homes on lots 230 and 232, exposing some of the dune sands. Note the general small size of the rocks which are easily eroded away.

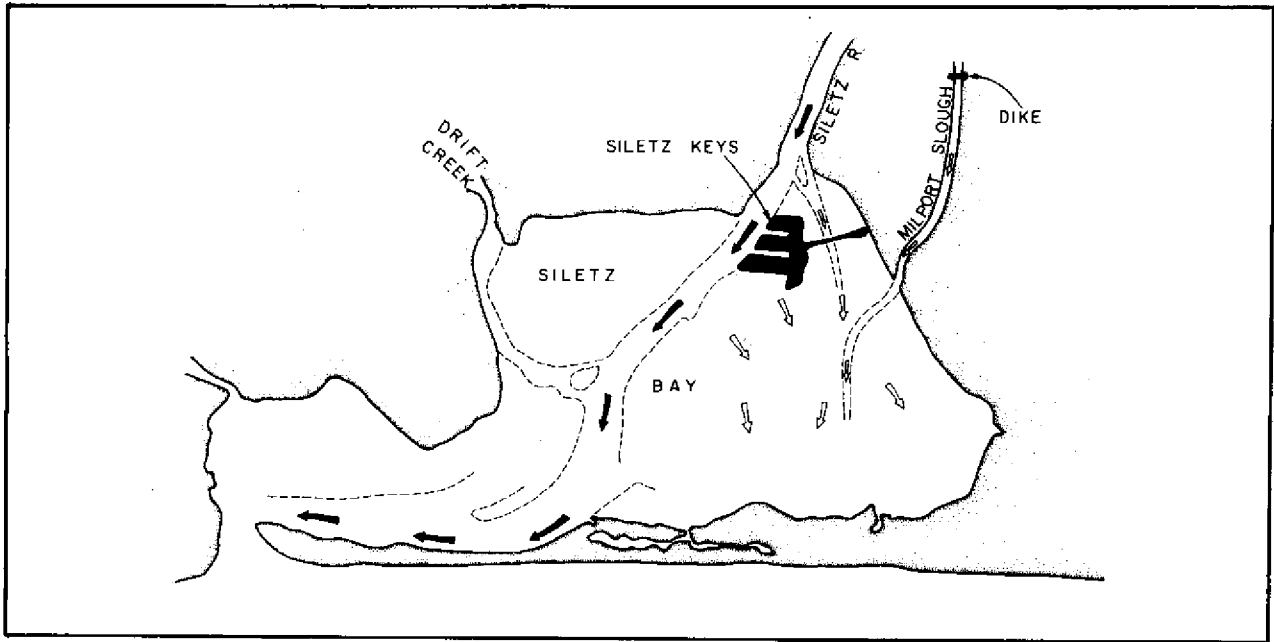
Fig. 12. Siletz River flow through the estuary. The open arrows show how flood waters formerly spilled into the south bay, prior to the diking of the Milport Slough and to the placement of the Siletz Keys fill. Not shown is the fill for the new highway bridge which also prevents spill in the Siletz Keys area. Now all of the flood waters flow down the main channel as shown by the black arrows, directed at the back of the spit.

Erosion has also been occurring on the bay side of the spit where the flow of the Siletz River through the bay impinges on the spit near its north end (Fig. 12). The progress of this erosion was studied with aerial photographs and old surveys dating back to 1875, the original survey of this area. Fortunately, one of the section lines passed directly across the eroded area (Fig. 13). This provided measurements of the distances A, B, C and D in Fig. 13. These same distances were measured on the series of aerial photographs dating back to 1939. The results are shown in the graph of Fig. 13.

Recent landfills in Siletz Bay have probably aggravated the erosion problem. These are shown in Figs. 12 and 15. Both the Siletz Keys fill and the dike on the Millport Slough prevent flood discharge spill into the south bay. Prior to these fills, flood waters would flow in part into the south bay and dissipate the energy of the flood waters. Now that this spill is prevented by the fills, the full flood discharge of the Siletz River is directed toward the back of the spit, into the area that is eroding. The expected increase in erosion has been reduced by the installation of riprap, but it is question-

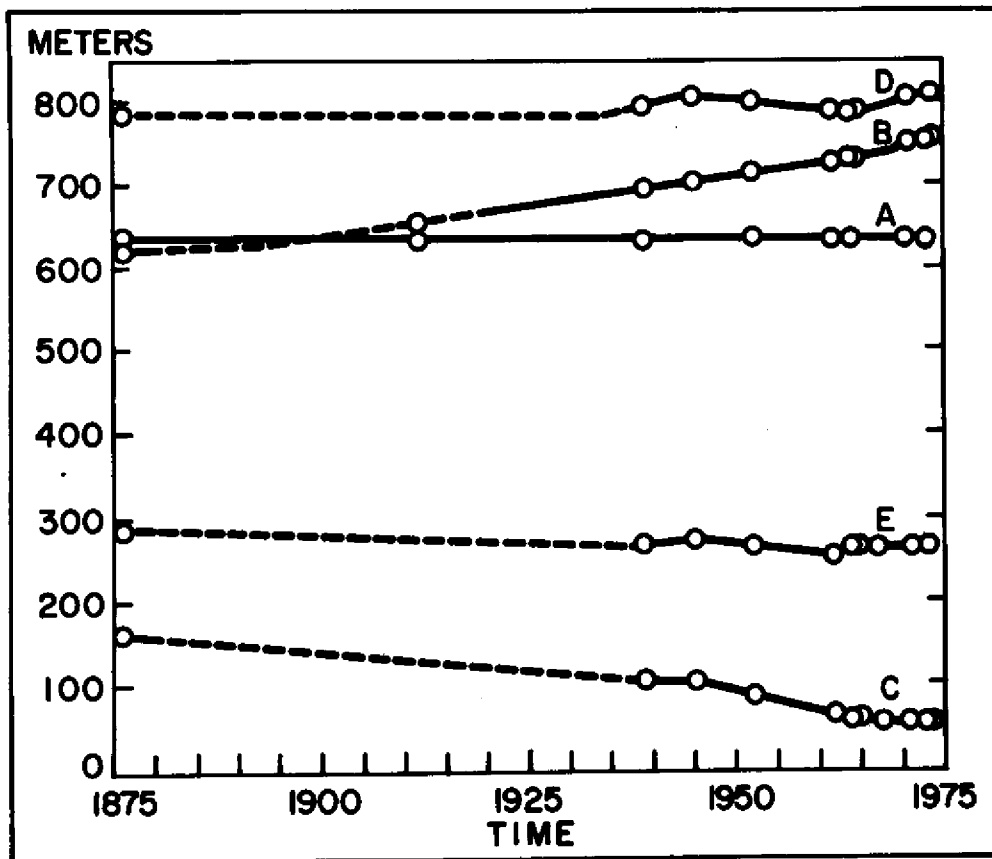
Fig. 13. Data from old surveys and aerial photographs, showing the progressive decrease in the spit width C due to erosion on the bay side.

In 1875 the width of the spit, C, was

163 meters (535 feet). By 1939 it had decreased to 102 meters (335 feet). Presently it is only 52 meters (171 feet) wide. The progressive increase in the distance B across Siletz Bay shows that the 111 meters (364 feet) decrease in the spit width was due entirely to erosion on the bay side. The edge of the foredunes (taken as the seaward limit of the spit width) fluctuated somewhat in position due to the cycles of erosion and dune reformation discussed above, but did not change its overall position in those 100 years. This is reflected in the wavy nature of the distance D in Fig. 13. The erosion on the bay side appears to have been fairly steady until recently when riprap was installed to stop the erosion (Fig. 14).

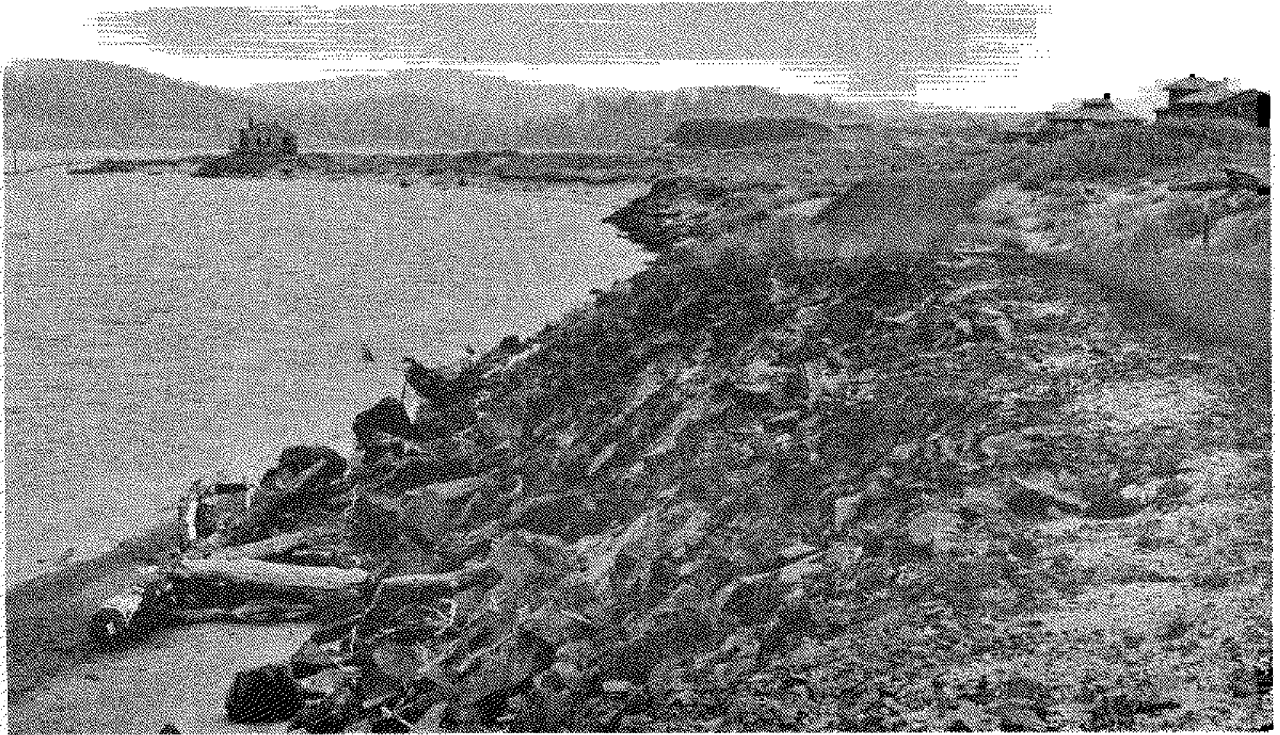
Fig. 14. Riprap placed on the bay side of the spit to prevent or decrease erosion.

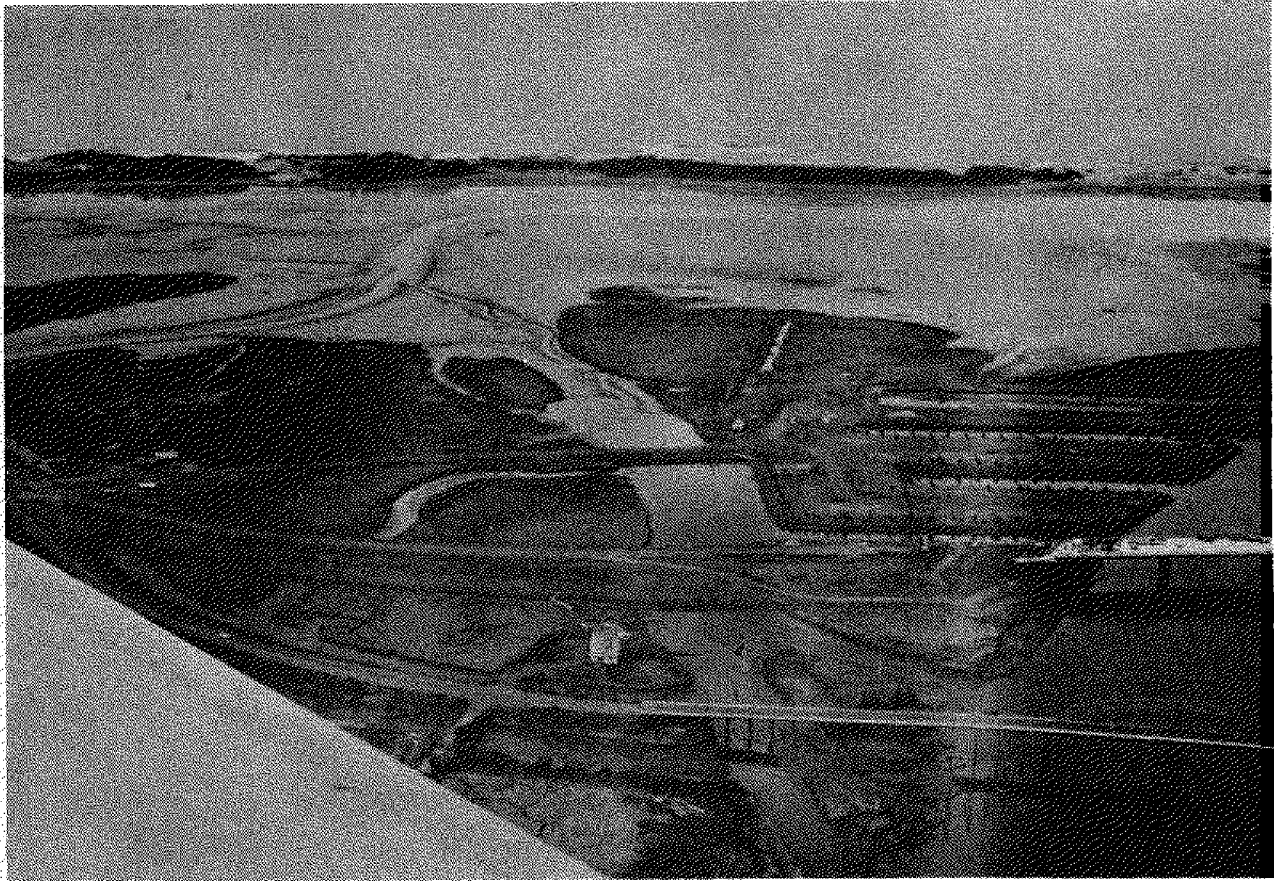
Fig. 15. Aerial view of the Siletz Keys fill and the approaches to the old and new highway bridge. Note how the access road to the Siletz Keys and the approach to the new bridge both block the channel leading to the south bay.

Removal of the dike on the Millport Slough would eliminate in part this aggravation and would improve water circulation in the south part of the bay. Removal of the dike-entrance to Siletz Keys is no longer sufficient as the recent construction of a new bridge for Highway 101 over the Siletz River has also blocked that spill channel (Fig. 15). A conduit under the approach to the bridge would also be necessary.
