**SHORELINE  
CHANGES**  
due to jetty  
construction  
on the  
**OREGON COAST**

**J. R. Lizarraga-Arciniega**  
and  
**Paul D. Komar**

**OREGON STATE UNIVERSITY**  
**SEA GRANT COLLEGE PROGRAM**  
Publication no. ORESU-T-75-004

**SEPTEMBER 1975**

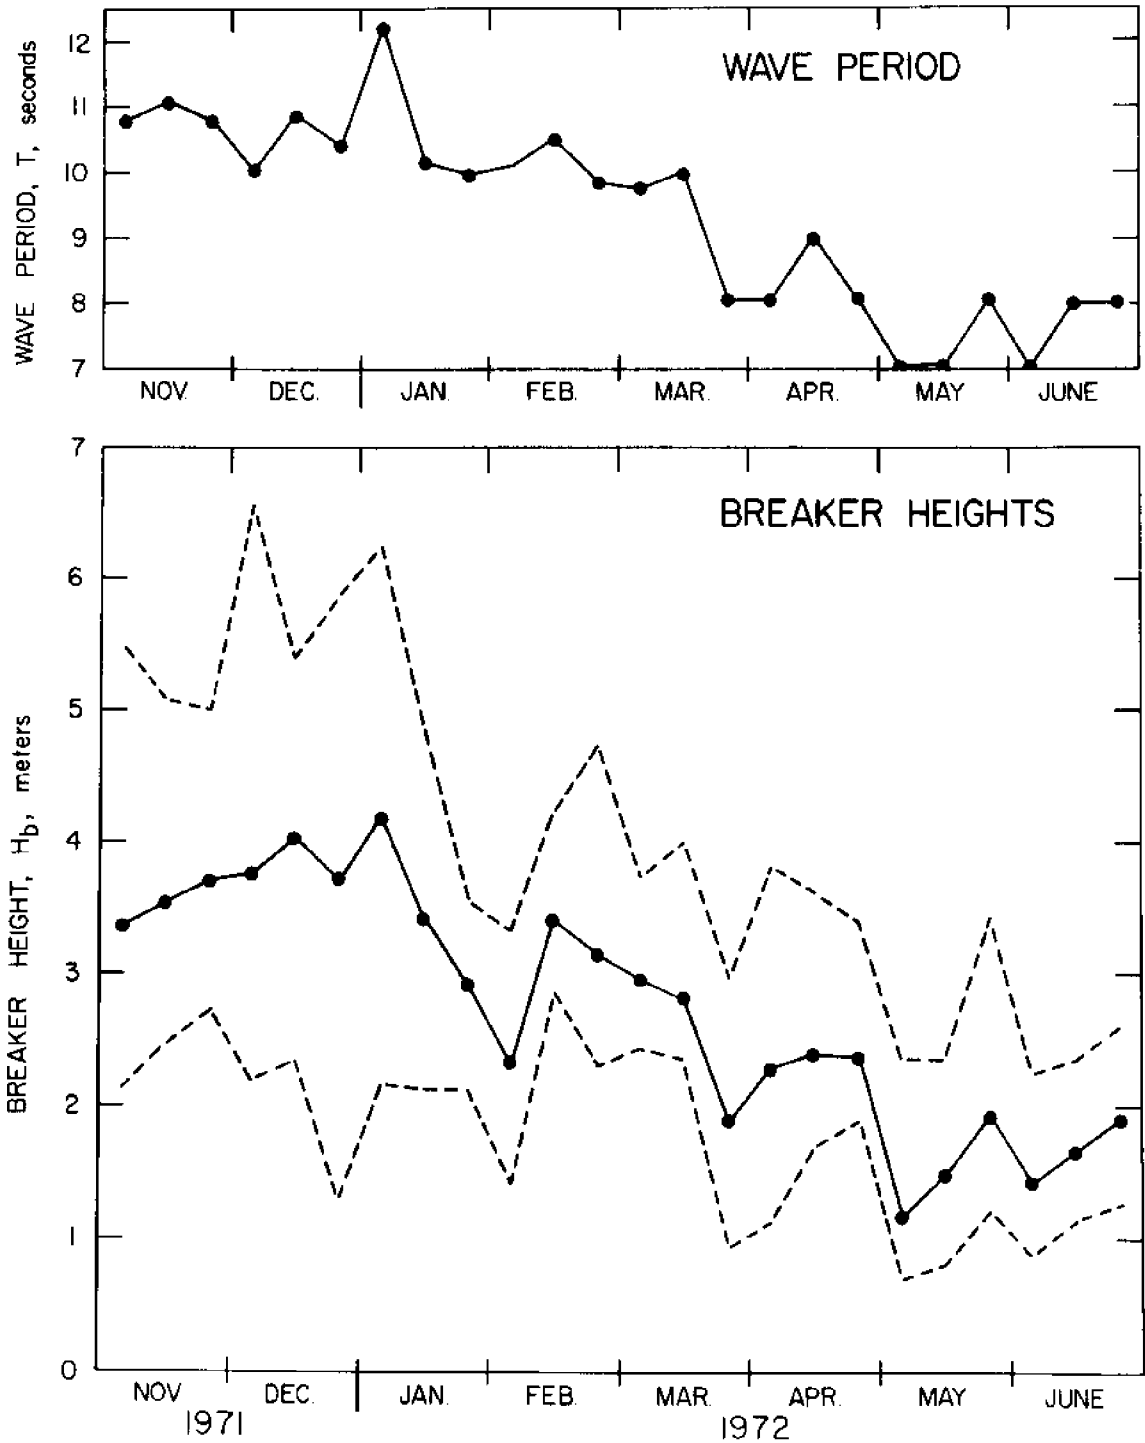
Figure 5A. Wave data from the seismic system at Newport, Oregon for November 1971 through June 1972. Each average  $H_b$  and wave period datum point represents a ten day average. Also shown are the maximum and minimum breaker heights that occurred within that ten day period.

where  $H_b$  is the breaker height,  $T$  the wave period, and  $H_{10}$  the deep water wave height provided by the seismic system. The four measurements for each day were averaged so that the analysis provided an average significant wave breaker height for each day. Such an analysis was performed for data obtained during the period November 1971 through January 1975. Figure 5 shows ten day averages, that is, averages for each one-third month, for this time span. It is seen that larger breaker heights prevail during the winter months, reaching a maximum of about 4.5 meters in this period. During the summer months of June through September the breaker heights average only a little over one meter. Also shown is a plot of the maximum average daily breaker height that occurred within the ten day averaging period. On several occasions during the winter months, daily average significant breaker heights were 6 to 7 meters.

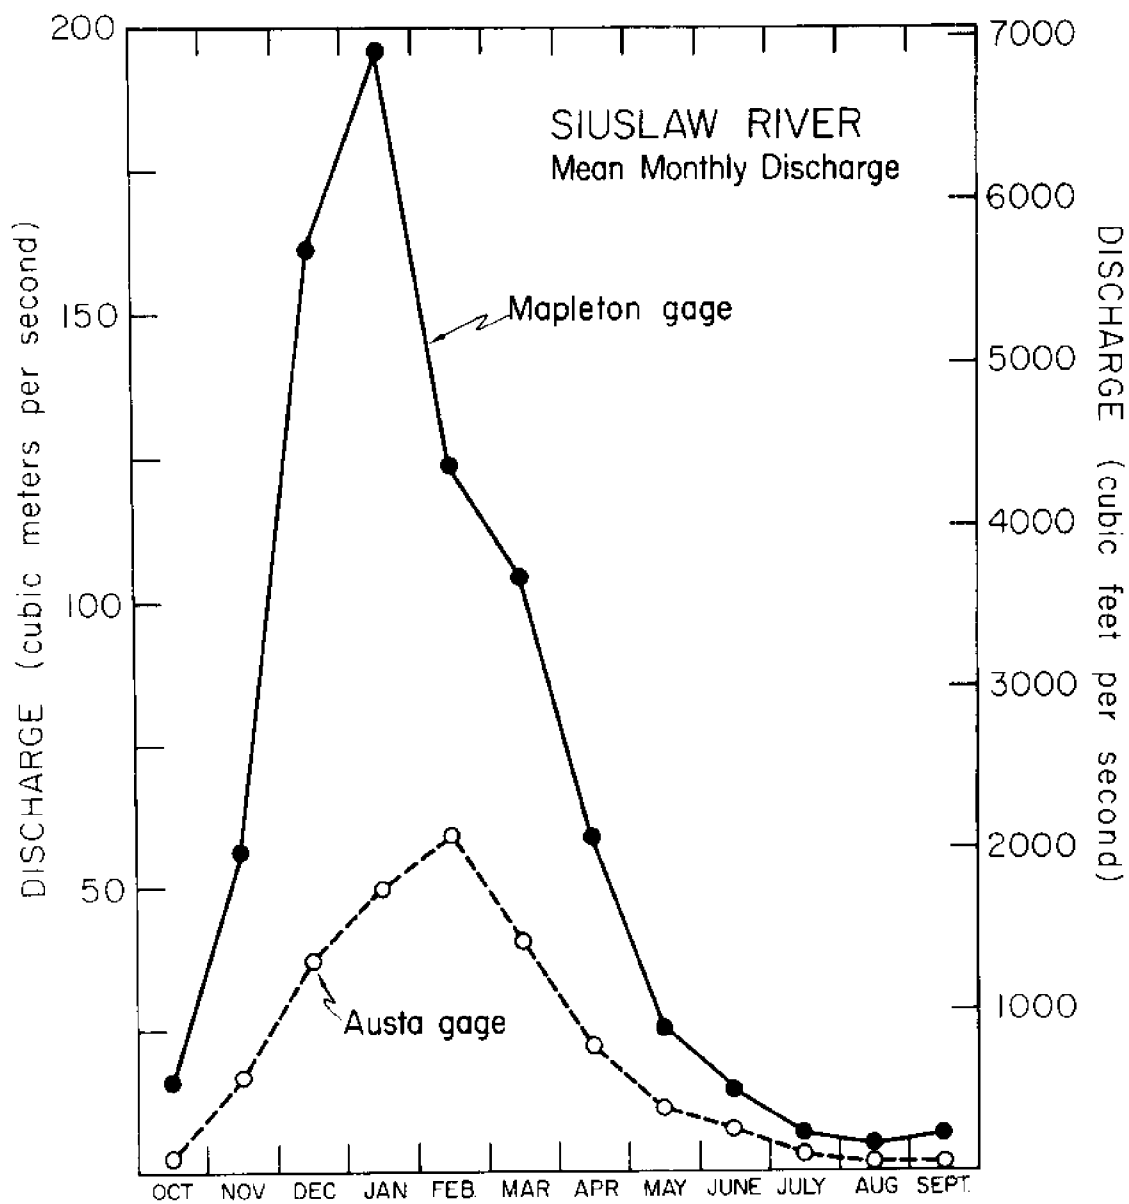
Figure 6. Mean monthly discharges of the Siuslaw River at two stations, the Mapleton gage near the estuary, and the Austa gage in the headwater. Data from USGS Water Supply Papers.

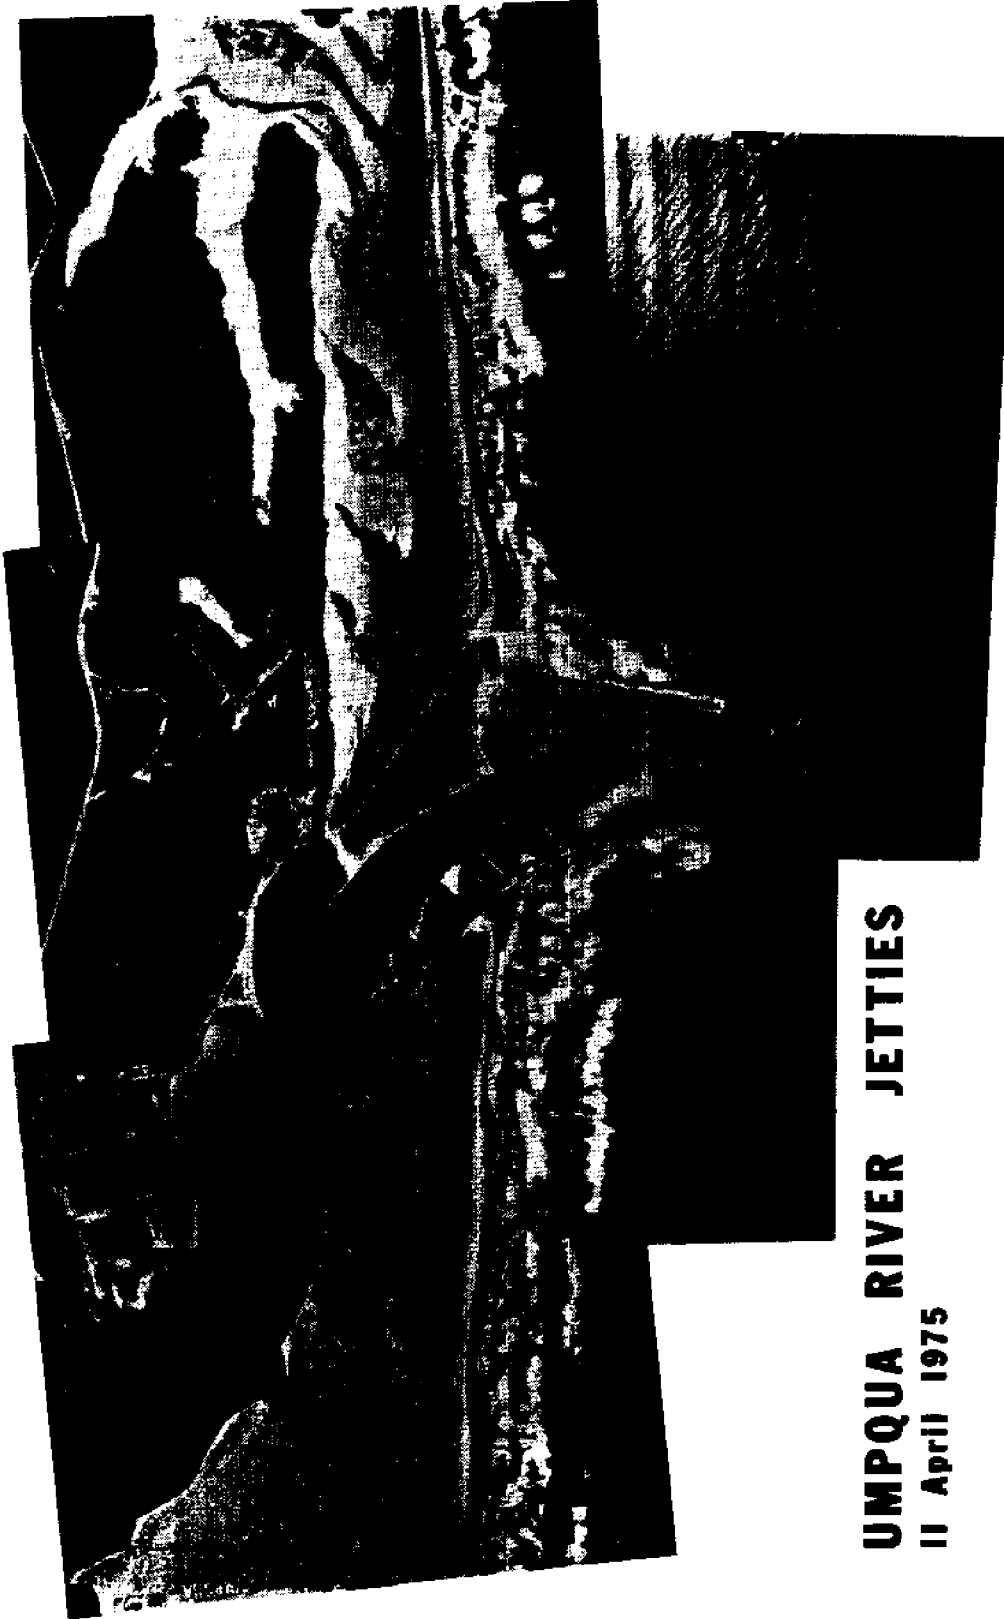
Figure 19. Aerial photographs of the jetties on the Umpqua River.

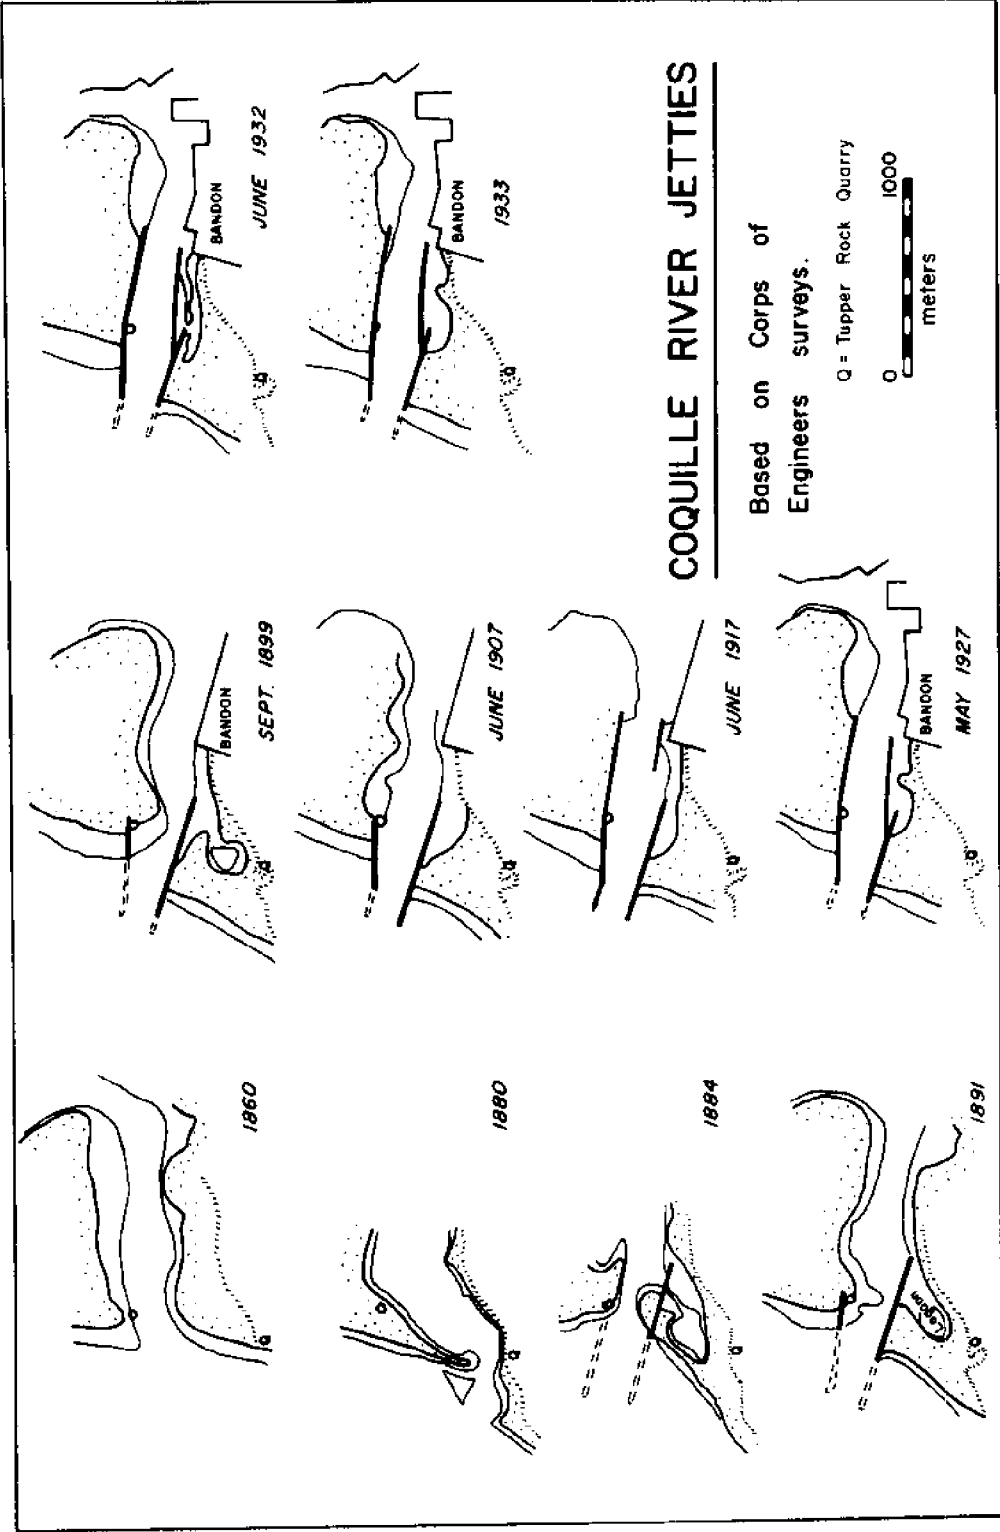
Figure 23. Compilation of shoreline surveys showing the effects of jetty construction on the Coquille River. The high tide shoreline is given as a dark line and the low tide as a thinner line.

Figure 23 summarizes the history of shoreline changes at the mouth of the Coquille River. Prior to jetty construction the river mouth shifted position considerably. The eroded bluff to the south indicates its southernmost migration, the survey of Figure 24 in 1874 showing this situation. The principal shoreline advance seaward following jetty construction occurred to the south of the jetties. It is seen that a lagoon was trapped in the process. This greater shoreline advance south of the jetties resulted from a larger embayment having been formed on that side due to the jetty construction. In contrast, north of the jetties only a small pocket beach was formed so that only minor shoreline advance was required to straighten the shoreline. It is interesting that the shorelines north and south of the jetties have the same orientation, necessary if they are to be in equilibrium with the existing wave climate such that there is a zero net sand transport. However, the shoreline south of the jetties extends further seaward than that to the north indicating an independence between the two. In this regard the jetties and river flow are acting as a barrier between two pocket beaches. The pocket beach to the south is much smaller than that to the north. If sand were removed from the south pocket or

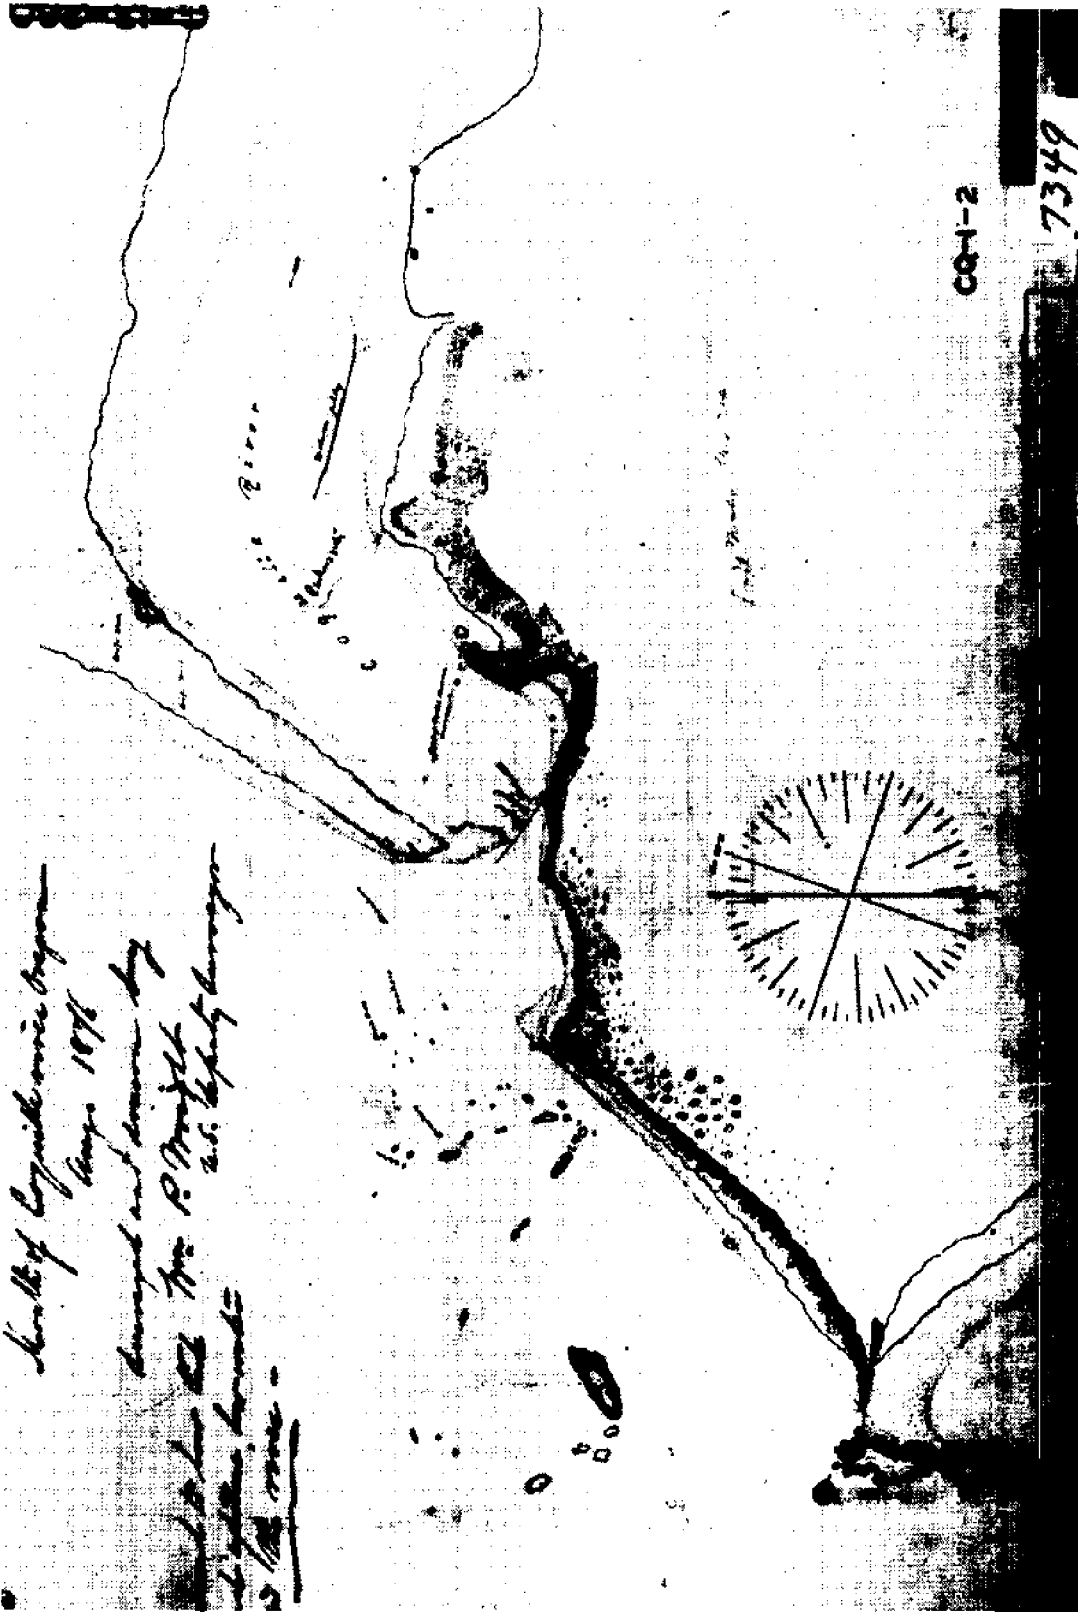
Figure 24. An 1874 survey of the mouth of the Coquille River, showing rocky formations as its south bank.

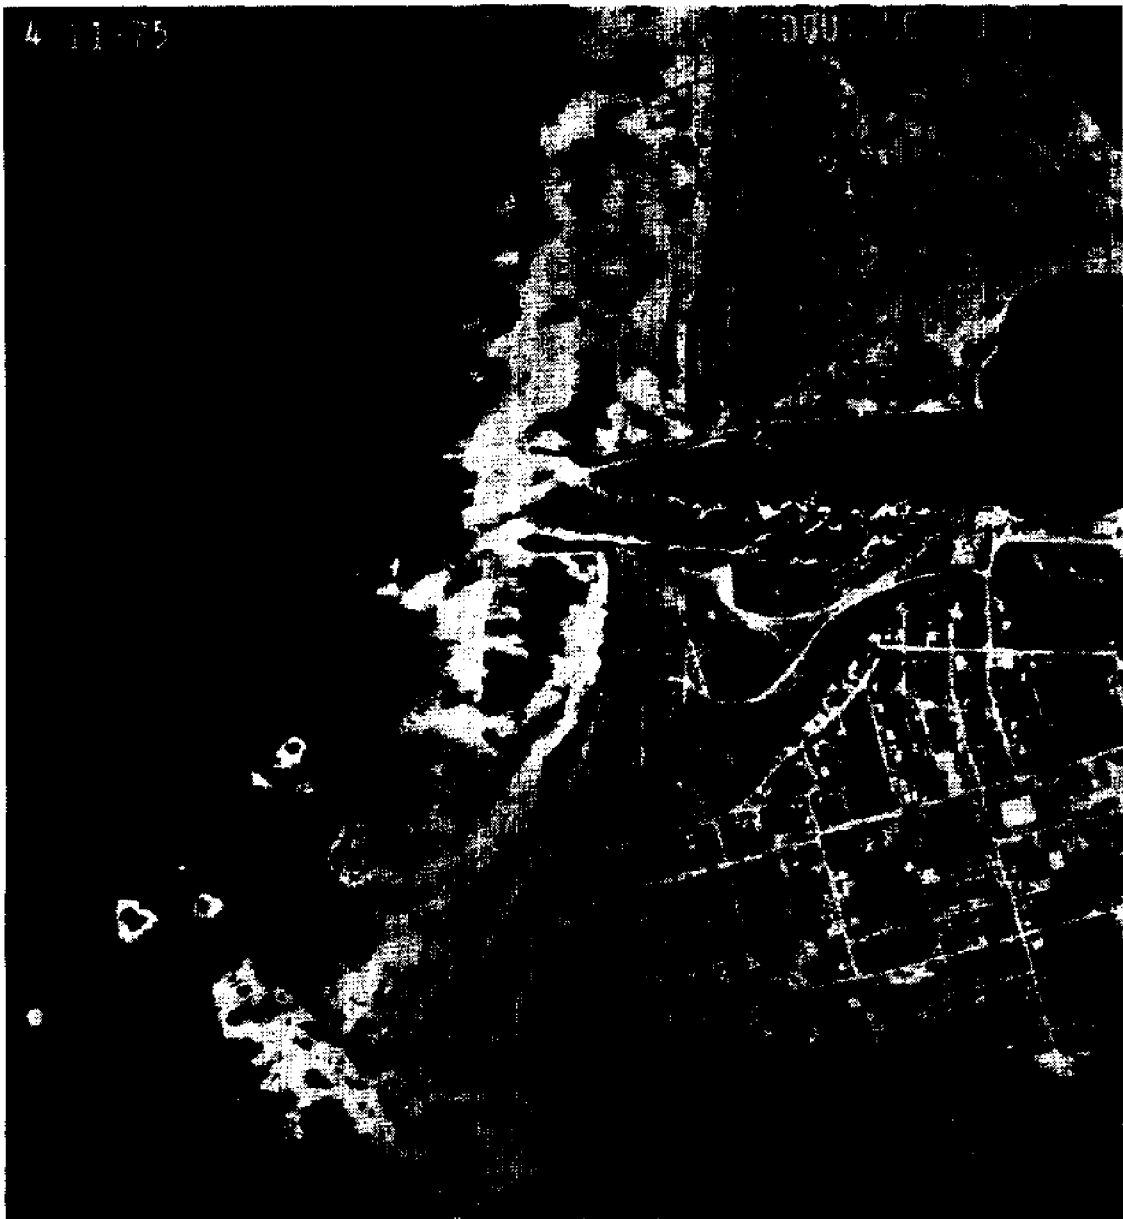
Figure 25. Aerial photographs of the Coquill River jetties, 11 April 1975.

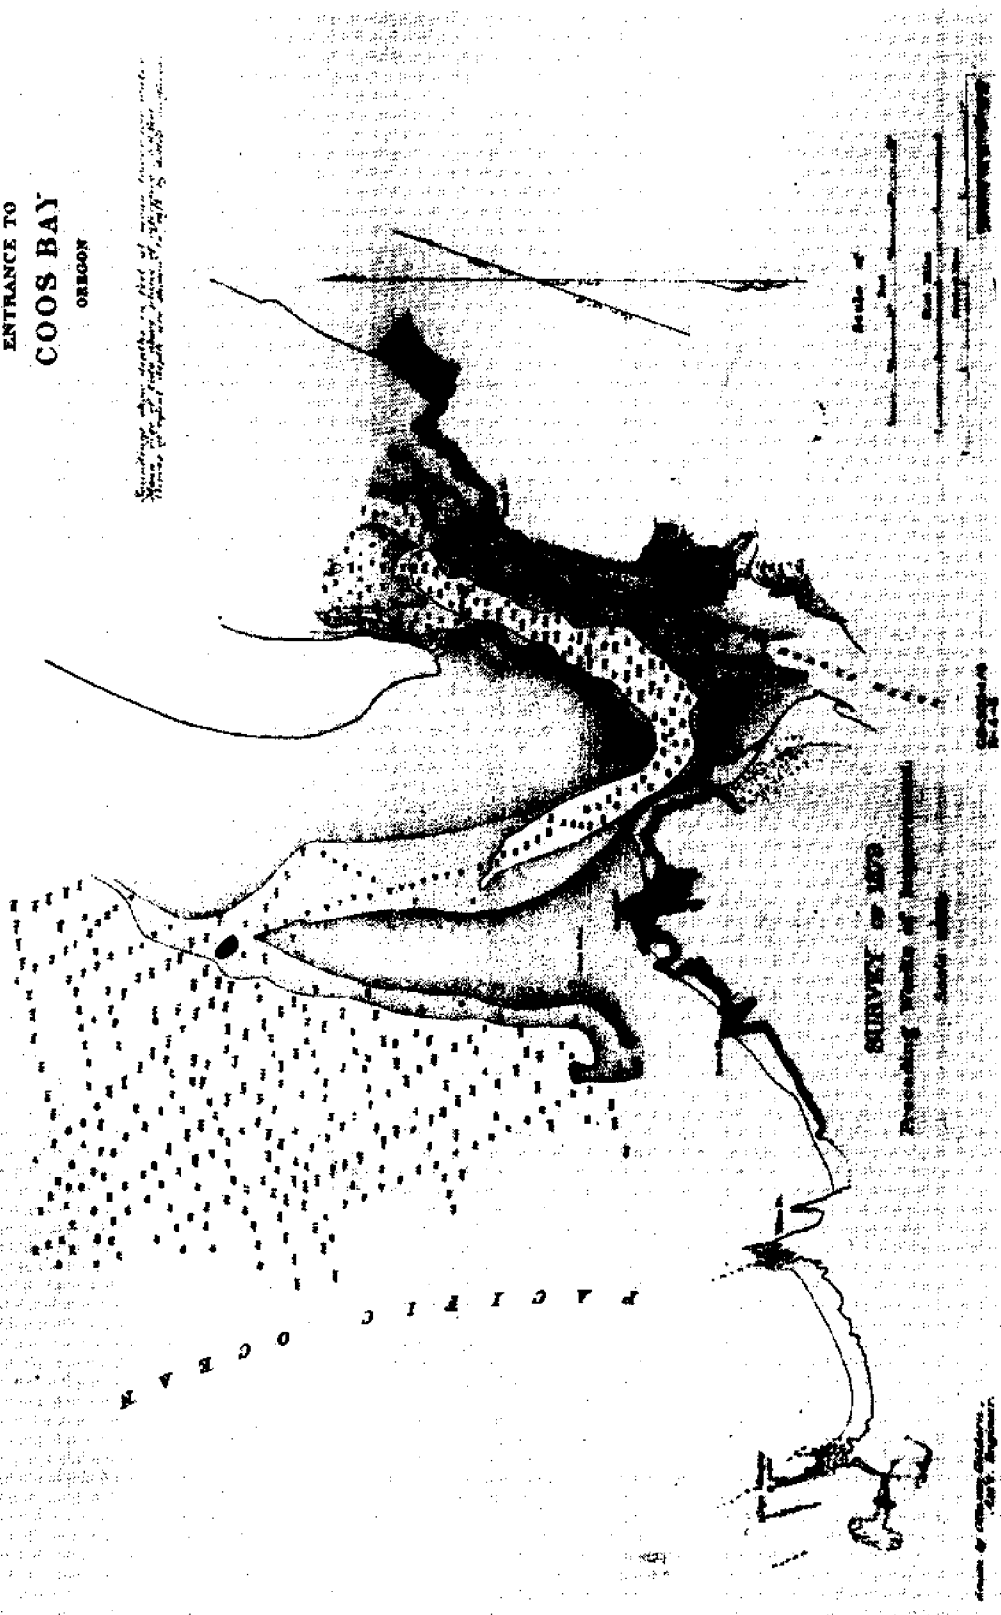
Figure 26. An 1879 survey of the entrance to Coos Bay, showing the configuration prior to jetty construction (Portland District, U. S. Army Corps of Engineers).

Prior to jetty construction, the entrance to Coos Bay had a rocky stretch of coast as its south bank, Figure 26. A long stretch of sand beach exists to the north. Figure 27 shows the shoreline changes produced by the north jetty construction. The shoreline advanced considerably from its pre-jetty position (1892). The post-jetty shoreline (1899) is seen to be very straight, again in equilibrium with the wave conditions to produce a zero net sand drift. Apparently degradation of the jetty made it partially porous to the sand movements as the 1916 shoreline indicates some erosion of sand from the beach, the sand being carried into the entrance forming a shoal. Figure 28 shows the shoreline changes resulting from the construction of a south jetty and a reconstruction of the north jetty. The south jetty formed a pocket beach with the rocks jutting seaward to the south. Sand was trapped in this pocket forming a beach, the shoreline slowly advancing seaward. As at the Coquille River jetties, the pocket to the south of the jetties and the long stretch of beach to the north have the same orientation with respect to the wave climate but have different seaward extents. It is concluded that the shoreline changes produced by jetty construction at the Coos Bay entrance were
