**SHORELINE SURVEY:  
GREAT PECONIC, LITTLE  
PECONIC, GARDINERS,  
AND NAPEAGUE BAYS**

A SHORELINE SURVEY:  
GREAT PECONIC, LITTLE PECONIC,  
GARDINERS AND NAPEAGUE BAYS

May 1977

Special Report 5

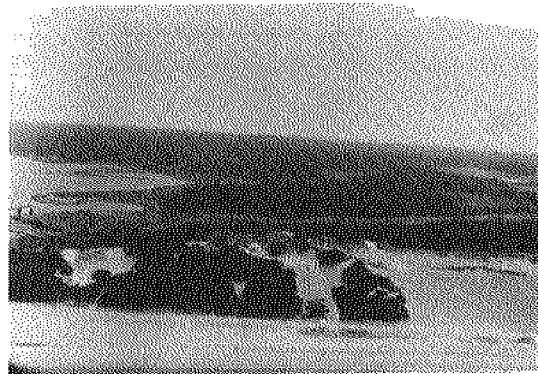
In addition to slumping and slides caused by clay movements, slides can also occur due to wave action at the base of the bluff, and seepage of water at the bluff face may cause sections of the bluff face to slide. A less dramatic motion, creep, is the slow movement of soil down a slope. In a number of places within the study area, vegetation and its supporting soil can be seen "creeping" down the bluff (Fig. 3-2).

Fig. 3-2. Vegetation "Creeping" Down Bluff Face.

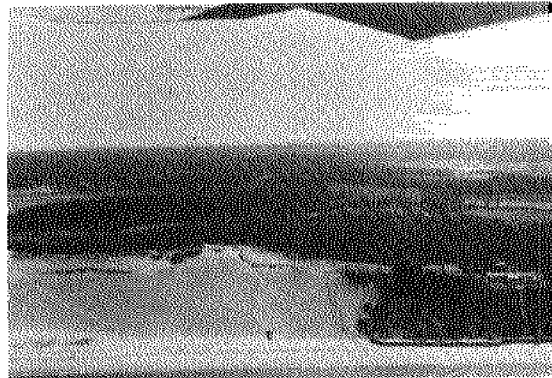
On the east side of the entrance to North Sea Harbor, there is a dune approximately 33.5 m (110 ft) high. Almost all the slope vegetation has crept down off the dune under the influence of gravity accompanied by mechanical weathering. On the dune face there also are many tracks created by people taking a short cut to the shorefront (Fig. 3-4).

Fig. 3-4. People Induced Erosion: Walking on Bluff Face Creates First Inroads to Vegetation Loss.

People erosion represents a substantial portion of dune and bluff erosion, because this erosion often starts the first inroads to vegetation loss on the slope

1. Construction of dwellings on eroding bluffs should not be permitted within 100 ft of the bluff face.
2. Those areas within the flood plain of a 100-year storm should be designated flood hazard zones. Only structures which are either shore dependent, or shore enhanced, should be permitted there. These structures should be flood-proofed, if possible.
