Technical Report Series
Number 77-3

**SAND STABILIZATION ON THE
DUNES, BEACH AND SHOREFACE OF A
HISTORICALLY ERODING BARRIER ISLAND**

**Wassaw Island Erosion Study
Part III**

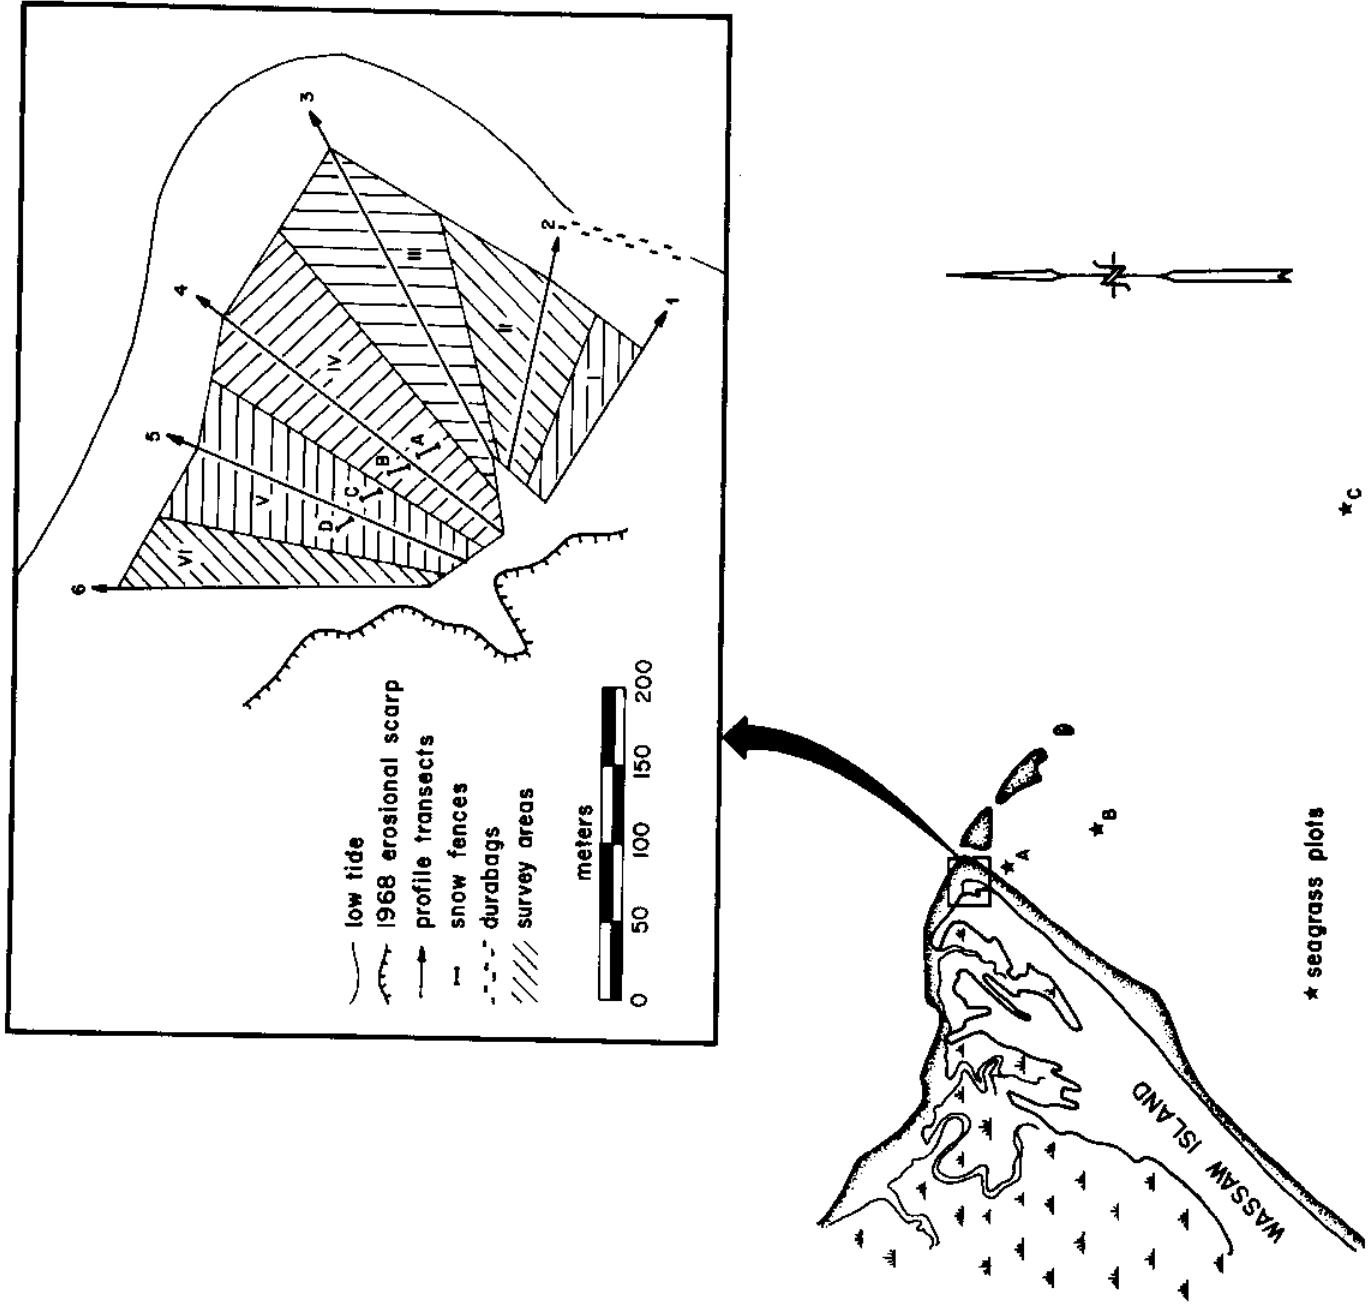
FIGURE 1 - Location map of study area, showing positions of profiles, snow fences, durabags, seagrass plots and survey areas.

On 12 December 1973, snow fences were installed on the north end of Wassaw Island (Figure 1). Four 50 foot long sections of snow fencing were established normal to the direction of dominant winds (Fig. 1). A simple design scheme was used to make comparisons with the more elaborated designs used and suggested by Savage (1963), Savage and Woodhouse (1968), Jagschitz and Wakefield (1971). The four sections of 4-foot high fence were surveyed in with respect to established markers in the stable dunes. Around each snow fence, twelve survey stakes were imbedded into the sand surface. Biweekly measurements were made of each set of stakes to determine the exchange in the thickness of the sediment carpet in the adjacent 168 square meters.

The sediment budget of the beach was approximated from biweekly profile surveys that were initiated in November 1973 (Appendix B). Six profile transects were mapped at the north end of Wassaw Island (Fig. 1), using a modified staff and horizon technique (Appendix C). The data points along each profile were 2 m apart and the vertical measurements were surveyed to ± 1 cm. After 8 months of profiling, a checkerboard pattern of sand bags was placed at the toe of the fore-shore between profiles 1 and 2 (Fig. 1). The sand bags formed a semi-pervious dike that was intended to serve several functions toward preventing beach erosion. The structure was intended to dissipate wave energy and to function as a subaqueous dike that would hold sand on the beach. The structure was also to help maintain the integrity of a shore-parallel tidal channel which supplies sediment to the north end of Wassaw Island (Oertel, in press). Beach profile surveys continued for approximately 1 year beyond the initial placement of the pervious dike.

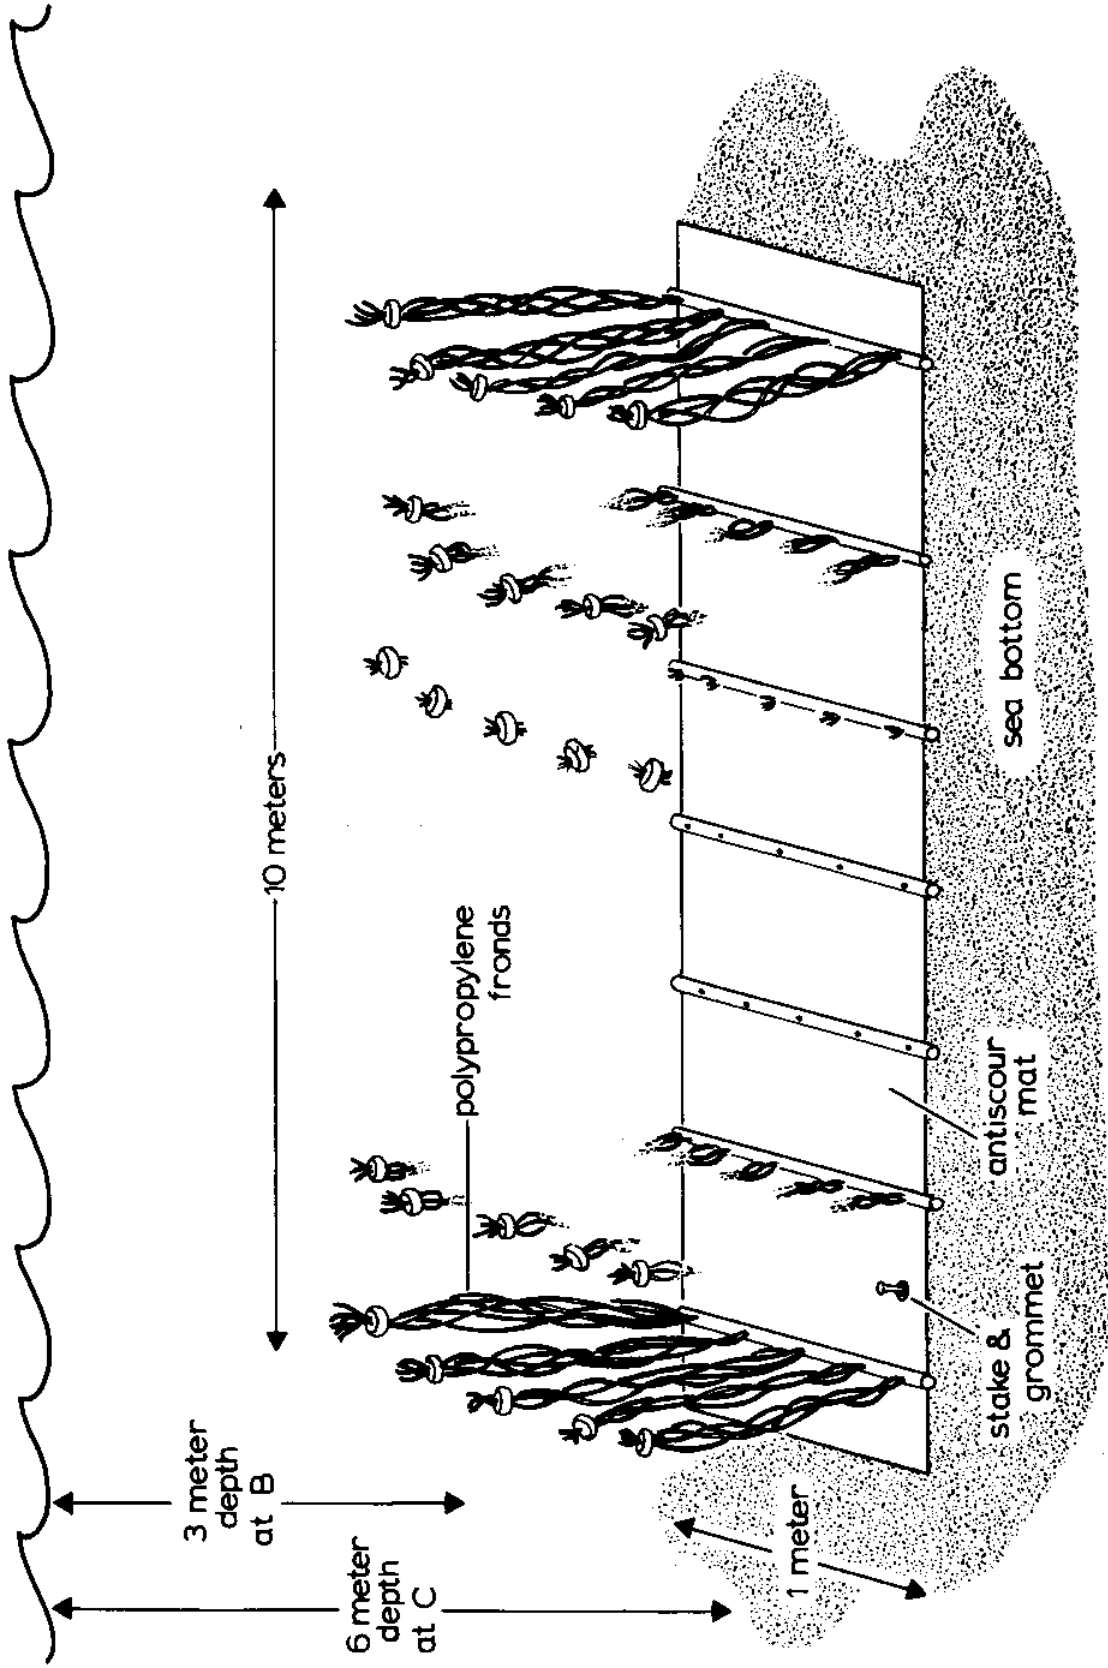
FIGURE 2 - Sketch plan of seagrass plots.

Patches of seagrass are believed to sufficiently disrupt the flow of sediment laden currents to cause deposition of sediment. Seagrass decreases current energy due to bending of fronds, increased bottom drag, internal deformation and refraction (Wayne, 1974). Four plots of artificial seagrass were tested adjacent to the north end of Wassaw Island to test their potential as sediment traps. Plots were placed in the intertidal zone .25 miles (.46 km) offshore at -1 m depth, 1 mile (1.85 km) offshore at -3 m depth and 3 miles (5.56 km) offshore at -6 m depth. Seagrass plots were 1 x 10 m and fronds were 1.1 meter long and supported by 4 inch diameter styrofoam floats. The frond density was 18 to 24 fronds per square meter. Seagrass plots were fastened to anti-scour blankets (Sea Mats) and secured to the seafloor by pins and weights

(Fig. 2). The effectiveness of plots was evaluated by SCUBA observations.

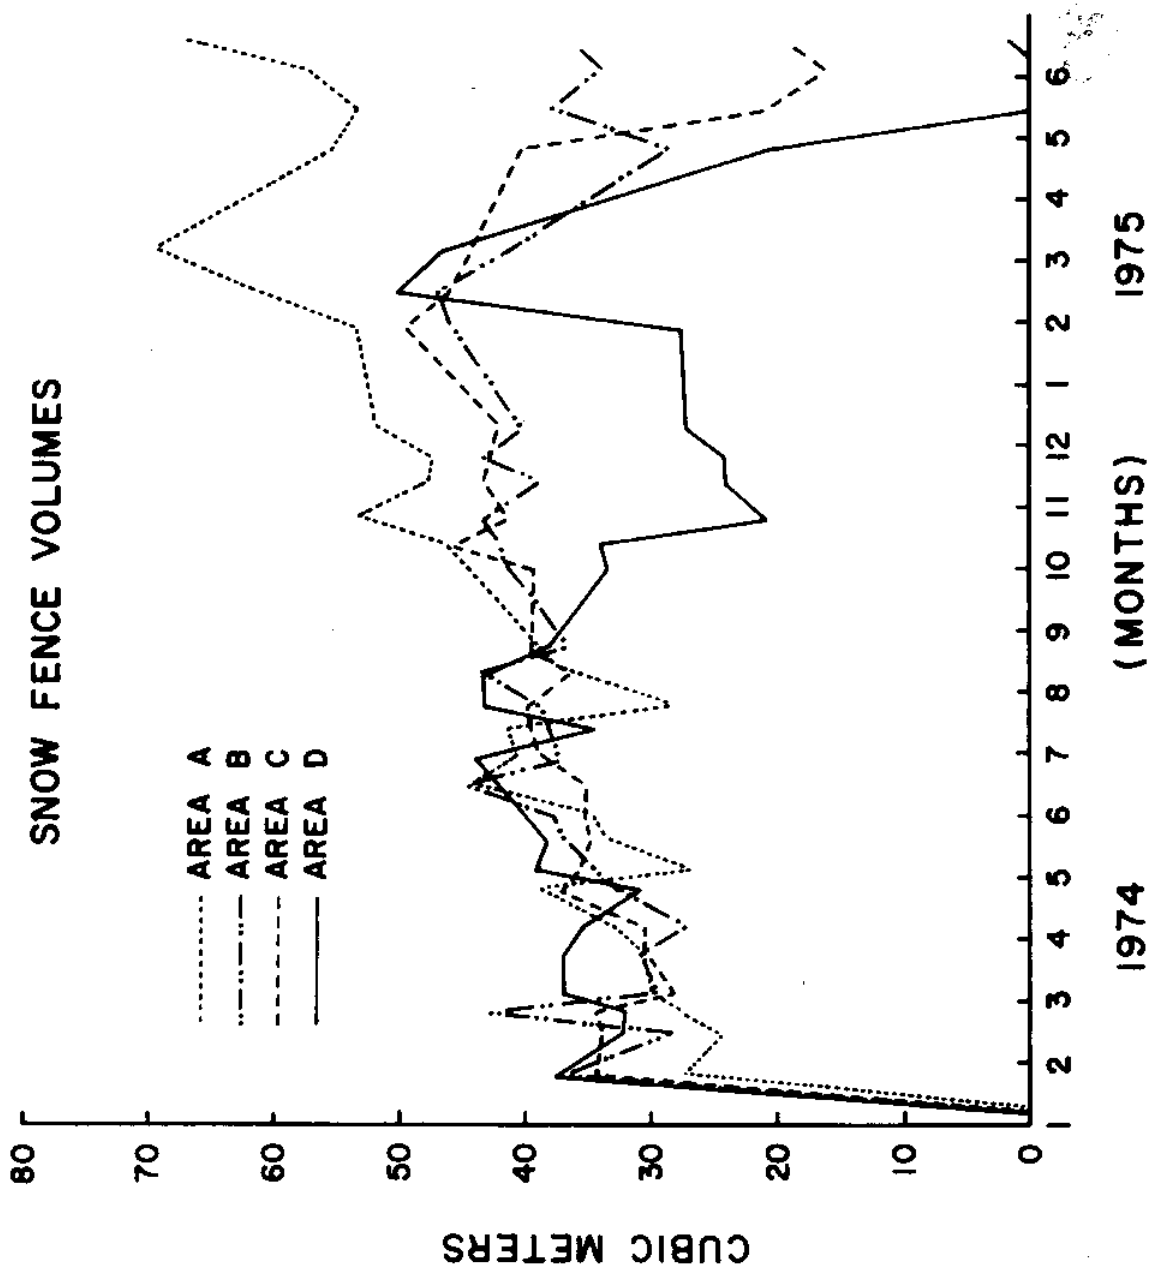
FIGURE 3 - Graph of volumes of sand trap on the vicinity of snow fence A,B,C,D.

The largest quantities of wind-blown sand were trapped during the first month following snow-fence installation. At the survey area of fence A, approximately 27 cubic meters of sand were trapped during the first month and after 1.5 years of a total of 69 cubic meters of sand was trapped (Fig. 3). Snow fences B, C and D were along the inlet shoreline, and were stepped back from the ocean shore. Initially during the first month, profiles B, C and D collected 36, 35 and 37 cubic meters of sand, respectively. In the pursuing year these volumes all increased to 50 cubic meters only to be followed by a deflationary period, which decreased volumes to 28, 39 and -1.0 cubic meters during the last six months of the 1.5 year.

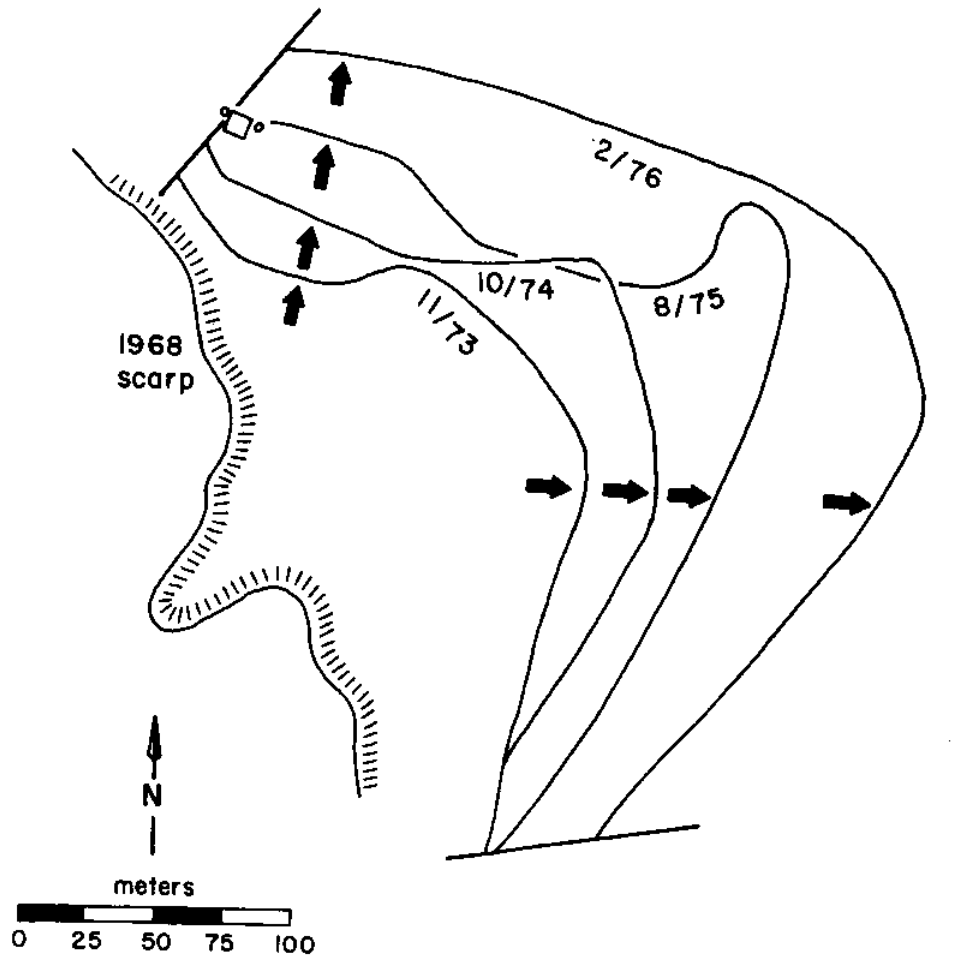
ONE YEAR DURATION
WITHOUT BAGS

(11/73 - 10/74)
+ 1.56 Acres

ONE YEAR DURATION
WITH BAGS, PLUS 3
MONTHS WITH BAGS
REMOVED*

(10/74 - 2/76)
+ 6.56 Acres

NET CHANGE

(11/73 - 2/76)
+ 8.12 Acres

*BAGS WERE REMOVED IN LATE
SEPTEMBER 1975

FIGURE 4 - Map of the northeast part of Wassaw Island (Fig. 1) showing 1968 scarp, and the positions of the 1973, 1974, 1975, and 1976 shorelines.

beach accretion with the pervious dike in place, as before installation. In all, approximately 8.12 acres of new shore accreted from November 1973 to February 1976.

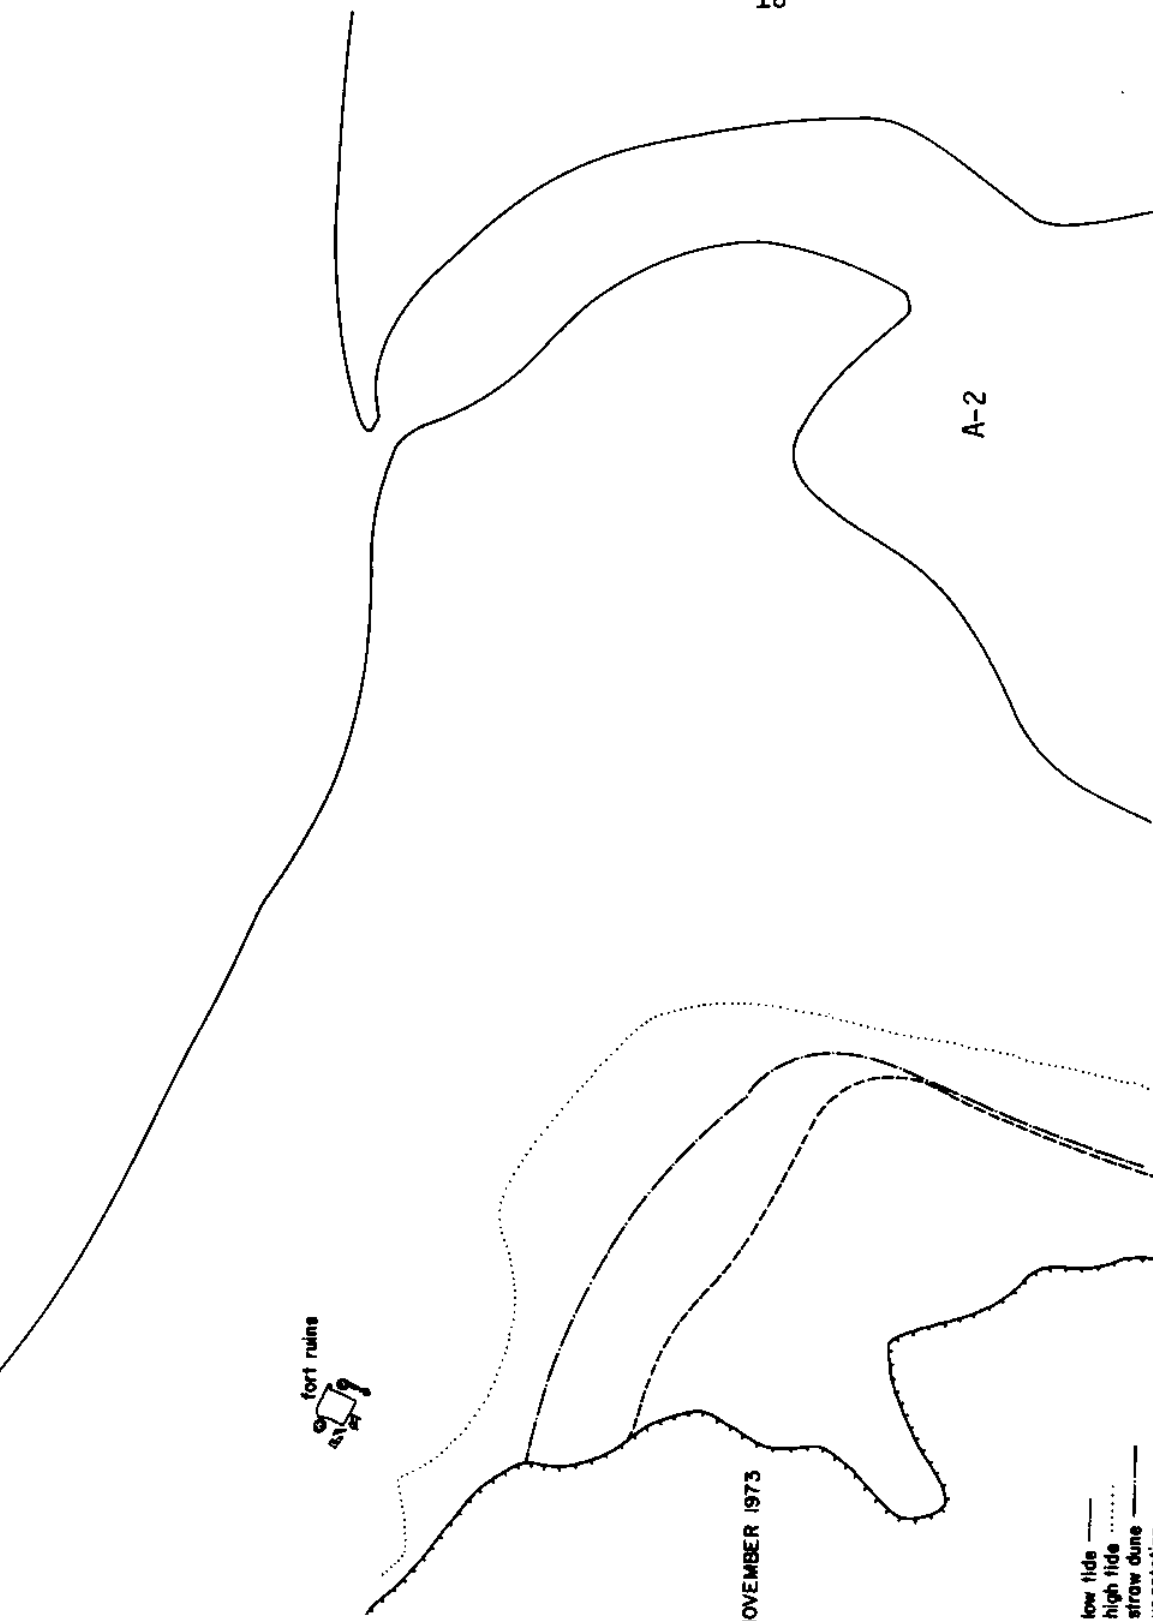
26 NOVEMBER 1973

- low tide ———
- high tide ·····
- straw dune - - - - -
- vegetation ———
- 1968 erosion scarp | | | | |
- snow fences ———

- A-1 9 August 1973 Survey
- A-2 26 November 1973 Survey
- A-3 13 February 1974 Survey
- A-4 19 April 1974 Survey
- A-5 12 July 1974 Survey
- A-6 10 October 1974 Survey
- A-7 13 December 1974 Survey
- A-8 6 March 1975 Survey
- A-9 29 May 1974 Survey
- A-10 21 August 1974 Survey
- A-11 11 February 1976 Survey
- A-12 10 June 1976 Survey

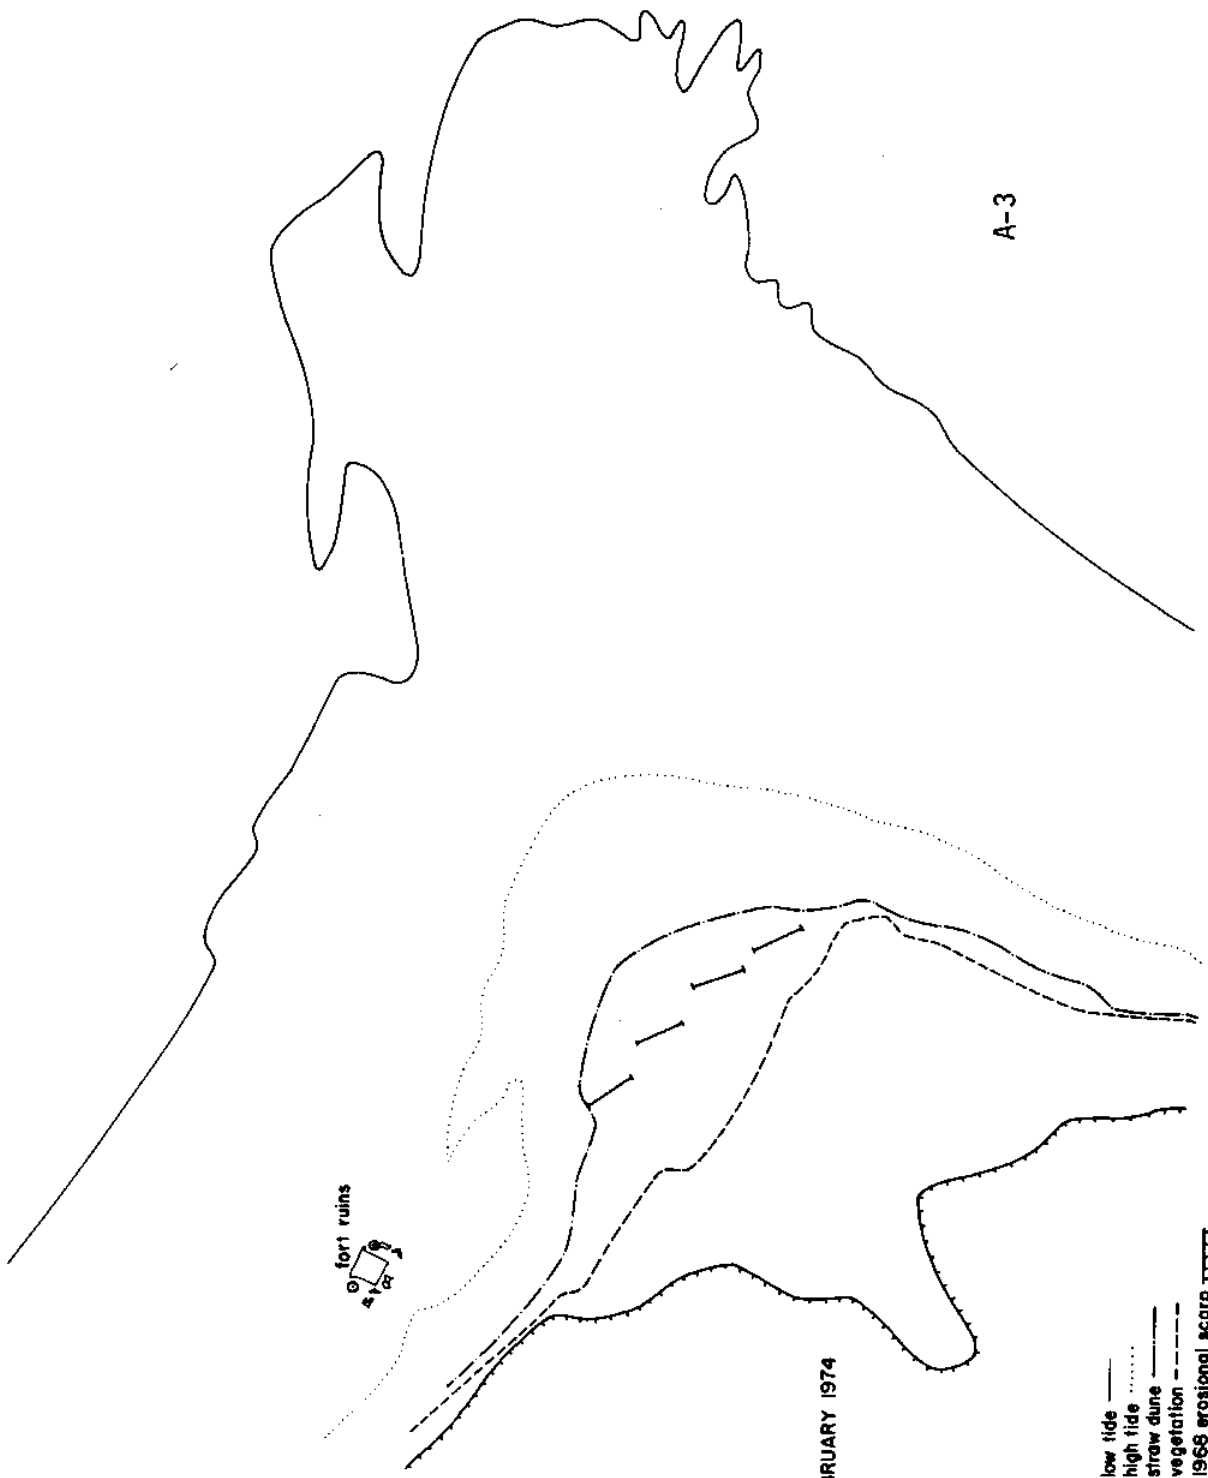
A-3

13 FEBRUARY 1974

- low tide ———
- high tide ·····
- straw dune ———
- vegetation - - - - -
- 1968 erosional scarp ~~~~~
- snow fences ———|

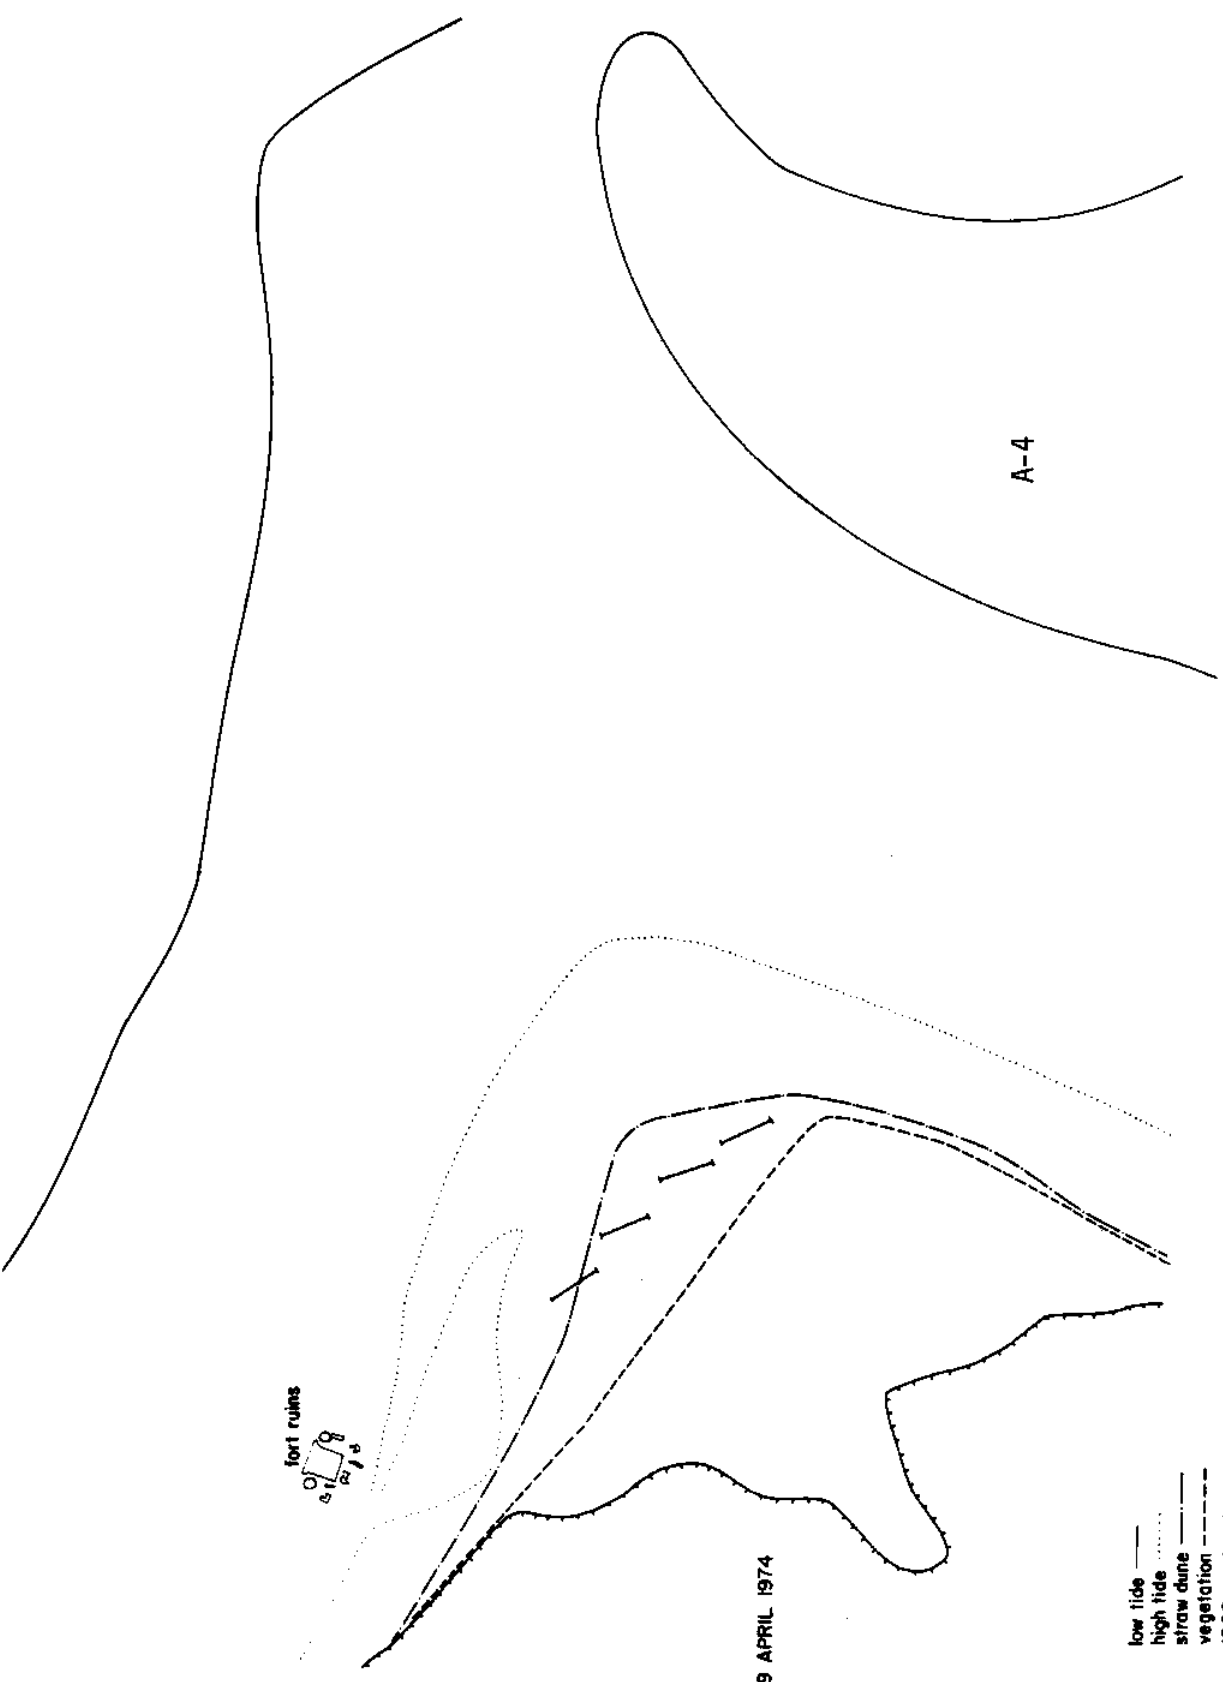
A-4

19 APRIL 1974

- low tide ———
- high tide ·····
- straw dune ———
- vegetation - - - -
- 1968 erosional scarp ~~~~~
- snow fences ———

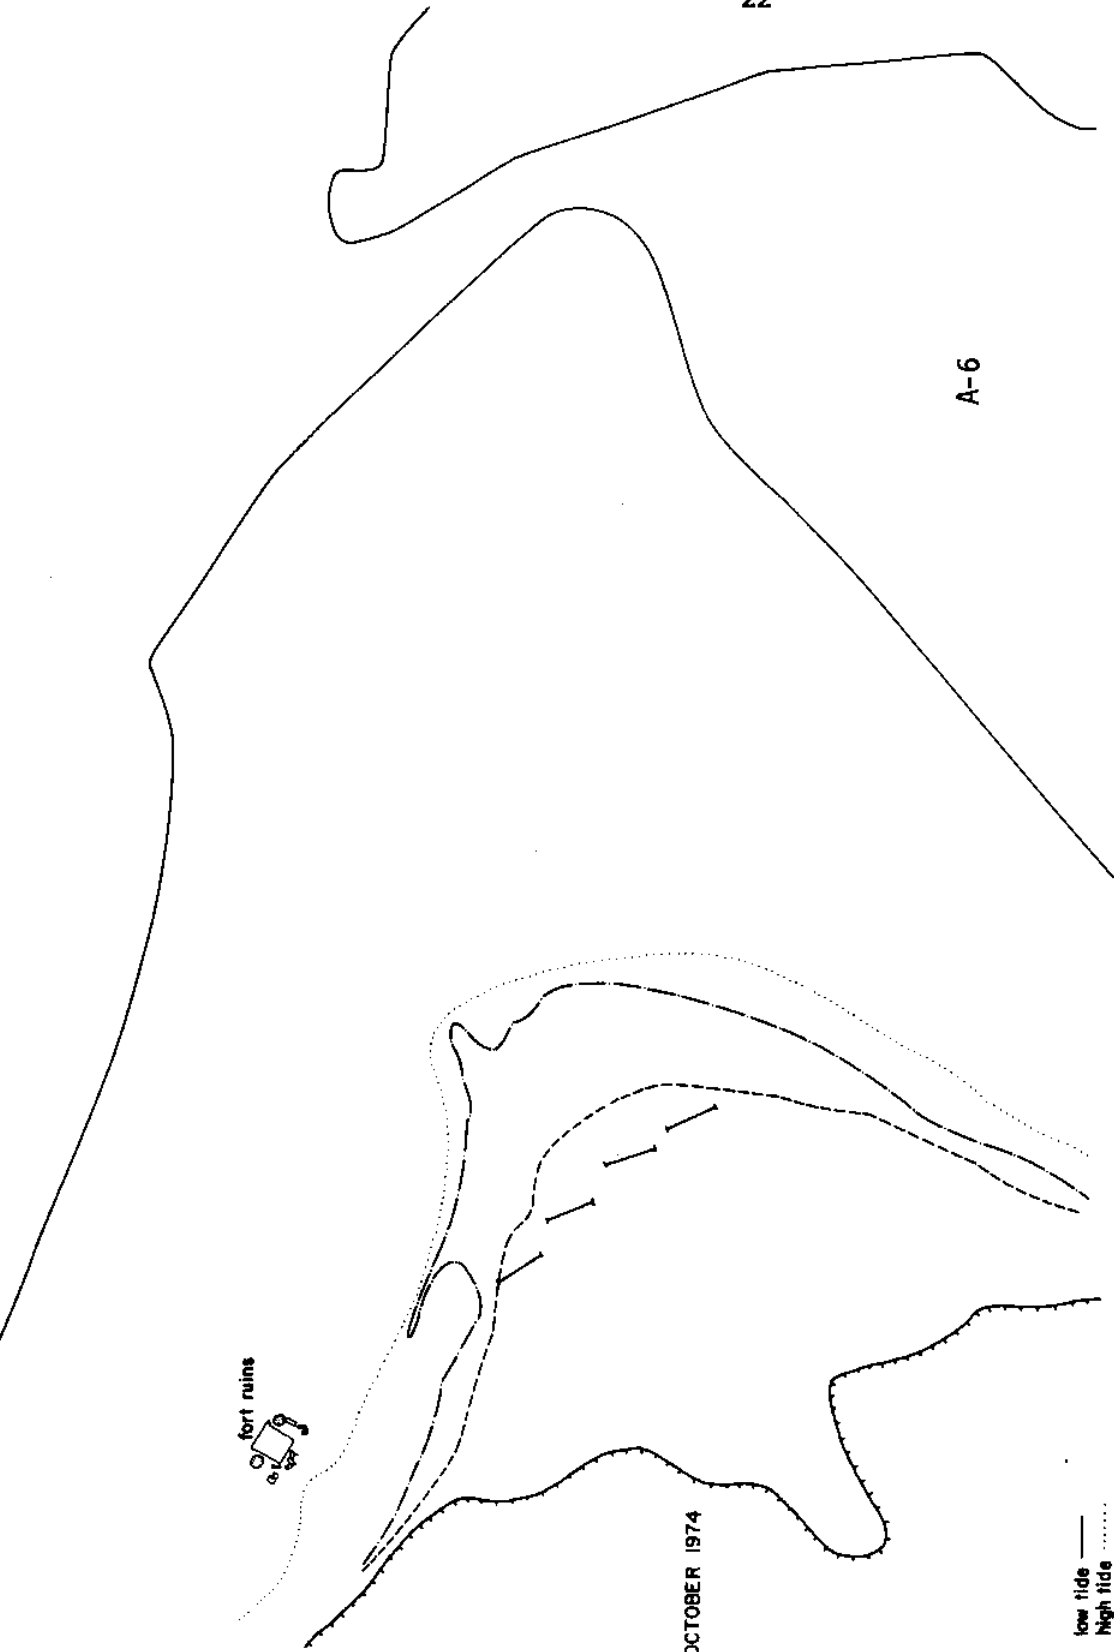
A-6

10 OCTOBER 1974

- low tide ———
- high tide ·····
- straw dune ———
- vegetation - - - - -
- 1968 erosional scarp - - - - -
- snow fences ———

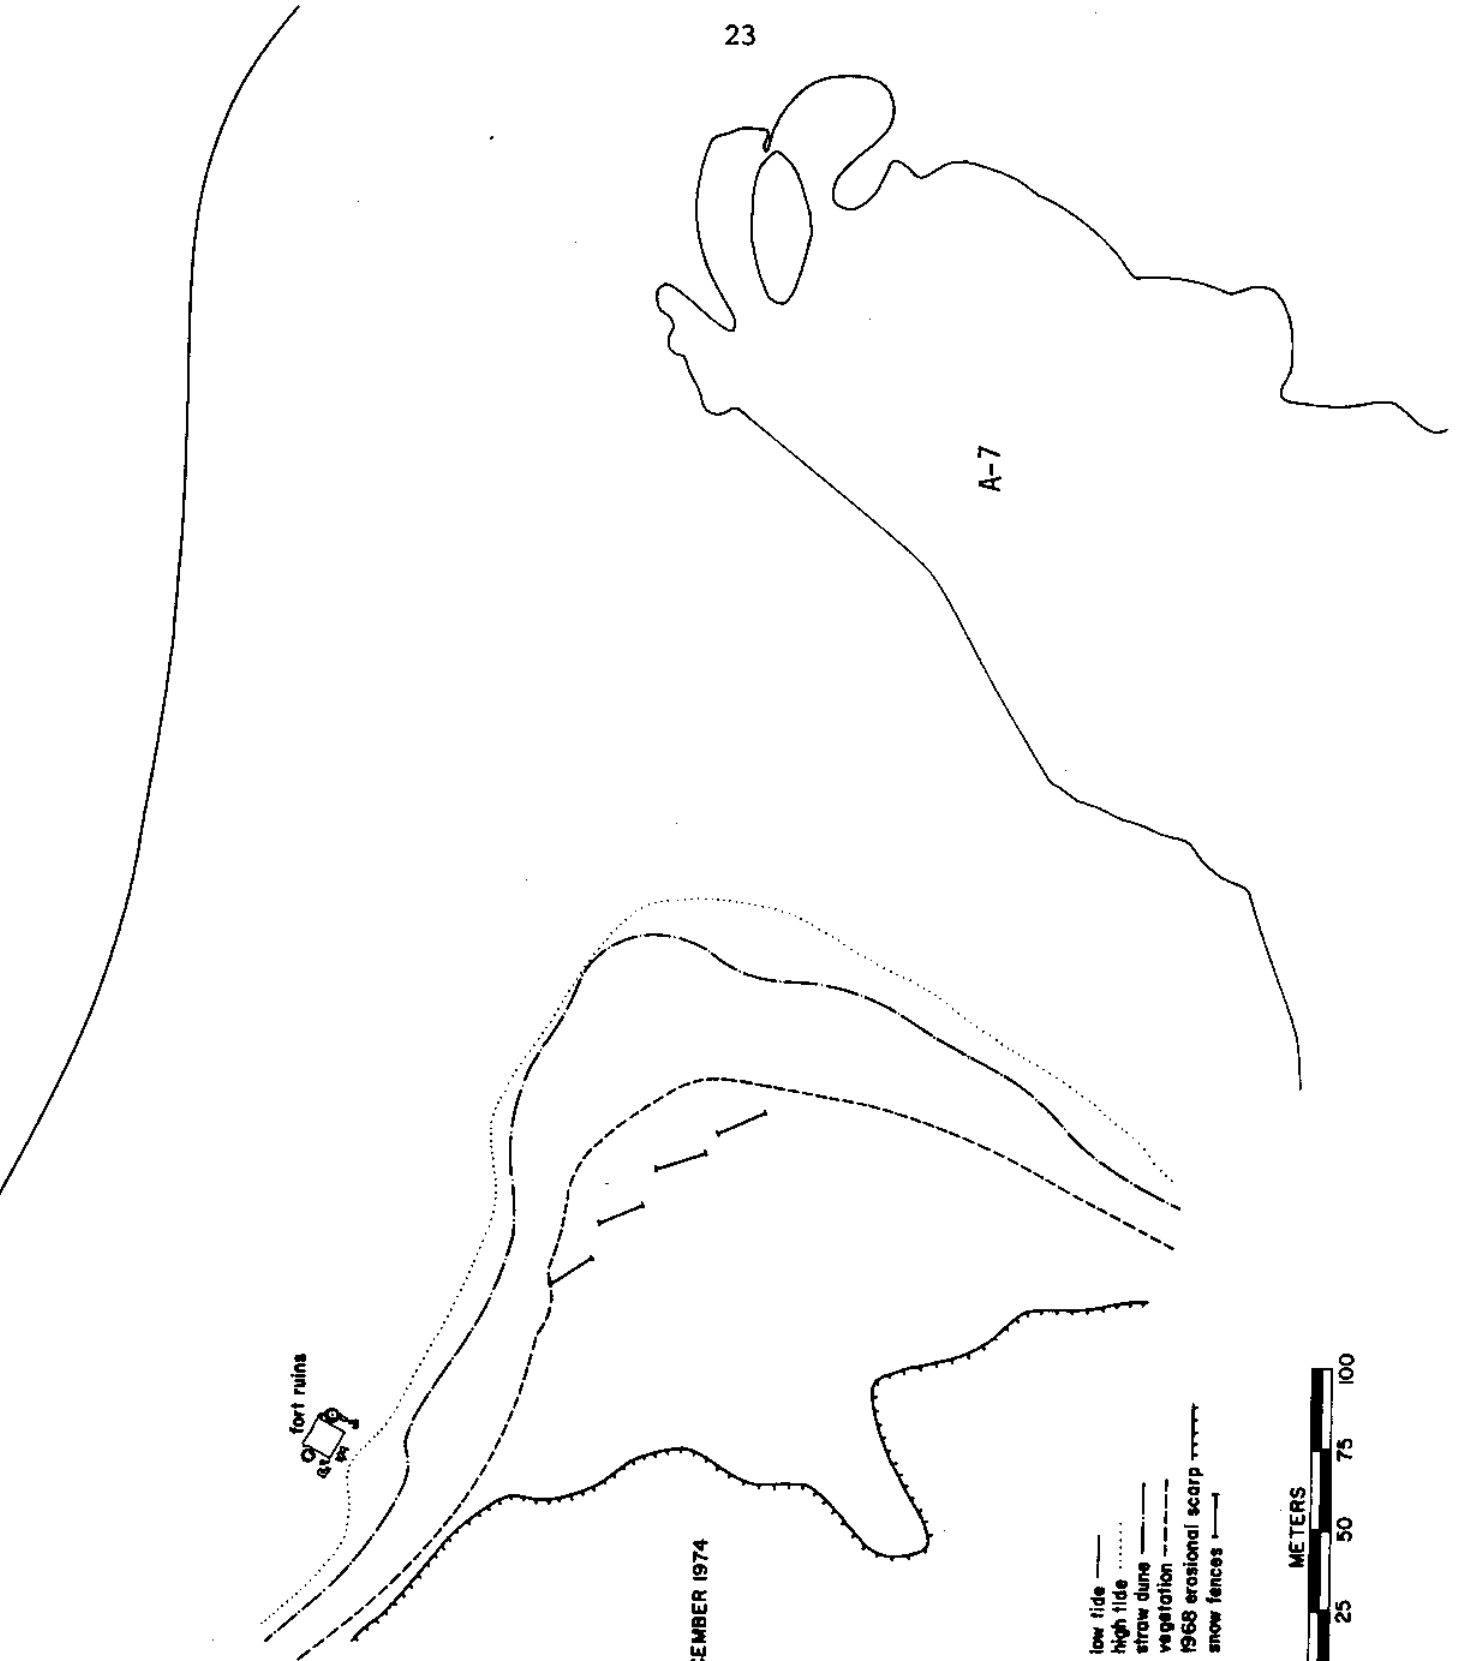
A-7

13 DECEMBER 1974

- low tide ———
- high tide ·····
- straw dune ———
- vegetation - - - - -
- 1968 erosional scarp - - - - -
- snow fences ———

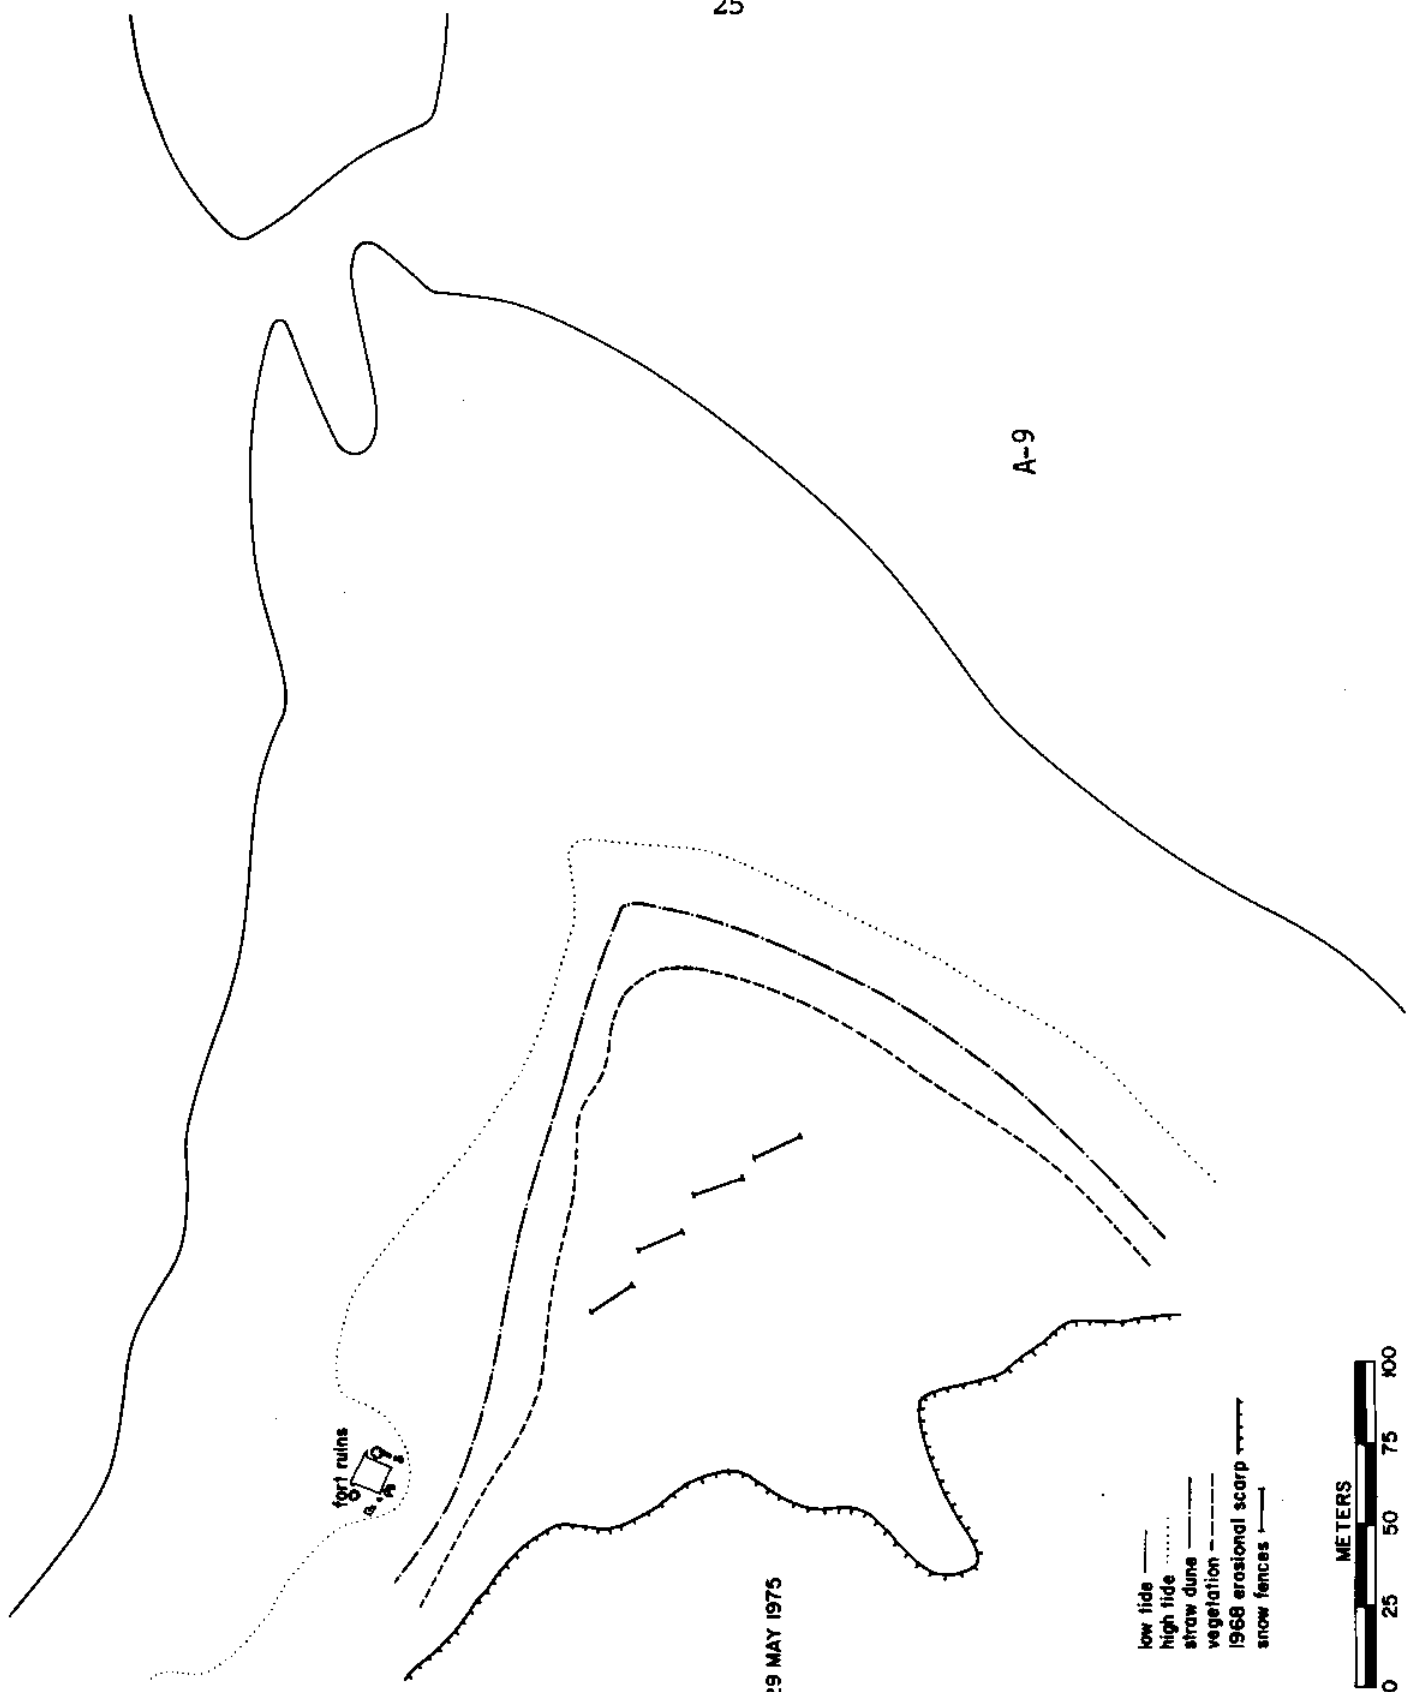
A-9

29 MAY 1975

- low tide ———
- high tide ·····
- straw dune - - - - -
- vegetation - - - - -
- 1968 erosion scarp - - - - -
- snow fences ———

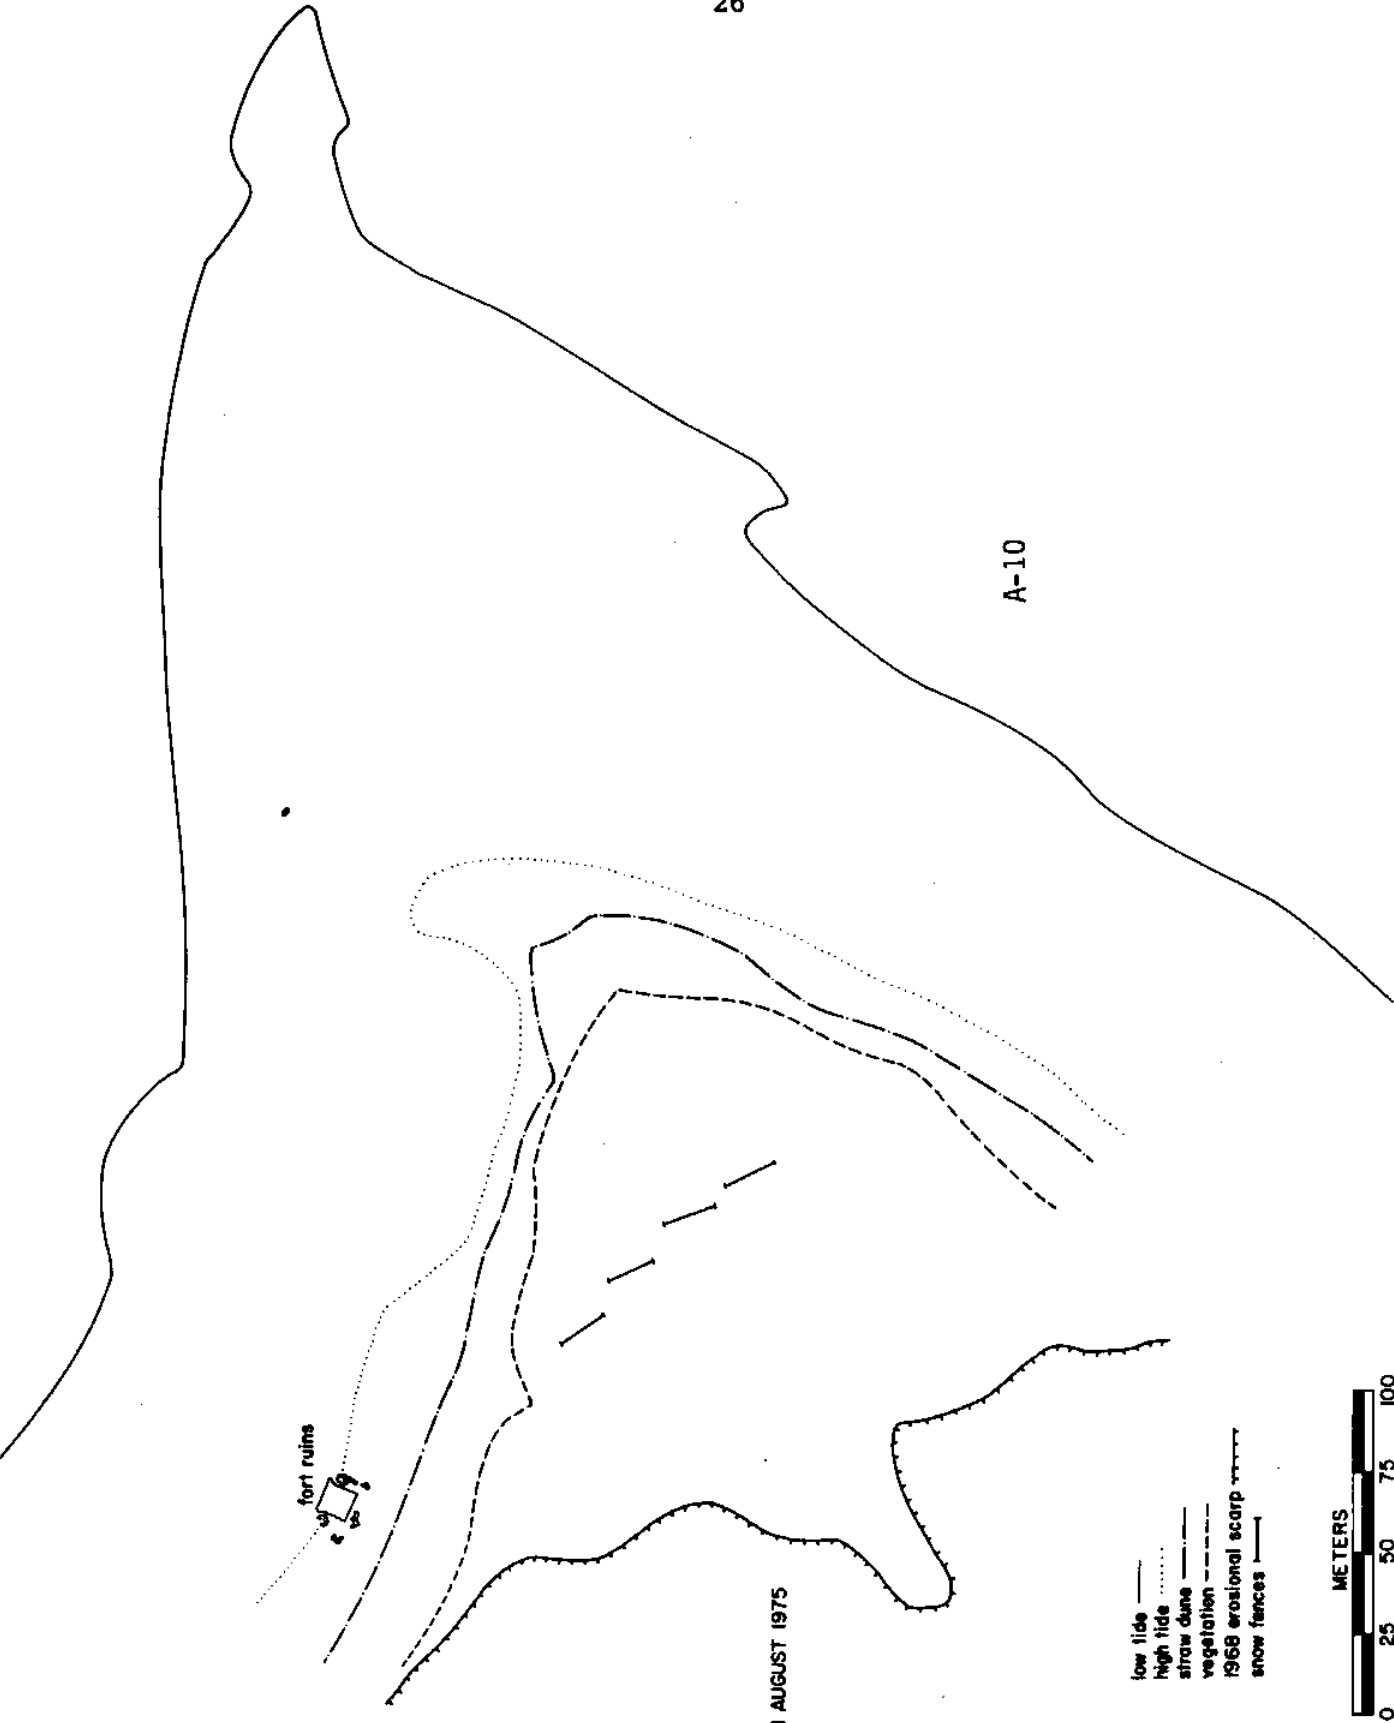
A-10

21 AUGUST 1975

- low tide ———
- high tide ·····
- straw dune - - - - -
- vegetation - - - - -
- 1968 erosional scarp - - - - -
- snow fences ———
