Technical Report Series
Number 77-3

**SAND STABILIZATION ON THE
DUNES, BEACH AND SHOREFACE OF A
HISTORICALLY ERODING BARRIER ISLAND**

**Wassaw Island Erosion Study
Part III**

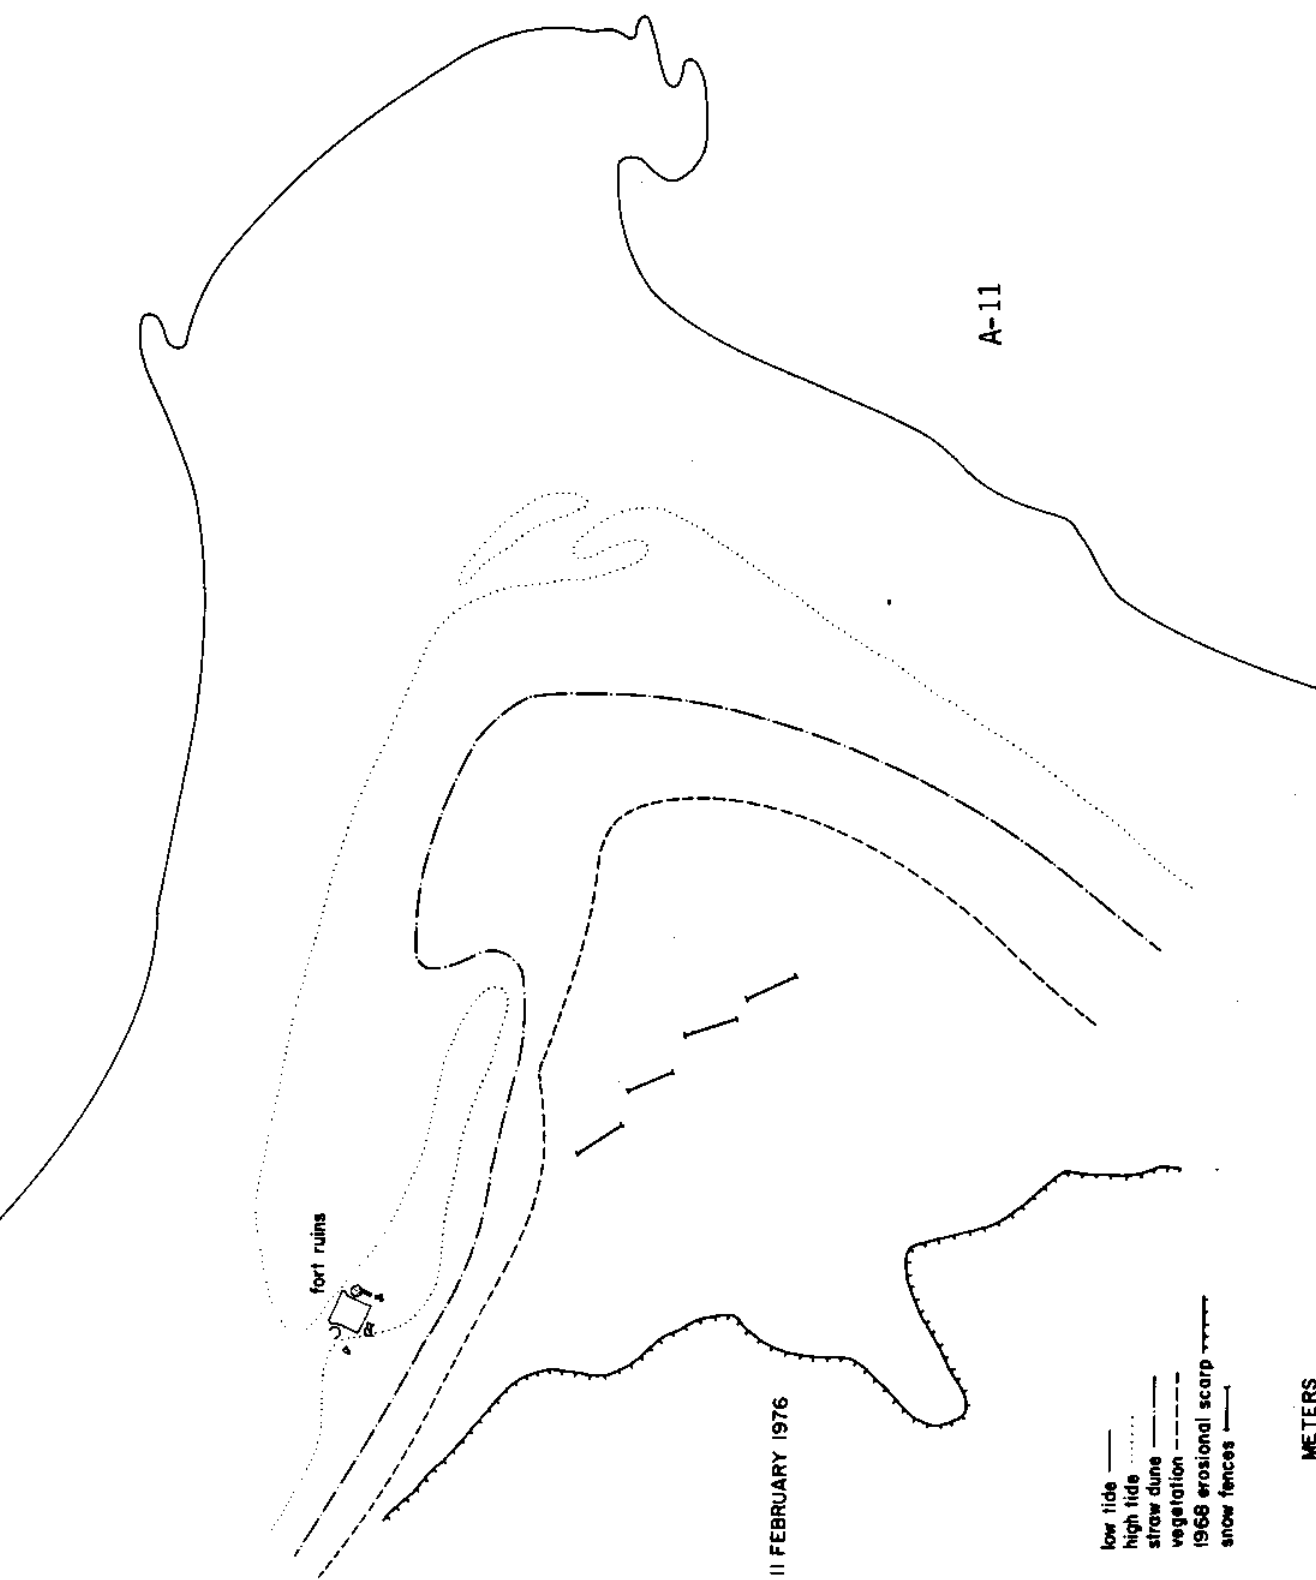
11 FEBRUARY 1976

- low tide ———
- high tide ·····
- straw dune ———
- vegetation - - - - -
- 1968 erosional scarp ~~~~~
- snow fences ———

- A-1 9 August 1973 Survey
- A-2 26 November 1973 Survey
- A-3 13 February 1974 Survey
- A-4 19 April 1974 Survey
- A-5 12 July 1974 Survey
- A-6 10 October 1974 Survey
- A-7 13 December 1974 Survey
- A-8 6 March 1975 Survey
- A-9 29 May 1974 Survey
- A-10 21 August 1974 Survey
- A-11 11 February 1976 Survey
- A-12 10 June 1976 Survey

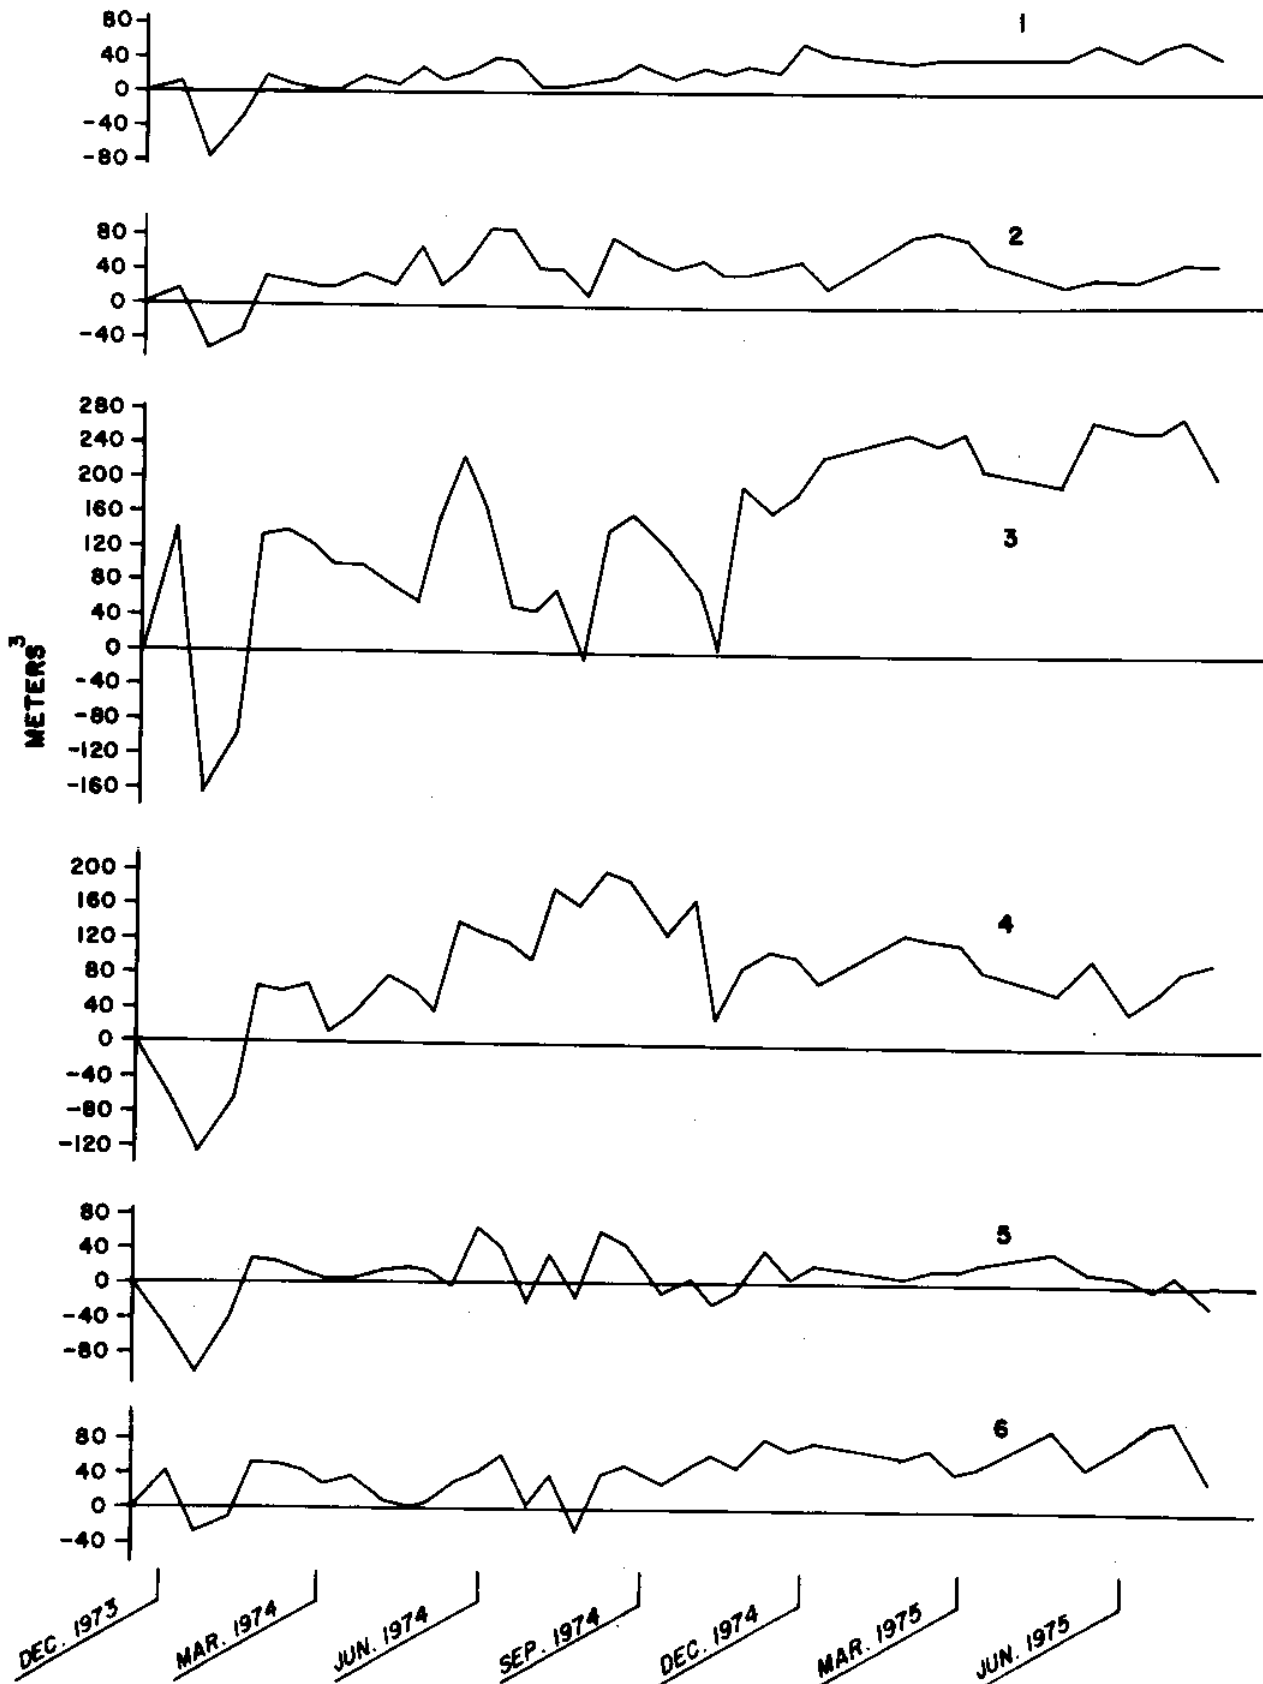
B-13

PROFILE VOLUMES

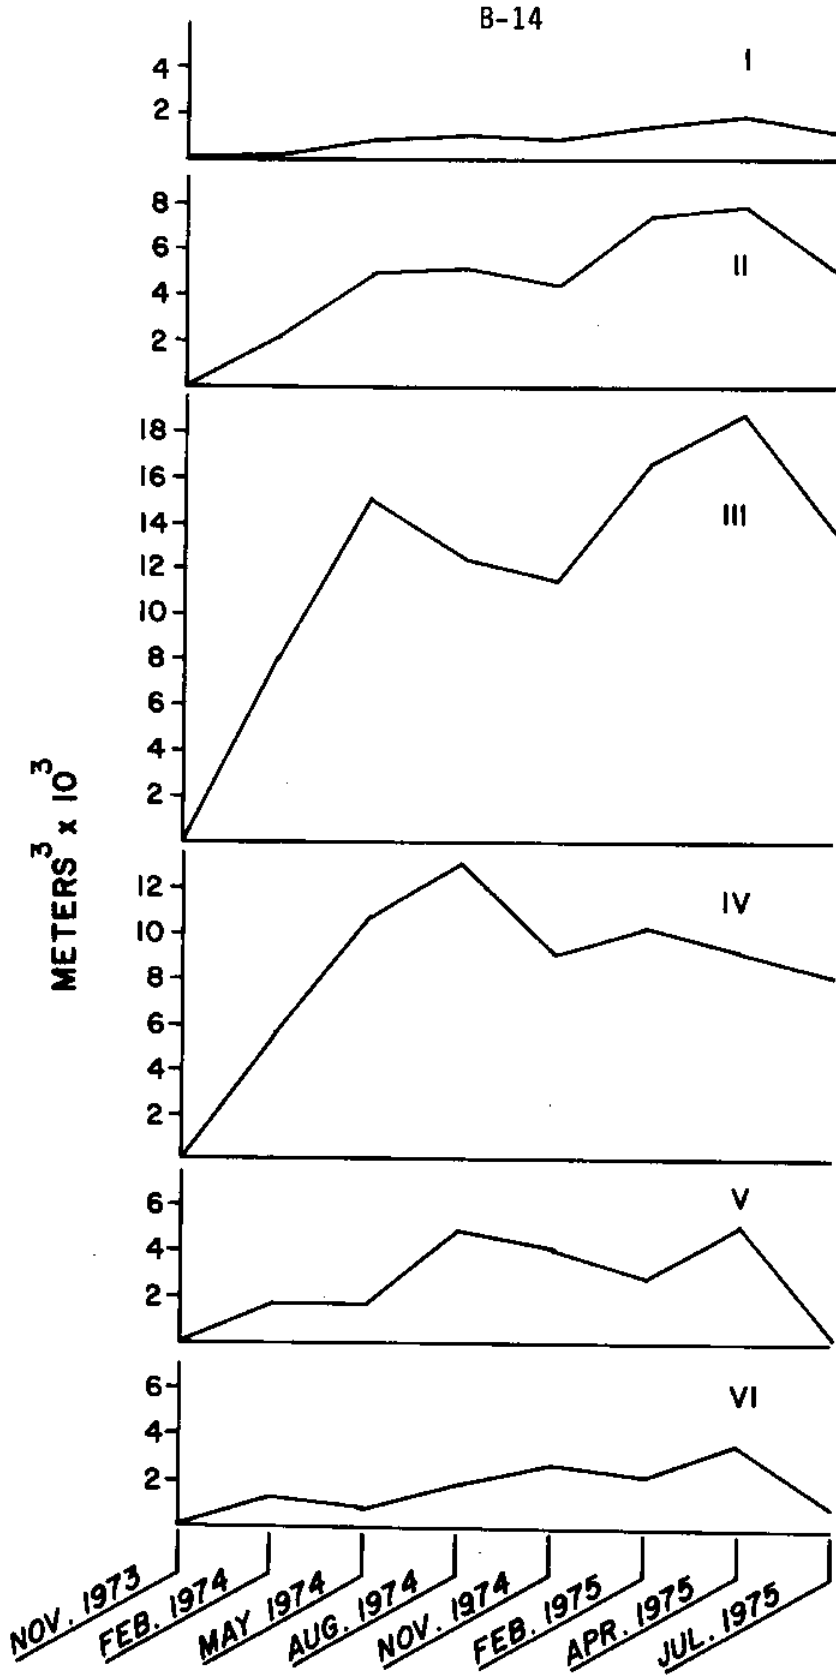
SECTION VOLUMES

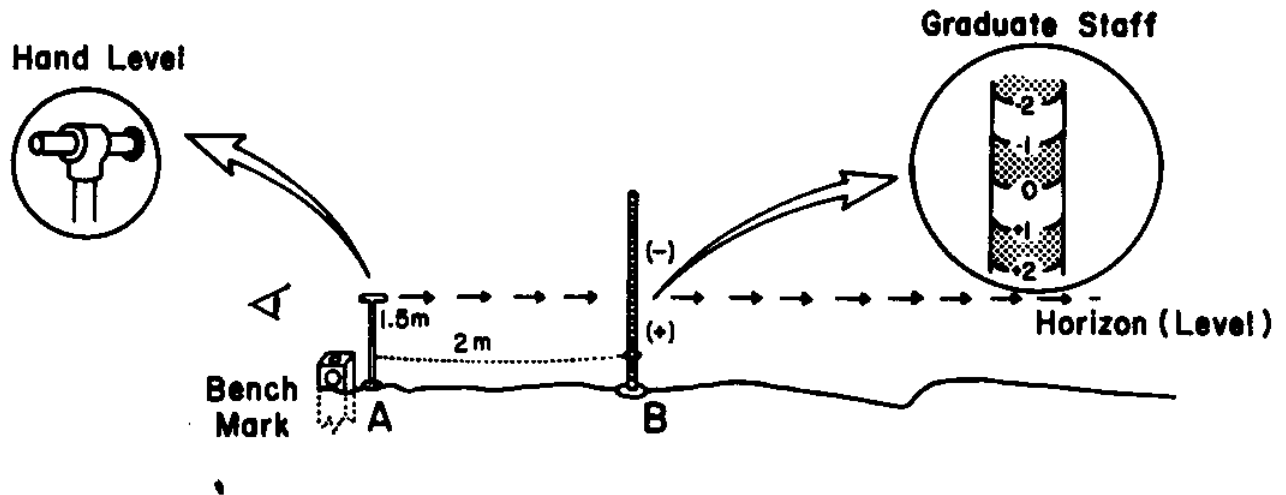
MODIFIED STAFF AND HORIZON TECHNIQUE FOR PROFILING

The elevation of the sand surface with reference to a stable marker (i.e., sea wall, bench mark, curb, etc.) is measured with the graduated staff. The hand level staff (A) is set up on that sand surface with the hand level viewing offshore. The graduated staff is moved seaward until the 2m chain is taut and level. The graduated staff is held directly upright and viewed with the hand level. When the center line on the hand level is super-imposed on the horizon, the the number on the graduated staff is recorded. If the horizon is poor, then the bubble in the hand level can be used for leveling.

Positive readings are located below the zero point and negative number above. After the number is recorded the hand level staff is moved forward to the position of the graduated staff and the procedure is repeated. We have found that a small tape recorder is two to three times more rapid than the pencil and paper recording method.

Plotting the data is done by establishing the marker on graph paper and plotting the sand surface from the initial measurement from the graduated staff. Each successive point is measured from the prior point and not the original marker.
