TOWN OF ROCKPORT GOODIES BEACH STORMWATER TREATMENT FEASIBILITY STUDY

November 7, 2016

TOWN OF ROCKPORT
GOODIES BEACH – STORMWATER TREATMENT FEASIBILITY STUDY
TABLE OF CONTENTS

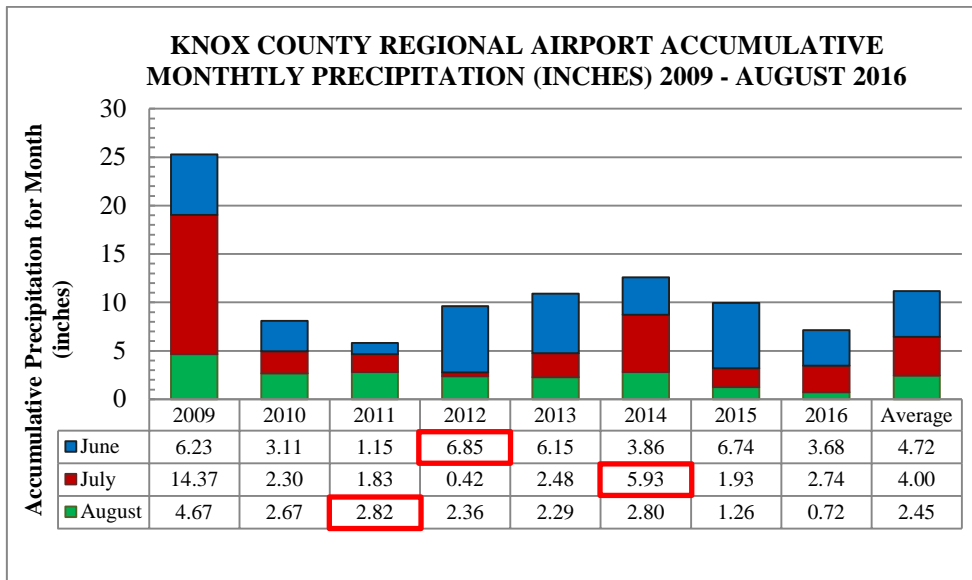
Figure 4: Accumulative Monthly Precipitation (2009 - August 31, 2016)

(Red boxes above in Figure 4 identify the three months circled in Figure 3 where Enterococci levels were found to be the highest on record. Precipitation data presented above in Figure 4 was obtained from: <https://www.wunderground.com/history/airport/KRKD> on August 31, 2016)

averages four observations per season that are less than 10 MPN/100 mL, with a total of 34 to date. This data indicates the level of Enterococci at Goodies Beach has improved as enhanced housekeeping efforts have coincided with relatively low amounts of rainfall (Figure 4).

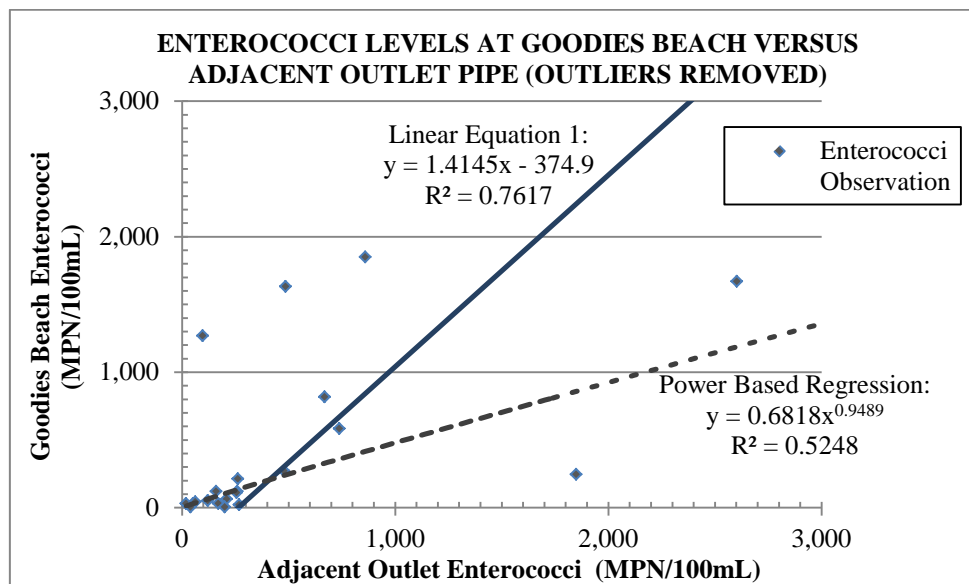
Figure 6: Enterococci Levels at Goodies Beach versus Adjacent Outlet (Observations Removed)

A review of the potential correlation (Linear Equation 1) presented in Figure 6 and poor correlation to precipitation levels (Figure 1) indicates a focus on components to bacterial contamination other than stormwater runoff is warranted. If the correlation depicted in Figure 6 (Linear Equation 1) is valid ($R^2 = 0.76$), then the minimum outlet concentration that is associated with beach closure events can be related as:

$$[\text{ENT.}]_{\text{OUTLET}} \text{ at } 338 \text{ MPN/100mL} \rightarrow [\text{ENT.}]_{\text{GOODIES BEACH}} = 104 \text{ MPN/100mL}$$
