Fort George Inlet Glossary of Inlets Report No. 10

by H. Kojima and S. D. Hunt

Coastal and Oceanographic Engineering Department
University of Florida
Gainesville, Florida 32611

Report Number 38
Florida Sea Grant College
November 1980

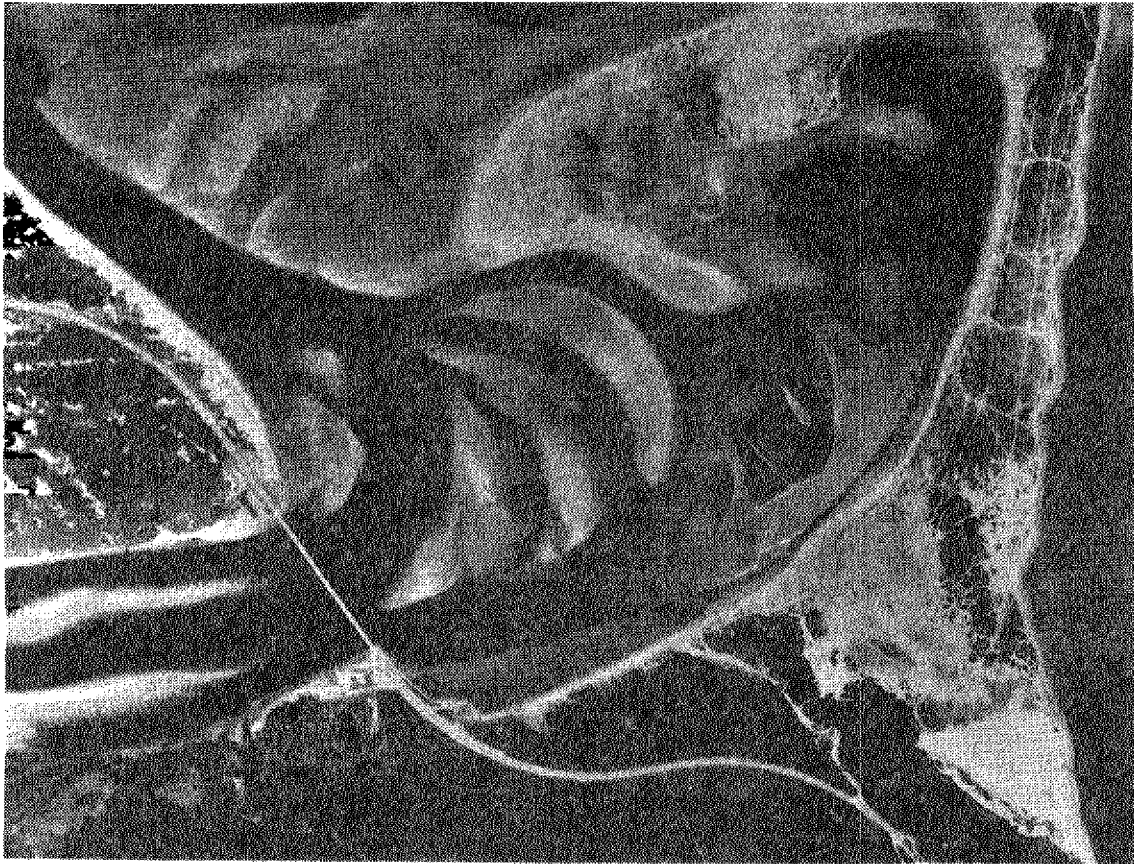
Fig. 1.3 Aerial View of Fort George Inlet showing the Inner-Tidal Shoals, May 1978. Scale 1" = 1250'

Fort George Inlet (shown in Figs. 1.1, 1.2 and 1.3), located on the east coast of Florida in Duval County, is a natural inlet connecting Fort George River to the Atlantic Ocean. This inlet lies immediately north of the St. John's River Entrance and approximately 6 miles south of Nassau Sound. Its coordinates are as follows:

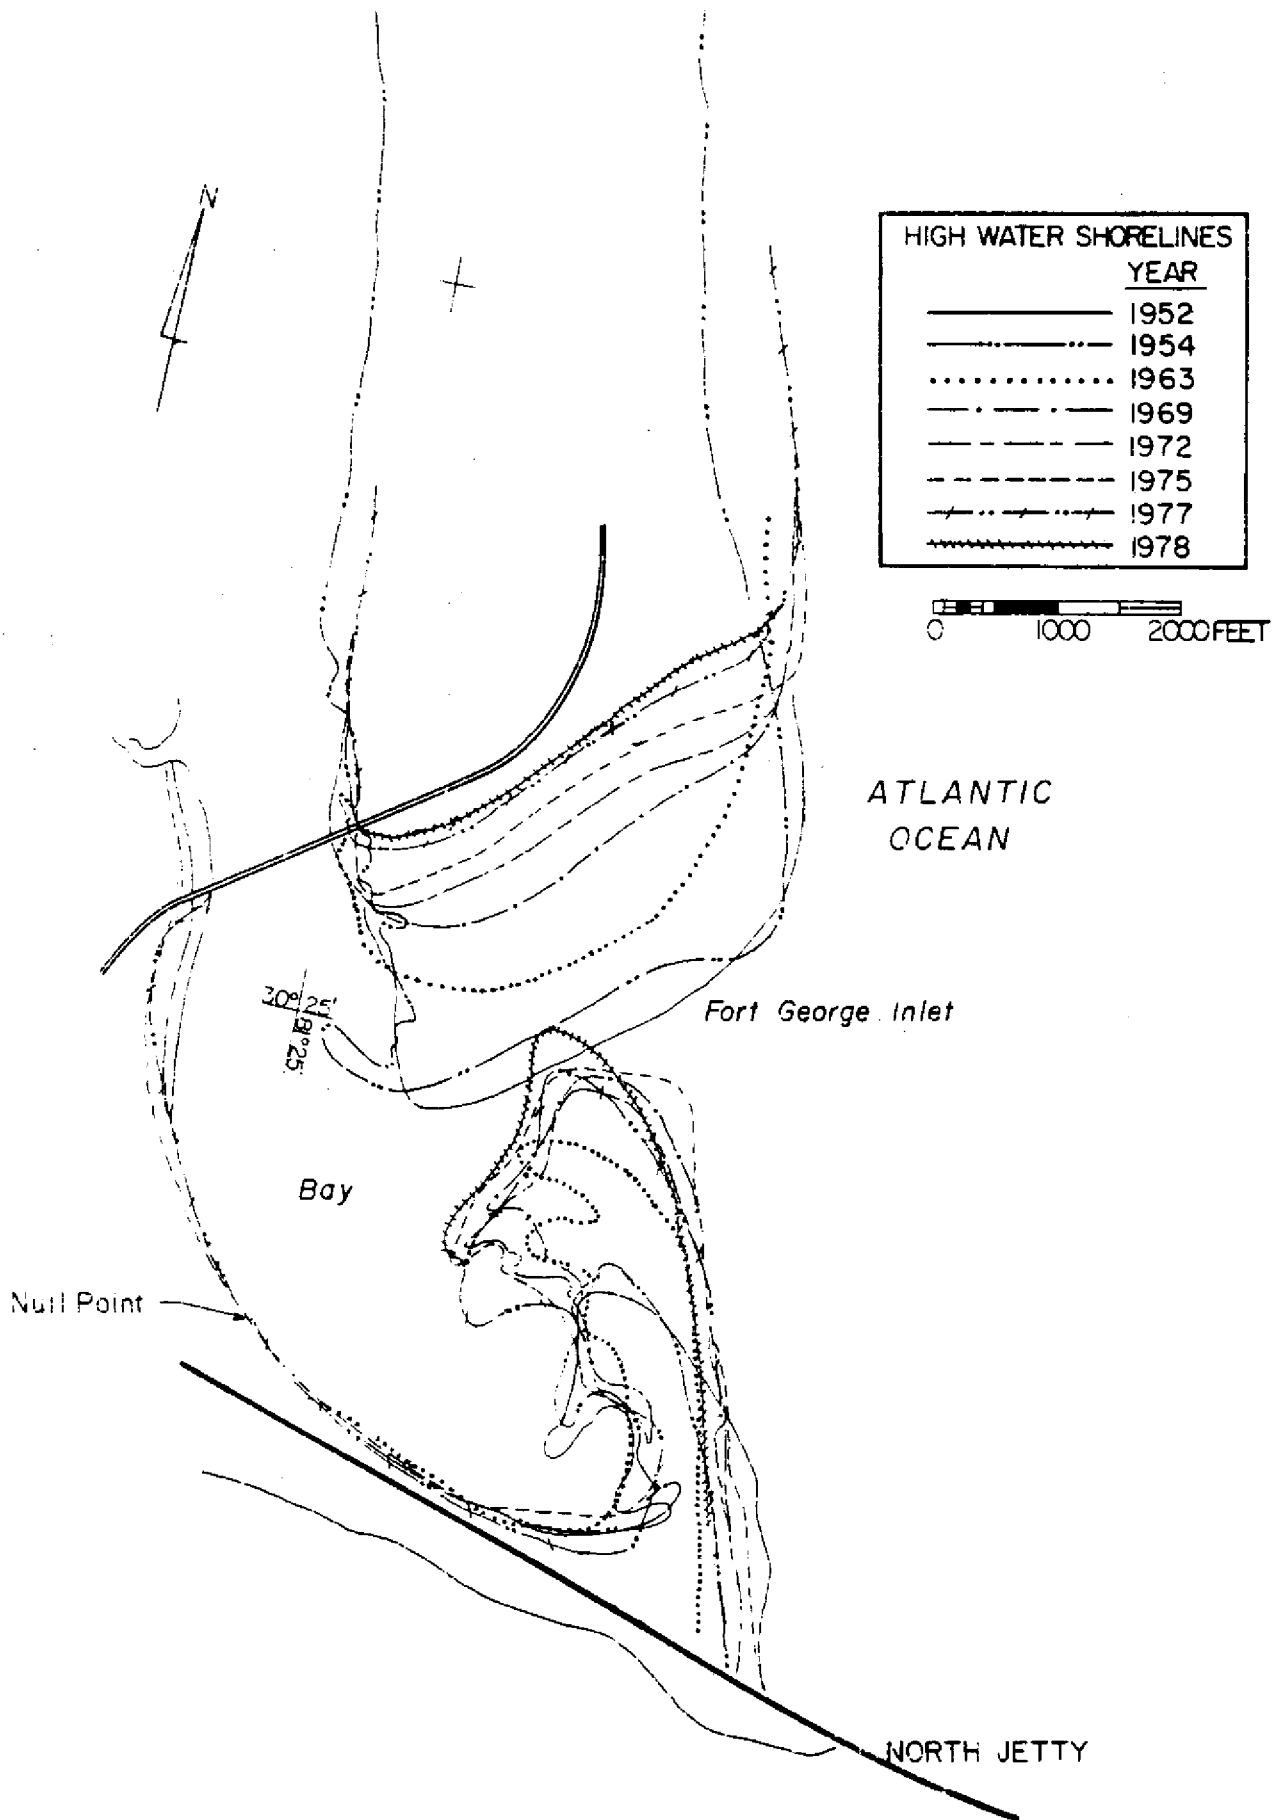
Fig. 5.12 Mean High Water Shoreline Changes - 1952-1978, for Fort George Inlet Vicinity

Significant shoreline changes in the inlet vicinity, as shown in Figs. 5.10 through 5.12, have been taking place since the first recorded map (Fig. 5.1) of the inlet was made. In the early 1900's the Corps of Engineers periodically made surveys of the area surrounding the inlet in conjunction with the St. John's River improvement project. These surveys detailed water depths of Fort George Inlet as well as the mean high water (mhw) shoreline over the area. Moreover, the Duval County Beach Erosion Board made a study of the comparative positions of the mhw shoreline over the period 1858 to 1963 using USCGS surveys as well as the Corps of Engineers survey of 1963. The report noted that, since 1853, the south end of Little Talbot Island, which was near the confluence of Fort George River and Simpson Creek in 1853, has extended about 9,000 ft. southward.

Volumetric changes for the regions surrounding Fort George Inlet (see inset of Fig. 7.2) were calculated based on the shoreline changes shown in Figs. 5.11 and 5.12 (Kojima and Mehta, 1979). Fig. 7.1 shows the volumetric changes of Little Talbot Island south of SR A1A. The region of interest as indicated in the inset is the shaded area south of the dashed line, which is a linear, eastward extension of the A1A bridge centerline. This region for the years shown in Figs. 5.11 and 5.12 was planimetered to obtain the surface area. This area was multiplied by a mean elevation of 5 ft. (assumed from consideration of typical land elevation above mhw in this region) to determine the volume of material. Between 1918 and 1934, approximately 2 million cu. yds. of sediment deposited in this region. Erosion of this area is estimated to have begun around 1938, and since then the south end of the island has been losing sediment at almost a constant volumetric rate. However, recent (1980) aerials show new zones of accretion.

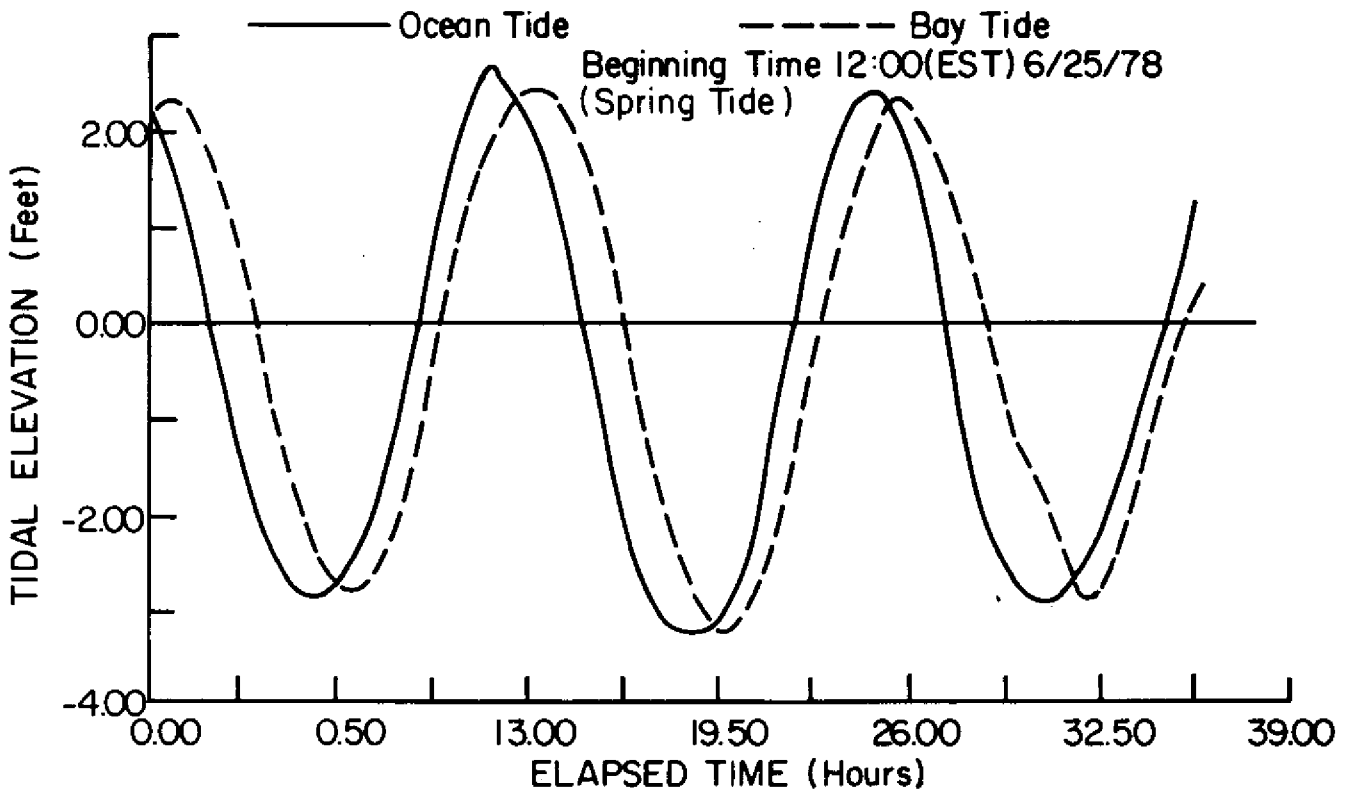
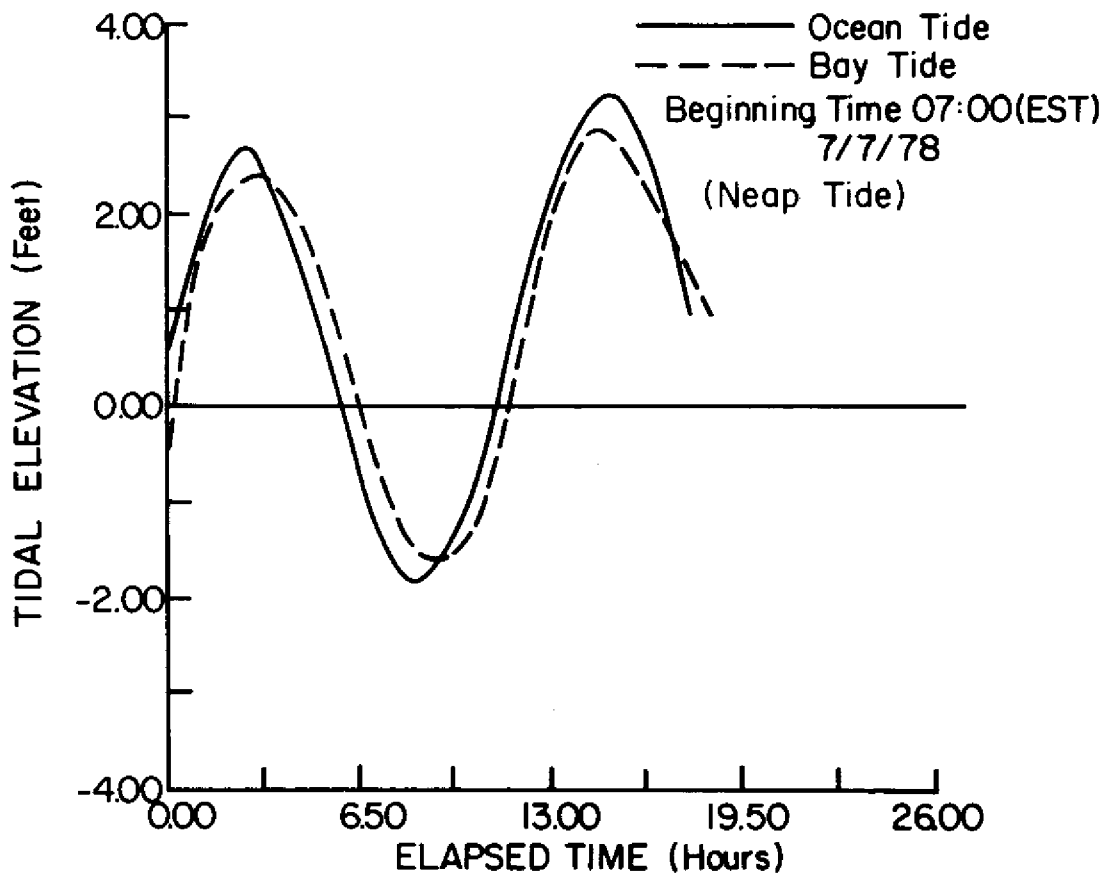
Fig. 6.1 Tidal Records for Ocean Tide and Bay Tide

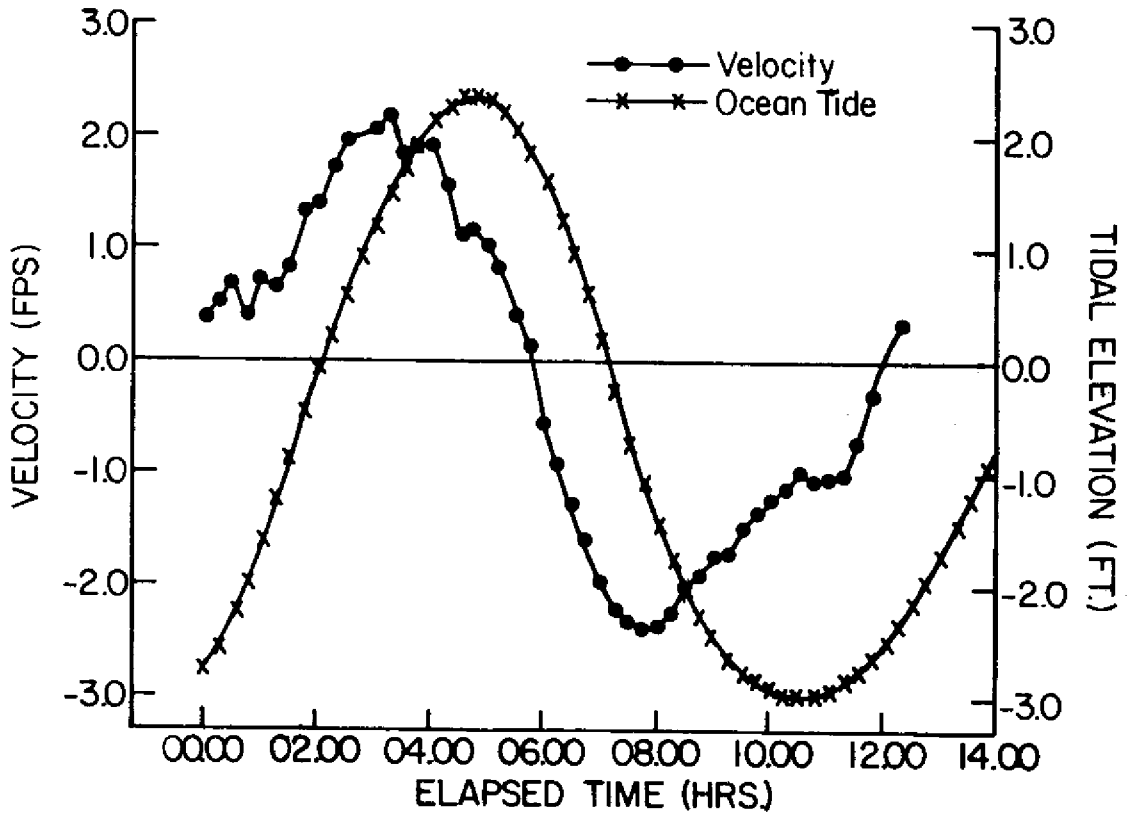
Fig. 6.6 Cross-sectional Average Velocity Near the A1A Bridge and Associated Ocean Tide. Starting Time is 08:15 on 6/26/78

cross-sectional average flood velocity was 2.20 fps and the corresponding ebb velocity was 2.38 fps. Note that the ocean tide range for these velocities was 5.6 ft.

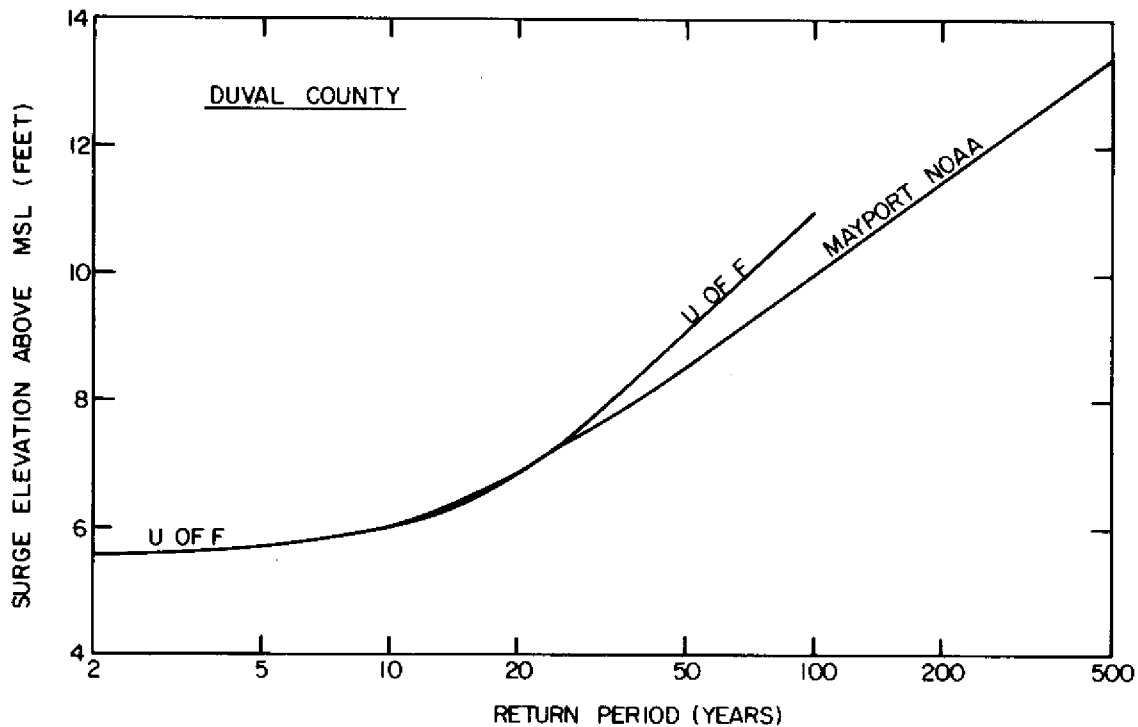
in terms of frequency of occurrence for a certain water level to be equaled or exceeded. Fig. 6.9 (COEL, 1975) shows storm surge elevation frequencies computed by the COEL and by NOAA. The storm surge elevation used to establish the coastal construction setback line for Duval County was 10.9 ft. (100 year return frequency according to COEL) which was superimposed upon a wave setup of 1.5 ft., resulting in a 12.4 ft. water level elevation above normal (COEL, 1975).

Fig. 6.9 Storm Surge Elevation Versus Storm Return Period for Duval County (COEL, 1975)

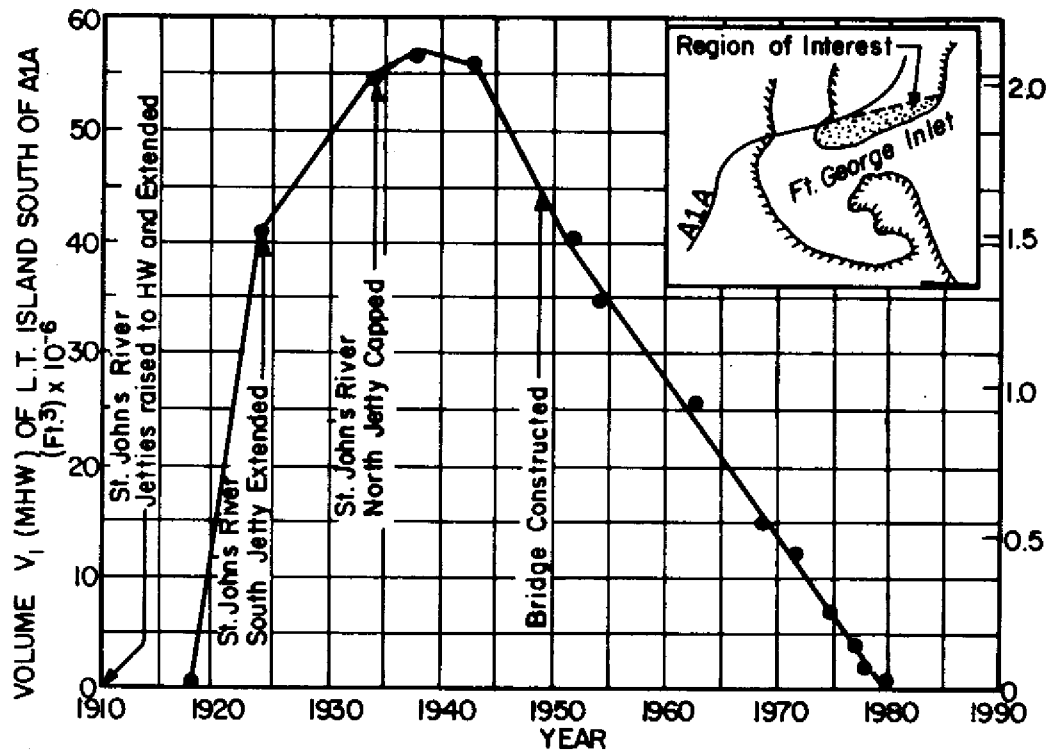
Fig. 7.1 Volumetric Change of Little Talbot Island South of A1A Versus Time
