SHIFTING SHORELINES:
A PICTORIAL ATLAS OF NORTH CAROLINA INLETS

BY WILLIAM J. CLEARY AND TARA P. MARDEN

Second Edition

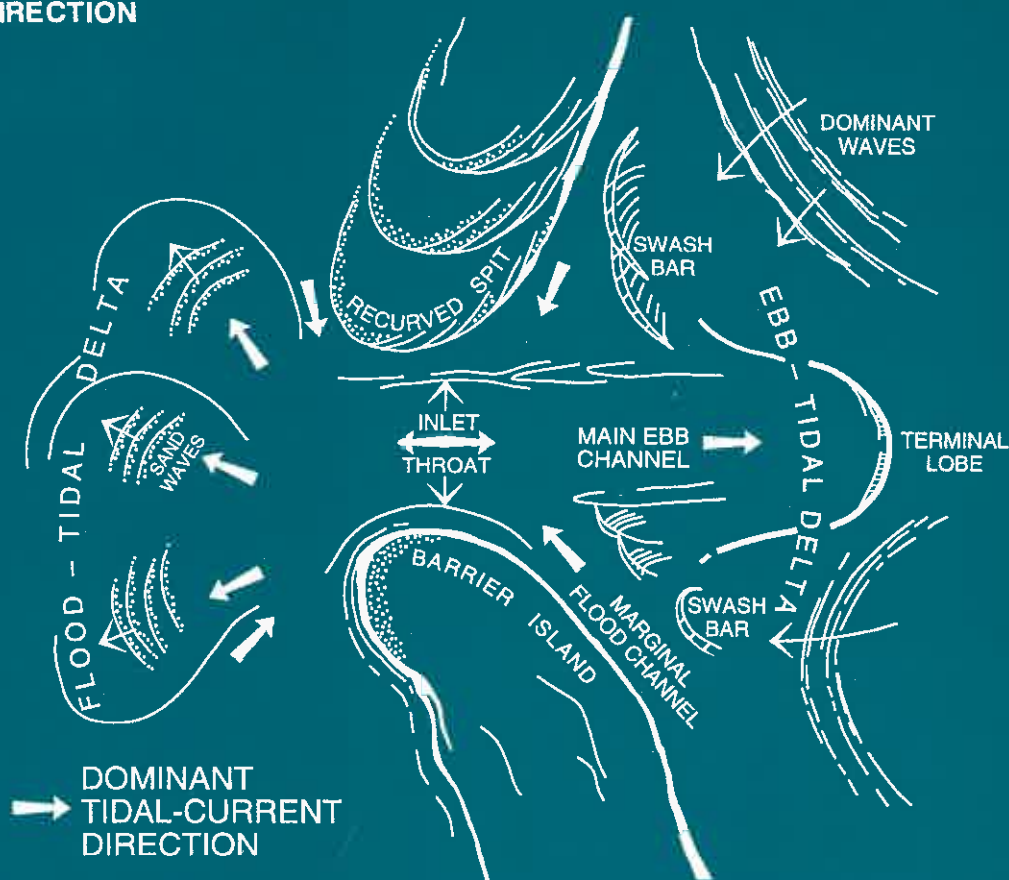
FLOOD-TIDAL DELTA

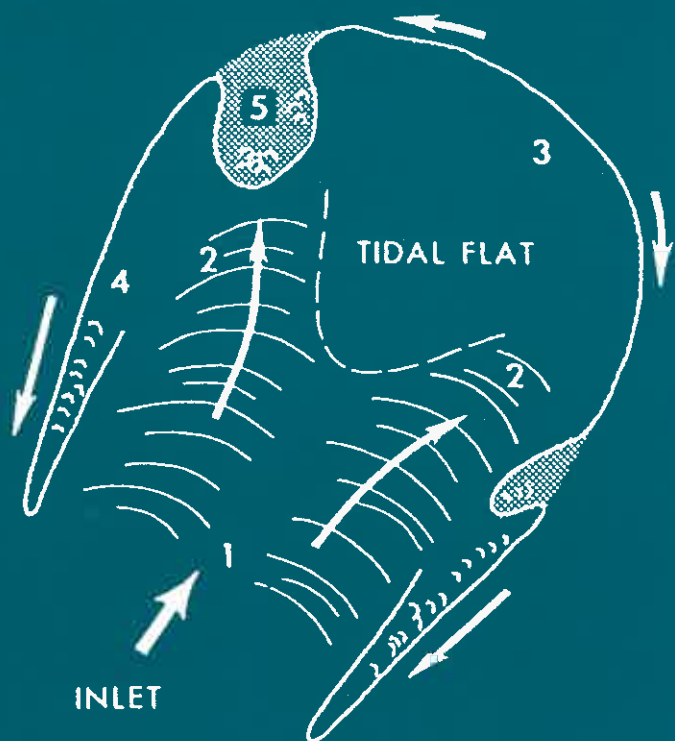
- 1 FLOOD RAMP
- 2 FLOOD CHANNEL
- 3 EBB SHIELD
- 4 EBB SPIT
- 5 SPILLOVER LOBE

A body of sediment sand found landward of a tidal inlet. Many marshes are formed on old flood-tidal delta deposits.

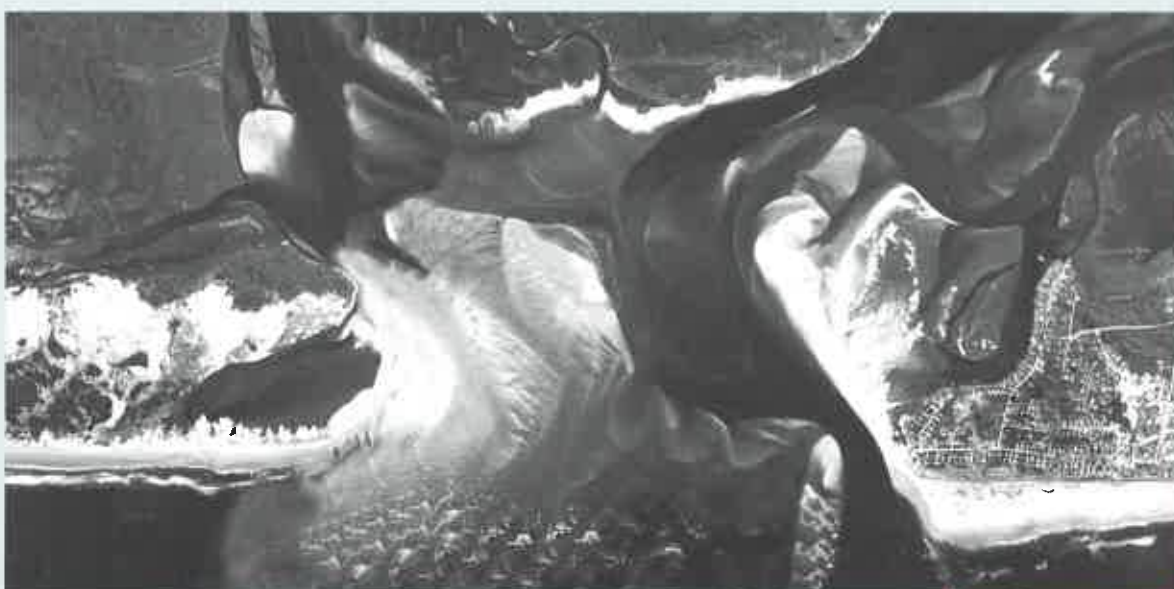
1996

The most recent photograph available, from April 1996, shows that the throat is occupied by a 1.4-kilometer-wide flood channel and a narrow, 200-meter-wide ebb channel positioned close to the Bogue Banks margin. If the ebb channel continues to migrate to the east, the inlet shoreline will erode while the oceanfront beach will accrete along an 800-meter stretch immediately downdrift of the inlet. A breach of the mid-throat shoals is likely, initiating channel reorientation. The breach is likely to occur seaward of the point where East Channel makes its approach to the inlet's throat. After channel repositioning, the ebb shoals will reorganize and the zones of erosion and accretion will switch locations.

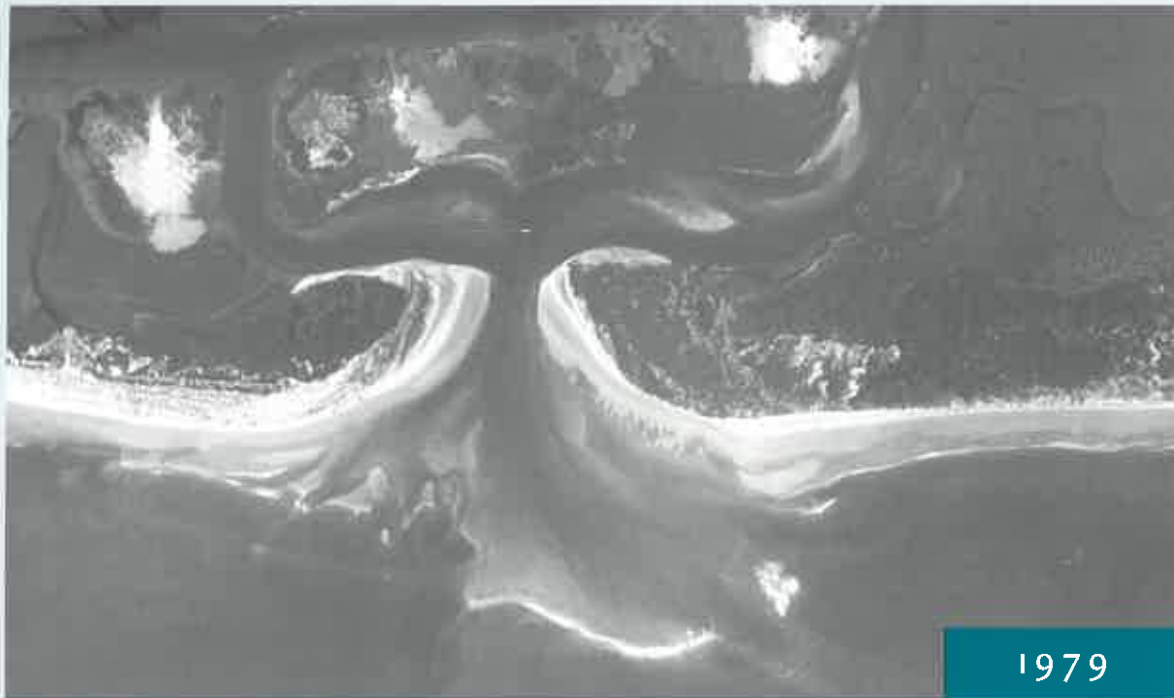
A recent cycle began in 1979 with the deflection of the ebb channel toward Brown's Island. Complex interacting variables caused the deflection. The deflecting channel promoted the development of an ebb-tidal delta that was strongly skewed to the northeast along Brown's Island. Concurrent enlargement of the flood channel on the Onslow Beach margin promoted erosion along the oceanfront and within the throat. Localized accretion occurred on Brown's Island within the one kilometer northeast of the inlet due to the attachment of sandbars.

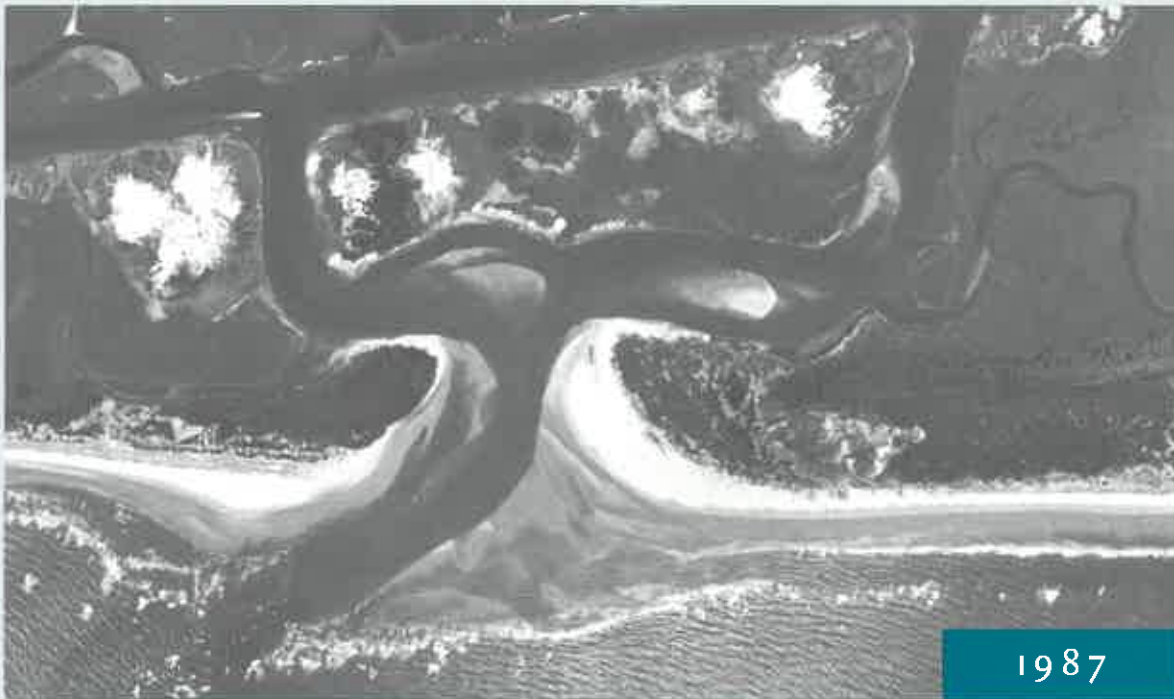
1987

A typical period of change occurred between 1979 and 1985, when Brown's Island built up as much as 120 meters. During the same period, the Onslow Beach oceanfront eroded as much as 30 meters. Between 1985 and 1987, both shoulders eroded. Brown's Island receded as much as 25 meters.

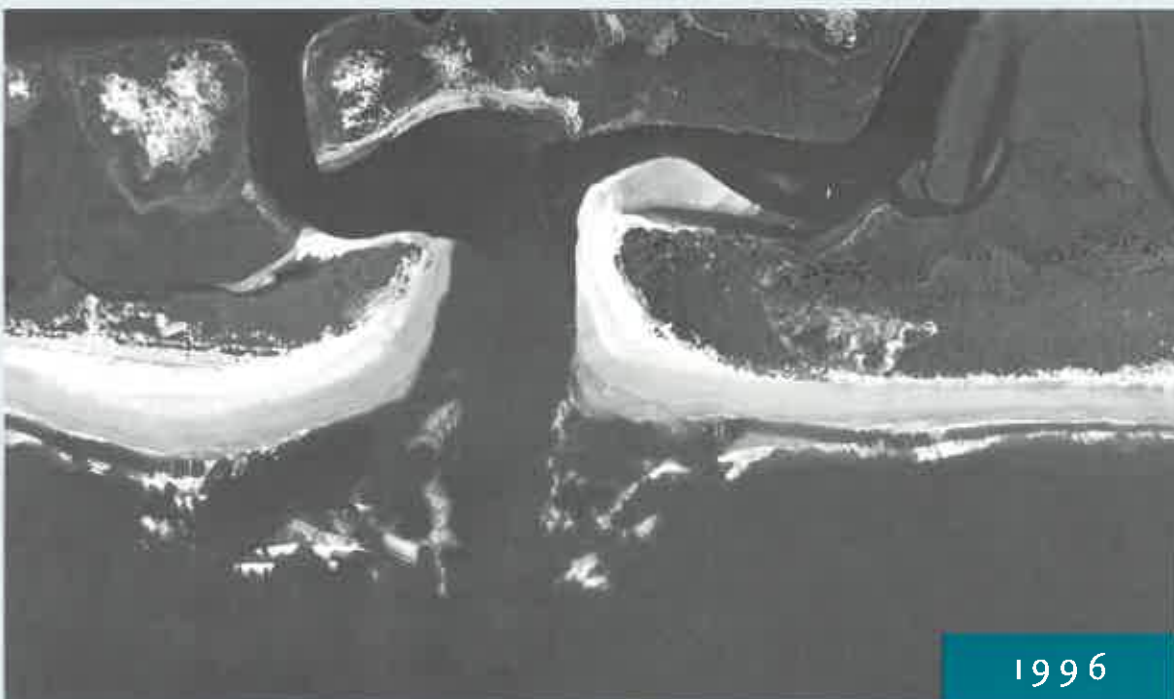
1996

By the mid 1990s, accretion dominated the entire Onslow Beach shoulder, which grew as much as 50 meters. By contrast, the Brown's Island oceanfront eroded more than 40 meters during the mid-1990s. The greatest net shoreline change occurred along the landward portion of the Onslow Beach throat, where as many as 607 meters of shoreline were lost. The average rate of erosion was 10.5 meters per year. On the opposite side of the throat, the Brown's Island shoreline grew by 493 meters at an average of 8.5 meters per year.

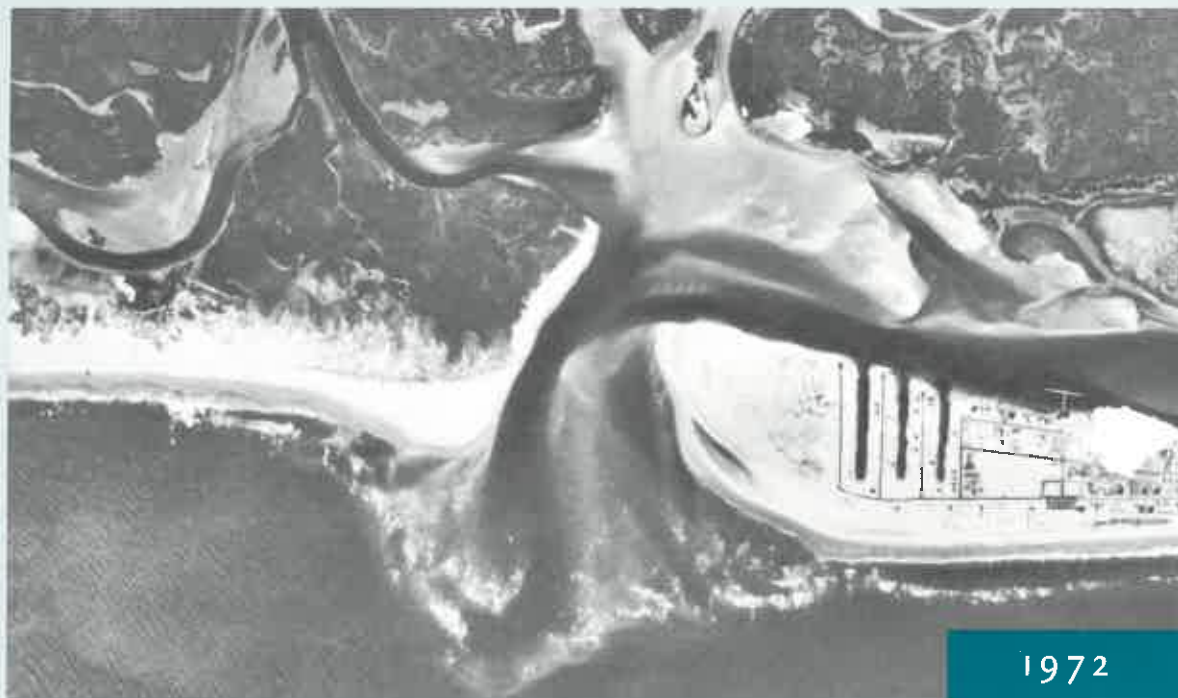
1972

One consequence of the inlet's southwesterly migration has been the chronic shoaling and deterioration of the AIWW access channels. Since 1932, Old Topsail Creek has been the primary access channel, but the flood-ramp sand shoal located at the landward end of the inlet throat has steadily encroached on the creek

since 1938. As a result, Old Topsail Creek has been artificially maintained since 1966, and the flood-tidal delta is now positioned in such a way that the access channel needs constant dredging. Since the 1980s, the USACE has placed the dredged materials on Topsail Beach to mitigate erosion.

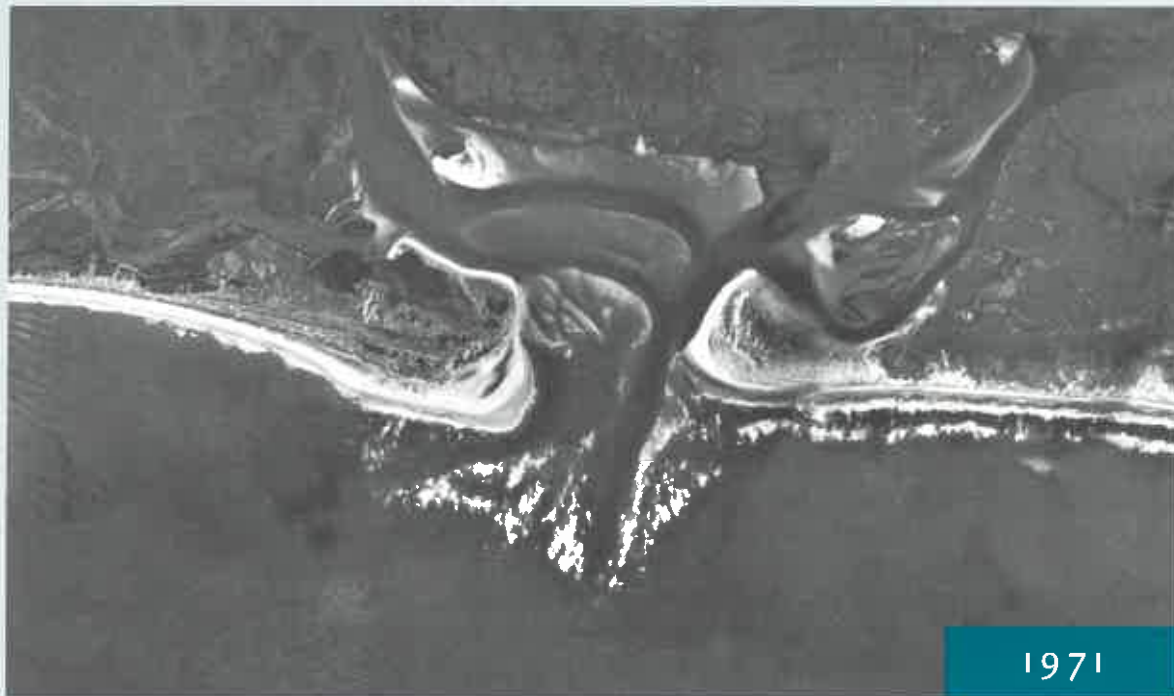
1971

The ebb channel, the major link between the ocean and the estuary, is comprised of the deep throat segment and the seaward portion that extends across the ebb-tidal delta. The orientation and position of both segments of the main channel have changed repeatedly. Over the past 60 years, the channel's orientation across the swash platform has ranged from 85 degrees to 184 degrees. The changing

alignment and position dictated much of the erosion and accretion trends observed along the 2-kilometer stretches of shoreline bordering the inlet.

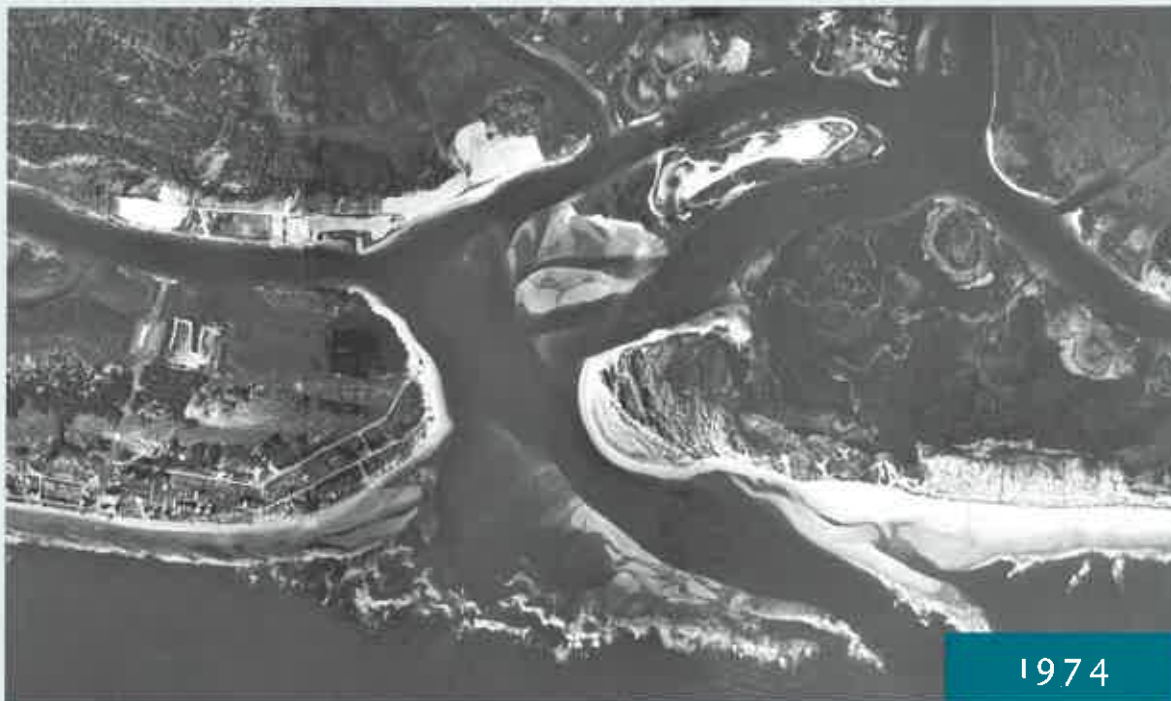
The bulbous shape along the Holden Beach shoulder — visible in the photographs from December 1974 to September 1996 — is a product of several factors, including a zone of sediment reversal. This zone developed in the vicinity of the inlet as waves refracted around the ebb-tidal delta, promoting the welding of swash bars. The present-day channel orientation of 104 degrees appears to be the most favorable orientation, facilitating the welding of sand packets onto the Holden Beach shoulder. If the channel orientation becomes more westerly, the Holden Beach accretion of the past

several decades will be replaced by erosion. If the ebb channel becomes strongly skewed toward Ocean Isle, as it was from 1938 to 1958, a similar bulbous configuration will occur along Ocean Isle.

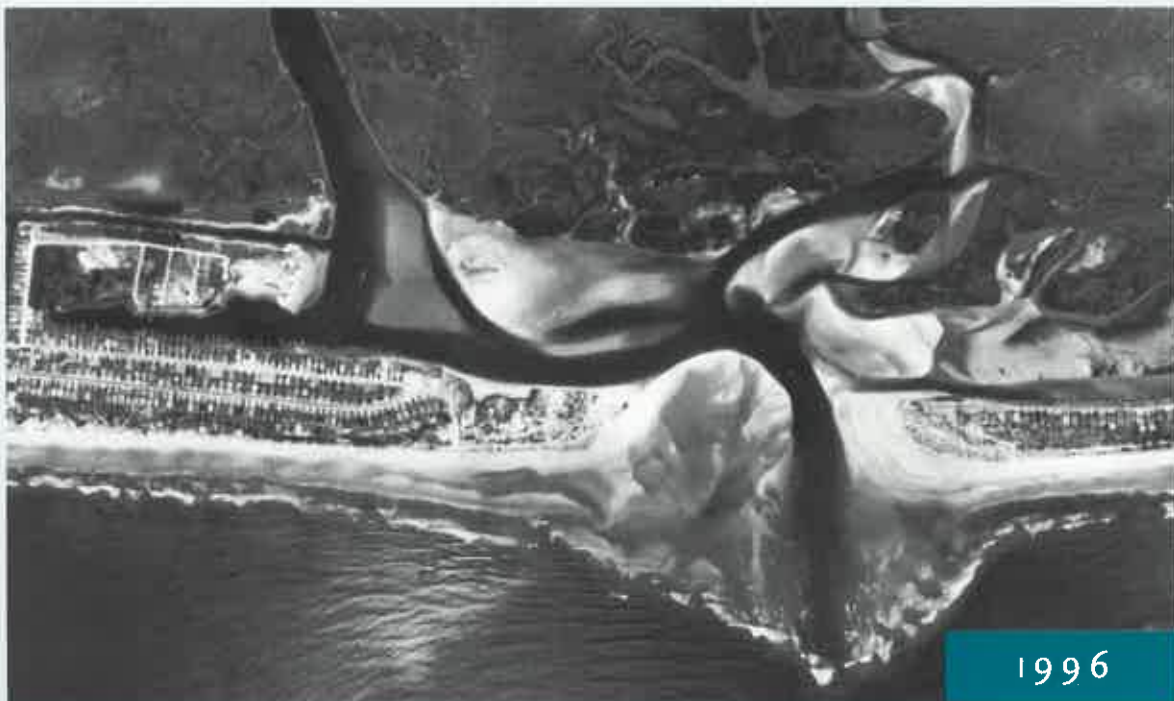
1996

1970 and 1996, erosion rates for the Ocean Isle shoulder averaged 28 meters per year while Sunset Beach extended eastward at an average rate of 14 meters per year.

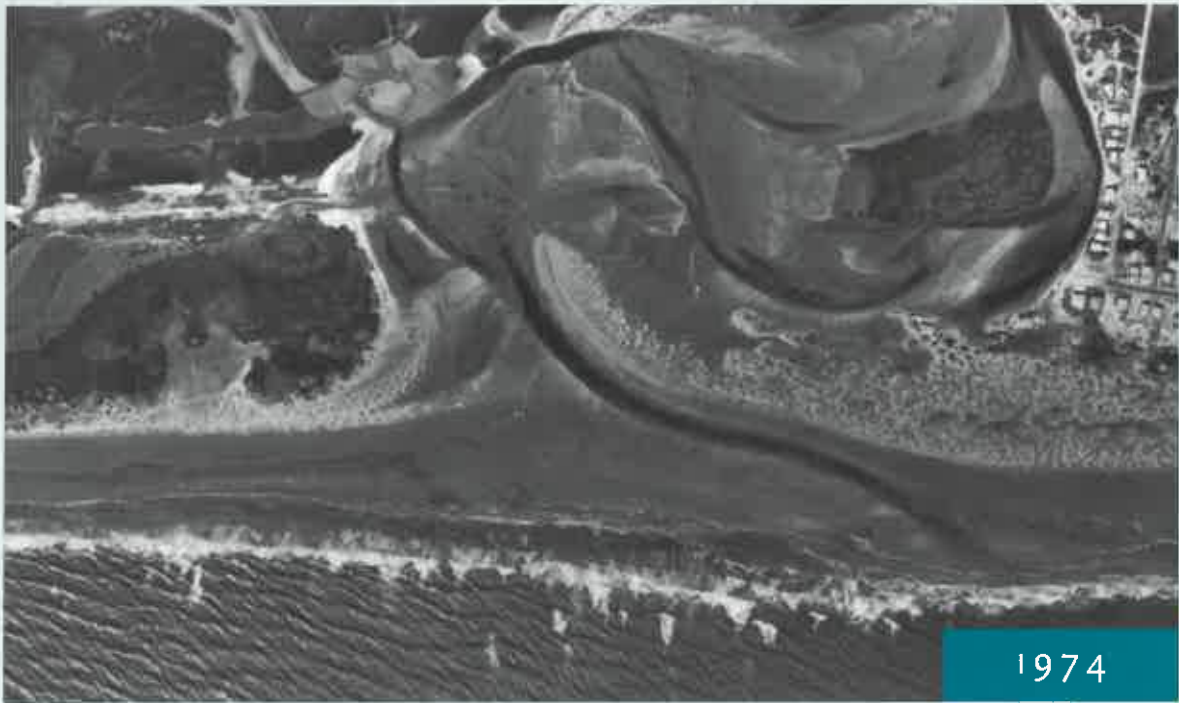
1974

The dominant littoral transport is from east to west, facilitating westward migration of the inlet. Between 1938 and 1954, the inlet migrated a net distance of approximately 215 meters at an average rate of 13 meters per year. In October 1954, surge associated with Hurricane Hazel breached the Sunset Beach spit in several places. The major breach occurred at the spit's point of attachment, approximately 915 meters east of the inlet's 1954 position. By 1956, the old ebb channel had filled in
