DEL-SG-14-81

THE INFLUENCE OF GEOLOGICAL STRUCTURE  
AND HISTORICAL CHANGES IN MORPHOLOGY  
OF DELAWARE BAY COMMUNITIES  
ON ENVIRONMENTAL PLANNING

Kathleen Susan Drew  
College of Marine Studies  
University of Delaware

August 1981

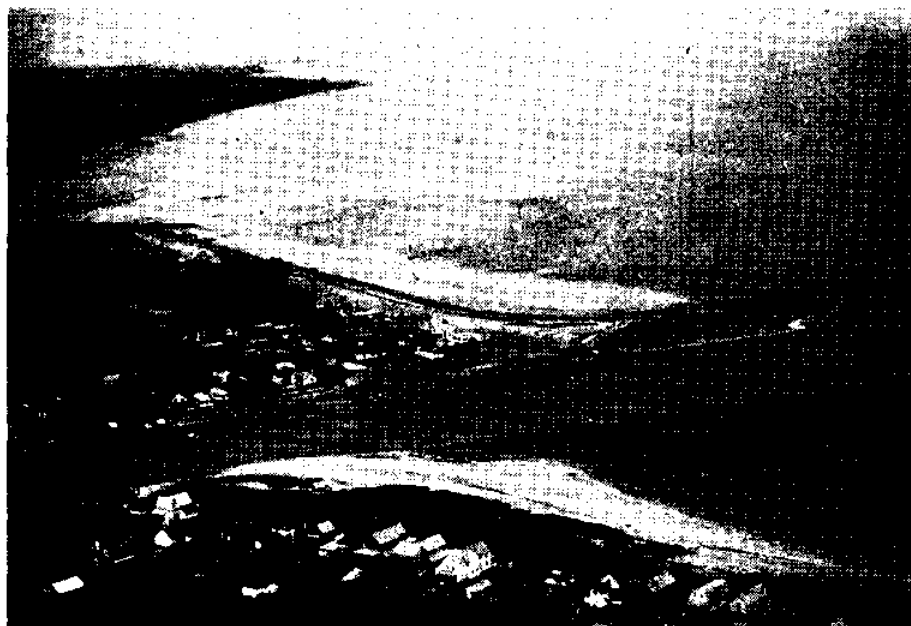
Figure 20. Aerial photograph of Bowers and South Bowers, Delaware (August, 1980).

Although Bowers and South Bowers are separated only by a river mouth (Figure 20), they are very different demographically and geologically. South Bowers is a small summer community, with no stores, restaurants, businesses, or churches. In 1965 there were only five permanent residents, and 120 summer residents (U.S. Army Corps of Engineers, 1966) occupying the 45 houses located in South Bowers. According to interviewees, these numbers (and the people themselves) have not changed much since then--there are at present only two or three year-round households. On the surface, South Bowers looks very much like Bowers (Figure 22), except there are no Pleistocene outcrops. The barrier is approximately 70 m wide, overall, with a maximum thickness of only 1.5 m, and a volume of approximately  $50\text{m}^3/\text{m}$  shoreline. Offshore, there is a wide expanse of relict marsh deposits which have a very gentle slope (about 1:1000) so that at spring low tide as much as 500 m of tidal flat may be exposed (Maurmeyer, 1978). The beach itself is about 13 m wide (Friedlander, et. al., 1977), with a slope of 1:16 (Maurmeyer, 1978). Landward of the berm crest there is a wide, flat washover terrace which is approximately 50 m wide. The wide, thin nature of this barrier is characteristic of a washover-dominated system (Maurmeyer, 1978). West of the barrier is one to two kilometers of wetlands which are bordered to the west by Pleistocene highlands. A coast-perpendicular cross section through South Bowers illustrates the difference between this area and Bowers in the subsurface (Fig-

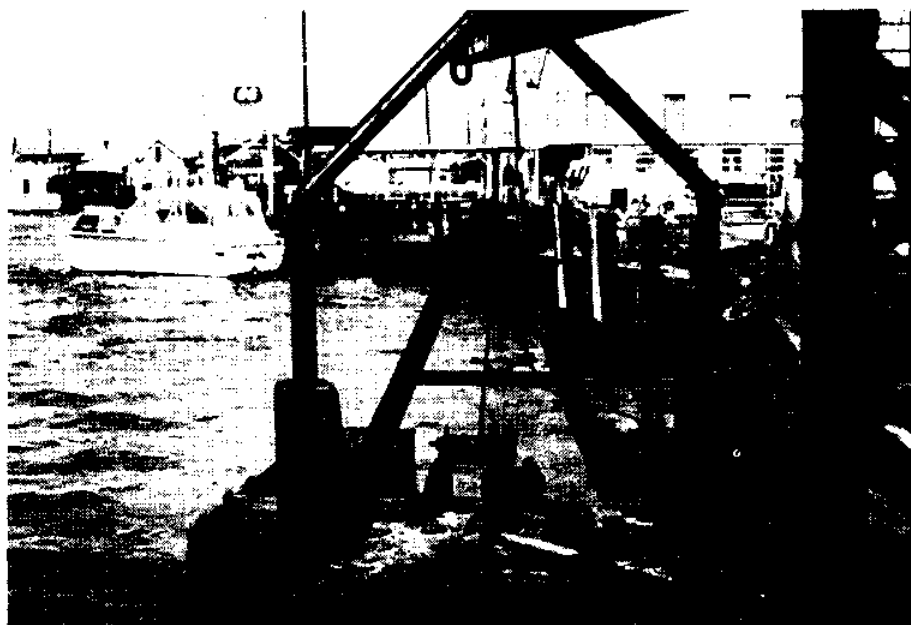
Figure 21. Fishing docks at Bowers, Delaware.

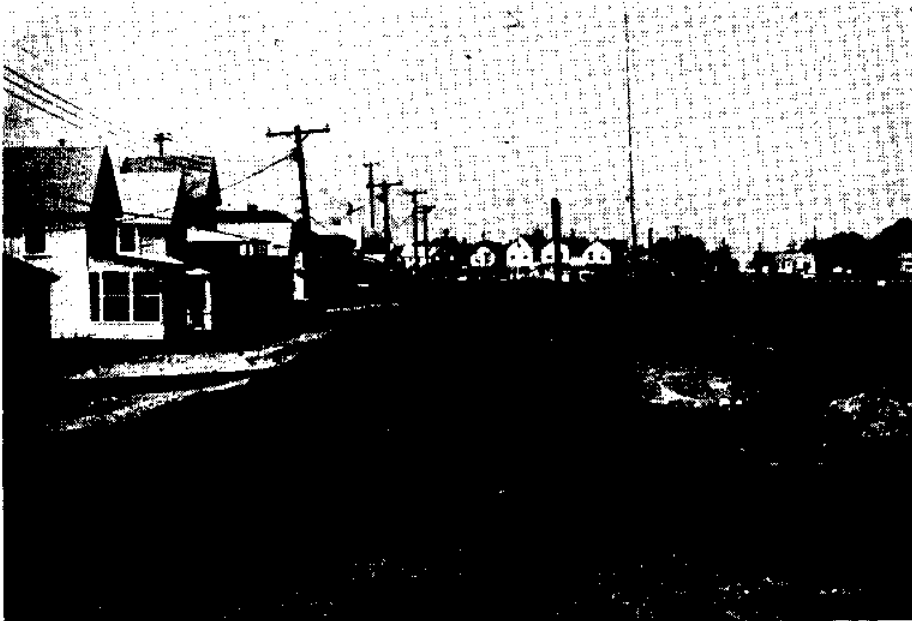
Figure 31. Ground photograph of South Bowers, Delaware, looking northward towards Bowers.

Like those of Bowers, interviewees of South Bowers were generally in agreement that the beach protection measures have been effective (Figure 31). Most liked the beach nourishment that was done (except one person, who said it made the beach coarser, with more shells and pebbles) and that it generally lasts a long time (although one resident said that it gets washed away during the next southeast storm). The groins are perceived to help control erosion as well, though their effectiveness may be diminished due to their state of disrepair. Somewhat surprisingly, about half of the people talked to did not realize that beach grass had been planted (probably since it was done in October, when few people were there) but the other half said that it has been effective in controlling aeolian erosion.

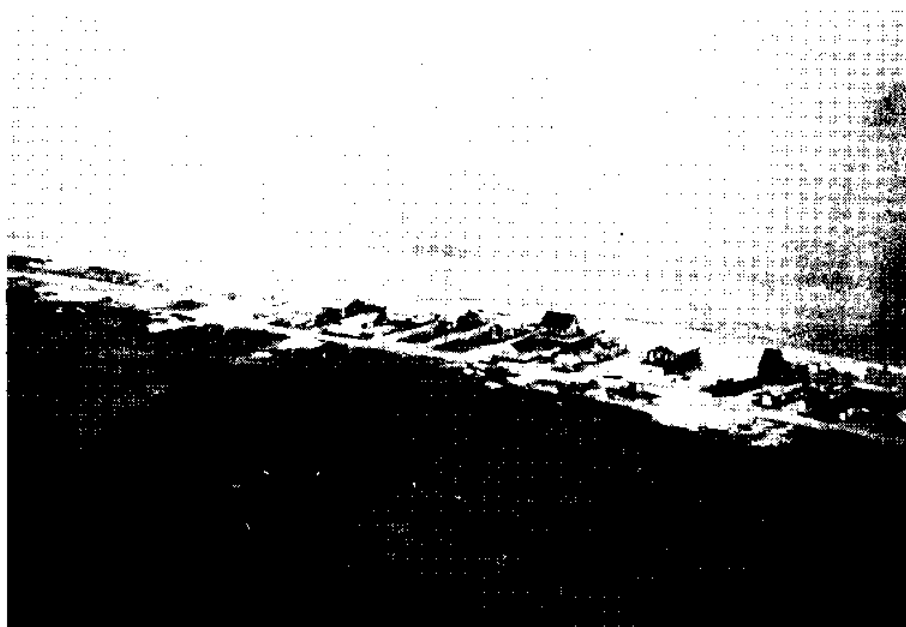
Figure 33. Aerial photograph of Big Stone Beach, Delaware (May, 1976).

Big Stone Beach, located approximately 4.0 km southeast of Bennett's Pier, has a developed section about 0.8 km long (Figures 33 and 36) with about 60 houses, most of which are only occupied in the summer. All of these are located along the landward edge of the dune line. The permanent population in 1965 was 20, and the summer population was 160. The beach in this area is approximately 21.3 m wide to the high water line, with a slope of 1:7, and is backed by a mixed sand and gravel dune, about 6.1 m wide at the base, with a maximum elevation of about 3.0 m above MLW (or 1.6 m above MHW) (U.S. Army Corps of Engineers, 1966). Several hundred meters west of the barrier, pre-Holocene highlands crop out at the surface, and, as indicated by a cross section through Big Stone Beach (Figure 37), although the barrier is situated over a thin (approximately one meter) layer of marsh muds, Pleistocene material is quite close to the surface (Kraft and John, 1976).
