# Recreational Motorboat Access on the Columbia River: Washington Shore, Dallesport to the Bar

**James M. Pacheco, Graduate Student Intern  
School of Marine Affairs  
University of Washington**

**Robert F. Goodwin, Principal Investigator  
Washington Sea Grant Program  
University of Washington**

WSG MR 96-02

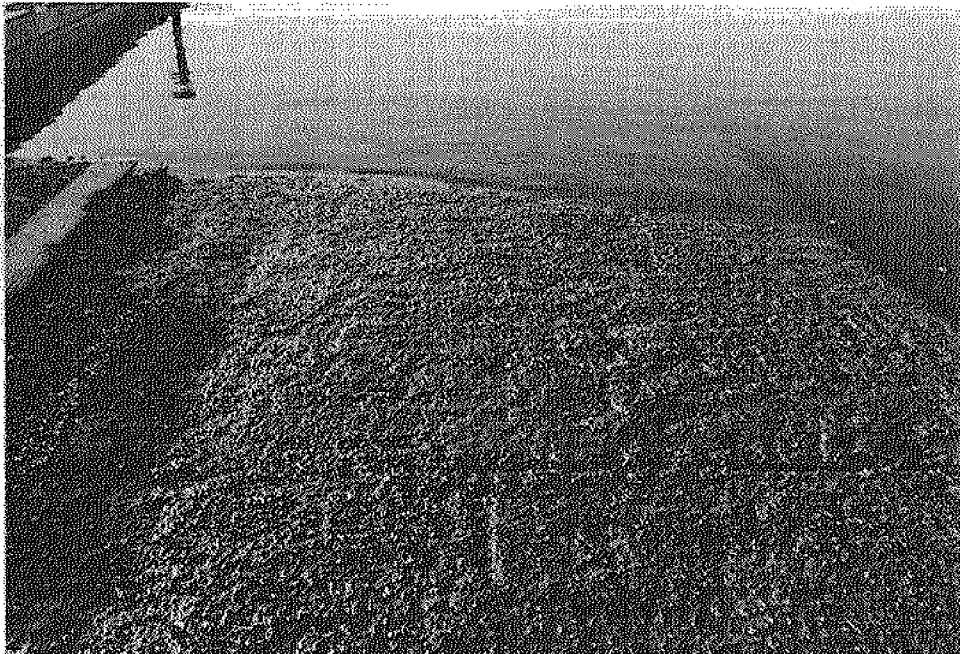
**Figure 1 (b):** Foot of boat ramp. Cracks and extensive pitting are apparent on the launch lanes.

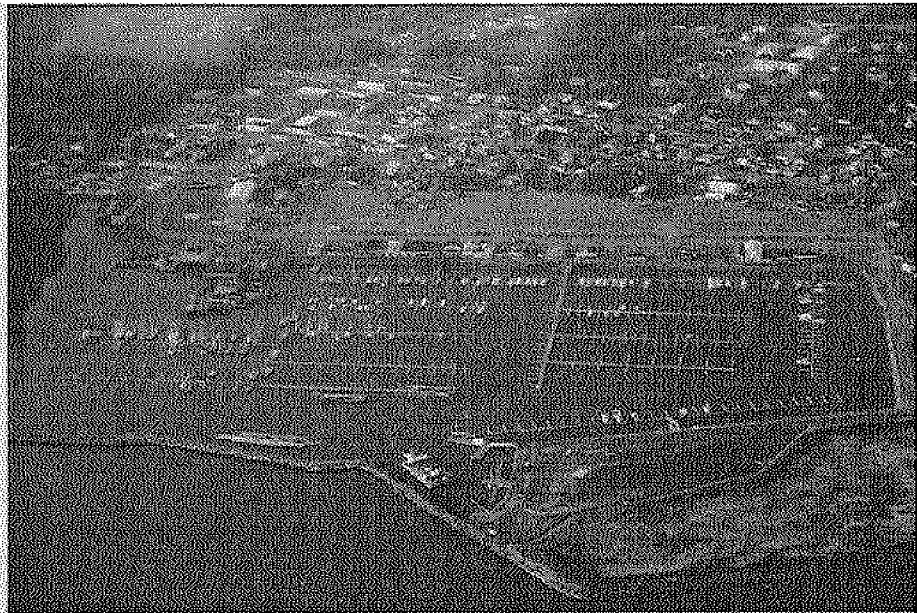
**Figure 2 (a):** Aerial view of Ilwaco. The boat ramp and boat hoists are on the lower left.

Ilwaco should consider placing additional restroom at several convenient locations. Port officials should perform a market analysis to compare their fees with other boating facilities. Because of the wind and shallow water in Baker Bay, Ilwaco may want to explore the potential of providing a launch site and services for windsurfers. However, there are many old pilings in the area. This could be a hazard and may limit the area's utility as a windsurf site. The port may also expand their recreational boater market share if it were to make appropriate managerial changes to make recreational boaters feel wanted and welcomed.

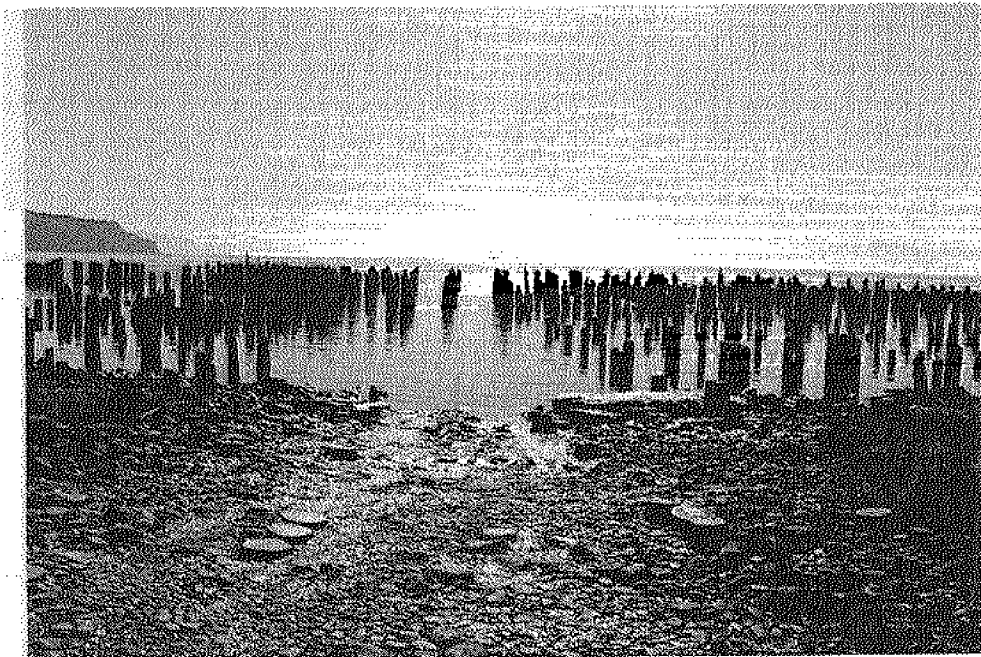
**Figure 4 (b):** Boater-improved "ramp". Boaters have removed pilings and obstacles from the beach to better access the river.

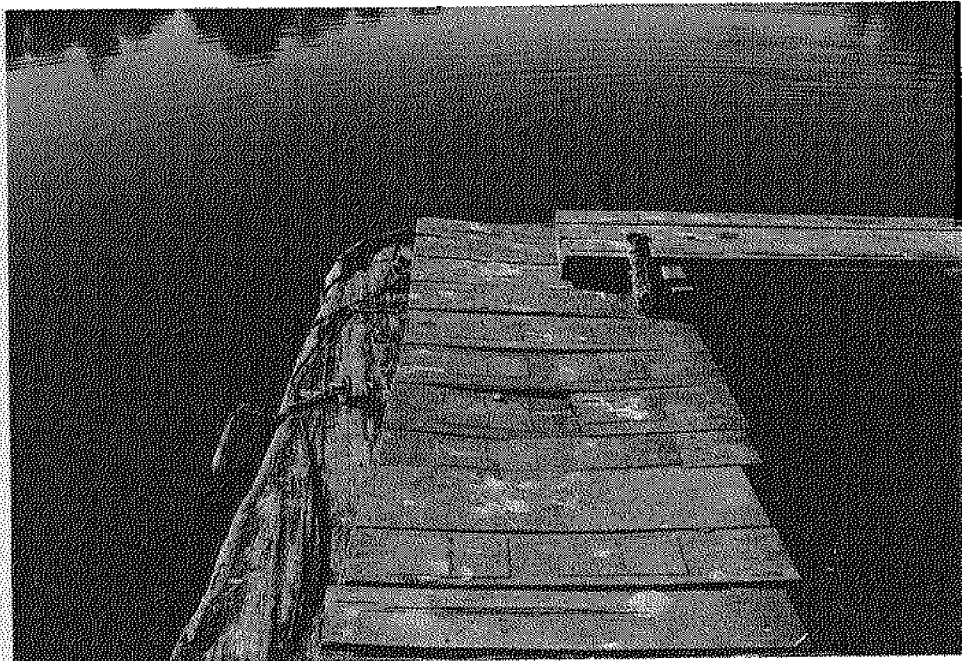
**Figure 5 (b):** Close-up of the courtesy dock. The boards on this log float are weak, patched, or broken.

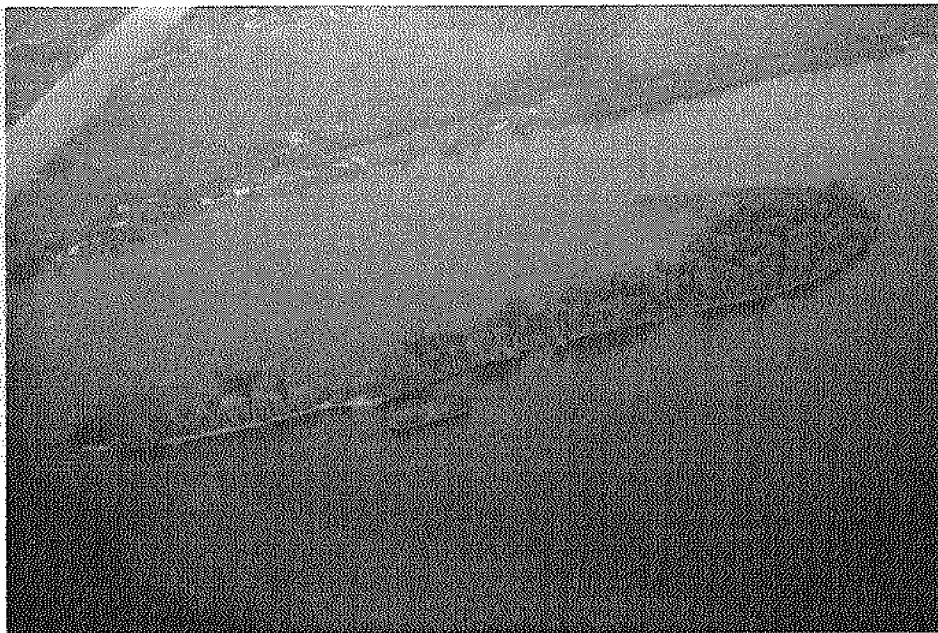
**Figure 16:** Aerial view of the Columbia River side of Coffee Pot Island.

Three boaters recommended developing a transient moorage facility on Coffee Pot Island. Investigators recommend constructing a transient moorage float with beach access near the northwest end of the island where water depths of 8 ft. 40 ft. from the shore are found. A primitive campground with a vault or composting toilet and designated fire pits should be developed on the island. Trash cans would be helpful, but would entail periodic pick-up. An alternative is to let the boaters self-police the area. Informative signage on the proper way to dispose of trash and human waste would not be as effective, but would reduce maintenance costs.

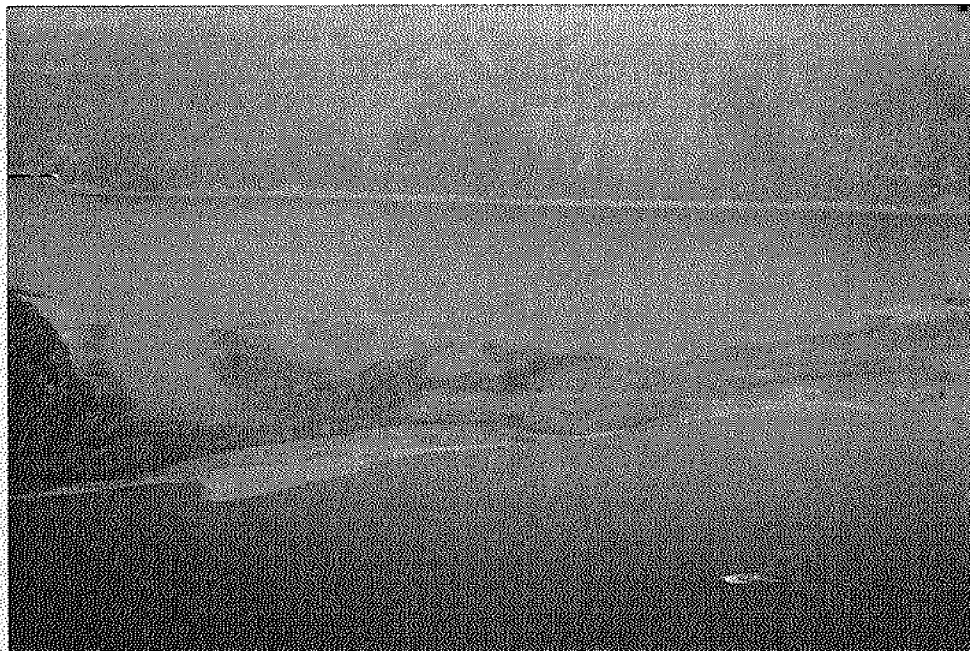
**Figure 17:** Aerial view of the eastern edge of Puget Island. The north side has adequate water depth and access to sandy beaches.

If a transient moorage and camping facility on Coffee Pot Island is not feasible, a facility on the northeast side of Puget Island, near the dolphins south of Nassa Point, should be considered as an alternative. A camping facility should also be considered for the boaters and sailboarders who frequent this site. This facility would have to be carefully sited due to the potential for high winds and flooding. This location is preferred over the others on the island because it offers deep water, some wind protection and is distant from the shipping channel. It is also close to good nature viewing areas and to the Elochoman Slough Marina to provide boater services. No boaters recommended this site.

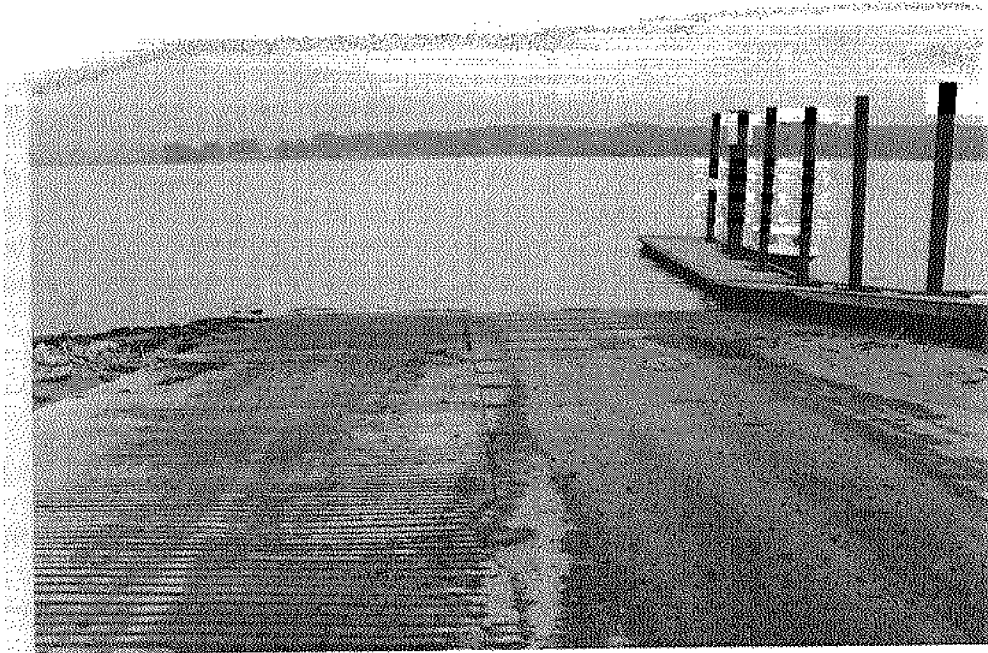
**Figure 22 (a):** The Weyerhaeuser courtesy dock is short, but in good condition. There are no cleats or tie-up devices on the ramp side of the dock.

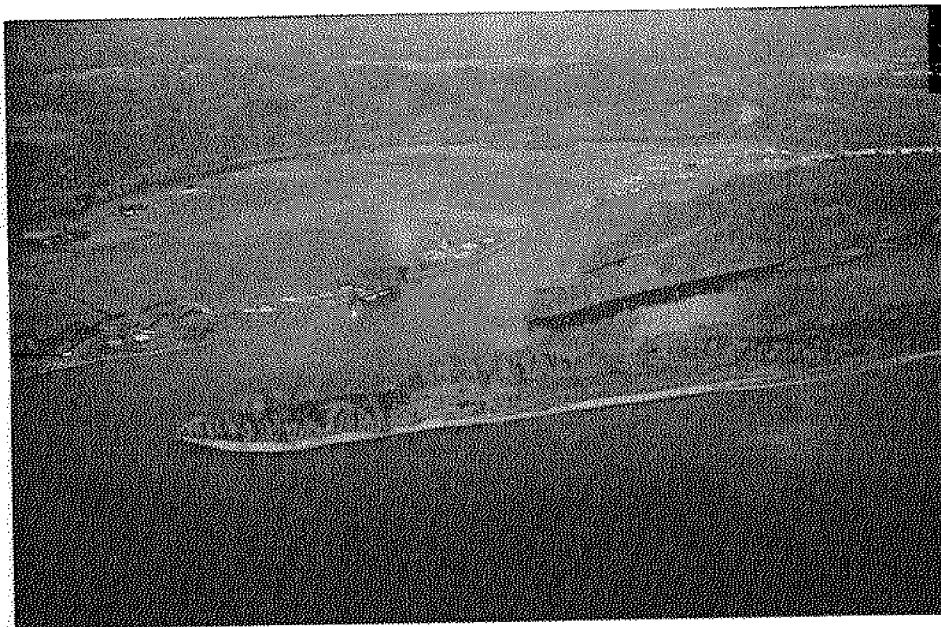
**Figure 27:** Aerial view of Hump and Fisher Island. Transient moorage is proposed below the western tip of Fisher Island.

Although Hump Island was not recommended by boaters, investigators believe it would make a good location for a transient moorage float. The site has adequate water depth, good wind and wake protection, sandy beaches, scenic views, and open areas already used for camping. Investigators recommend constructing a transient moorage float with shore access along the western third of the northwest side of the island to make the existing recreational use of the island more convenient. Trash cans would be helpful, but would entail periodic pick-up. An alternative is to ask the boaters to self-police the area. Informative signage on the proper way to dispose of trash and human waste may not be as effective, but would reduce maintenance costs. Adjacent Fisher Island does not have any open areas and is not suitable for development.

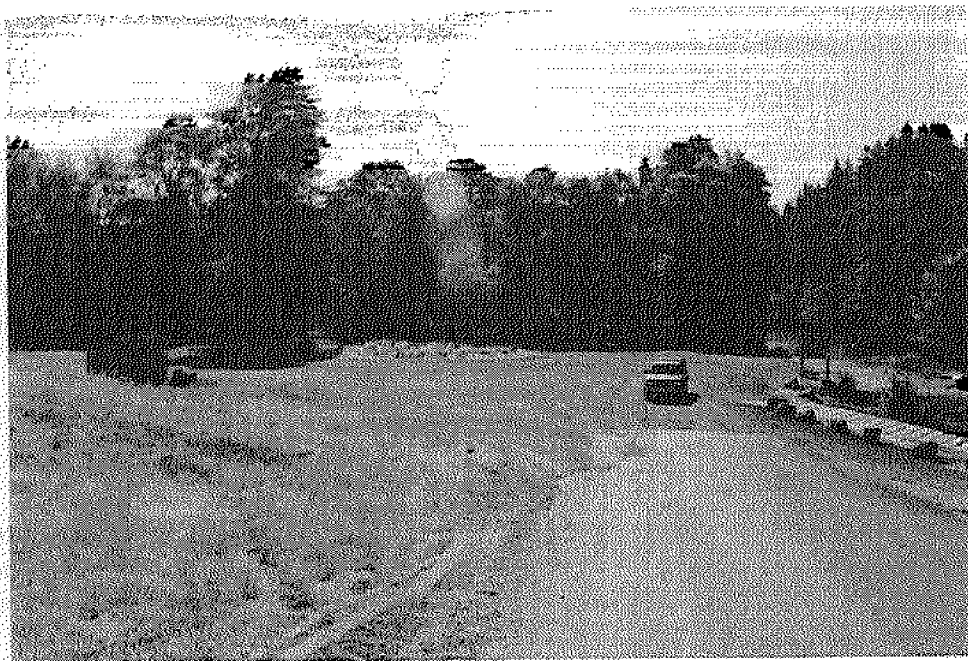
**Figure 34 (b):** A standard Washington Department of Fish and Wildlife public fishing wildlife access area with a ramp, gravel parking area, and a vault toilet.

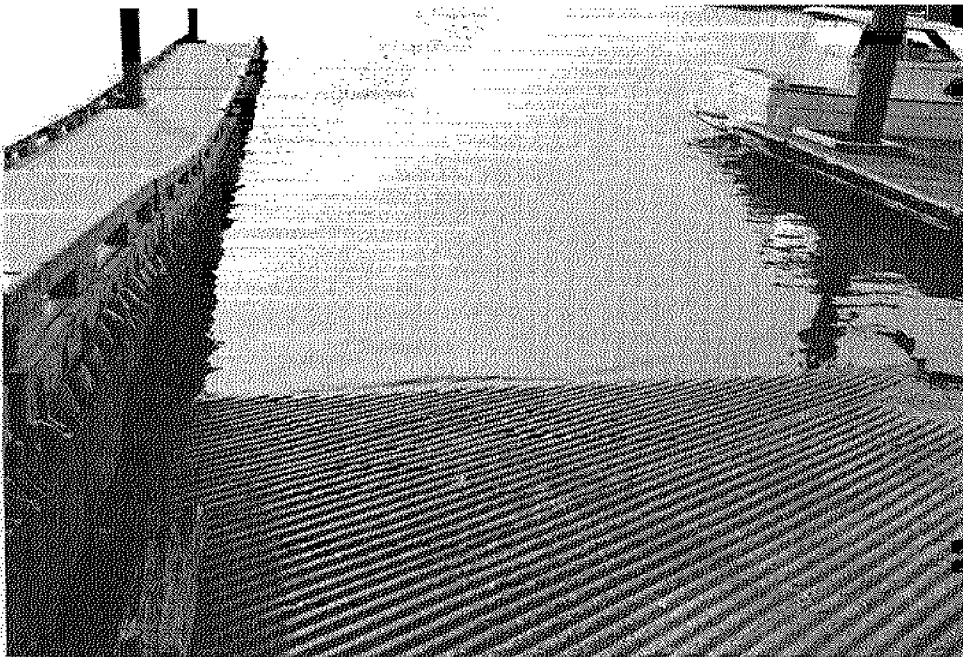
**Figure 35 (b):** A close-up of the ramp and courtesy dock. Both are in good condition. The dock on the right needs repair.

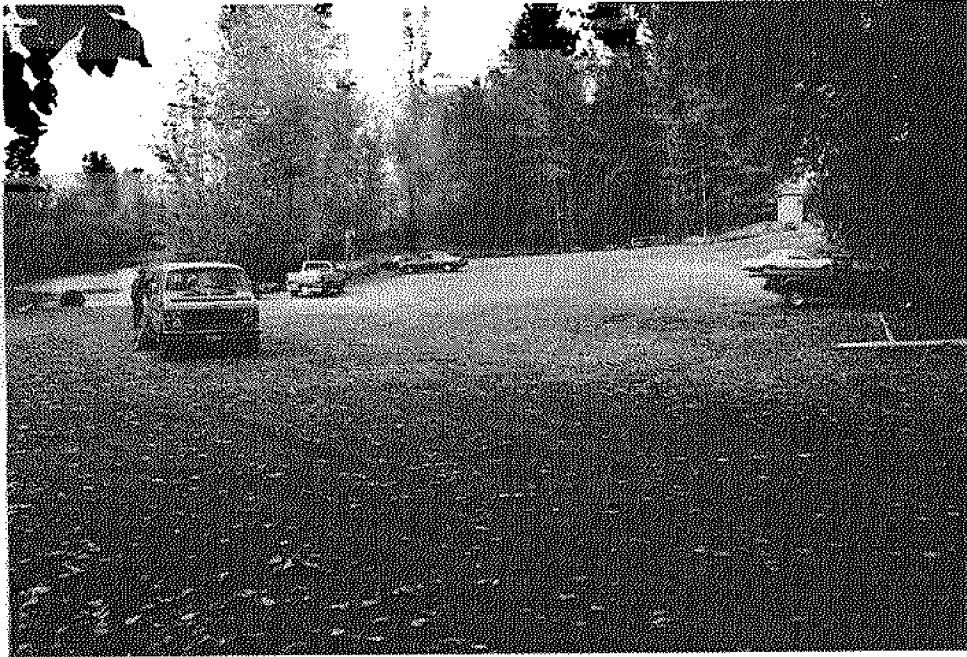
**Figure 36 (a):** The amenities offered at Caterpillar ramp are limited to a parking area and a vault toilet (right). A van preparing to use the launch ramp.

A courtesy dock is needed. A dock parallel to the shore would give boaters a useful facility and fishermen a better point for bank fishing. A trash can is also needed. Local fishermen in other areas take responsibility for emptying trash cans. They might be willing to do the same here.

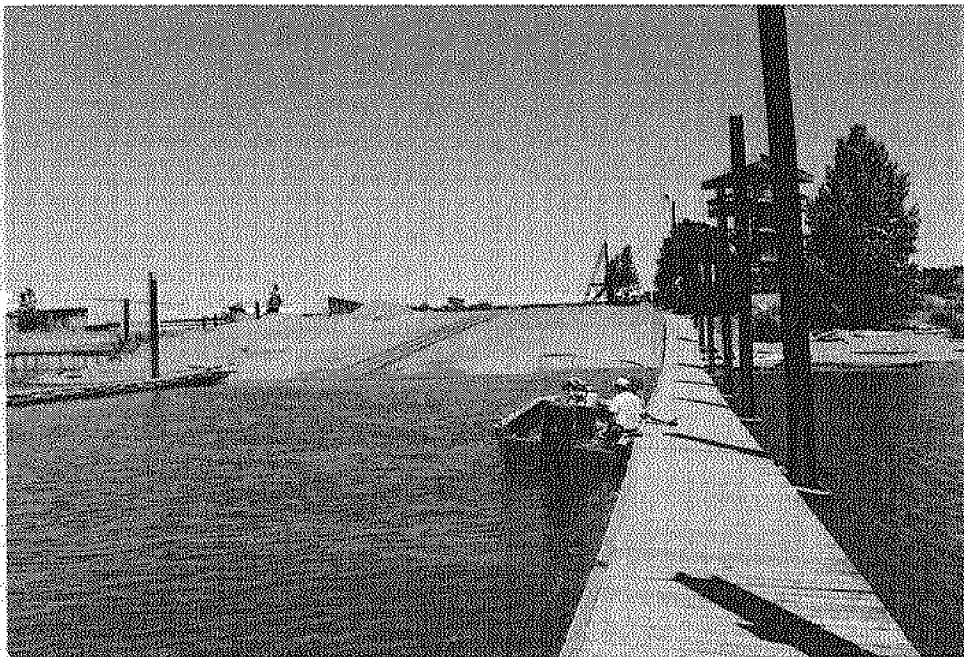
**Figure 43 (b):** Boating access at Marine Park. The launch ramp is in good condition, but has faded lane markers. The two courtesy docks are in good condition. The viewing platform is on the distant right.

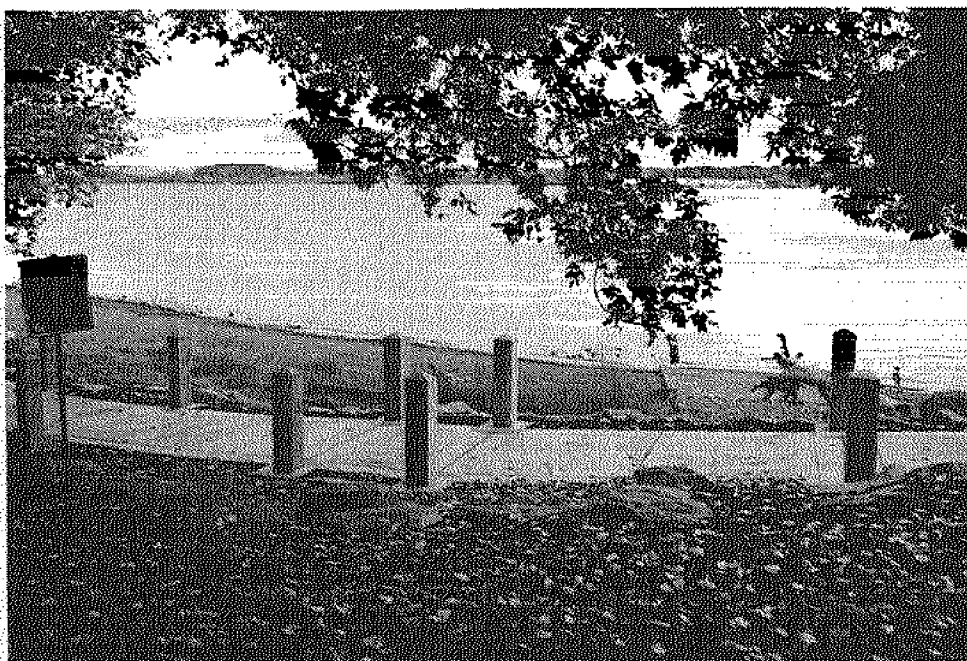
**Figure 45:** Waterfront Park has a barrier free access trail to the beach. The remains of the old ramp are on the distant right.

Although this site was not mentioned, eleven boaters wanted additional facilities in Vancouver. Because additional waterfront land is expensive to acquire, it is hard to justify blocking off an existing site. Vancouver Marine Park is only one-mile upstream, but it is heavily congested and experiences conflicts between user groups, e.g., between cruising boaters and personal watercraft (PWC) users. Since separating PWC from other launching vessels would alleviate some of these conflicts, investigators recommend reopening the old ramp but only for PWC and hand launched vessels. A transient moorage dock was considered at the north end, but is not recommended due to the close proximity of the shipping channel and Vancouver Landing.

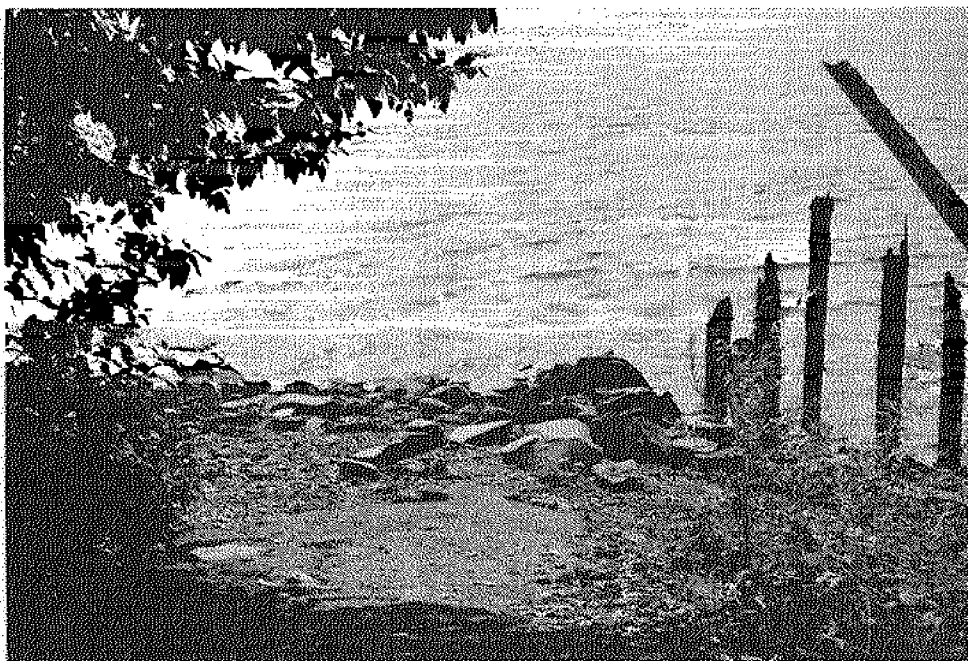
**Figure 47:** The remains of an old asphalt boat ramp and dock at Fishers Landing at a low water level. The ramp drop-off and large rocks prevent current boating access.

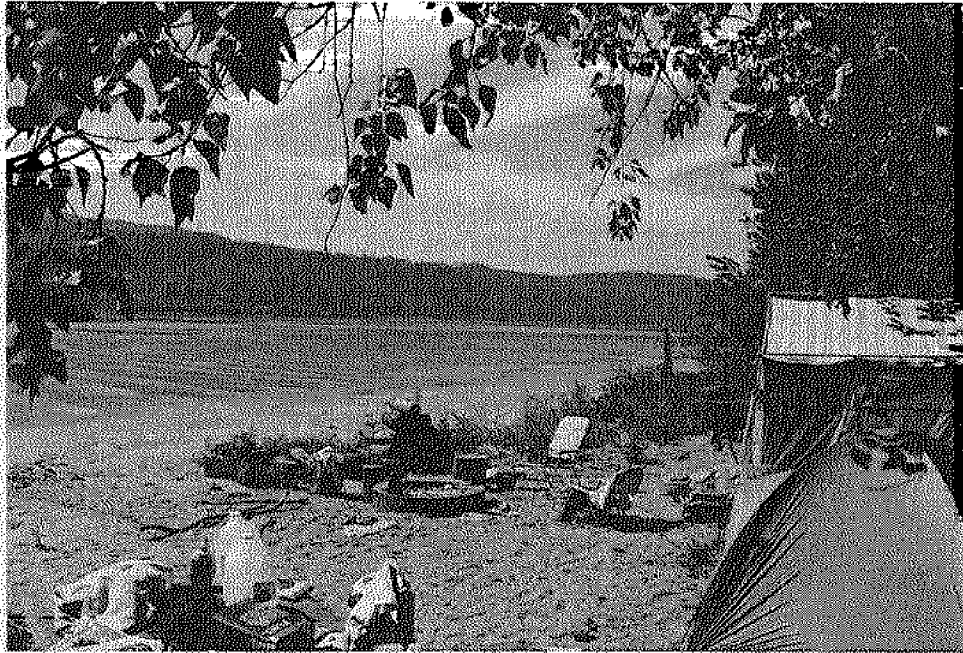
**Figure 51 (a):** A scenic view from Reed Island's only remaining campsite. All other campsites and the restroom have been washed away.

Reed island will continue to erode unless it receives some protection. A series of training dikes should be placed to direct river flow into the main channel and around the back side of Reed Island. This would protect the island itself, and it would also protect the shallow shelf which was observed to be excellent fish habitat.

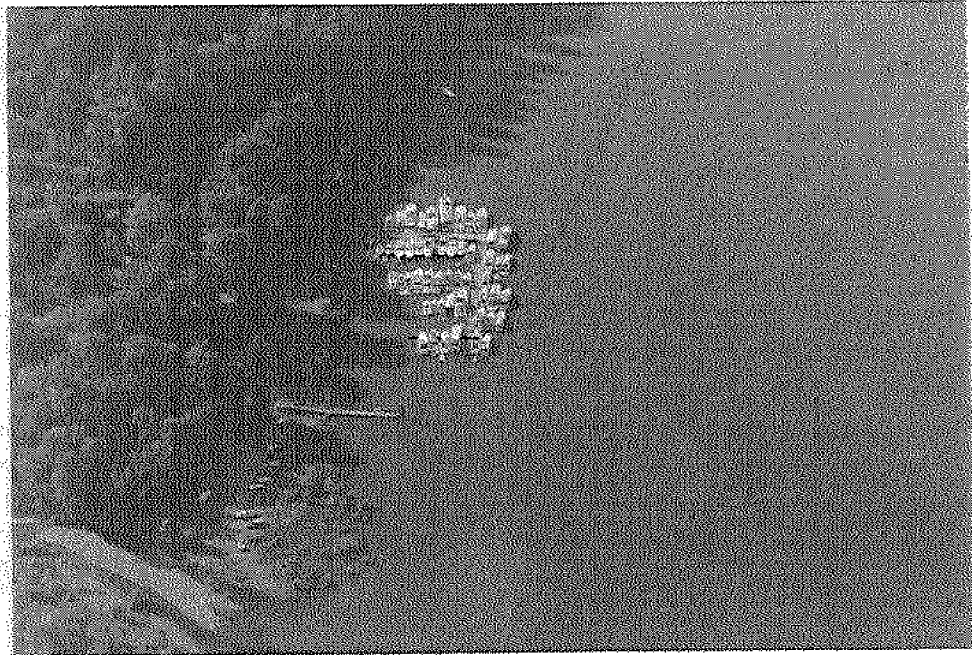
**Figure 52 (a):** Beacon Rock on Memorial Day weekend, 1995. The boat ramp and courtesy dock are below the transient dock.

Transient moorage would be improved with additional dock space. The plans for a pump-out station would also be a welcomed improvement. At the campground and boat ramp, the plans to replace the restroom and improve the water supply are needed, but Beacon Rock also needs to have its parking area expanded and reorganized so that it leave the shoreline available for walking and viewing. In addition, the effects of the strong current need to be reduced and past damage repaired.

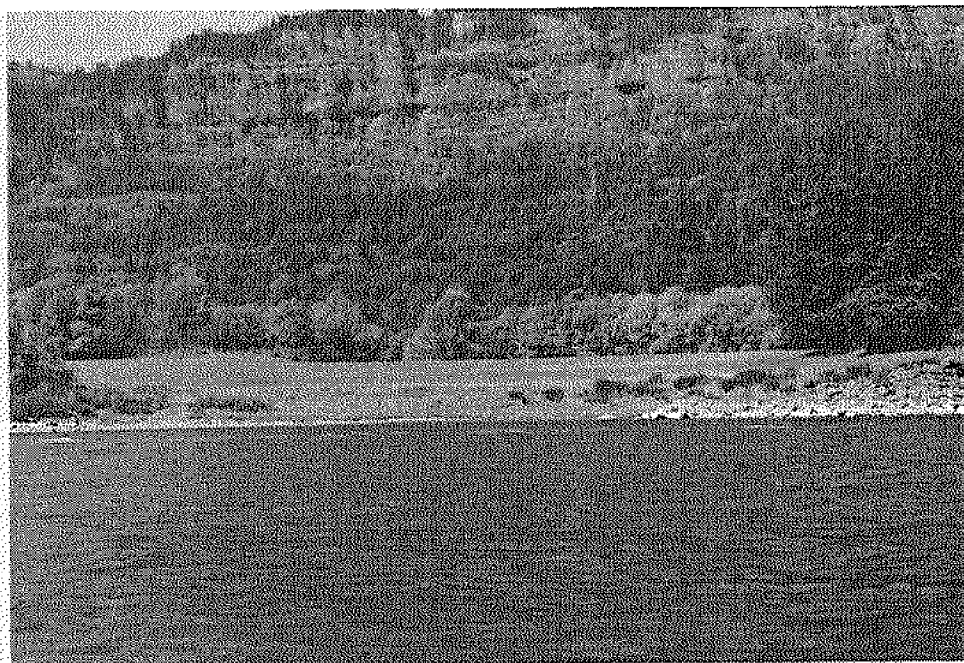
Figure 55 (b): Fir Point has a flat, well protected site behind Skamania Island that is suitable for a boat ramp and transient moorage facility.

This site was not recommended by boaters. However, since the nearest boat ramps are 10.5 miles downstream and 6 miles upstream, investigators recommend acquiring this site and developing a boat ramp, transient moorage, and a day-use and/or camping facility. This reach is quite scenic, but there are few public boating access points. Investigators give priority to trying to develop a boating access facility at publicly owned St. Cloud. However, if that is not possible, state and local agencies should acquire this site and try to obtain a variance to construct a single lane boat ramp, a transient moorage facility and day use area. If the variance is not given, this site could still be used for transient moorage. The site would probably be expensive to acquire, but since there are so few potential public boating access sites on this stretch of the river, it should be considered.

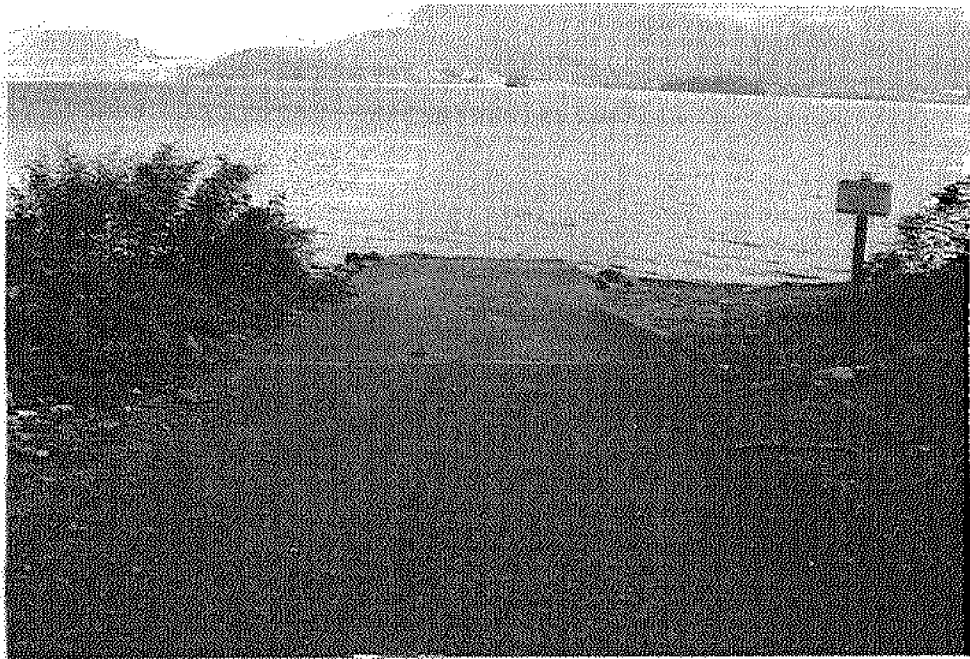
**Figure 57 (a):** The simple boat launch facility at the Port of Skamania. The sign on the right warns boaters of the strong unpredictable winds common in this area.

Because public boating access is limited in this area, the Stevenson site should be improved. The ramp should be expanded to a double lane with a courtesy dock, it should have wind and wave protection, and it should include a transient dock with shore access. The addition of a pump-out and fuel dock would be a welcomed improvement to this stretch of the river.

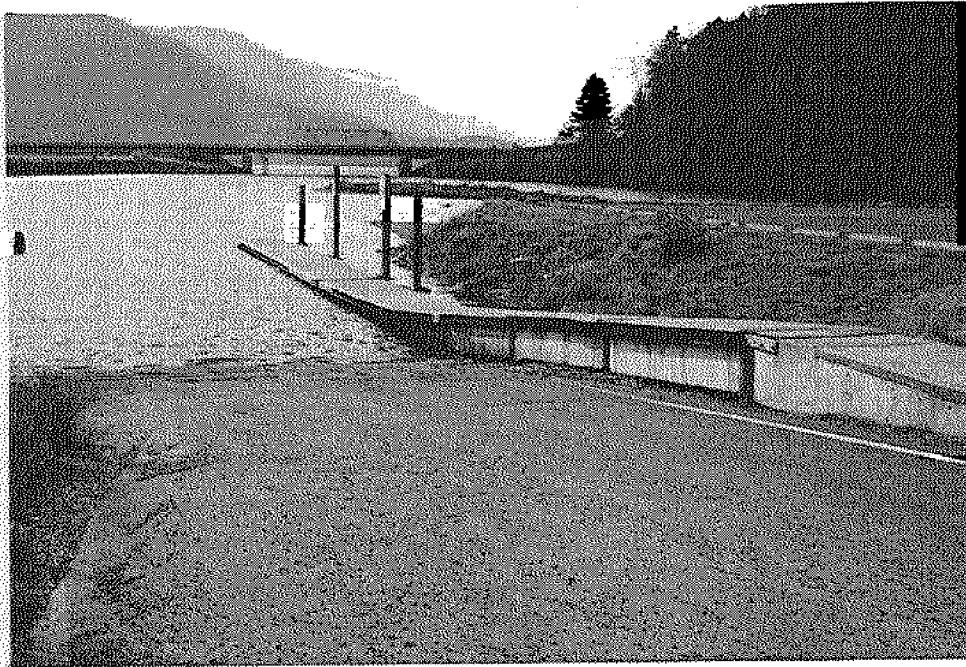
**Figure 58 (a):** A boating access facility at Wind River. The parking lot is on the right. There are no tie-up devices on the courtesy dock.

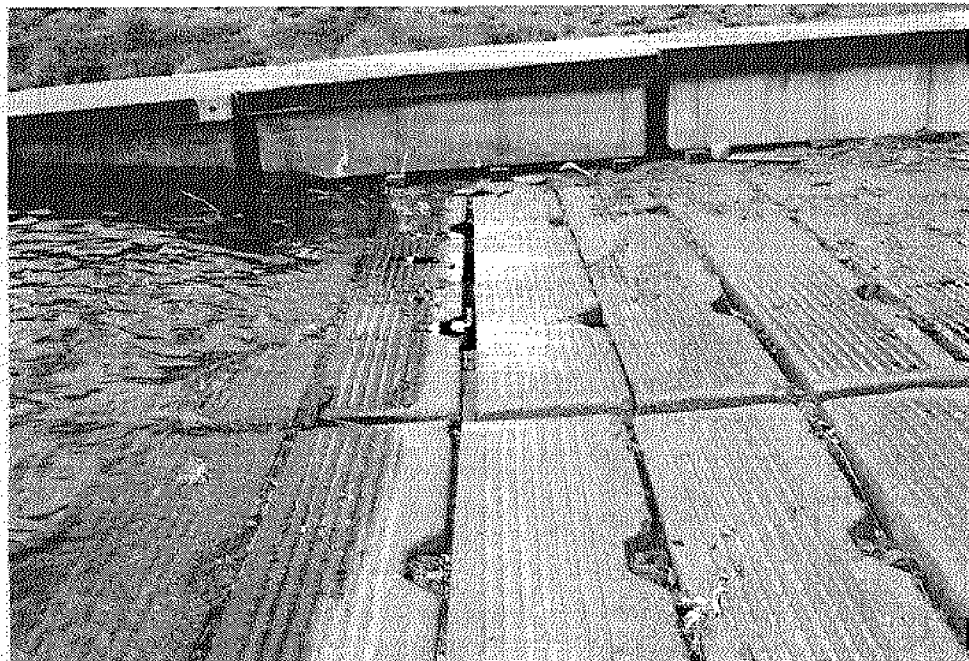
**Figure 58 (b):** Close-up view of the ramp. Some scuffing between the planks has occurred and should be repaired.

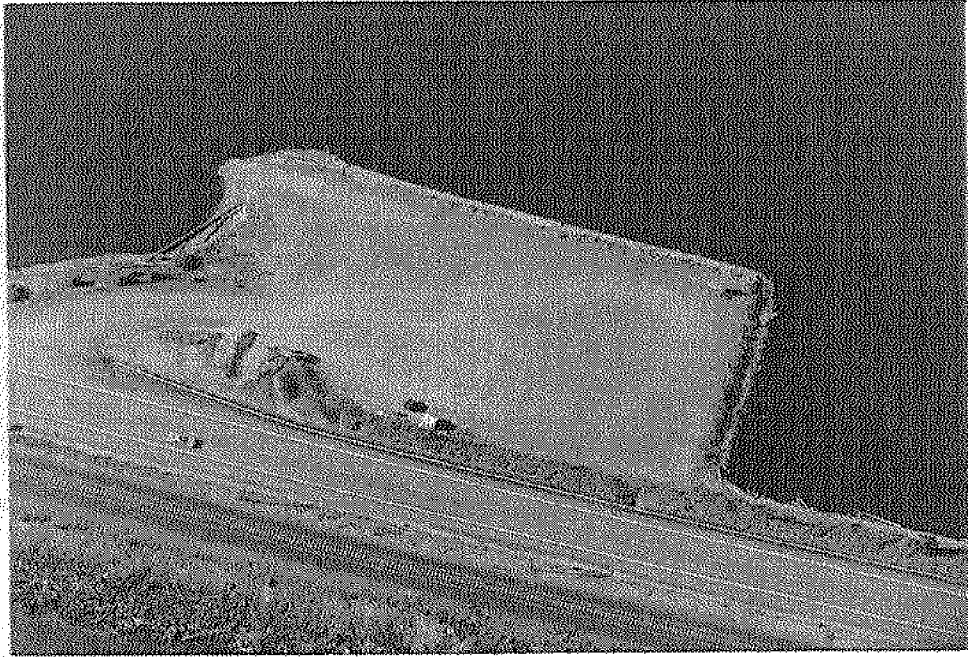
**Figure 59 (a):** Aerial view of the boating access facility at Drano Lake. A portable toilet and trash can are the only amenities.

This area shows a demand for camping. In addition to improving this site as planned, the county should investigate providing a camping area around Drano Lake.

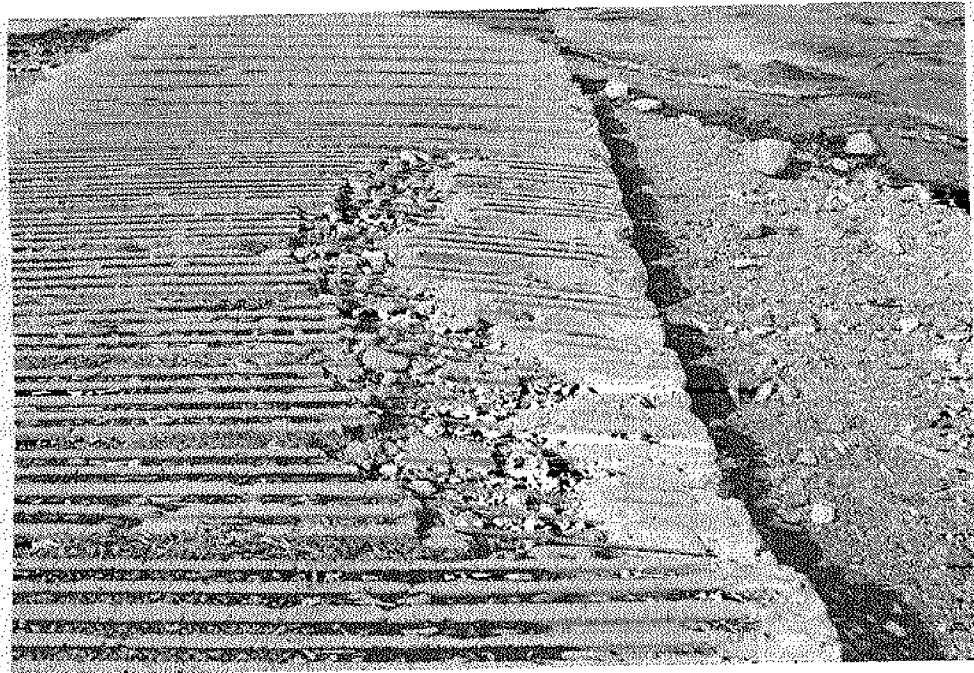
**Figure 59 (b):** A close-up view of the concrete plank launch ramp at Drano Lake. The ramp is structurally damaged.

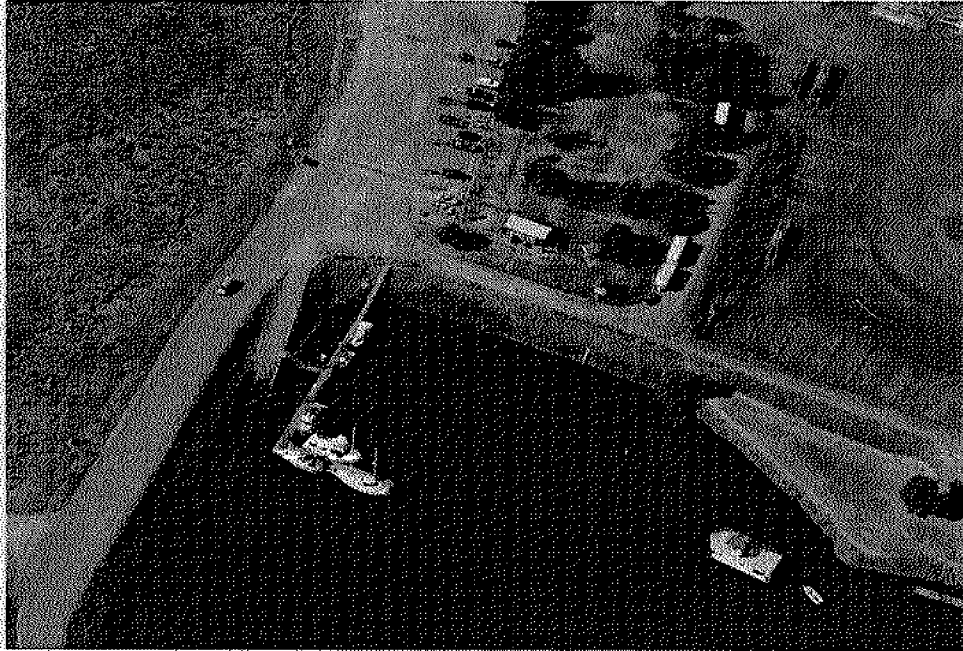
**Figure 60 (a):** Aerial view of the Bingen Marina. The grassy area (upper center) is the R/V park. A separate trailer parking area has been developed.

In addition to the marina development plans, the port should continue its efforts to develop viewing platforms and interpretive signage along the wetland.

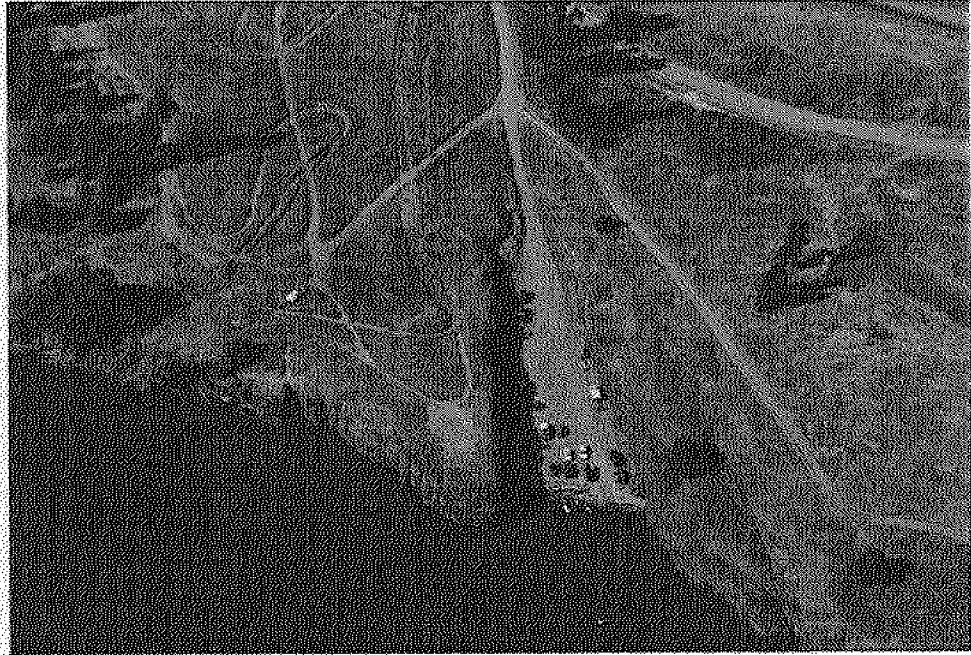
**Figure 61 (a):** Aerial view of the Lyle ramp. The site is not well organized.

As the only access point in the area, this site represents an important opportunity for improvement and expansion. Much needs to be done. A new two lane ramp with a courtesy dock should be constructed on the west side of the canyon. Signage and a better access road are also needed. Transient moorage could be developed along the point, one-quarter mile east of the ramp. This point provides protection from westerly winds and has deep water. The transient dock should be attached to land providing boaters with easy access to Lyle.
