# **PRESQUE ISLE BAY WATERSHED RESTORATION, PROTECTION, AND MONITORING PLAN**

April 2010

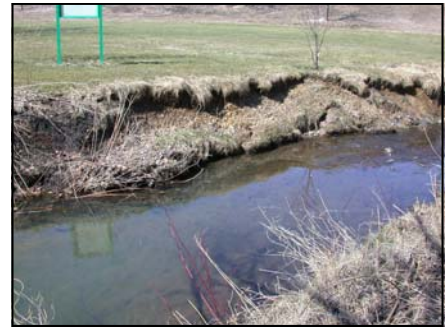
Figure 6. Loss of streamside riparian habitat along Cascade Creek

Overall results from the physiochemical assessment indicated that the loss of streamside riparian habitat (**Figure 6**) was a major factor contributing to degraded water quality in the more developed areas of the Presque Isle Bay watershed (Campbell *et al.* 2002). Diz and Johnson (2002) concluded that the restoration of stream banks and riparian zones with natural vegetation (in already developed areas), and limiting construction activities in areas where these habitats are currently intact would be helpful to protect the streams in the watershed from pollution.

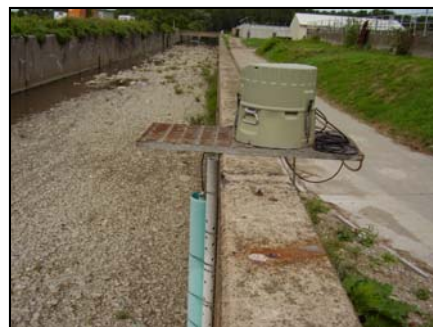
Figure 8. ISCO 6712 sampler used to collect storm water from Mill Creek

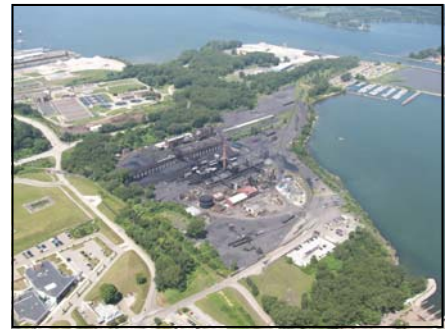
Figure 9. Potential sources of point source pollution

Point source pollution, commonly associated with facilities and/or locations with the potential to impact the watershed, refers to single, identifiable sources that discharge pollutants into the environment ([Figure 9](#)). While there are many federal (e.g. Clean Water Act and Clean Air Act) and state (e.g. Pennsylvania Clean Streams Law and Air Pollution Control Act) regulations in place to prevent these facilities and locations from impacting the watershed, it is important to document these facilities due to the fact that pollutants have the potential to be introduced into the environment through point sources (e.g. air emission, wastewater discharge, etc.). The GIS-based point source assessment data were created by

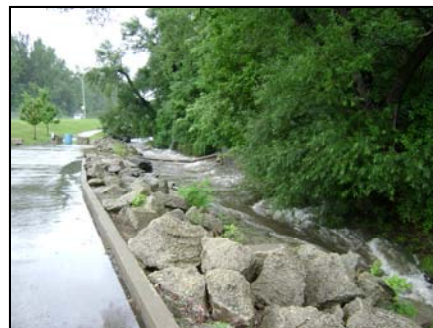
Figure 10. Storm water runoff entering Cascade Creek along the Bayfront Highway

Nonpoint source pollution is pollution whose sources cannot be traced to a single point. This occurs when rainfall, snowmelt, or irrigation water moves over the land or through the ground, picks up pollutants, and deposits them into streams, lakes, and oceans; or introduces them into our ground water (**Figure 10**). Major types of nonpoint source pollution include pathogens, nutrients, toxic contaminants, and debris (Arnold and Gibbons 1996). In 2003, the National Pollutant Discharge Elimination System (NPDES) Phase II regulations were implemented with the intention of improving waterways by reducing the quantity of pollutants that storm water picks up and carries into storm sewer systems during storm events. Despite the NPDES Phase II program, nonpoint source pollution from storm water runoff continues to be the leading cause of water quality problems in the United States.

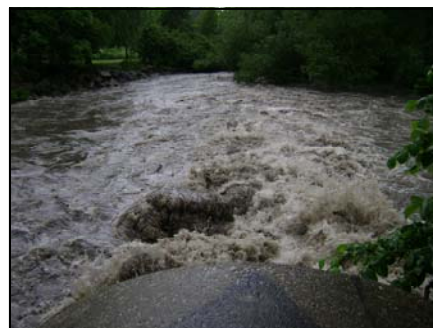
Figure 12. Increased volume of storm water entering Cascade Creek during a storm event

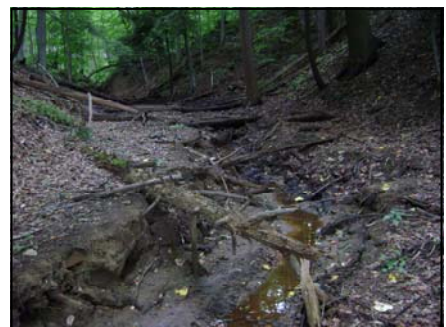
Figure 14. Steep slopes along Scott Run

Disturbance of steep slopes along stream banks can result in erosion processes from storm water runoff and the subsequent sedimentation of surface waters, often leading to degraded water quality and loss of aquatic life (**Figure 14**). Other effects include soil loss, changes in natural topography and drainage patterns, increased flooding potential, further fragmentation of forest areas, and compromised aesthetic values. Because sloping terrains are prone to erosion if disturbed, Arendt

(1999) suggests slopes over 25% should be avoided for clearing, re-grading, or construction, and slopes between 15-25% require special site planning and should also be avoided whenever possible. The vast majority of land within the Presque Isle Bay watershed is sloped less than 15%, and only a small fraction of land is sloped greater than 25% ([Map 33](#)). Areas within the watershed with greater than 25% percent slope should be restored and protected.

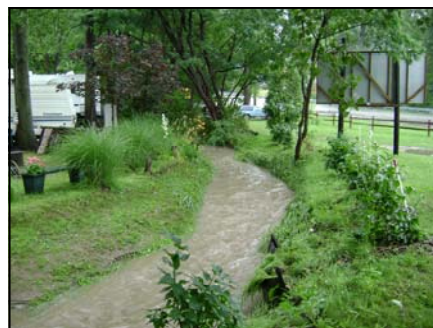
Figure 15. Scott Run riparian buffer

- Scott Run has the potential for 0.04 mi<sup>2</sup> of 30 m buffers and 0.12 mi<sup>2</sup> of 90 m buffers. The existing vegetated buffer for Scott Run is 0.04 mi<sup>2</sup> and includes 46% (0.02 mi<sup>2</sup>) of the potential 30 m buffer, 27% (0.03 mi<sup>2</sup>) of the potential 90 m buffer, while 19% (0.007 mi<sup>2</sup>) of the existing vegetated buffer expands beyond 90 m ([Map 34](#); [Figure 15](#)).

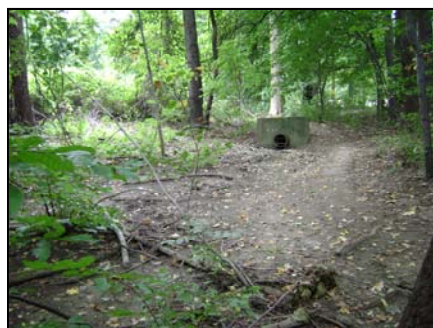
Figure 16. Unnamed Tributary One riparian buffer

- Unnamed Tributary One and Two have the potential for 0.06 mi<sup>2</sup> of 30 m buffers and 0.15 mi<sup>2</sup> of 90 m buffers. The existing vegetated buffer for the Unnamed Tributaries is 0.16 mi<sup>2</sup> and includes 77% (0.04 mi<sup>2</sup>) of the potential 30 m buffer, 56% (0.09 mi<sup>2</sup>) of the potential 90 m buffer, while 46% (0.07 mi<sup>2</sup>) of the existing vegetated buffer expands beyond 90 m ([Map 35](#); [Figure 16](#)).

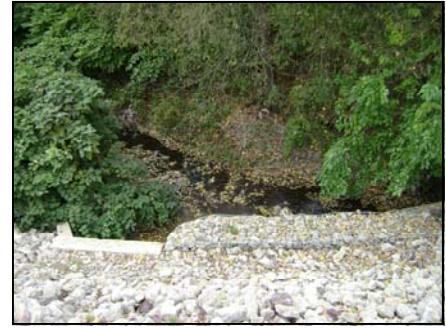
Figure 19. Garrison Run riparian buffer

- Garrison Run has the potential for 0.03 mi<sup>2</sup> of 30 m buffers and 0.08 mi<sup>2</sup> of 90 m buffers. The existing vegetated buffer for Garrison Run is 0.02 mi<sup>2</sup> and includes 51% (0.01 mi<sup>2</sup>) of potential 30 m buffer, 23% (0.02 mi<sup>2</sup>) of potential 90 m buffer, while 13% (0.003 mi<sup>2</sup>) of the existing vegetated buffer expands beyond 90 m ([Map 38](#); [Figure 19](#)).

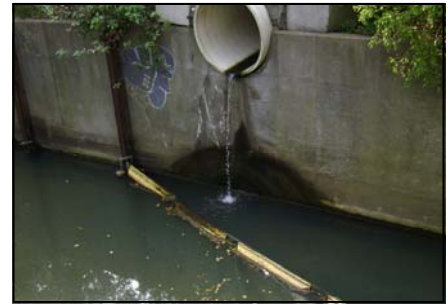
Figure 20. Pipe discharging into Cascade Creek during dry weather

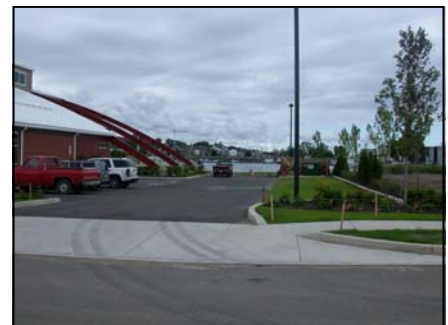
Figure 22. Grass parking lot at the Bayfront Center for Maritime Studies

- Goal #3:** Reduce the impacts of storm water runoff on water quality and increase the natural filtering capacity of the Presque Isle Bay watershed. Objectives include:
- reduce the percentage of impervious cover within the sub-basins (i.e. Scott Run, Cascade Creek, Mill Creek, Garrison Run, and Unnamed tributaries) of the Presque Isle Bay watershed;
  - install rain gardens, green roofs, pervious pavement, and other storm water reducing best management practices within the watershed (**Figure 22**); and
  - increase the acreage of wetlands within the Presque Isle Bay watershed.

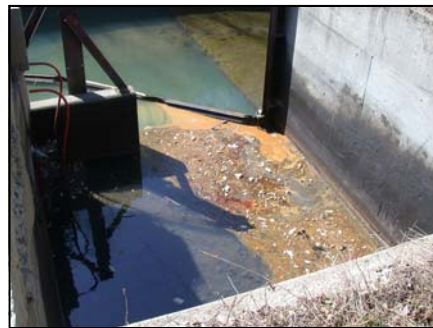
Figure 23. Debris separator located on Cascade Creek in Cascade Creek subarea 12

Cascade Creek subarea 12 drains a predominately industrial and residential area, and includes an 85 linear foot daylight segment of the Main Branch of Cascade Creek. Currently, there is a debris separator installed on Cascade Creek within this subarea (**Figure 23**). This debris separator should be regularly

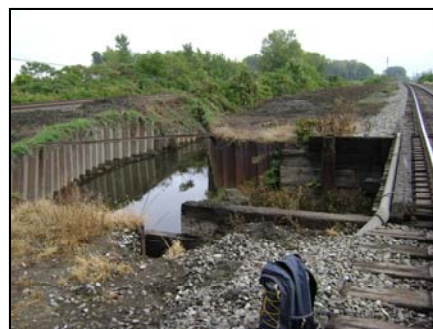
Figure 24. Impaired riparian buffer along Cascade Creek in Cascade Creek subarea 8

- establishing a riparian buffer (**Figure 24**);
- separating commercial and residential down spouts from the storm sewer system;
- installing rain gardens in residential areas; and
- assessing and expanding existing wetlands ([Map 54](#)).

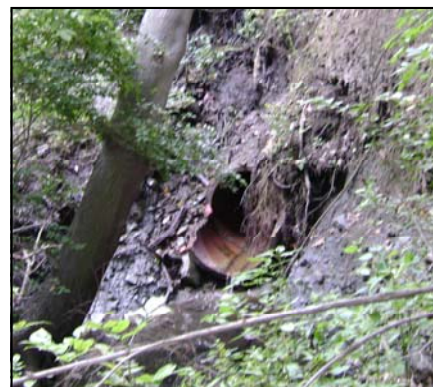
Figure 25. Storm water outfall located in Direct Runoff subarea 3

Direct Runoff subarea 3 drains a predominately residential area adjacent to Frontier Park and includes one direct storm water discharge to Presque Isle Bay (**Figure 25**). Restoration efforts should focus on:

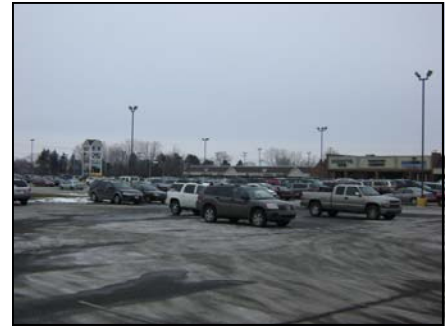
Figure 26. Commercial area located in Scott Run subarea 1

Scott Run subarea 1 drains a predominately commercial and industrial land area, including Yorktown Center (**Figure 26**). Restoration efforts should focus on:

- separating commercial down spouts from the storm sewer system;
- installing oil/grit separators in storm sewer grates; and
- removing any unused impervious surfaces ([Map 56](#)).

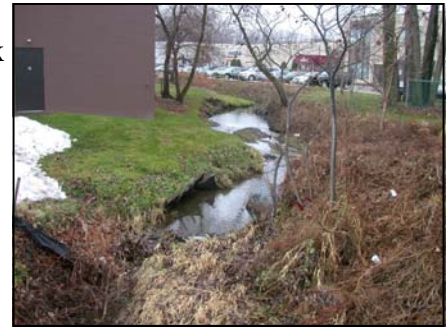
Figure 27. Impaired riparian buffer along Cascade Creek in Cascade Creek subarea 7

- establishing a riparian buffer (**Figure 27**);
- re-vegetating the concrete stream channel along Cascade Creek (**Figure 28**);
- separating downspouts from the stream (**Figure 29**); and
- assessing, remediating, and expanding wetlands.

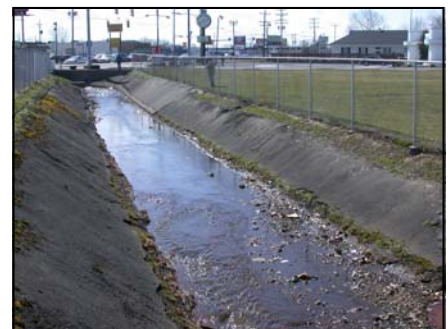
Figure 28. Channelized section of Cascade Creek in Cascade Creek subarea 7

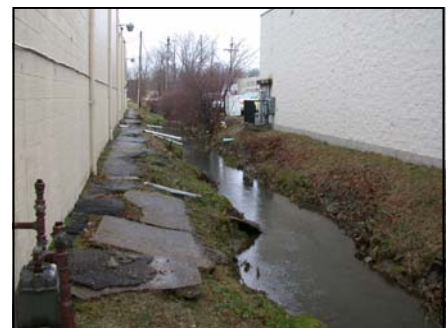
Figure 29. Downspouts discharging into Cascade Creek in Cascade Creek subarea 7

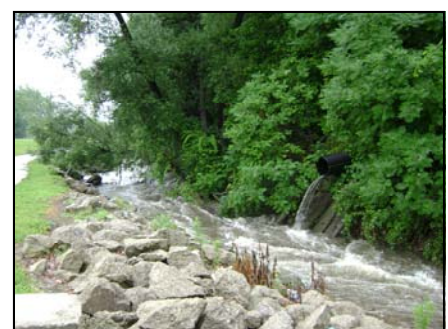
Figure 30. Riparian buffer along Cascade Creek in Cascade Creek subarea 2

- the expansion and remediation of vegetated riparian buffers along the Bayfront Connector Highway (**Figure 30**),
- assessment and restoration of wetlands near the mouth of Cascade Creek, and

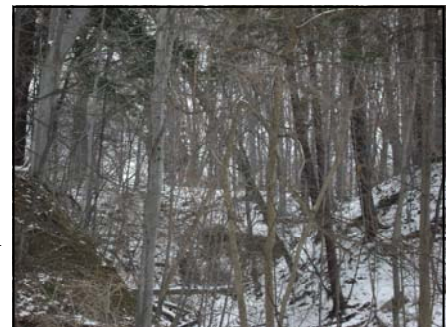
Figure 31. Forested area in Unnamed Tributary One subarea 2

Unnamed Tributary One subarea 2 (UN1 2) (score = 33): This subarea is < 25% high intensity land use, wetlands are present, and the riparian buffer is > 75% vegetated. A portion of this subarea is within the boundaries of Scott Park and is currently protected by Millcreek Township (**Figure 31**); however, the remainder of the subarea is owned by Erie Water Works (Sommerheim Water Treatment Plant) and privately owned ([Map 60](#)). Property owners within this subarea should be contacted in regard to conserving their properties.

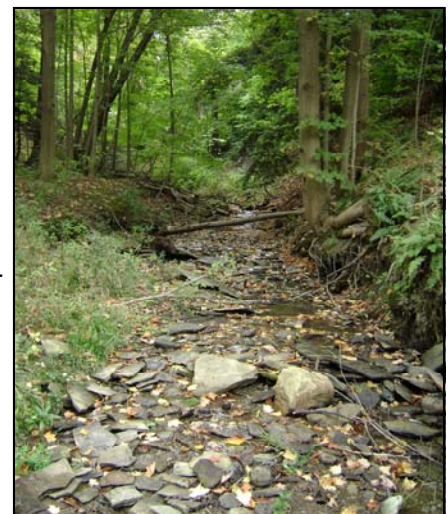
Figure 32. Riparian buffer along Mill Creek in Mill Creek subarea 17

Mill Creek subarea 17 (MC 17) (score = 32): This subarea is <25% high intensity land use, wetlands are present, the floodplain is > 75% vegetated, and the riparian buffer is > 75% vegetated. Protection efforts should focus on conserving existing wooded land, wetlands, riparian corridors, and vegetated floodplains ([Map 61](#); **Figure 32**). Property owners within this subarea area, particularly those owning property within the riparian zone, should be contacted in regard to conserving their properties. In addition, any future residential development in this subarea should consider utilizing residential conservation design techniques.

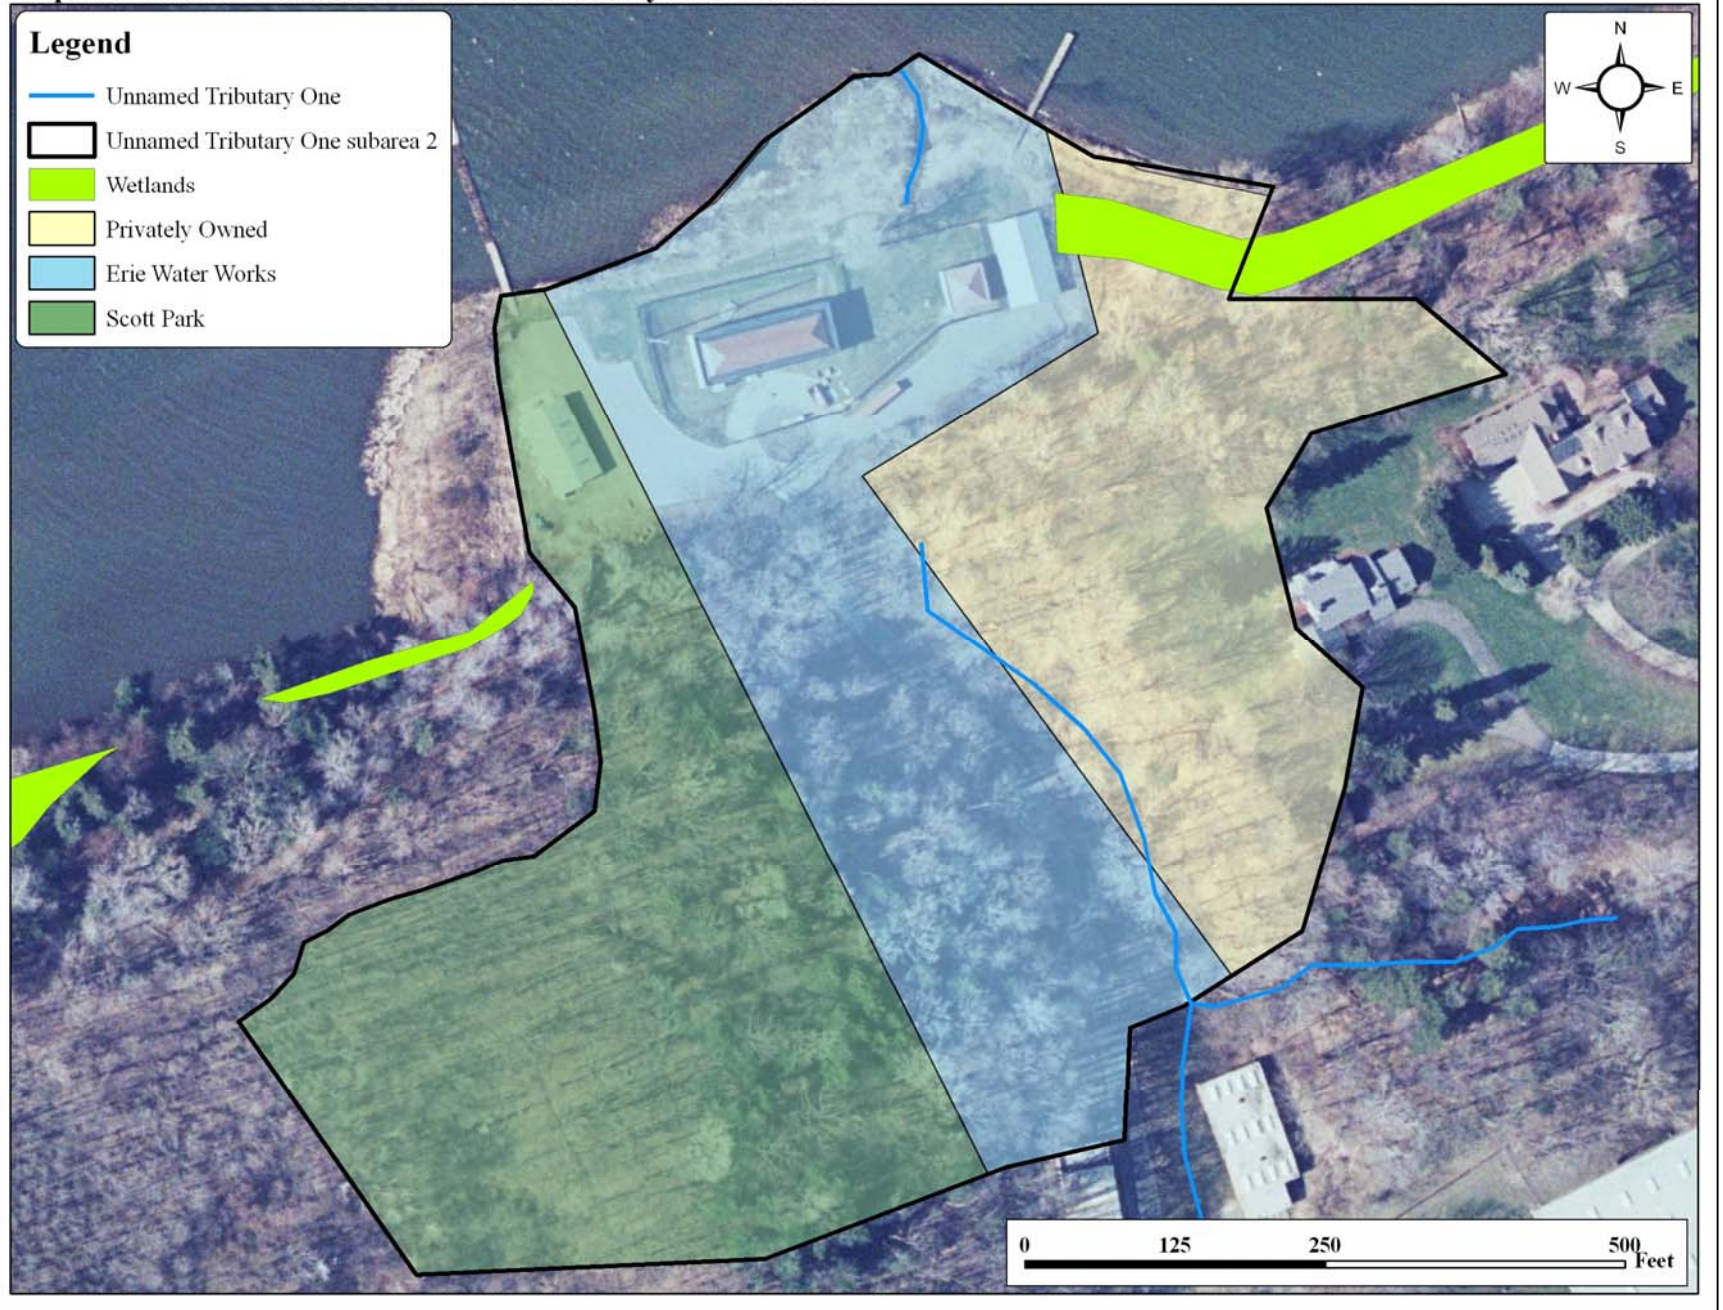
**Map 60: Protection focus for Unnamed Tributary One subarea 2**
