# An Elusive Compromise: Rhode Island Coastal Ponds and Their People

Coastal Resources Center  
University of Rhode Island  
Marine Technical Report 73

Coastal Resources Center  
University of Rhode Island  
Marine Technical Report 73  
1980

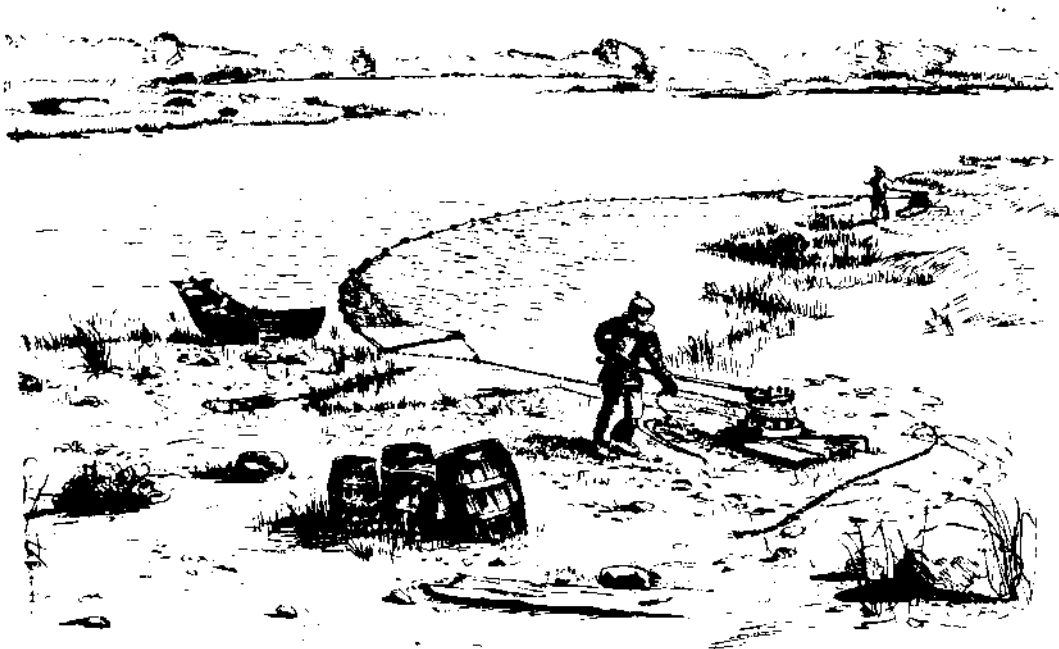
Figure 7. Seining in the ponds before the stabilized breachways. The net was laid into the water from the stern of the scow, as it was rowed in an arc from shore. Then it was hauled in with the aid of capstains. The fish were barreled and carted to shacks to be preserved in salt and packed for market.

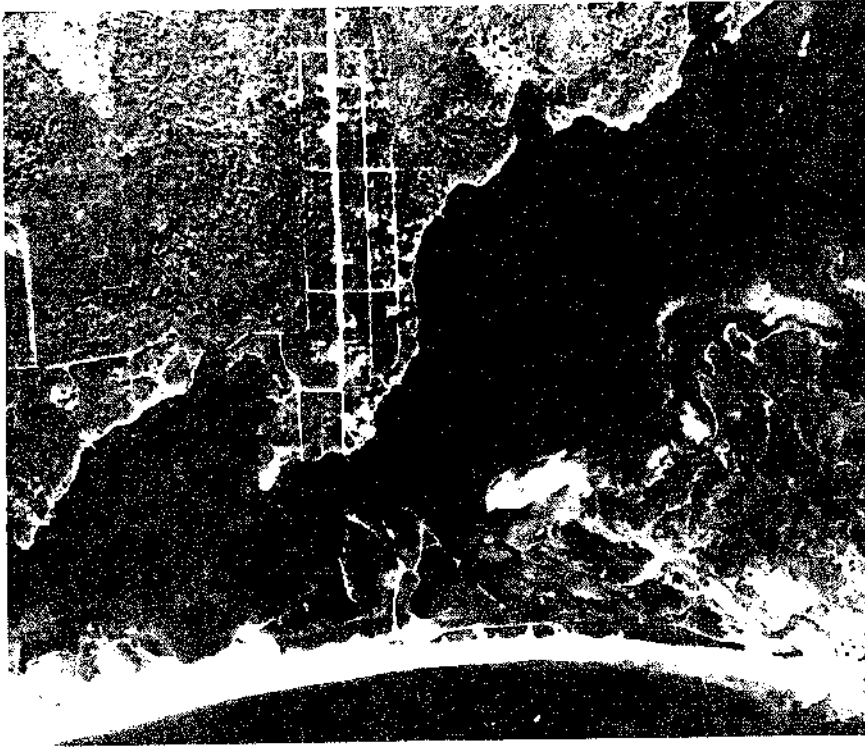
Figure 16. Aerial photograph of Quonochontaug Pond showing the large amount of sand transported into the ponds after the permanent breachway was opened.

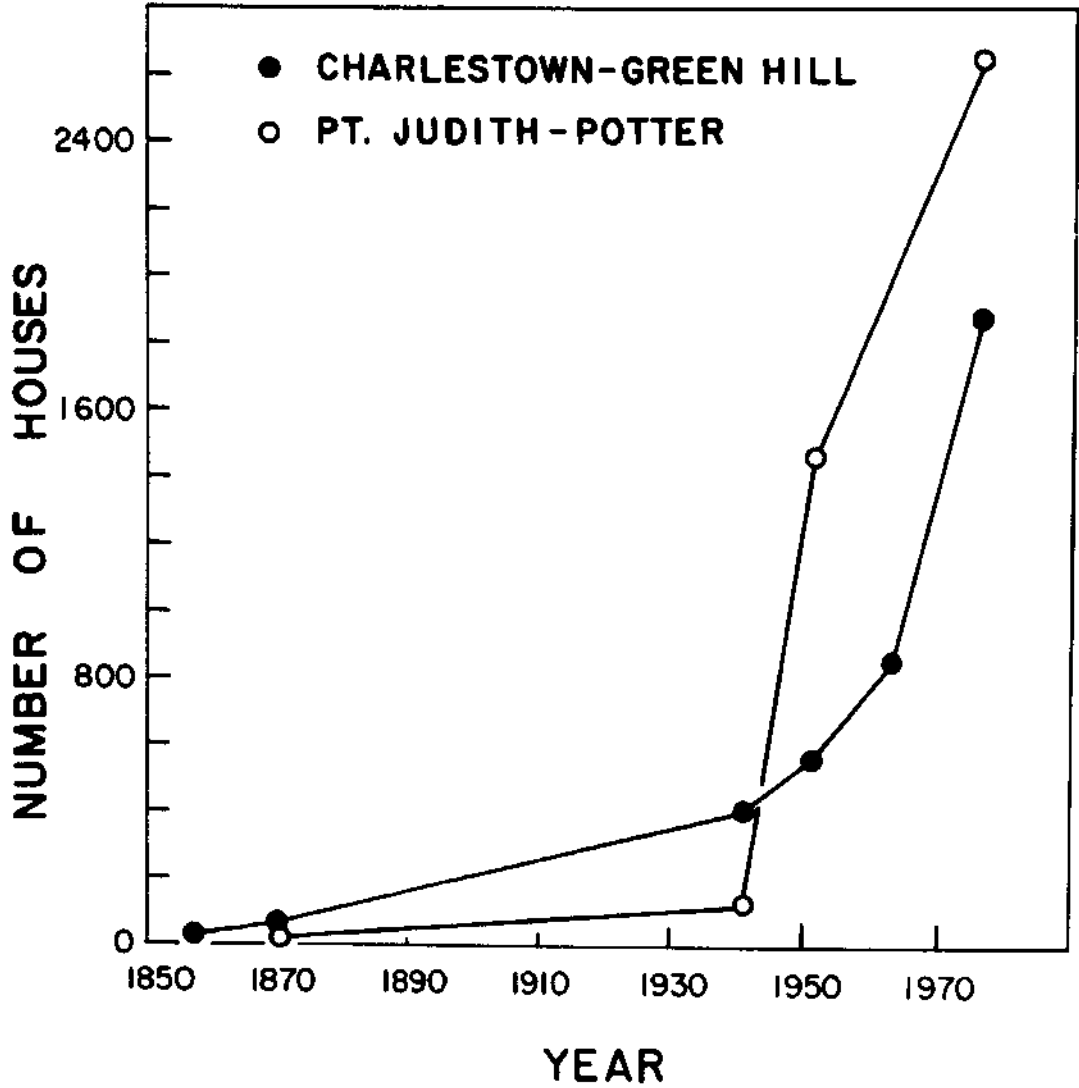
Figure 17. A graph of the dramatic increase in housing development in the area around the ponds south of Route 1. Note the particularly rapid growth rate since the 1950s.

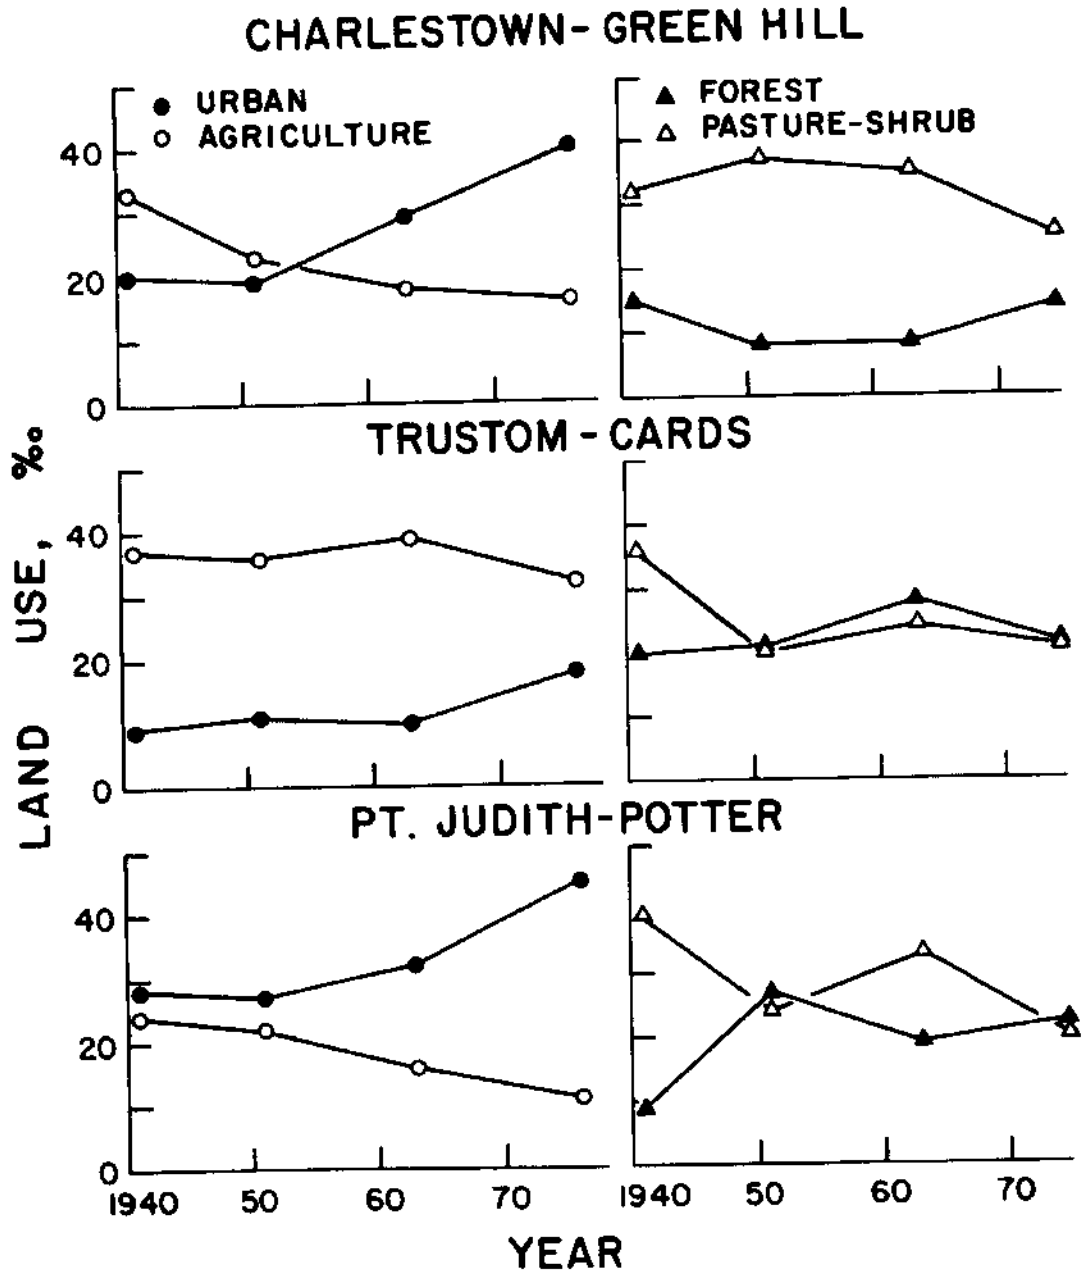
Figure 18. A graph of changes in land use over time around each of the ponds. Note that urban or residential development has occurred on the prime agricultural lands with the exception of Trustom and Cards.
