Optimizing Tori Line Designs for Pelagic Tuna Longline Fisheries

Report of work under
New Zealand Ministry of Fisheries
Special Permit 355

Edward F. Melvin and Nathan Walker

August 5, 2008

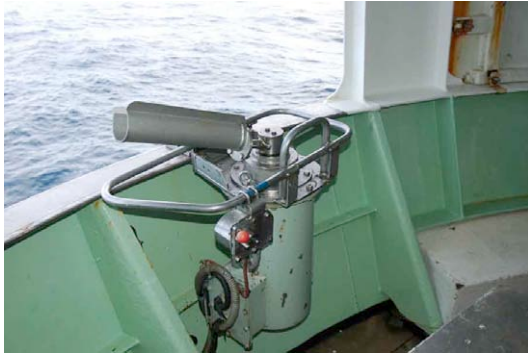
Figure 1. Bait casting machine.

The observed vessel was over 55 m (length overall) with a crew of 22 persons. It sets longlines at a vessel speed of 10.6 knots and retrieves gear on average at 6.6 knots. Baited hooks were deployed using a bait casting machine (Figure 1), which delivered each bait approximately 8 m to the port side beyond the vessel's wake every 7 seconds. The bait casting machine functions to uncoil the monofilament trace of the branchline without tangles, thus making the setting process more efficient and consistent. Floats are tossed just starboard of the midline or at the midline.

Clearly the seabird bycatch mitigation tools – dual tori lines and 12 g leads on each hook – failed during daylight hours, killing 20 birds in 138 minutes. This failure was due to the bait casting machine delivering baited hooks 2-3 m outside the port tori line and the first streamer of the tori line being over 25 m astern³. Together these factors left a 20 m span that seabirds could exploit baited hooks at will. When the first streamer of the port tori line was moved to within 11 m of the stern on the second day, the capture rate dropped from 0.30 birds per min to 0.08 birds per min. Although an improvement, this rate of seabird mortality is unacceptable. Being that baits landed port of the port tori line, the starboard tori line became irrelevant to scaring birds. In this case, the bait casting machine neutralized the mitigation effect of tori lines by pitching the bait beyond their protection. Bait loss to birds of 14.7% to 15.9% could have huge negative consequences for the fishing operation – a clear example of a no-win situation.

Because of language differences, possible modifications to the bait casting machine were not discussed (with me) or explored while at sea. It is clear that this device makes longline deployment more efficient by uncoiling the monofilament trace of the uncommonly long branchline (37 m). Tangles in this part of the line would defeat the fishability of that branchline. Also tossing each bait by hand is likely to be less efficient, require more effort by crew, and result in wide variability in where the bait lands at the surface throughout a 5.5-hour gear setting process. Adjustments to the bait casting machine to better place the baits should be explored and implemented to make this vessel less of a threat to seabirds. This experience makes it absolutely clear that a bait casting machine is not a seabird bycatch mitigation tool as has been suggested by some in the RFMO community.

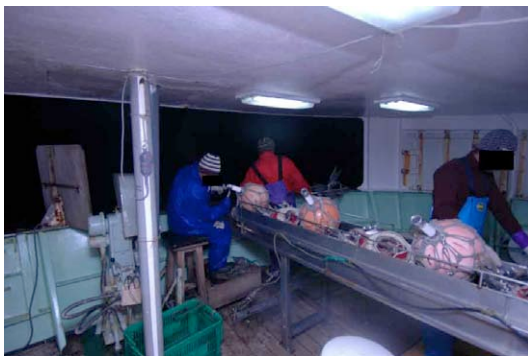
Figure 3. Setting longlines.

floats and branchlines ready for deployment (Figure 3). A third crewman baited the hooks on coiled branchlines stacked in piles of ten between tuna floats. In each basket of ten branchlines, three hooks were baited with whole *Illex* squid and the other seven were baited with whole sardine. The sequencing of the two bait types was consistent from basket to basket and set to set. Twenty “baskets” were deployed between radio beacons. Fourteen units of 20 baskets were deployed each set for a total of 2,840 hooks over an estimated distance of just less than 60 nm. This process takes 5.5 hours. Sets were made from north to south while hauls retrieved gear from south to north (See Anderson and McArdle 2002, Figure 1, for basic description of pelagic longline gear).

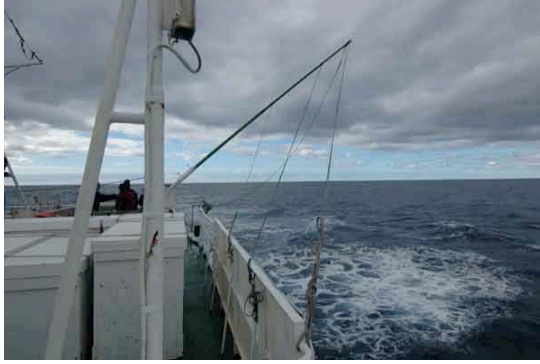
Figure 7. Port tori pole

The port tori pole stood approximately 13 m above the water. Its base was a stout, 2 m davit that arced 30 degree outboard from vertical at its top (Figure 8). The remainder of the pole was round stock steel telescoping in decreasing diameter and was further secured with 3 backstays running to the forward port rail. The tori pole (Figure 7) extended the

tori lines an estimated 3 to 4 m outboard of the port side. At a setting speed of 10.6 knots, the aerial extent was 80 to 100 m with no towed device at the seaward end. The port tori line was hauled via a dedicated winch (Figure 8) and streamers were clipped on and off using tuna snaps. The stern mast was solid steel with a cross tree at approximately 8.2 m above the water line. Several crewmen hauled the starboard tori line manually.

Although the configuration of the bait casting machine and the port tori line performed very poorly, either redesigning the tori pole and/or adjusting the force of the bait cast by the bait casting machine can fix the situation. Regarding the former, the tori pole at 9 m above the deck with three backstays was highly stressed even with nothing on the seaward end of a 200 m tori line. Any thought of attaching even a seine float as a towed device to increase the aerial extent or the port tori line attached to the pole was quickly dismissed for fear of breaking the delicate pole. There were several replacements on board suggesting that the crew anticipated tori pole breaks. A supporting structure along

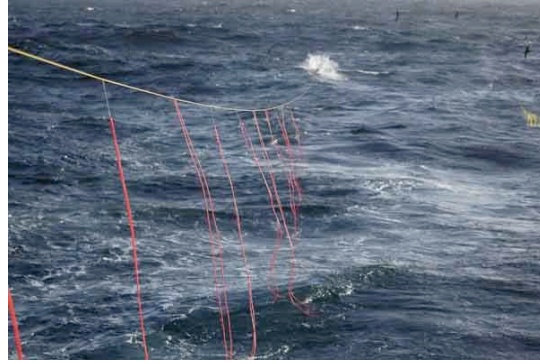
Figure 10. Alaskan tori line.

A tori line of the Alaskan design (Melvin 2000) was deployed on 29 April from the stern mast or starboard tori line with a road cone minus the rectangular base (see results) as a towed device (Figures 10 and 11).

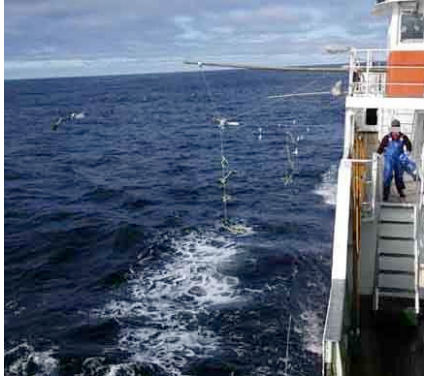
Figure 12. Haul mitigation.

The observed vessel also used mitigation to prevent seabird bycatch while hauling longlines (Figures 12 and 13). Haul mitigation consisted of two 3 to 4 m stout bamboo booms lashed to the forward and aft stairway railings at the top deck with single poly line suspended from it. The suspended line had yellow packing strap material pushed through the twist of the line at approximately one meter intervals and held a plastic ring with bands of packing strap material hanging from the ring that just touched the water. This haul mitigation system was very effective at keeping birds away from baited hooks as gear was hauled – no interactions with hauled baited hooks were observed as retained bait was discarded at or near the starboard sea door.

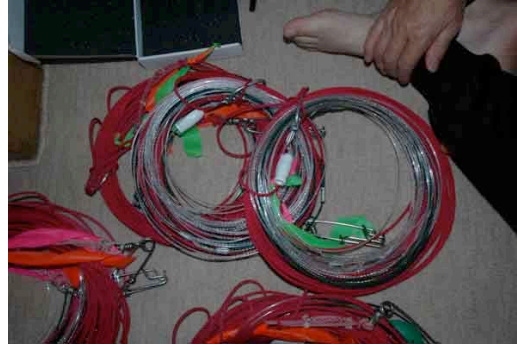
Figure 14. Star-Oddi TDRs taped to branchlines at the hook.

Star–Oddi time depth recorders (TDRs), model DST Centi – ex, were used to measure the sink rate of baited hooks (Figure 14). These devices are relatively small and light measuring 15 mm x 46 mm and weighing 12g in water and 19g in air. These instruments were configured by the manufacturer to measure depth at 0.07 m intervals with an accuracy of ± 0.12 m every second from 1 m to 280 m. TDR data files were converted into EXCEL worksheets and transducer records were adjusted to the transducer reading at the known depth at 2 m as determined from static tests for each instrument. Time in seconds and sink rate in m/sec were calculated for each TDR record to 2 m, 5 m, and 10 m depths. In addition, the fishing depth and temperature one hour post setting were tabulated with the hope that it might provide some insight to the fishing operations.

On 25 April a single TDR was deployed. It was placed 1 m above the hook attached with Tesa tape and white plastic tape favored by the Fishing Master. With successful retrieval of this one TDR, two multiple TDR deployments were made on 26 and 27 April. In the first, five TDRs were attached with white plastic tape just above the weight at the hook on the first, third, fifth, seventh, and ninth branchlines within a single ten branchline basket. In the second, TDRs were attached in the same way to the 5th branchline in the first two baskets of the first, fourth, seventh, tenth and 13th 20 basket units between radar reflectors

Given that this effort is one of the two first applications of Star-Oddi TDRs to measuring the sink rates of pelagic longline gear and sink rates in the upper two meters of the water column were highly variable, these sink rate data, especially to 2-m, are considered preliminary. Plans are being developed to further test and calibrate these “new” devices at a wide range of known depths. Calibration issues aside, these data suggest that the baited hooks on this vessel sink relatively quickly compared to other tests, and that a well designed tori line must protect baits from birds – especially aggressive diving birds like Buller’s albatross and white-chinned petrels – out to 80 m or more to be successful.

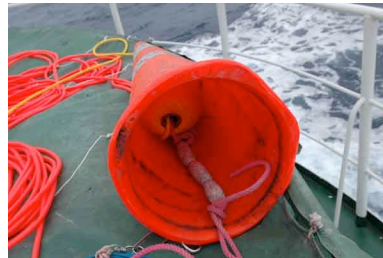
Figure 15. Modified road cone with 1.7 kg weight as a tori line towed device.

A 1-m road cone was deployed on a 6.4 mm diameter line to determine how it would track and function as a tori line towed device. In this case the goal was to increase drag so as to increase the aerial extent and to have the device track in a predictable manner. The cone held in the water but would release suddenly flying up to a meter in the air leaving the 50-line to go alternately slack and very tight. This erratic behavior was deemed too unpredictable to function as a towed device for a tori line on a vessel setting at over 10 knots. At the suggestion of the Fishing Master, the rectangular base of the cone was removed leaving a simple cone shape with less drag (Figure 15). This altered cone was deemed acceptable because the cone tracked predictably holding the line at constant tension. The cone was rigged to the Alaska style tori line, which was deployed from the aft mast on the set made on 29 April.

Trials of the purpose built towed device in which the line snapped due to the amount of drag created by the offset tube and the attached cone strongly suggests the towed device created too much drag and should be redesigned for vessels setting this fast (10.6 knots). Washington Sea Grant plans to redesign the towed device using a smaller diameter PVC tube (10.2 cm or 4 inch) and to ballast the device with water rather than lead. Using water

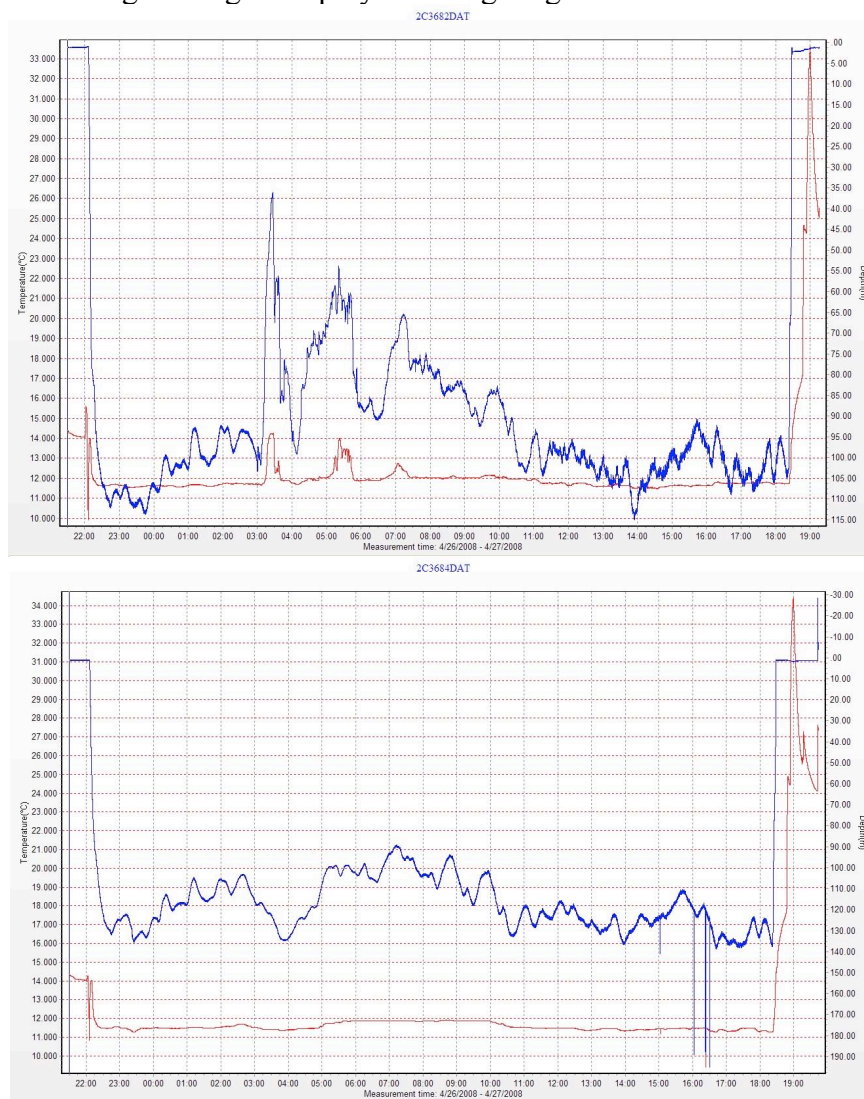
Figure 16. The depth (m) and temperature (°C) for TDRs 3 (top) and 5 (bottom) deployed 26 April 2008 throughout a gear deployment targeting southern bluefin tuna.

In the within basket comparison, the hook on branchline one (closest to the float) reached 62 m, while, the hook on branchline 7 reached 127.4 m (Table 2). Temperature varied little for hooks 3 to 9 (11.5° to 11.6° C) beyond 100 m, while the shallower branchline at 62 m occupied water over 2 degree Celsius warmer (13.9°). Branchline 3 occupied a wide range of depths (35 m to 115 m) throughout the set suggesting a fish capture (Figure 16, top). Hook five occupied a narrower range of depths (< 90 m to 135 m) and a fairly constant temperature (Figure 16, bottom). All 15 records with the TDR at the hook showed a continuous sine wave throughout the set perhaps suggesting the catenary of line between floats and the branchlines are in a state of constant up-down motion.

Hooks set at the fifth place within a 10-branchline basket occupied a wide range of depths within a single set (105 to 177 m) but a fairly narrow range of temperatures (11.1° to 12.6°C; Table 2).
