# Laying the Foundation for Resilient Coastal Communities

## Case Studies – Port Heiden and Goodnews Bay, Alaska

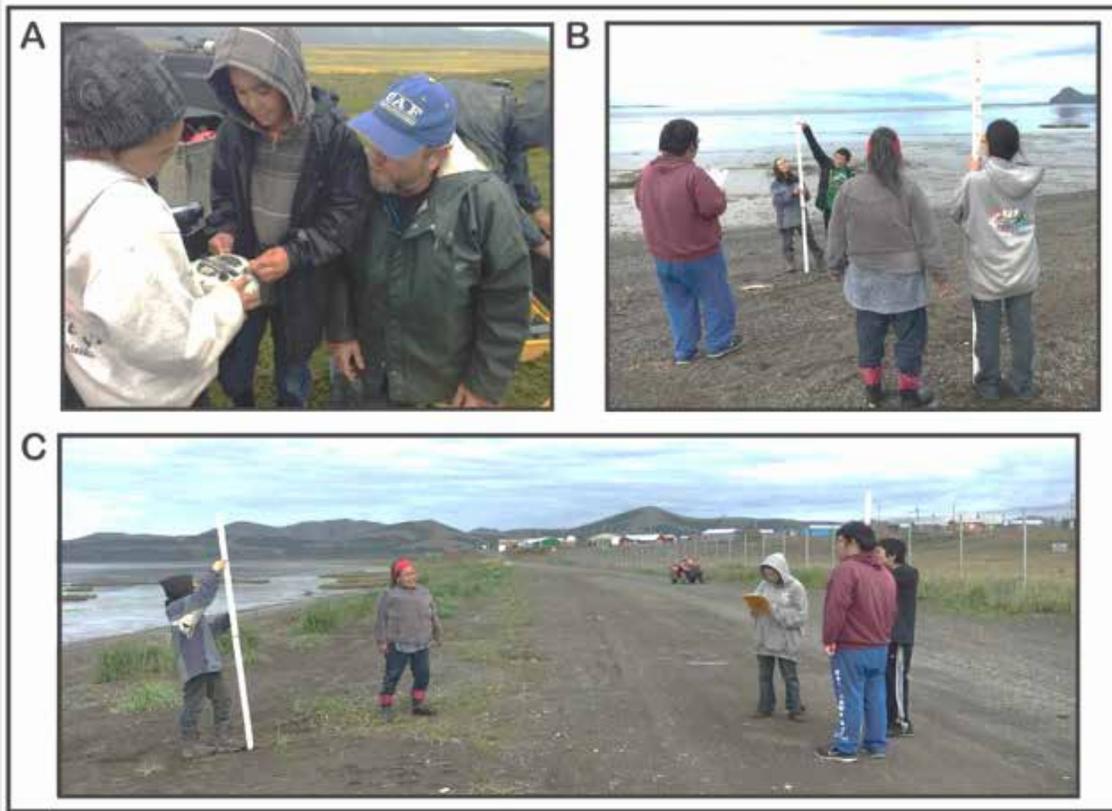
Figure 5. Rocky Mountain School (Goodnews Bay) high school students and local environmental coordinator, Alice Julius, assist with data collection. A) Students are taught about GPS systems in preparation for a topographic survey. B & C) High school students are trained by Alice Julius to collect coastal profile measurements using the simple Emery rod method.
