Ocean Exploration and Research

FY17 FFO Projects

1. Grant Number (if applicable): NA17OAR0110214
2. Amount of funding from OER: \$89,969
3. Project Title: Peleliu's Forgotten WWII Battlefields
4. Area of Operation (include a map and/or coordinates):
Peleliu, Republic of Palau, Caroline Islands. WWII invasion beaches: White 1, 2 and Orange 1, 2, 3 (Appendix 1)

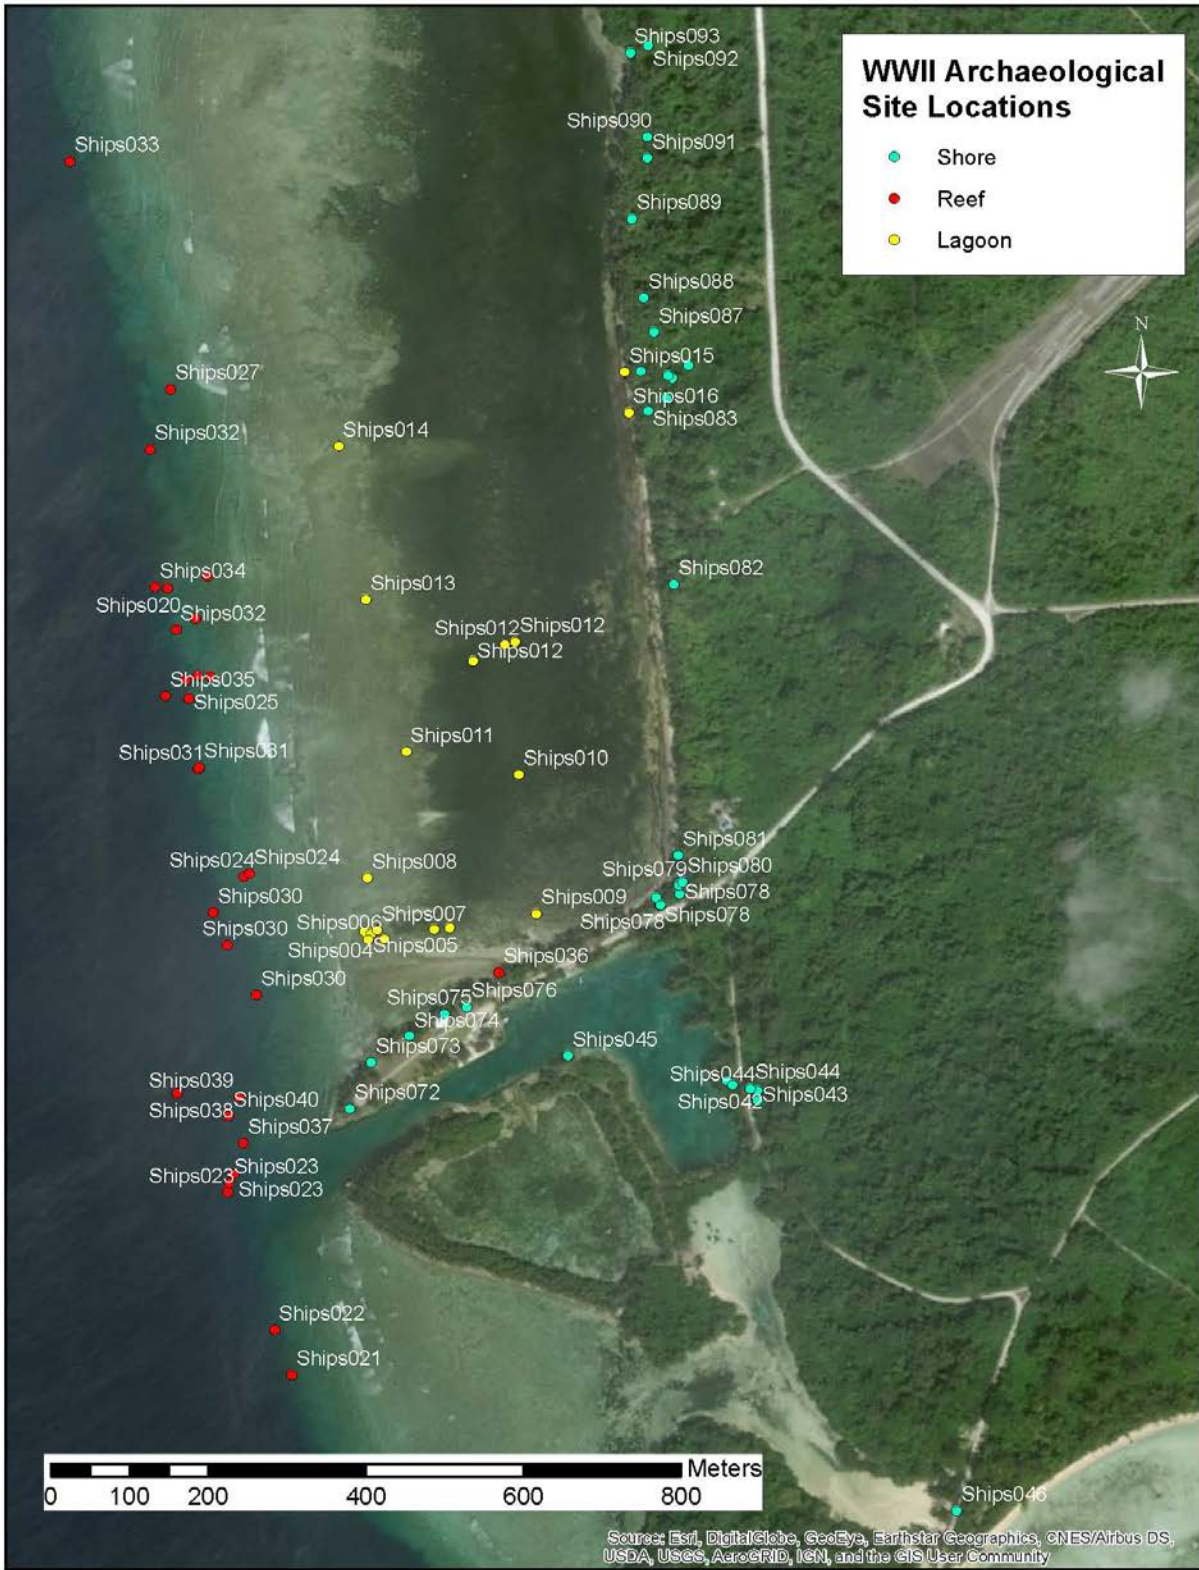
Figure 5. Orange Beach archaeological sites. Map by Roth/Ships of Discovery Science Team.

5. Survey inshore of the invasion beaches identified 60 sites representing both modern debris and historic defensive positions, small artifact scatters, miscellaneous debris, equipment dumps, or pieces of equipment (Table 9). The team revisited 14 sites previously recorded by Denfeld (1980) and/or by Knecht, Price and Lindsay (2012) and identified 11 new defensive positions (Table 10 and Table 11). Figure 4 and Figure 5 illustrate the general locations of the archaeological sites located.

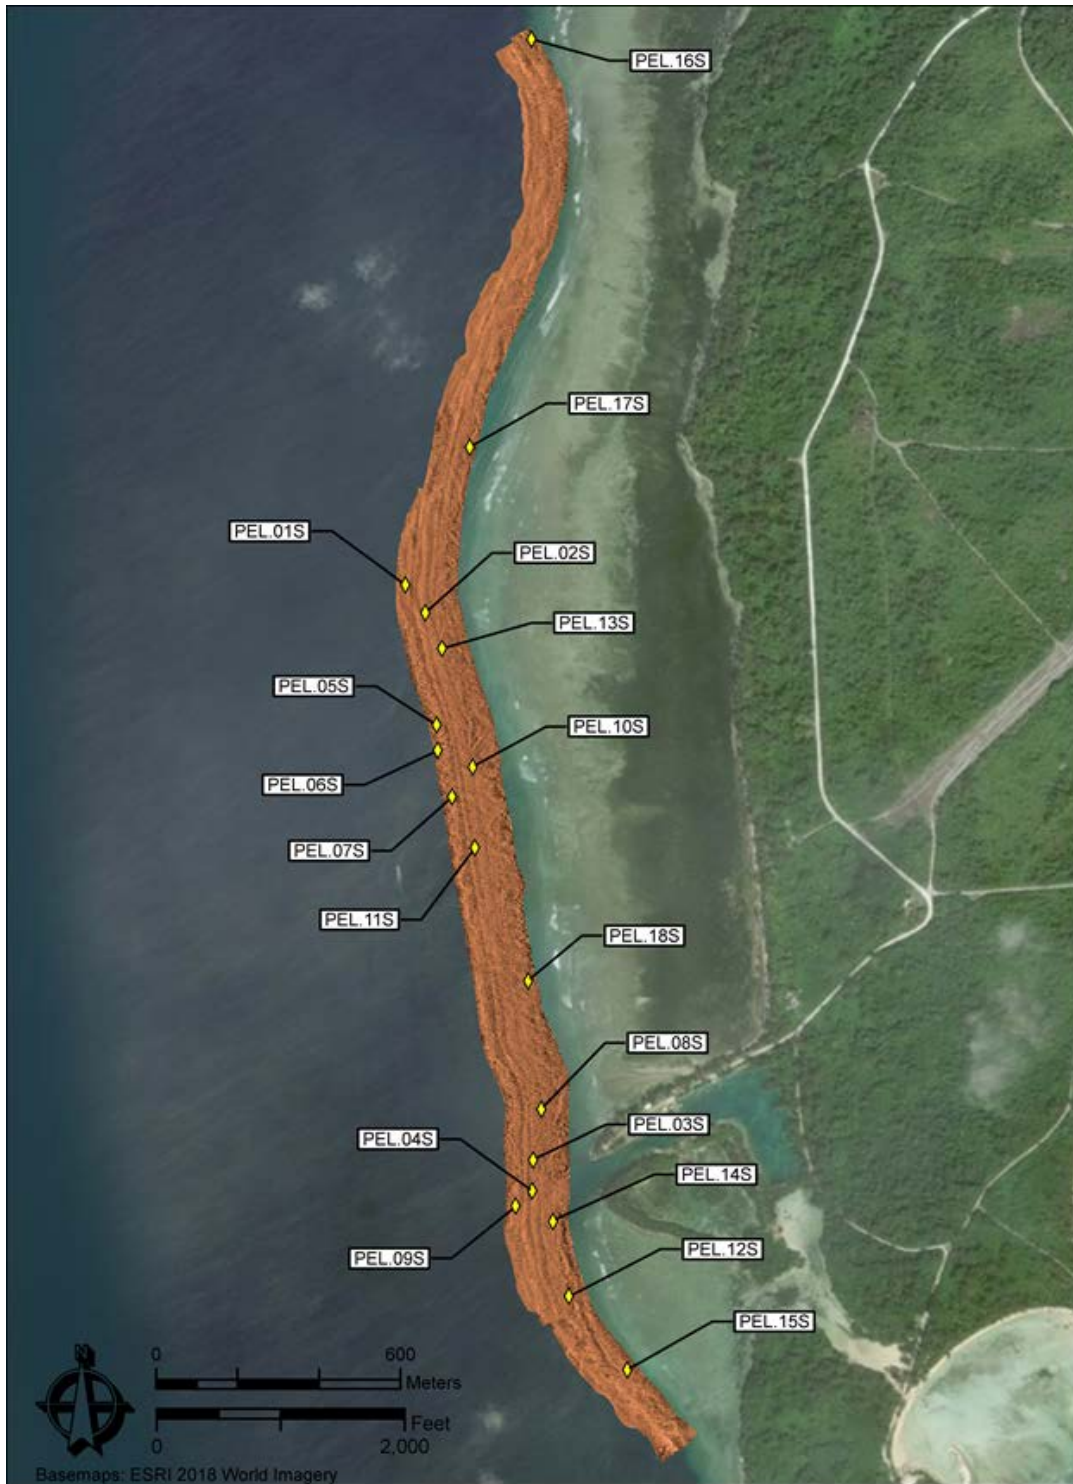
Figure 6. Side scan track plots and targets. Map by SEARCH, Inc.

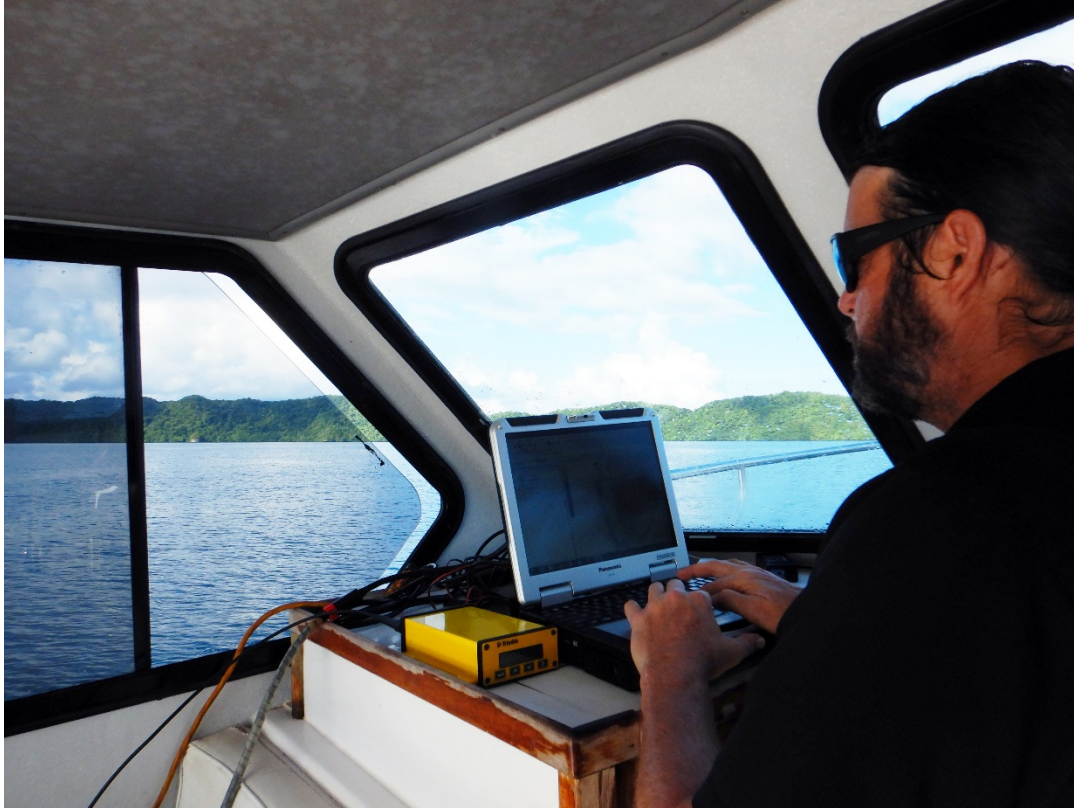
Figure 10. Panasonic Toughbook survey laptop outfitted with Hypack® Navigation Software and Trimble® DSM-232 dGPS (yellow box). Carrell/Ships of Discovery Science Team.

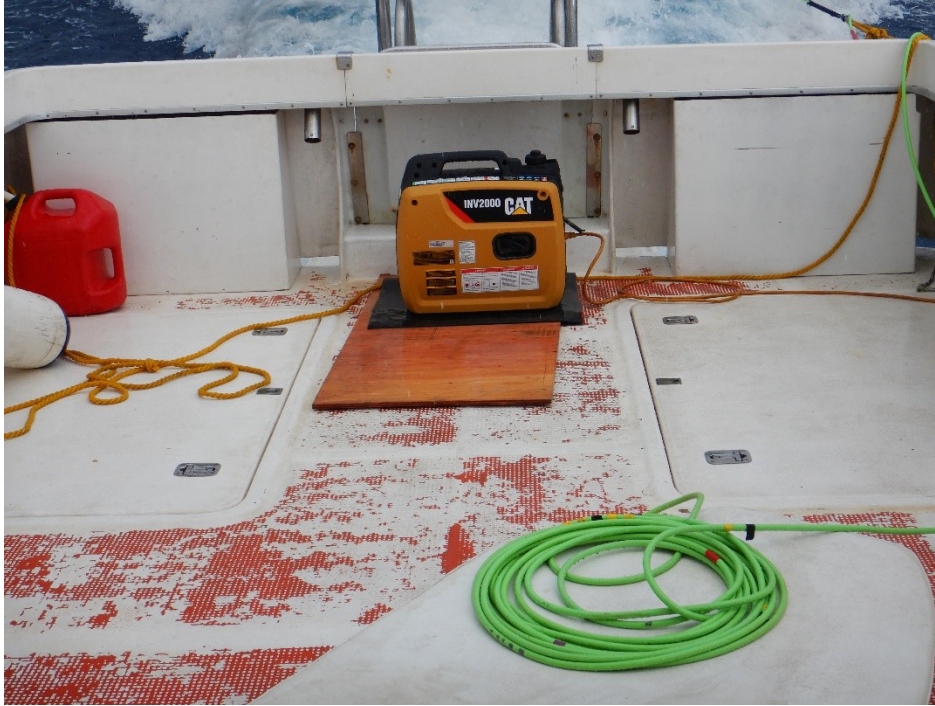
Figure 12. A CAT INV2000 inverter generator provided power during the magnetometer survey. Carrell/Ships of Discovery Science Team.

The equipment used included Hypack® Navigation Software (integrated with a Trimble® DSM-232 dGPS (Figure 10) and Geometrics G-882 magnetometer (Figure 11). A Cat INV2000 generator was used to provide clean power to the instruments (Figure 12).

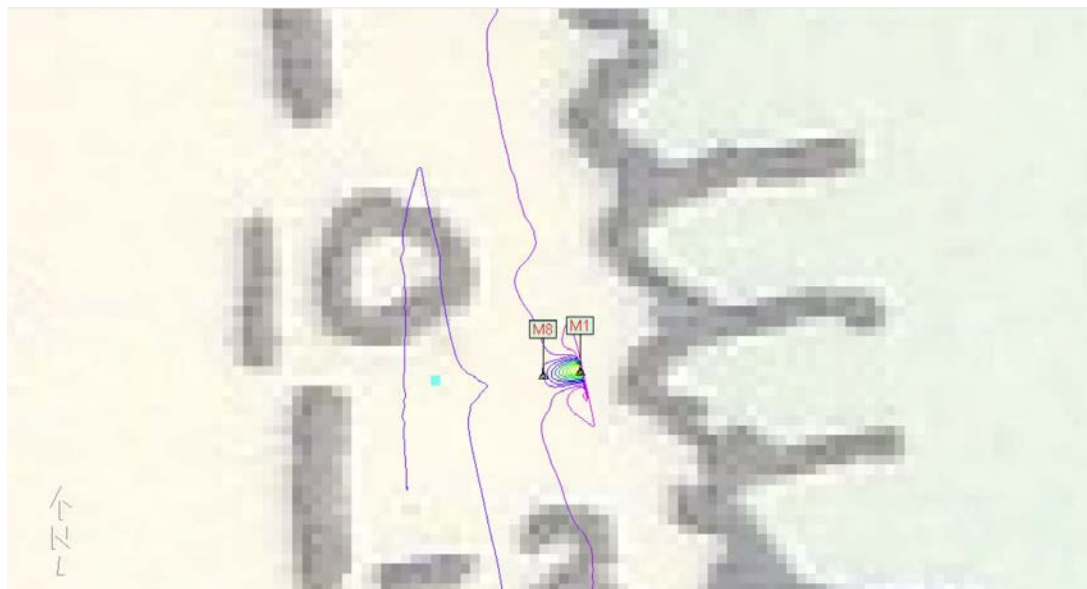
Figure 20. Magnetic contour map of Targets M1 and M8]; Contour interval equals 5 gammas (Palau Islands “Peleliu I. and Angaur I.”; from U.S.S. Hydrographer Survey November 1944 – January 1945). Krivor/Recon Offshore.

Targets M1 and M8 comprise one ferrous metal target located near the reef line and is one of the larger anomalies documented during the magnetometer survey (Figure 20).

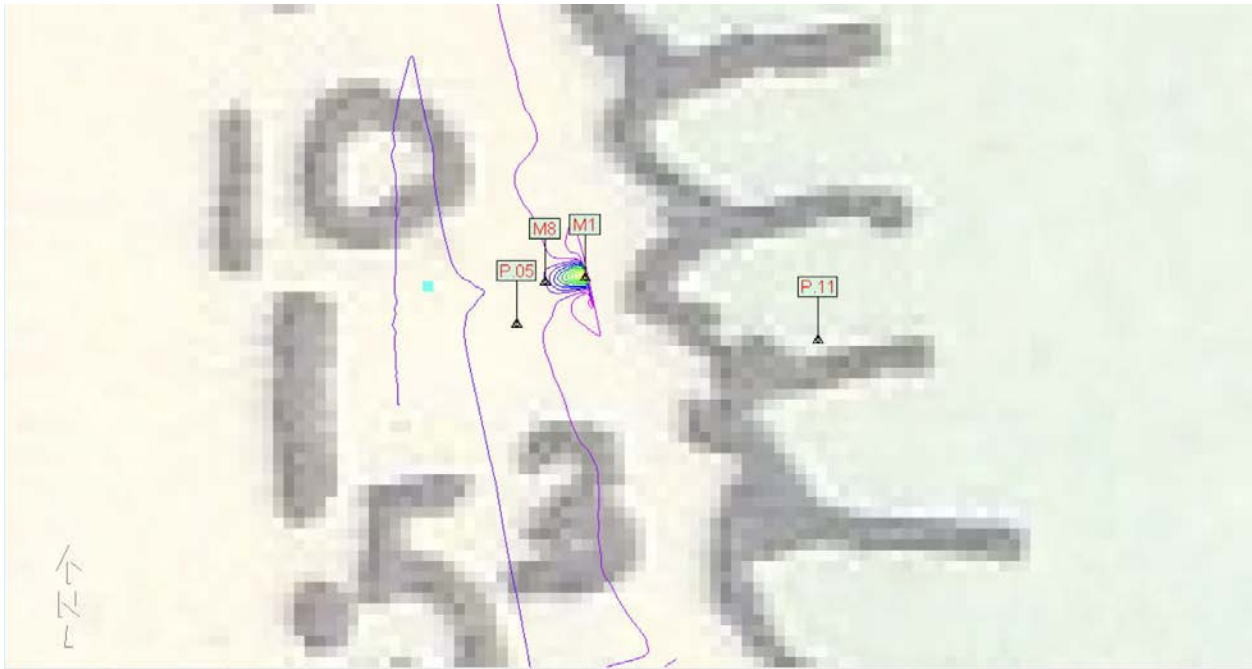
Figure 21. Magnetic contour map of Targets M1 and M8 with previously documented targets (P.05 and P.11) plotted; Contour interval equals 5 gammas (Palau Islands “Peleliu I. and Angaur I.”; from U.S.S. Hydrographer Survey November 1944 – January 1945). Krivor/Recon Offshore.

Plotting targets from the side-scan sonar survey and diver investigations indicate two targets are in the general location of Targets M1 and M8 (Figure 21). Review of the previous investigation indicate both Targets P.05 and P.11 are “Survey points identified during Sonar Anomaly. No cultural material located.” Therefore, side-scan sonar targets were plotted in the area, but nothing was confirmed during diver investigations. Targets M1 and M8 remain unidentified.

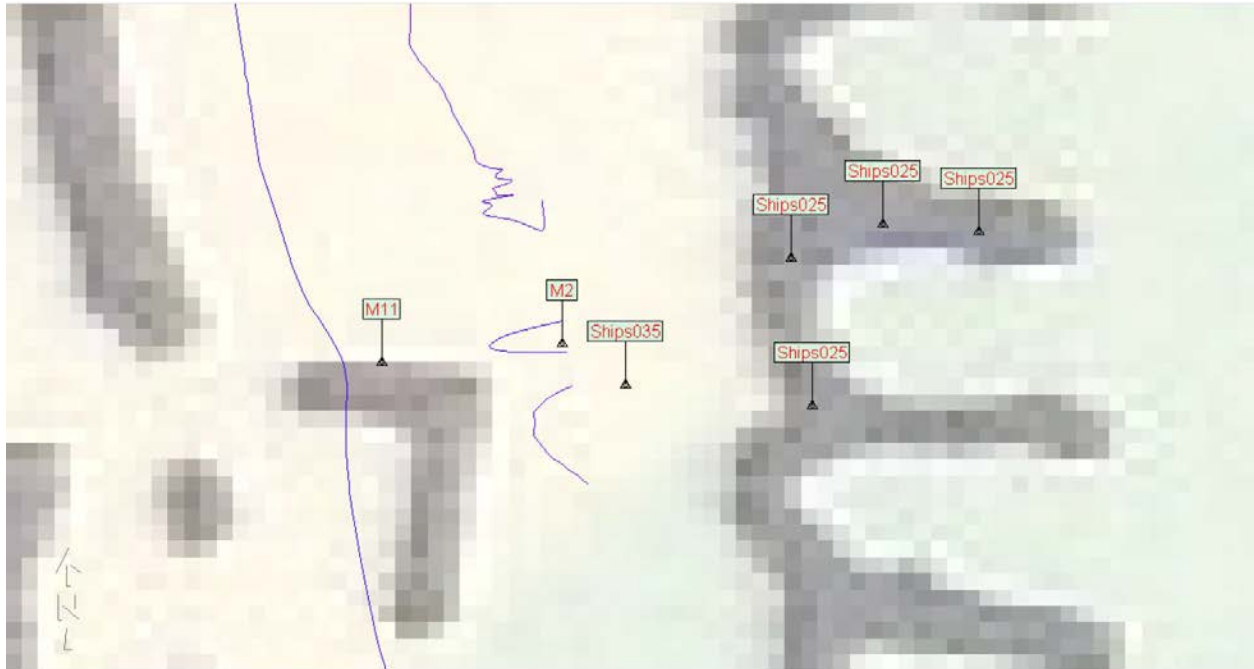
Figure 22. Magnetic contour map of Targets M2 and M11 with previously documented targets (Ships025 and Ships035) plotted; Contour interval equals 5 gammas (Palau Islands “Peleliu I. and Angaur I.”; from U.S.S. Hydrographer Survey November 1944 – January 1945). Krivor/Recon Offshore.

Targets M2 and M11 represent another single ferrous metal anomaly documented on more than one survey track line. Plotting the location of previously recorded anomalies indicates Targets M2 and M11 are associated with Targets Ships025 and Ships035 (Figure 22).

Review of the previously documented targets indicate Ships025 and Ships035 was identified as a “Large stud link anchor chain which runs from the reef crest to edge.” In addition, an unidentified (UID) site was documented in the area. Results of the magnetometer survey would indicate Targets M2 and M11 represent the same stud-link anchor chain that continues to extend offshore from the reef line.

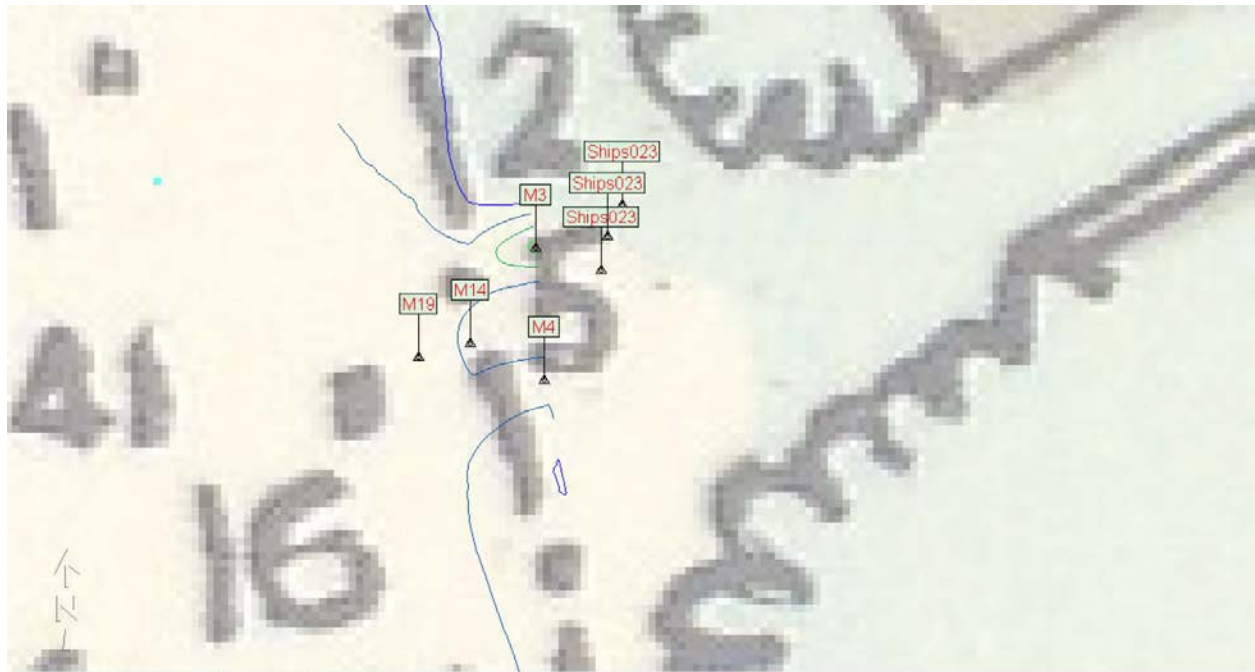
Figure 24. Magnetic Targets M3, M4, M14, and M19 and Targets Ships023 represent the remains of a Pontoon Barge and Pontoon Fragments; Contour interval equals 5 gammas (Palau Islands “Peleliu I. and Angaur I.”; from U.S.S. Hydrographer Survey November 1944 – January 1945). **Krivor/Recon Offshore.**

Plotting the target locations from the previous investigations indicate the cluster of magnetic anomalies are associated with Targets Ships023 identified as a “Pontoon Barge and Pontoon Barge Fragments” (Figure 24).

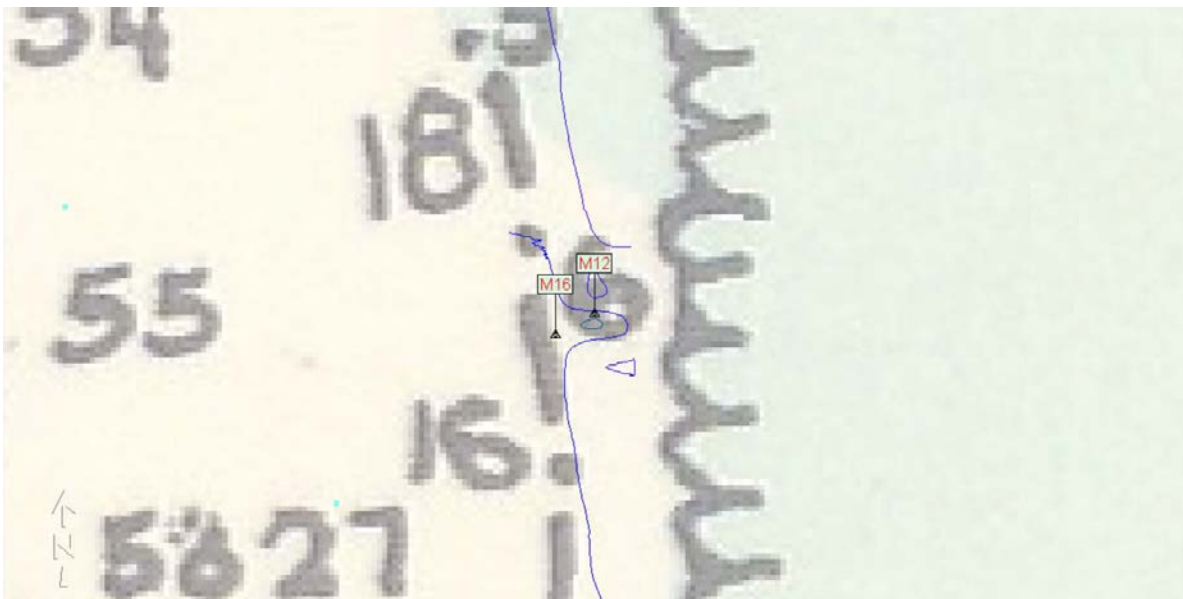
Figure 25. Magnetic Targets M12 and M16; Contour interval equals 5 gammas (Palau Islands “Peleliu I. and Angaur I.”; from U.S.S. Hydrographer Survey November 1944 – January 1945). **Krivor/Recon Offshore.**

Targets M12 and M16 represent a single magnetic anomaly documented on two adjacent track lines (Figure 25).

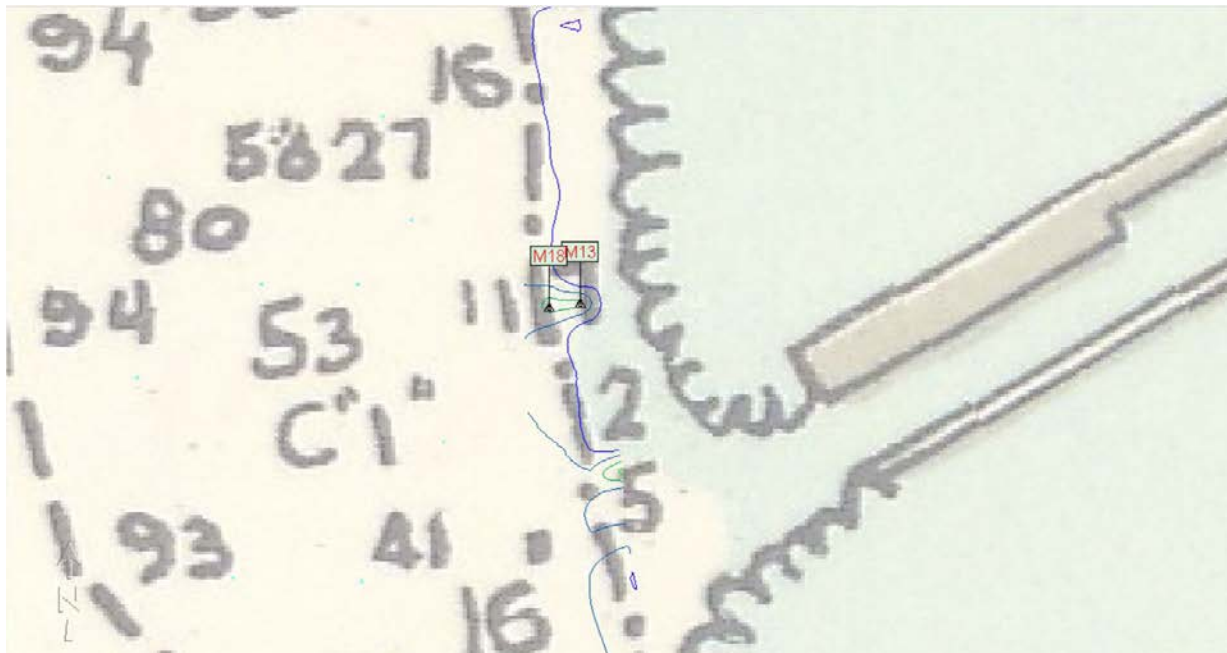
Figure 27. Magnetic Targets M13 and M18; Contour interval equals 5 gammas (Palau Islands “Peleliu I. and Angaur I.”; from U.S.S. Hydrographer Survey November 1944 – January 1945). Krivor/Recon Offshore.

Targets M13 and M18 represent one magnetic target located immediately north of the manmade jetty located near the southern end of the Landing Beaches (Figure 27).

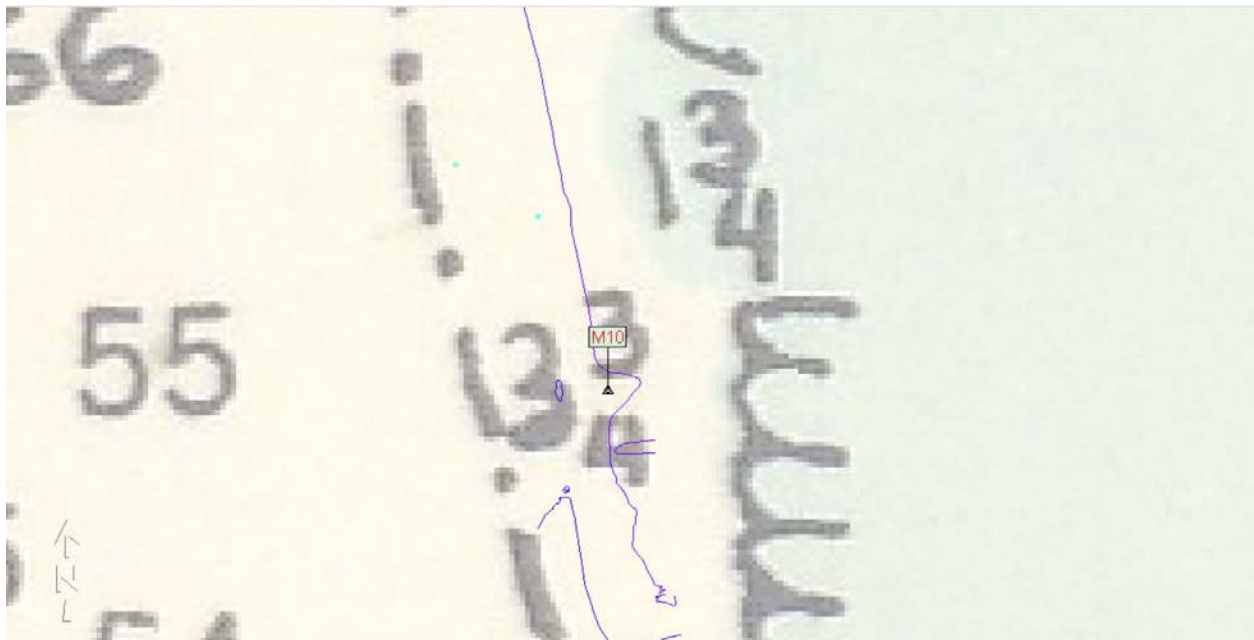
Figure 29. Magnetic Target M10; Contour interval equals 5 gammas (Palau Islands “Peleliu I. and Angaur I.”; from U.S.S. Hydrographer Survey Nov. 1944 – January 1945). Krivor/Recon Offshore.

Target M10 is a single, isolated 3-gamma magnetic anomaly documented on one track line (**Figure 29**).

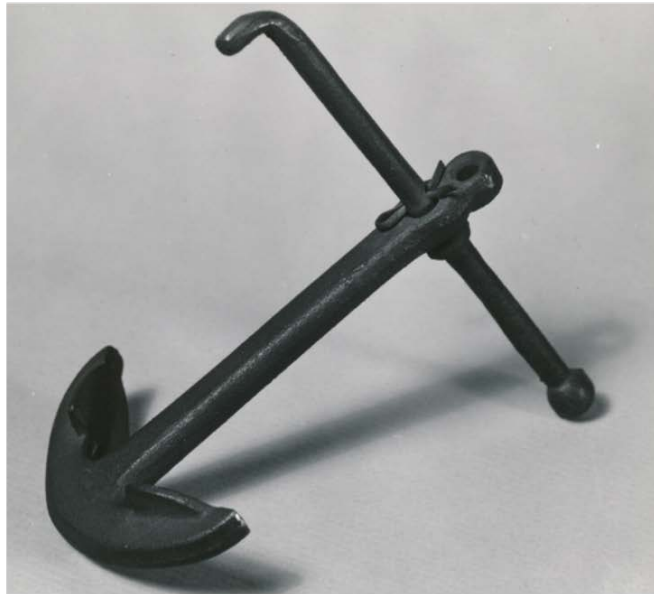
Figure 34. Admiralty anchor. The Mariners’ Museum and Park.

Navy stockless anchors, or “patent anchors” as they were known during WWII, began to replace Admiralty, or “old fashioned” anchors in the United States Navy around 1875 (Figure 34 and Figure 35). Admiralty anchors had fixed flukes and stocks. The stocks were set at 90 degrees from the direction of the flukes. During the war, Admiralty anchors were only used on some older destroyers. Admiralty anchors were stowed on horizontal platforms near the bow. Deploying and recovering them presented some challenges because as they had to be brought completely over the side of a vessel during either process (U.S. Naval Institute, 1940:442-445).

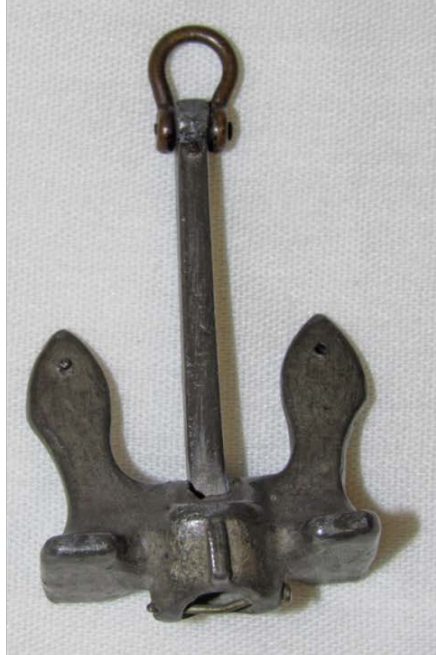
Figure 35. Stockless anchor. The Mariners' Museum and Park.

Stockless anchors had no stock and flukes that could swing from 40 to 45 degrees. The lack of a stock allowed the anchor to be brought up into a hawse pipe rather than completely onboard a vessel – so deployment and recovery of these anchors was less complicated than that of Admiralty anchors (U.S. Naval Institute, 1940:445).

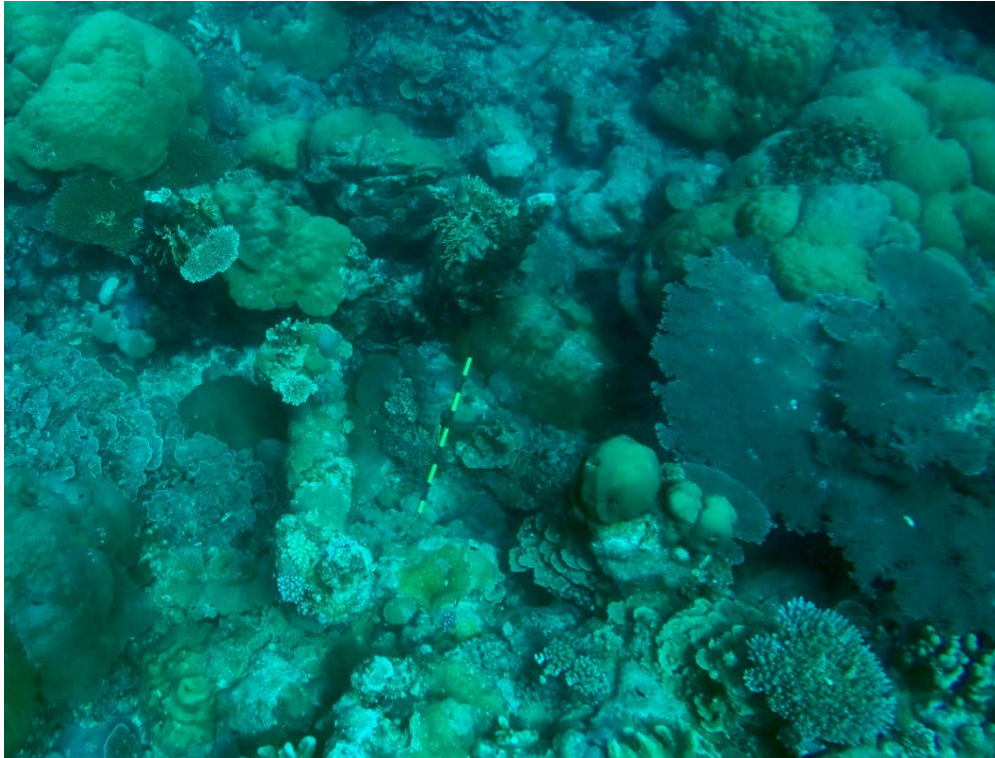
Figure 36. Navy stockless anchor (Ships030). The shank is 2.50m long, and the flukes are 1.15m. The anchor was found in a scatter of unidentifiable debris. Raupp/Ships of Discovery Science Team.

Ships030 was found off Orange Beach 3 (Figure 36) and Ships021 (Figure 37) was found in the vicinity of the "right flank of Orange Beach" in 40 ft. of water. No other related artifacts were located in the area. The potential exists that either Ships030, or Ships021, is the anchor lost from the crane barge. Ships028 (Figure 38) was located off White Beach in approximately 6 ft. of water. It is not associated with any other debris or site.

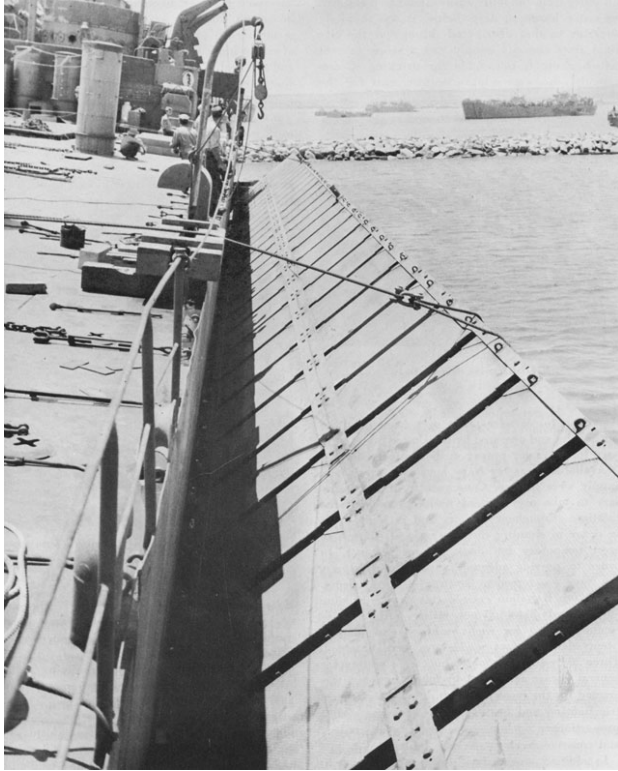
Figure 40. Pontoon causeway section being released from the side of an LST. Department of the Navy, Bureau of Yards and Docks 1947b:78.

The draft of a loaded LST (Landing Ship, Tank) ranged from more than three feet forward to over nine feet aft (Department of the Navy, Bureau of Yards and Docks 1947a:114). This draft was too deep for LSTs to be beached and unloaded in many areas. So, pontoon causeways were often used to help facilitate offloading. LSTs transported causeway sections slung on shelves and secured by rope on the ship's sides. They were released as the vessel moved shoreward letting momentum carry the sections toward the shore where one end was beached (Figure 40).

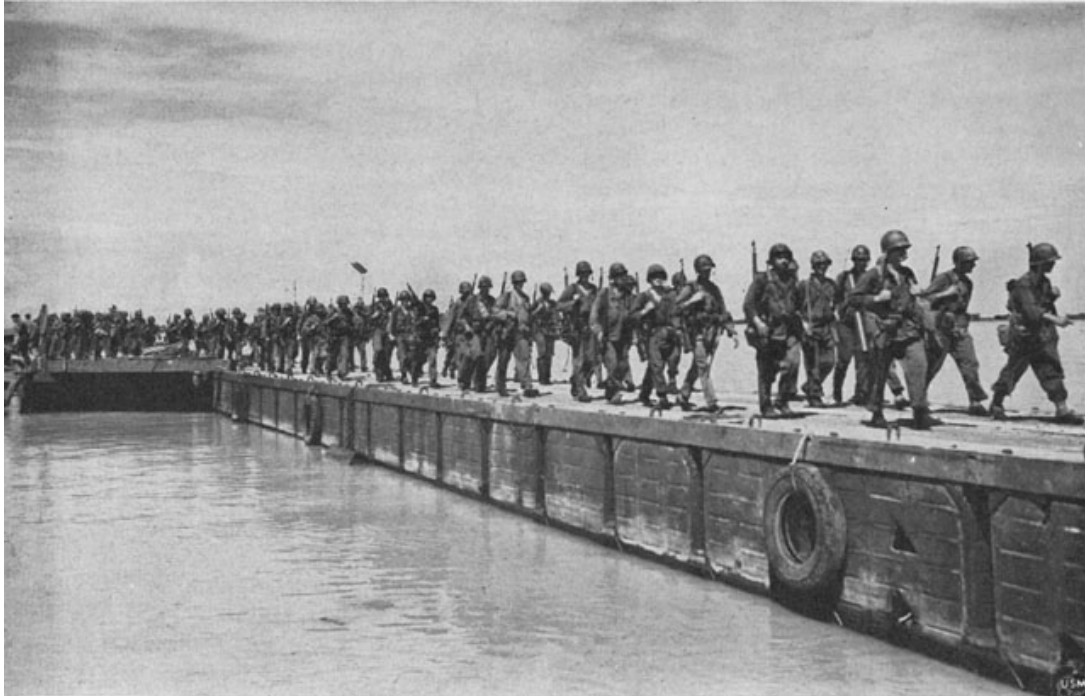
Figure 43. Soldiers land on Peleliu using pontoon causeway. Hough 1950:110.

On Peleliu, pontoons were used for three primary purposes: as causeways, barges, and in the construction of the harbor. Causeways were constructed on Orange Beach 3 and on Purple Beach (Figure 41). The causeway at Orange Beach 3 was started on D-day September 15, 1944 and completed six days later (Figure 42). Seabees and engineers built it under Japanese fire using bulldozers to clear coral heads from the reef before the causeway could be installed. (Doane 1945:414-415, Hough 1950:22). Six LSTs brought pontoon causeway sections to Peleliu consisting of 2 x 30 pontoons, and were approximately 175 ft. long and 14 ft. wide (Figure 43) (Doane 1945:414, Hough 1950:23).

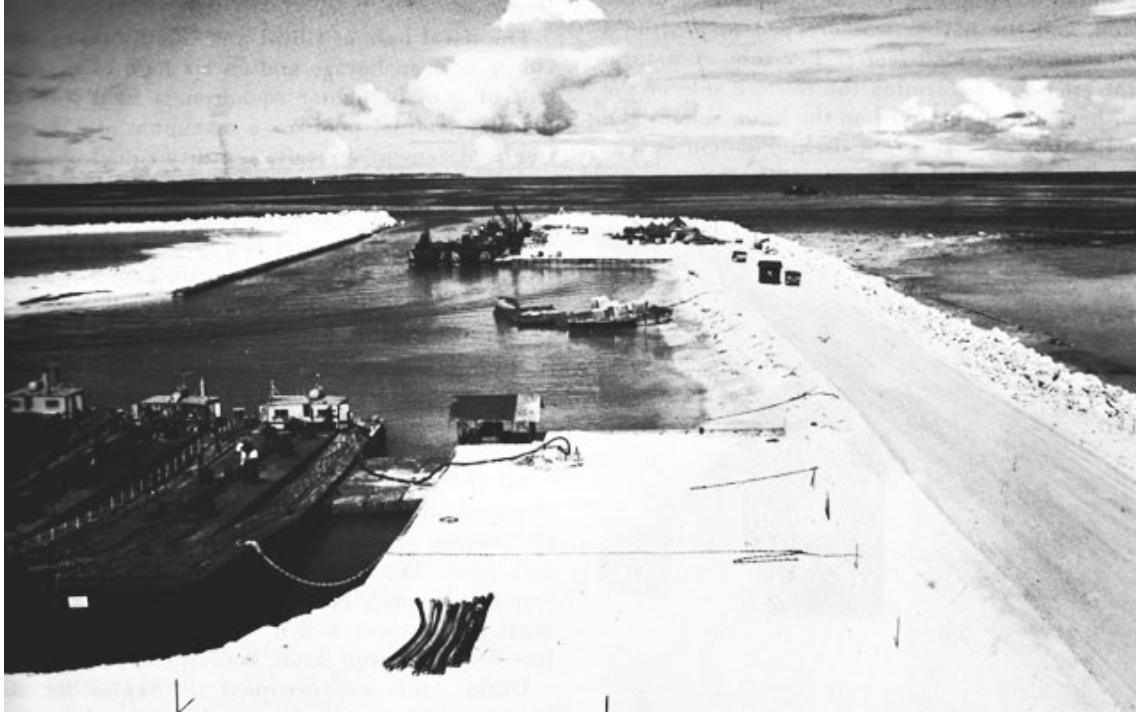
Figure 45. Harbor at Peleliu. Department of the Navy, Bureau of Yards and Docks 1947b:331.

Construction of a channel and harbor began on October 20, 1944 (Figure 45). The channel was located just south of the causeway at Orange 3. The causeway became the northern bulkhead of the channel, and was eventually covered with coral rubble. Cranes for dredging the channel were mounted on barges and on the beach. Dredging continued 24 hours per day for three months. Coral-filled pontoons were laid alongside the channel to form a dock on which cranes could be mounted. Pontoons were also used to line the harbor to create bulkheads and piers for a boat basin. This was the final stage of harbor construction, and because they were no longer needed to support operations, pontoons were taken from the barges and causeways used in the invasion (Doane 1945:415-417). These pontoons are still in evidence today at the harbor (Figure 46).

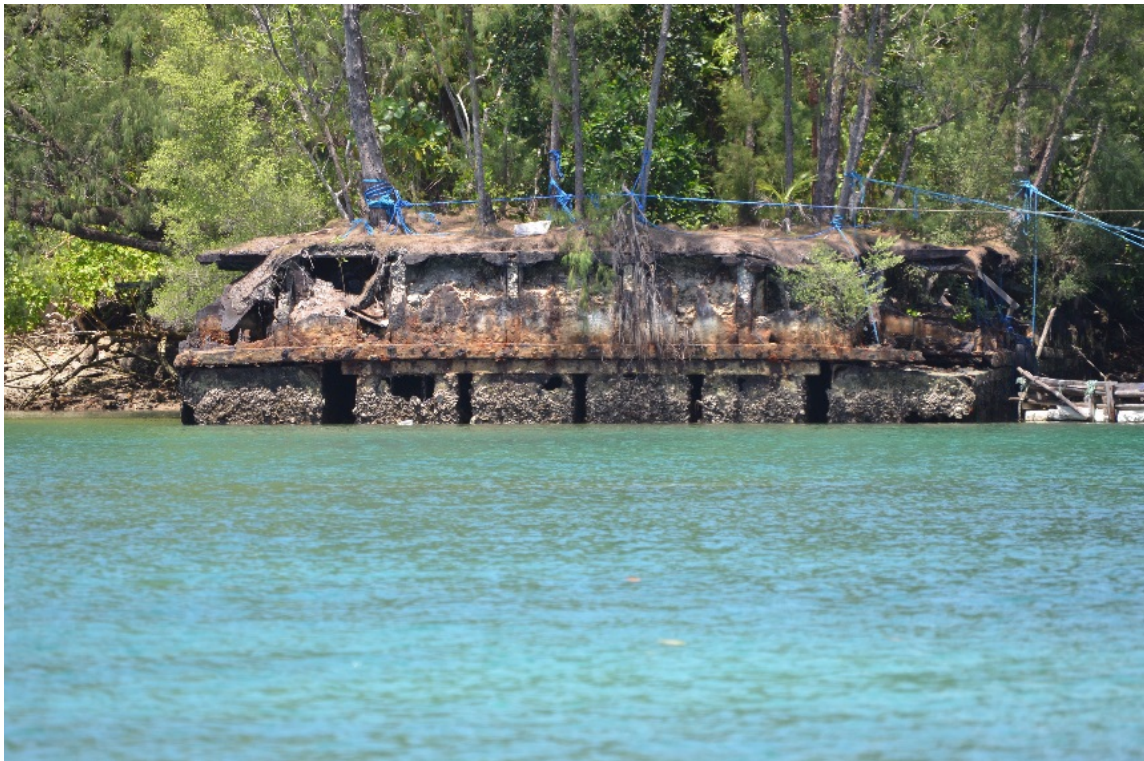
Figure 46. Remains of a pontoon used in the construction of the harbor. Roth/Ships of Discovery Science Team.

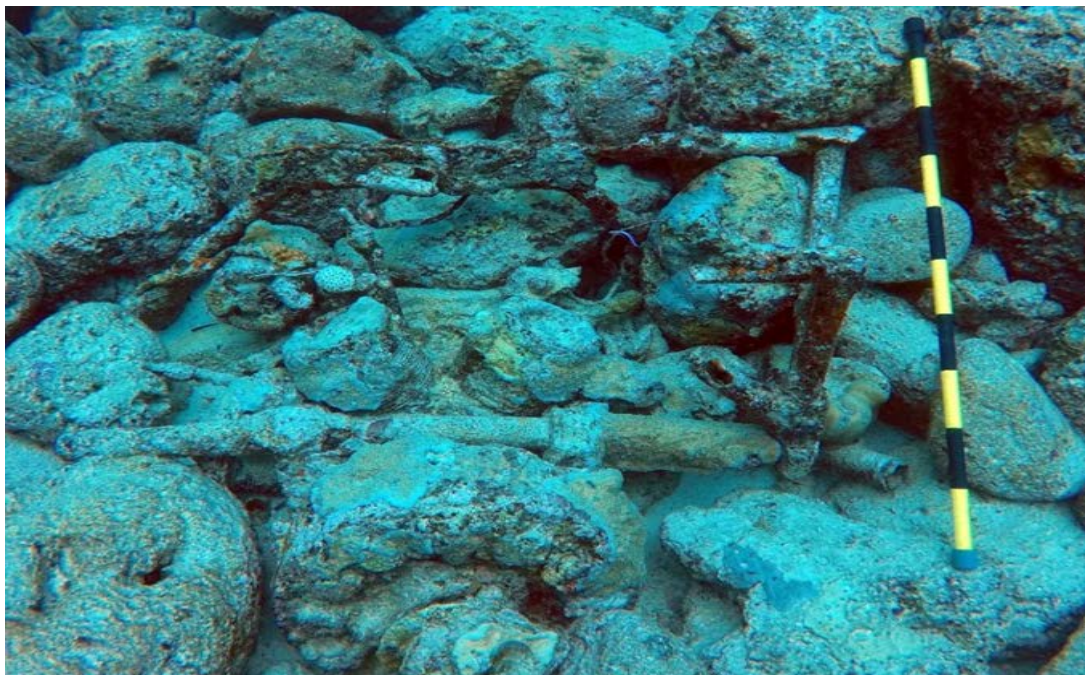
Figure 49. Portion of the disarticulated remains of an LVT (Ships032). Raupp/Ships of Discovery Science Team.

The site consists of a radial engine, miscellaneous framing (Figure 48), and multiple roller assembly pieces (Figure 50). The remains of this LVT were few and widely scattered across the sea floor. Most of the pieces remaining of this LVT are unidentifiable pieces of metal and tubing. Divers searched the area but were unable to locate any further remains of this vehicle. However, the radial engine is recognizable and still inside its engine mount. Three rollers that were used to guide the vehicle's tracks are also scattered about around the site. The only other identifiable piece is a ring hook that is located towards the beach from the engine. Ring hooks like this were found on the bow of most LVTs. The scatter and lack of material remains at this site are what one would expect to find in the event of a catastrophic loss. It is impossible to determine the

model of this LVT, but it is probably a LVT 2 or 4 based on the fact that there is not a turret nearby. This LVT was most likely destroyed on its way to the beach.

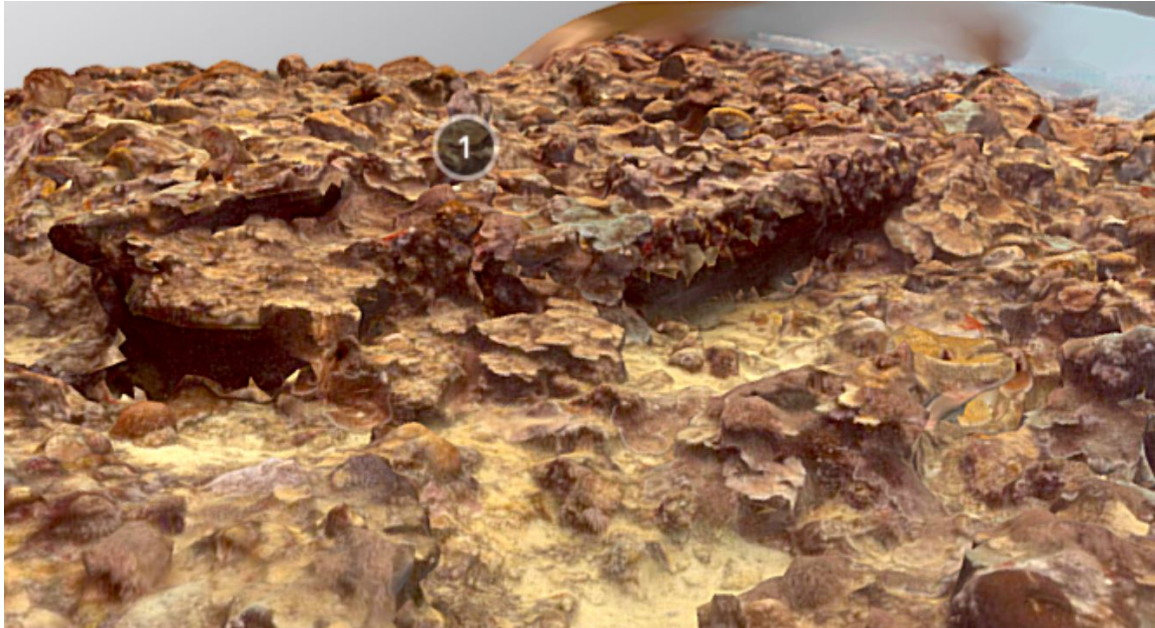
Figure 53. LVT #2 has collapsed under the weight of the coral (Ships039). 3D model by Burns/UHH/Ships of Discovery Science Team.

Based on the preliminary inspections of the three sites, is no indication any of these vehicles possess the mechanical or electrical equipment required to operate. During WWII, troops regularly salvaged every piece of usable material from the wreckage of battle. The purpose was twofold. One, these parts could be used to repair other vehicles. Two, the opposition would salvage and use anything available to them against the invasion forces. The coral encrusted breach of LVT #1 is the only item that seems to not have been salvaged.

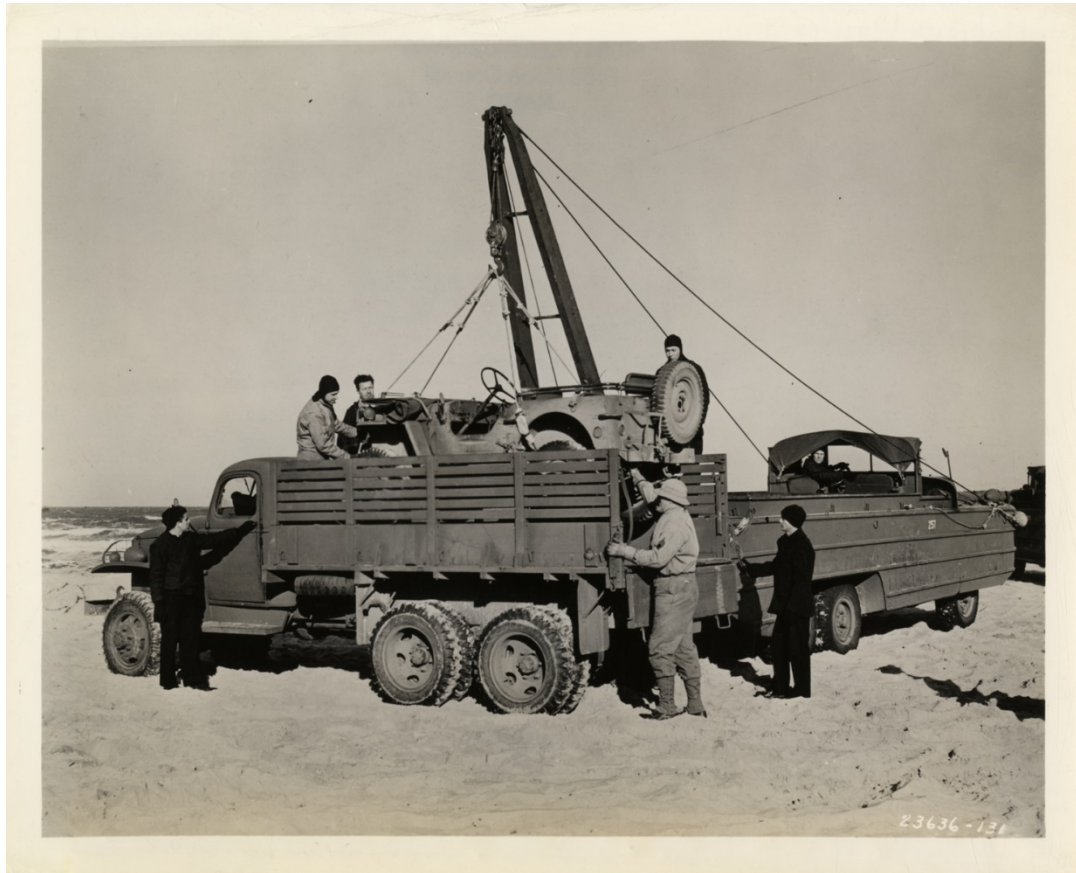
Figure 56. DUKW using aft-mounted A-frame boom to load jeep onto a CCKW 6 x 6 truck. Headquarters United States Army Forces, Pacific Ocean Areas 1944:2.

could not. They were capable of crossing fringing reefs and offshore bars that might prevent the use of landing craft, and could also operate in rough surf that would stop landing craft (Younts 1950:5). An A-frame boom with a 5,000 lbs. capacity could be mounted on the rear of a DUKW (Figure 56). This A-frame allowed a DUKW to unload other vehicles when cranes were not available (Doyle 2013:101).

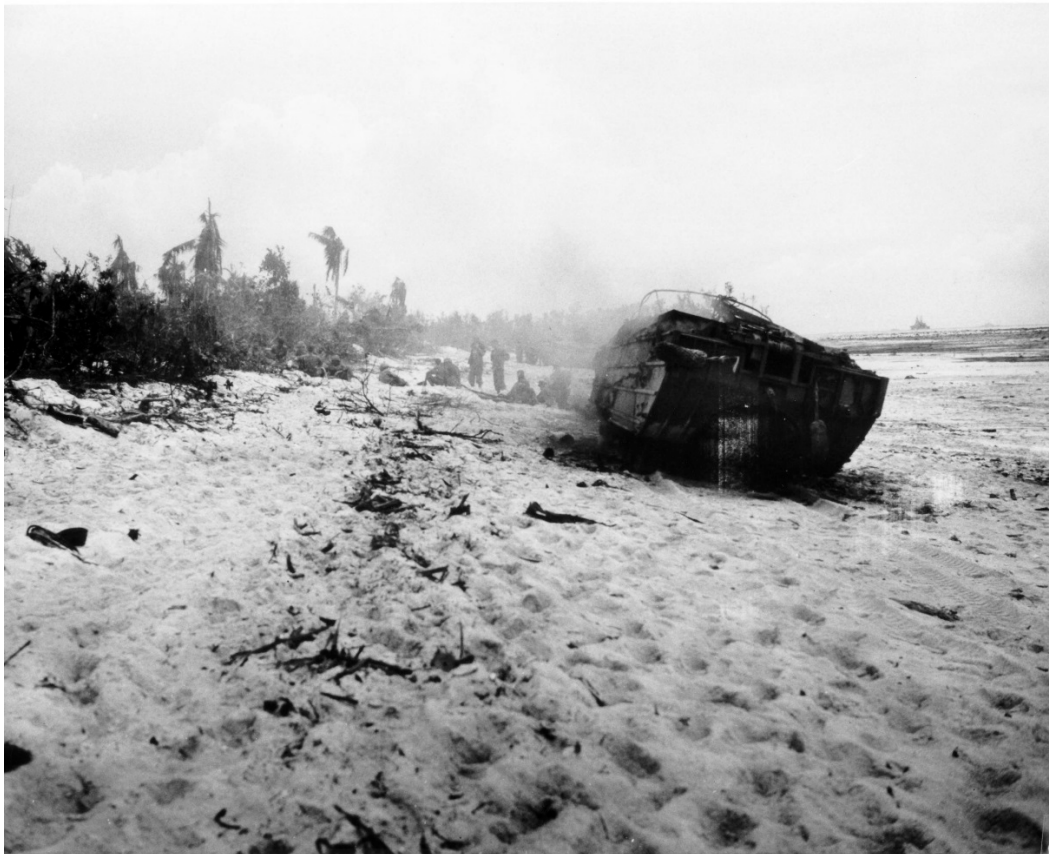
Figure 57. DUKW smoldering on beach Peleliu after taking a direct hit. Norm Hatch Collection, National Pacific War Museum, image Peleliu 039, 1944.

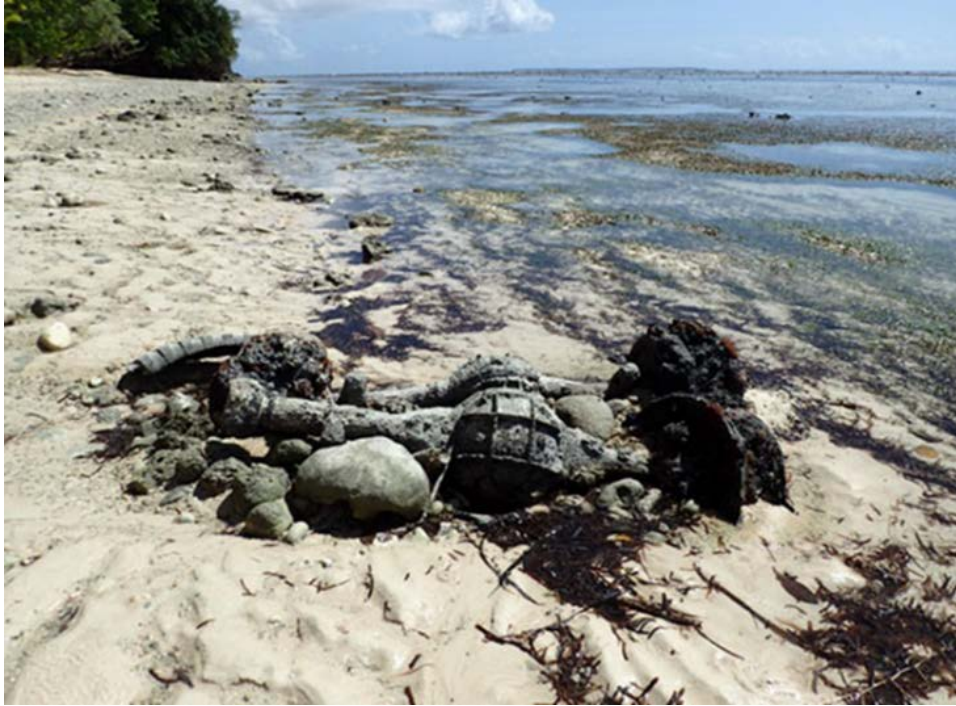
Figure 58. Wheel rims and axles from a DUKW exposed during low tide off White Beach 2 (Ships052). Carrell/Ships of Discovery Science Team.

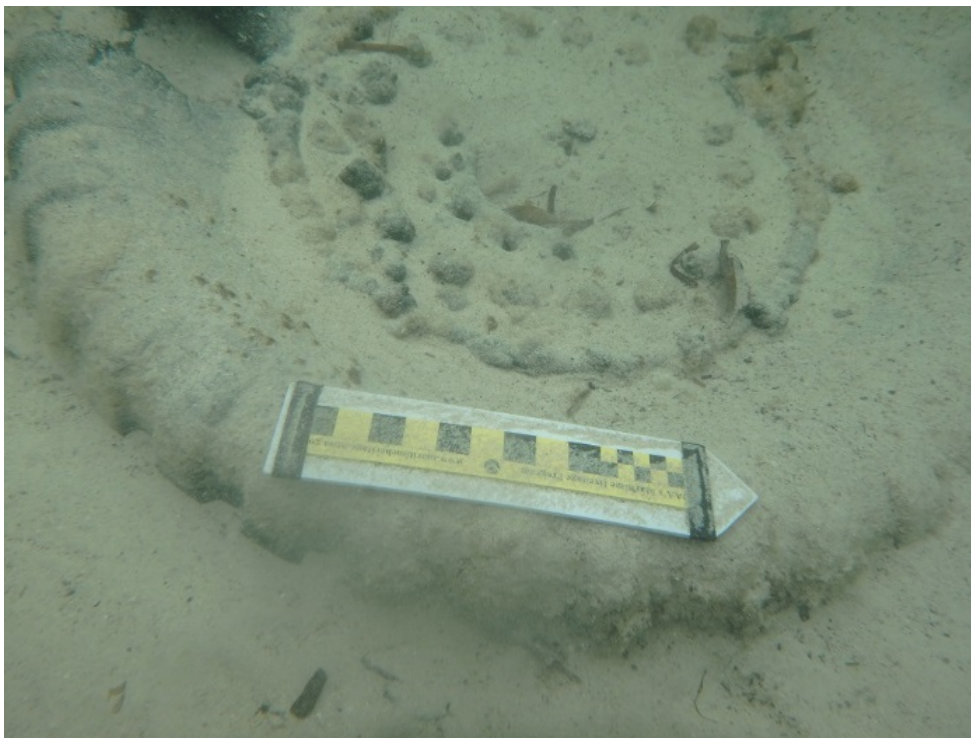
Three axle and wheel assemblies (Ships052) are exposed on the shore at White Beach 2 (Figure 58). The distribution of these axles indicates that they probably originated from a single amphibious vehicle. Denfeld previously recorded this as Site 1, Feature 5 (Denfeld 1988:54). A previously unrecorded DUKW wheel was found in shallow water off Orange Beach 1 (Ships015) (Figure 59). No other remains were located in association with Ships015, suggesting it was dumped rather than from of a combat loss.

Figure 59. DUKW wheel in shallow water off Orange Beach 1 (Ships015). Arnold/Ships of Discovery Science Team.
