Ocean Exploration and Research

FY17 FFO Projects

1. Grant Number (if applicable): NA17OAR0110214
2. Amount of funding from OER: \$89,969
3. Project Title: Peleliu's Forgotten WWII Battlefields
4. Area of Operation (include a map and/or coordinates):
Peleliu, Republic of Palau, Caroline Islands. WWII invasion beaches: White 1, 2 and Orange 1, 2, 3 (Appendix 1)

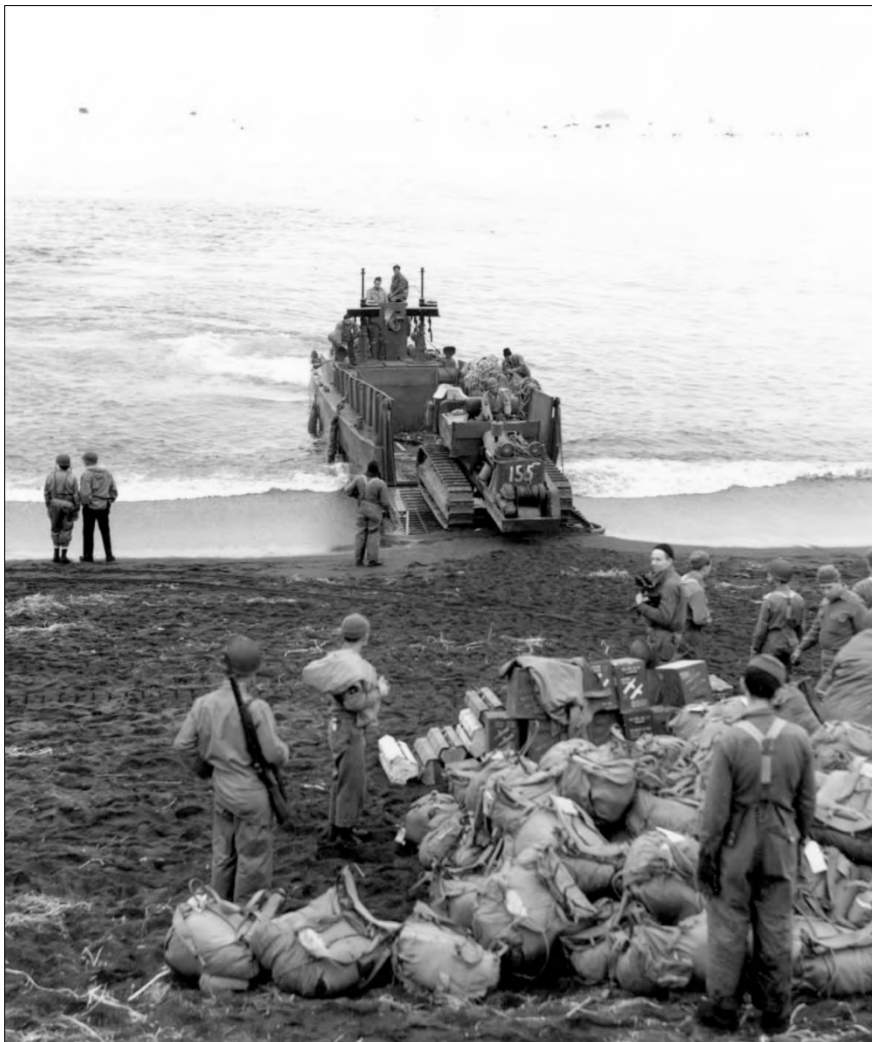
Equipped with bow ramps, the LCM (3) type was primarily employed for landing bulldozers, medium tanks, guns, and trucks in ship-to-shore traffic (Vagts 1963:634) (Figure 60). Until 1940, amphibious warfare vessels were not part of the U.S. Naval fleet; instead ship's launches and lifeboats were employed as landing craft, though they were entirely unsuited for the task (Rottman 2004:31). With the entry of the U.S. into WWII, it soon became clear that purpose-built landing craft were needed for amphibious invasions.

Figure 60. The LCM in Peleliu is likely similar to the pictured LCM(3) offloading a bulldozer on the Aleutian Islands in April 1945. Greenfield, 1952, pg. 181.

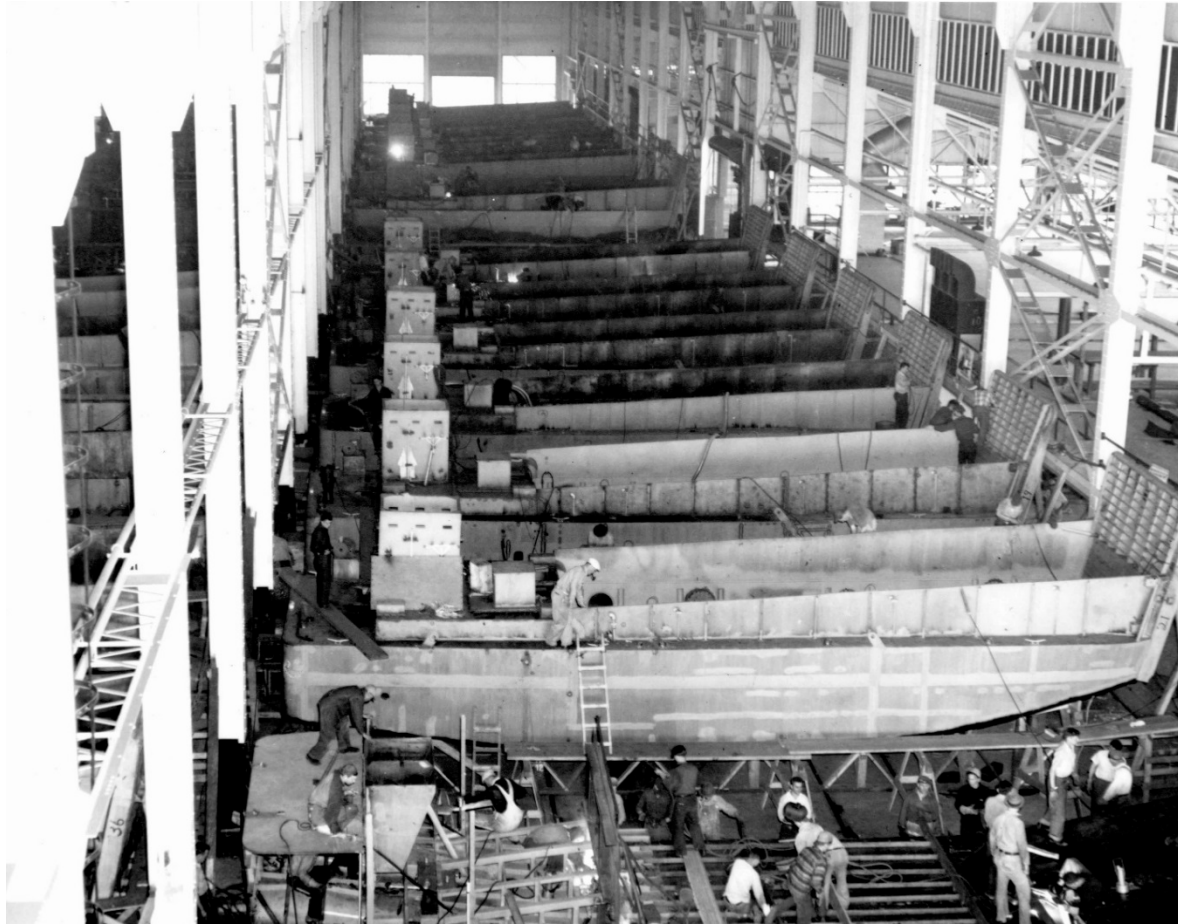
Though numerous designs were considered, an adaptation of the Higgins Corporation's "Eureka Boat" was adopted by the U.S. Navy Bureau of Ships in 1942 (Figure 61) and designated the LCM (Neushul 1998:153). Used during battle and the ensuing aftermath, the LCM (3) was essential to securing WWII battlefields and establishing necessary infrastructure thereafter.

Figure 61. LCM-3 production line at the Boston Naval Shipyard 1942. NARA 7326808

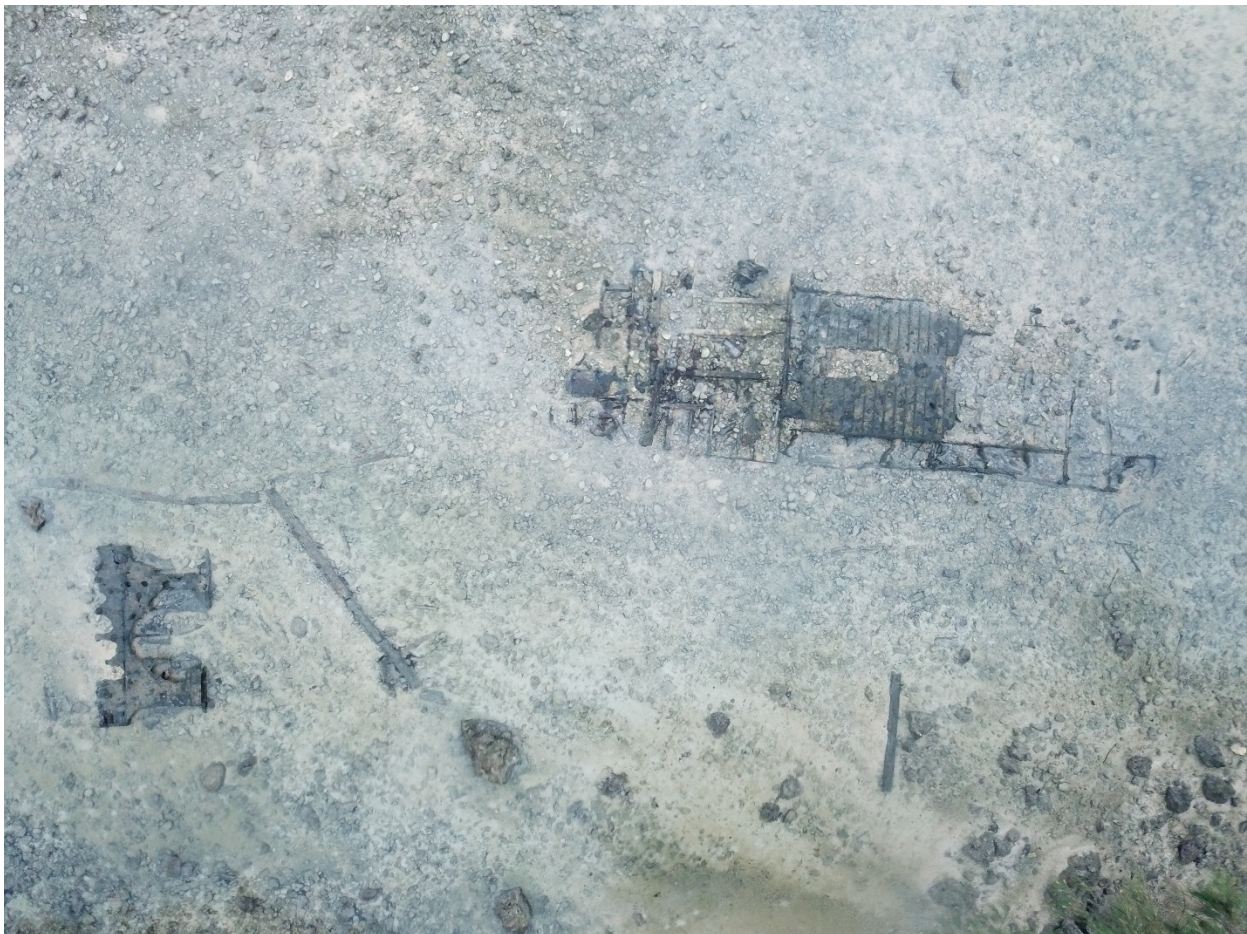
Figure 63. Aerial view of LCM in the shallow lagoon at Orange Beach 3. The nearly 13m by 4 m remains are barely awash at high tide and completely exposed at low tide. Raupp/Ships of Discovery Science Team.

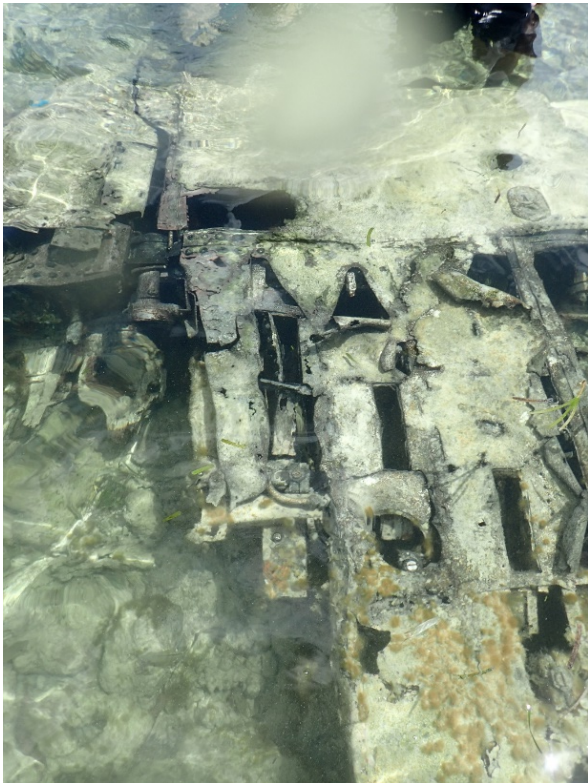
Based on the short length of the strut and configuration, the curvature of the wing and port configurations configuration, as well as the three .50 caliber wing ports, this structure matches a Corsair plane design (Figure 66, Figure 67, Figure 68, and Figure 69).

Figure 67. Inverted wing. Note rectangular and circular ports patterns. McKinnon/Ships of Discovery Science Team.

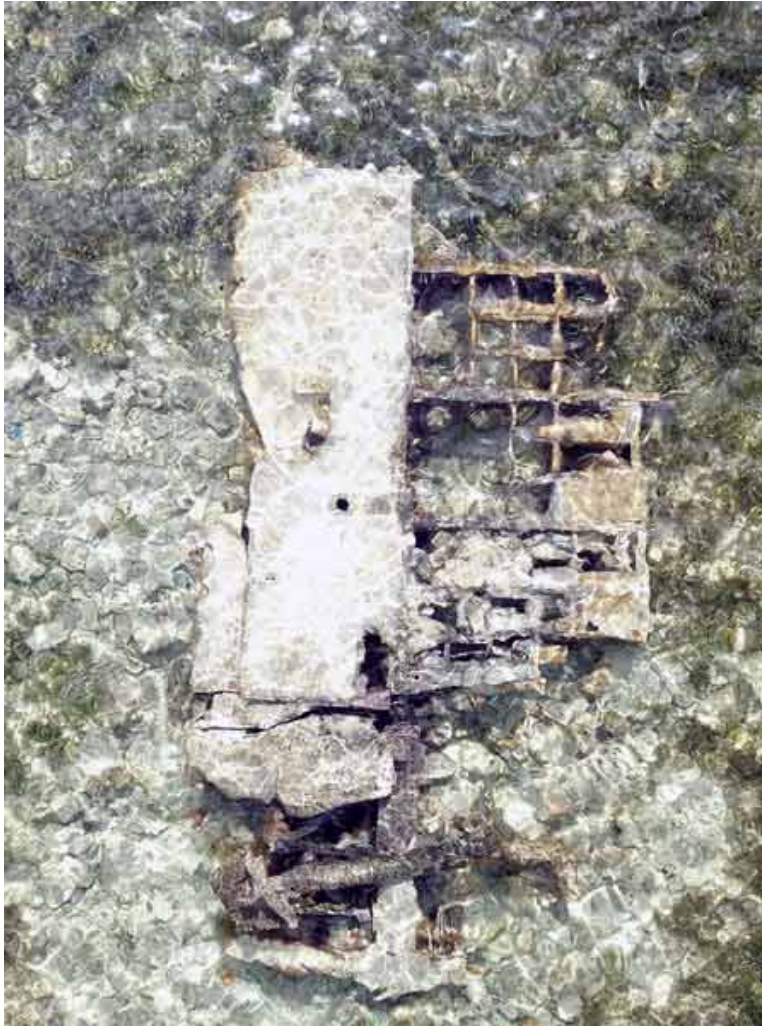
Figure 69. Aerial view of the aircraft wing at low tide in the lagoon. The landing strut is visible at the bottom of the photo. Raupp/Ships of Discovery Science Team.

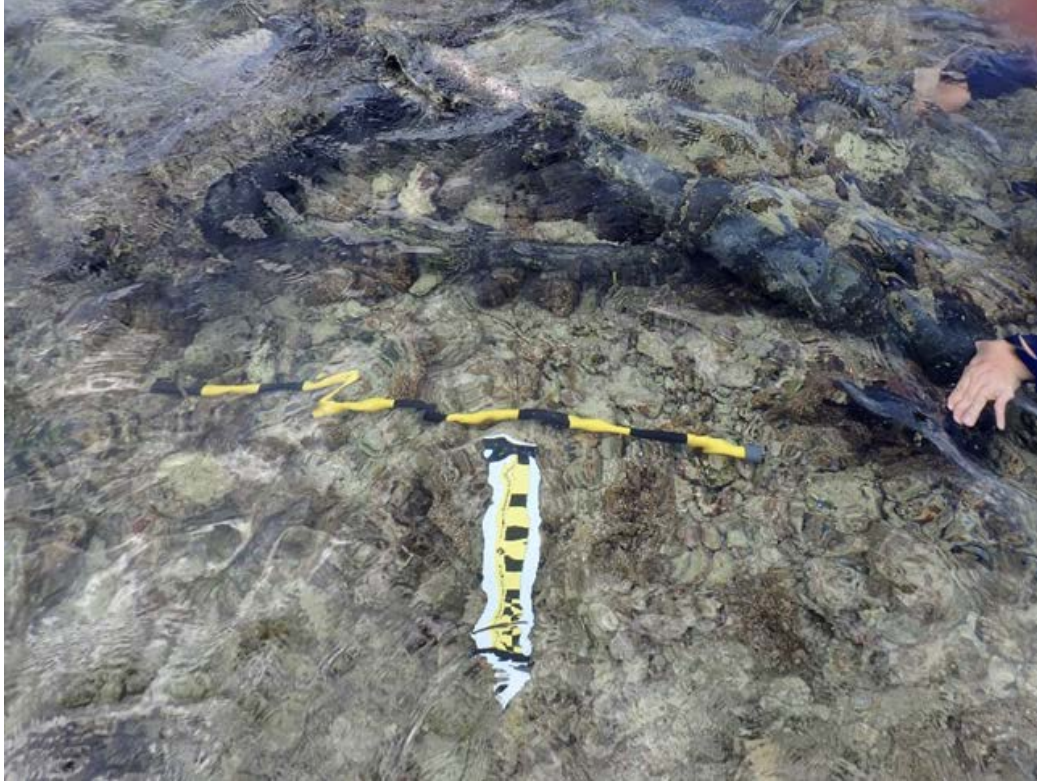
Figure 70. Detached strut located in shallow water. Arnold/Ships of Discovery Science Team.

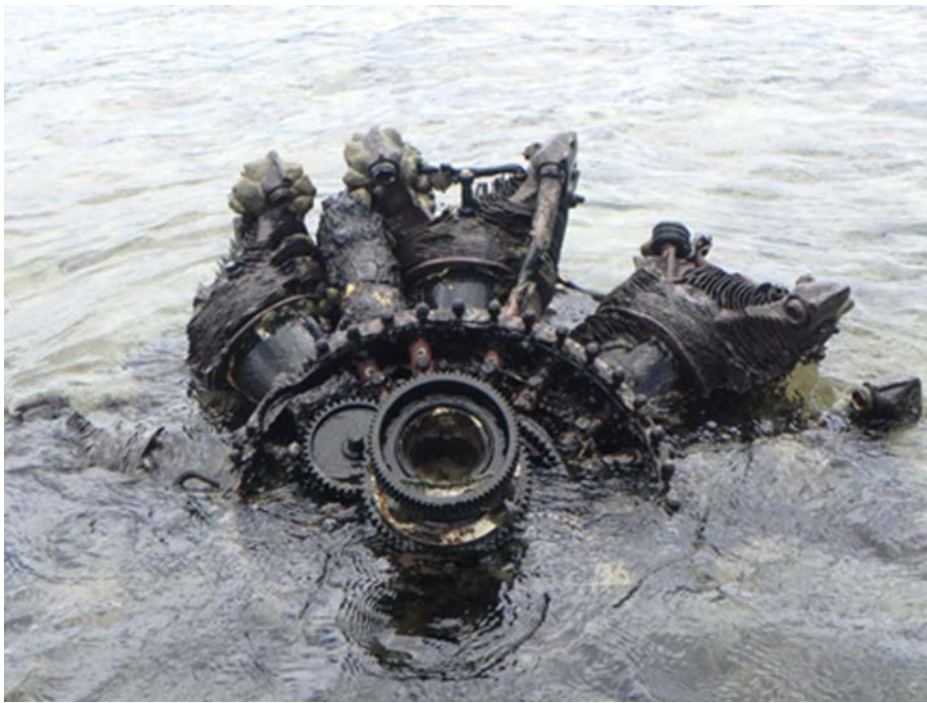
Engine and possible engine parts: Approximately 156 m northwest of the wing is a radial engine (Ships013) (Figure 71) and a possible section of engine cowling. The engine appears to match a Pratt & Whitney Double Wasp twin-row, 18-cylinder radial engine, which was the type used on Corsairs. This piece is considered to be part of the same wreckage (Figure 72). The possible engine cowling is buried and encrusted with marine growth, which makes its identification difficult (Figure 73). It is lying about 10 m from the engine

Figure 71. Radial engine exposed on the reef. Arnold/Ships of Discovery Science Team.

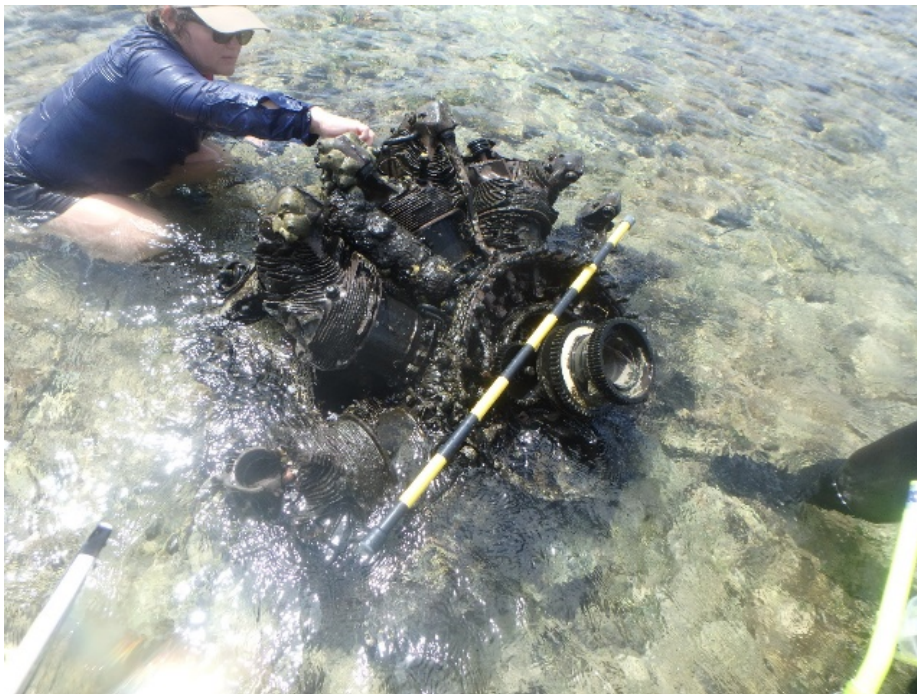
Figure 72. Radial engine. Keusenkothen/Ships of Discovery Science Team.

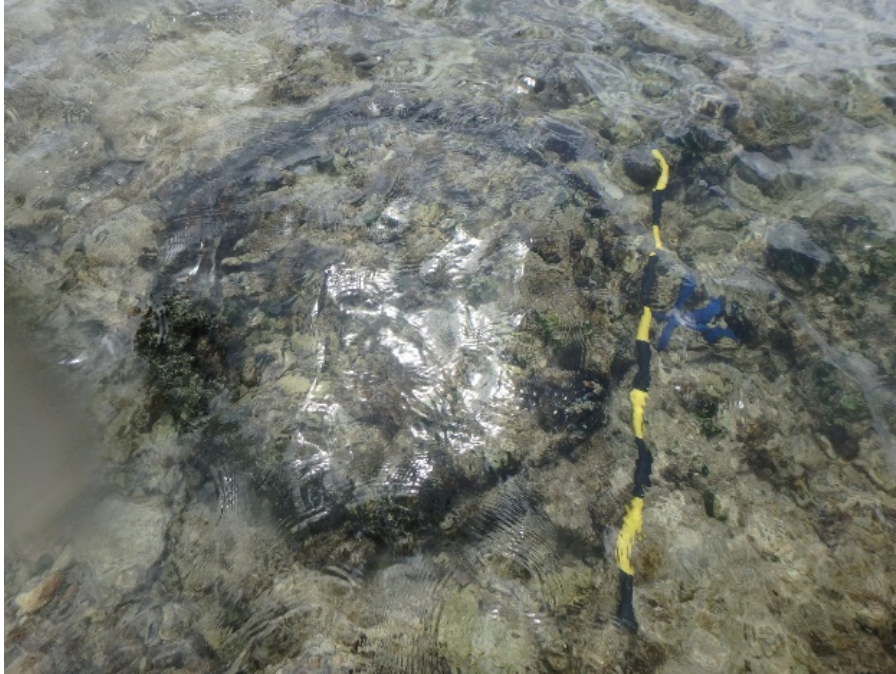
Figure 73. Possible engine cowling. Keusenkothen/Ships of Discovery Science Team.

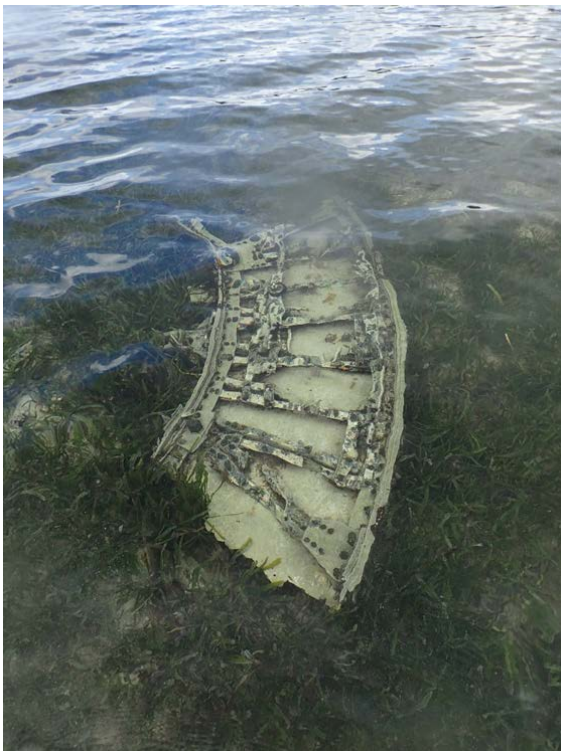
Fuselage: Approximately 45 m northeast of the aircraft wing, lies a section of internal fuselage (Ships012). It appears to be a portion of the main beam assembly center section that supports the inverted gull wing shape (Figure 74, Figure 75, Figure 76, Figure 77).

Figure 74. Curved piece of aluminum fuselage. McKinnon/Ships of Discovery Science Team.

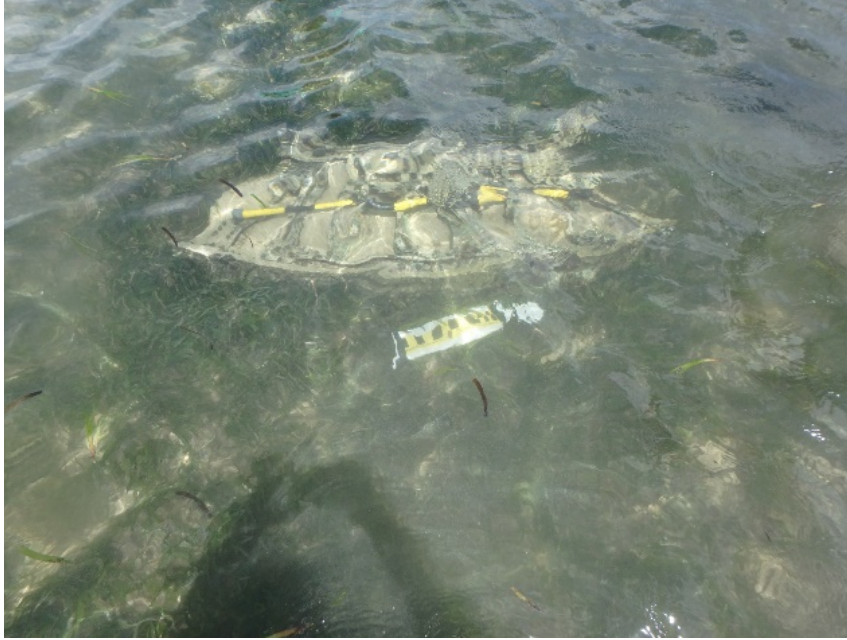
Figure 75. Disarticulated portion of the main beam assembly center section of the inverted gull wing shape. Keusenkothen/Ships of Discovery Science Team.

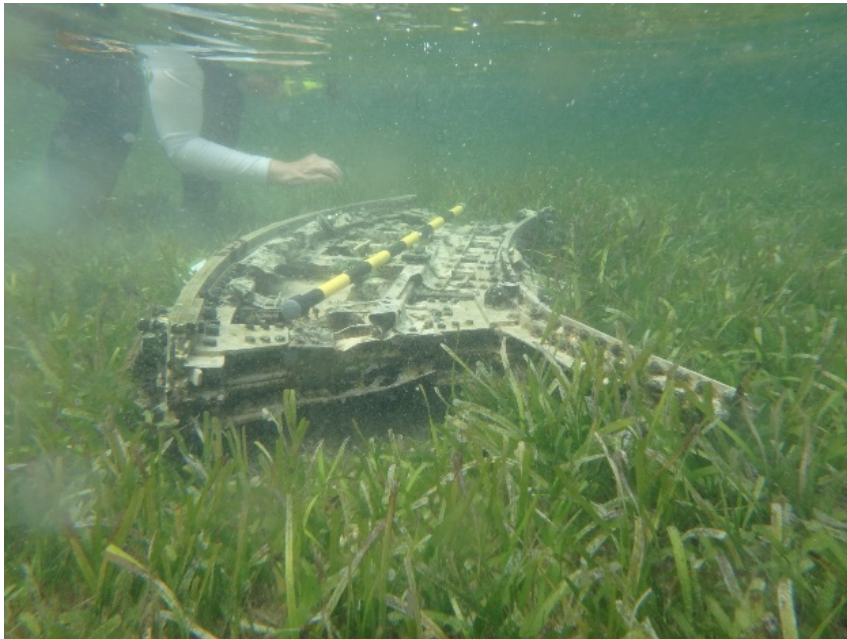
Figure 76. Disarticulated portion of the main beam assembly center section of the inverted gull wing shape. Keusenkothen/Ships of Discovery Science Team.

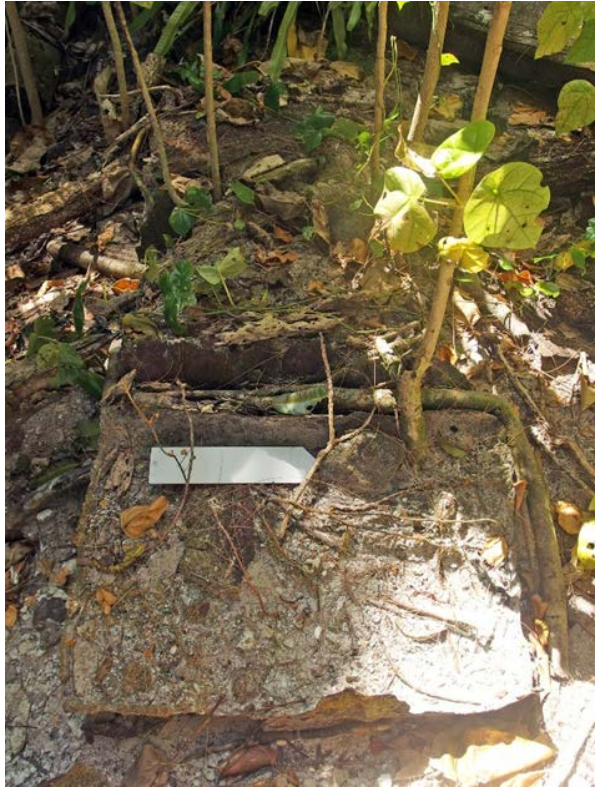
Site Number	Denfeld Site ID	Price/Knecht Site ID	Description
Ships047	N/A	N/A	<p>Fuel Drum Embankment.</p>

<p>Fuel drums were used to create the corner of a built up Japanese defensive position. The rim of a second fuel drum sitting upright is visible at the top edge of the fuel drum in the foreground. Roth/Ships of Discovery Science Team.</p>
Ships061	N/A	N/A	Japanese Fuel Drum Embankment with pipe fixture

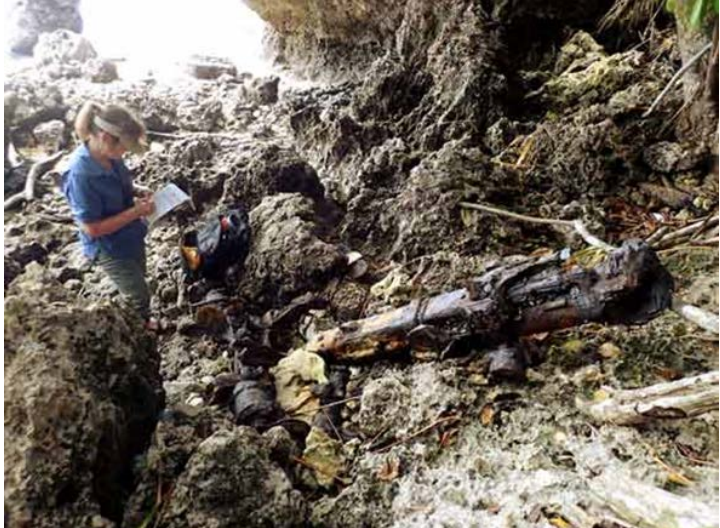
Site Number	Denfeld Site ID	Price/Knecht Site ID	Description
Ships068	N/A	N/A	<p data-bbox="683 275 1403 373">Gun. A recently exposed Japanese gun eroding out of a defensive position (associated with Ships069). Roth/Ships of Discovery Science Team.</p>

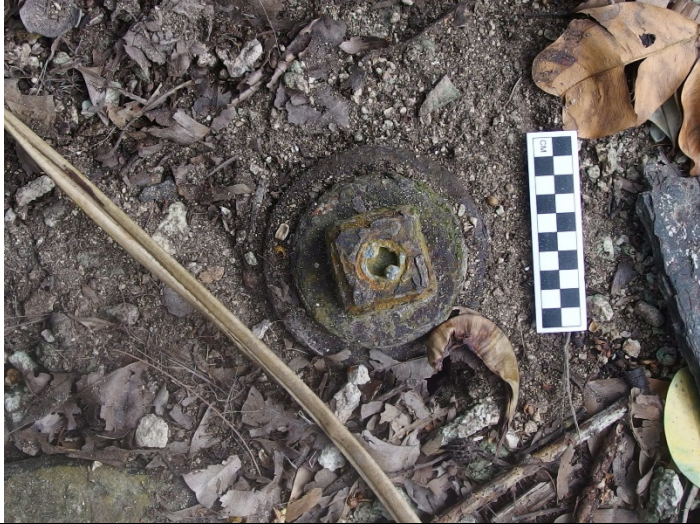
Ships069	N/A	N/A	<p data-bbox="683 938 1321 1003">Fixture on Concrete Mount; associated with Ships068. Roth/Ships of Discovery Science Team</p>

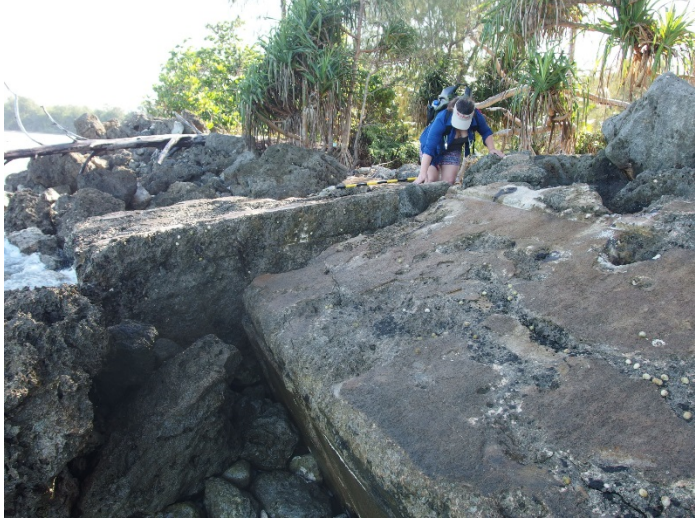
Site Number	Denfeld Site ID	Price/Knecht Site ID	Description
Ships073	N/A	N/A	<p data-bbox="683 275 1325 338">Concrete Box-like structures, collapsed. Roth/Ships of Discovery Science Team.</p>

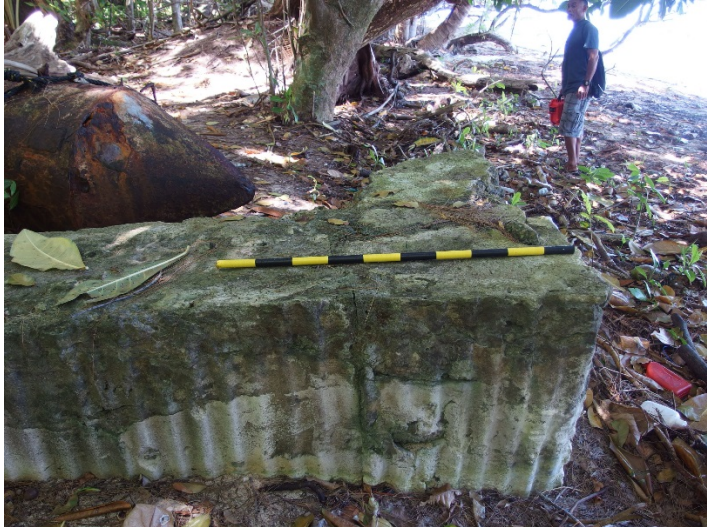
Ships083	N/A	N/A	<p data-bbox="683 858 1373 921">Low Defensive Position constructed of rebar and concrete. Roth/Ships of Discovery Science Team.</p>

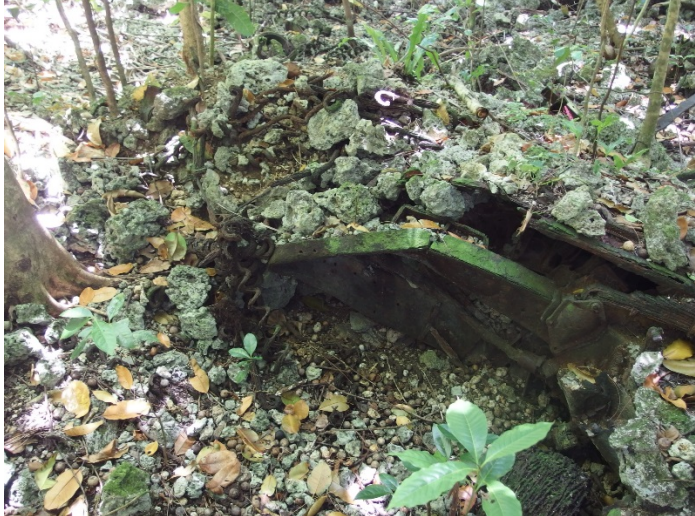
Site Number	Denfeld Site ID	Price/Knecht Site ID	Description
Ships085	N/A	N/A	<p>Japanese Defensive Trenches associated with a dumpsite. Roth/Ships of Discovery Science Team.</p>

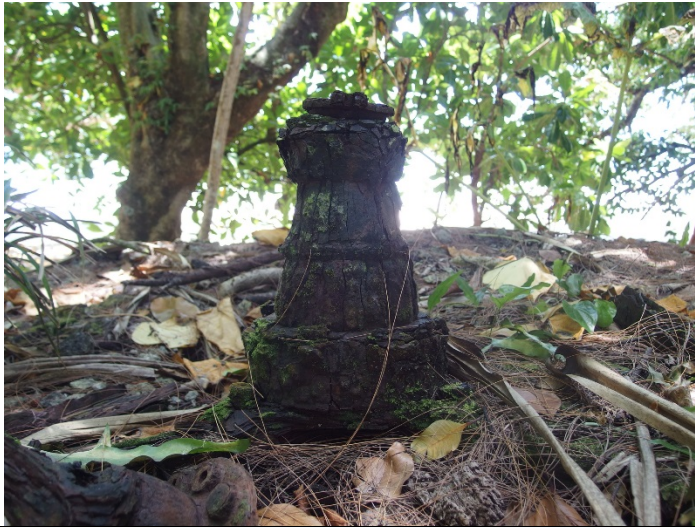
Ships086	N/A	N/A	<p>Defensive Position With Gun Mount. Roth/Ships of Discovery Science Team.</p>

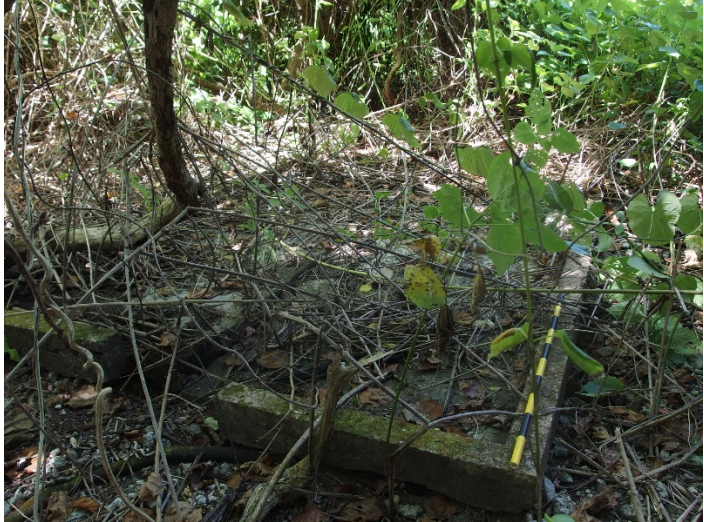
Site Number	Denfeld Site ID	Price/Knecht Site ID	Description
Ships092	N/A	N/A	<p data-bbox="683 268 1349 331">Concrete Building Foundation. Roth/Ships of Discovery Science Team.</p>

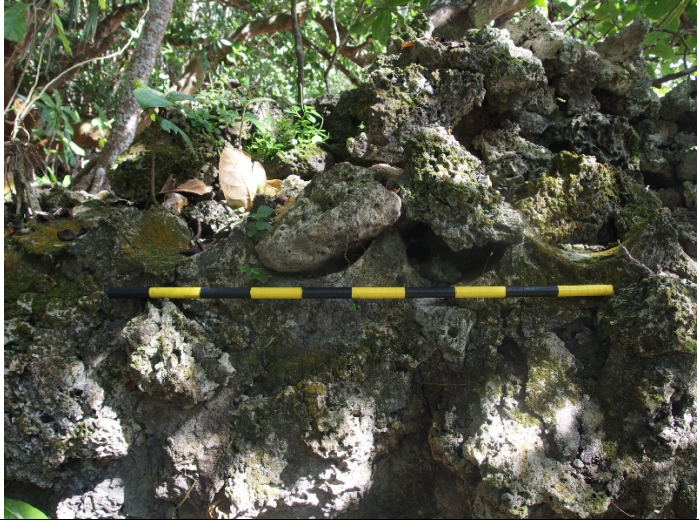
Ships095	N/A	N/A	<p data-bbox="683 856 1338 919">Japanese Defensive Position (collapsed) built into rock. Roth/Ships of Discovery Science Team.</p>

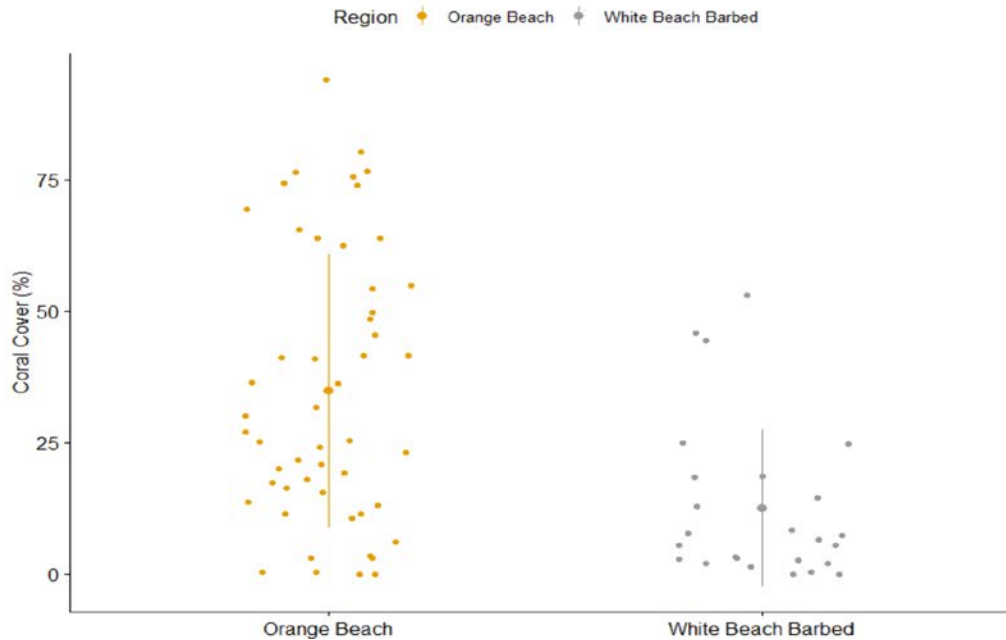
Figure 82. Coral cover percent among regions. Scatter plot points represent the averages for each plot surveyed at each region. Along with the average with standard deviation for each region. Pascoe and Burns/UHH/Ships of Discovery Science Team.

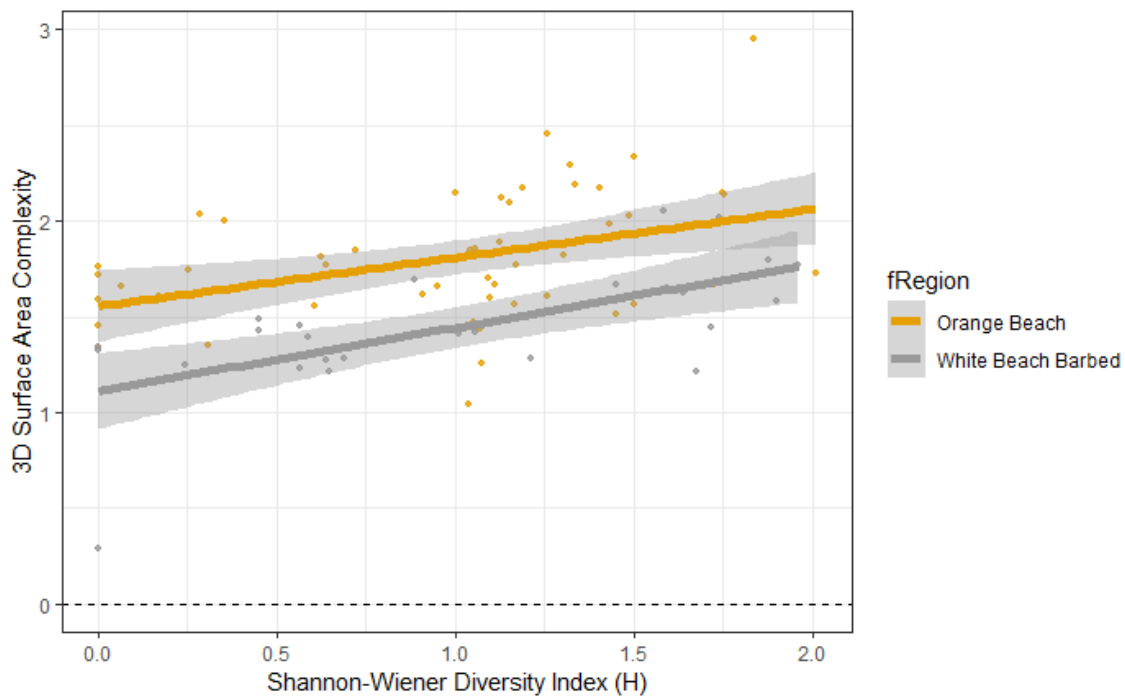
Figure 86. Diversity of coral showed a positive relationship with 3D surface area complexity. Between regions White and Orange there was also a significant difference in 3D surface area complexity. Pascoe and Burns/UHH/Ships of Discovery Science Team.

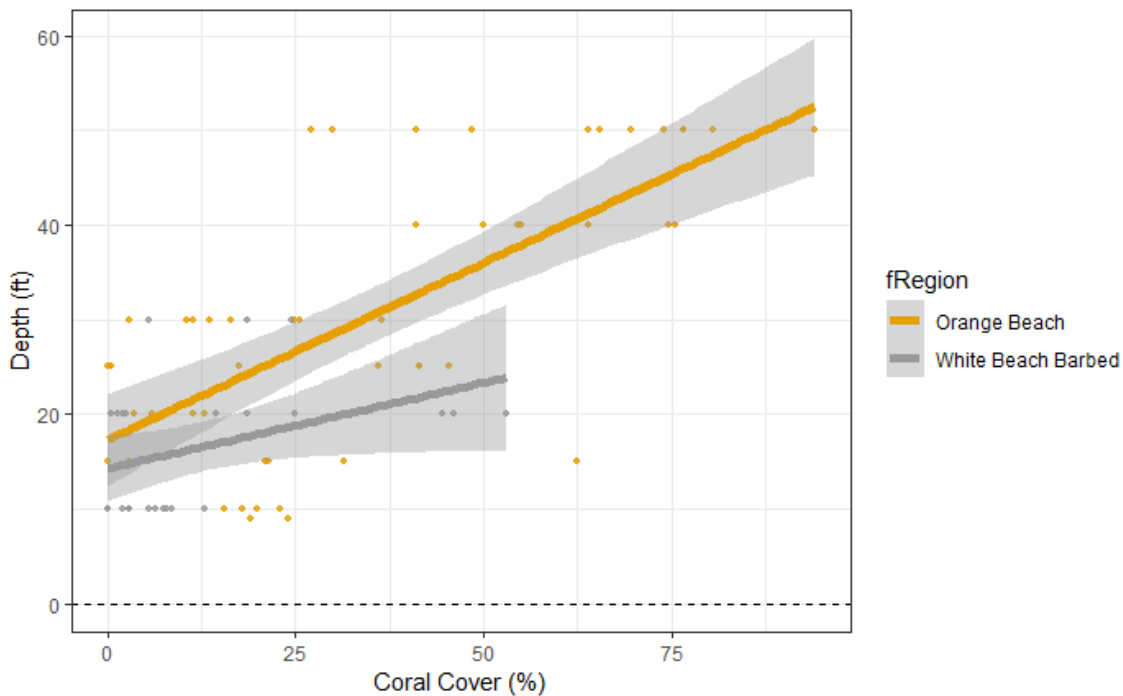
Figure 87. Coral cover showed a positive relationship with depth. As depth increased coral cover also increased. Pascoe and Burns/UHH/Ships of Discovery Science Team.

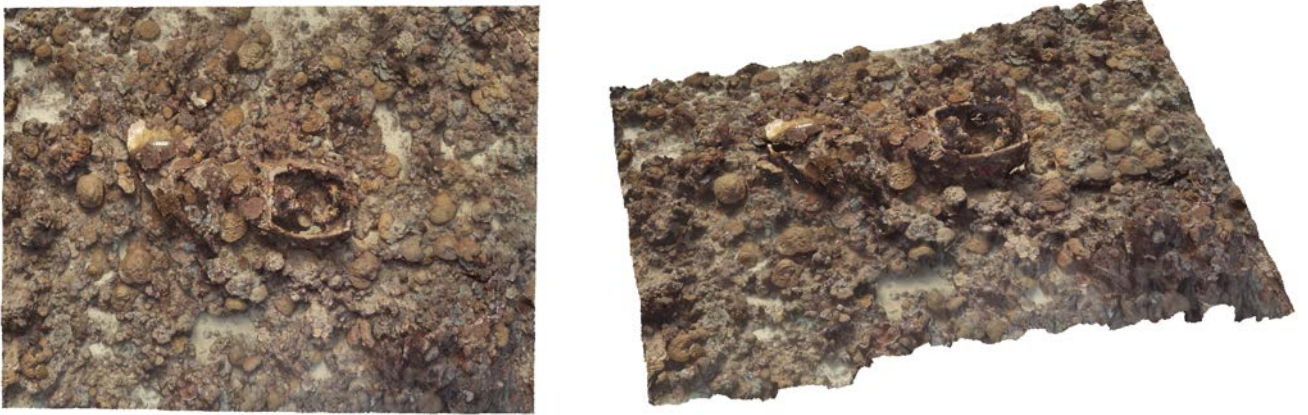
Figure 89. Sfm model of one of the LVT wrecks located in the LVT dumpsite at Peleliu, Island. Pascoe and Burns/UHH/Ships of Discovery Science Team.

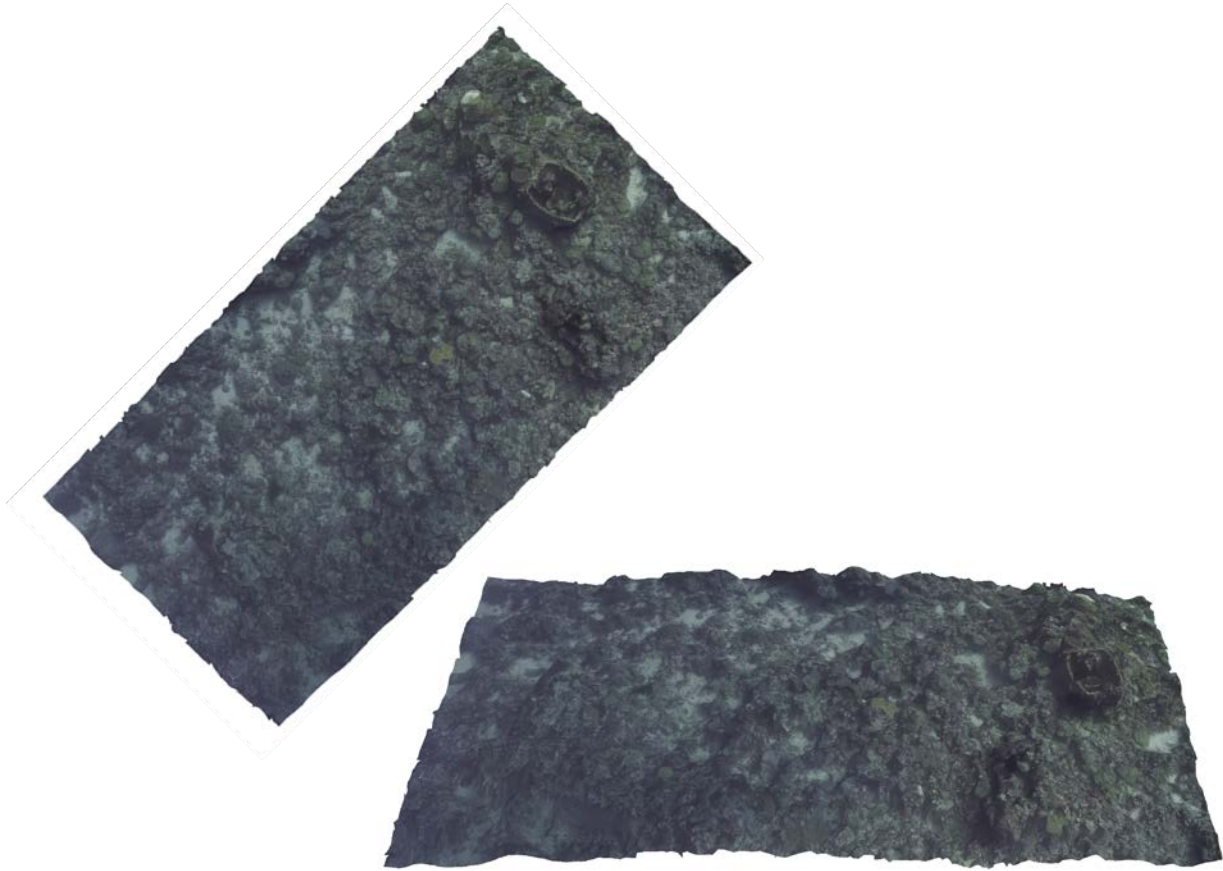
Figure 90. Large SfM model of an LVT Dump Site located off Orange Beach, Peleliu. Potentially there are three LVT located within this model. Pascoe and Burns/UHH/Ships of Discovery Science Team.

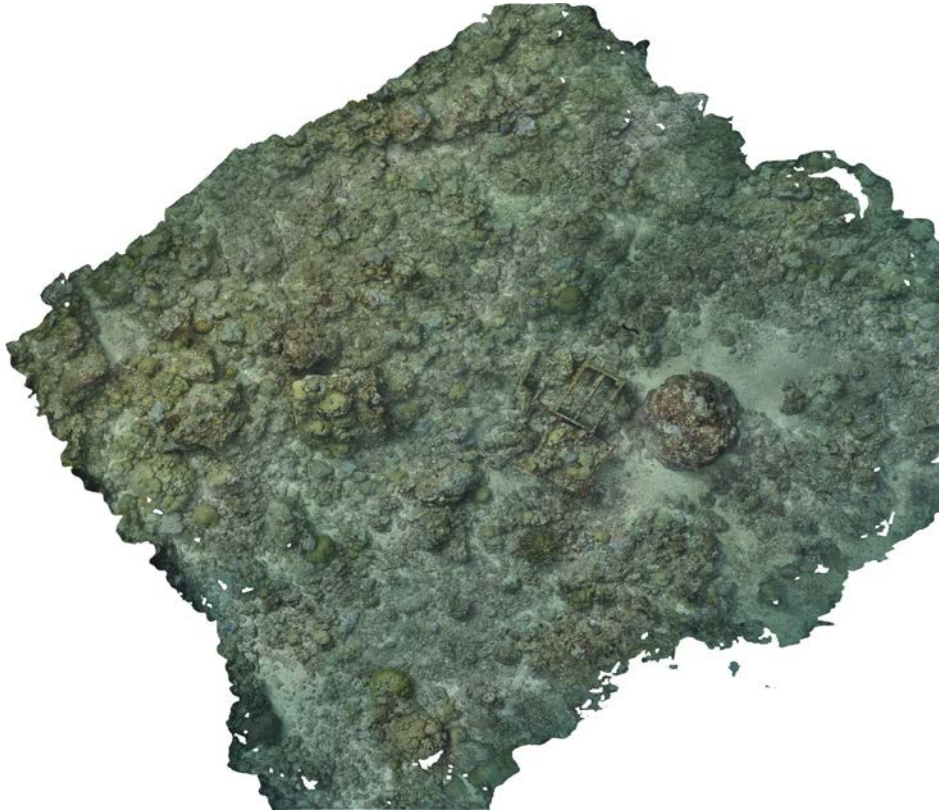
Figure 92. SfM model of remains a pontoon barges. Pascoe and Burns/UHH/Ships of Discovery Science Team.

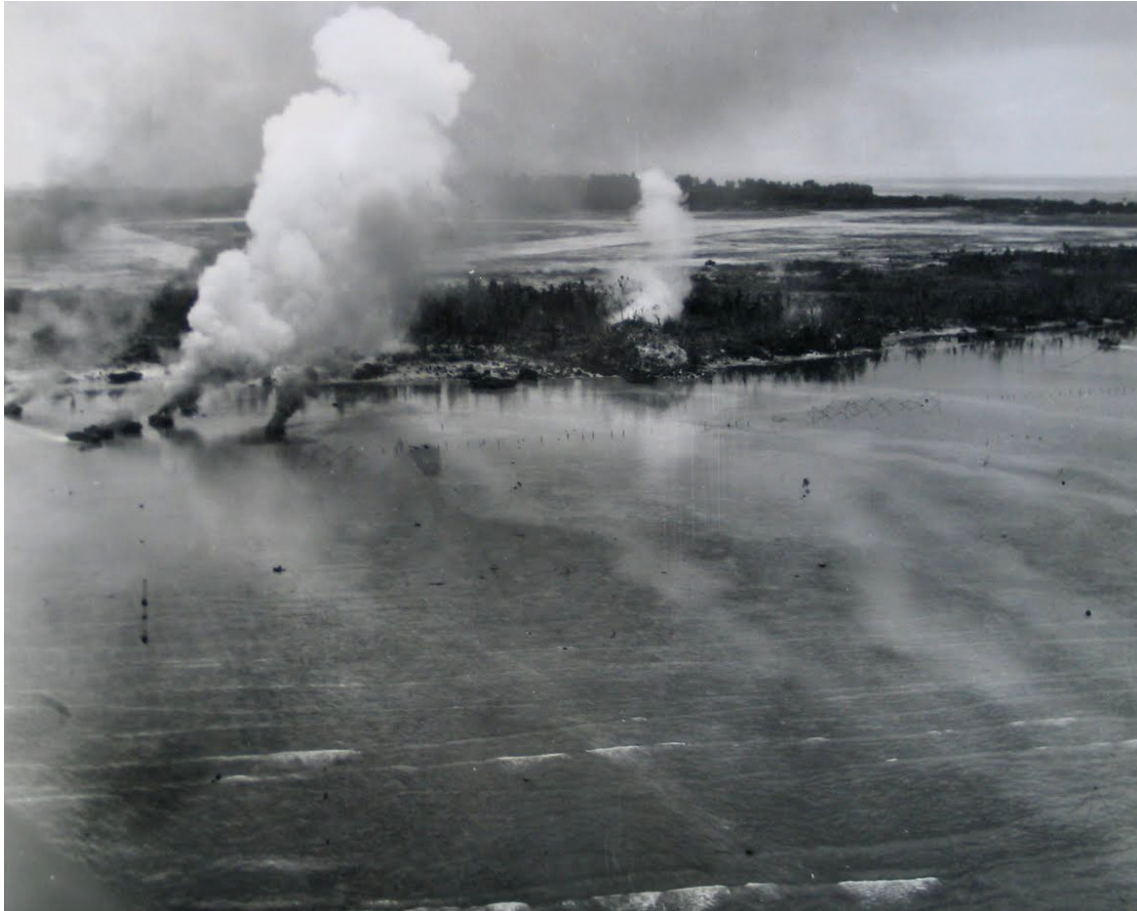
Of the 50 DUKWs in Bronemann's transportation division, half were knocked out from mortar and artillery fire (Figure 97) (Bronemann 1982:47). While the abandoned vessels became chokepoints for transport across the reef, men and provisions eventually made it onto the White beachfront.

Figure 97. Burning amphibious vehicles off White beaches 1 and 2 on September 15, 1944. The White/Orange coral promontory is visible with smoke rising behind in center of image. Note range markers and posts off the beach. Bureau of Aeronautics Materials, 46697.

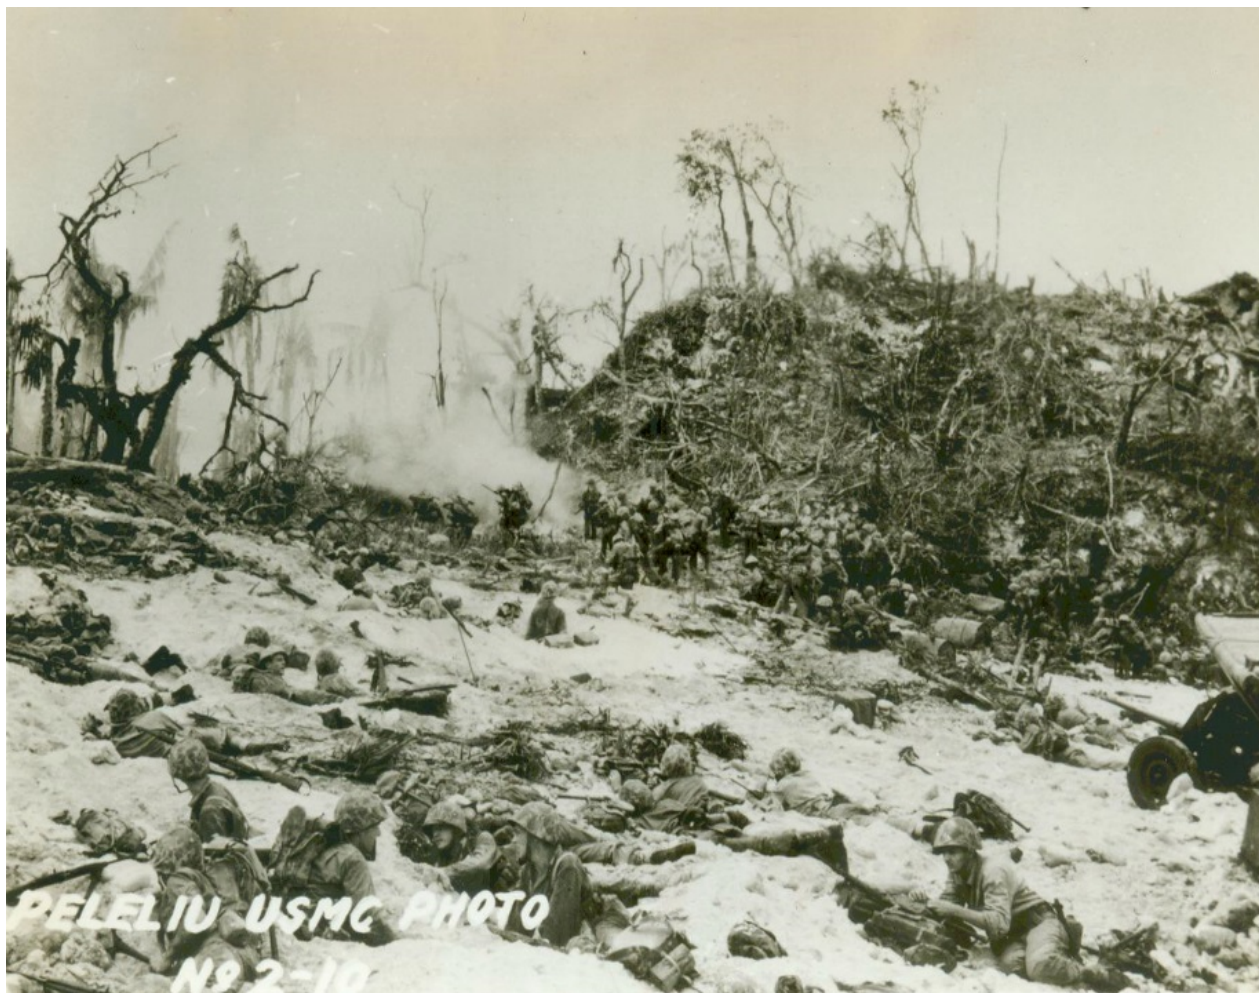
Figure 98. The White/Orange promontory, seen on the right, caused little delay in troop movement on White 2. By the time Davis reached the area, the majority of men were already nearing the airfield. Frederick R. Findtner Collection, USMC Archives, 2-10.

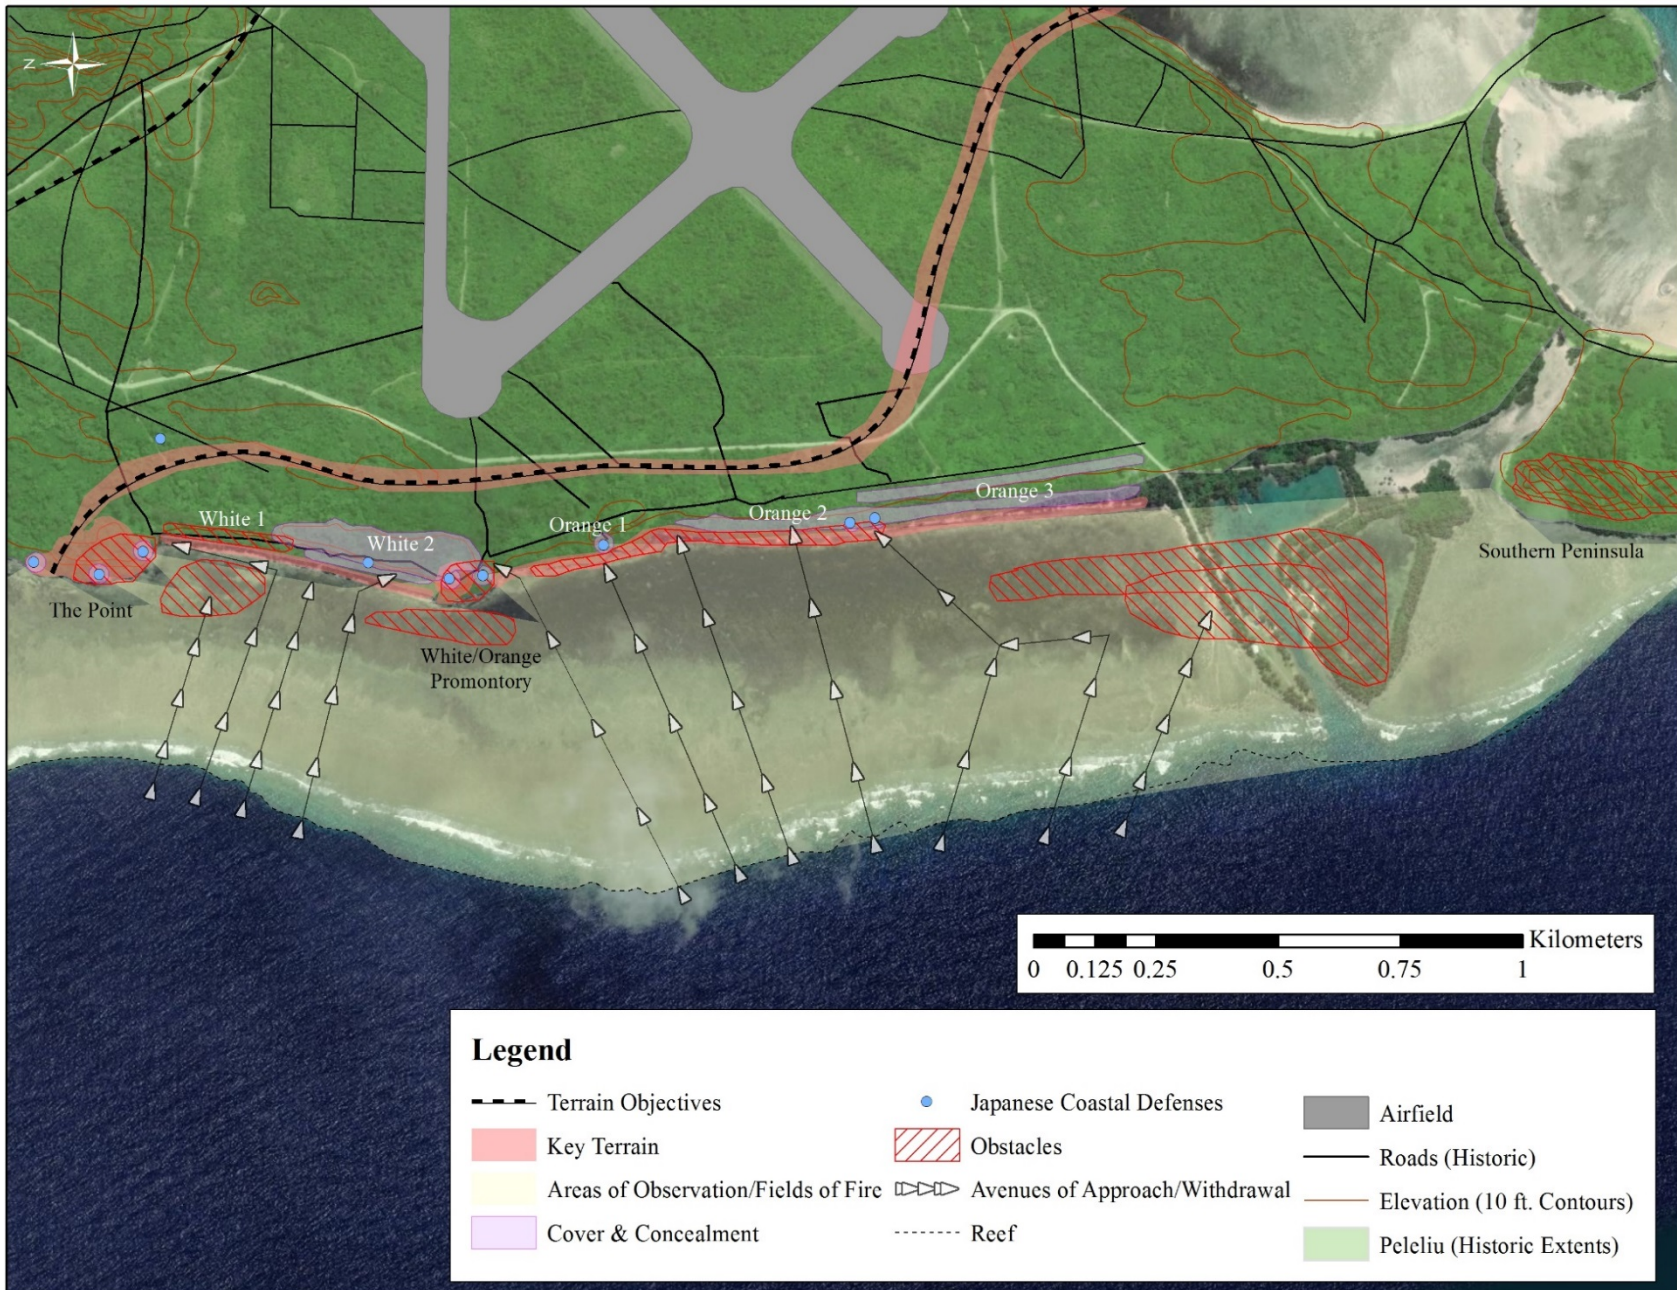
Figure 101. KOCOA terrain features on the Peleliu Landing Beaches. Map by Roth/Ships of Discovery Science Team.
